OUTBUILDING TO REAR OF 36 BRIDLINGTON STREET,
HUNMANBY, NORTH YORKSHIRE YO14 0JR

HISTORIC BUILDING RECORDING

Report no: 2020/612.R01
Version: Final
Date: February 2020
Author: Shaun Richardson & Ed Dennison

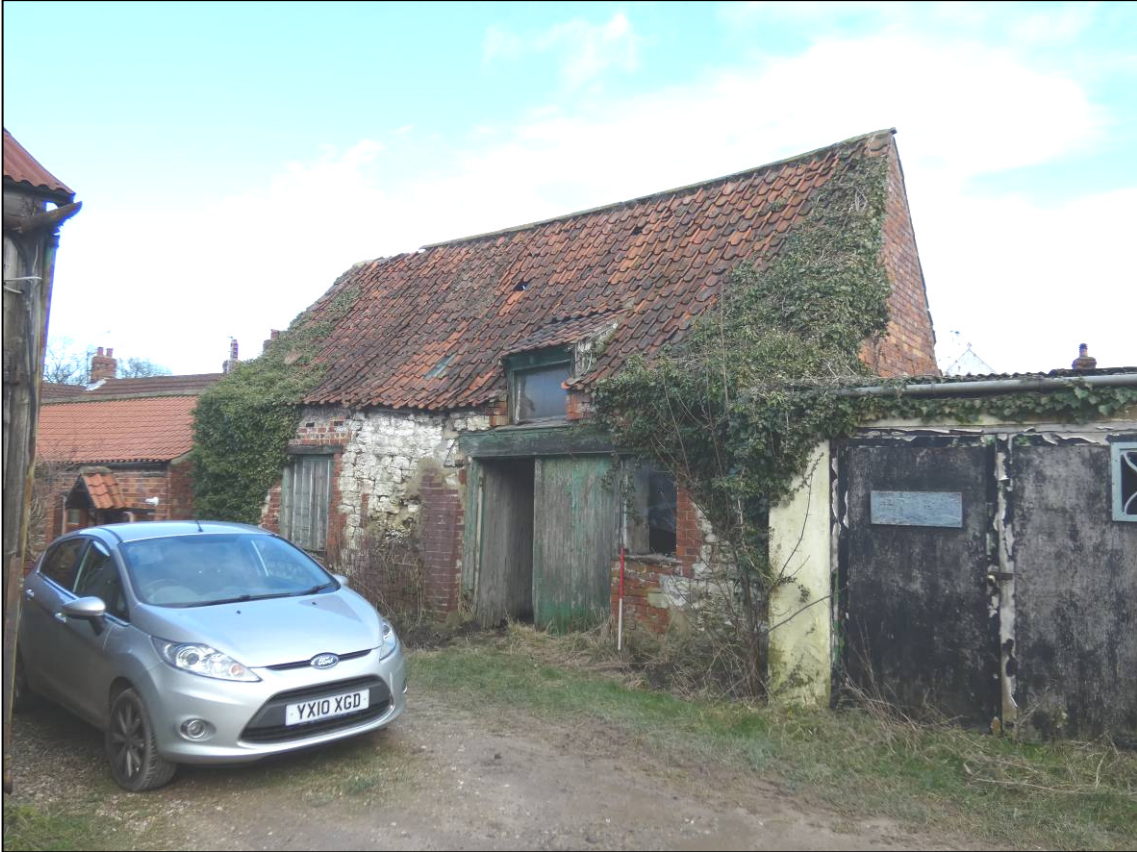
- 3.5 The recorded building is of a tall single storey, with a relatively steeply pitched, pantiled roof [1/872, 1/890, 1/893] (see plates 1 and 2). At ground level, the building has maximum external dimensions of 10.30m long (north-south) by 5.80m wide (east-west). It is sub-rectangular in plan, indeed slightly parallelogram in shape, with the gables set parallel to one another but at a slight angle to the long walls. There is a small, single storey brick outshut to the east wall, with a modern

Plate 1: Recorded building, looking N (photo 1/893).

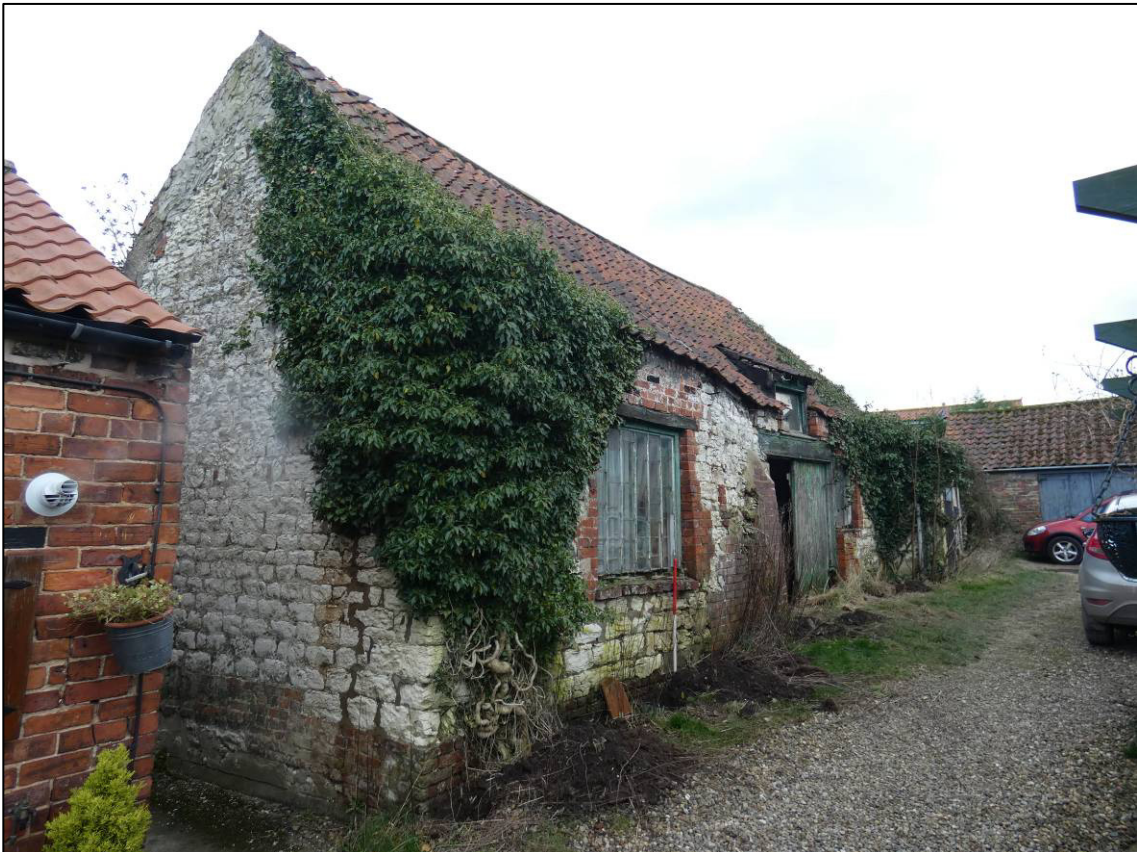
- 3.6 The west elevation of the building faces into the yard, and is partly obscured by ivy growth at either end [1/888, 1/889, 1/905, 1/906]. The main feature of the elevation is a wide cart or vehicle entrance with a substantial timber lintel, positioned to the south of centre; the entrance is probably a later insertion or enlargement of an original opening, but this is not certain [1/895, 1/896] (see plate 3). It is fitted with a late 19th or early 20th century two-leaf door of board and batten construction, hung on wide strap hinges [1/901, 1/902]. The door opens inwards, and to the internal south jamb, there is an upright timber with rounded corners that may relate to an earlier opening or door arrangement [1/915]. The area of walling above the entrance has been partly re-built in brick, whilst above this there is an inserted dormer, fitted with a wooden-framed single-light glazed window which pivots vertically about the centre [1/897]. The west jamb forming the north side of the entrance has been rebuilt using brownish-red machine-made engineering bricks (average dimensions 210mm by 100mm by 70mm); some of the bricks are stamped with the numbers '12' in very small numerals.

Plate 2: Recorded building, looking SE (photo 1/905).

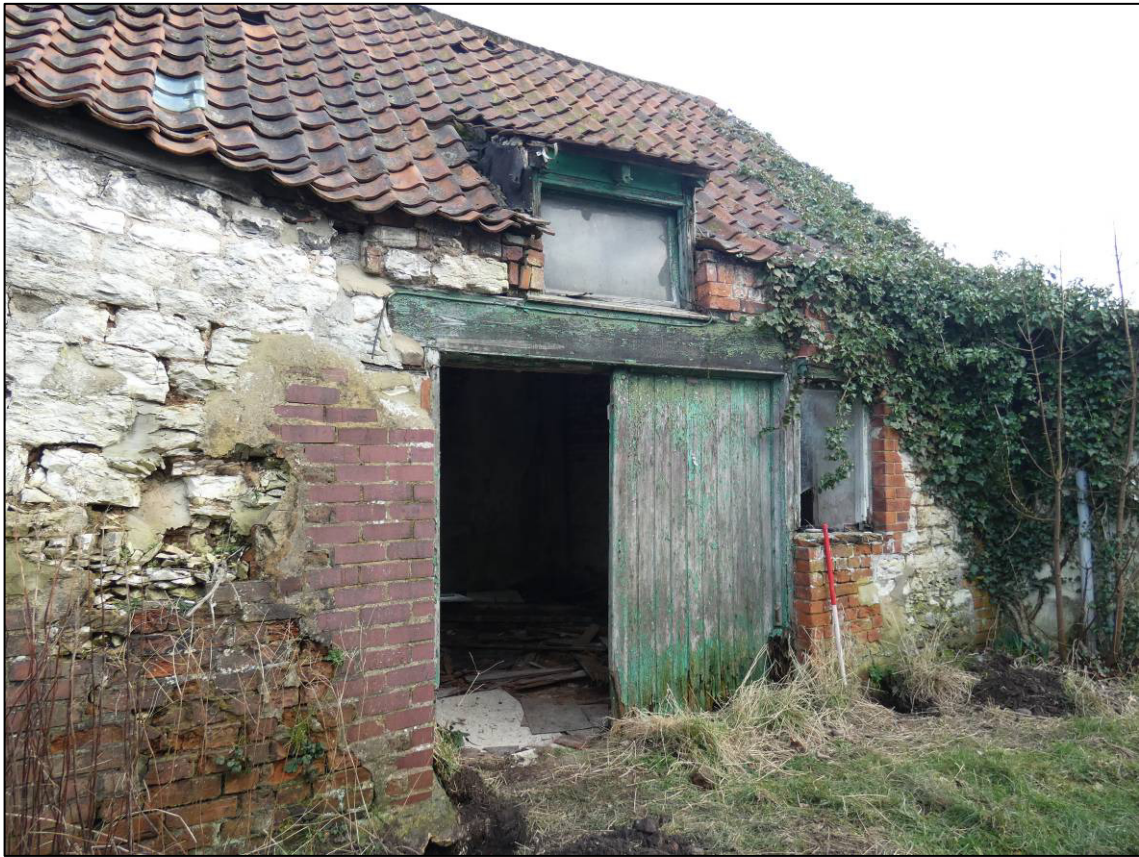
Plate 3: West elevation, central part showing entrance, looking E (photo 1/895).

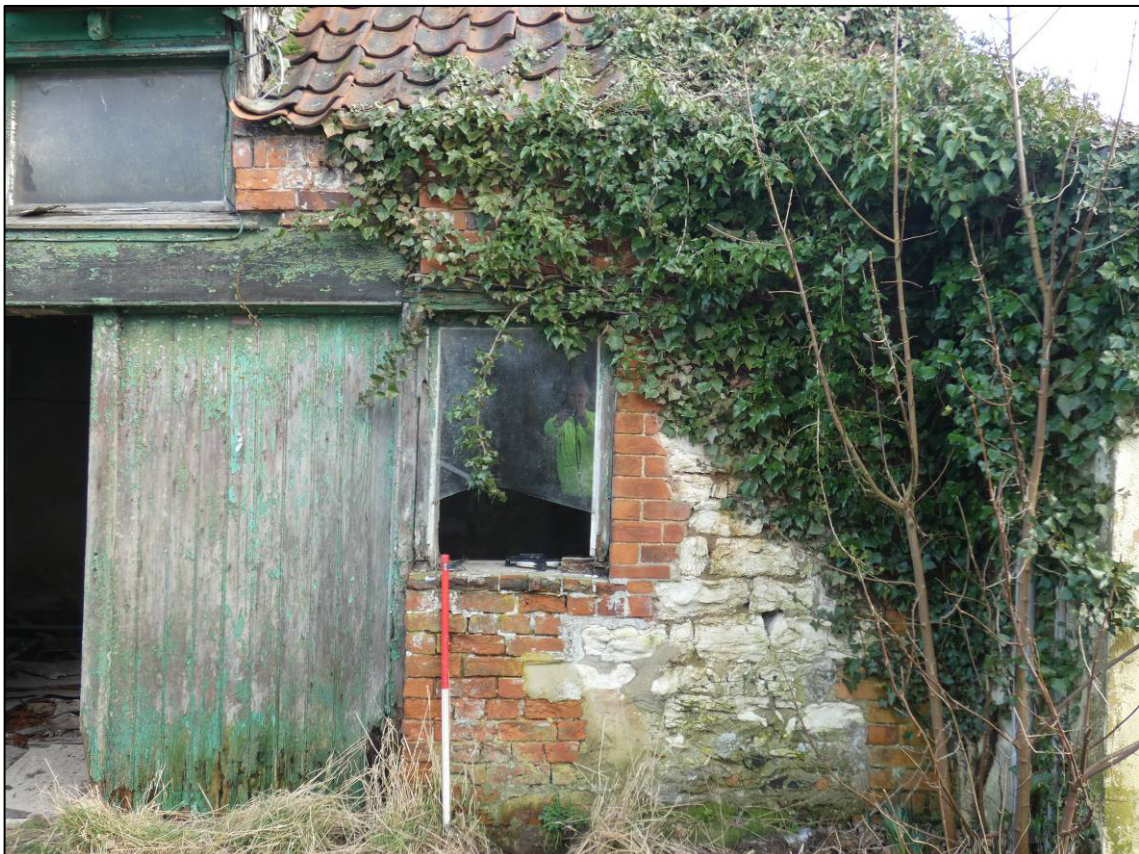
- 3.7 Immediately to the south of the entrance, there is an inserted window opening, with a wooden lintel and slightly projecting brick sill; it is fitted with a fixed, single-light, wooden-framed window, and a slightly projecting brick sill [1/894] (see plate 4). The bricks around the window opening are red, handmade (average dimensions 230mm by 120mm by 75mm), and set with a lime mortar. To the north of the entrance, there is what appears to be a former slit ventilator, blocked with brick [1/900], with an area of brick repair or rebuilding below (see plate 5).

Plate 4: West elevation, southern part, looking NE (photo 1/894).

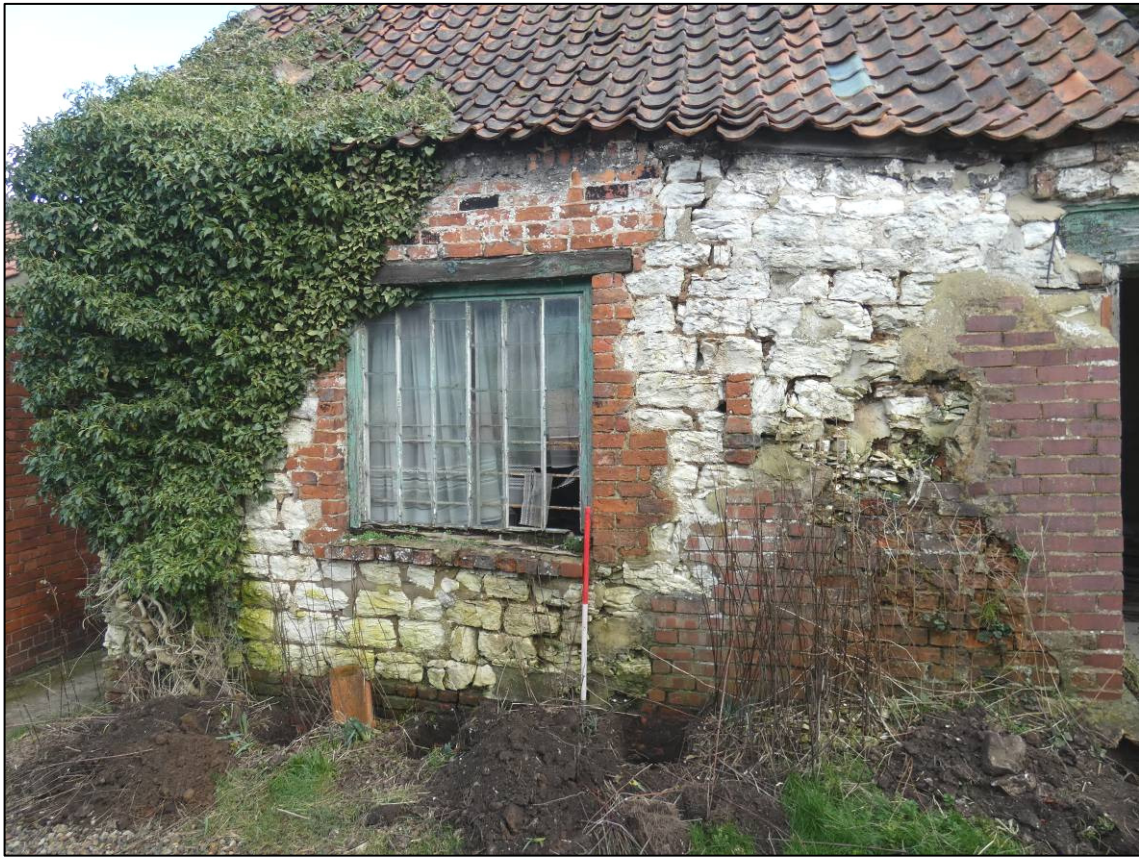
- 3.8 Towards the north end of the elevation, there is a second inserted window opening, larger than the first, again with a wooden lintel and a projecting brick sill; the area above the window has been rebuilt in brick [1/898, 1/903, 1/904] (see plate 5). It is barred internally and fitted with a wooden-framed window, divided into six vertical strips by thin glazing bars [1/899]. Each strip is glazed using small, over-lapping plates of glass, a technique used to the windows of some of the other buildings standing around the sides of the yard. The bricks around the window opening are the same as those used around the window to the south of the entrance. It is interesting to note that many of these have horizontal cuts or grooves to the surface of the long faces, and very similar bricks are used throughout the south gable of the domestic dwelling to the north of the building.

Plate 5: West elevation, northern part, looking NE (photo 1/898).

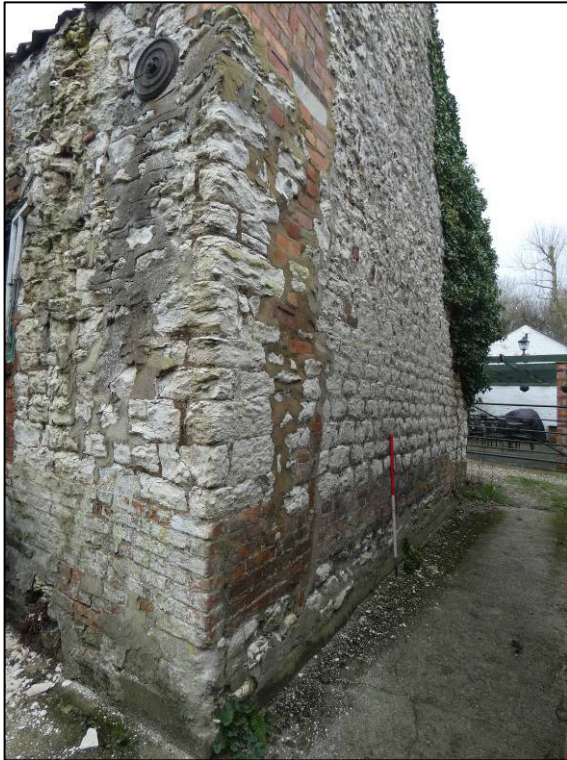
- 3.9 The north gable of the building is largely blank. The aforementioned chalkstone footings and brick band with coursed and squared chalkstone above are all clearly visible [1/884-1/887] (see plates 6 and 7). There appears to be a line of blocked joist holes at first floor level, which must relate to the northern structure of the yard's east range, shown joined to the building in 1857 and 1891 (see figure 3). There is little visible evidence for the removal of this structure, although there has been considerable re-building to the north-east corner of the gable, where the long, very narrow structure is shown joined to it in 1891.

Photo 6: North gable, looking SW (photo 1/884).

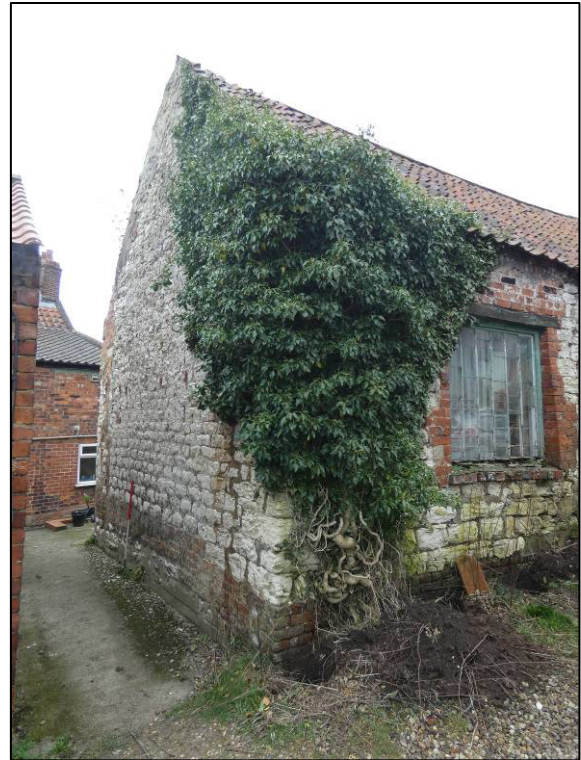
Plate 7: North gable, looking E (photo 1/887).

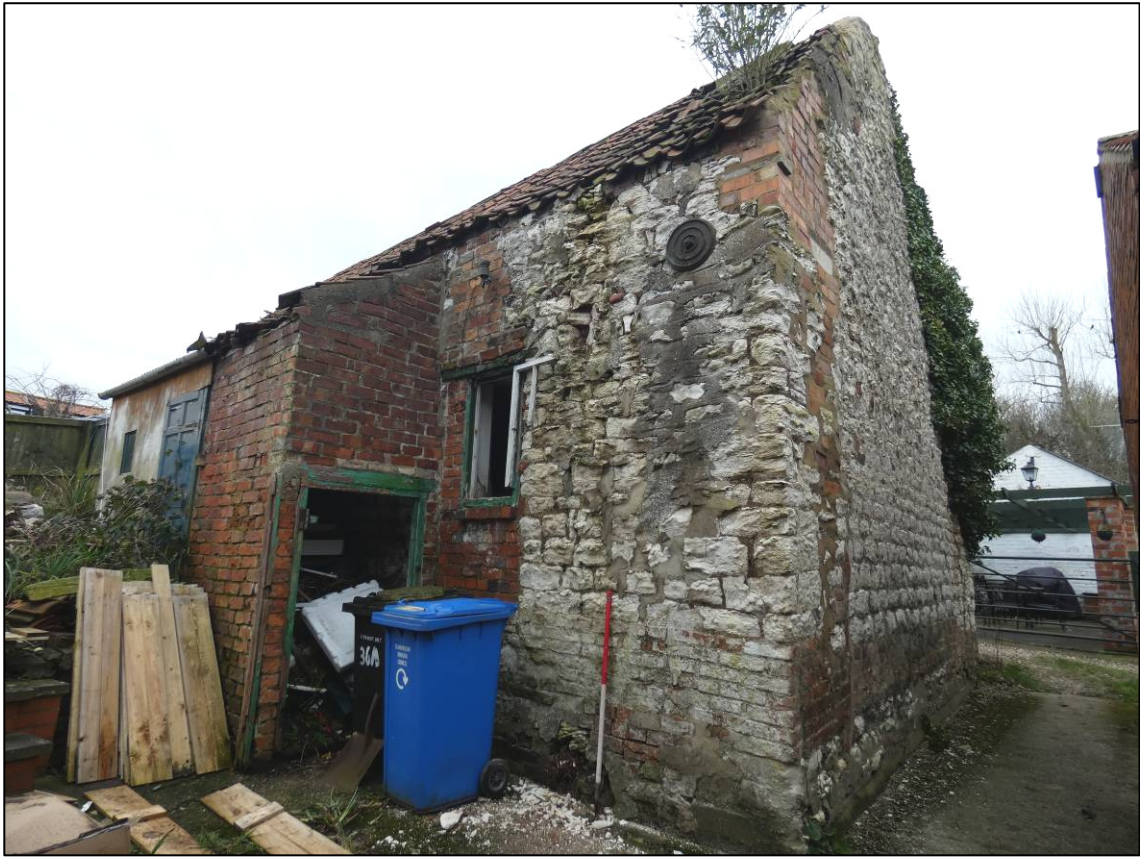
- 3.10 The chalkstone footings, brick band and coursed/squared chalkstone continue around to the north end of the east elevation [1/876, 1/877, 1/881, 1/882] (see plate 8). This too has been subject to disturbance and repair, and a long wall anchor with a circular cast-iron plate has been inserted towards the top of the north-east corner [1/883]. Moving south, there is a former doorway, blocked with the same brickwork as used around the inserted windows in the west elevation. The base of the doorway is set c.0.80m above the external ground level here, so either the ground was once higher or there were steps that have since been removed. The blocking of the doorway was used to create a window opening, with a slightly projecting brick sill; the wooden window frame appears to make use of an earlier lintel from the doorway. Above the window, the elevation has been repaired using machine-made bricks similar to those in the south gable (see below).

Plate 8: East elevation, north part, looking S (photo 1/881).

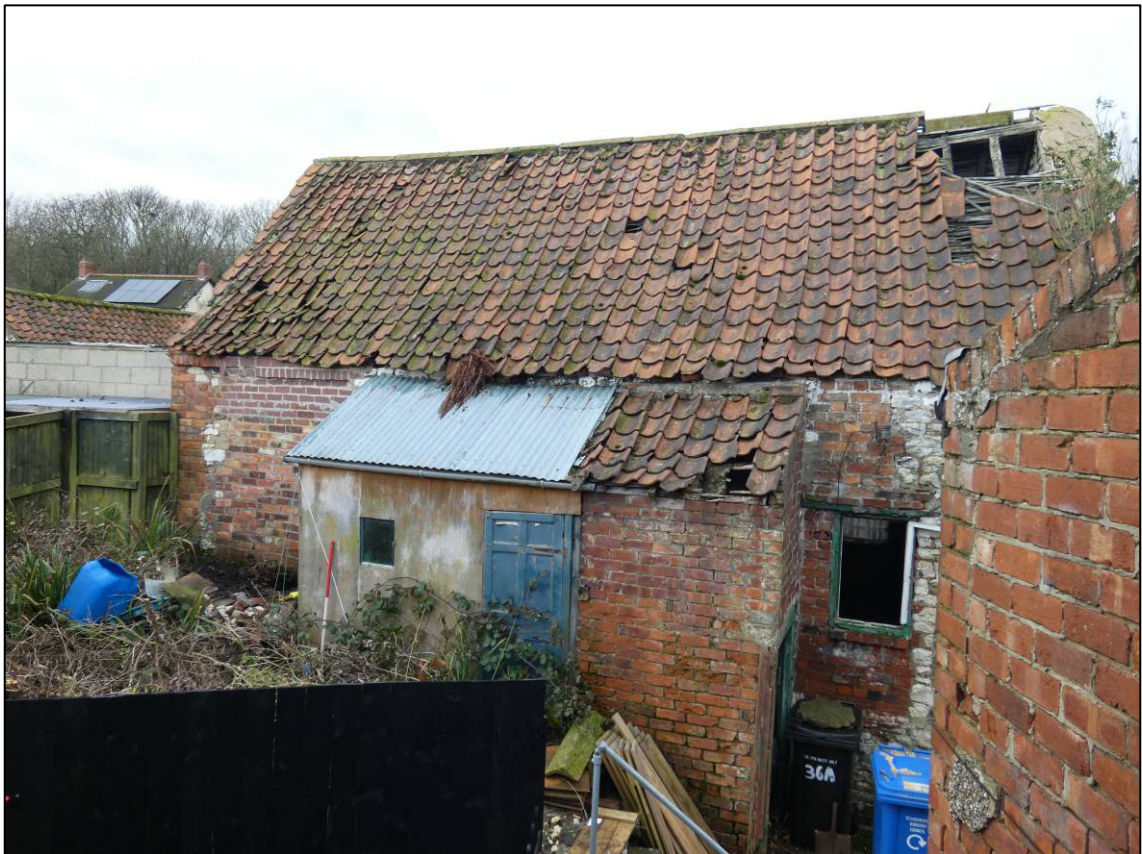
Plate 9: East elevation looking S (photo 1/872).

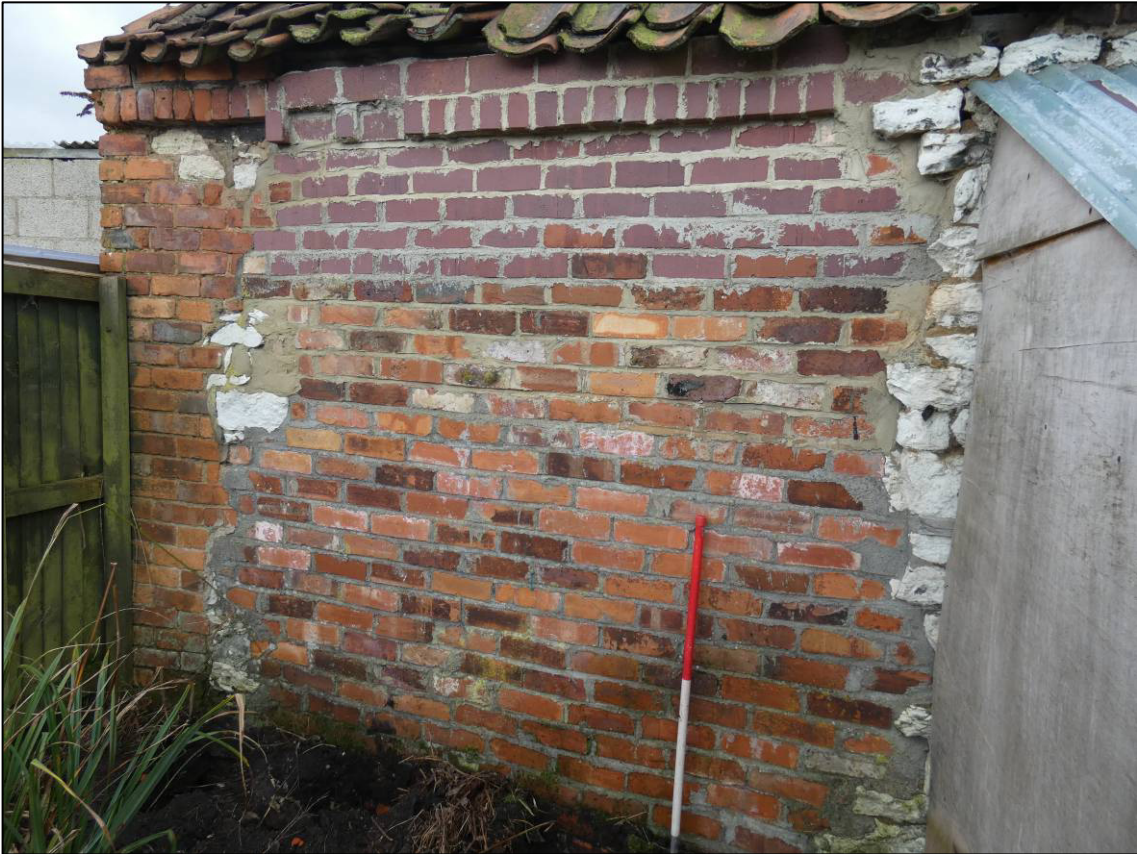
- 3.12 Beyond the modern extension, the raised ground level here again obscures much of the elevation. The upper part that remains visible has been rebuilt/repared using similar brickwork to the south gable (see below) together with some of the engineering bricks stamped with a small '12' as seen in the west elevation [1/878] (see plate 10); it is unclear whether this area of repair relates to a former opening, but it would seem unlikely given the difference in height with the internal floor level.

Plate 10: East elevation, south part, showing area of rebuild, looking SW (photo 1/878).

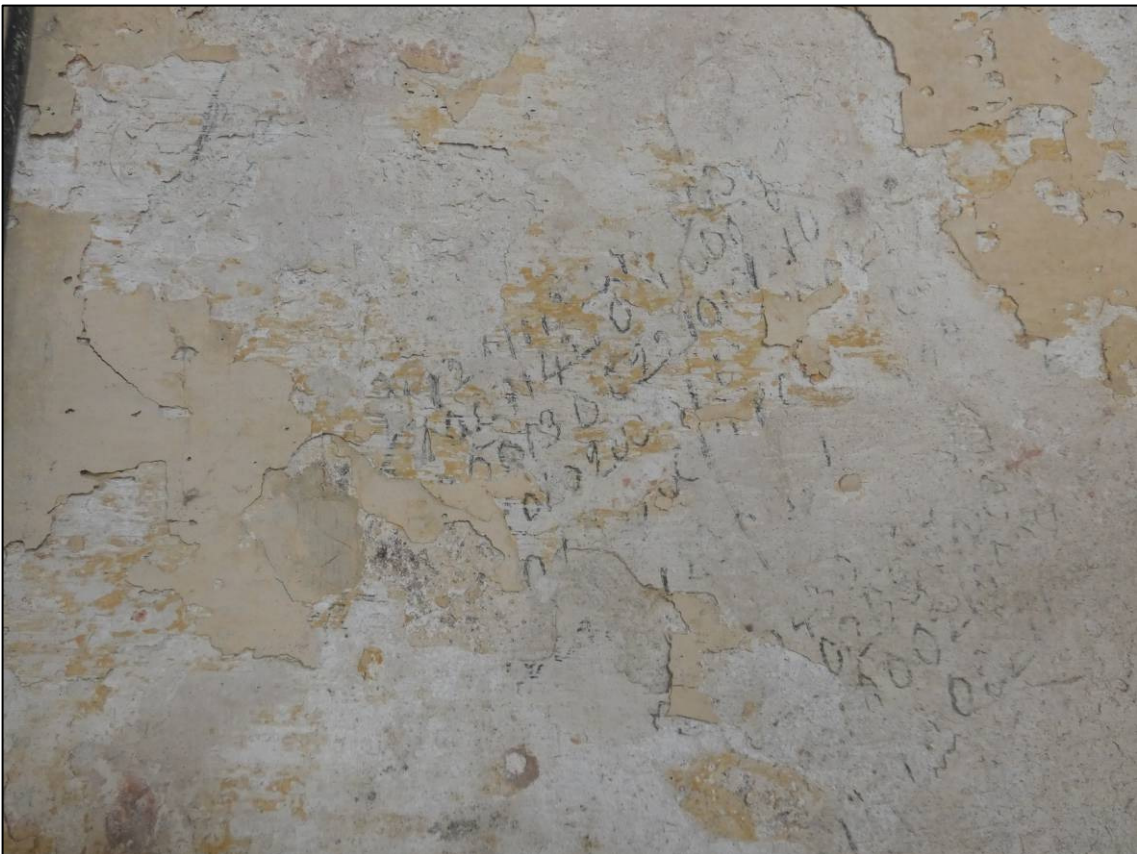
Plate 11: Internal graffiti to east wall (photo 1/942).

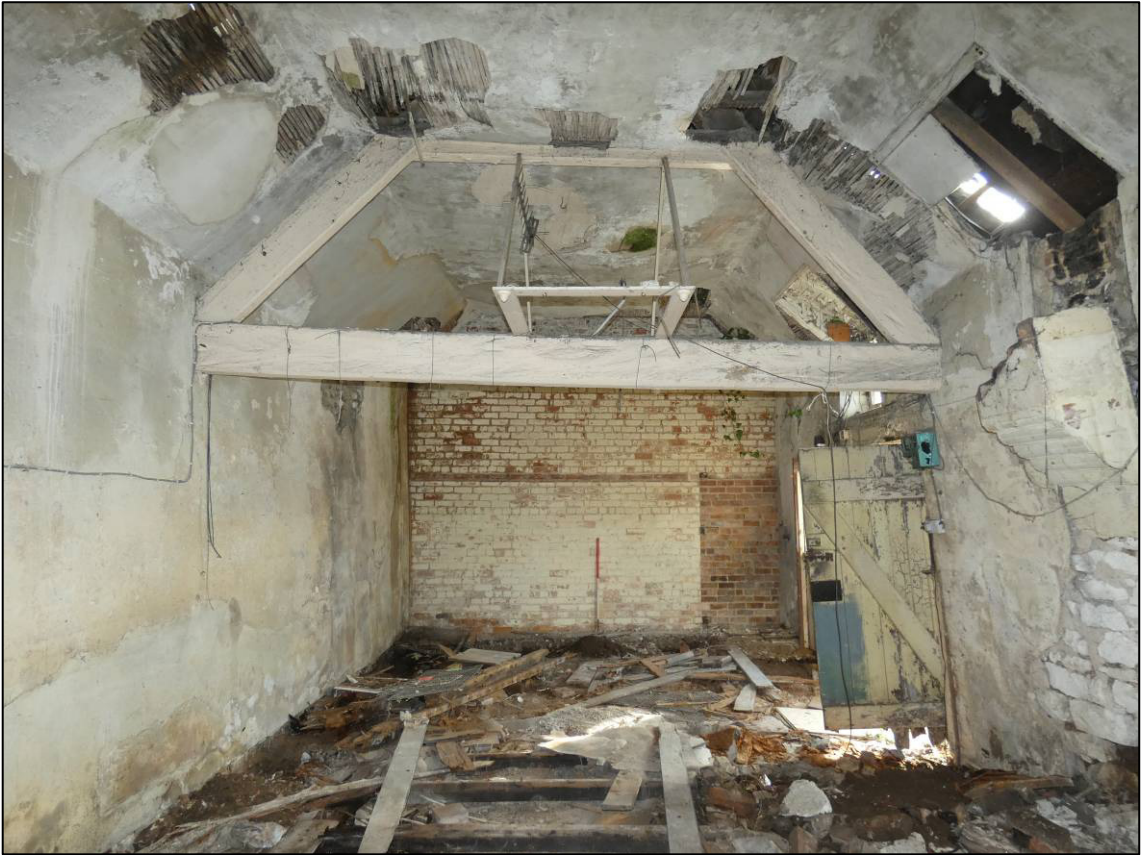
- 3.15 Due to the plaster and painting, there are few features visible internally that have not already been described externally [1/911, 1/919, 1/924, 1/930-1/933] (see plates 12 and 13). To the north of the entrance in the west wall, a short brick pier supported on modern corbelled brickwork has been built out from c.1.50m above the former internal floor level [1/920]. The brickwork is very poorly tied into the chalkstone walling, and there is an opening in the roof slope above the pier, filled with two glass tiles. The purpose of the pier is unknown. The north [1/922] and south [1/909] internal walls are both blank; scarring caused by differential painting at the west end of the wall might suggest a blocked opening, but this is not the case and the brick coursing runs through. The blocked doorway at the north end of the east wall is clearly visible [1/927]. The iron rod of the long wall anchor visible to the east elevation crosses the full width of the north wall internally, but the external plate cannot be seen to the west elevation due to ivy growth.

Plate 12: Interior, looking S (photo 1/911).

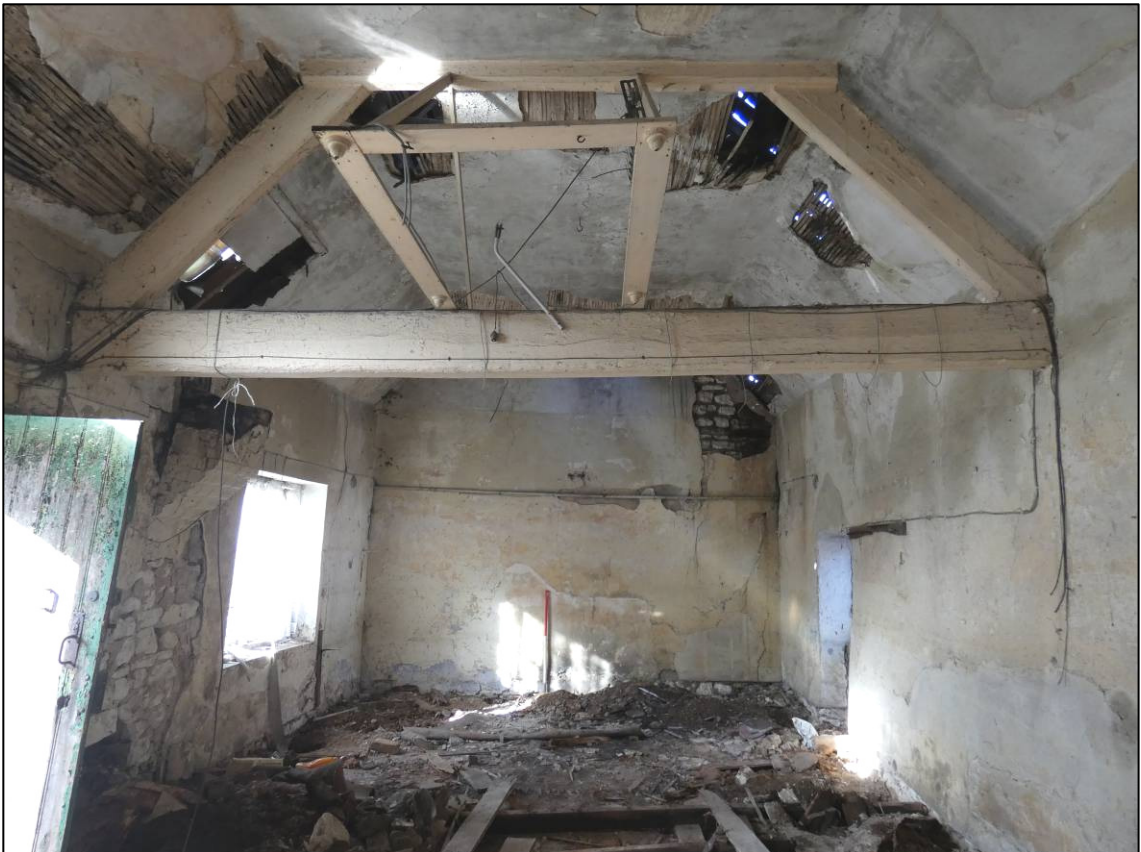
- 3.16 The interior of the building is divided into two bays of slightly uneven size by a single roof truss [1/913, 1/917, 1/923, 1/934] (see plates 12 and 13). The upper part of this was partly obscured by a lath and plaster ceiling at the time of the survey, and so could not be viewed in detail, whilst below the ceiling the truss had been painted. The truss is of pegged, (softwood?) construction throughout and appears to contain no re-used timber. The truss comprises a substantial tie-beam with stop-chamfered soffits, and principal rafters; the ends of the tie-beam are set directly into the walls and there appear to be no wall-plates. A shallow mortice to the west end of the tie-beam's soffit suggests that an upright timber was inserted beneath it here, but there is no evidence for the presence of any other features such as a partition. A collar is joined to the south face of each principal using a halved lap joint, with a lath and plaster ceiling extending up to the height of the collar [1/935, 1/936]. The principals appear to be halved where they cross immediately below the diamond set ridge-piece, supporting it and extending upwards for a short distance to either side after crossing [1/938]; this arrangement is sometimes seen in cruck-framed buildings. Each principal carries a single back purlin; both purlins, and the ridge-piece, incorporate a splayed scarf joint over the truss. The common rafters appear to be original, and have a layer of large, closely spaced laths placed over them, immediately below the pantiles [1/937]. No assembly or carpenters' marks could be seen on the truss. When the building was used as a village hall, a metal-frame with a pendant light fitting to each corner was added above the tie-beam, and this subsequently had several aerials attached to it for use by the television repair business.

Plate 13: Interior, looking N (photo 1/923).
