WESTMORLAND DALES HIDDEN LANDSCAPE
PARTNERSHIP
MONUMENTS AT RISK SURVEY

ARCHAEOLOGICAL SURVEYS OF
SMARDALE KILNS AND QUARRY,
PENDRAGON CASTLE,
RAVENS' GILL BARROWS AND
CROSBY LODGE SHIELING

Report no: 2017/548.R01
Version: Final
Date: July 2018
Author: Ed Dennison & Shaun Richardson

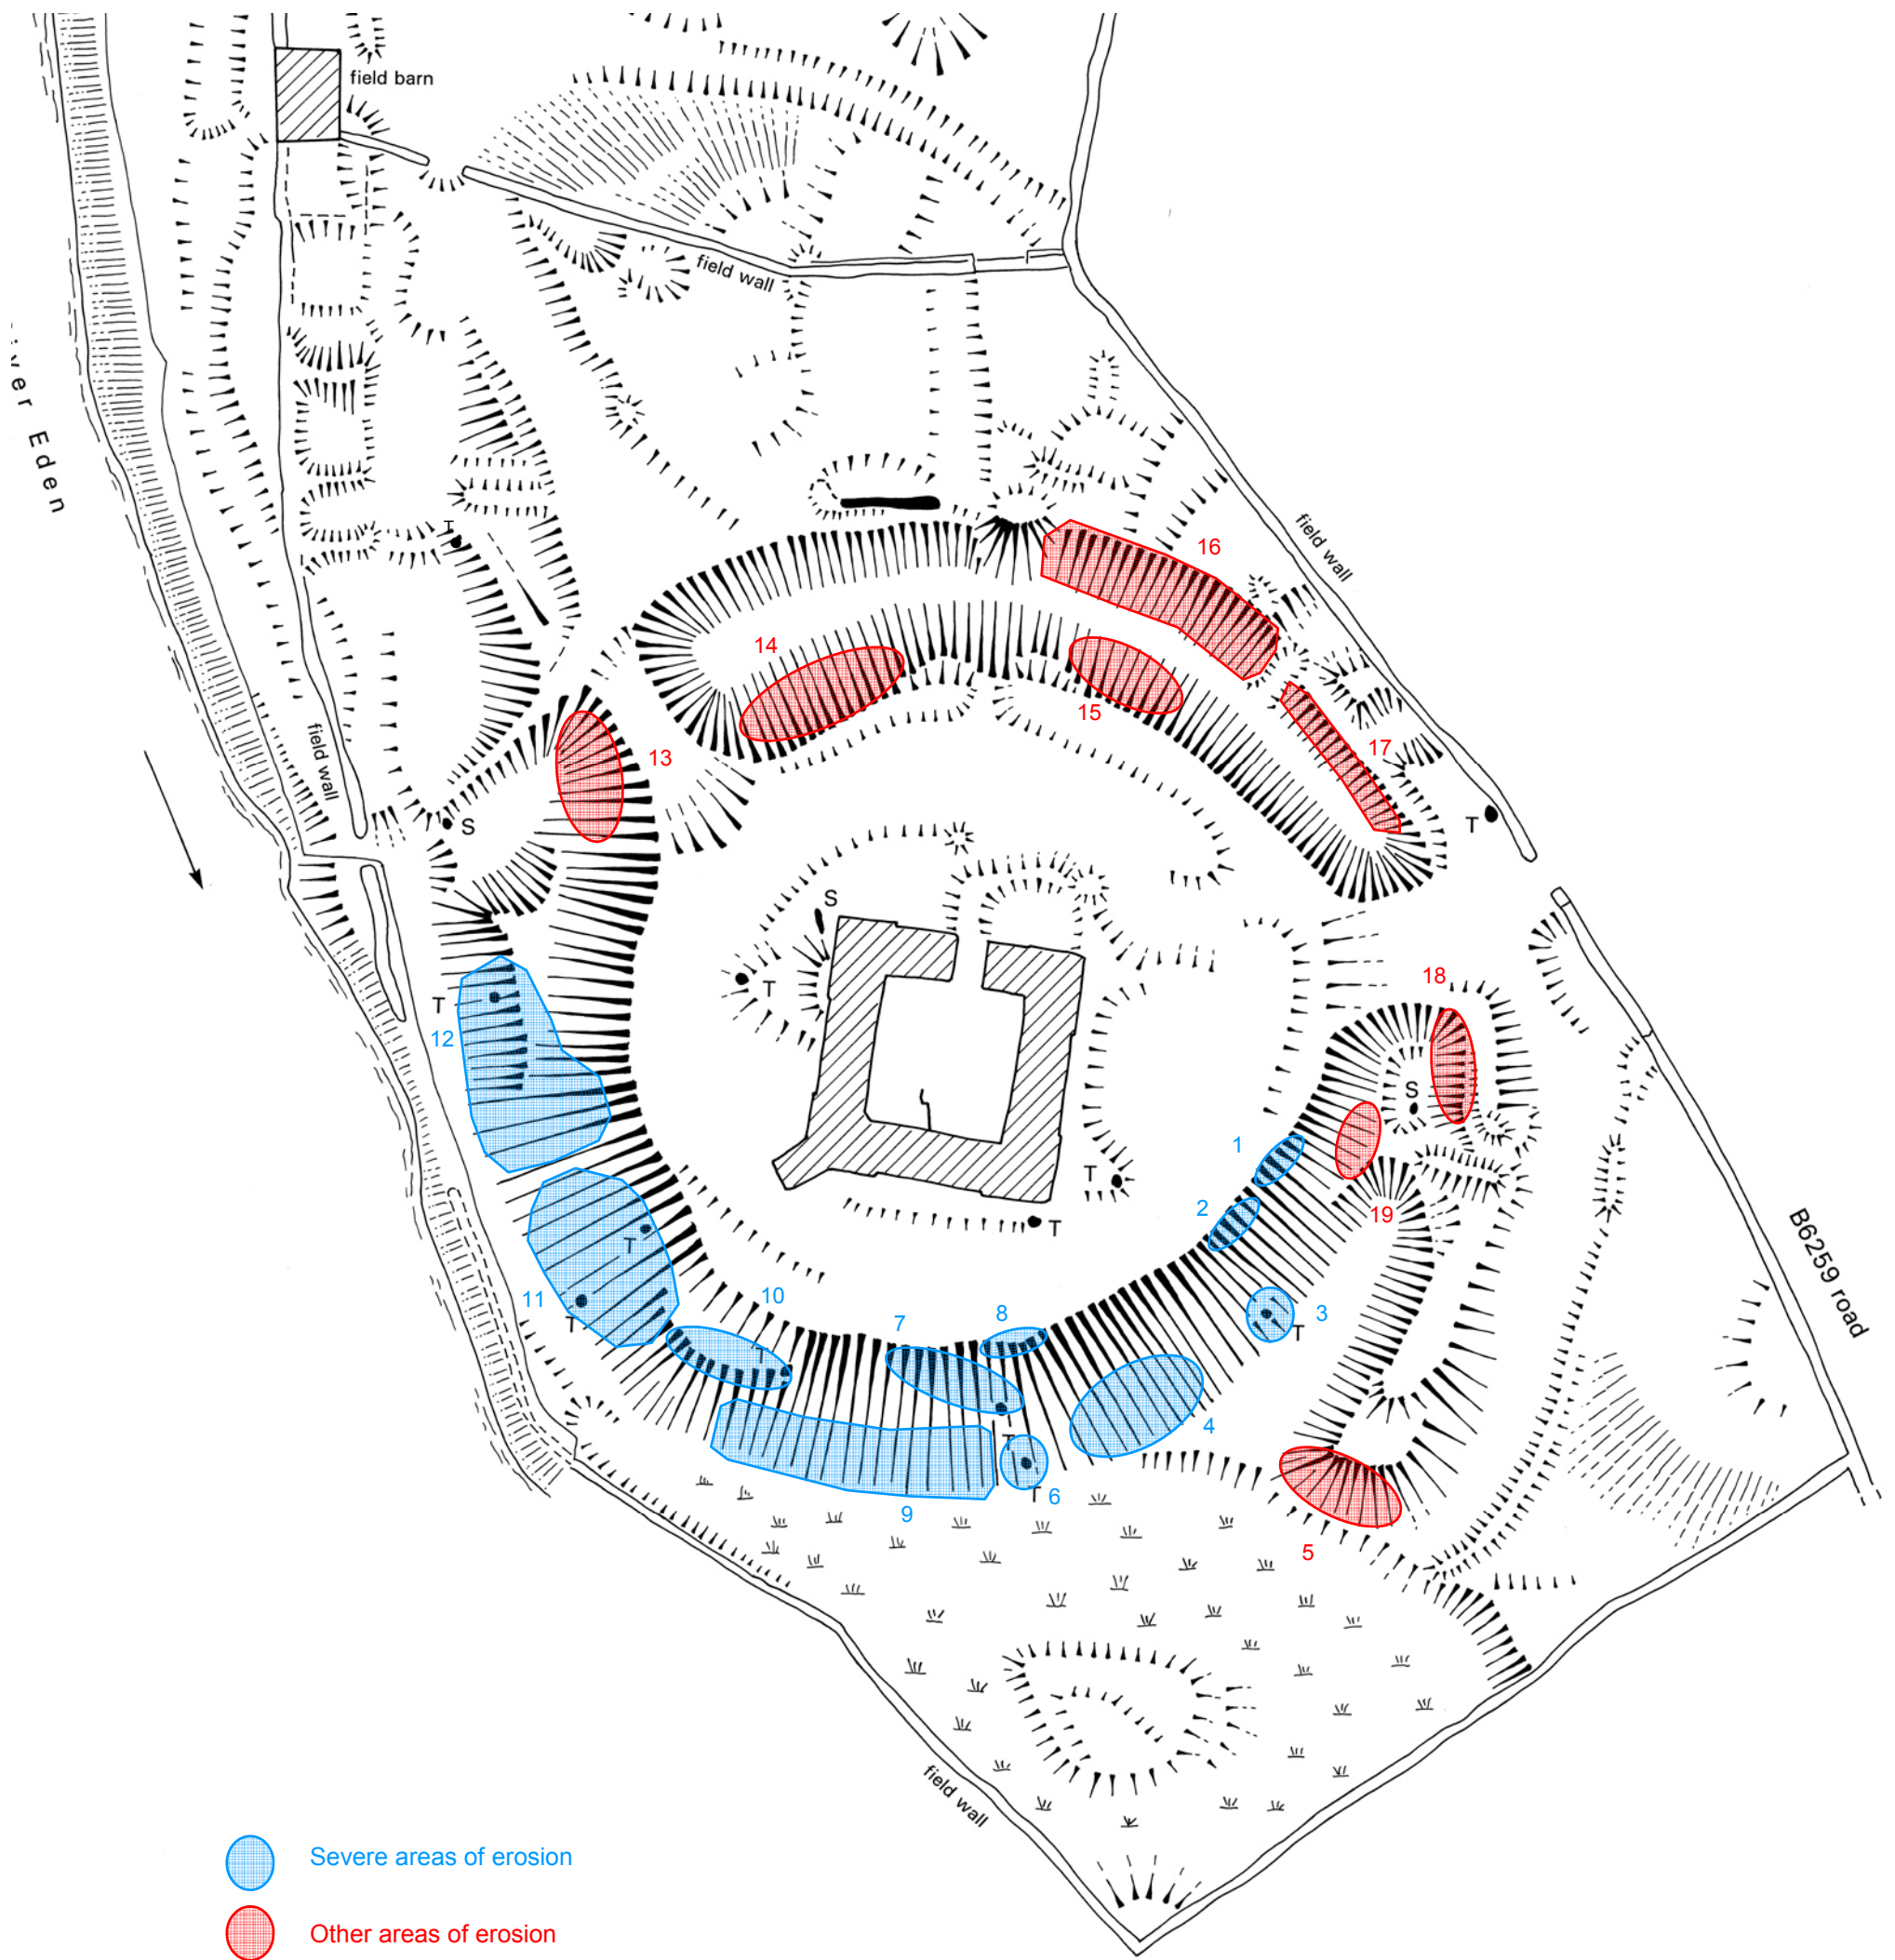
PROJECT		WESTMORLAND MARS	
TITLE			
PENDRAGON CASTLE SITE EROSION			
SCALE	AS SHOWN	DATE	JUL 2018
EDAS		FIGURE	19

- Severe areas of erosion
- Other areas of erosion

Clear loose rubble from
window openings

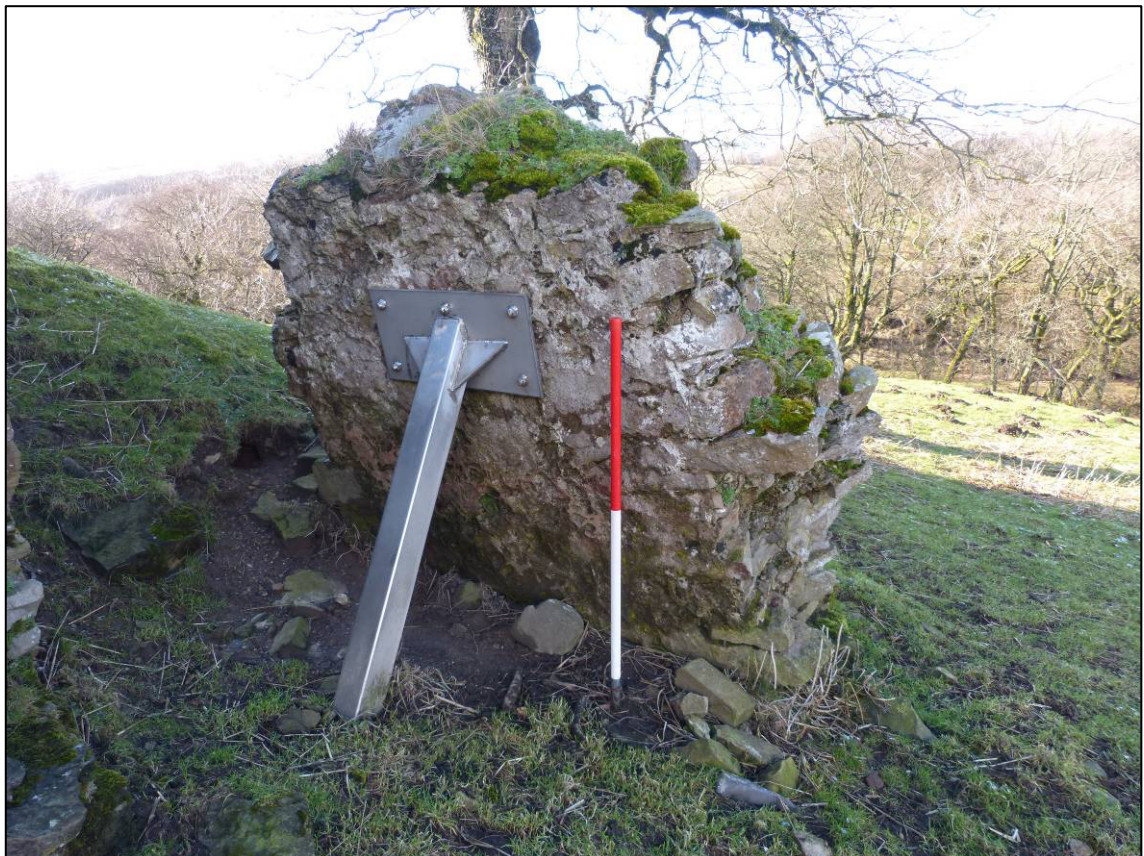
Plate 47: Pendragon Castle, propped masonry at north-west corner of castle, looking SW (photo 9/574).

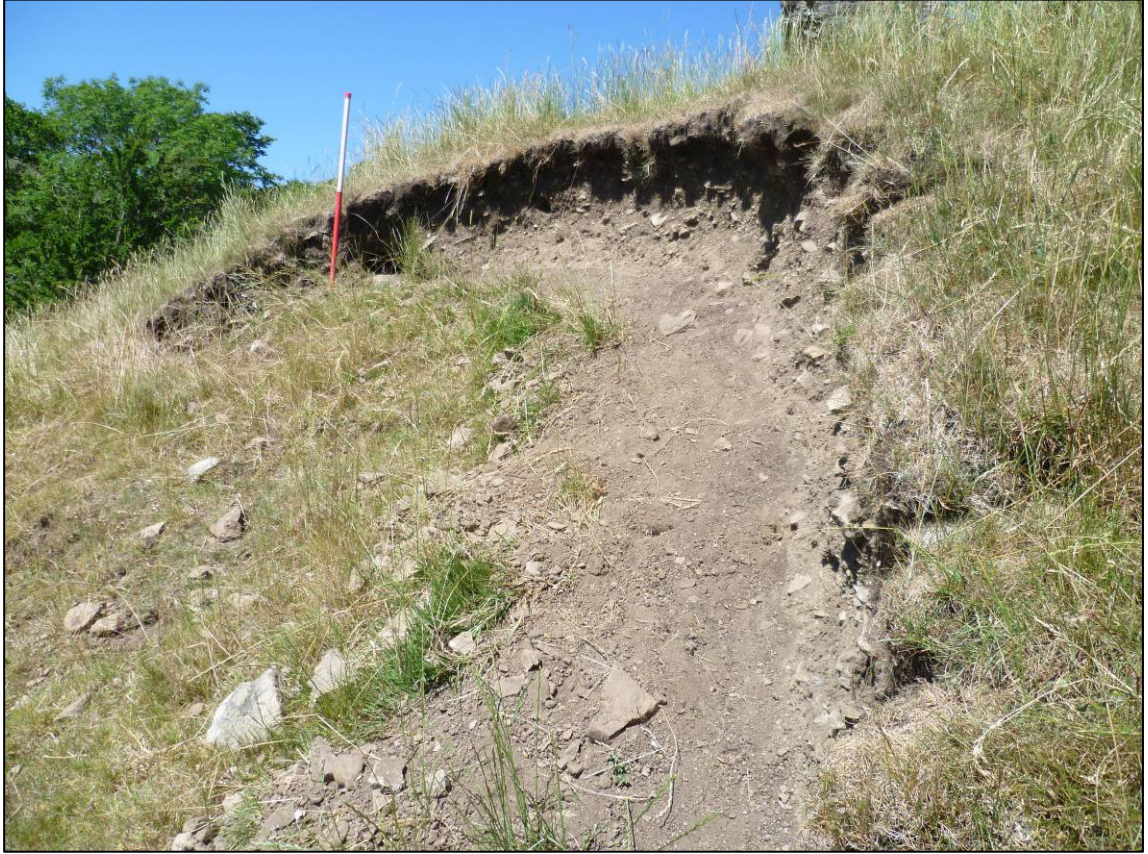
Plate 73: Pendragon Castle, slumping scar (Area 7), on south side of castle mound (Site 201), looking NW (photo 10/132).

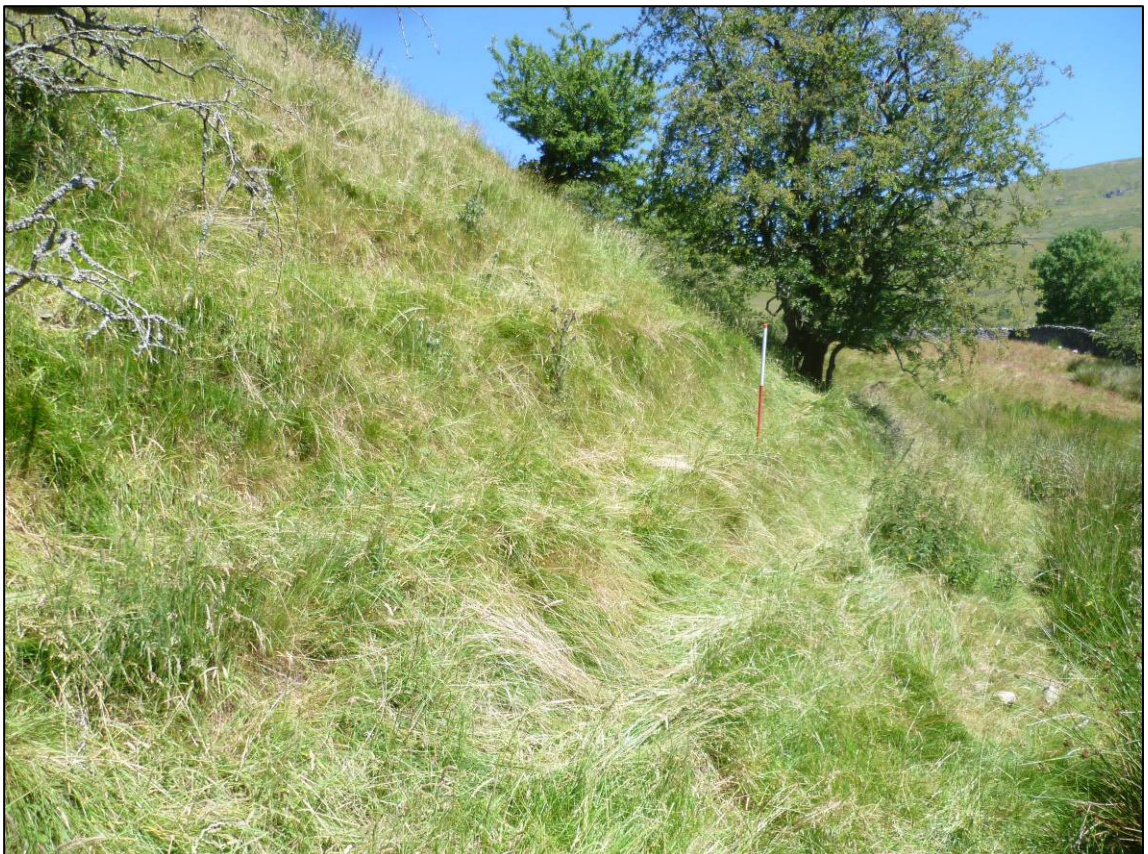
Plate 74: Pendragon Castle, grassed over ground slips/sheep tracks (Area 9), on south side of castle mound (201), looking NE (photo 10/138).

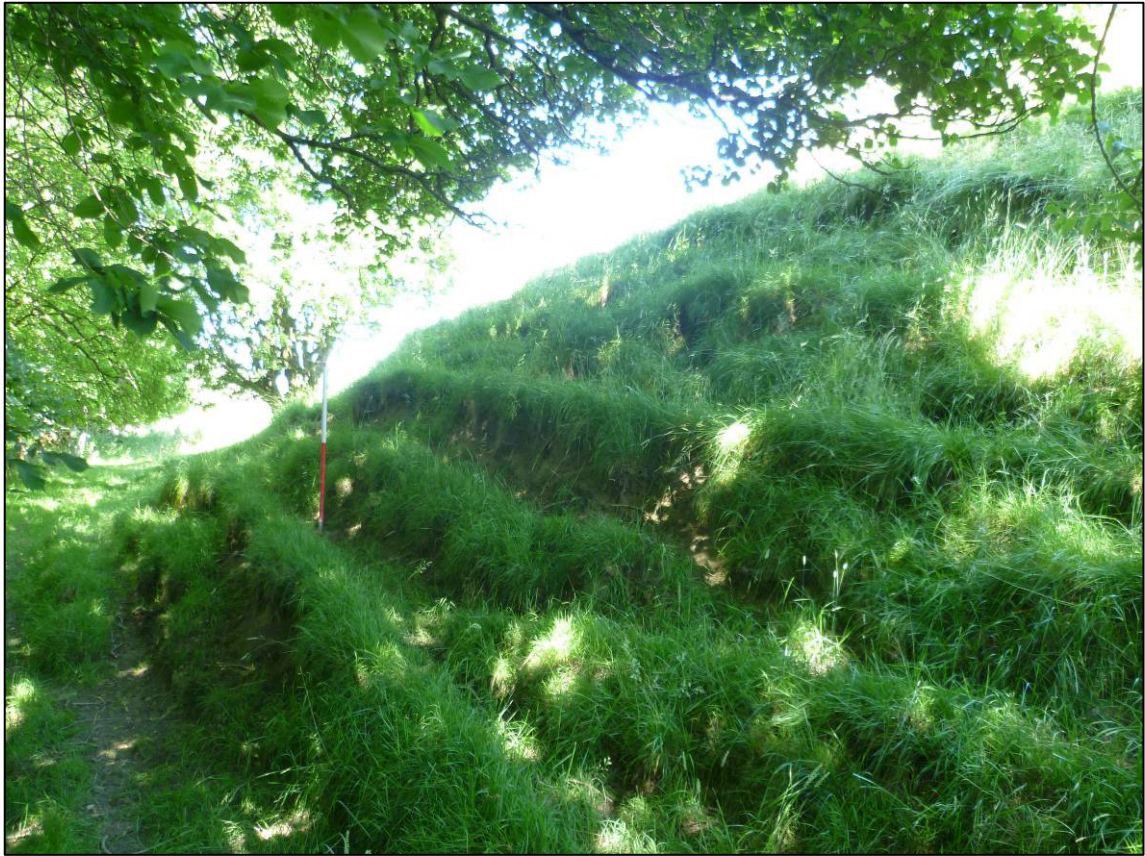
Plate 79: Pendragon Castle, ground slip/sheep tracks (Area 12) on west side of castle mound (201), looking NW (photo 10/146).

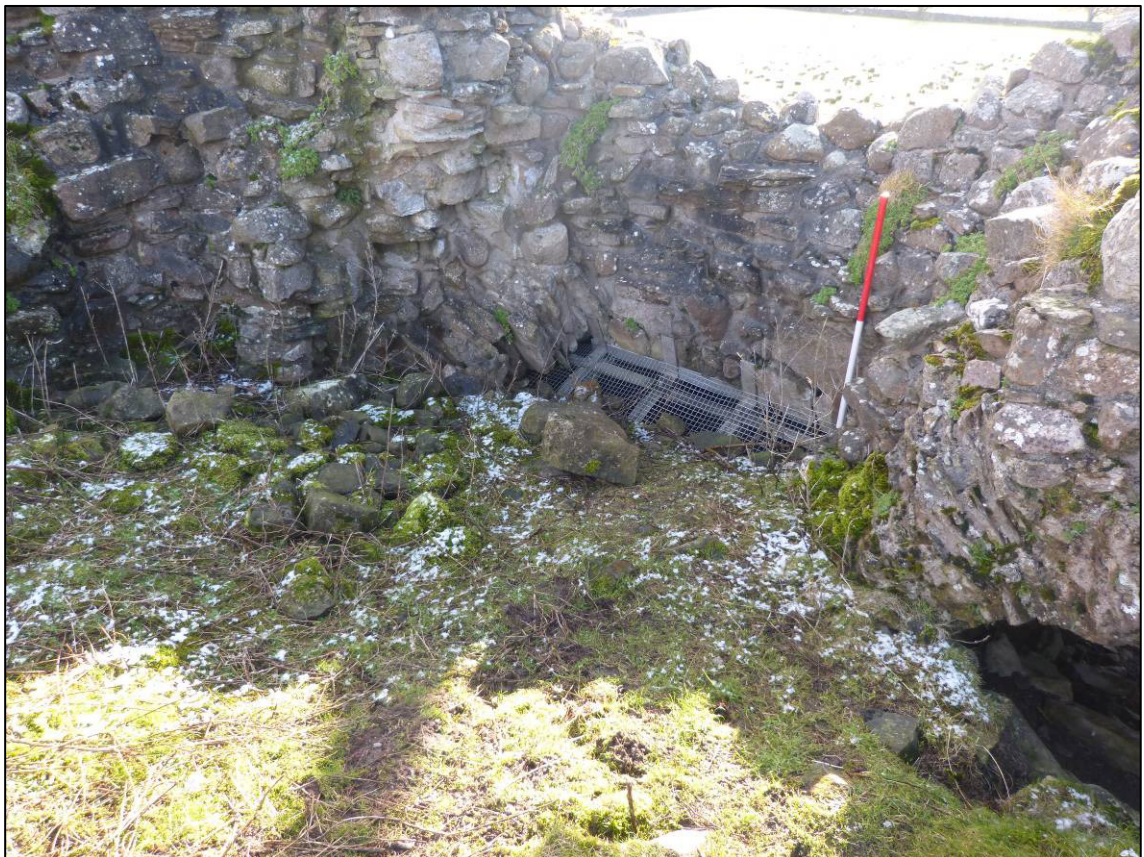
Plate 83: Pendragon Castle, interior, repaired roof of SE chamber, looking SE (photo 9/555).

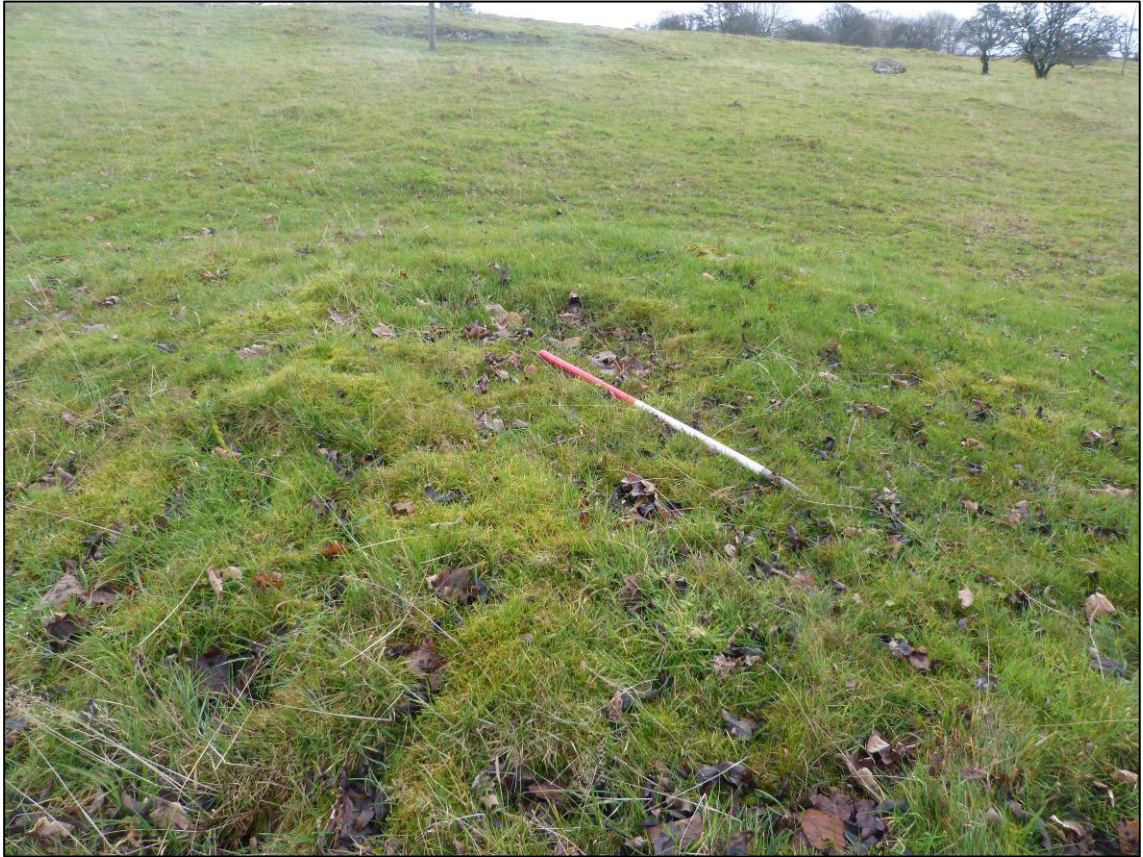
Plate 88: Ravens' Gill barrows, disturbance to top of barrow (Site 302), looking E (photo 5/246).

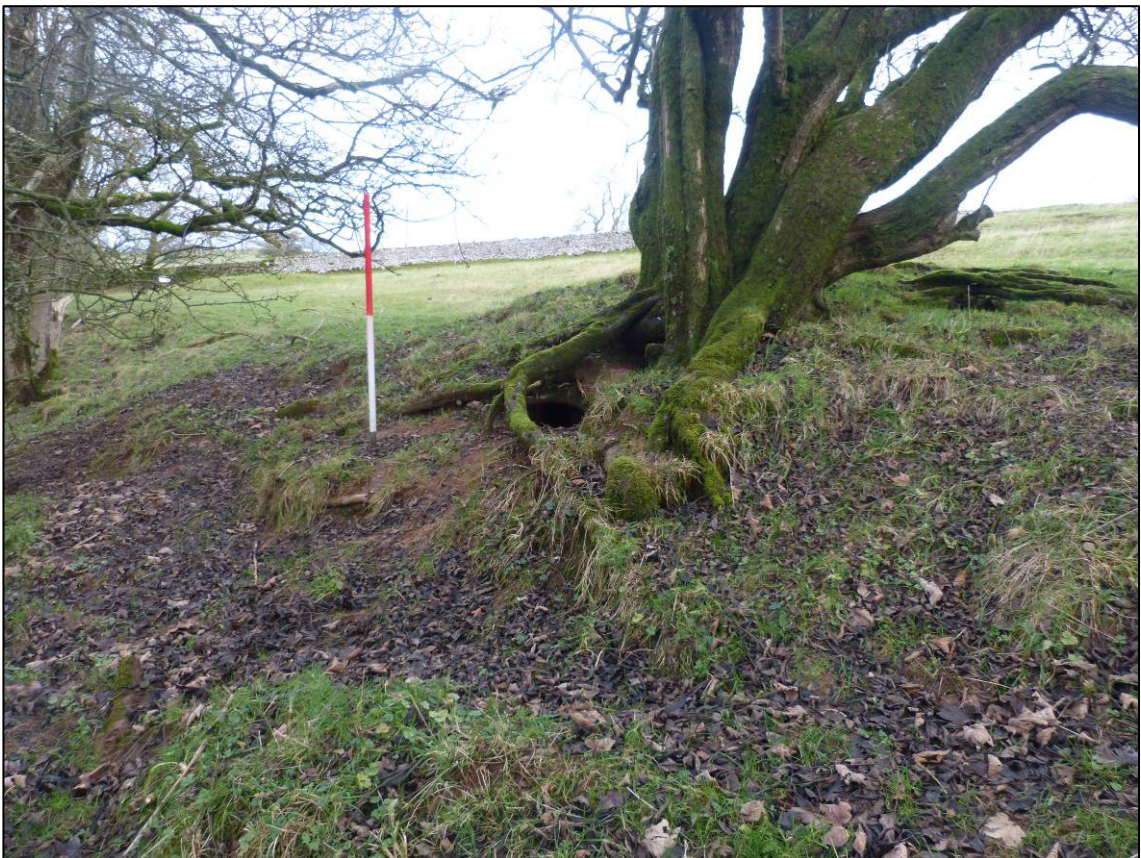
Plate 94: Ravens' Gill barrows, barrow (Site 305), rabbit and stock erosion, looking NE (photo 5/259).

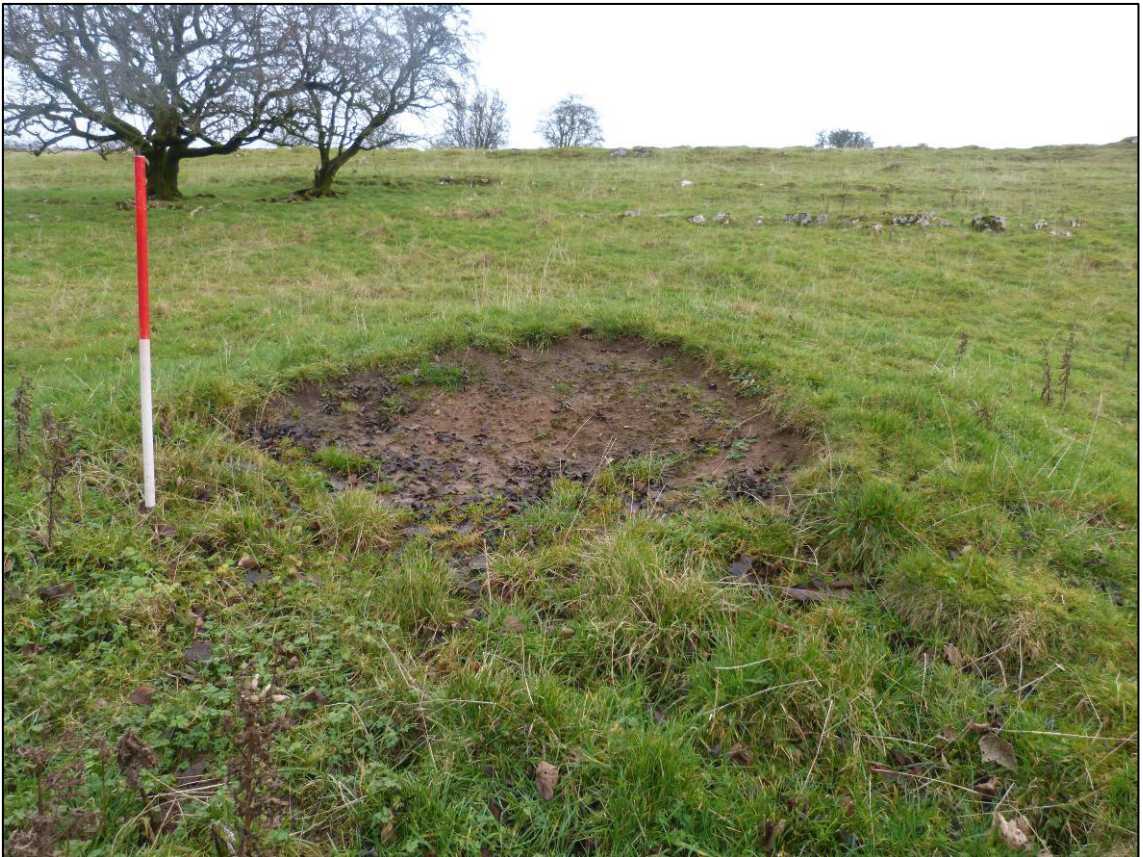
Plate 96: Ravens' Gill barrows, erosion scar in barrow (Site 306), looking E (photo 5/263).
