EXPOSED CULVERT, OLD GANG SMELT MILL,
SWALEDALE, NORTH YORKSHIRE

ARCHAEOLOGICAL WATCHING BRIEF

Report no: 2007/317.R01
Version: Final
Date: February 2008
Author: Shaun Richardson & Ed Dennison

Yorkshire Dales National Park Authority
Yorebridge House
Bainbridge
Leyburn
North Yorkshire DL8 3EE

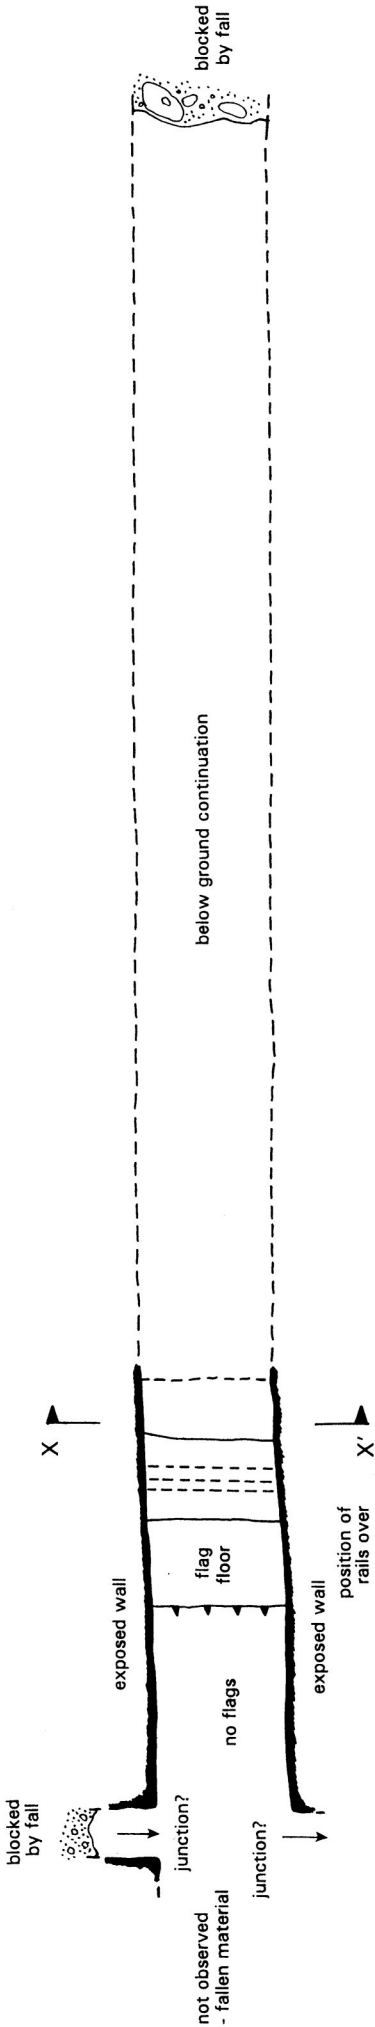
Plan of culvert

- 4.1 Following the clearance of overburden in the vicinity of the collapse, it was discovered that the culvert had formerly been roofed with large flat flagstones, on average 0.12m thick. Over time, several of these had also collapsed into the culvert, and so they had to be removed before clearance could take place.

- 4.2 Once clearance was complete, a c.1.70m section of culvert was exposed (see plate 1). The culvert was aligned north-west/south-east along the north side of the track; its line could be traced for a further 4.60m to the east, where it was blocked by a fall. The culvert was also choked to the immediate west of the exposed section by stones, soil and fallen material. Beneath the flagstone capping, the sides of the culvert were c.0.80m deep and built of roughly coursed and squared unmortared stone. The culvert had an average width of 0.50m and was floored with neatly-cut flagstones (see plate 2), although these were missing at the western end of the exposed section. Also at the west end, a smaller culvert (0.18m wide) appeared to enter the main culvert from the north, whilst opposite, a similar feature appeared to leave the south side to run to the south; the latter was in line with the remains of a wheelpit positioned on the dressing floor to the south.

- 3.2 Investigation showed that the hole was over a culvert, which had been capped with flagstones and then sealed with roadstone, mainly mine and dressing waste. The collapse was due to a failure of the capping flags. Accordingly, a decision was made to replace and re-wall the failed sides of a short section of the culvert, insert new flag capping with stone taken from the stream outside the scheduled area, and reseal the structure to match the surrounding surface.

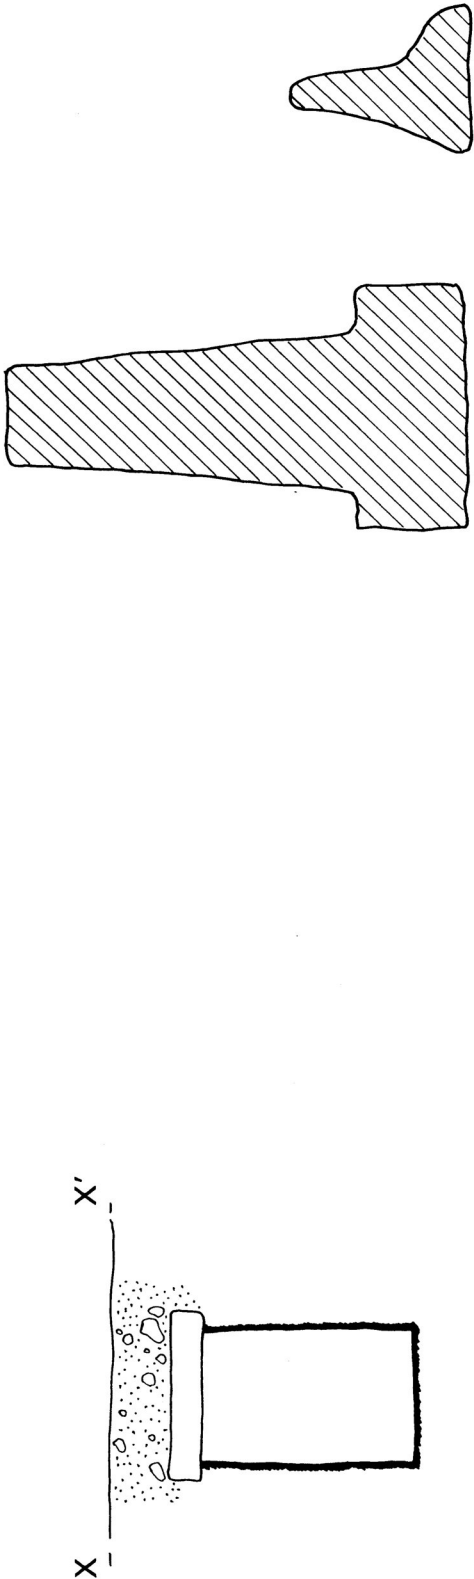
Section through culvert

- 4.3 Whilst the overburden was being cleared, it was observed that the flagstone roof of the culvert was supported in a number of places by re-used rails laid across its width. Furthermore, other short sections of rail had been placed vertically against the sides to prop up the flagstones. The rails had two distinct profiles (see figure 4). A high proportion of rotten wood was also present in the overburden above the smaller culverts seen in the north and south sides of the main feature, together with a 0.80m long piece of wrought-iron or steel with a U-section and pierced by several neat circular holes along one side and the base.

Cross sections of rails used to support sides and roof

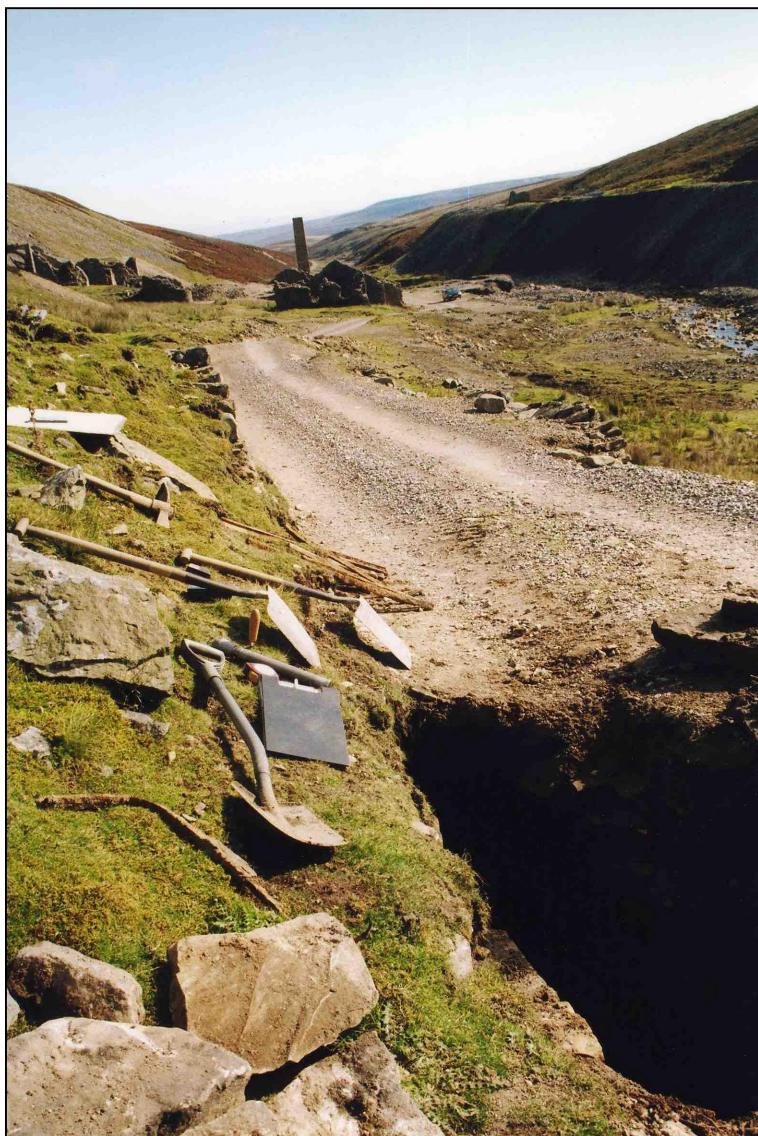
Plate 1: General view of site, looking east.

- 4.4 As stated above, all loose metal items or those disturbed during the course of the works were replaced within the culvert, which was then re-roofed using the fallen flagstones or other stones obtained from the base of Mill Gill. The overburden was subsequently replaced.

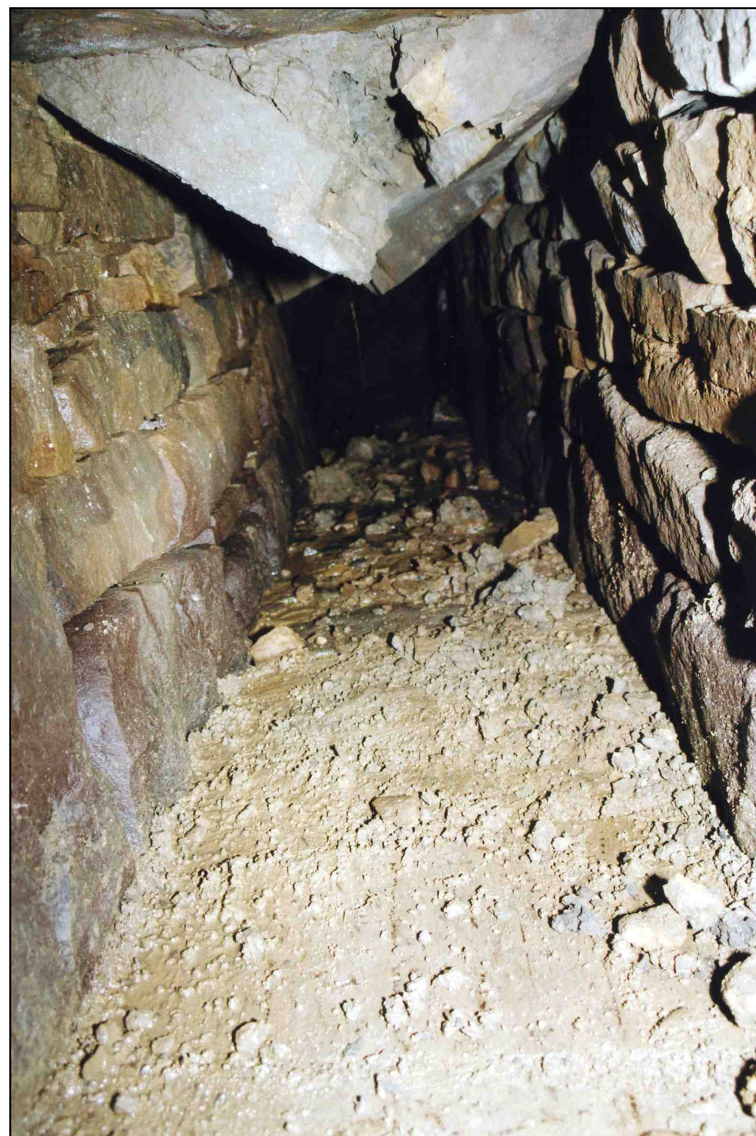
Plate 2: Interior of exposed culvert, looking east.
