ENGLISH HERITAGE BUILDINGS AT RISK
(2004) PROJECT, NORTH YORKSHIRE

SEAMER MANOR HOUSE, SEAMER

PHOTOGRAPHIC SURVEY AND
ARCHAEOLOGICAL OBSERVATIONS

Report no: 2004/247.R02
Version: Final
Date: October 2007
Author: Ed Dennison & Shaun Richardson

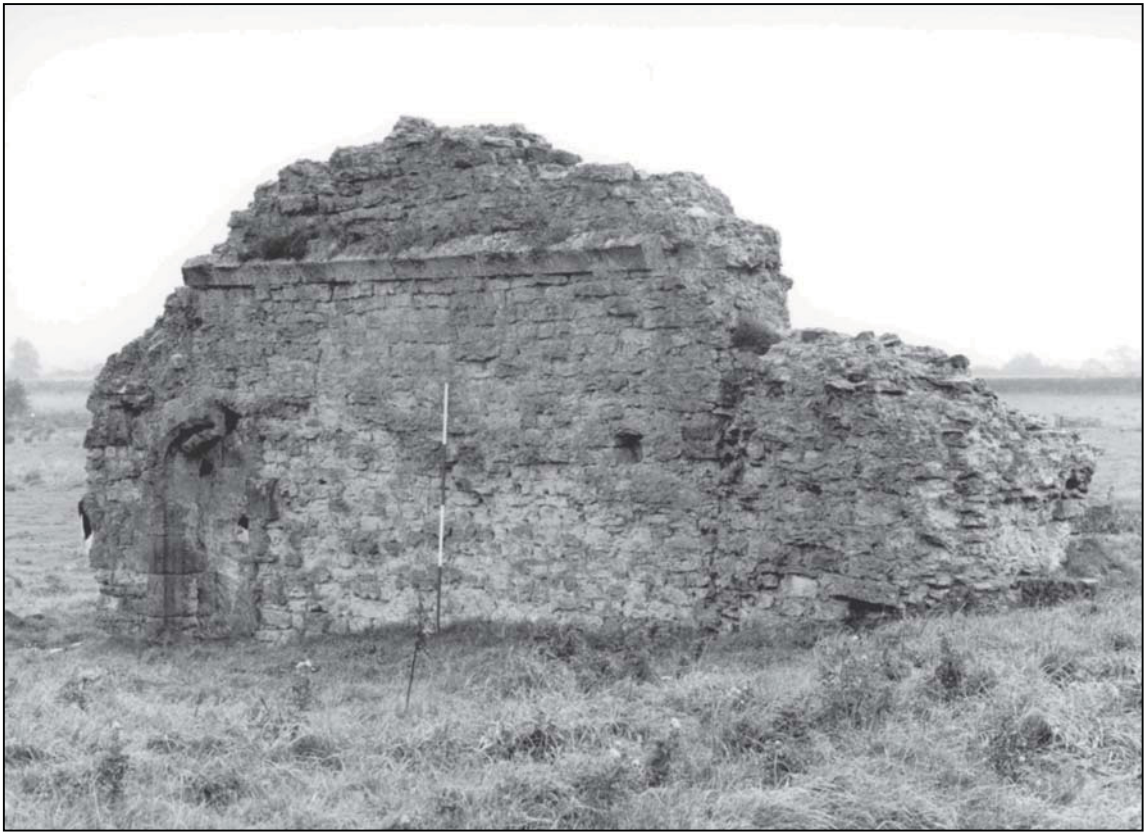
- 4.5 The eastern face of the wall also retains some structural evidence to suggest that the north end is not contemporary with the main body (see plate 1). The wall appears to return to the east at its north end and there is clearly a joint between the return and the main body, although it is not clear which is the earlier. The return is c.2.4m wide and it may retain traces of facing stone to the base of the east and north sides. To the south, there is a possible socket for a timber, set at approximately the same level as the head of the doorway, perhaps with a levelling course or a building break in the masonry running between the two. The four-centred doorway at the south end has a hollow moulded surround, the moulding dying into a chamfered stop; the doorway is rebated to the rear (see plate 2). Approximately 1.26m above the outer order of the doorway moulding, a string course of slightly concave corbelling runs along the length of the face as far as the return at the northern end.

Plate 1: East elevation prior to consolidation, looking SW (photo 1/17).

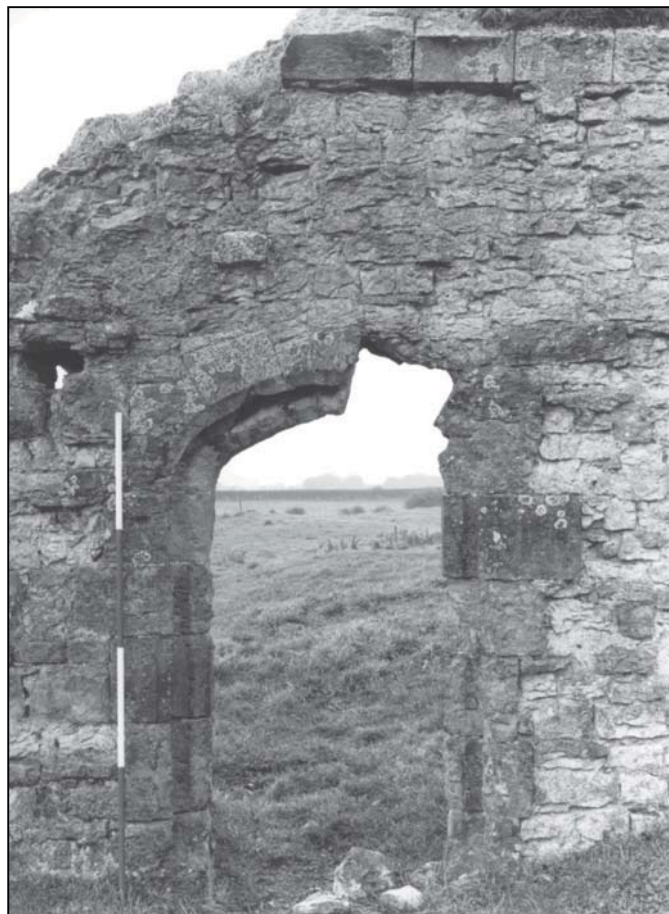
Plate 2: Detail of doorway in east elevation, prior to consolidation, looking W (photo 1/18).

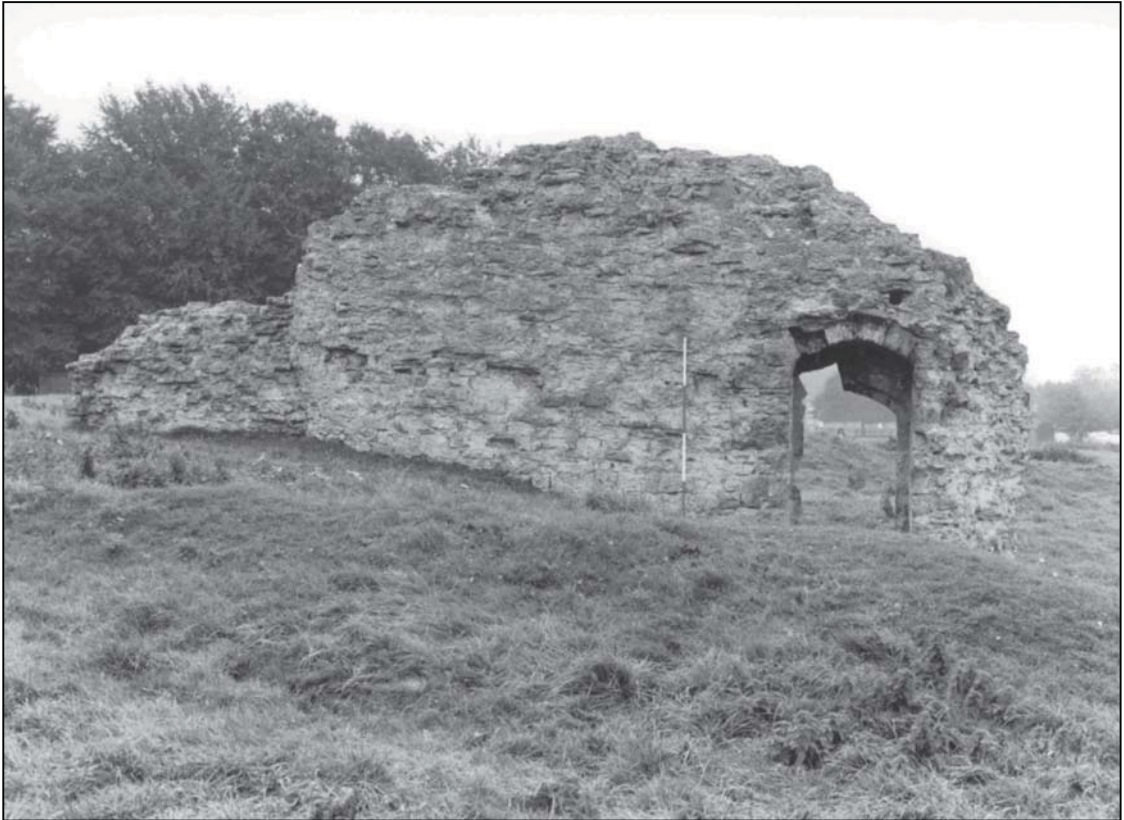
- 4.4 Both faces of the wall preserve a number of features. Some 3.40m to the south of the north end of the western face, there appears to be a rough vertical joint in the wall (see plate 3). The masonry to either side of this joint is very similar, but that to the north is pointed with a pinkish lime mortar in contrast to the buff mortar seen elsewhere; it also lacks the brick and tile inclusions. To the south of the joint, there are two eroded possible timber sockets, with a further socket located at a higher level adjacent to the doorway. There may be two further sockets on the south side of the doorway. The shallow arched head of the doorway is formed from squared voussoirs and the walls of the door passage retain their coursed squared limestone facing. There is a rebate to the rear of the doorway, with holes for pintles on the south side.

Plate 3: West elevation prior to consolidation, looking E (photo 2/6).

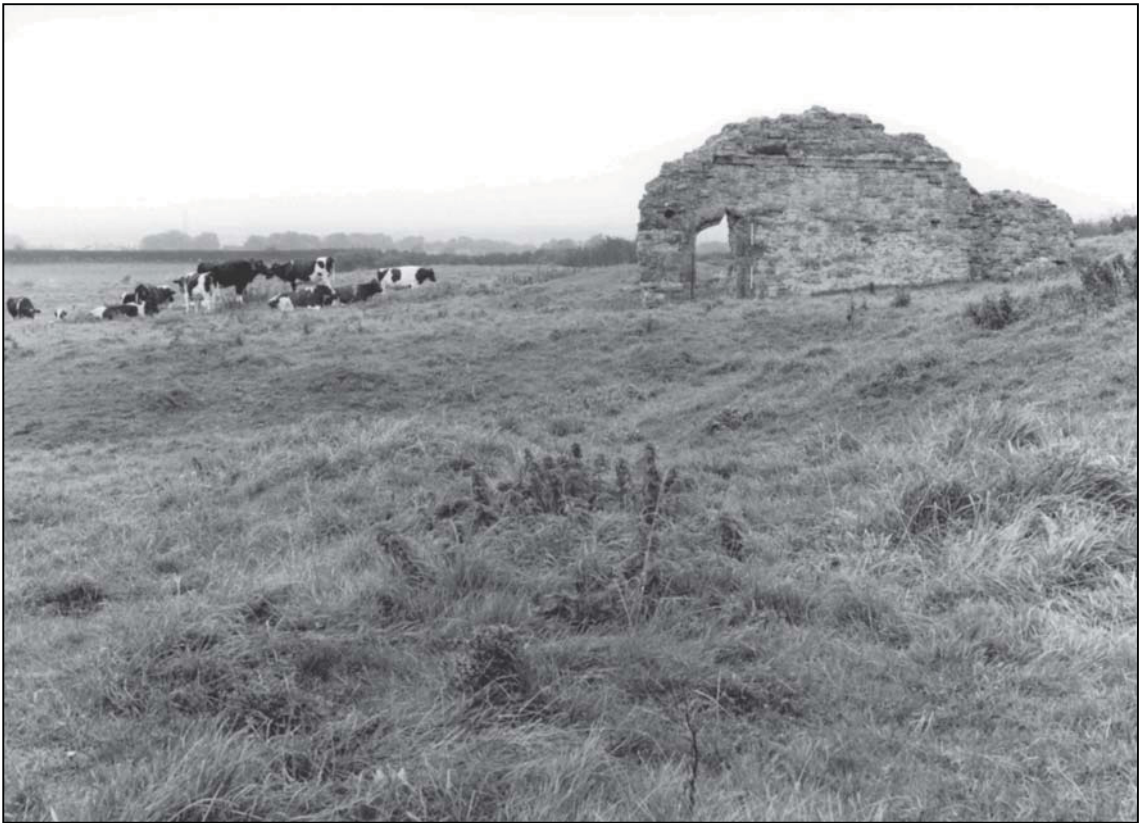
Plate 4: Ruin in earthwork setting, looking W (photo 2/9).
