ALL SAINTS CHURCH, SILKSTONE,
SOUTH YORKSHIRE

ARCHAEOLOGICAL WATCHING BRIEF

Report no: 2001/152.R01
Version: Final
Date: March 2006
Author: Ed Dennison & Shaun Richardson

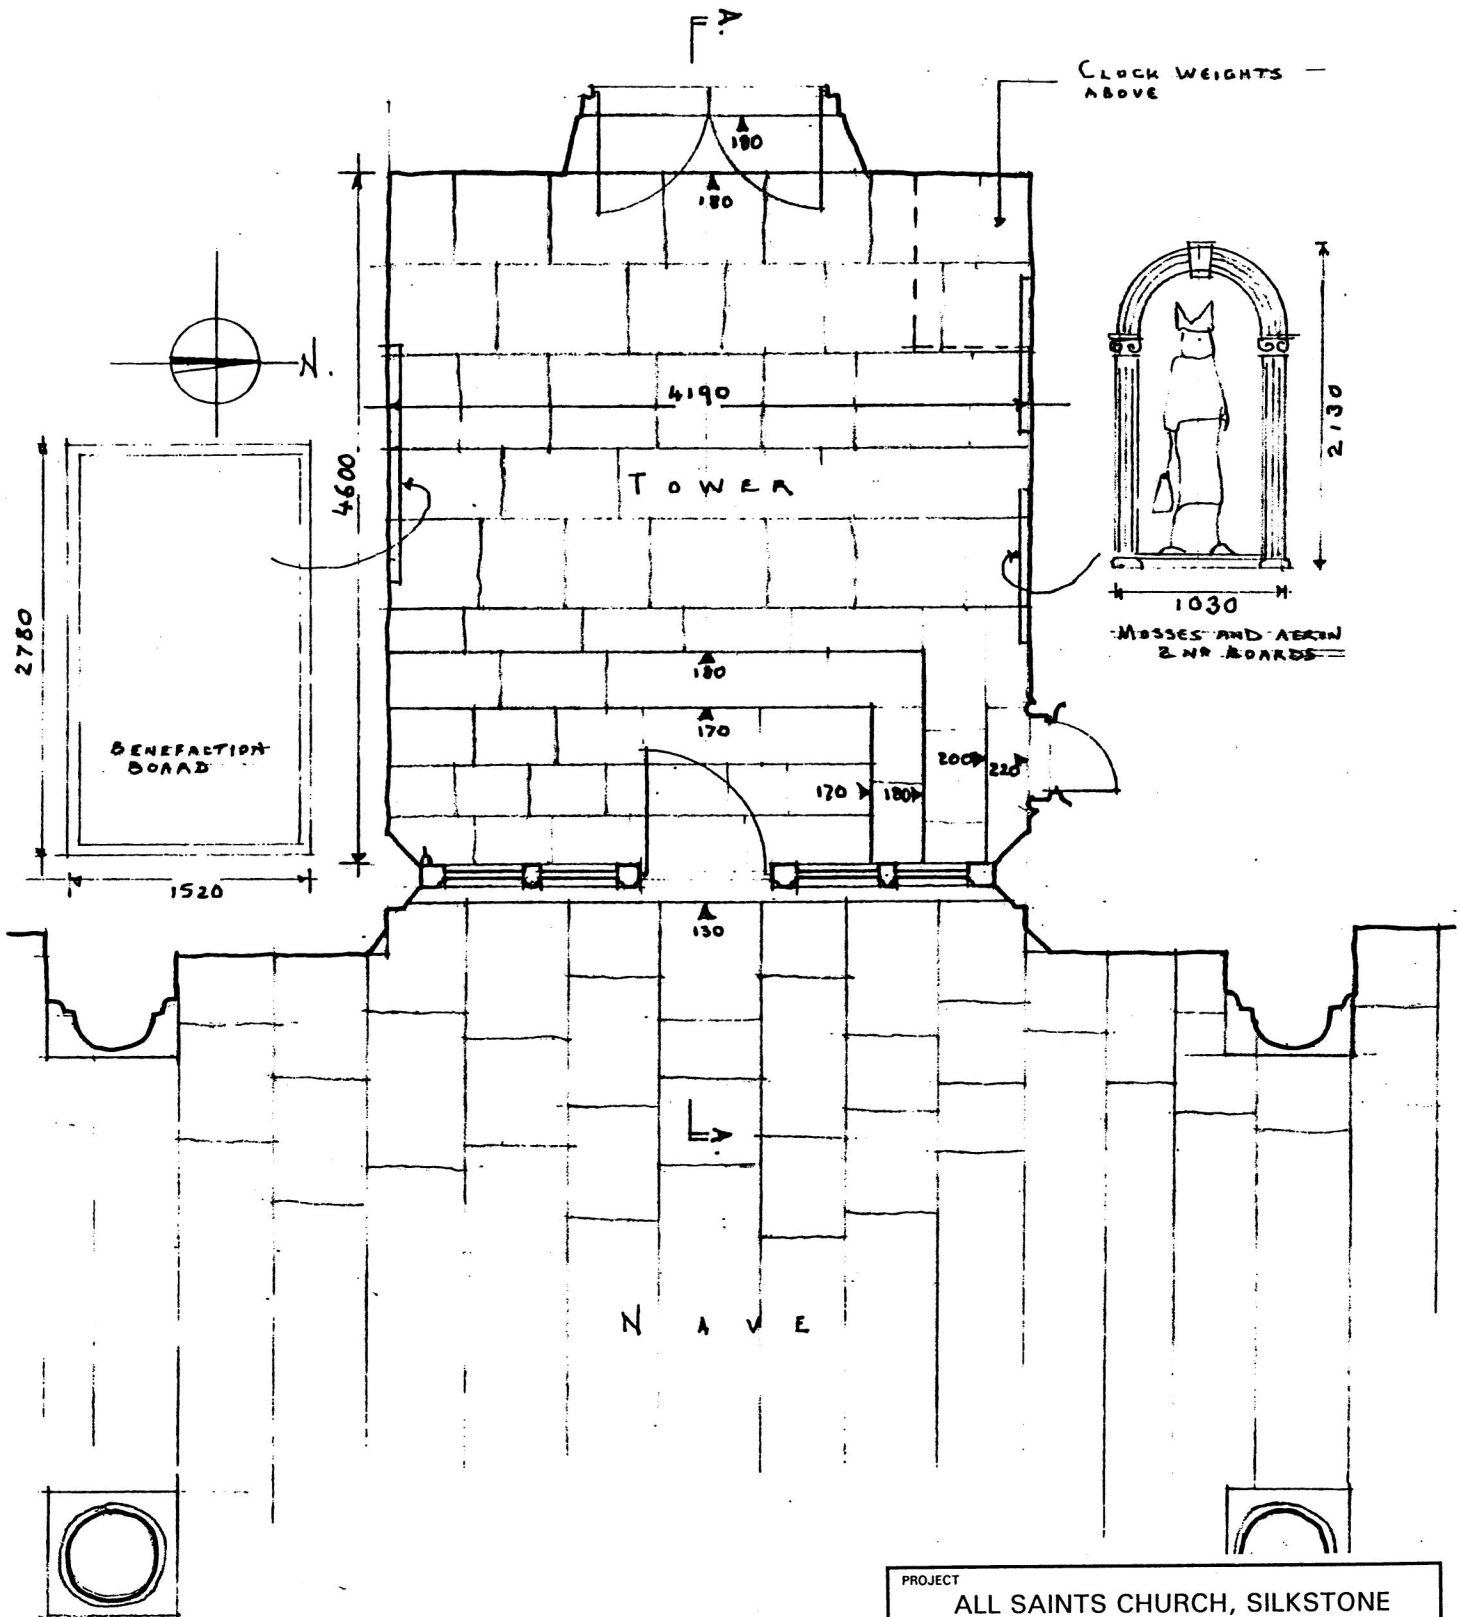
PROJECT ALL SAINTS CHURCH, SILKSTONE	
TITLE WEST END OF CHURCH AS EXISTING	
SCALE 1:50	DATE MAR 2006
EDAS	FIGURE 2

- 5.1 Prior to the commencement of the works, the internal floor of the church tower consisted of north-south aligned rows of large rectangular sandstone flags (001) which had been laid down in 1934 as part of the restoration works carried out at that date (Rev'd Simon Moor, *pers comm*; see figure 2). This floor sloped gently downwards from west to east, and there were two steps on the east side leading down into the nave.

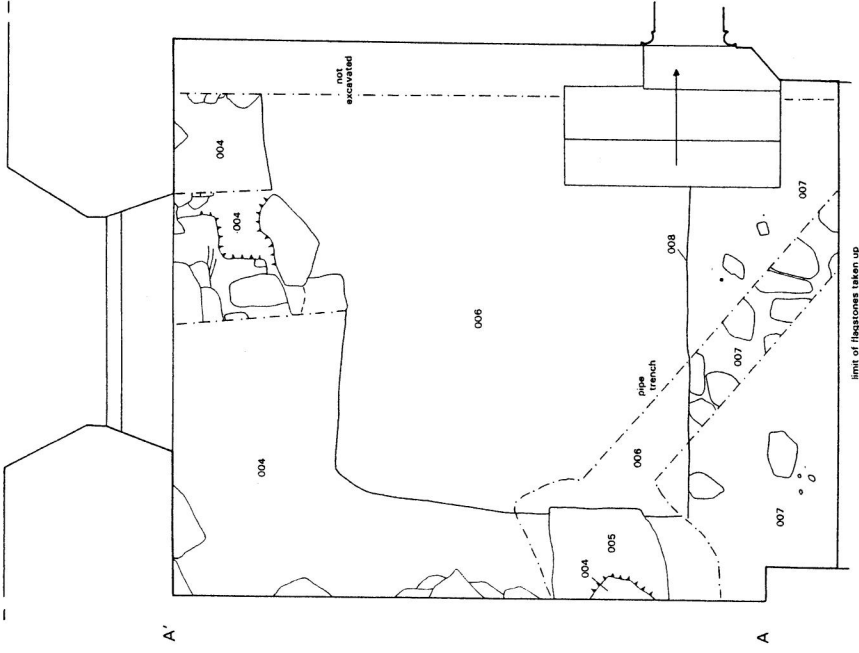
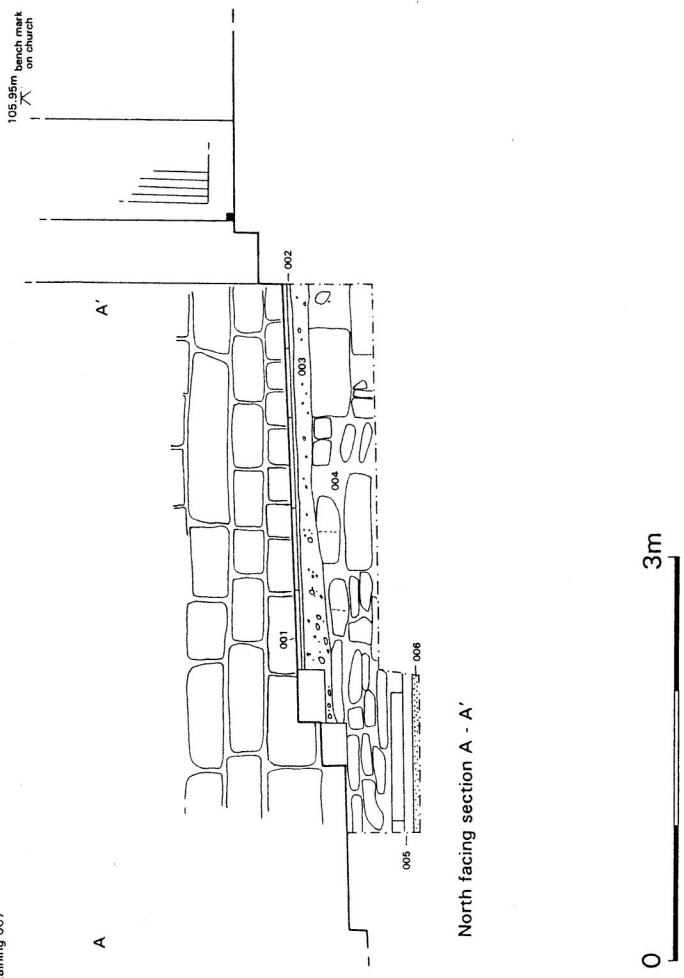
PROJECT		ALL SAINTS CHURCH, SILKSTONE
TITLE		WATCHING BRIEF RESULTS - TOWER
SCALE	AS SHOWN	DATE
		MAR 2006
FIGURE		3

- 5.3 The flagstones (001) were bedded on a 0.05m deep layer of gritty orange sand (002), which in turn overlay a deposit of mixed dry brown silt and yellow clay containing frequent inclusions of small angular stones (003) (see figure 3). Immediately beneath this were the foundations of the tower itself (004), formed by massive pieces of local Coal Measures sandstone up to 1.2m long by 1m wide by 0.3m deep and bonded with a yellow clay (see plate 1). Most pieces were irregularly coursed large flat slabs, but some had one or more faces dressed to a flat finish, suggesting that they may have been re-used. The foundations projected a maximum of 1.2m from the face of the west wall but only 0.65m from that of the south. The inside of the north wall of the tower was not exposed but where foundations could be seen, at the west end of the south-facing elevation of the excavated area, they projected by c.0.40m. Many of the largest foundation stones were set at an angle of c.45 degrees to the walls above, rather than in alignment.

- 5.4 At the east end of the south wall, the lowest course of the foundations was exposed by the pipe trench, and these were formed by large flat thin sandstone slabs (005), laid in regular courses. Immediately above the slabs, the sandstone rubble foundations were only 0.30m deep but, assuming the slabs are level around the tower, the foundations increase in depth to c.0.60m around the west door. The slabs were laid directly upon a dry natural yellow clay (006).
- 5.5 The pipe trench excavated across the south-east corner of the tower also exposed the west side of a north-south aligned cut (008), at least 1.10m wide. It was backfilled with hard packed angular pieces of sandstone rubble set within a dry yellow clay (007); the backfill of the cut appeared to overlay the lowest part of the tower foundations (005).

- 6.2 The foundations exposed in the interior of the tower, as might be expected, are very similar to those previously exposed around the exterior (see figure 4). The total width of the foundations beneath all three sides of the tower is up to c.3m, and they have an average depth of c.0.5m. The projection of the foundations beneath the west wall, up to 1.2m into the tower's interior, supports a previous suggestion that a late change in the design of the tower may have resulted in it being 0.50m longer than was originally planned, and therefore not positioned symmetrically to its foundations (Roberts 2001). The cut (008) exposed at the east end of the present watching brief area is probably the trench used to rob out the foundations of the original west end of the nave.

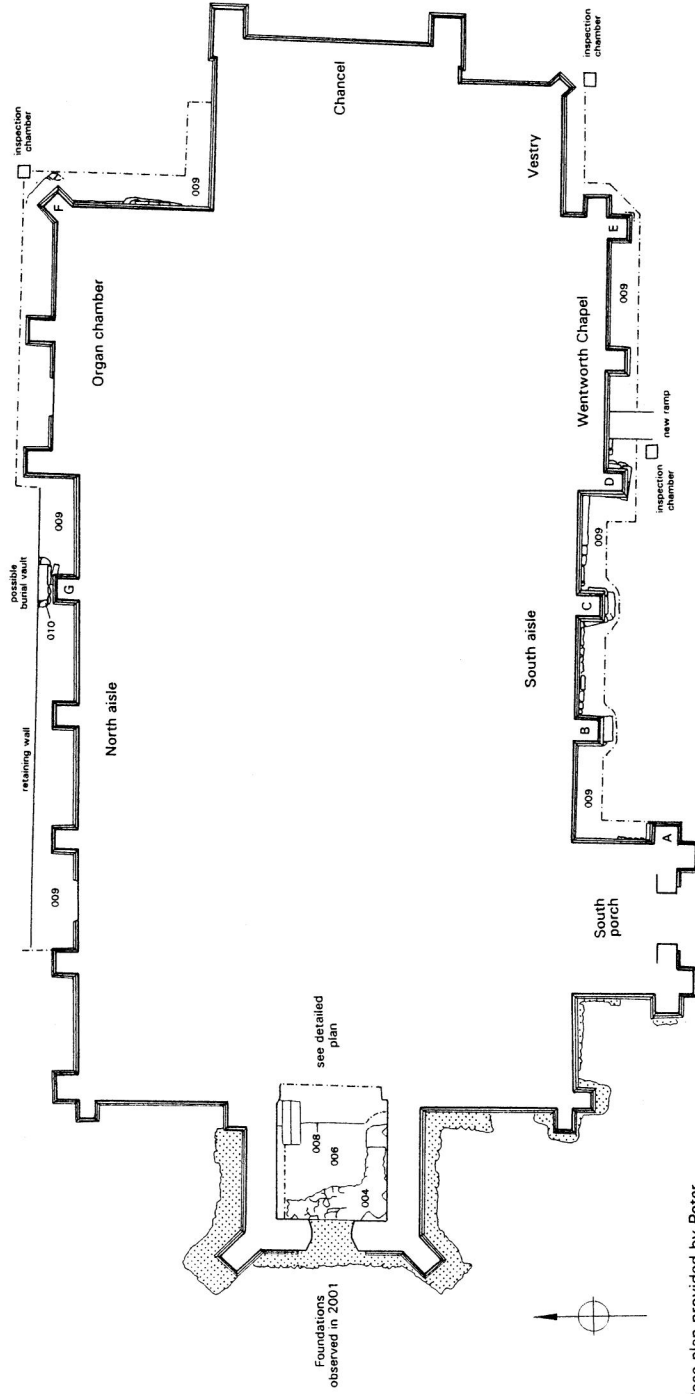
PROJECT	ALL SAINTS CHURCH, SILKSTONE		
TITLE	WATCHING BRIEF RESULTS - CHURCH		
SCALE	AS SHOWN	DATE	MAR 2006
	EDAS	FIGURE	4

- 5.8 The chamfered plinth of the east buttress on the east side of the south porch (A on figure 4) was seen to rest on a single stone, which projected 0.10m out from the face of the plinth. Moving northwards towards the junction of the south porch with the south aisle, the porch's plinth rested on slightly projecting stone rubble. This ran as far as a drain; to the north, the rubble footings were approximately flush with the plinth above.

- 5.9 The south side of the south aisle is divided into three bays of equal size by two buttresses. To the west of the western buttress (B), the footings of the chamfered plinth were again formed by rough stone rubble which projected slightly from the plinth above. The western buttress itself rises from a large stone slab which projects beyond its south face, with smaller pieces of adjacent rubble. Between the two buttresses, the plinth footings comprise roughly squared rubble which projected 0.20m from the plinth face, whilst the footings of the eastern buttress (C) include a fragment of chamfered stone set at an angle to the buttress above (see plate 3). The plinth footings to the east were of the same form as those described between the two buttresses.

- 5.10 For the majority of its length, the ashlar masonry of the Wentworth Chapel continued below the base of the excavation for the French drain. However, the westernmost buttress (D) to the south wall had footings formed partially from inverted fragments of a chamfered offset, whilst beneath the easternmost buttress (E), the top of an *in*

- 5.11 Turning along the north side of the church, the ashlar masonry of the north wall of the chancel continued below the base of the French drain. However, a mass of rubble footings, c.2.5m long, projected from the east wall of the organ chamber. They were surmounted by three pieces of ashlar, apparently *in situ* and pre-dating the wall above. At the north end of the wall, the footings were only visible in plan, projecting 0.60m beyond the angle buttress (F) here; their form and size suggest that they might be the remnants of a larger earlier buttress, but this is not certain.

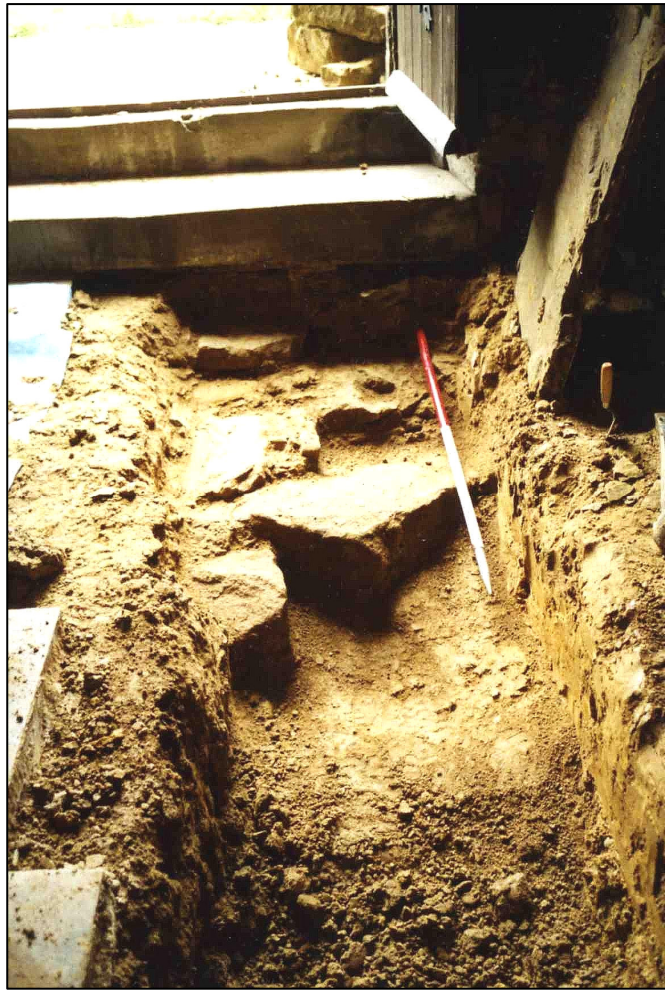
Plate 1: Foundations (004) exposed beneath west wall of tower in initial trench, looking west.

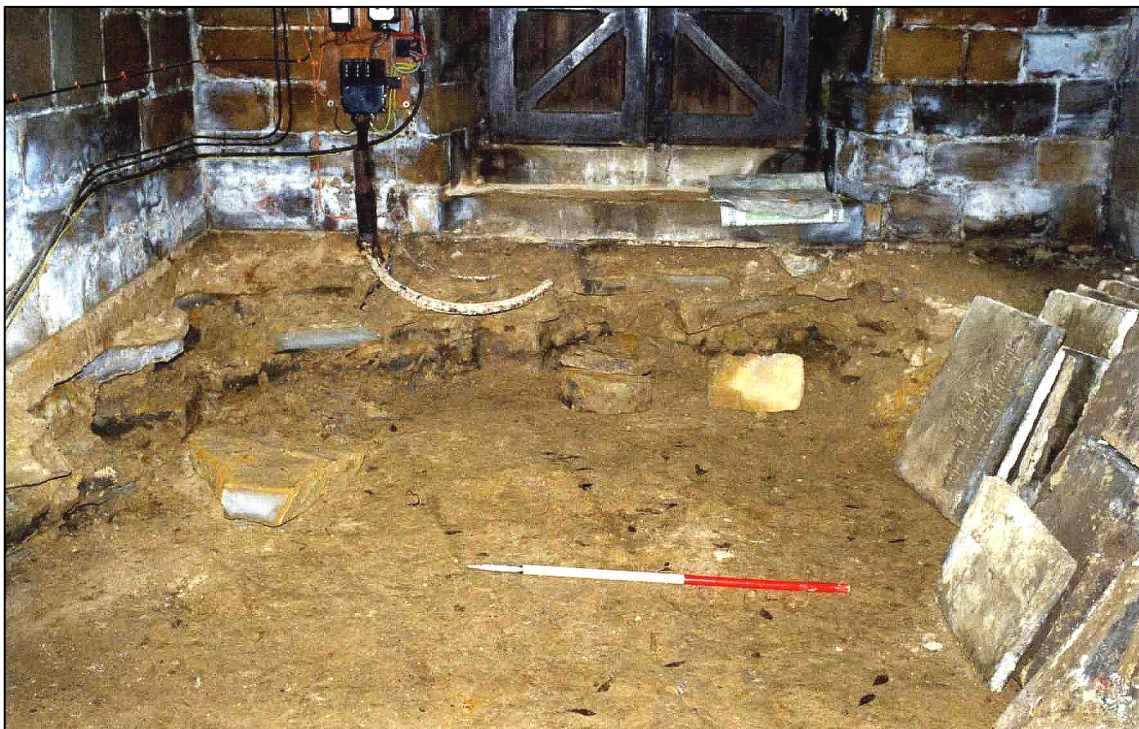
Plate 2: Interior of tower after reduction of floor level, looking west.

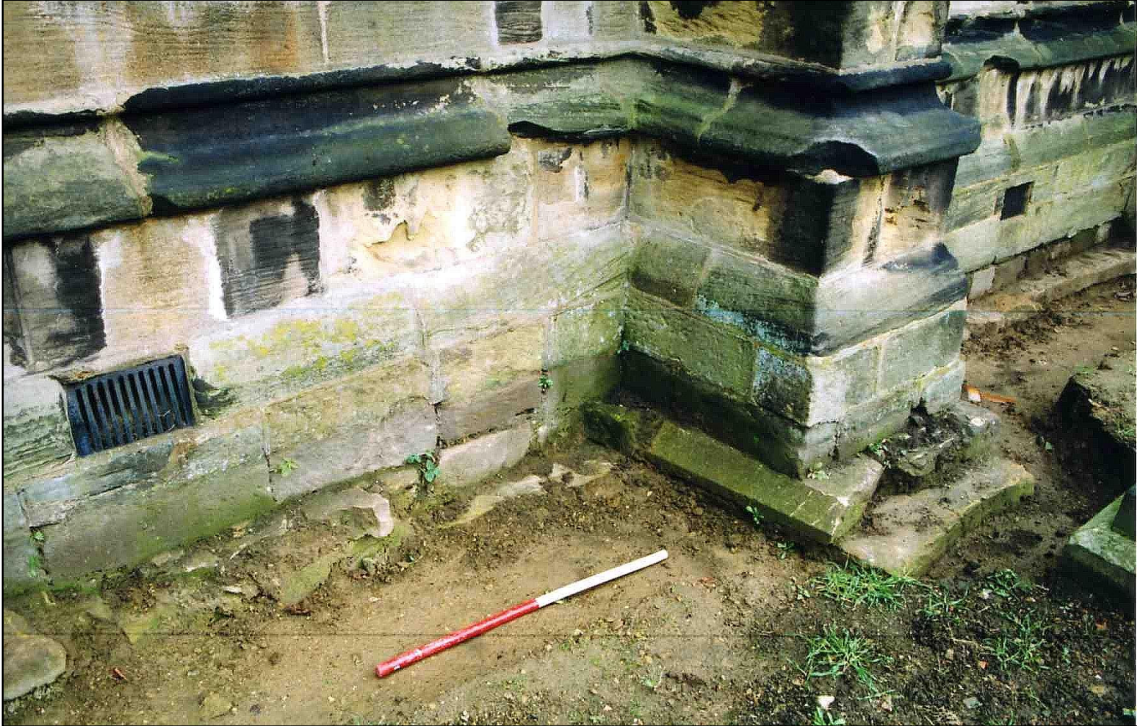
Plate 3: Footings beneath buttress C of south aisle, looking north-east.

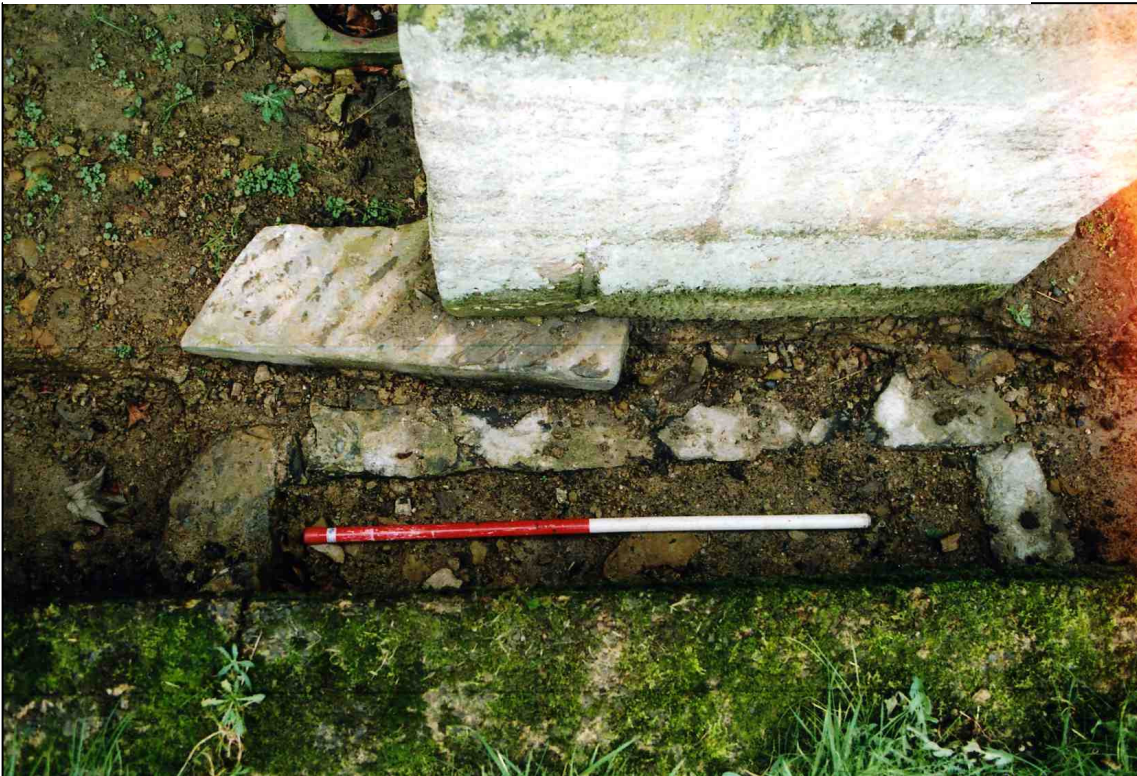
- 5.12 The only feature of interest exposed on the north side of the north aisle was a possible burial vault (010), located immediately adjacent to the north side of the easternmost buttress (G) of the north aisle (see plate 4). The possible vault was only partly visible in the base of the trench, the north side disappearing under the retaining wall of the churchyard. The vault was lined with stone rubble, roughly dressed to the inner face, with internal dimensions of 1.30m in length (east-west) by 0.33m wide (north-south). The fill was very similar in appearance to the surrounding sub-soil (009).

information. The mass of rubble and chamfered offset beneath the east wall of the organ chamber might be the remnants of an earlier structure here, perhaps pre-dating the work undertaken during the mid 19th century, although this is not certain. Similarly, the footings exposed beneath the angle buttress at the north end of the same wall might be the remains of an earlier, larger buttress, although the foundations revealed beneath the tower buttresses also projected outwards for some distance (Roberts 2001). Only the upper levels of a structure (010) exposed on the north side of the north aisle were revealed, but their size and orientation suggest that it is most likely to be a burial vault lined with stone rubble.

Plate 4: Possible burial vault, north side of north aisle.
