ST PETER'S CHURCH,
OLD EDLINGTON, SOUTH YORKSHIRE

ARCHAEOLOGICAL WATCHING BRIEF

Report no: 2005/273.R01
Version: Final
Date: March 2006
Author: Ed Dennison & Shaun Richardson

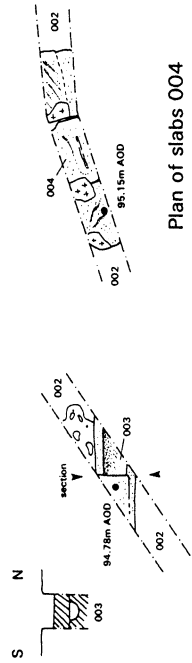
Plan and section of drain 003

- 5.2 Three structures were recorded within, and were partly overlain, by the light brown/orange sandy silt loam (002). To the east of the south-east corner of the chancel, an east-west orientated drain (003) was observed crossing the service trench. This drain had a total width of 0.30m; the lower section was formed by a single piece of brown sandstone dressed to give a concave profile to the upper surface, and this was capped by two more pieces of sandstone bearing prominent diagonal tooling marks. There was a deposit of mixed lime mortar and the light brown/orange sandy silt loam (002) adhering to the north side of the drain. A series of flat slabs set into the ground surface adjacent to the south-east corner of the chancel may mark a western continuation of the drain.

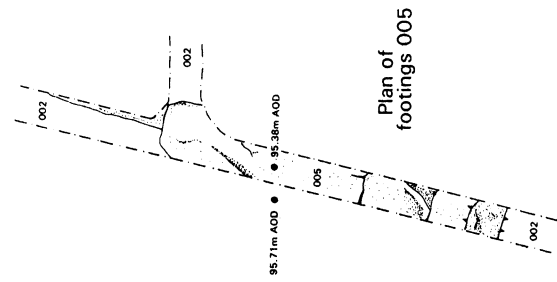
Plan of footings 005

- 5.5 To the south of the porch, a line of north-east/south-west wall footings (005) were exposed in the base of the trench (see plate 2). These footings had a total length of c.3.60m and an average width of 0.45m or less, and first became visible in the west-facing section of the trench some 1.2m to the south of the porch itself. The footings comprised creamy-yellow limestone rubble set with a pink/buff lime mortar and included one large piece of stone over 1.0m in length. The footings terminated at a stone set slightly above the rest of their length, possibly the remnants of an edge or other feature marking the end of the footings.

- 6.2 The limestone wall footings (005) uncovered to the south of the porch are more difficult to interpret. As noted in a previous report (EDAS 1999b), it has always been assumed that the porch was added to the church at a relatively late date; Philipps notes in 1874 that the Norman south doorway was in an excellent state of preservation "owing to its having been protected from the effects of the weather by a more modern porch...". The footings exposed in the service trench did not appear to form part of any earlier porch structure, and indeed seemed to bear little relation to the church itself. At present, their date and function remains unclear - it is possible that they might be part of another detached structure or be associated with former drainage works or a burial chamber.

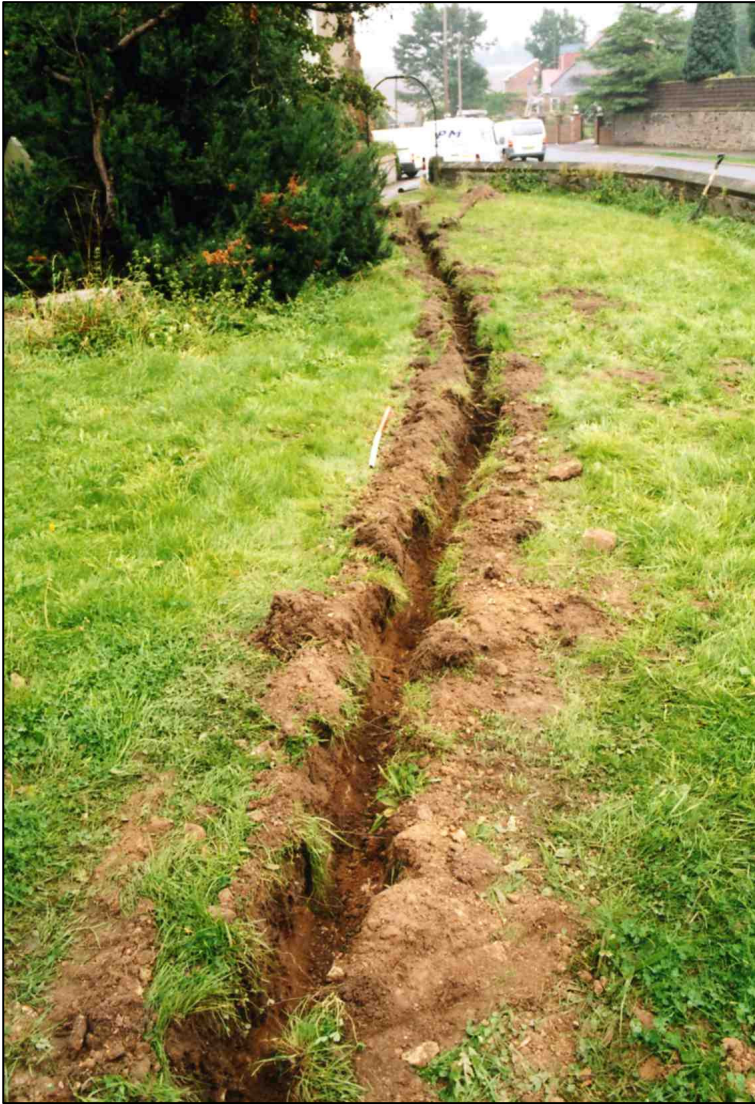
Plate 1: General view of service trench, looking north-east.

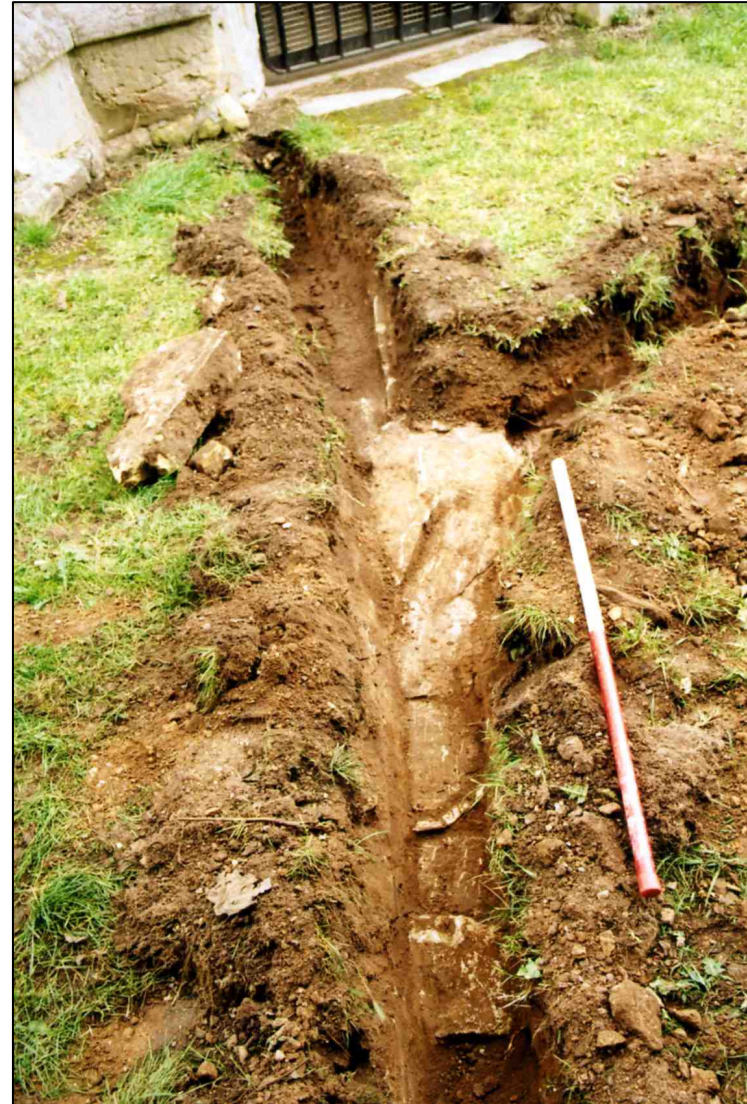
Plate 2: Wall footings (005) to the south of the porch, looking north-east.
