ST PETER AND ST PAUL'S CHURCH,  
PICKERING, NORTH YORKSHIRE  
ARCHAEOLOGICAL WATCHING BRIEF

ARCHAEOLOGICAL WATCHING BRIEF

Report no: 2006/292.R01  
Version: Final  
Date: July 2007  
Author: Ed Dennison

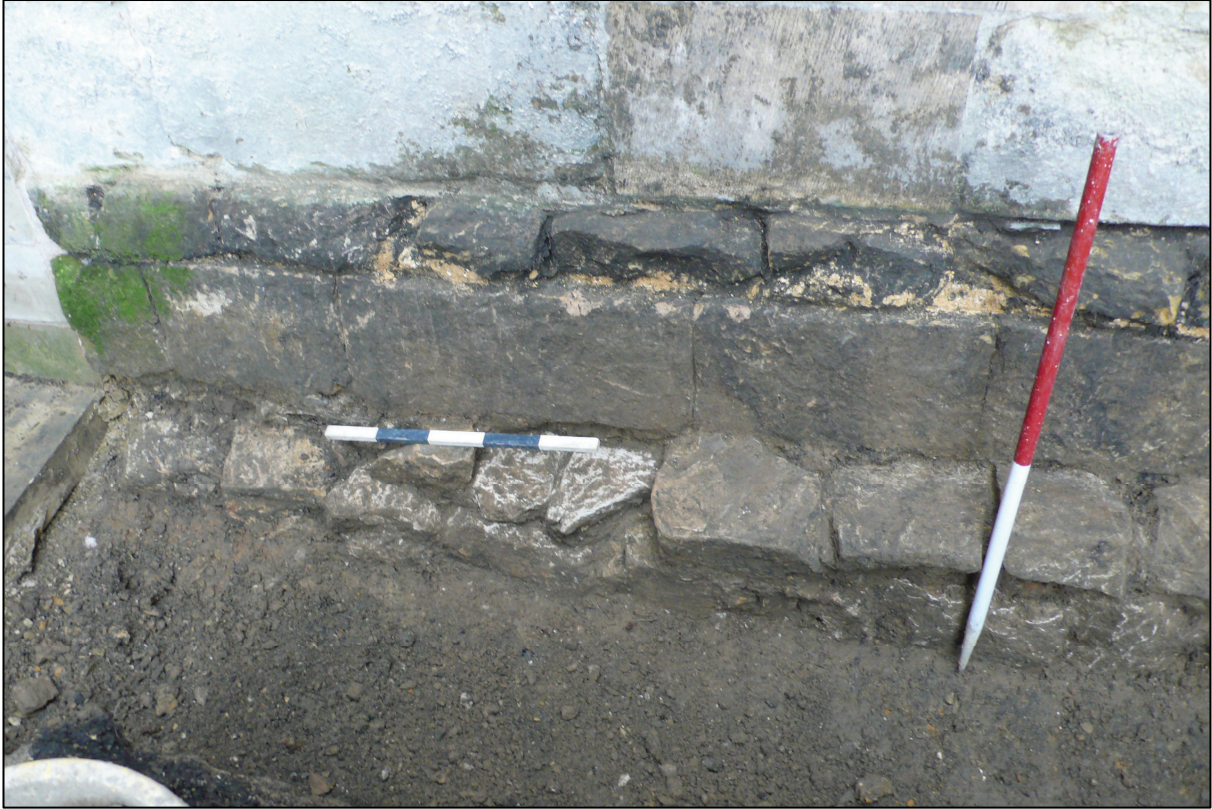
- 4.6 The foundations of the west wall of the south chapel and the south wall of the chancel (006 and 017 respectively) were exposed by the groundworks, and were both seen to be composed of soft yellow semi-dressed sandstone rubble of a generally uniform character (see plates 1 and 2). These foundations stepped out from, and appeared to be on a slightly different alignment to, the chamfered plinths and walls of the south side of the chancel (022 and 019) and the west wall of the south chapel (020), which have a more east-west alignment but which rest on these foundations. It appears that the foundations might well be those of an earlier structure, and this is reinforced by the curious relationship between the upper and lower parts of the buttress located at the south-west corner of the south chapel.

Plate 1: Exposed foundations of south chancel wall (017), looking N.

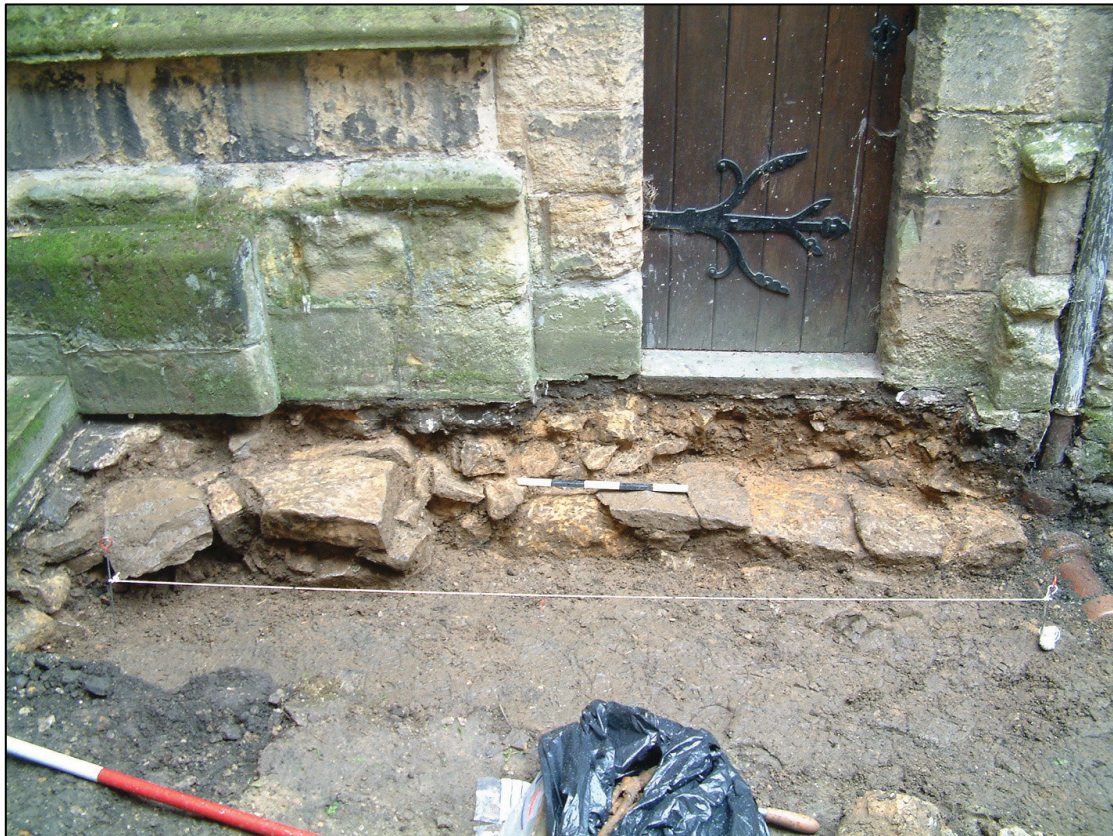
Plate 2: Exposed foundations of west wall of south chapel (006), looking E.

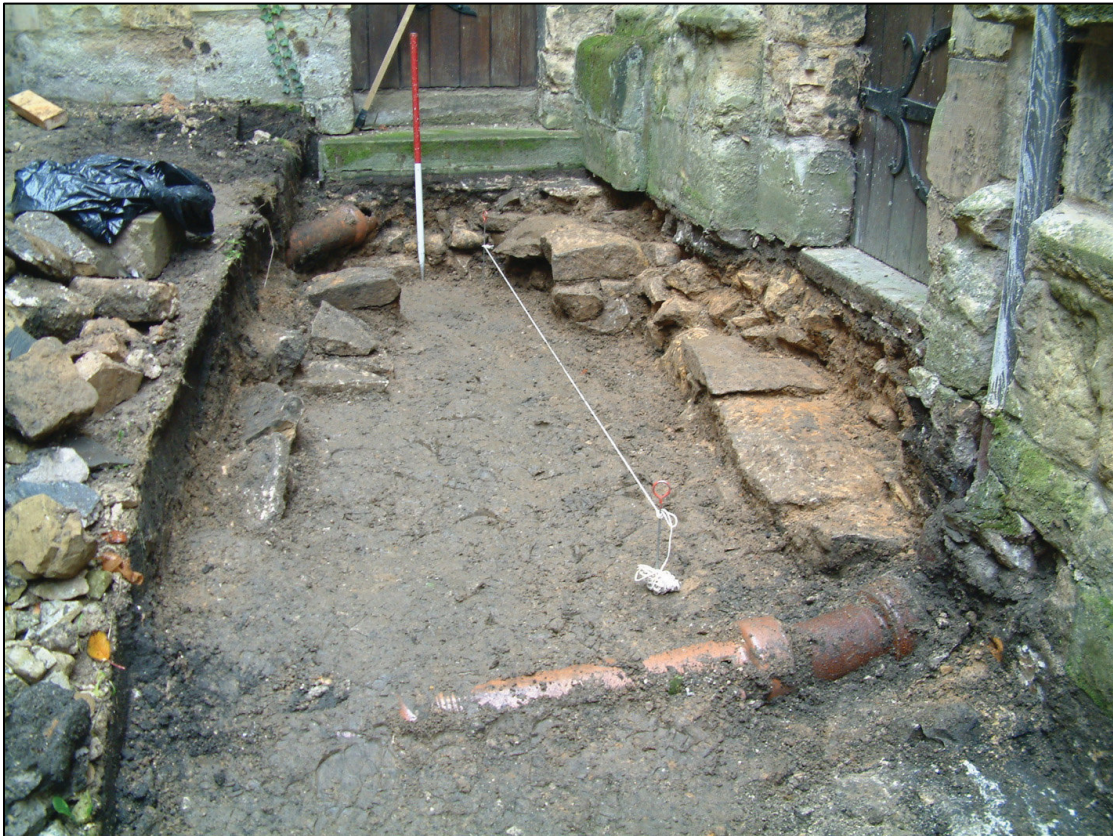
- 4.3 Halfway along Trench 1, an east-west aligned salt-glazed ceramic drainage pipe (009) was seen below the flagstone path (001), running away from a downpipe secured to the west wall of the south chapel (see plate 3). The pipe had been inserted into a 0.3m wide trench (011) which had been cut through the dark brown loam (002) and into the grey-brown gritty clay (013). The flagstones forming the surface of the path in the southern part of the trench were simply lifted and relaid, with no further ground disturbance.

Plate 3: General view of Trench 1, looking N.

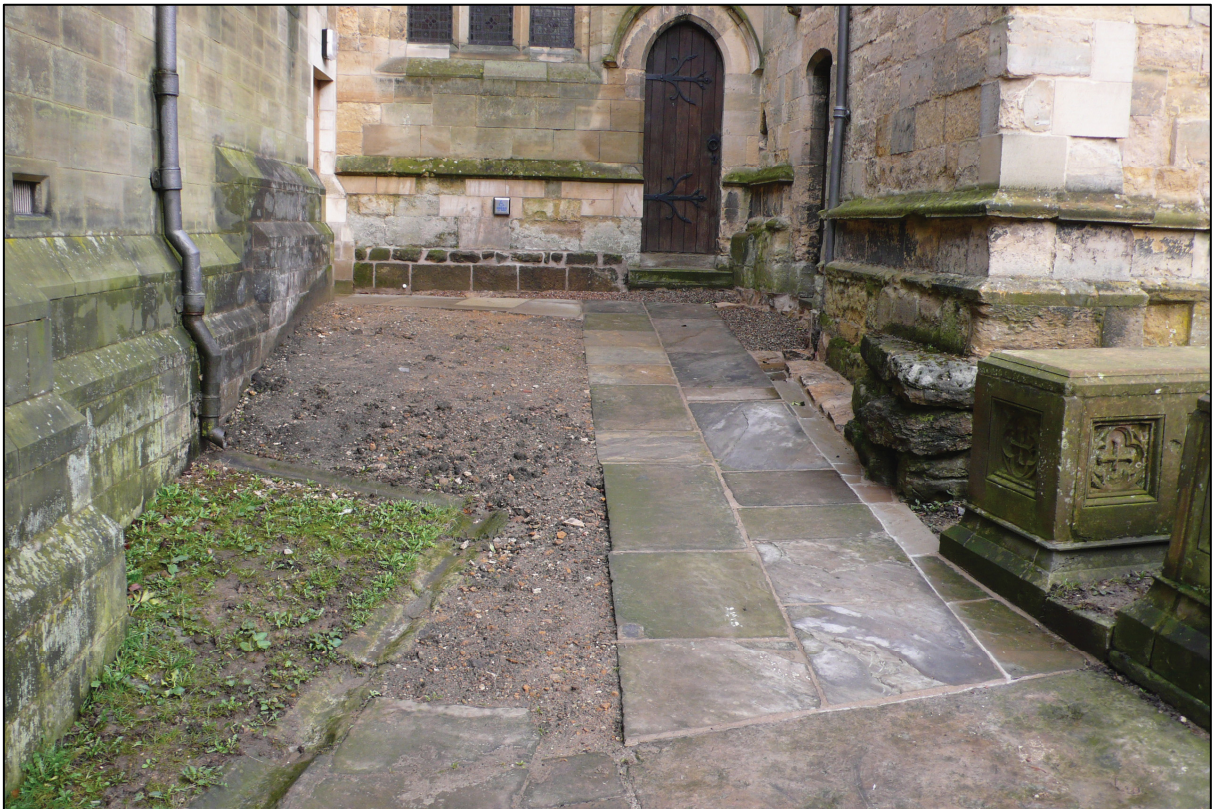
- 4.7 This south-west corner buttress appears to have been built on top of what seems to be a differently aligned and presumed older structure (010), possibly another buttress (see plate 4). The angle of the older rubble stonework (010) is more consistent with the adjacent exposed foundations (006) to the north, although it is not perfectly aligned, and the top of the older stonework lies 0.28m above the

exposed foundations and 0.71m above the existing adjacent ground level. The upper part of the east side of the buttress is flush with the presumed older base, which may have been reshaped to fit. Without exposing more of the older structure (010), which was not within the area of the watching brief, it was not possible to clarify its relationship with the other foundations (006) or indeed the south chapel in general. However, it was noted that one of the partially visible large limestone fragments (024) forming the top of the presumed older structure was dressed and had a large chamfer visible; it might possibly be a re-used hog-back stone or a remnant from a chamfered plinth, placed upside down. The adjacent stone, also forming the top of the older structure, was an unusual dark grey stone (025) of uncertain origin.

Plate 4: Completed works, looking N.
