ST PETER'S CHURCH, ROWLEY,
EAST YORKSHIRE

ARCHAEOLOGICAL OBSERVATION,
INVESTIGATION AND RECORDING

Report no: 2006/291.R01
Version: Final
Date: January 2007
Author: Shaun Richardson & Ed Dennison

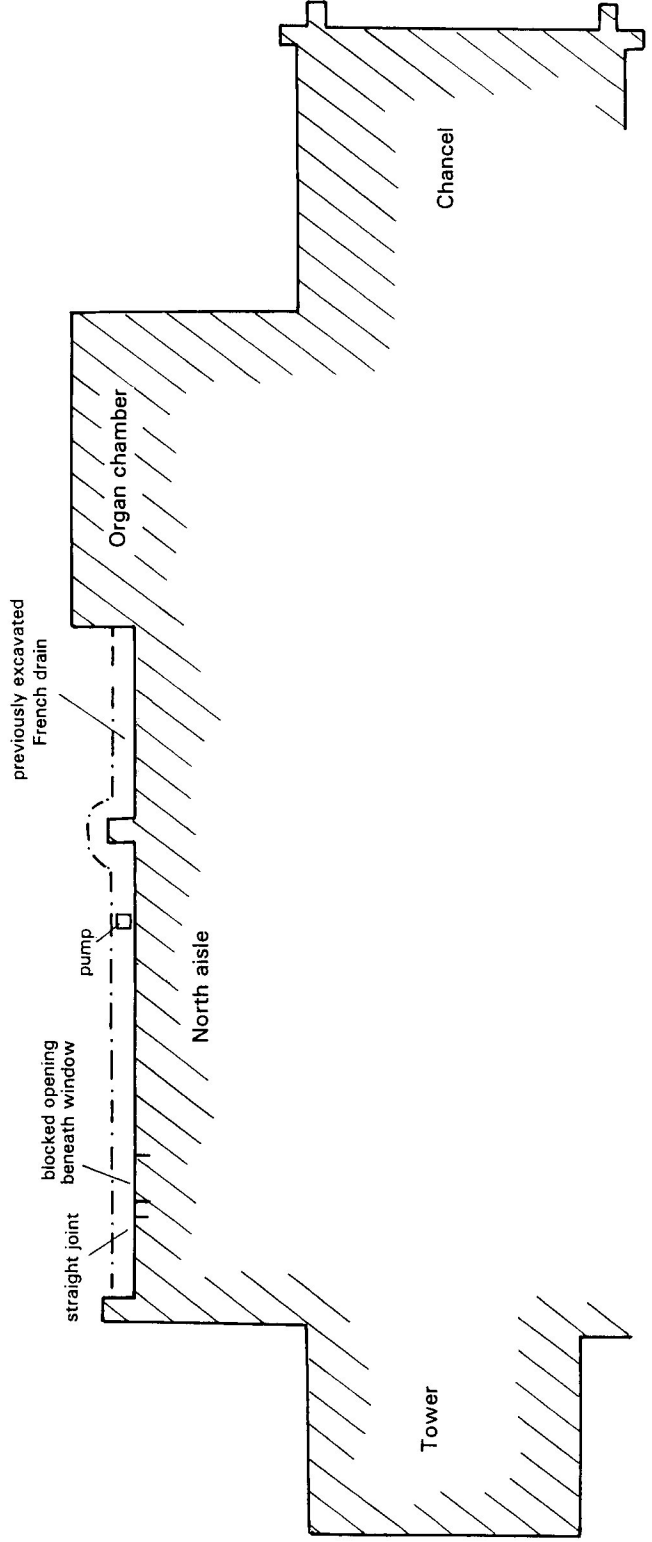
PROJECT	ST PETER'S CHURCH, ROWLEY		
TITLE	WATCHING BRIEF RESULTS		
SCALE	AS SHOWN	DATE	JAN 2007
	EDAS	FIGURE	2

- 5.1 As noted above, the below-ground excavations were limited to the digging of a small test pit to the north of the north aisle (see figure 2). The pit was 0.90m square and was excavated to depth of 0.90m below the existing ground level. Beneath the 0.20m depth of black silt loam topsoil (001), a compacted mid brown silty clay (002) was exposed, containing frequent inclusions of angular chalk pieces up to 0.15m across. The clay (002) continued beyond the bottom of the test pit, becoming more chalky towards the base. No artefacts were identified.

- 5.2 As noted above, two underground water storage tanks were identified to the north of the church. A stone slab covering the mouth of the southern water tank is located 5.60m to the north of the north aisle (see figure 2). When the slab was raised, a circular opening 0.50m in diameter with inclined sides was exposed. The tank had a bell-shaped section, with a maximum diameter of c.2.20m and a depth of c.3.30m; there was c.0.50m of water in the base at the time of survey. The sides of the tank were largely rendered, but where this had fallen away the tank could be seen to be built of red handmade bricks (average dimensions ? by 120mm by 100mm) set with a lime mortar. Two inlets were noted towards the upper part of the tank's south-east and south-west sides, both connected via drains to down pipes on the north aisle's north wall. An overflow outlet was positioned at a high level on the south-west side, whilst a lead pipe rises from the south side to serve a pump fixed to the north aisle's north wall. This pump is housed in a rotting wooden case (see plate 3).

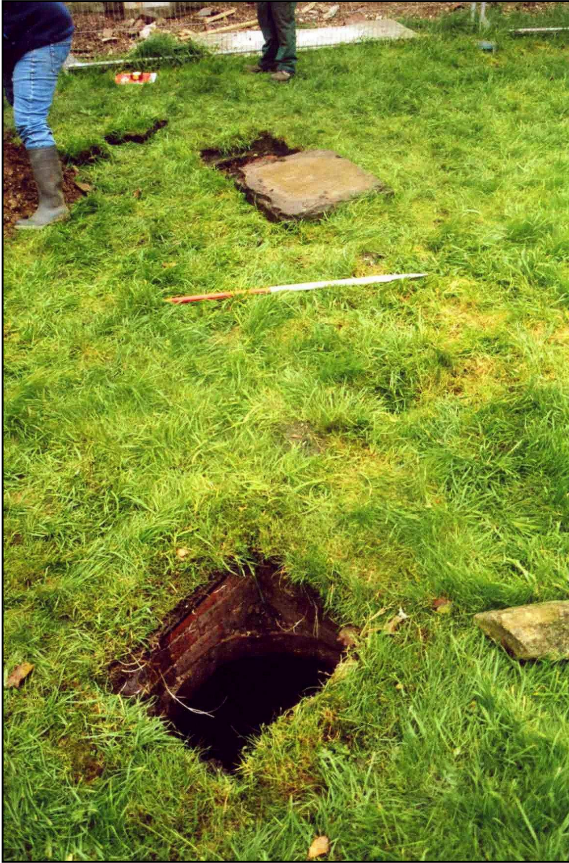
- 5.3 A galvanised lid covering the mouth of the northern water tank is located 9.10m to the north of the north aisle, to the north of the previous chamber (see plate 1). When the lid was raised, a 0.50m square opening built of modern machine-made brick was exposed, clearly a later addition to the original 0.52m diameter opening which had inclined sides. This tank also had a bell-shaped section, with a maximum diameter of c.2.60m and a depth of c.3.80m; there was c.0.50m of water in the base at the time of survey. The sides of the tank were largely rendered, but where this had fallen away the tank could be seen to be built of red handmade bricks (average dimensions ? by 120mm by 100mm) set with a lime mortar. Restricted access to the interior made it difficult to locate inlets or outlets but it is likely that a lead pipe rising up the north side of the interior once served a pump in this area, possibly located to the north of the adjacent churchyard wall.

Plate 1: Openings of both underground water storage tanks, looking S.

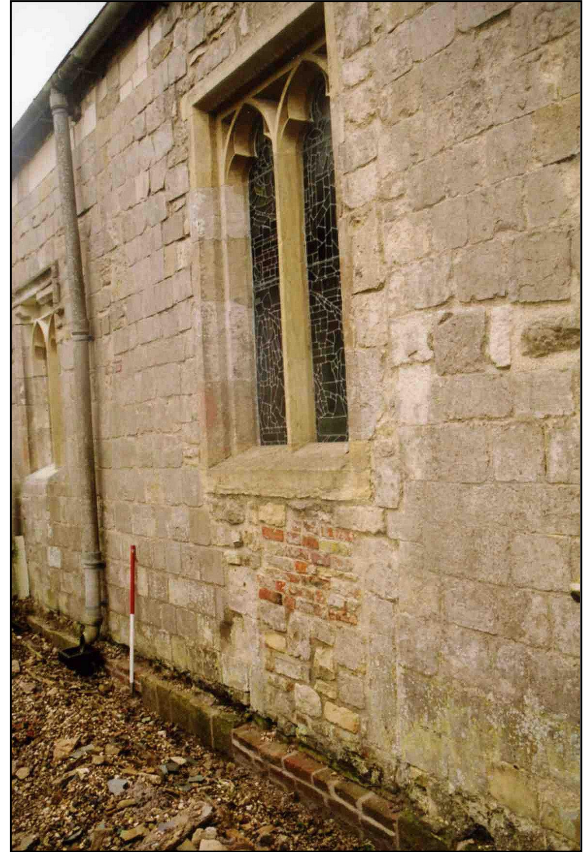
- 5.4 The existing trench containing the French drain along the whole of the base of the north aisle was cleaned out to a depth of 0.30m, with an average width of between 0.30m and 0.50m. This work revealed no deposits of archaeological interest, although a slightly projecting plinth was exposed at the base of the north aisle. Towards its west end, the plinth was interrupted by a 0.90m wide brick blocking, corresponding with a similarly-sized blocking beneath the two-light window above (see plate 2). The blocking appeared to fill a former opening, presumably a doorway, beneath the window , whilst a straight joint rises up the west side of the window to the level of the eaves. This joint, and the appearance of the other masonry surrounding the window, suggests that it is a later insertion here.

Plate 2: West end of north aisle, showing blocked opening beneath window, looking SE.

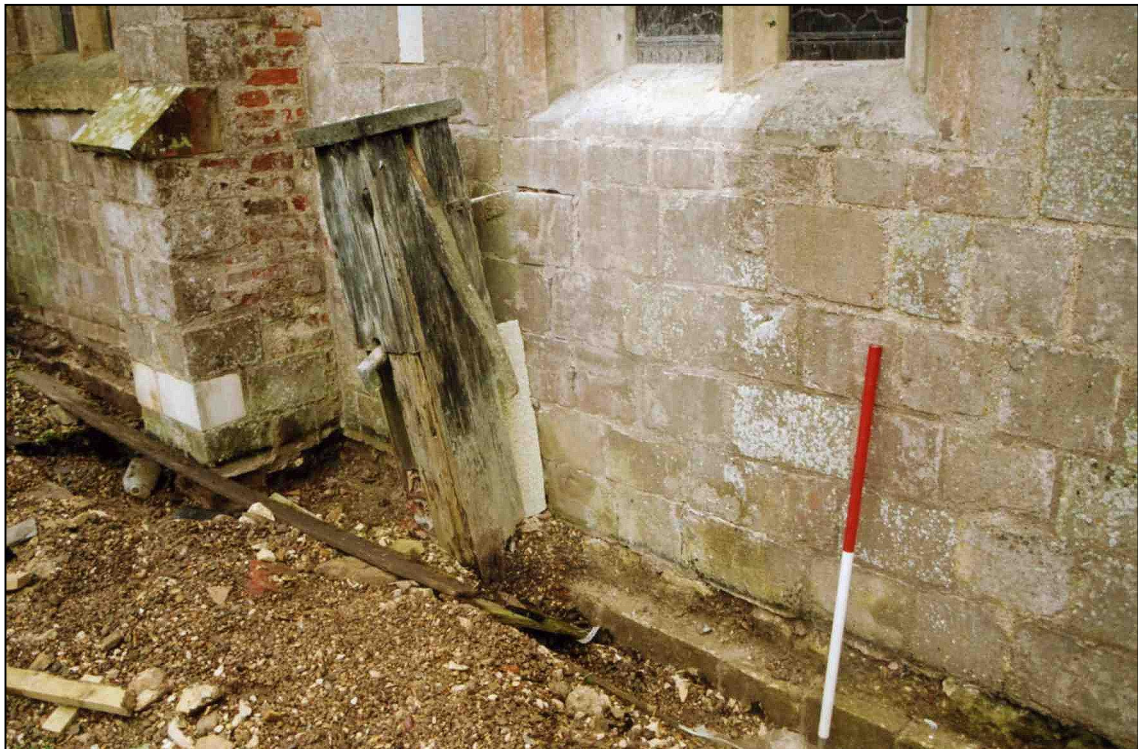
Plate 3: Central part of north aisle showing old pump and cleaned out French drain, looking SE.
