GRINTON LEAD SMELTING MILL,  
COGDEN GILL, SWALEDALE,  
NORTH YORKSHIRE

ARCHAEOLOGICAL RECORDING AFTER  
JULY 2019 FLOOD DAMAGE

Report no: 2019/599.R01  
Version: Final  
Date: August 2020  
Author: Shaun Richardson & Ed Dennison

Yorkshire Dales National Park Authority  
Yoredale  
Bainbridge  
Leyburn  
North Yorkshire DL8 3EL

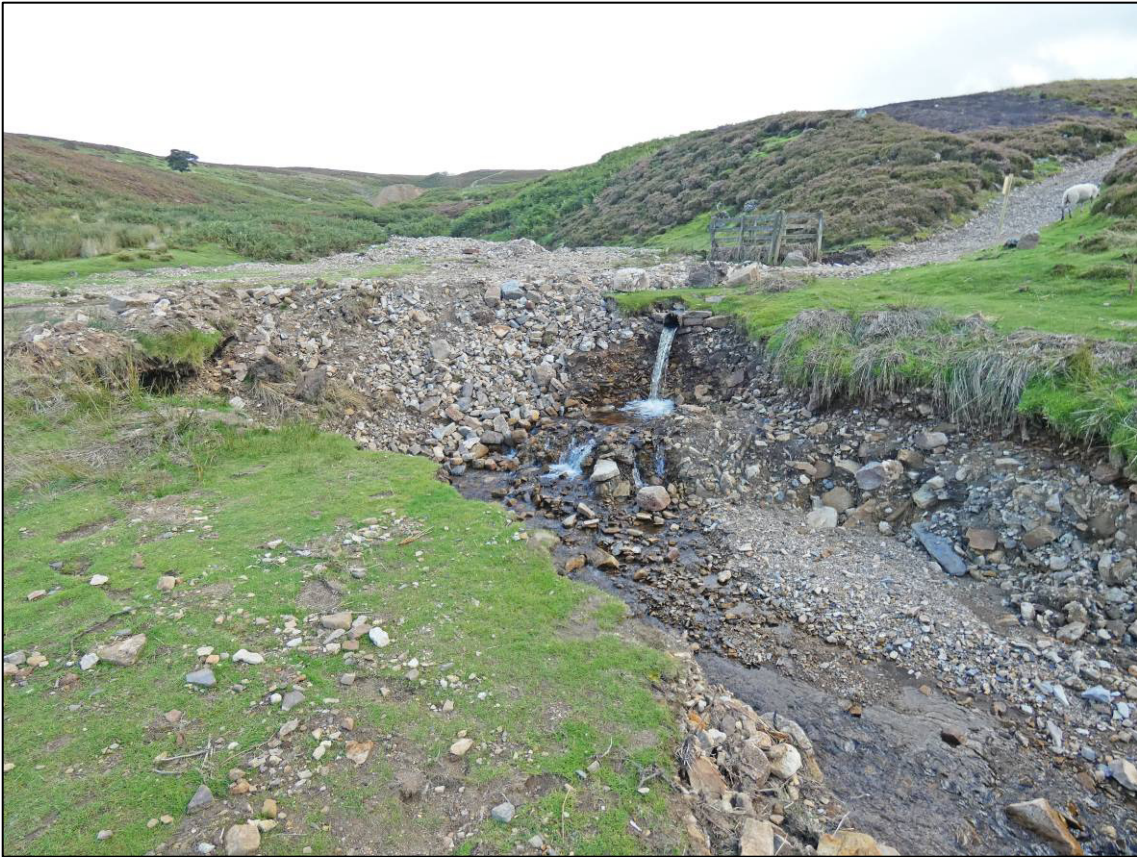
Plate 3: Flood damage adjacent to spring outfall, with reinstated track across gully, looking S (photo 2/900).

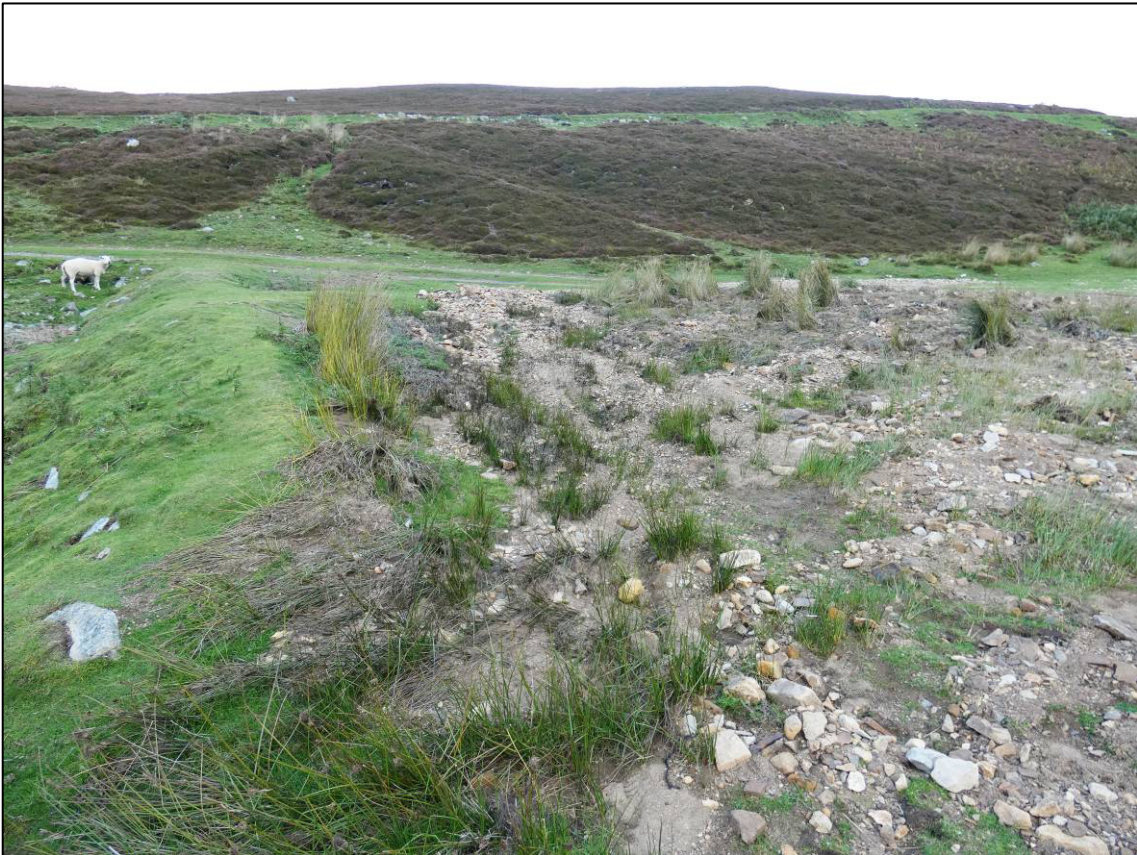
Plate 4: Flood debris in reservoir, looking E (photo 2/901).

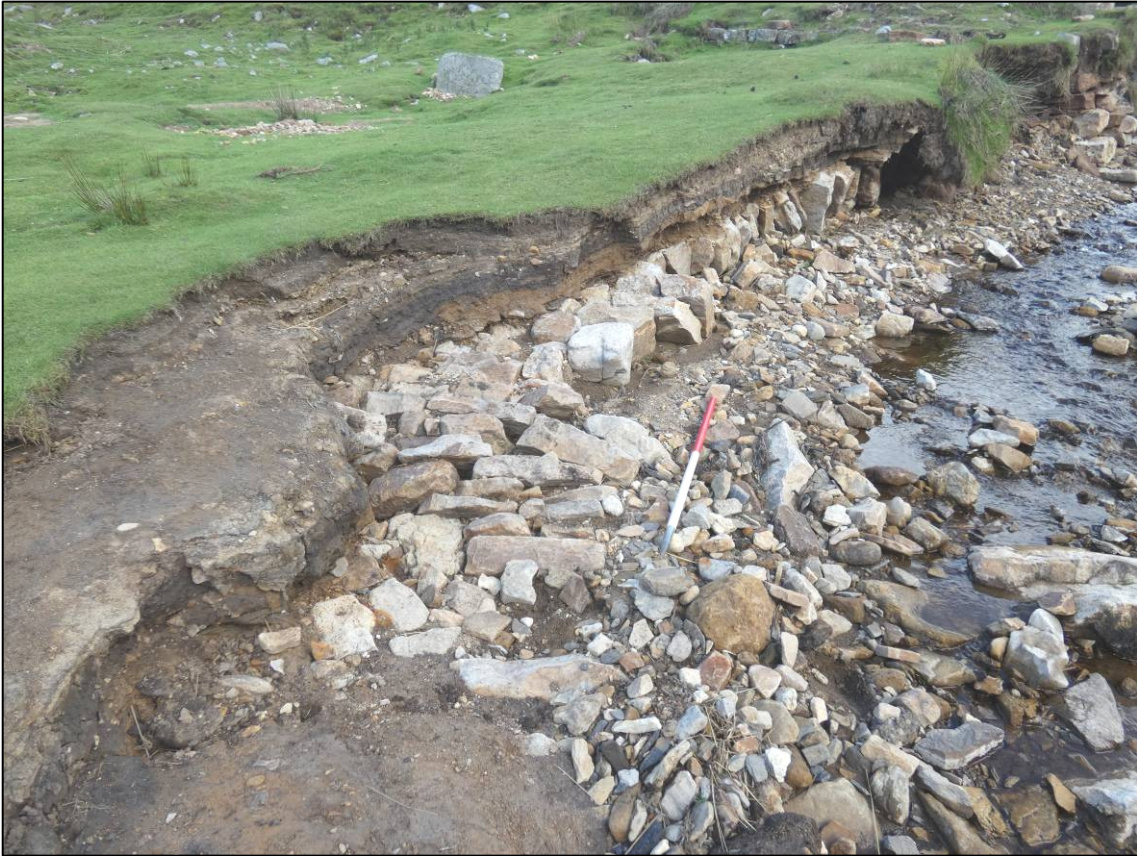
Plate 5: Exposed section of pitched stone surface in east side of beck/spillway, looking S (photo 2/896).

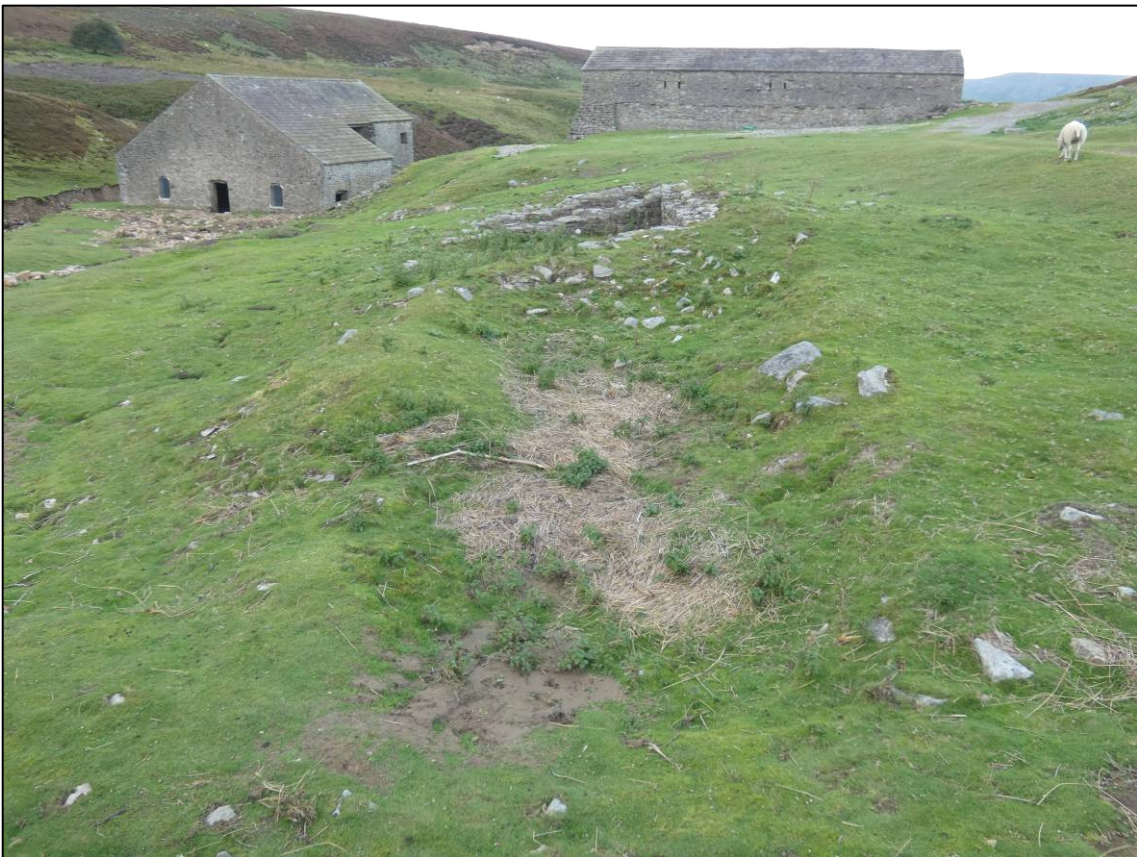
Plate 6: Flood debris in south cell of smithy range, looking N (photo 2/904).

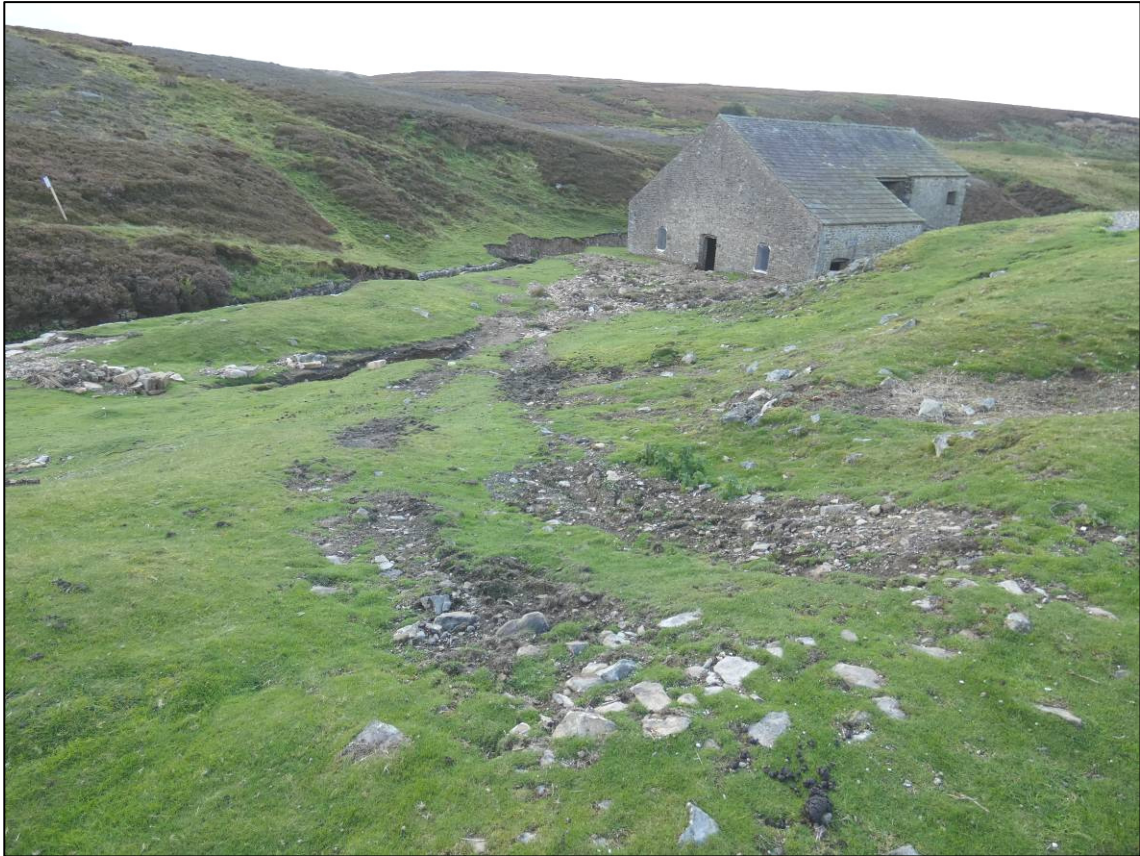
Plate 7: Erosion scars following vehicle tracks off north-west corner of smithy range, looking NW (photo 2/890).

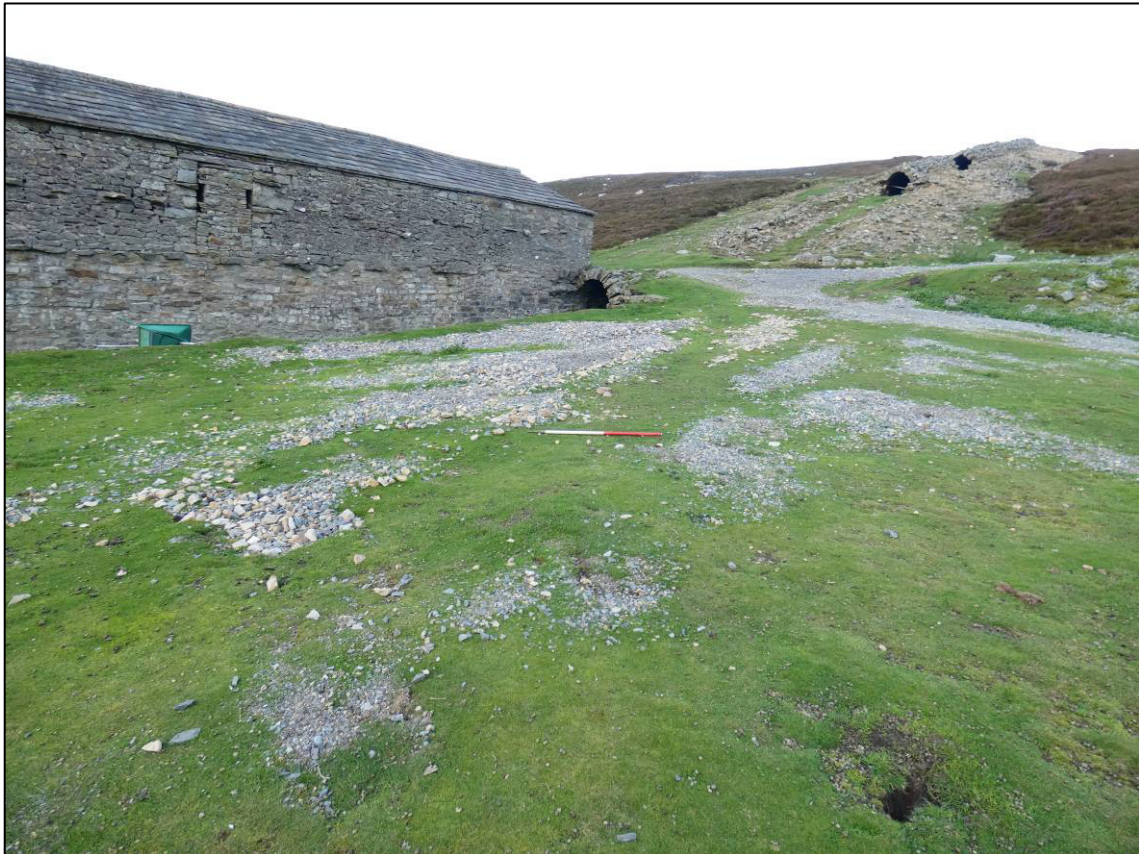
Plate 8: Abraded gravels washed into area to south of peat house, looking E (photo 2/889).

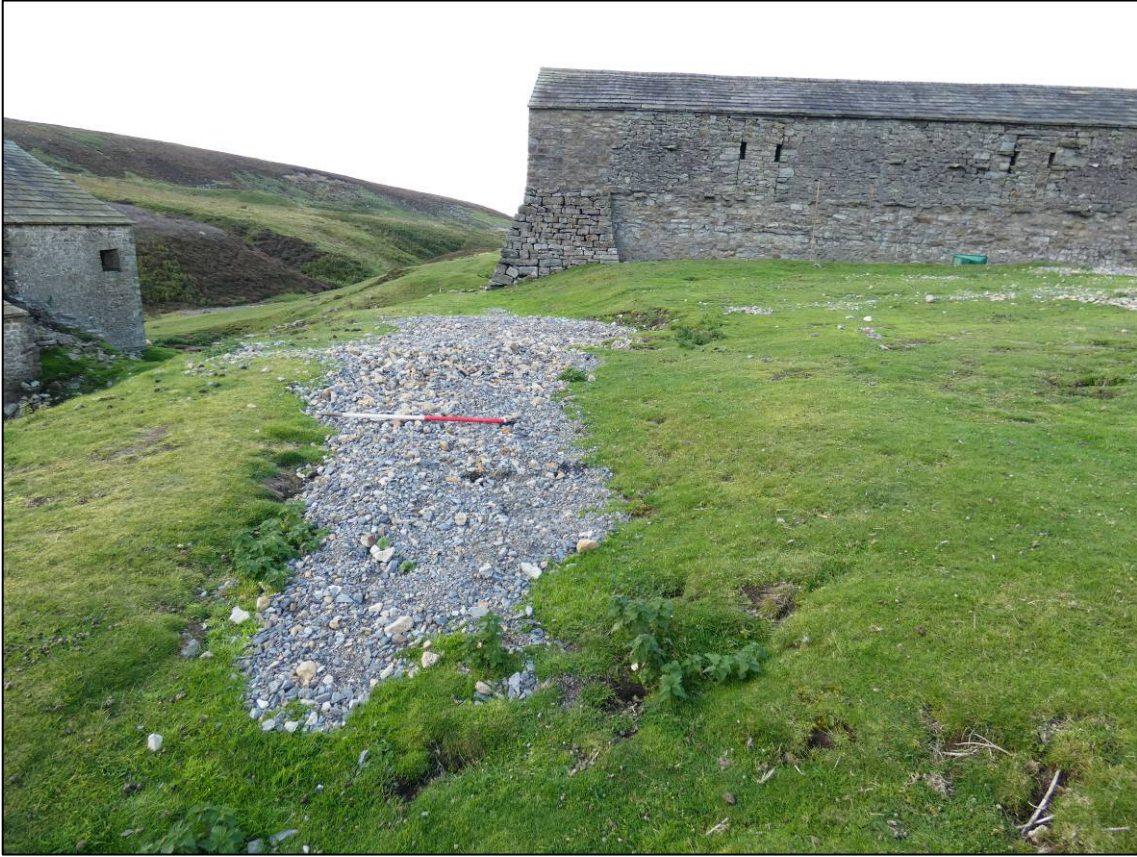
- 3.10 The higher part of the area between the dam and the smelt mill, to the west of the track, was unsurprisingly less damaged than the lower part adjacent to the beck. To the north of the dam, the southernmost cell of the former office/smithy range, formed by a sub-rectangular earthwork, had had a small amount of silt and vegetation washed into it by the floodwater, although the earthwork itself was largely unaffected [2/904] (see plate 6). Further to the north, water had scoured out a pair of vehicle tracks leading down the slope towards the smelt mill; the tracks were c.16m long and c.3m wide in total [2/890, 2/892] (see plate 7). The flooding had also washed down a large spread of small angular stones and gravel from the adjacent track into the area to the south of the peat house, forming an abraded pattern [2/889] (see plate 8), and some of this material partly filled the earthwork marking the former course of the leat to the smelt mill ('p') [2/888] (see plate 9).

Plate 9: Gravel washed into line of head race off south-west corner of peat house, looking N (photo 2/888).

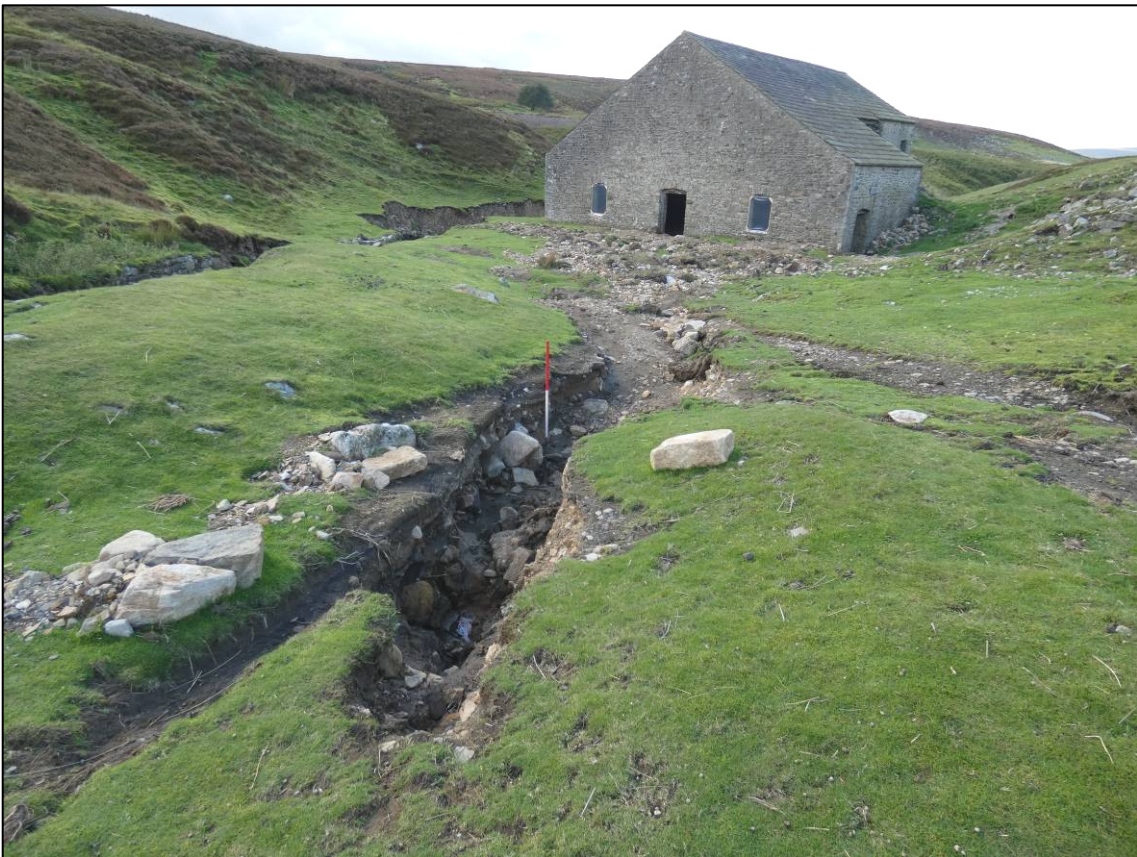
rather than being caused by flood water coming over the dam, the channel had been created by water exploding through an underground fissure (Miles Johnson, YDNPA, *pers. comm.*).

Plate 10: Erosion channel to south of smelt mill, looking NW (photo 2/894).

- 4.5 Further to the north, the prominent erosion channel that may have been caused by water exploding through an underground fissure to the south of the smelt mill was infilled. The wider spread of loose material washed down by the flood into the area to the immediate south of the smelt mill was then stripped away to the former pre-flood turf level, using a toothless scraper bucket; as the ground surface was not to be disturbed, and was in any case devoid of any earthworks, this was not subject to detailed archaeological monitoring [4/143]. A c.11m long section of the west revetment wall of the canalised beck was rebuilt using large sub-rectangular stone blocks, including the c.5m long section which had collapsed during the flooding [4/141, 4/142] (see plate 39). Any erosion behind the new wall was then infilled with reclaimed material.

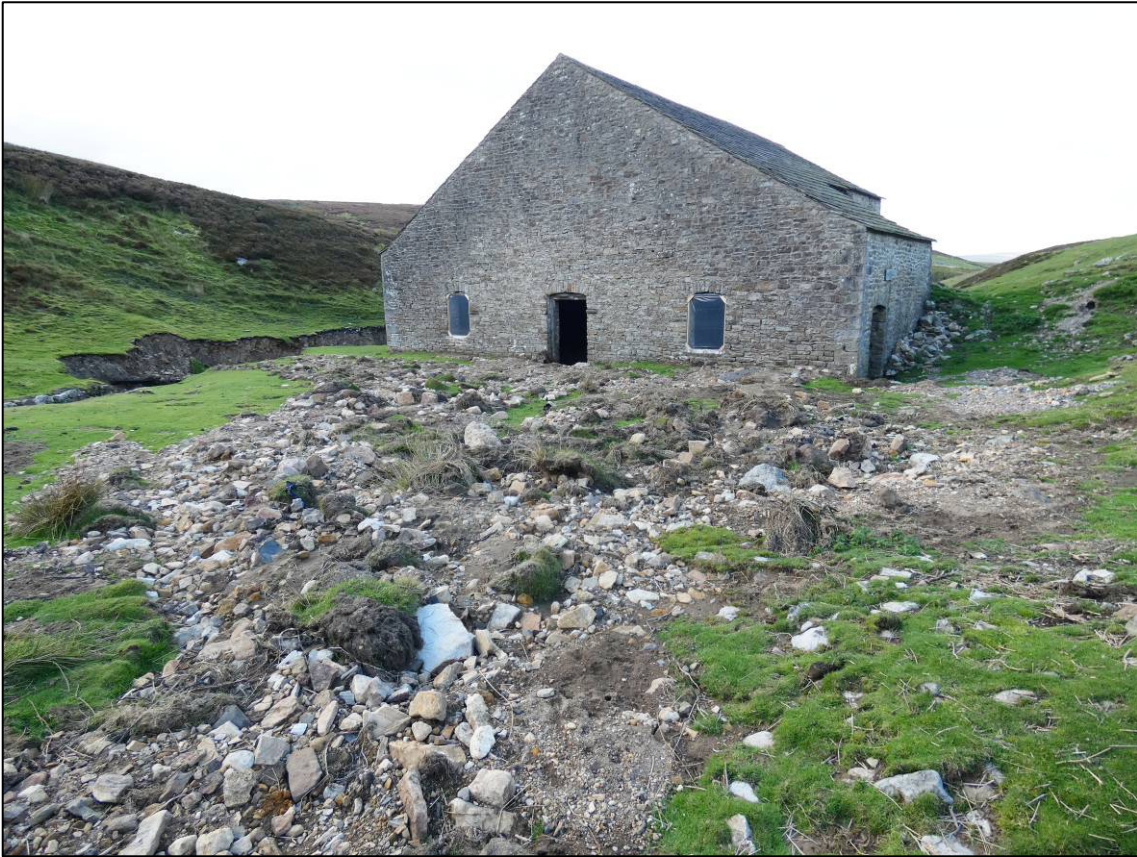
Plate 11: Flood debris to south of smelt mill, looking N (photo 2/891).

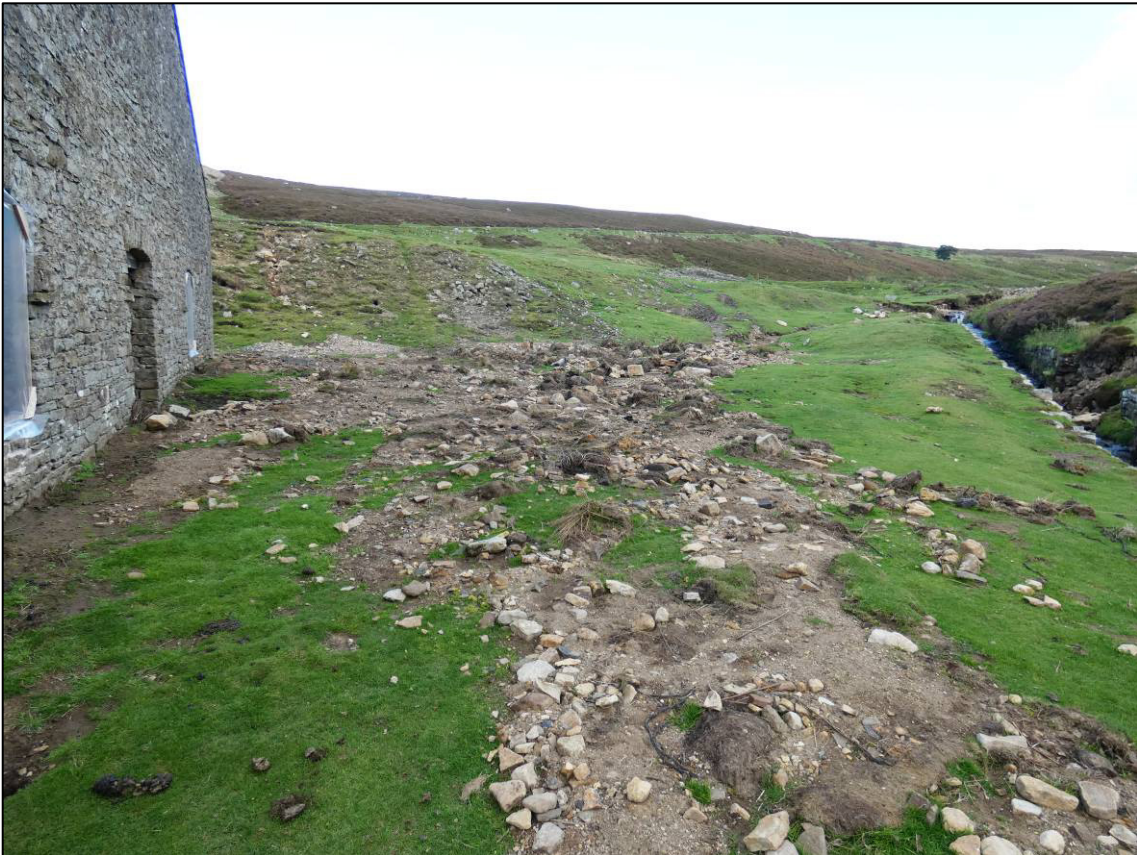
Plate 12: Flood debris to south of smelt mill, looking SE (photo 2/869).

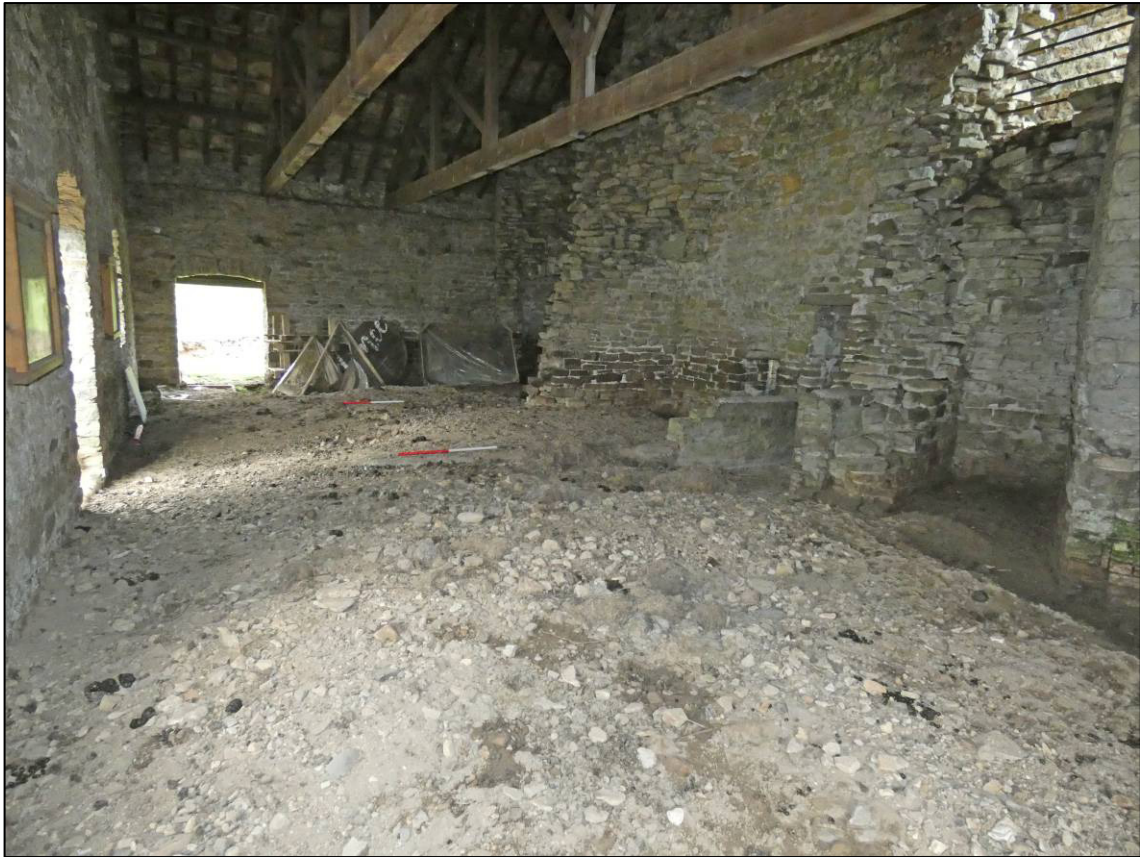
Plate 13: Flood debris in furnace room of smelt mill, looking W (photo 2/907).

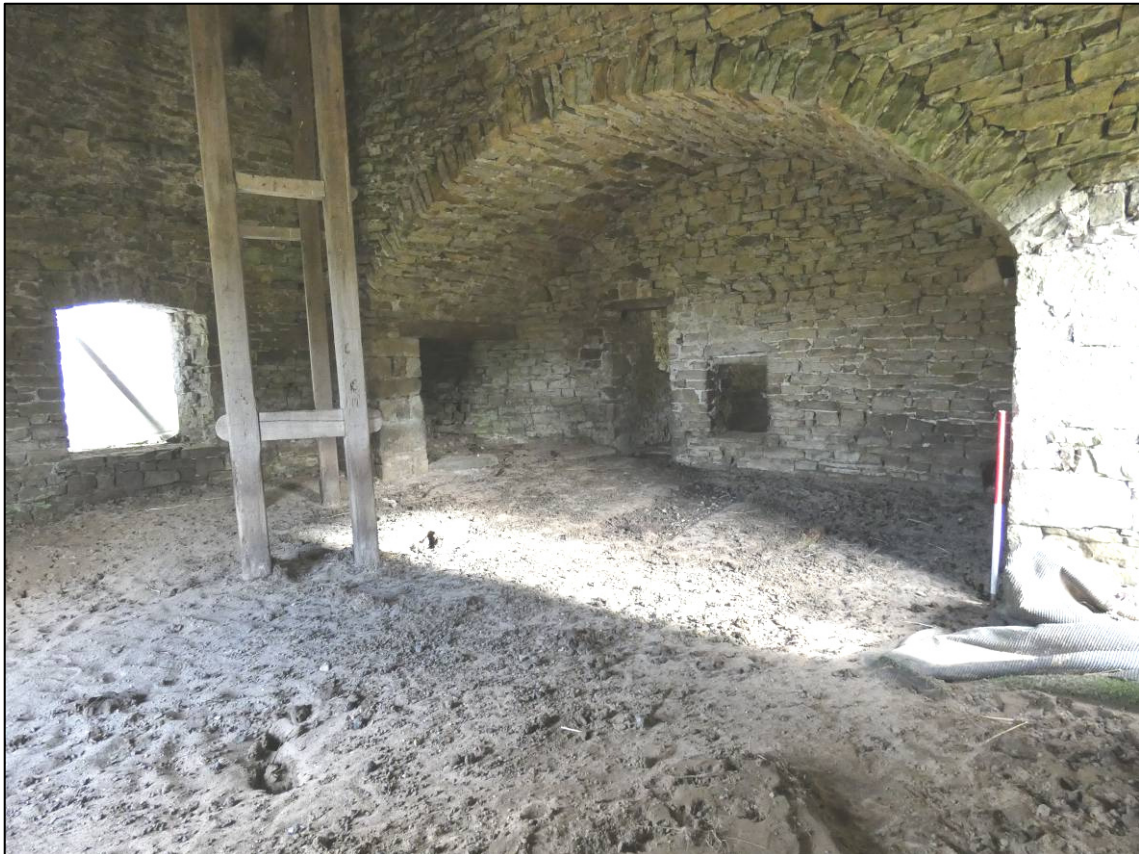
Plate 14: Flood debris in bellows room of smelt mill, looking SE (photo 2/924).

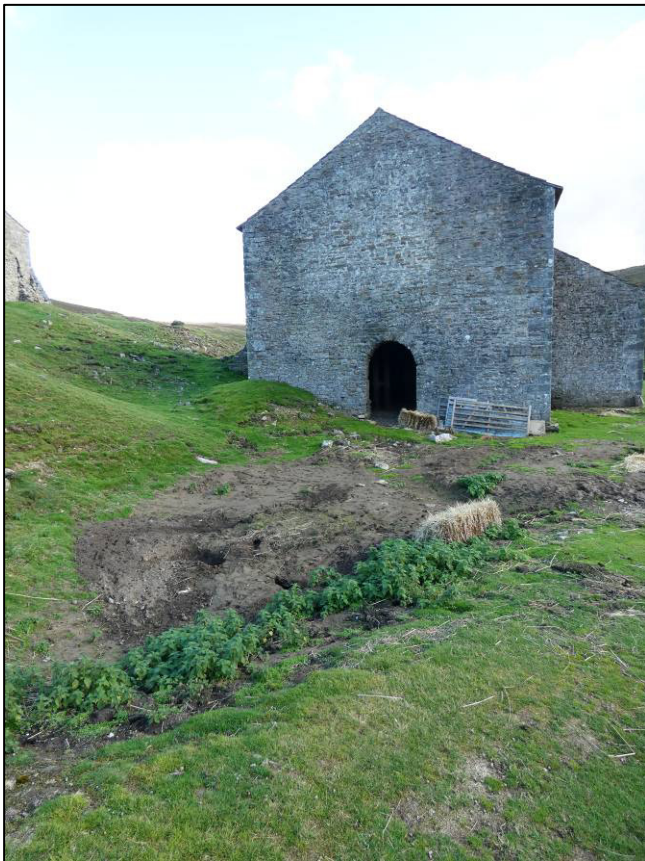
Plate 15: Flood debris in depression to north of smelt mill, looking S (photo 2/857).

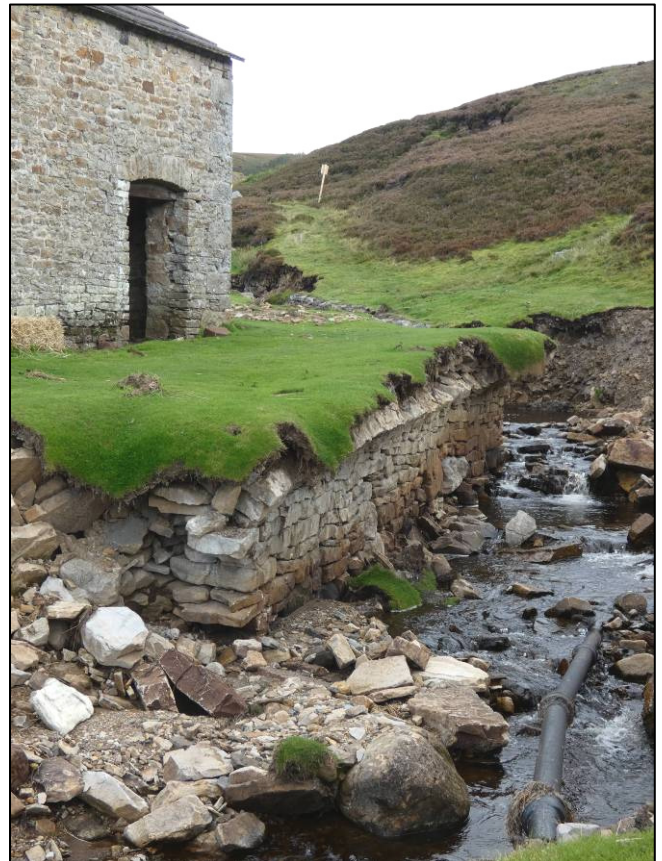
- 3.19 The culverted section of the beck, which extended for a distance of c.34m at the time of the 1996 survey (the northern c.7m having been repaired at this time) had been almost completely destroyed by the flooding. At the point where the south end of the culvert used to begin, the flood water had gouged out a second large pool, also removing the pitched rubble base here [2/867, 2/878, 2/879] (see plate 19). The beck now ran in a channel measuring up to 6m wide and with near vertical sides over 2m deep [2/859, 2/860, 2/876, 2/877], bringing it to within less than 3m of the smelt mill's south-west corner [2/852, 2/854] (see plate 20). A 9m long section of the culvert's east wall survived in the side of the beck adjacent to the smelt mill, with a substantial soil overhang to the upper part [2/872-2/875, 2/880; 3/818, 3/820-3/822] (see plates 16 and 21). There was no evidence remaining for the corresponding west wall.

Plate 16: Remains of culvert wall, east side of beck adjacent to smelt mill, looking SE (photo 2/873).

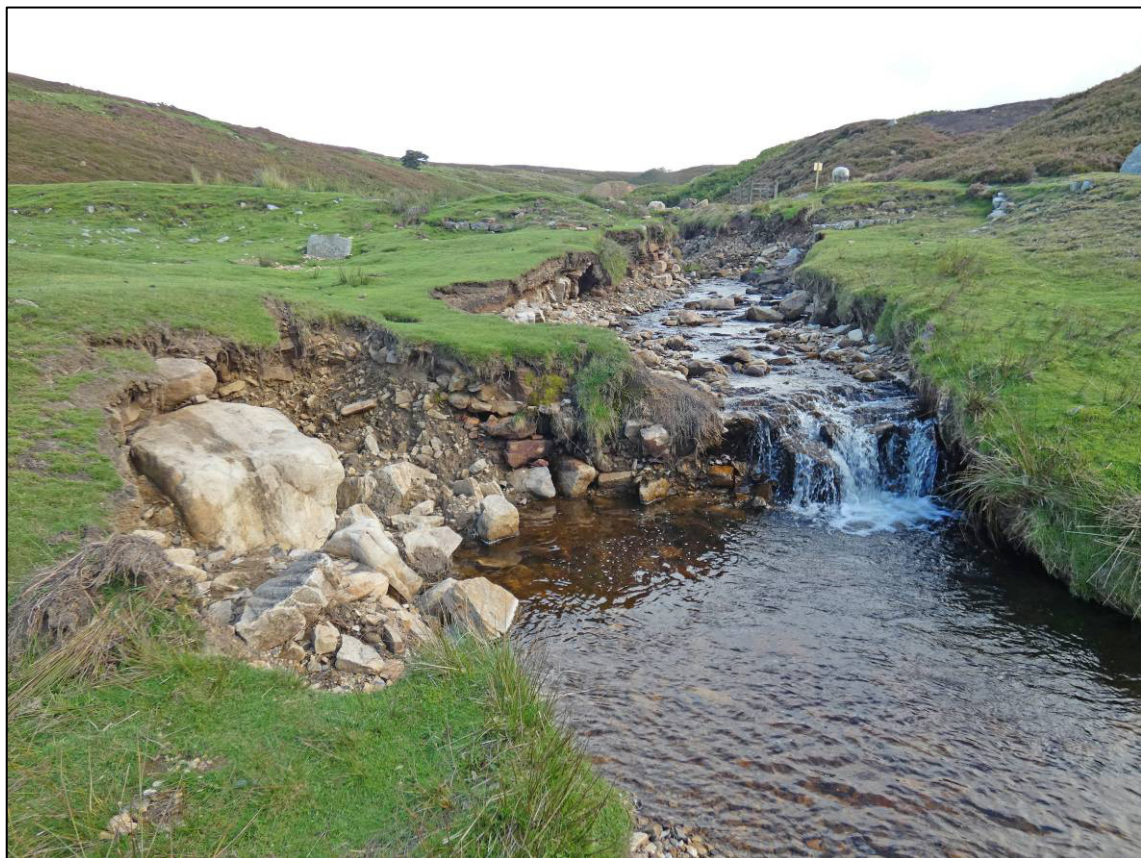
Plate 17: Flood damage to beck between dam and smelt mill, looking S (photo 2/895).

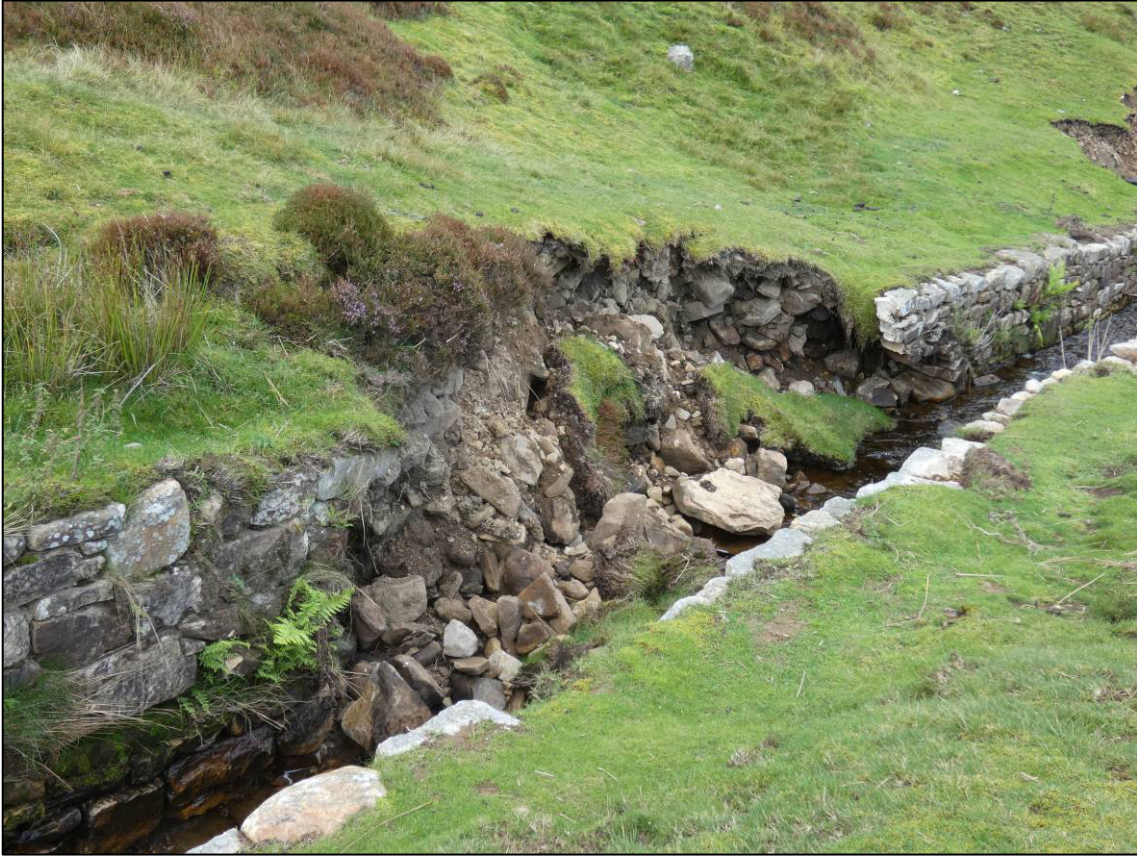
Plate 18: Localised collapse to retaining wall, west side of beck, looking NW (photo 2/905).

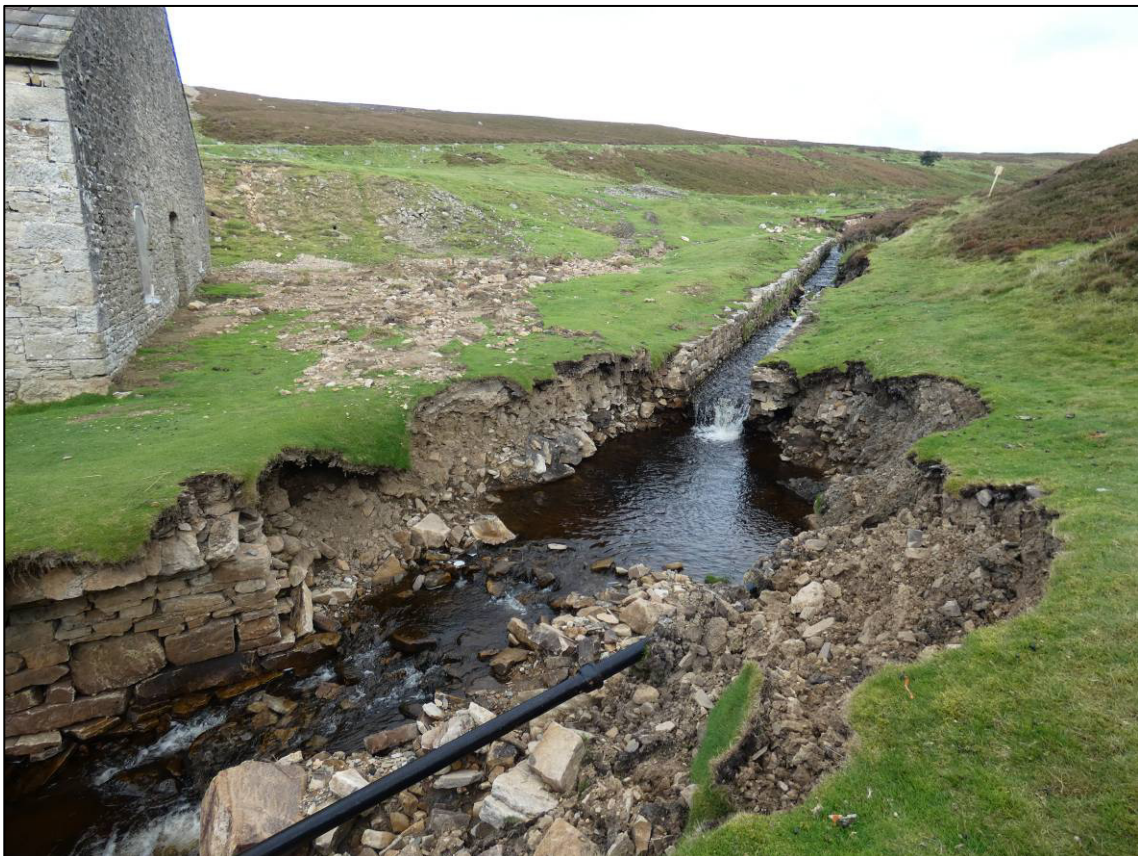
Plate 19: Flood damage off south-west corner of smelt mill, at site of south end of former culvert, looking S (photo 2/878).

- 4.6 The most substantial works were undertaken along the line of the former culvert to the west of the smelt mill, where the erosion had threatened to undermine the south-west corner of the building. As previously noted, the flood had left only 9m of the original 27m length of the east wall of the culvert standing. This did not provide adequate protection for the smelt mill, and further heavy rain in December 2019 caused the soil bank at the southern end of the surviving wall to fall away still further. Therefore, a c.40m long rock-armoured wall was constructed along the east side of the erosion gully created by the July flooding to the north of the revetted section of watercourse; a similar wall, c.4m long, was built to the south end of the west side [3/810-3/817, 3/825; 4/144] (see plate 40). Soil was taken from the partially eroded natural slope on the west side of the beck, creating a scarp, and was used to infill the void behind the new wall [3/823; 4/145, 4/146] (see plate 41). Whilst these works were taking place, a temporary pond was created in the base of the beck [3/829]. Several different layers of made-up ground were exposed in the west-facing section created to take the new wall. Beneath the turf and topsoil, there were at least four level layers of gritty ashy sand containing frequent inclusions of small stones, and varying in colour from an orange-brown through dark grey [3/832] (see plate 42). The new revetment wall stood three courses high, and had an average height of 2m [4/155-4/163, 4/166-4/168] (see plates 43 and 45). A gap was left where the smelt mill's tailrace emerged into the beck, and new walls curved inwards to meet it [4/150, 4/152, 4/153] (see plate 44). To undertake these works, access was required by the tracked excavator down the track to the north of the smelt mill [4/147].

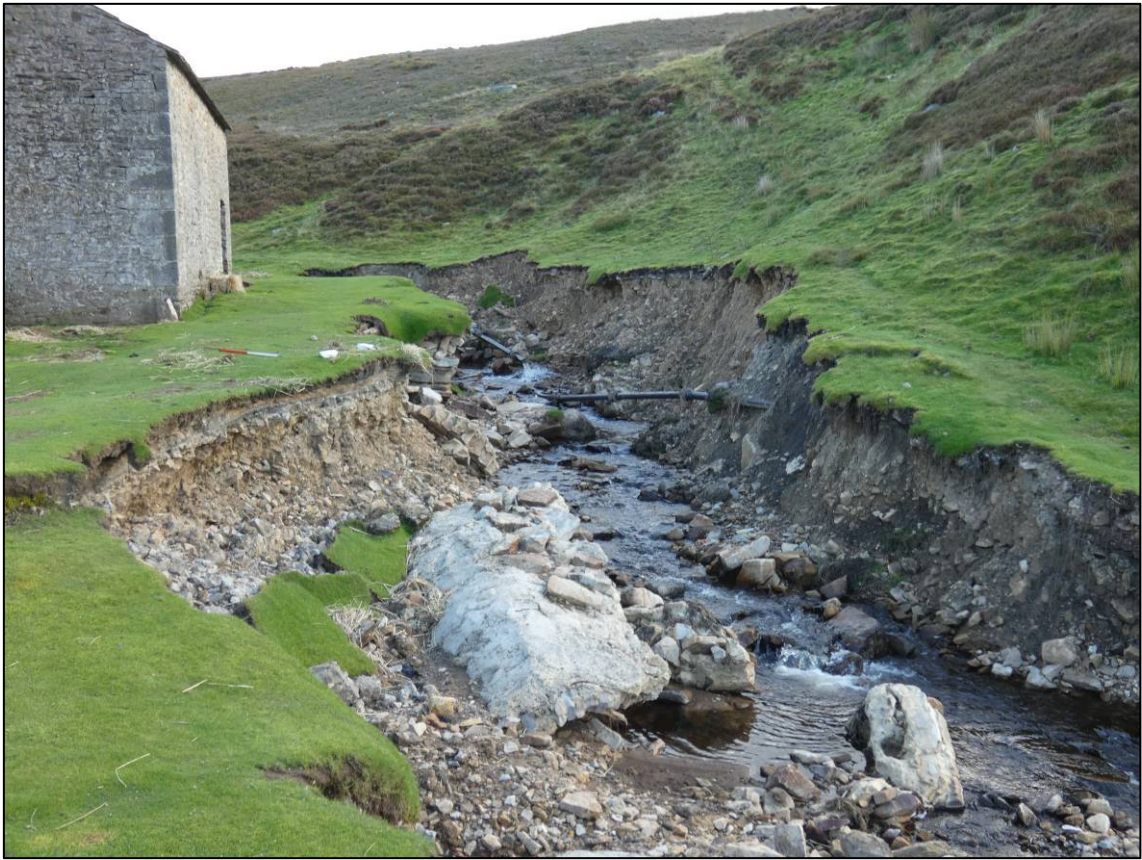
Plate 20: Damage to beck, north-west of smelt mill, looking S (photo 2/859).

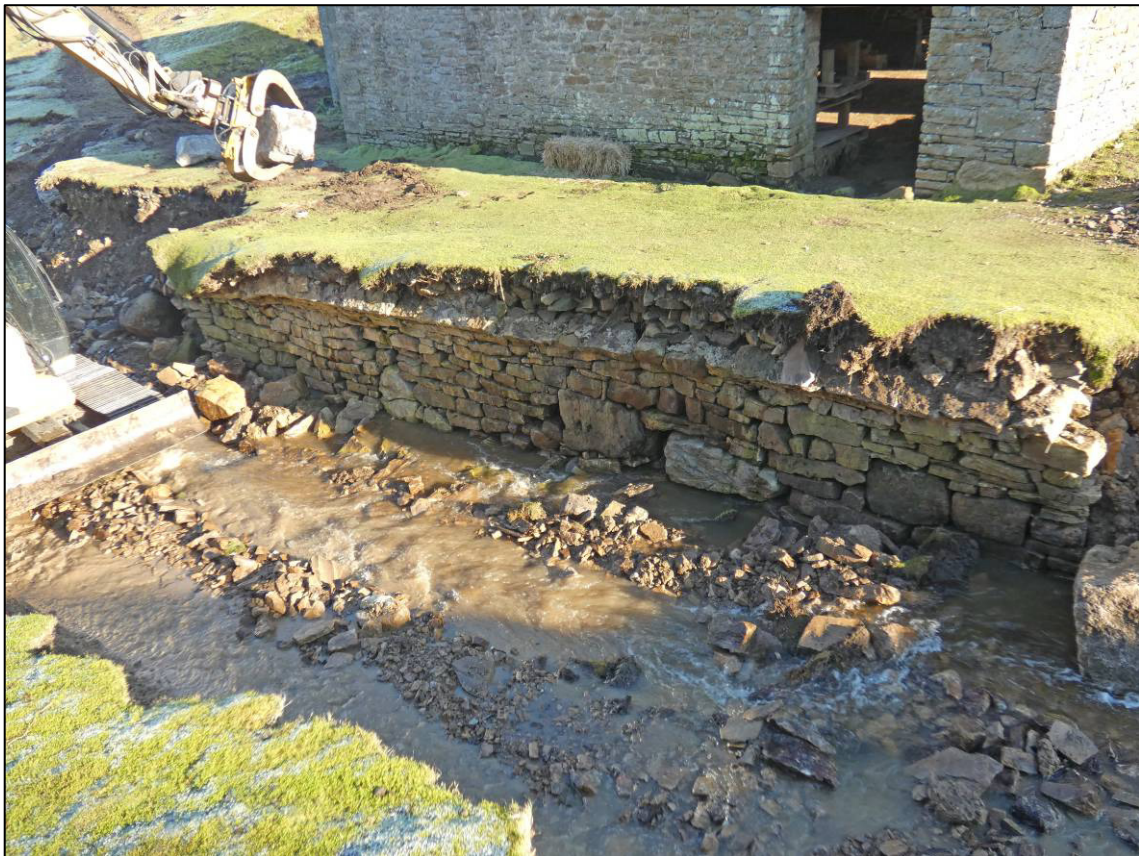
Plate 21: Remains of culvert east wall, adjacent to smelt mill, looking E (photo 3/818).

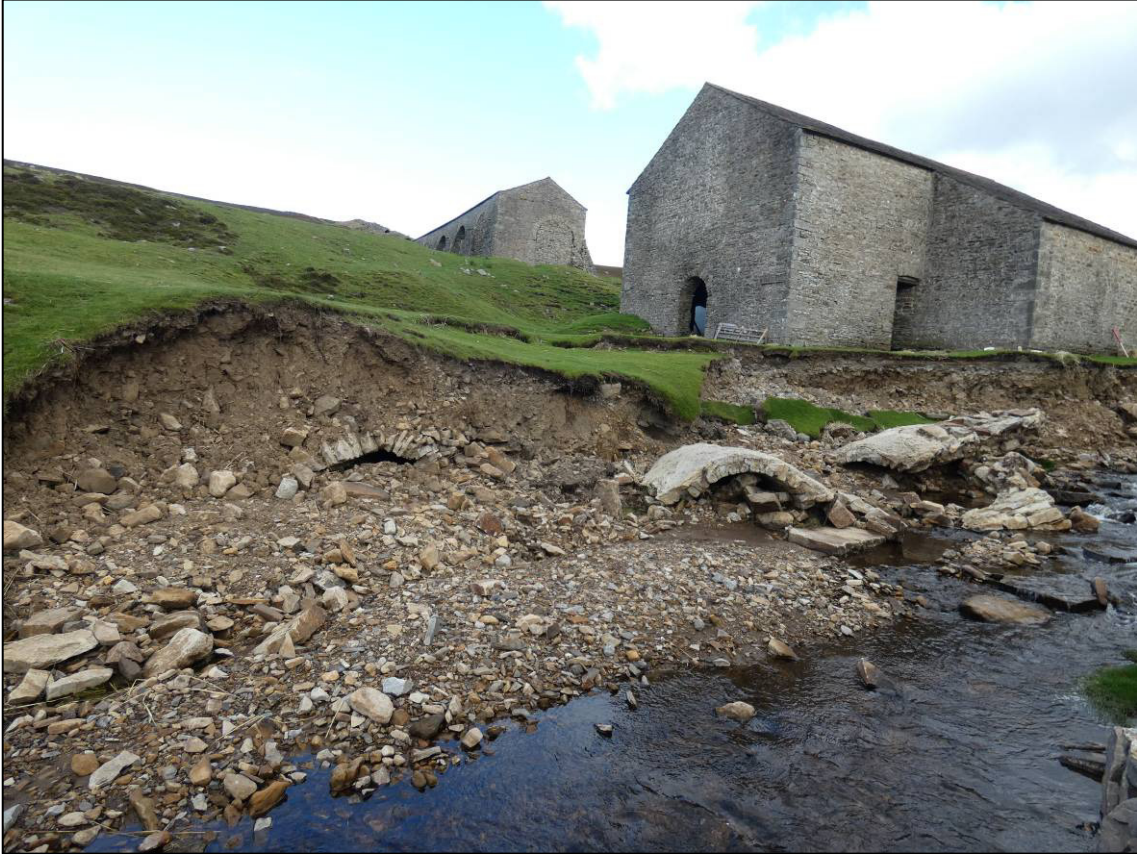
Plate 22: Remains of culvert roof and smelt mill tailrace, east side of beck, looking SE (photo 2/870).

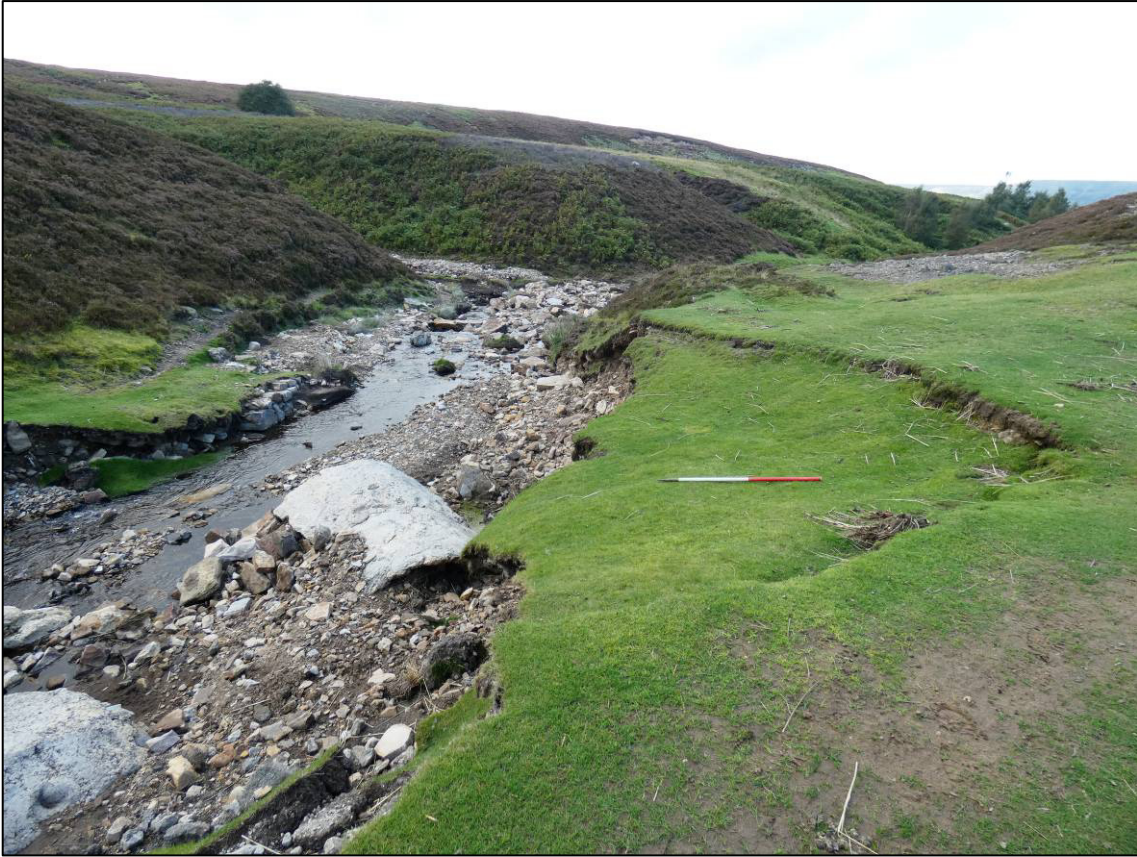
Plate 24: Slumped ground, east side of beck, north-west of smelt mill, looking N (photo 2/866).

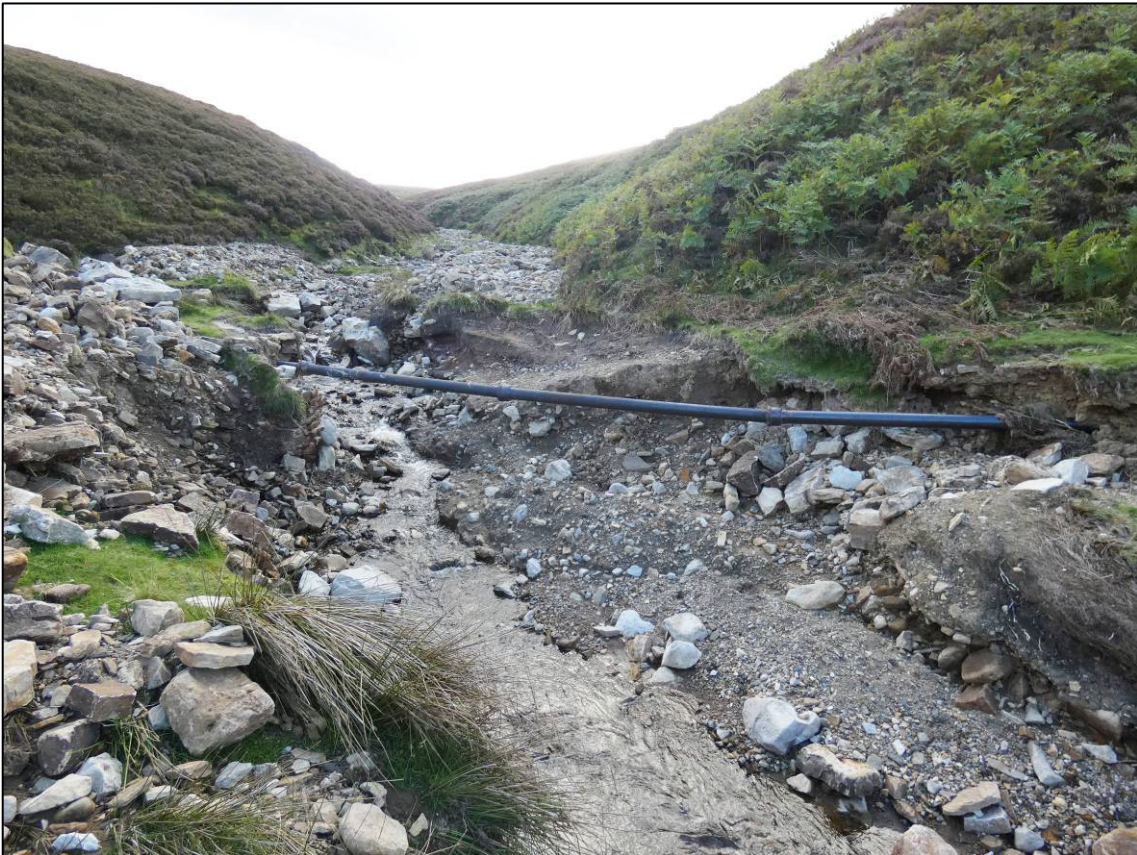
Plate 25: Flood debris at confluence of Smales and Lemon becks, looking W (photo 2/864).
