GRINTON LEAD SMELTING MILL,  
COGDEN GILL, SWALEDALE,  
NORTH YORKSHIRE

ARCHAEOLOGICAL RECORDING AFTER  
JULY 2019 FLOOD DAMAGE

Report no: 2019/599.R01  
Version: Final  
Date: August 2020  
Author: Shaun Richardson & Ed Dennison

Yorkshire Dales National Park Authority  
Yoredale  
Bainbridge  
Leyburn  
North Yorkshire DL8 3EL

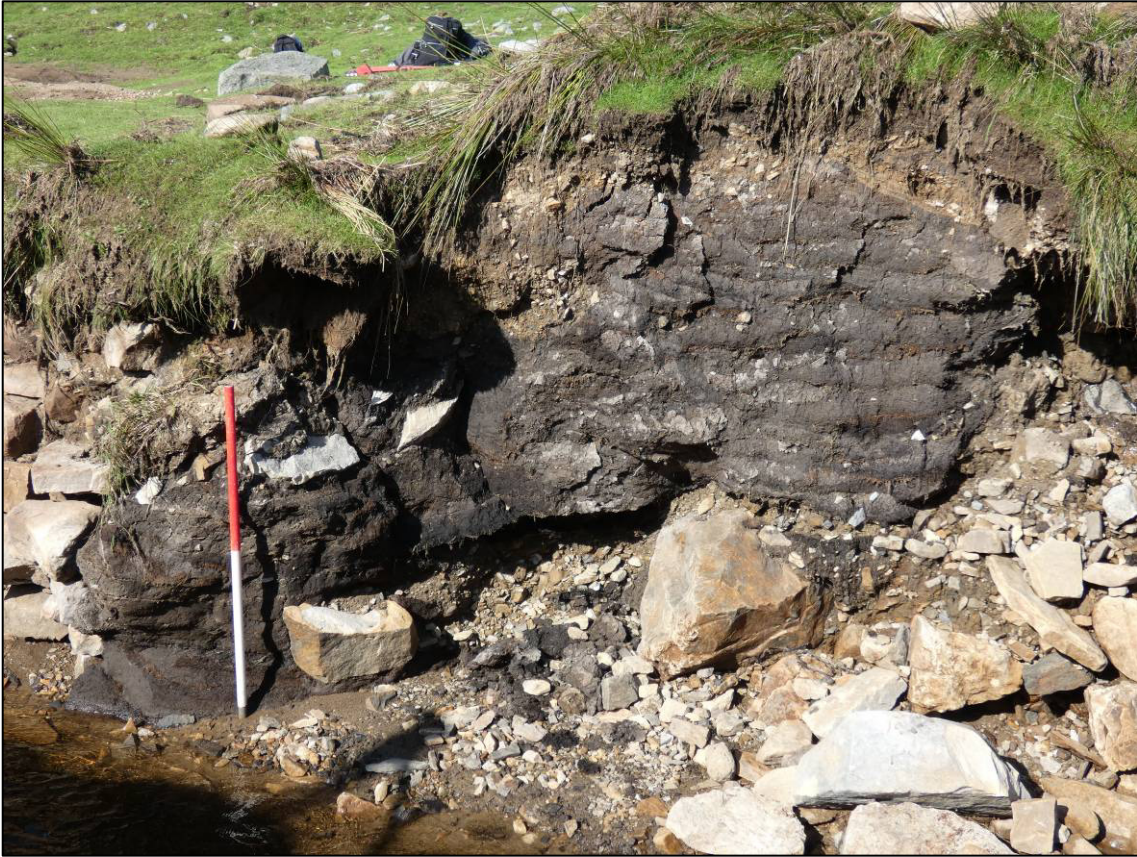
- 3.33 The main body or core of the dam comprised layers of inverted peat turves (026) [1/536] (see plate 32). It is likely that, as in the east-facing section, the upper surface was originally formed by a flat-topped bank, with sides sloping downwards at an angle of approximately 45 degrees, although the top and northern edge were subsequently damaged. The bank was at least 2.50m wide by 1.50m high [1/533]. The individual layers of turves within had an average depth of 0.10m, and were laid evenly. They were only clearly visible in the southern and northern thirds of the bank, and were apparently absent from the central part [1/537]. The peat dam structure may have butted, or been contemporary with, the earliest visible part of the dam, comprising the front revetment wall (024) [1/534] (see plate 33). This wall was 1.20m wide and was built from apparently large unmortared pieces of roughly coursed and squared stone, and it stood c.1.50m high, with both faces having a slightly battered profile; there was a step at the base of the north side. What appears to be a crude buttress structure (023) of stone rubble, 0.50m wide and c.1.0m high, had been added to the north side of the wall at a later date. The core of the dam (026) overlay an orange-brown silty clay with frequent inclusions of angular stone up to 0.50m across (029). This continued to the south below the reservoir layers and the base of the section, and appeared to be a natural deposit.

Plate 32: Reservoir dam, west facing section (S2), detail of peat infill (026), looking E (photo 1/536).

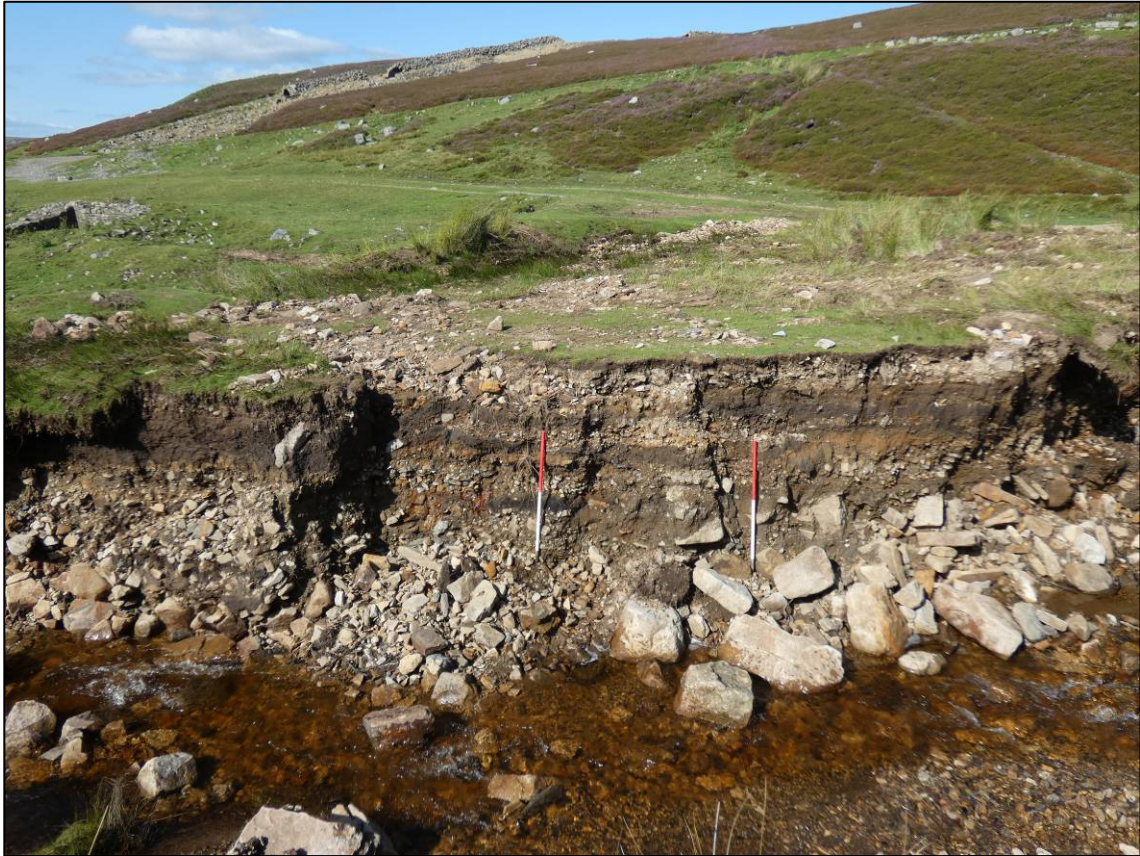
- 3.35 A representative part of the west-facing section through the reservoir, exposed in the east side of the watercourse, was also recorded; the recorded section was 2m long and stood a maximum of 2m in height [1/538-1/542] (see plate 34).
- 3.36 The uppermost layer was formed by topsoil up to 0.08m thick (001). Beneath this, there was a deposit of loose sandy-silt containing a high proportion of angular stones up to 0.10m across (030), extending to 0.40m below ground level (BGL). It

Plate 34: Reservoir, west facing section (S3) showing laminated deposits, looking E (photo 1/538).

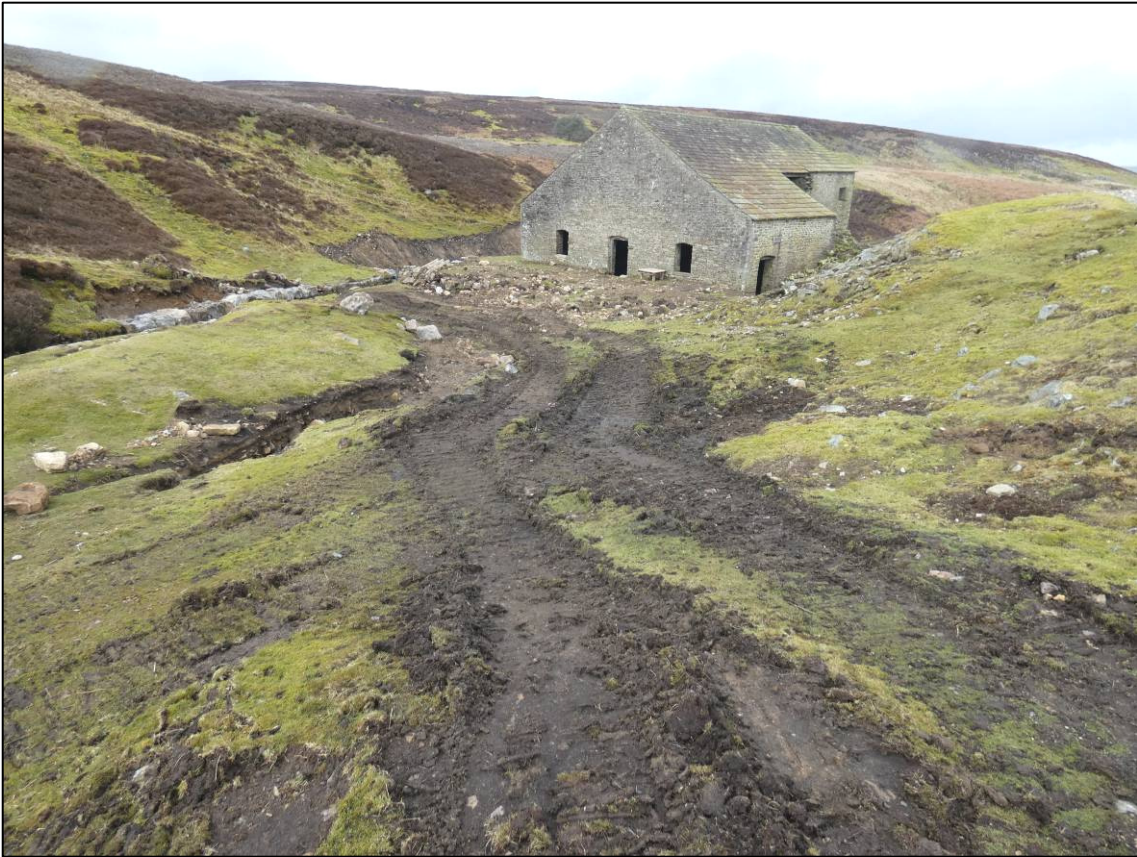
access the eroded area to carry out the repairs, it was necessary to drive the tracked excavator and other vehicles across the ground to the east. This disturbed and flattened some of the shallow earthworks which had previously been recorded [4/135-4/138] (see plate 38), which caused some rutting, but any significant areas of disturbance were repaired at the end of the remedial works.

Plate 38: Vehicle tracks to area between reservoir dam and smelt mill, looking NW (photo 4/138).
