EROSION REPAIRS,  
OLD GANG LEAD SMELTING MILL,  
MILL GILL, SWALEDALE, NORTH YORKSHIRE

ARCHAEOLOGICAL MONITORING AND RECORDING

Report no: 2022/665.R01  
Version: Final  
Date: May 2022  
Author: Shaun Richardson & Ed Dennison

Yorkshire Dales National Park Authority  
Yoredale  
Bainbridge  
Leyburn  
North Yorkshire DL8 3EL

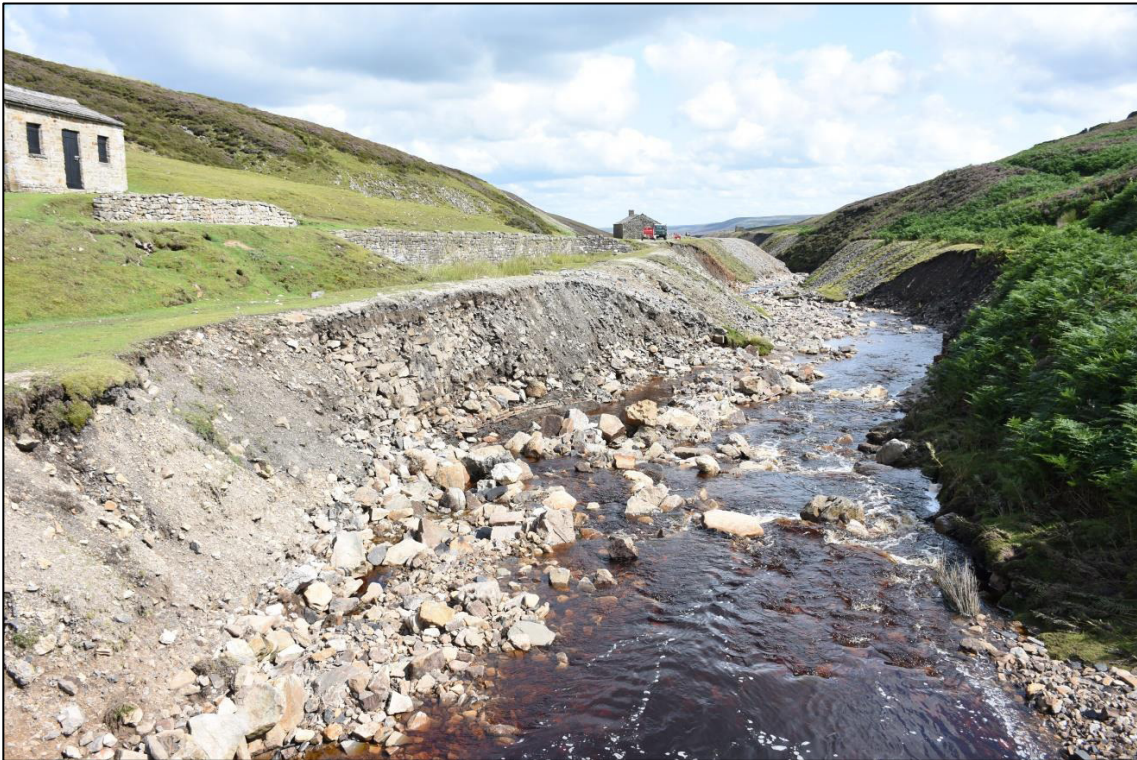
- 7.4 The July 2019 flooding had cut into the looser deposits forming the long linear spoil heap (ST3) (see plates 1 and 2). In 1992, the base of the south scarp of the spoil heap (i.e. where it met the flattened bottom of Mill Gill) was set c.14m to the south of the south side of the main track through the mine complex; by 2022, this measurement had been reduced to c.12.50m [1/839, 1/840]. The top of the spoil heap's south scarp appeared largely unchanged since 1992, although the cutting back of the lower deposits had caused a slump, revealing a section of retaining wall not visible in 1992. The exposed part of the retaining wall was set within the western part of Area 1, and had a total visible length of c.7m; it was placed broadly in line with the top of the spoil heap's south scarp [1/834, 1/835] (see plate 3). It may have supported a tramway shown here on the Ordnance Survey map of 1895, and also depicted in historic photographs (Gill 2004, 76); the latter suggests the presence of a retaining wall to the beck (see figure 3). The wall stood c.2m in height, and was of drystone construction, using pieces of roughly squared rubble; these were roughly graduated in size from bottom to top, with some of the lower stones measuring c.0.70m by 0.50m [1/832] (see plate 4). The wall had a slightly battered profile, whilst in plan, it was slightly angled, with both ends angling away to the north from the centre [1/833].

Plate 1: Area 1N, prior to start of works, looking SE (photo courtesy YDNPA).

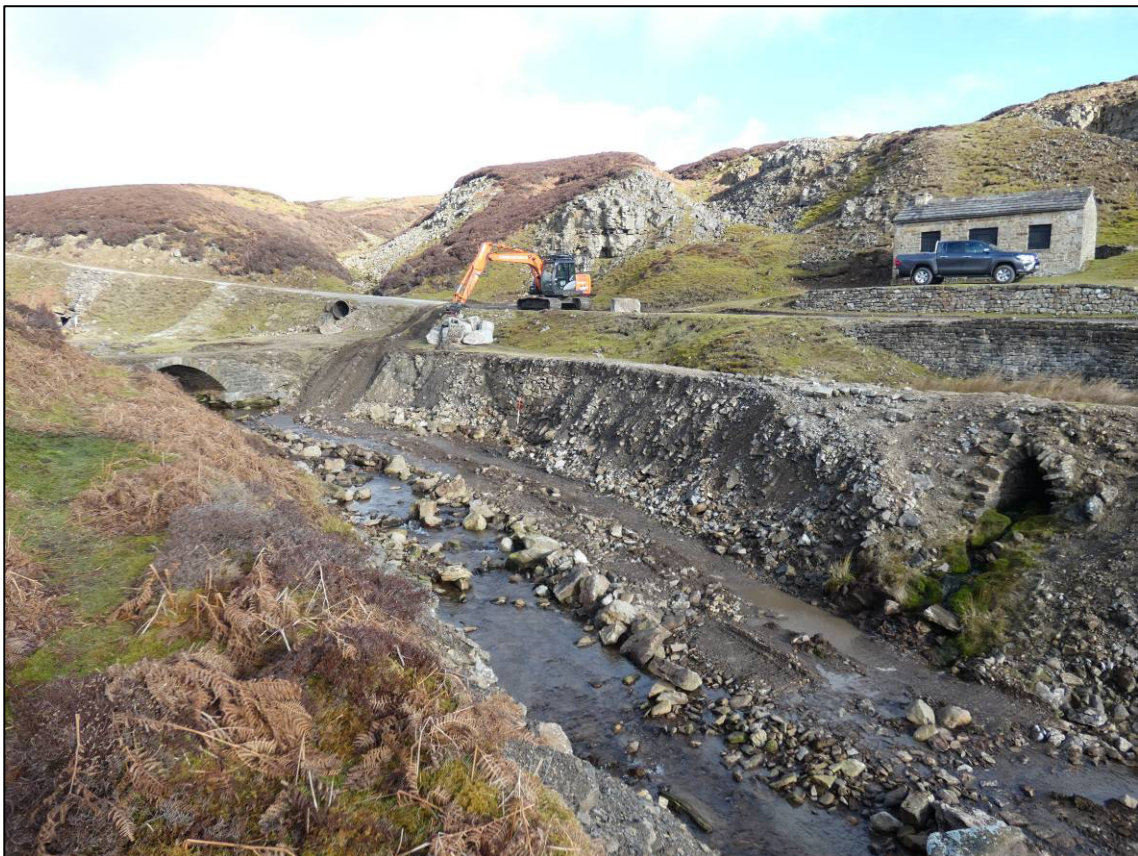
Plate 2: Area 1N, works in progress, looking N (photo1/839).

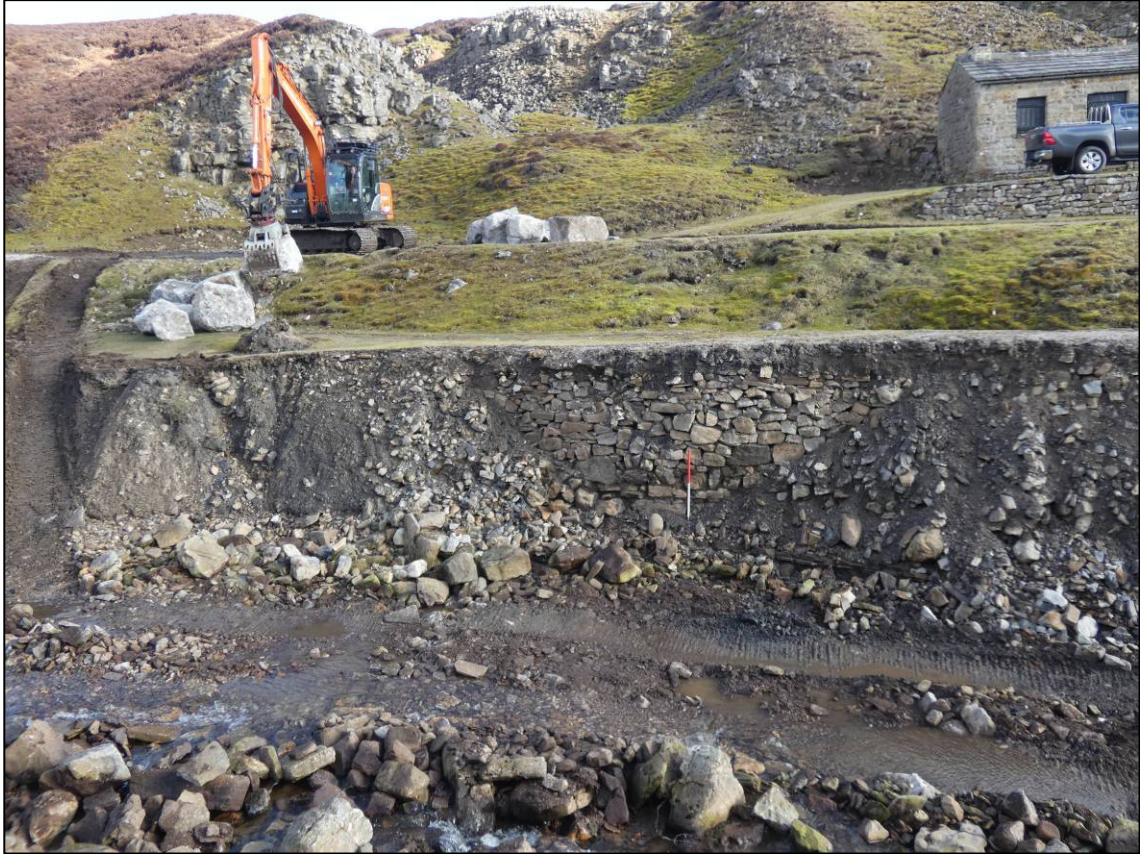
Plate 3: Area 1N, exposed revetment wall, looking NE (photo 1/835).

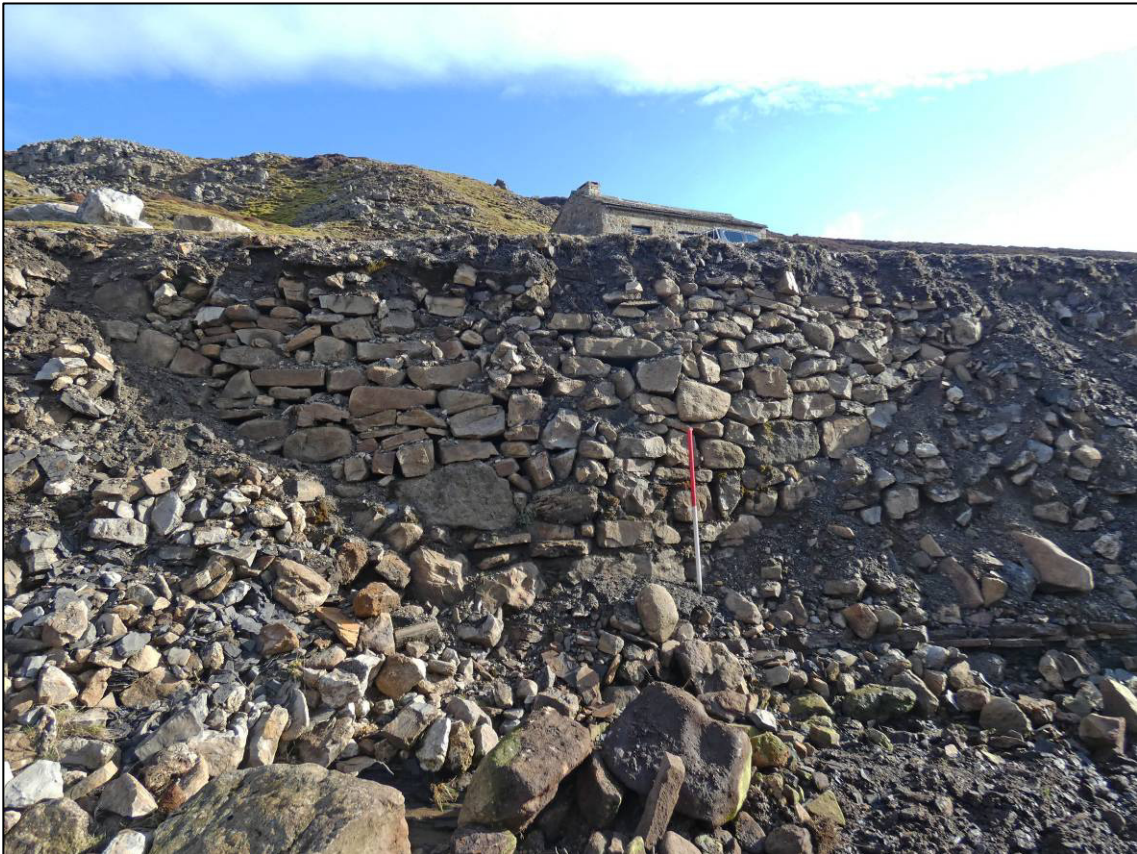
Plate 4: Area 1N, exposed revetment wall, looking NE (photo 1/832).

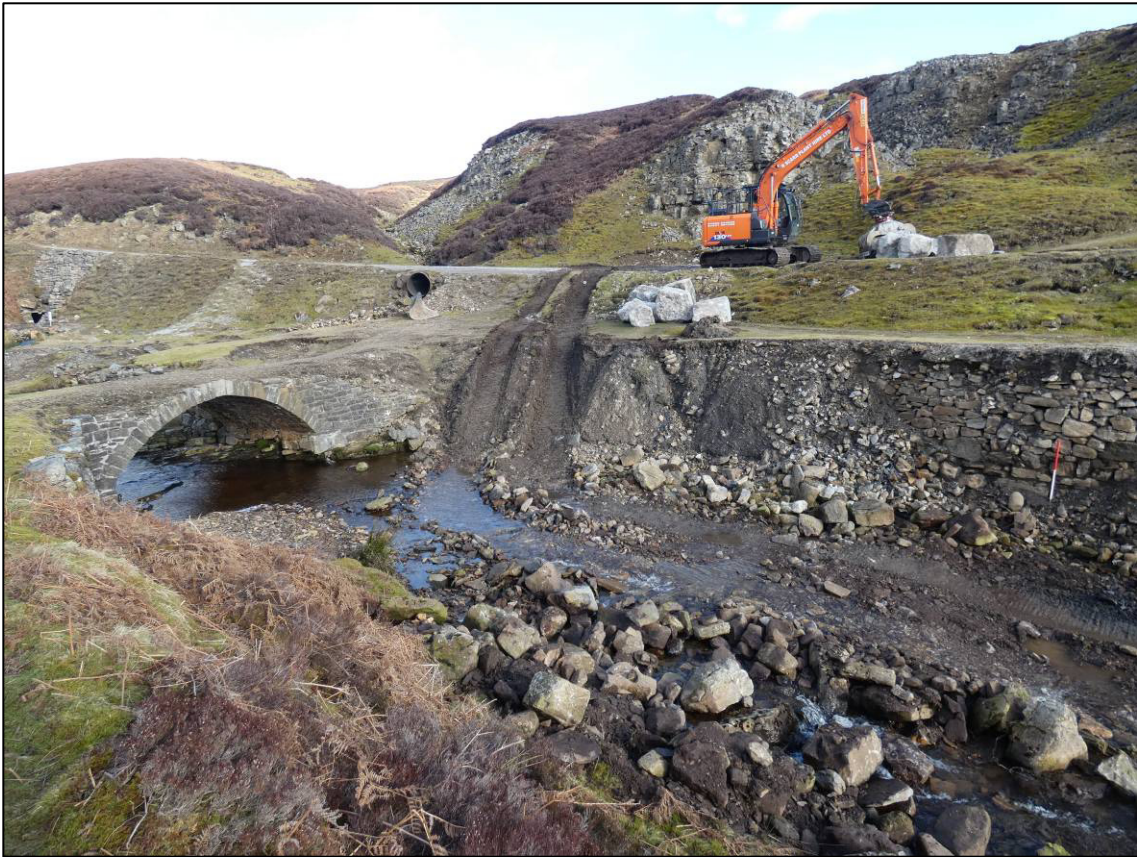
Plate 5: Area 1N, works in progress, looking N (photo 1/836).

- 7.5 In order to repair this area of erosion, the required total length of rock armouring was c.36m. Machine access was gained from the east side of the bridge [1/836, 1/837] (see plate 5). The rocks were laid mostly in two courses, standing up to c.1m in height, although towards the eastern part there were three courses to take account of the falling levels, making the armoured wall up to 1.5m in height [2/877, 2/881, 2/884, 2/896] (see plate 6). The outer face of the armoured wall was set between c.3m and 5.5m south of the top of the south scarp of the spoil heap (ST3), with between c.2m and 5m of loose material from the bed of the beck meeting the scarp [1/871, 1/872]. The newly exposed revetment wall referred to above was retained, with the armoured wall being built in front of it [2/882; 3/244] (see plate 7). The east end of the new section of wall stopped just short of the central culvert of the reservoir (R4) [3/250], while the west end butted up against northern bridge abutment [2/880; 3/247]. By May 2022, the new armoured wall was well bedded-in, although the exposed revetment wall is perhaps in danger of collapse without some consolidation [3/277, 3/280] (see plate 8).

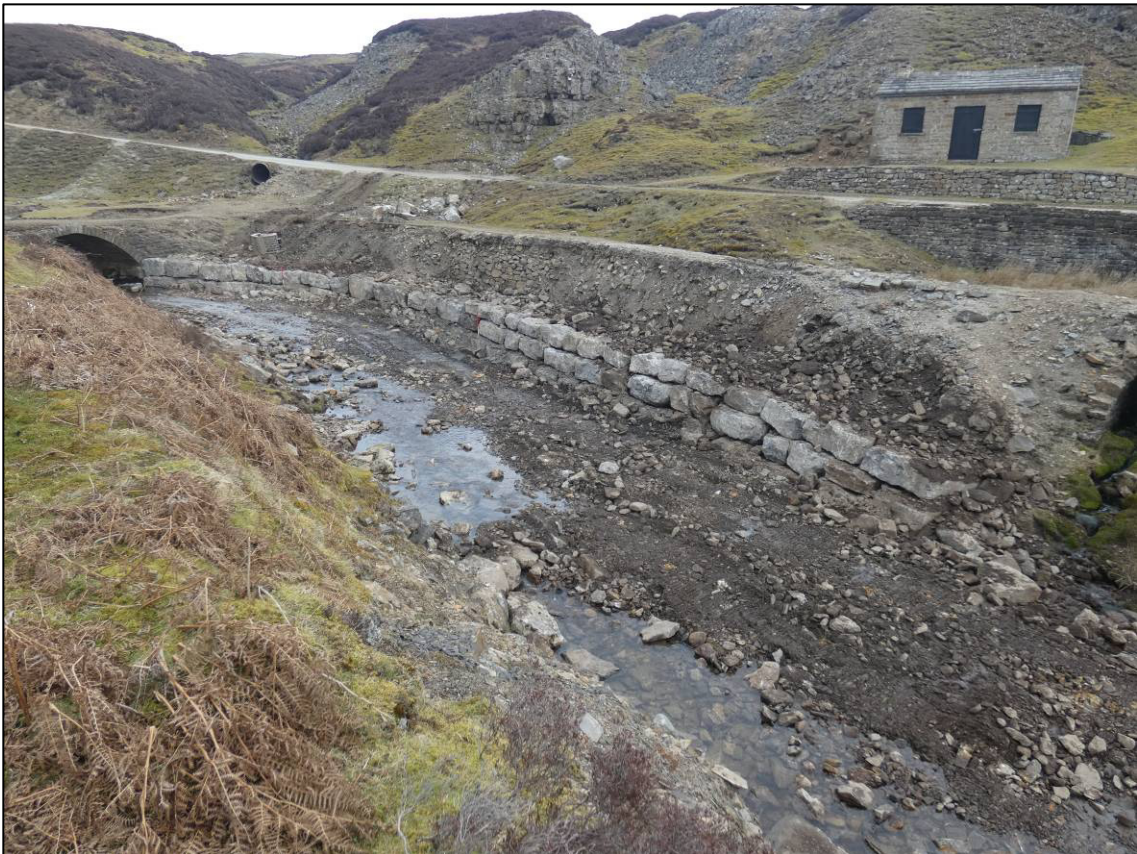
Plate 6: Area 1N, works complete, looking N (photo 2/884).

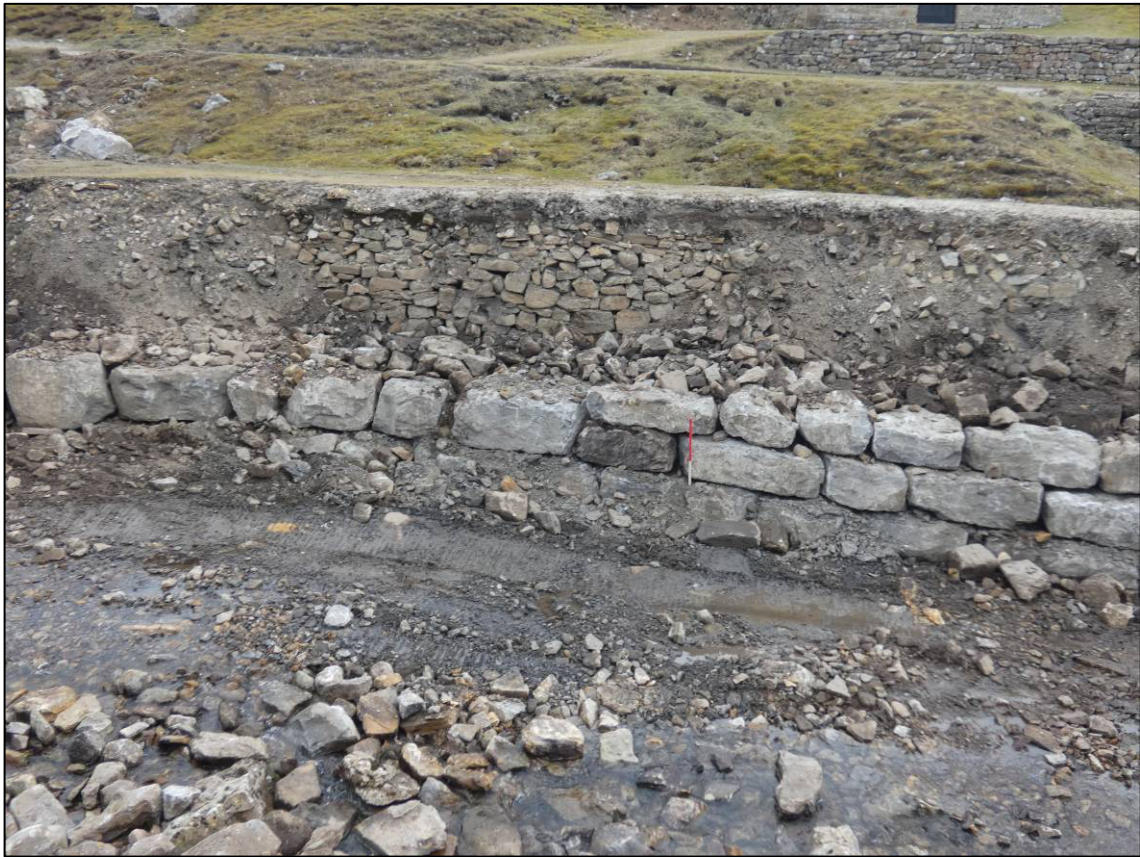
Plate 7: Area 1N, exposed revetment wall behind rock armour, looking NE (photo 2/882).

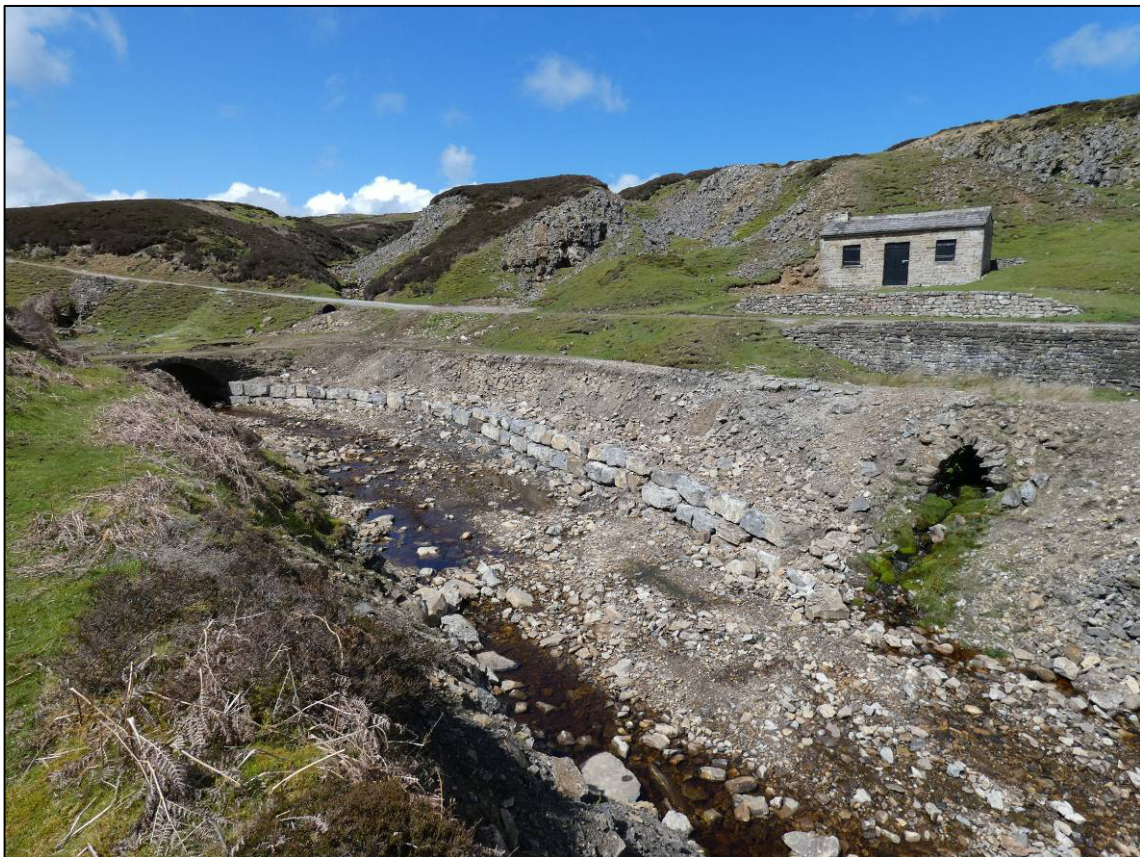
Plate 8: Area 1N, works complete and bedded-in, looking N (photo 3/280).

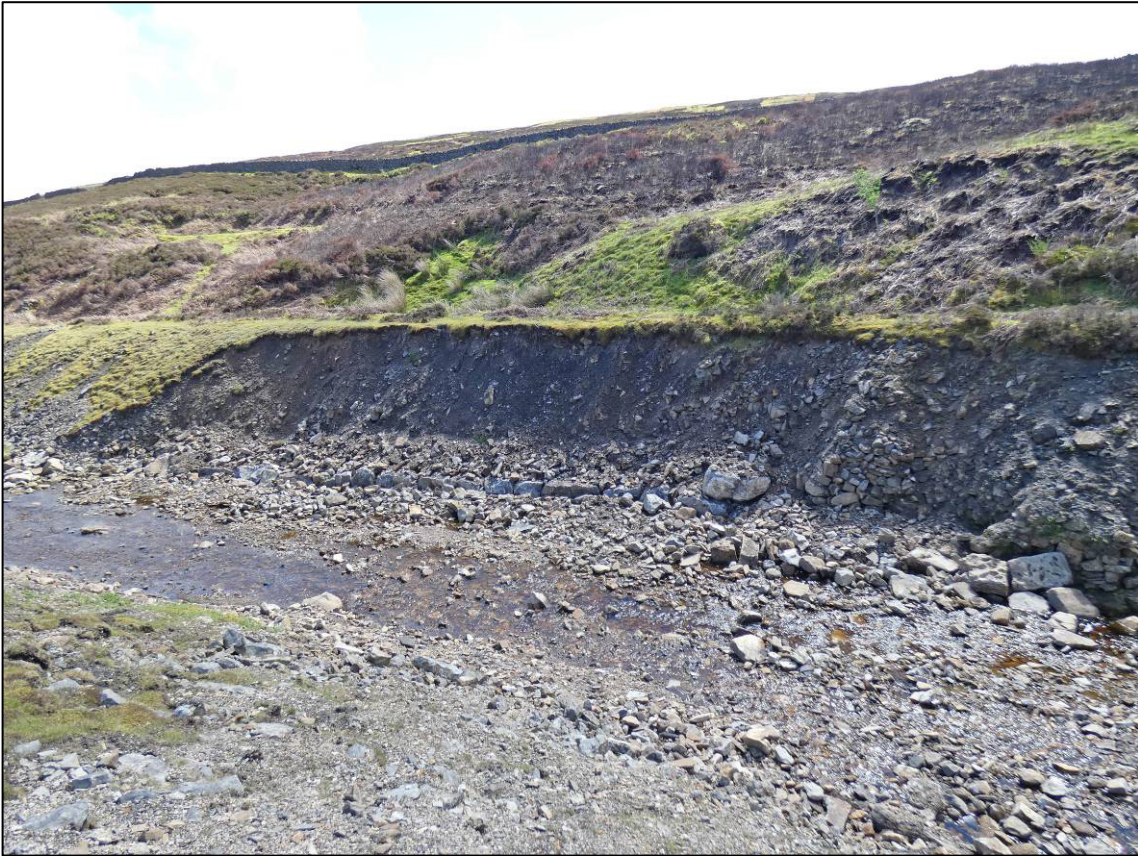
Plate 9: Area 1S, works complete and bedded-in, showing newly-exposed revetment wall at west end, looking SW (photo 3/284).

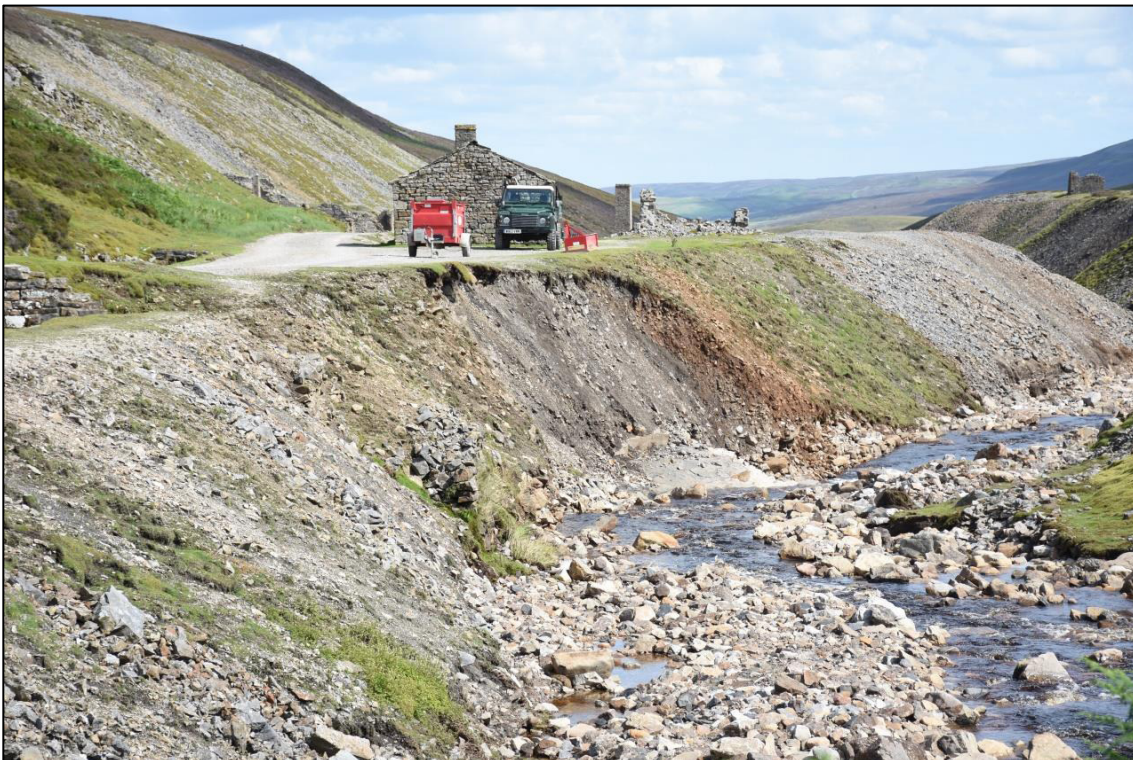
- 7.8 The July 2019 flooding had cut into the looser deposits forming the south side of the long linear spoil heap (ST3) (see plate 10). In 1992, the base of the south scarp of the spoil heap (i.e. where it met the flattened bottom of the beck) was set c.12.50m from the south side of the main track through the mine complex; by 2022, this measurement had been reduced to c.10.50m in places, with part of the spoil heap having collapsed into the beck, leaving a near vertical scarp [1/846, 1/847]. At the very western end of the area, a retaining wall recorded in 1992 remained visible [1/843, 1/844, 1/854] (see plates 11 and 12); this wall may also have been associated with the outflow from the south-east corner of the reservoir (R4) above. Unfortunately, the new armoured wall was already in place at the time of the first EDAS site visit, and so it was not clear whether the other sections of retaining walls recorded in 1992 had still been present.

Plate 10: Area 2, prior to start of works, looking E (photo courtesy YDNPA).

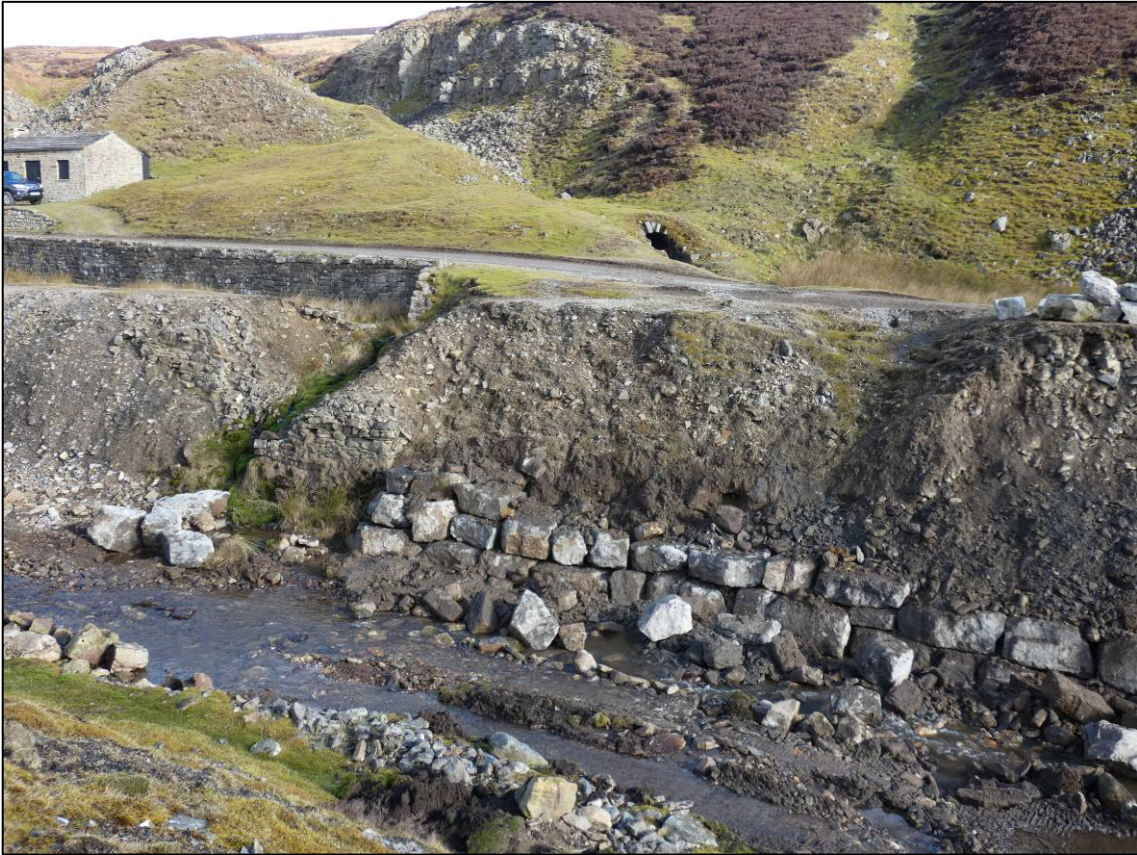
Plate 11: Area 2, west end, works complete, looking NE (photo 1/844).

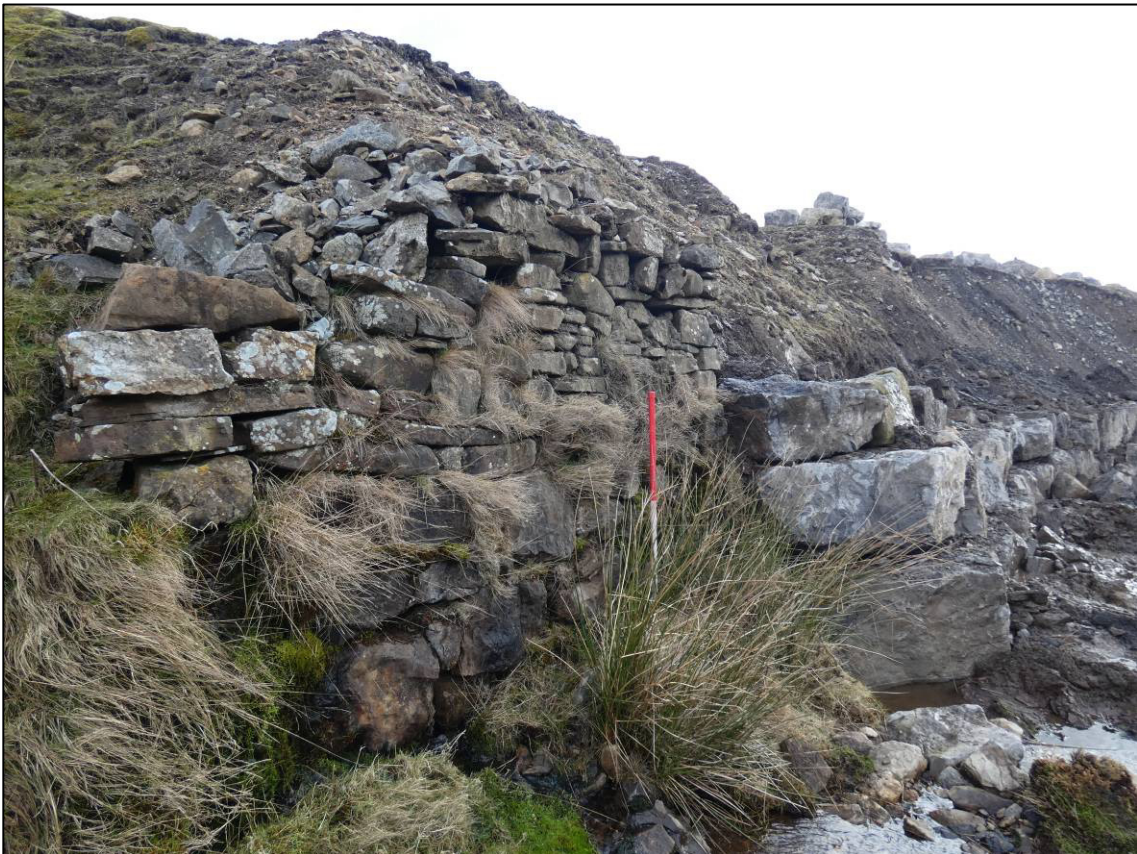
Plate 12: Area 2, existing retaining wall at west end of works, looking E (photo 1/854).

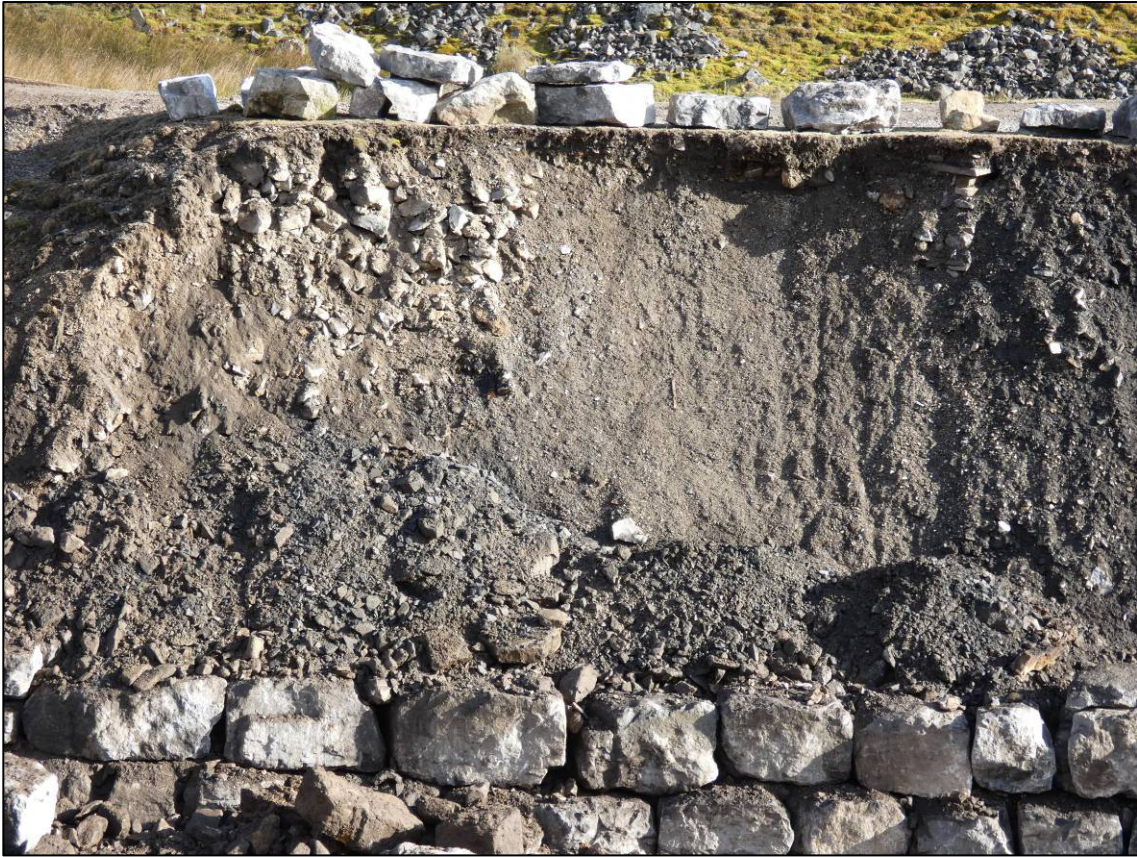
Plate 13: Area 2, exposed retaining wall in edge of scarp, looking NE (photo 1/845).

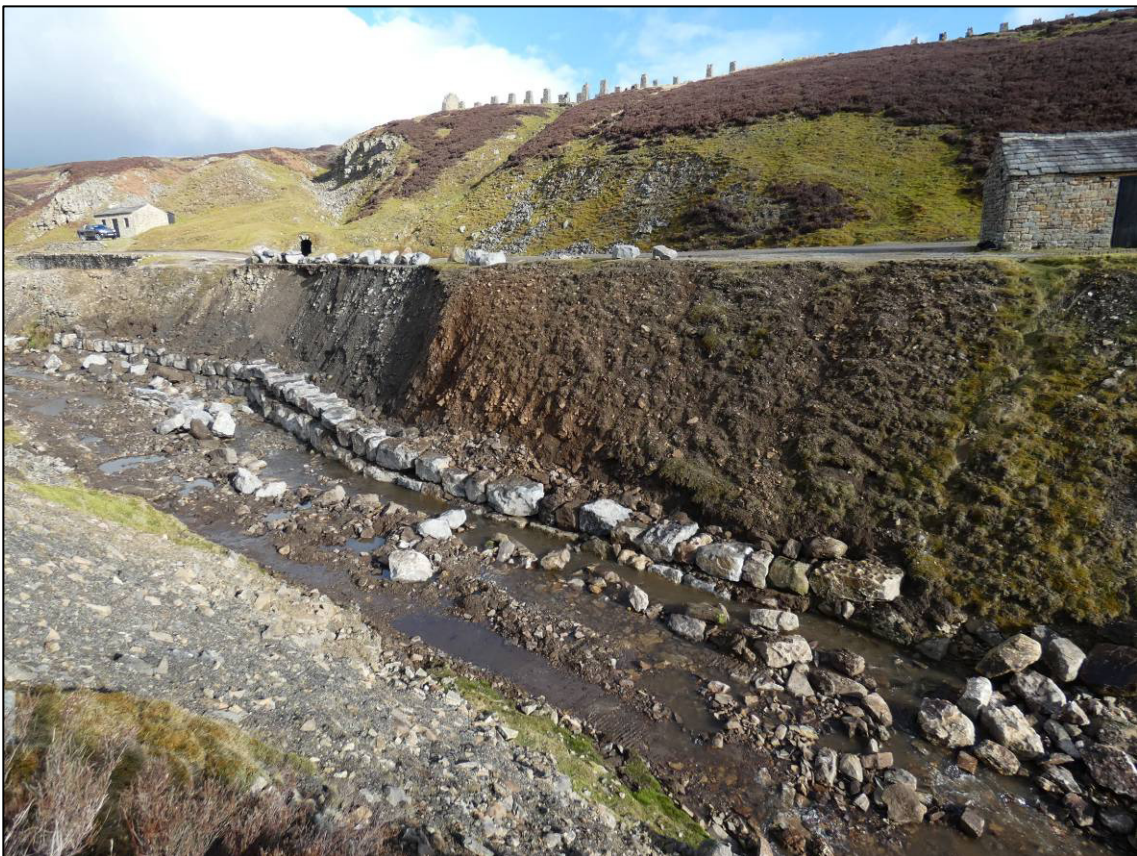
Plate 14: Area 2, works complete, looking N (photo 1/848).

- 7.10 In Area 2, the total length of rock armouring required was c.43m. The rocks were laid mostly in two courses, standing up to c.1m in height, with three courses only at the very western end [1/842, 1/848, 1/851, 1/855; 2/888-2/890] (see plate 14); the west end of the new wall ran as far as the 1992 retaining wall [3/271]. The outer face of the armoured wall was set between c.5m and 6m south of the top of the south scarp of the spoil heap (ST3), with c.2.5m of loose material from the bed of the beck meeting the scarp and infilling the gap behind the new wall. By May 2022, the new armoured wall was well bedded-in [3/253, 3/256, 3/259, 3/263, 3/265, 3/269, 3/275] (see plate 15).

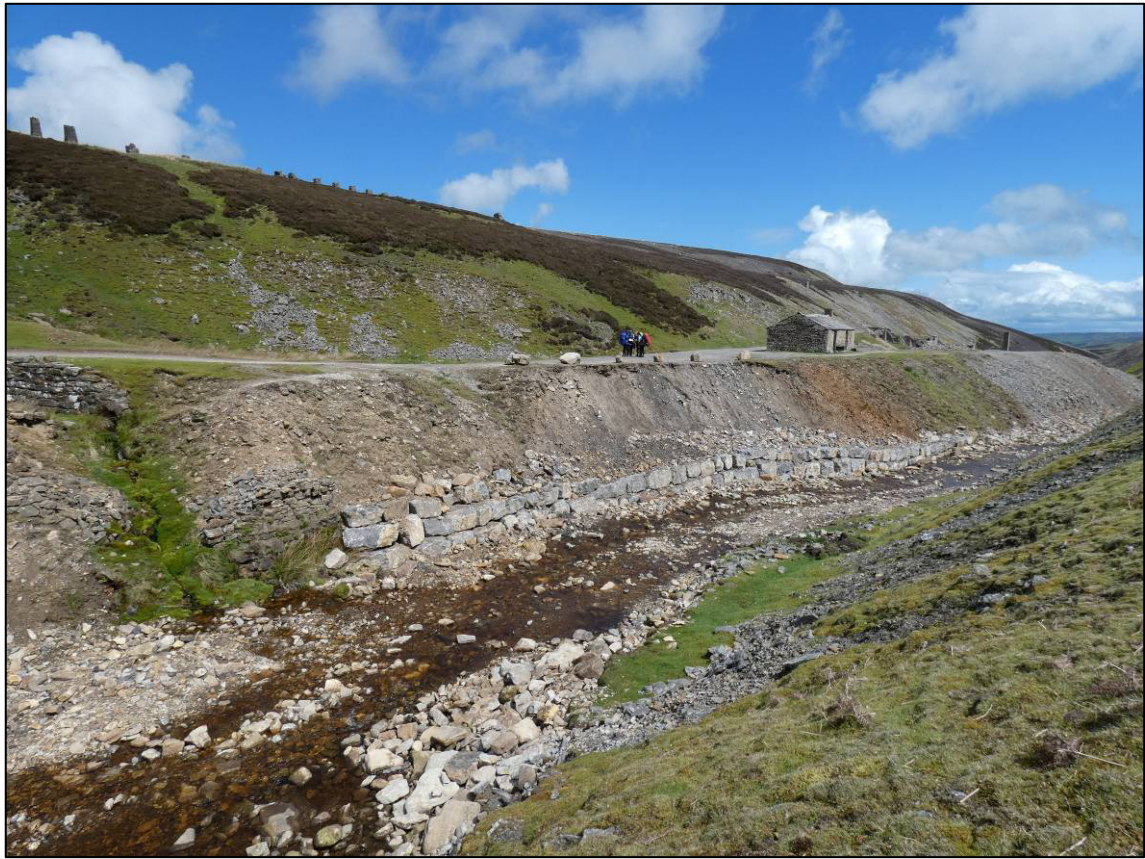
Plate 15: Area 2, works complete and bedded-in, looking E (photo 3/253).

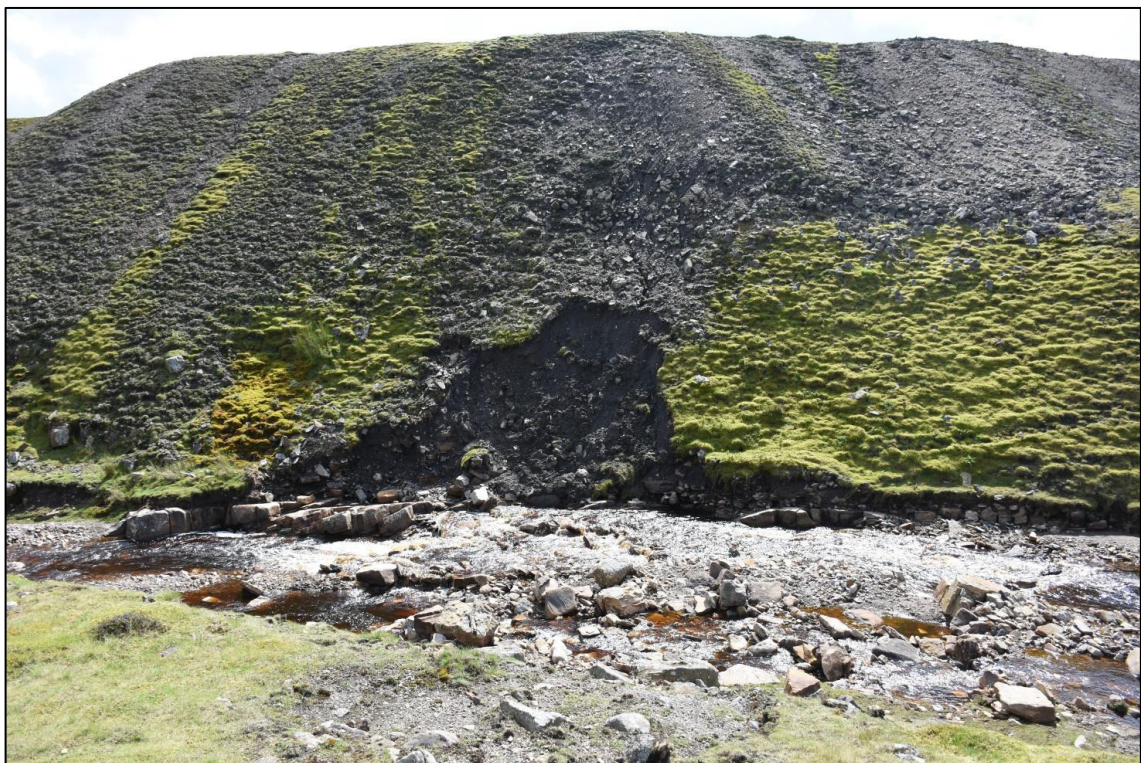
Plate 16: Area 3E, prior to start of works, looking SW (photo courtesy YDNPA).

- 7.12 A section of the base of the large spoil tip had been eroded by the July 2019 floods, and was to be repaired by a c.10m long section of armoured wall (see plate 16). This was duly done, with no other structures or features being noted; the majority of the new wall was two courses high (c.1m) although towards the east a single course of larger blocks was used [2/907, 2/908; 3/211, 3/214, 3/220] (see plate 17). Material gathered from the river bed was used to infill the gap behind the wall.

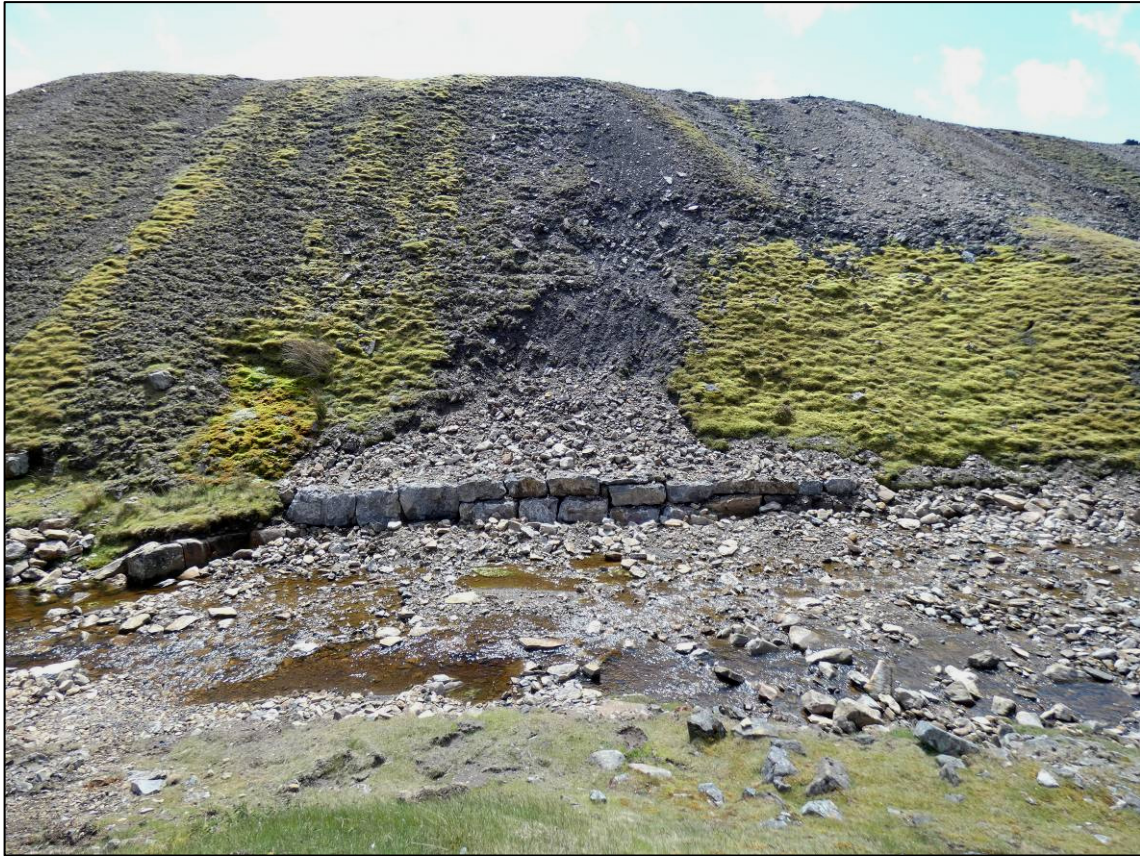
Plate 17: Area 3E, works complete and bedded-in, looking SW (photo 3/211).

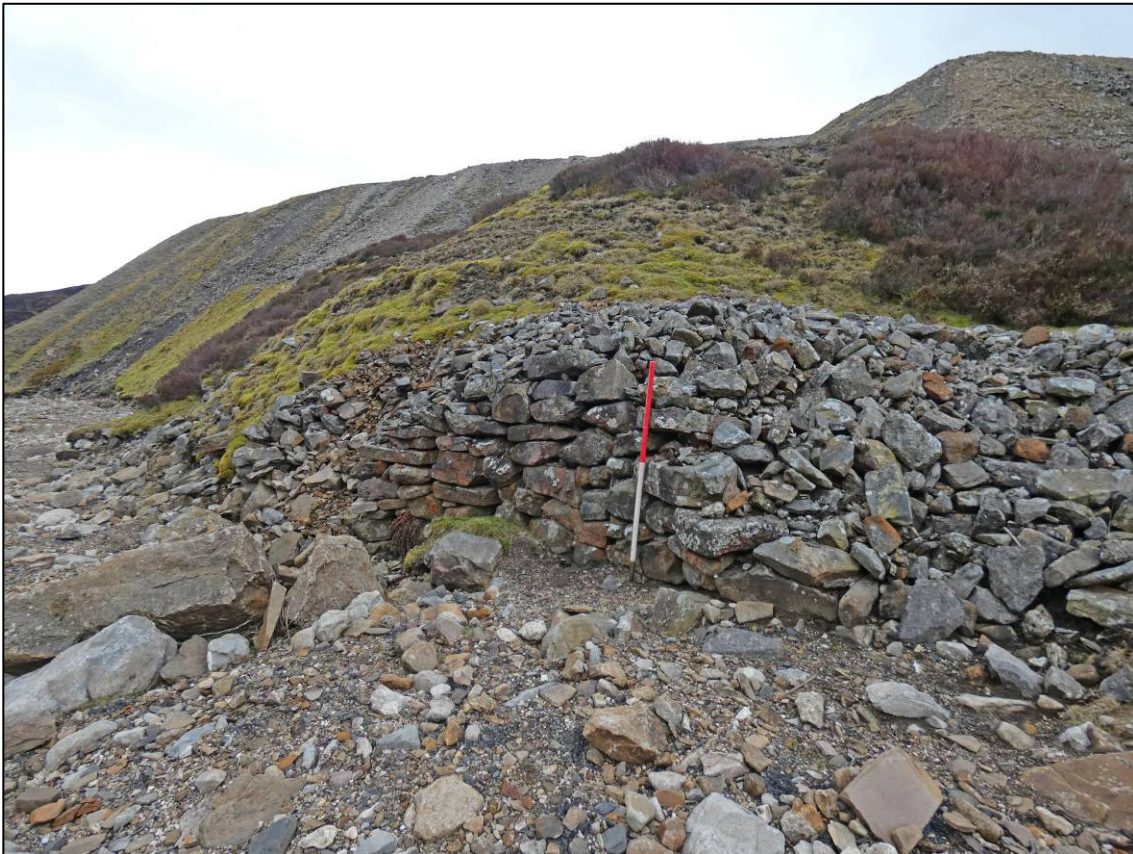
Plate 18: Area 3W, existing revetment wall to small spoil heap, looking S (photo 1/858).

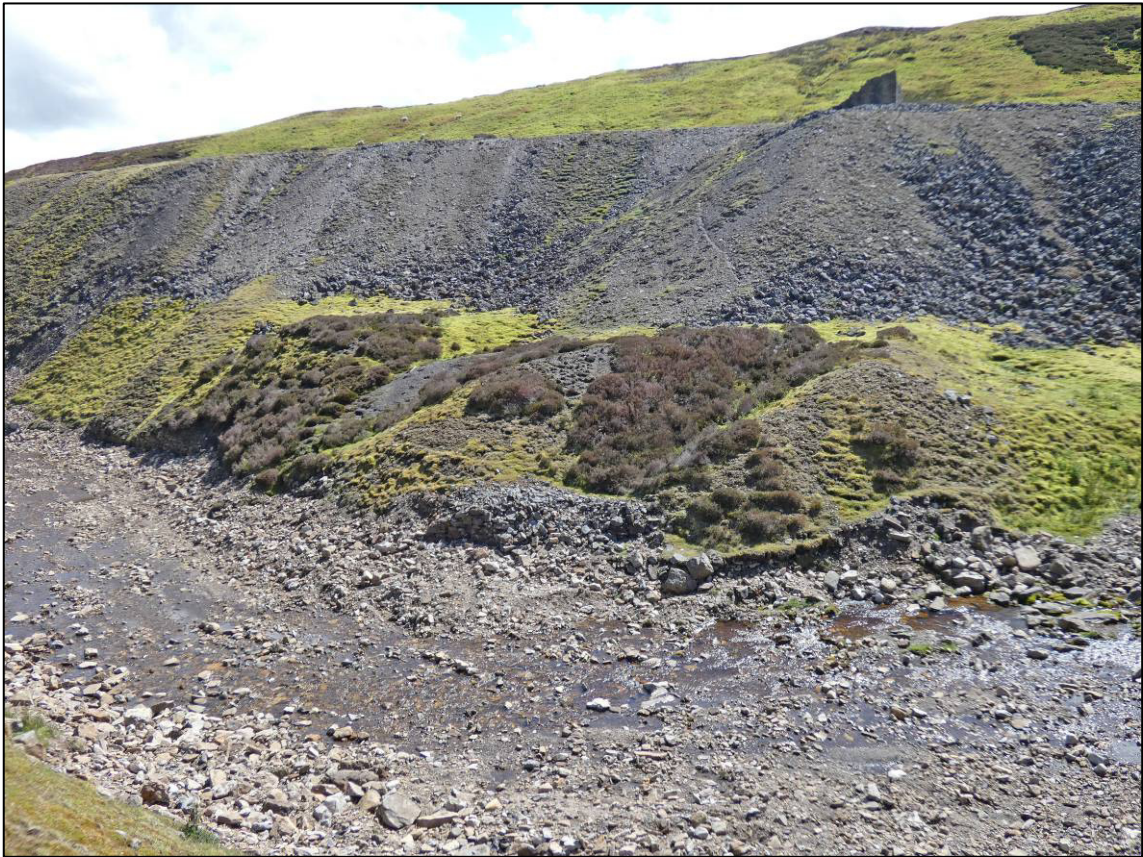
Plate 19: Area 3W, works complete and bedded-in, looking S (photo 3/311).

- 7.14 Rather than building a section of armoured wall here, loose material from the river bed was heaped up as a low bank along the base of these smaller spoil tips to direct the water away [2/901, 2/902]. By May 2022, the new low bank was virtually indistinguishable amongst the rest of the beck [3/302, 3/311, 3/314] (see plate 19).

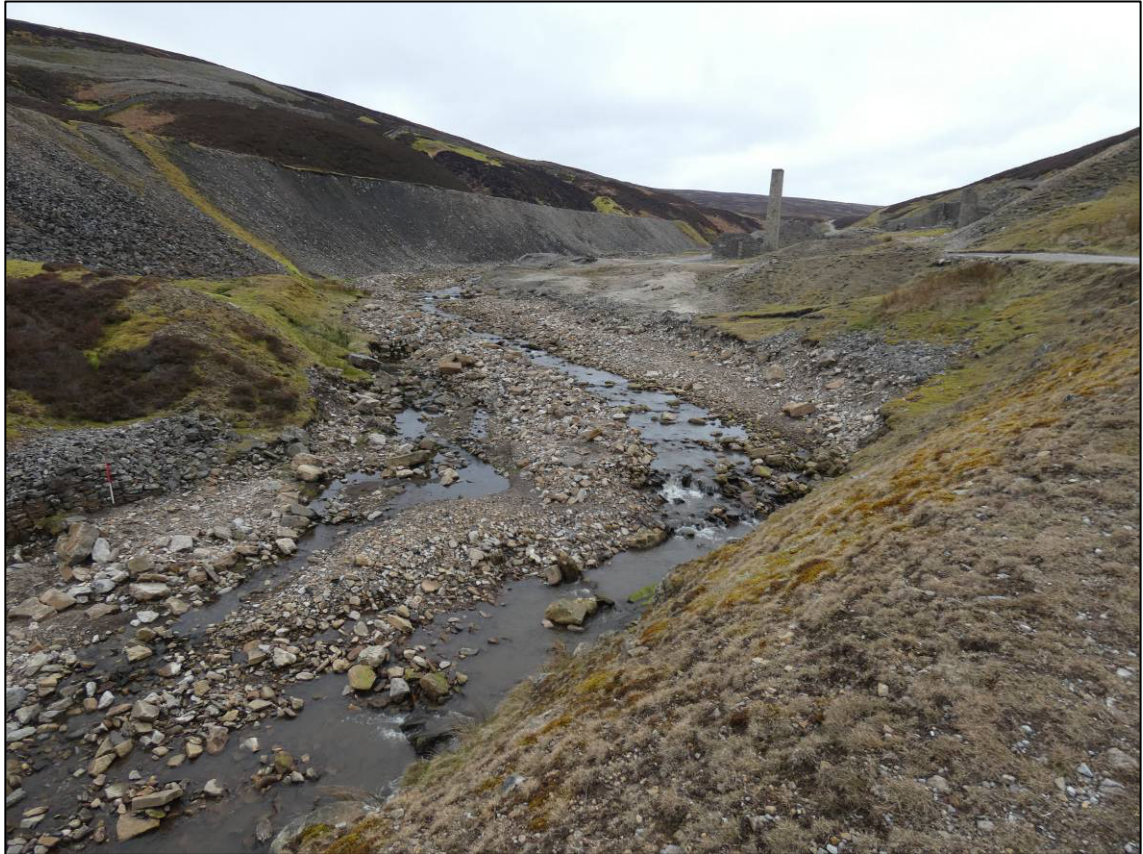
Plate 20: Area 3N, prior to start of works, looking NW (photo 1/870).

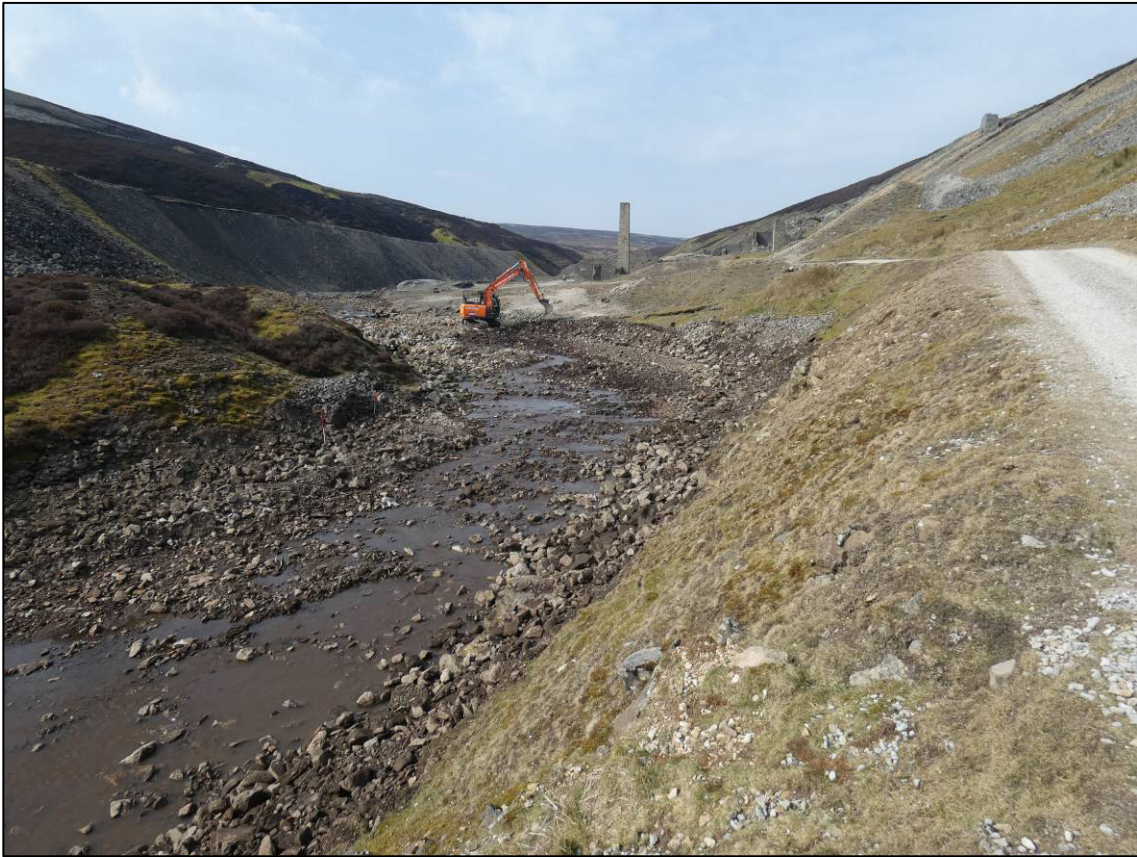
Plate 21: Area 3N, works in progress, looking NW (photo 2/905).

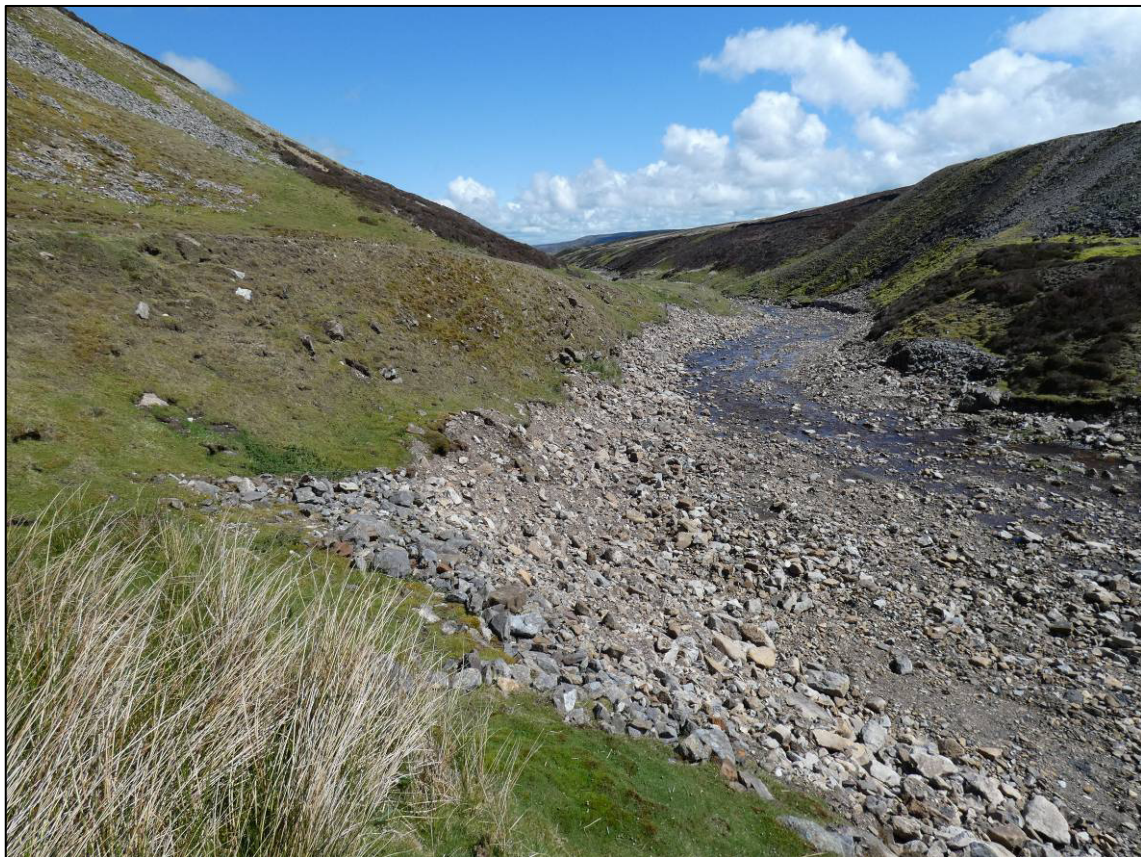
Plate 22: Area 3N, works complete and bedded-in, looking S (photo 3/305).
