EROSION REPAIRS,  
OLD GANG LEAD SMELTING MILL,  
MILL GILL, SWALEDALE, NORTH YORKSHIRE

ARCHAEOLOGICAL MONITORING AND RECORDING

Report no: 2022/665.R01  
Version: Final  
Date: May 2022  
Author: Shaun Richardson & Ed Dennison

Yorkshire Dales National Park Authority  
Yoredale  
Bainbridge  
Leyburn  
North Yorkshire DL8 3EL

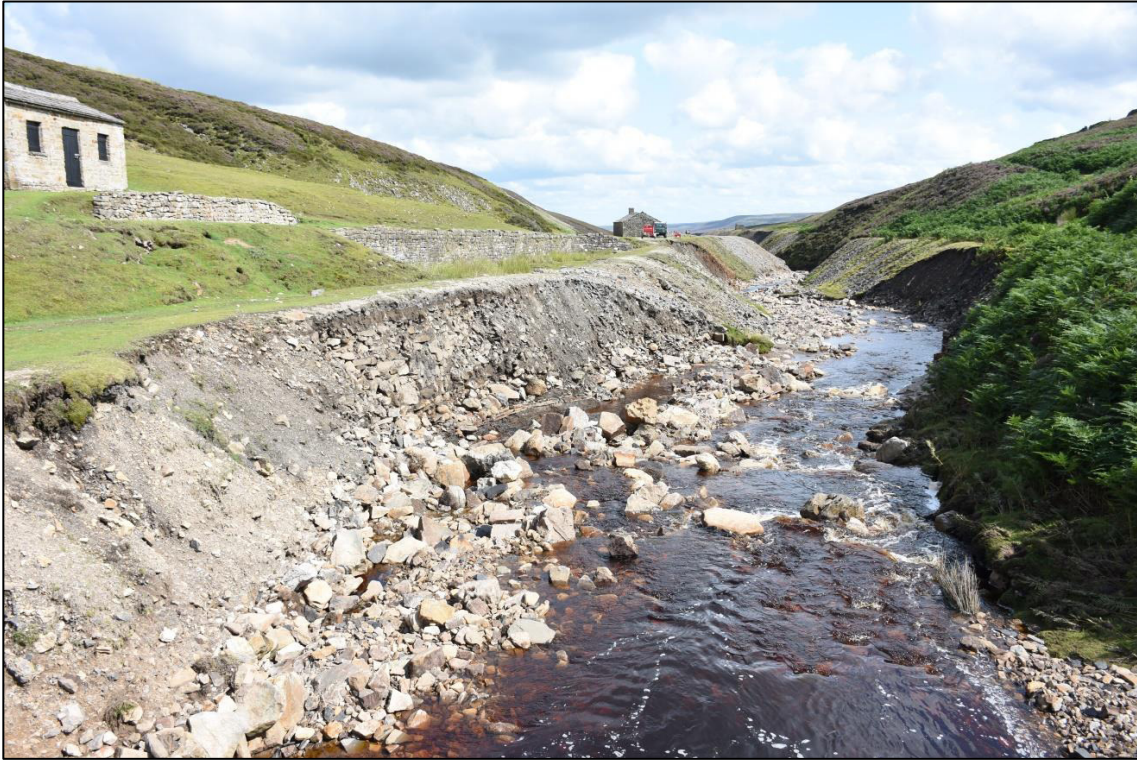
Plate 1: Area 1 erosion to north side of gill, looking SE (photo courtesy YDNPA).

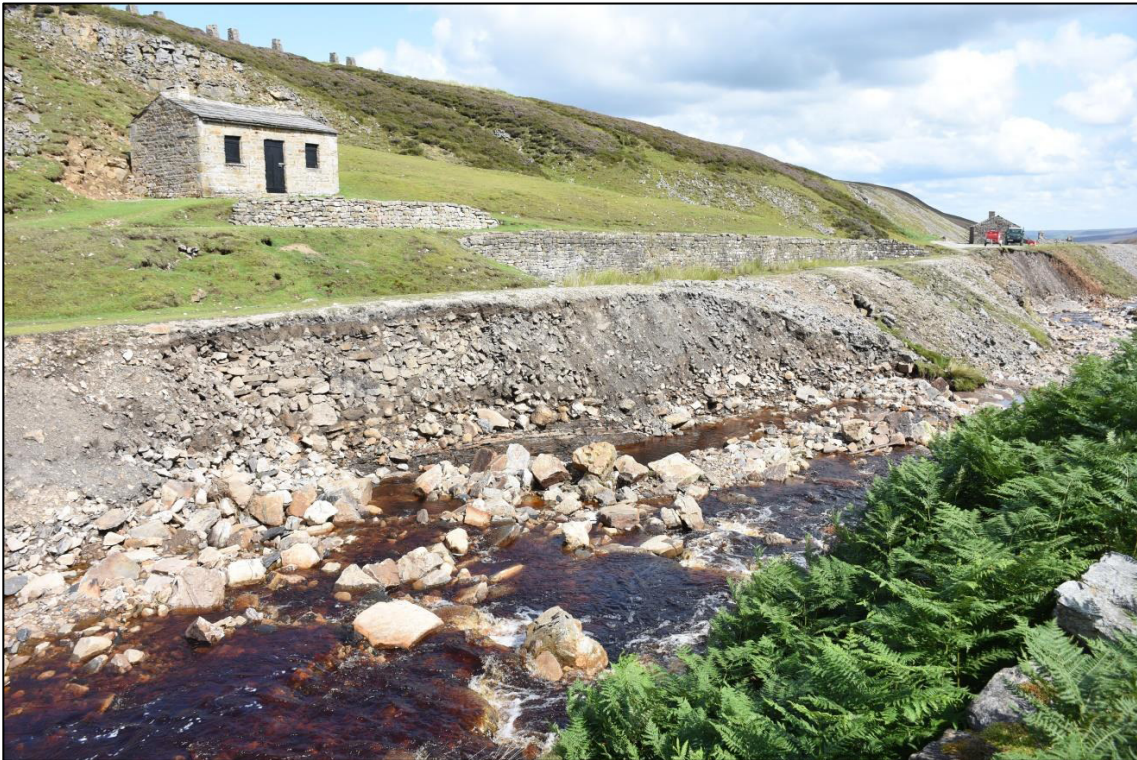
Plate 2: Area 1 erosion to north side of gill, looking E (photo courtesy YDNPA).

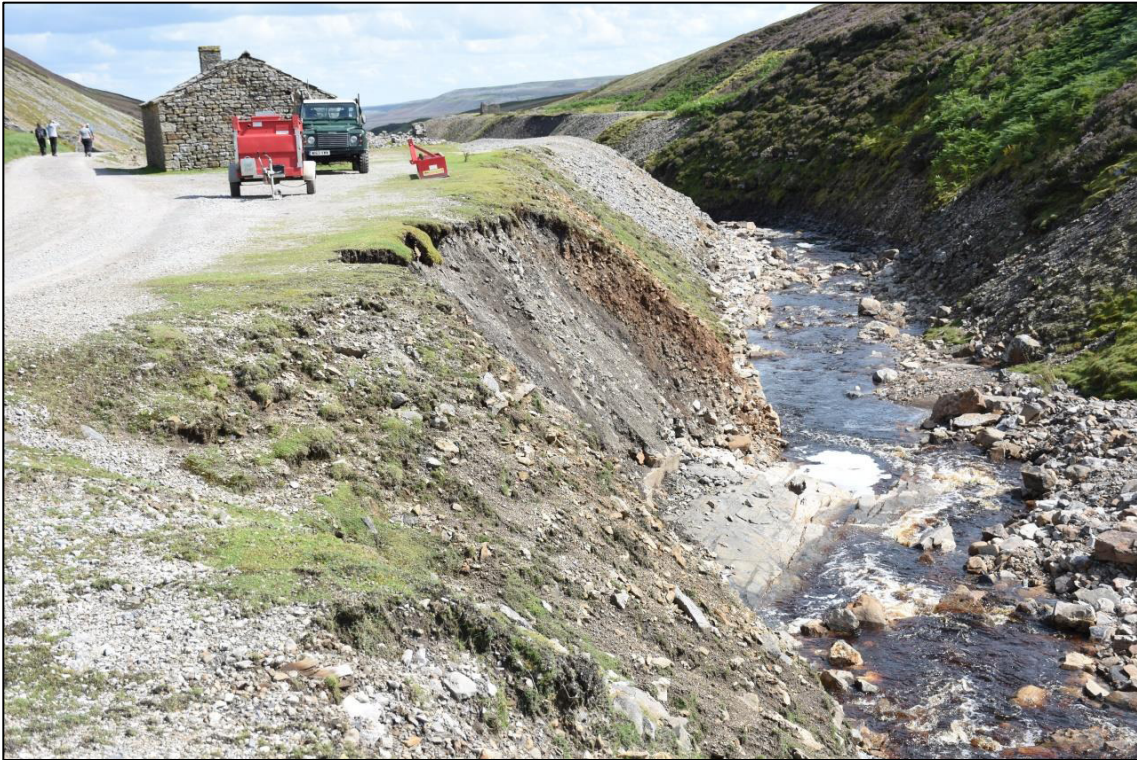
Plate 3: Area 2 erosion to north side of gill, looking SE (photo courtesy YDNPA).

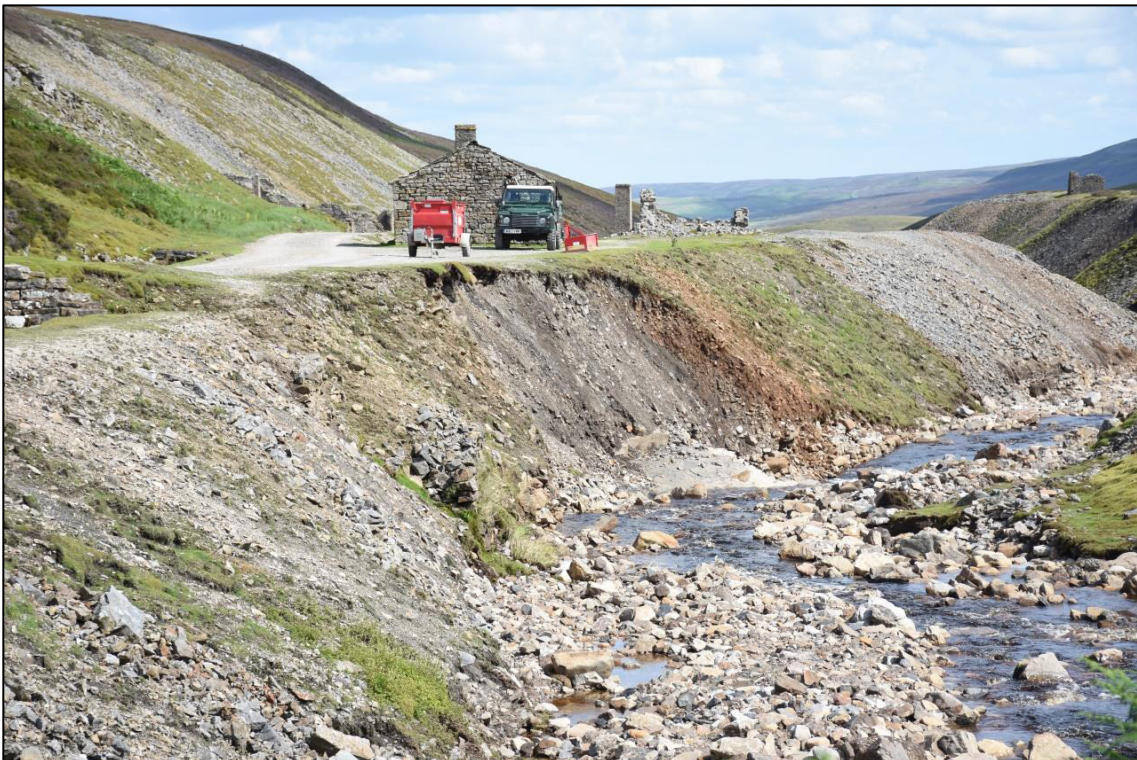
Plate 4: Area 2 erosion to north side of gill, looking E (photo courtesy YDNPA).

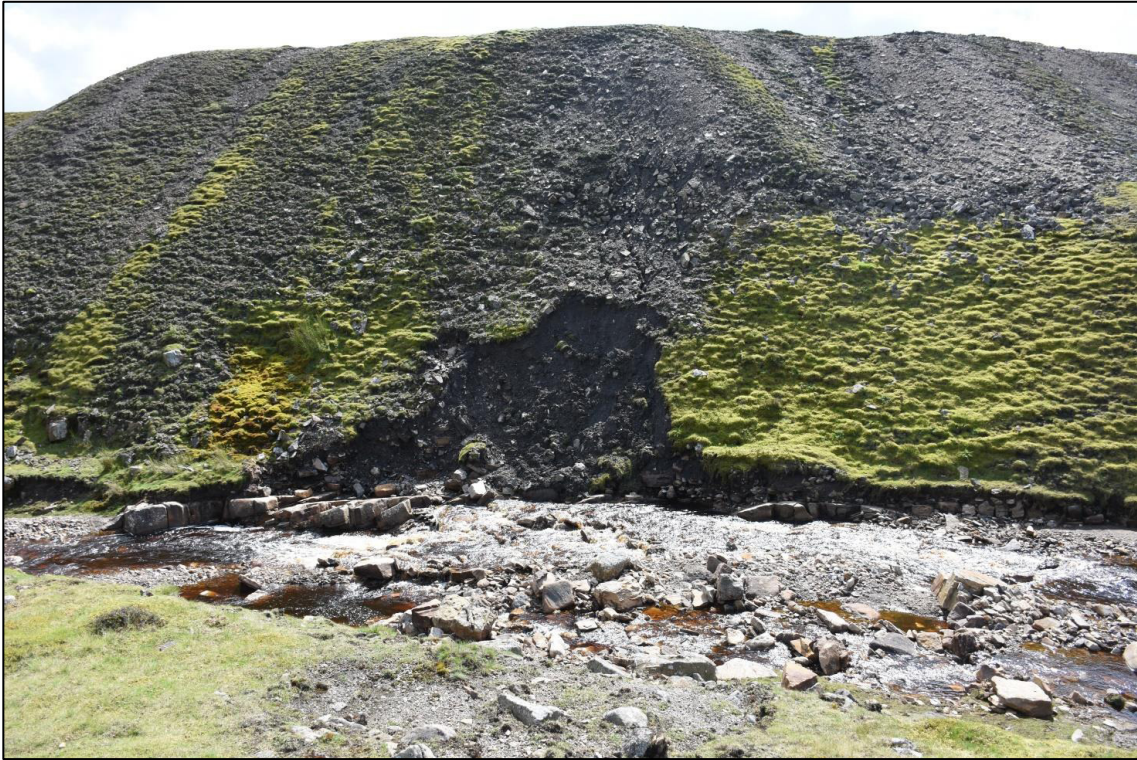
Plate 5: Area 3 erosion to south side of gill, looking NE (photo courtesy YDNPA).

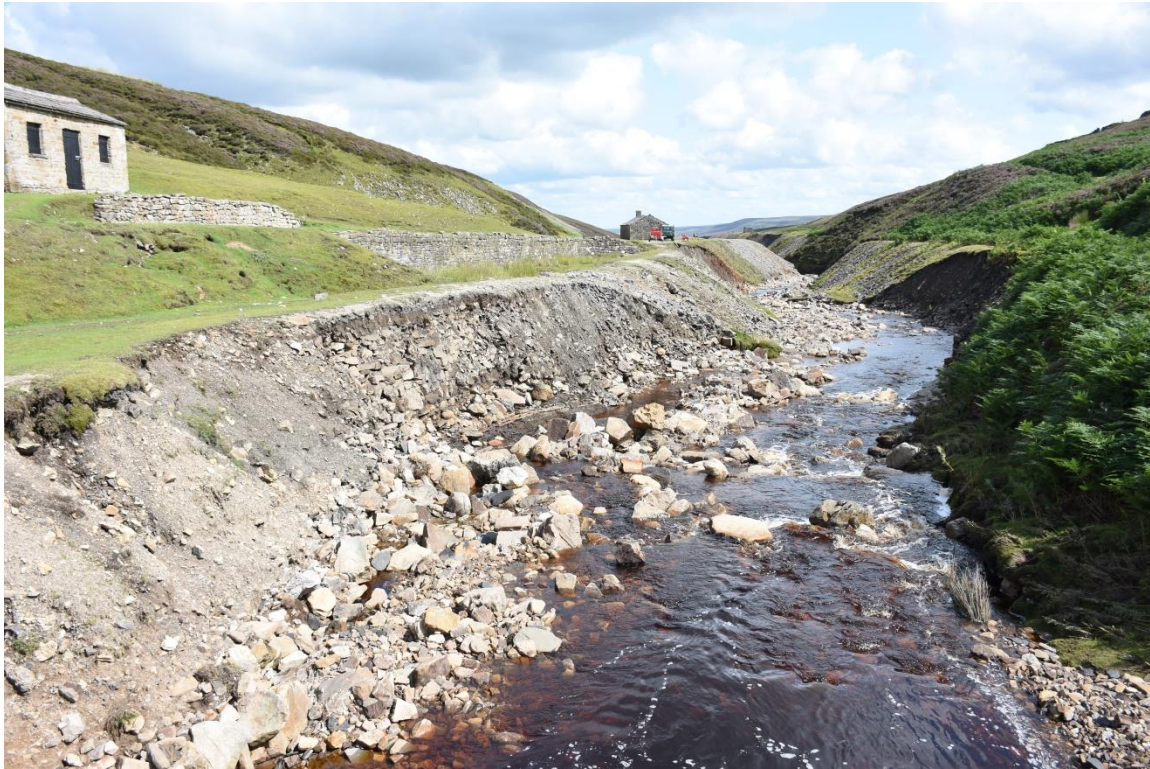
***Bank erosion adjacent to dam (approx. 40m)***

- Supply and install sufficient ½ - 1 tonne stone blocks/boulders to protect eroded sections of the edge of the watercourse to the north of the dam and shooting hut – as outlined on the accompanying plan. The blocks may need to be imported from a suitable local quarry, although a number of suitable sandstone blocks may be available from within the stream channel. Blocks should be positioned to prevent future erosion of the dam and of the bank underneath the spoil heaps, and undercutting of the bank beneath the shooting hut. The total length of rock armouring required is approximately 85m (approximately 40m at Area 1 adjacent to the dam, approximately 40m at Area 2 in front of the shooting hut and approximately 5m at Area 3 in front of the spoil heaps). The contractor is to back fill as needed behind the blocks to provide a level surface. The blocks should be laid in tight formation minimising gaps that water can eddy in.

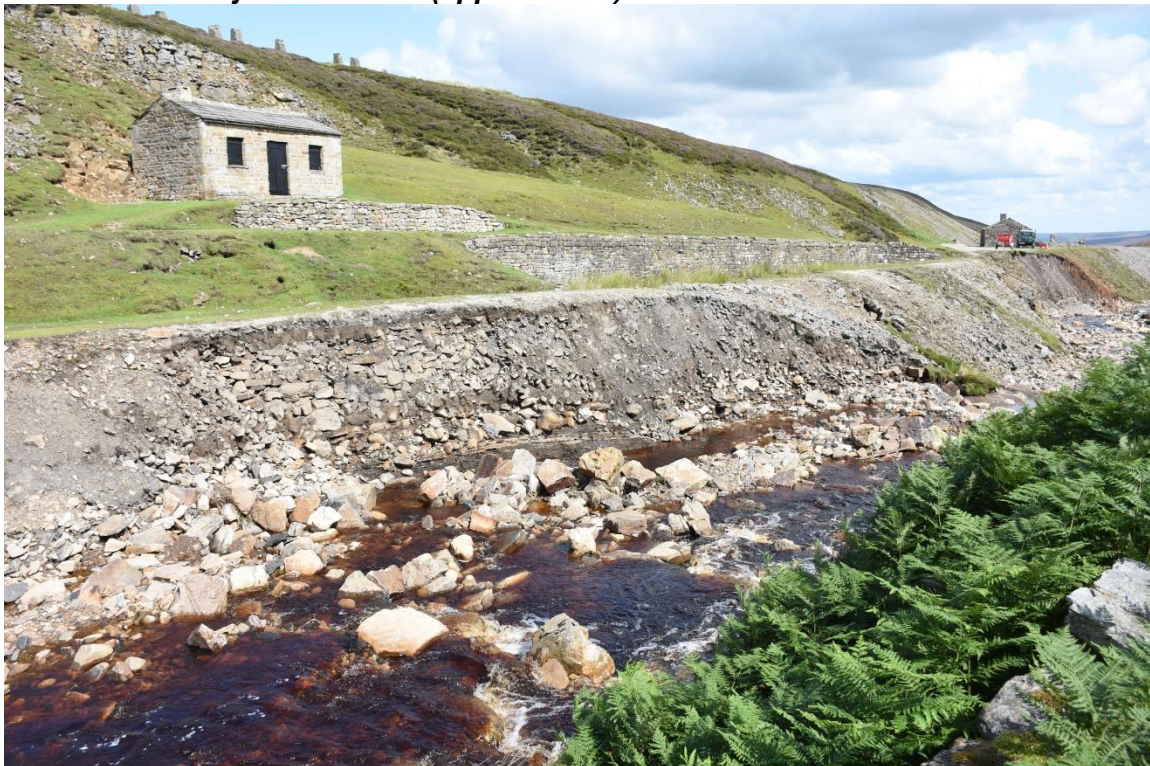
***Bank erosion adjacent to dam – area 2 visible in top right***

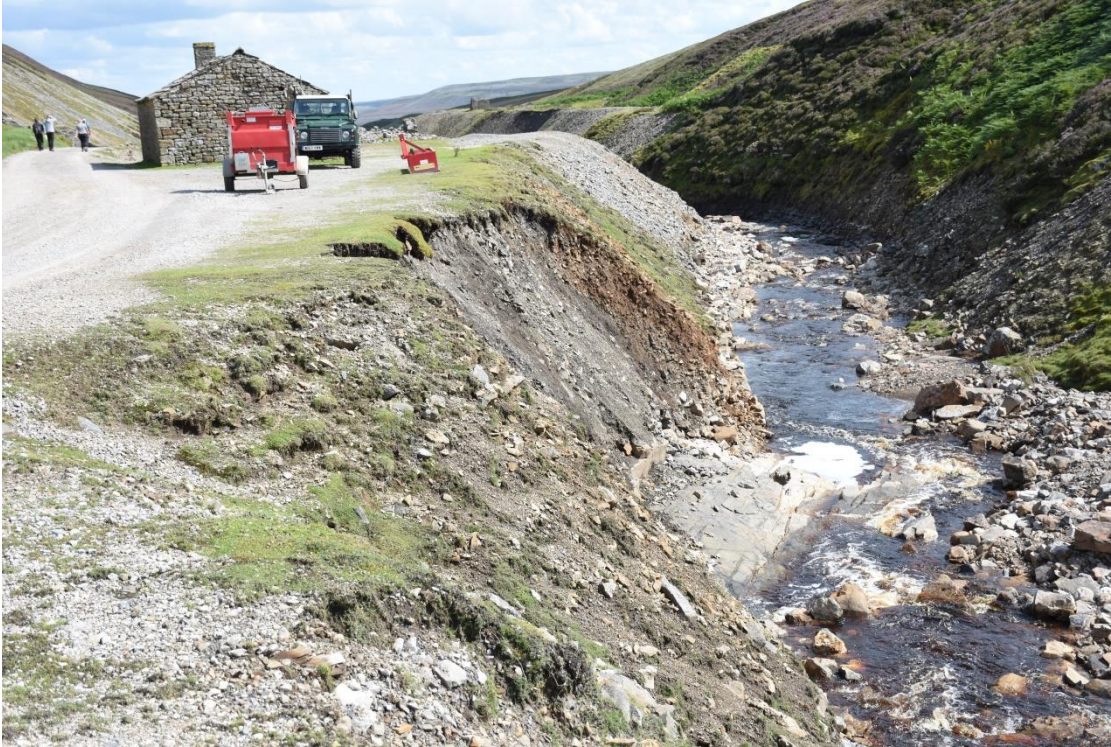
***Bank erosion in front of shooting hut (approx. 40m).***

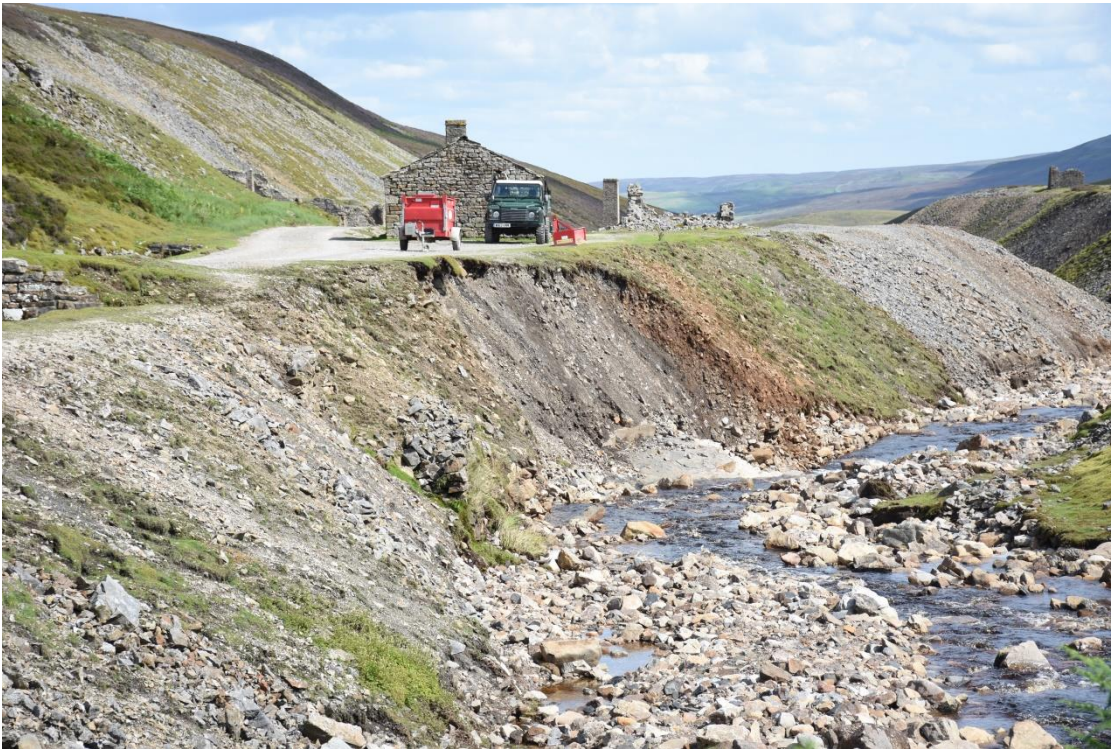
***Bank erosion in front of shooting hut***

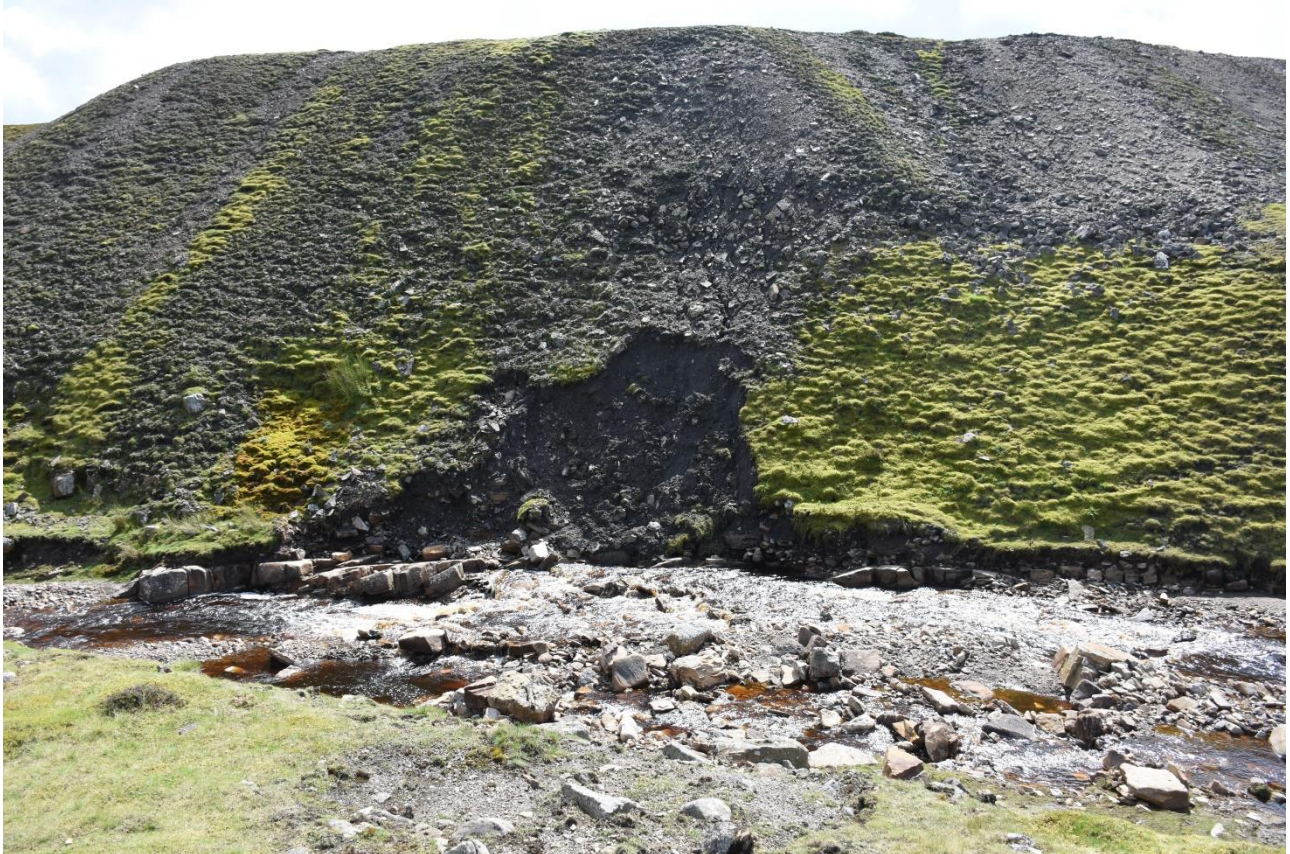
***Spoil heap erosion at south-east of the mill complex***
