FORMER CLAYTON HOSPITAL,
NORTHGATE, WAKEFIELD WF1 3JS

ADDITIONAL ARCHITECTURAL RECORDING

Report no: 2021/649.R01
Version: Final
Date: December 2021
Author: Shaun Richardson & Ed Dennison

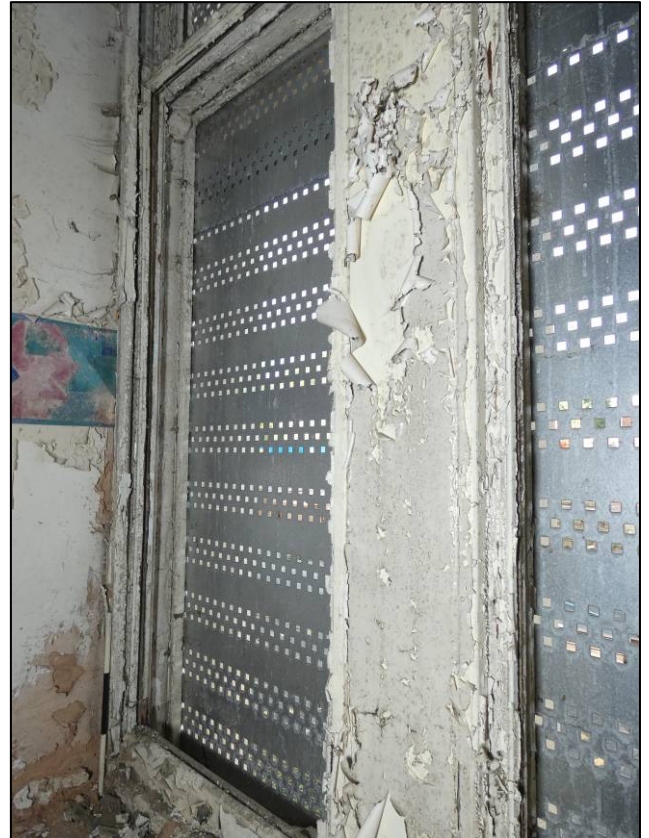
Plate 4: Ground floor room (G5), Type 1 window in north wall, looking W (photo 1/730).

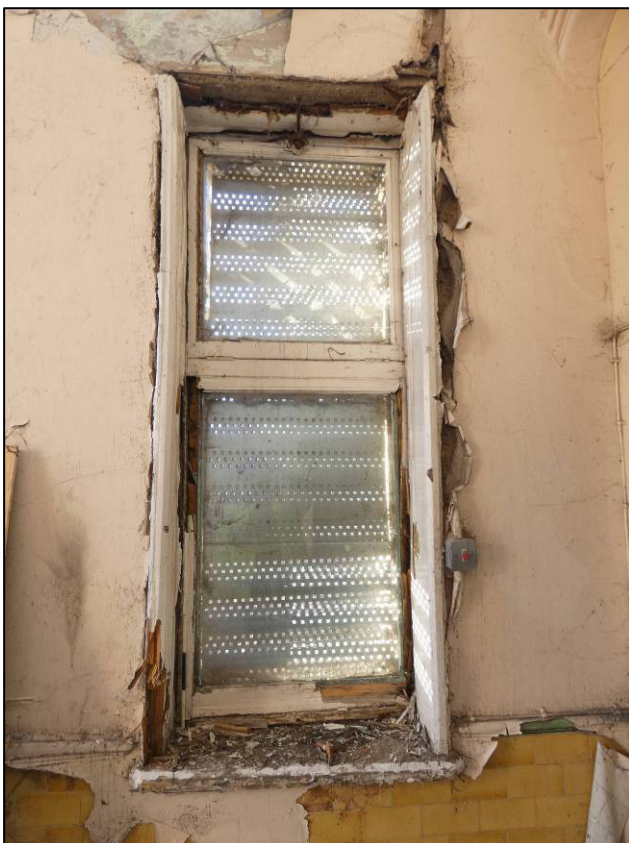
frames, all in poor to very poor condition and only partially complete. The former Surgeon's room (G8) to the east has a six-light mullioned and transomed window to the north wall fitted with Type 1 frames, again all in poor condition. The room to the east again (G9) has a large eight-light mullioned and transomed window to the north wall, fitted with Type 1 frames, all in poor condition. The former Operating Theatre (G10) (now sub-divided) at the east end of the block was only partly accessible due to the dangerous condition of the floor, and the windows in the north wall and at the north end of the east wall could not be inspected closely. However, although they may have been altered externally, internally the pair of windows to the north wall and two smaller windows in the east walls appear to be fitted with Type 1 frames, all of which appear to be in poor condition and some have replacement glass. The eastern part of the main circulation corridor (G11) has four windows of differing size to the south wall (G11/1-G11/4), but all are fitted with Type 2 frames in poor condition [1/725-1/727] (see plate 5).

Plate 5: Ground floor room (G11), Type 2 window (G11/1) in south wall, looking S (photo 1/725).

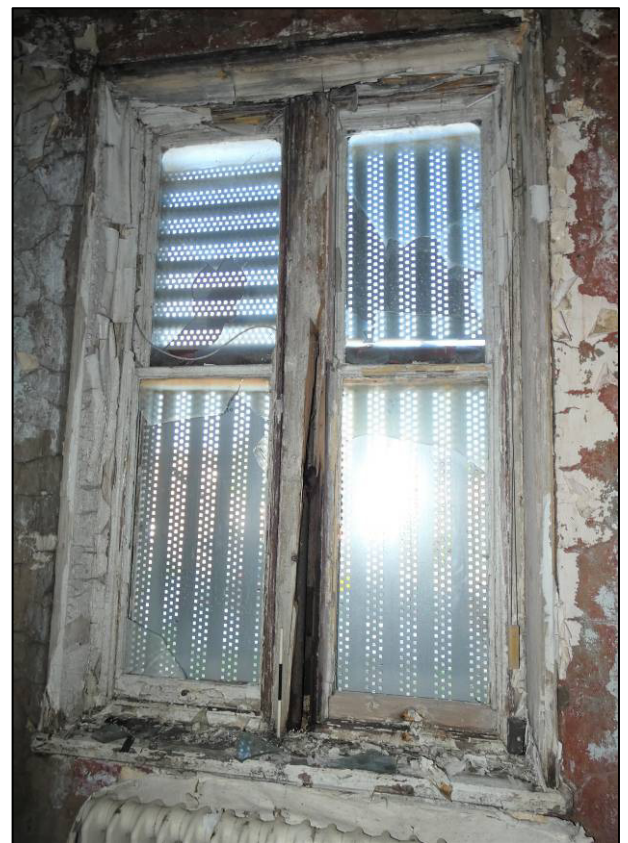
Plate 6: First floor room (1F2), Type 1 window in north wall, looking N (photo 1/741).

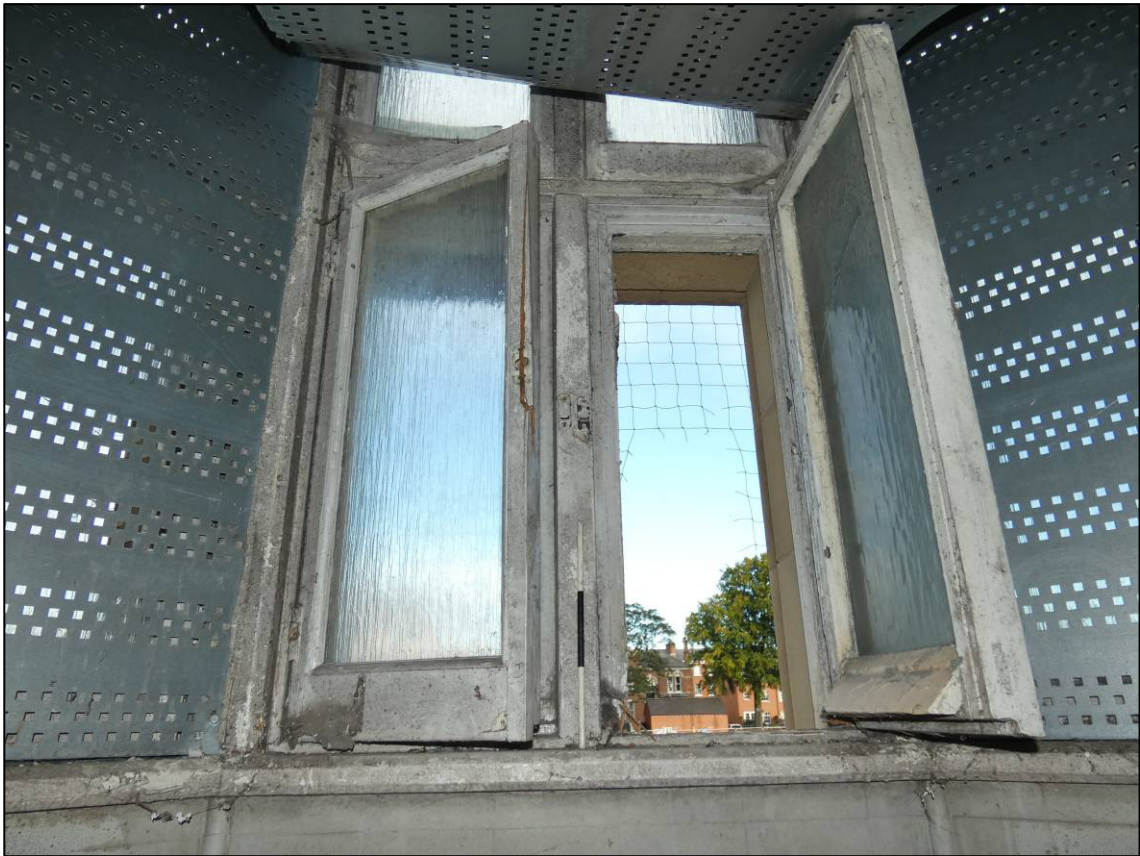
- 4.11 The first floor of the tower (1F5) formed a 'Museum'. The oriel window to the north wall is of canted plan form, with three sides. The single outer lights appear to be fitted with fixed softwood casement frames, but the central paired lights have side-hung opening softwood casements, which open inwards [1/736, 1/737] (see plate 7). The frames, perhaps originally of Type 1 form, are probably later replacements, and are in poor condition, with some parts having collapsed into external pigeon netting [1/752] (see plate 8). They are fitted with opaque glass, reflecting the changing function of the space during the 20th century.

Plate 7: First floor room (1F5), lower lights in oriel window to north wall of central tower, looking N (photo 1/737).

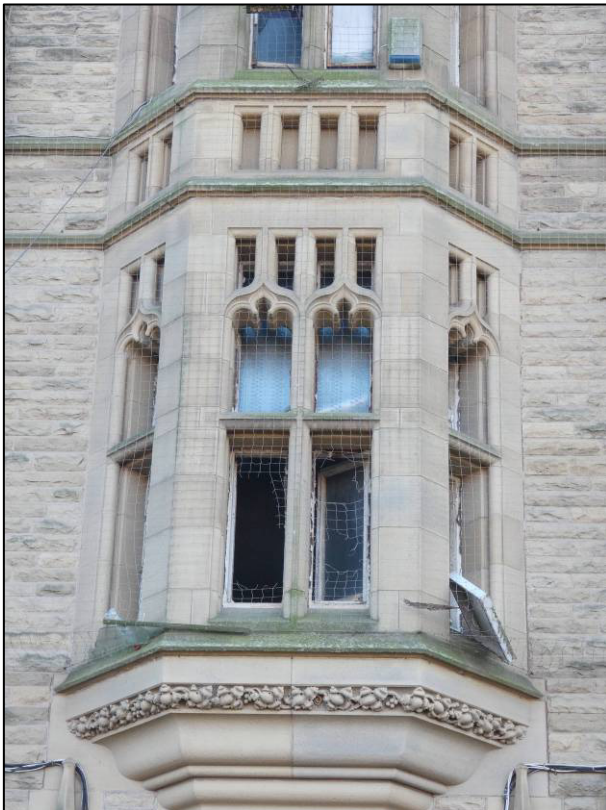
Plate 8: First floor oriel window to central tower (1F5), looking S (photo 1/752).

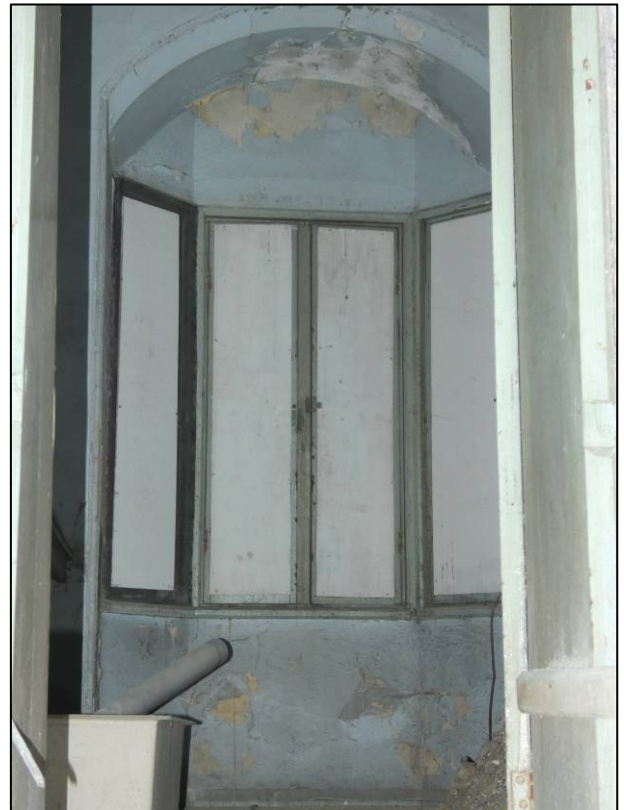
Plate 9: Second floor room (2F1), oriel window to north wall, looking N (photo 1/746).

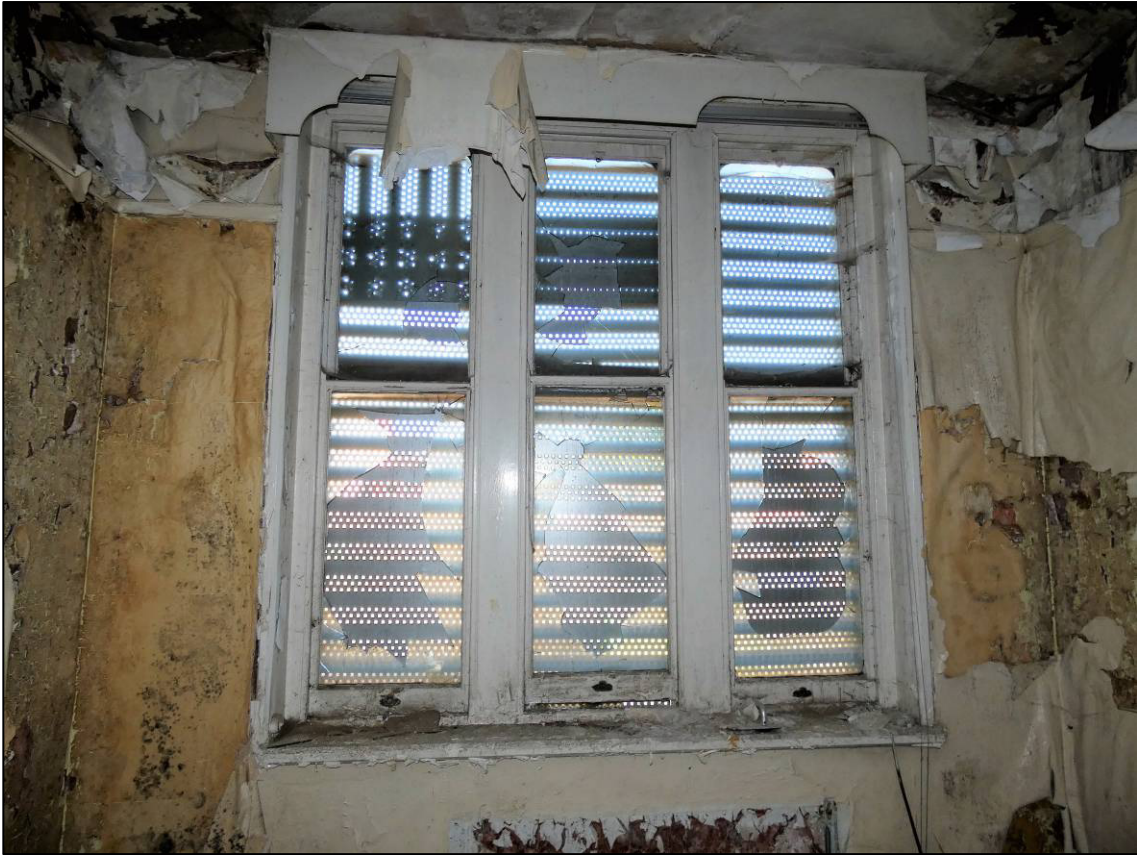
Plate 10: First floor room (1F7), Type 1 window to north wall, looking N (photo 1/738).

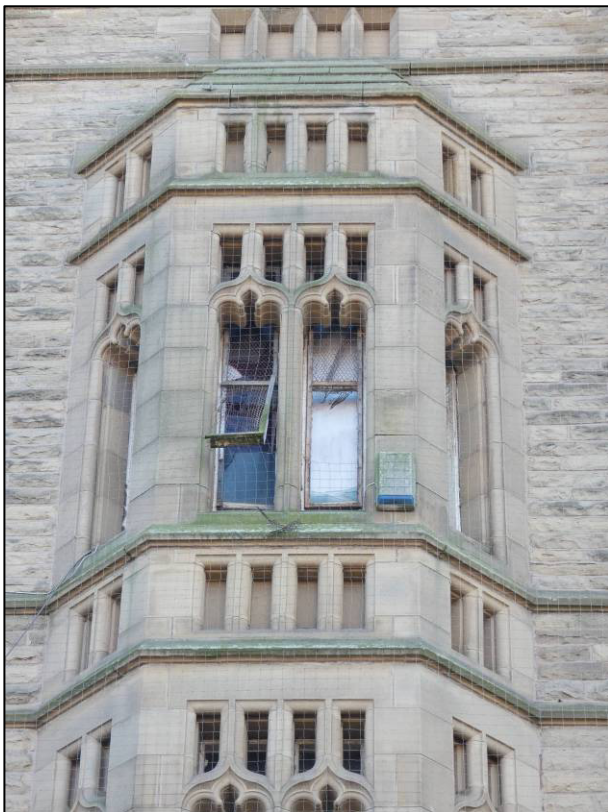
- 4.14 The second floor of the tower can only be reached through a low hatch, and then over a board walk which is now in dangerous condition. Viewed through the hatch, the north-western room (2F1) contains an oriel window to the north wall which is of canted plan form with three sides, as on the floor below. All lights appear to be fitted with internal shutters, which have had later plywood boards nailed to them [1/746] (see plate 9); the form of the frames could not be determined. This area was more safely accessible in 2018 when the historic building recording was undertaken, and the shutters were described as 'original' (Wyre 2018, 68-70). When viewed externally, the oriel window appears to be fitted with modern casement frames to which chicken wire has been fixed. They are in poor condition, with some parts have collapsed into external pigeon netting [1/753] (see plate 11).

Plate 11: Second floor oriel window to central tower (2F1), looking S (photo 1/753).

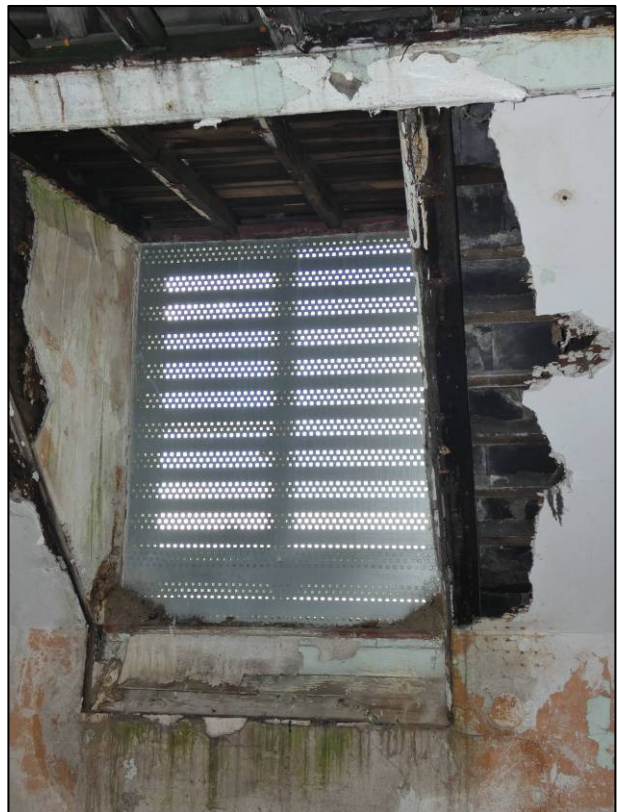
Plate 12: Second floor room (2F4), dormer window to south wall, looking S (photo 1/750).

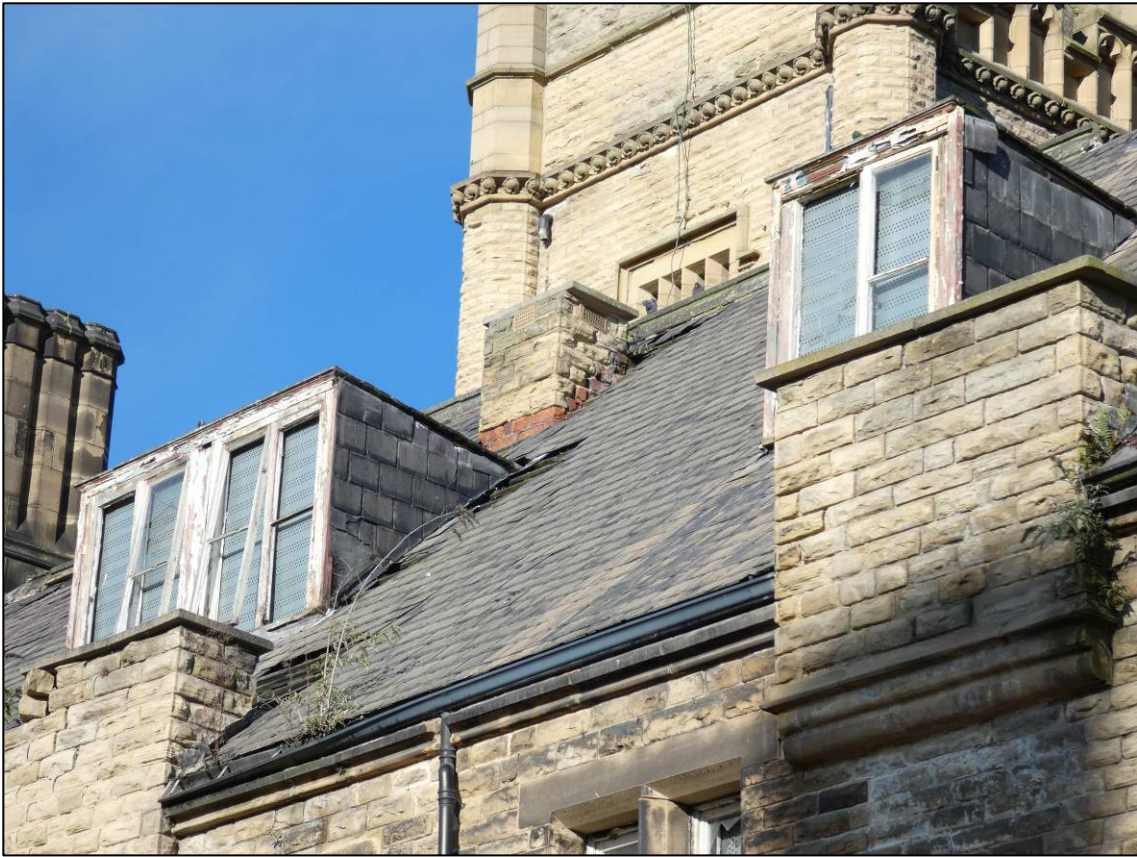
- 4.15 The room to the south (2F2) has dormer windows to the south wall. It is unclear whether these dormers are original features - when viewed externally, they are fitted with top-hung, single-glazed, opening casement frames, each casement comprising two panes of equal size [1/765, 1/766] (see plate 13).

Plate 13: Second floor rooms (2F2 and 2F4), dormer windows, looking NW (photo 1/765).

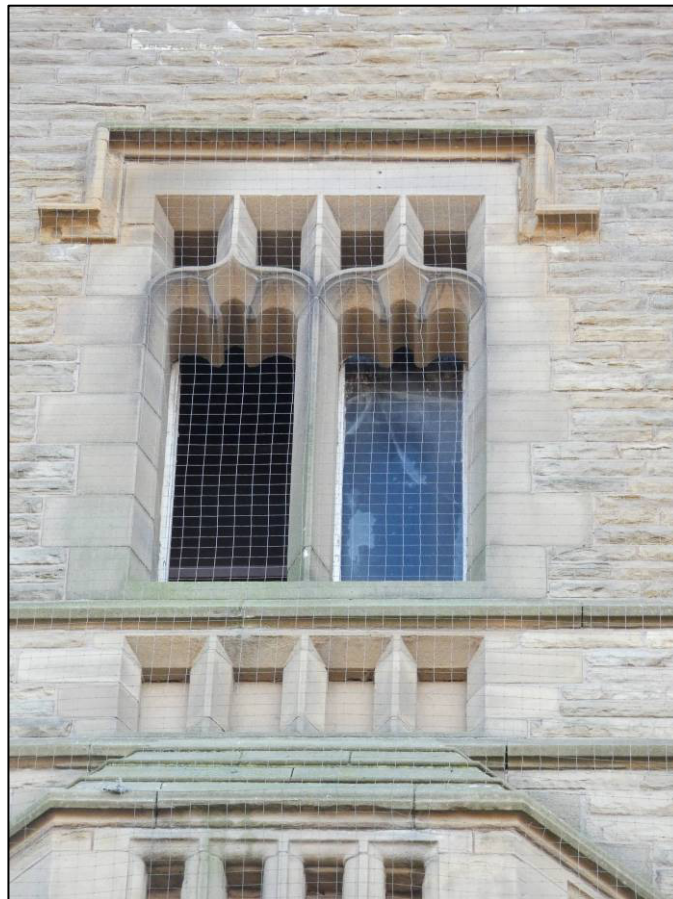
- 4.17 At the time of the window survey site visit, there was no access to the third floor of the tower, which is via a climbing ladder rising from the second floor (Wyre 2018, 70). However, when viewed externally, the window to the north wall appears to have softwood frames which are incomplete [1/754] (see plate 14).

Plate 14: Third floor window to central tower, looking S (photo 1/754).

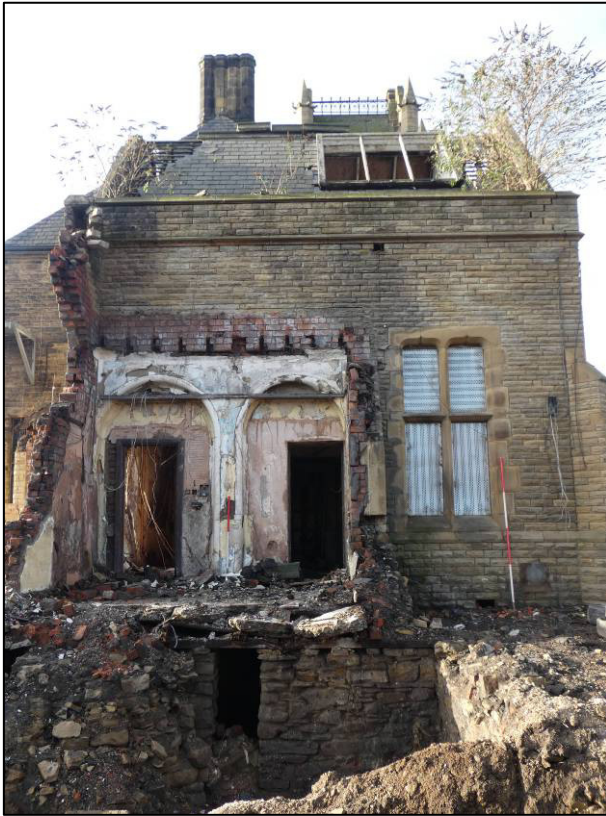
- 5.3 To the south of the Operating Theatre (G10) window, the elevation comprises what was once the interior of the Consulting Room (G12) [2/158-2/160] (see plate 15). This former interior wall is built of dark-red handmade bricks (average dimensions 230mm by 100mm by 70mm), with shallow frogs to both the upper and lower faces. These were used throughout the original parts of the hospital building, but bear no impressed marks relating to manufacture. As would be expected, examination of demolition rubble revealed a number of examples of bricks by local makers, for example 'WINDHILL BRICK CO WAKEFIELD' and 'WILSON BROS SANDAL', as well as those from further afield such as 'EASTWOOD 4 PRESSED', made in the Peterborough and Kent areas (<https://www.brocross.com/Bricks/Penmorfa/Pages/england7.htm>). The bricks to the former Consulting Room interior are set with a lime mortar and laid in a variation of English Garden Wall bond (five stretcher courses to each header course). There are two tall recesses with semi-circular heads, both of which now contain smaller, flat-headed doorways. The original plans (Kerr 2016, 39) show that only the south recess originally contained a doorway, and this retains what appears to be its late 19th century architrave. The north recess has had an off-centre doorway inserted within it at a later date. Above the recesses, there is a line of sockets for roof joists. Small projecting stubs of the Consulting Room's north and south walls survive at either end. The north wall was built of brick faced with stone, whilst the south wall (shared with the adjacent corridor - G11) has a blocked original doorway with a timber lintel and a brick relieving arch over.

- 5.4 In addition, some minor remains of a below ground structure were exposed beneath where the Consulting Room (G12) used to stand (see plate 15). This structure does not appear on the architect's plans (Kerr 2016, 38), and so it is assumed to have been used as foundations or to accommodate services.

Plate 15: East elevation after demolition, looking W (photo 2/159).

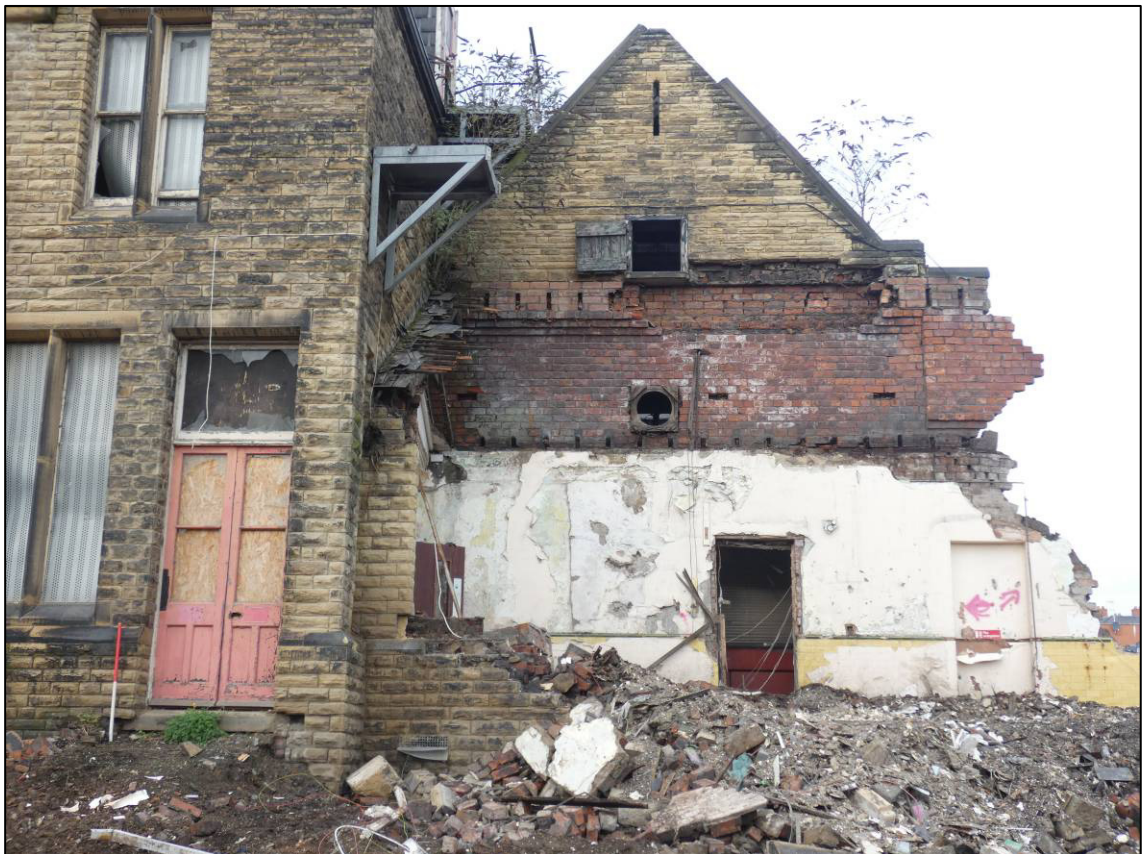
- 5.5 The corridor (G11) itself was tiled to dado level with mustard-yellow rectangular wall tiles, manufactured by the Craven and Dunhill Tile Works at Jackfield, Shropshire. The green ceramic dado was probably by the same maker, with the walls plastered and painted above this. Above the lath and plaster ceiling, the corridor had a simple single-pitch softwood roof structure, sloping downwards from north to south. After demolition, only the north and west walls of the corridor remain. The corridor's north wall retains the tiles to dado level (although now painted over), and is plastered and painted above [2/170]. There are two doorways; the west doorway lead into the Operating Theatre (G10) and the east into the Consulting Room (G12). Above the plaster, there is a line of recesses for the raking struts of the former corridor roof structure, and then a band of blank brickwork pierced by a circular vent [2/171]. The brickwork rises to three corbelled courses, which formerly supported the principal rafters of the corridor roof structure. Above the corbelling rises the south gable of the Operating Theatre (G10). This has a small opening fitted with a plank and batten door at a lower level, and a narrow slit to the gable apex; the gable retains some of its stone coping [2/172-2/174, 2/204-2/210] (see plate 17).

Plate 17: East elevation after demolition, former north wall of corridor (G11) with Operating Theatre (G10) behind, looking N (photo 2/209).

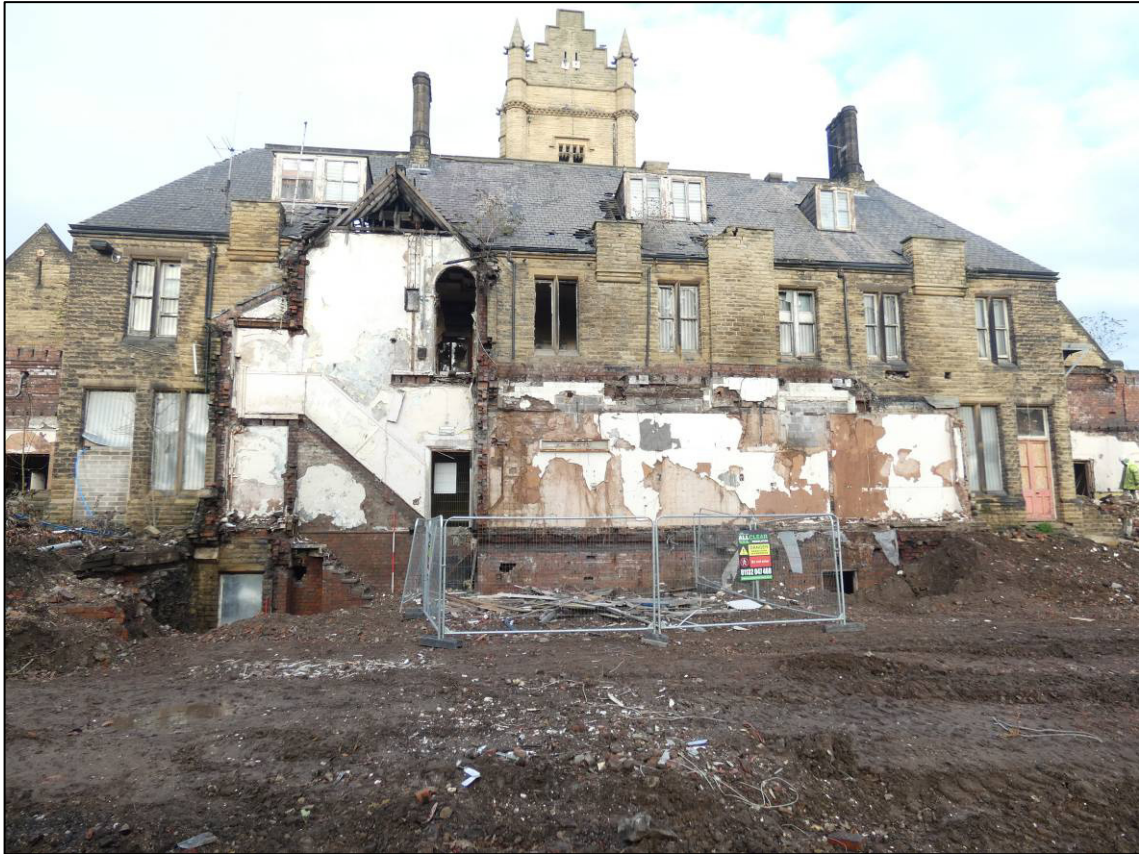
- 5.8 The south elevation of the retained section is of two storeys with an attic; in places, elements of the adjacent cellar, that once lay beneath the demolished adjacent structures, also remain visible. The majority of the elevation is faced with neatly (and rather shallowly) coursed and squared rock-faced sandstone set with a lime mortar; there is a chamfered inset just below ground floor window sill level [2/194-2/197, 2/199-2/203] (see plate 20).

Plate 20: South elevation after demolition, looking N (photo 2/197).

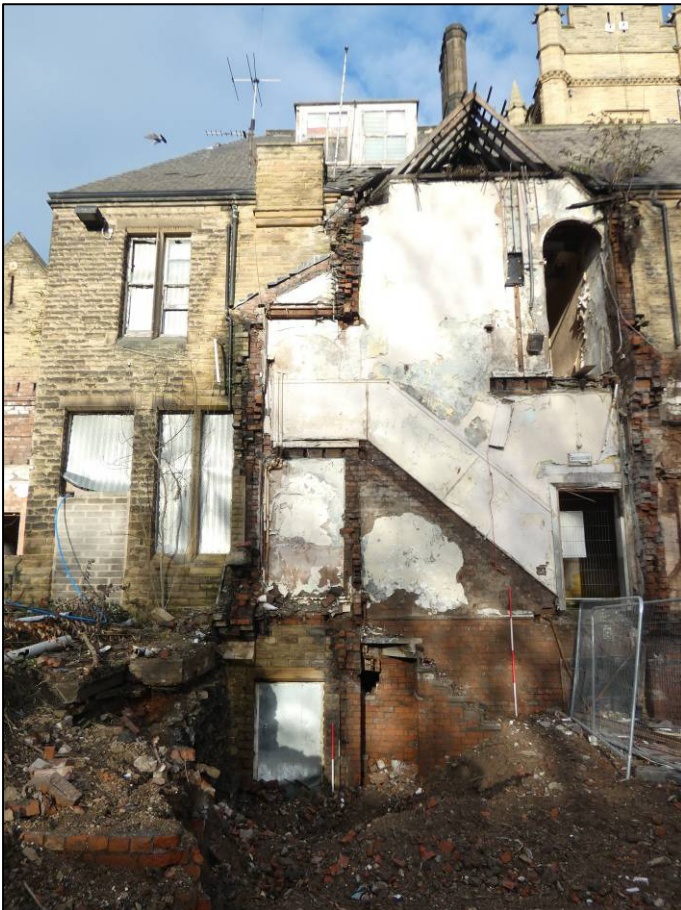
- 5.11 To the west of the scullery, the service wing rose to two full storeys, with a hipped, slated roof [2/183-2/193] (see plate 21); the ground floor was occupied almost completely by the mess room, whilst beneath at cellar level there was the coal store. The first floor formed the Servant's dormitory (Kerr 2016, 38-40) which extended south from the elevation. At the base of where the service wing once met the south elevation, the remains of the stone steps positioned at the west end of the main east-west aligned cellar corridor are visible; an adjacent (blocked) door to the immediate west once led into the beer cellar. Parts of these areas were photographed during the previous historic building recording work (Wyre 2018, 83-84). The walls here are bare brickwork, but above to the ground and first floors, they are largely plastered and painted brickwork. The position of the former staircase rising from the ground to the first floor is clearly defined, with a ground floor doorway at the east end, and the remains of a W.C. beneath the west end. At the former half-landing level, the western part of the staircase appears to have a segmental headed arched opening above, and a similar feature was photographed here in 2018 (Wyre 2018, 95-96); the original plans show only a W.C. in this location (Kerr 2016, 40). There is however a semi-circular headed doorway to the first floor. Above the doorway, a small element of the service wing's softwood pitched roof structure remains in place, and behind this, the slated south roof slope of the attic [2/198] (see plate 23).

Plate 21: South elevation after demolition, former two storey part of service wing, looking N (photo 2/185).

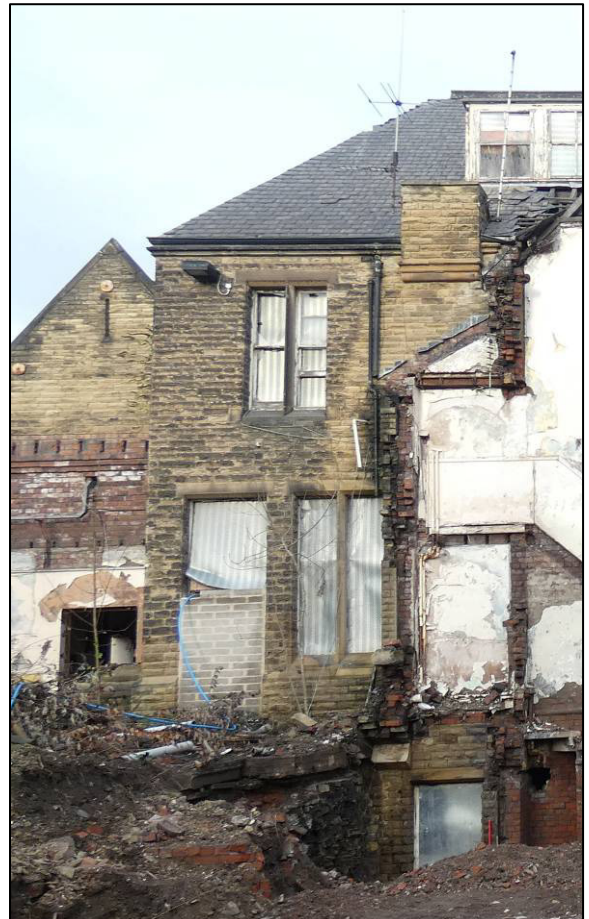
- 5.12 To the west of the service wing, the remainder of the south elevation is essentially a mirror image of the east end described above [2/195] (see plate 22). To the ground floor, there is a tall, flat-headed, external original doorway (now partly blocked with blockwork), with a tall but narrow four-light mullioned window (G3/1) to the immediate east. Above, to the first floor, there is a single window of the same form as those to the east of the service wing. A shallow projection to the east side of the window housed the flue from the fireplace formerly heating the Nurses' dormitory (1F9).

Plate 22: West end of south elevation after demolition, looking N (photo 2/195).

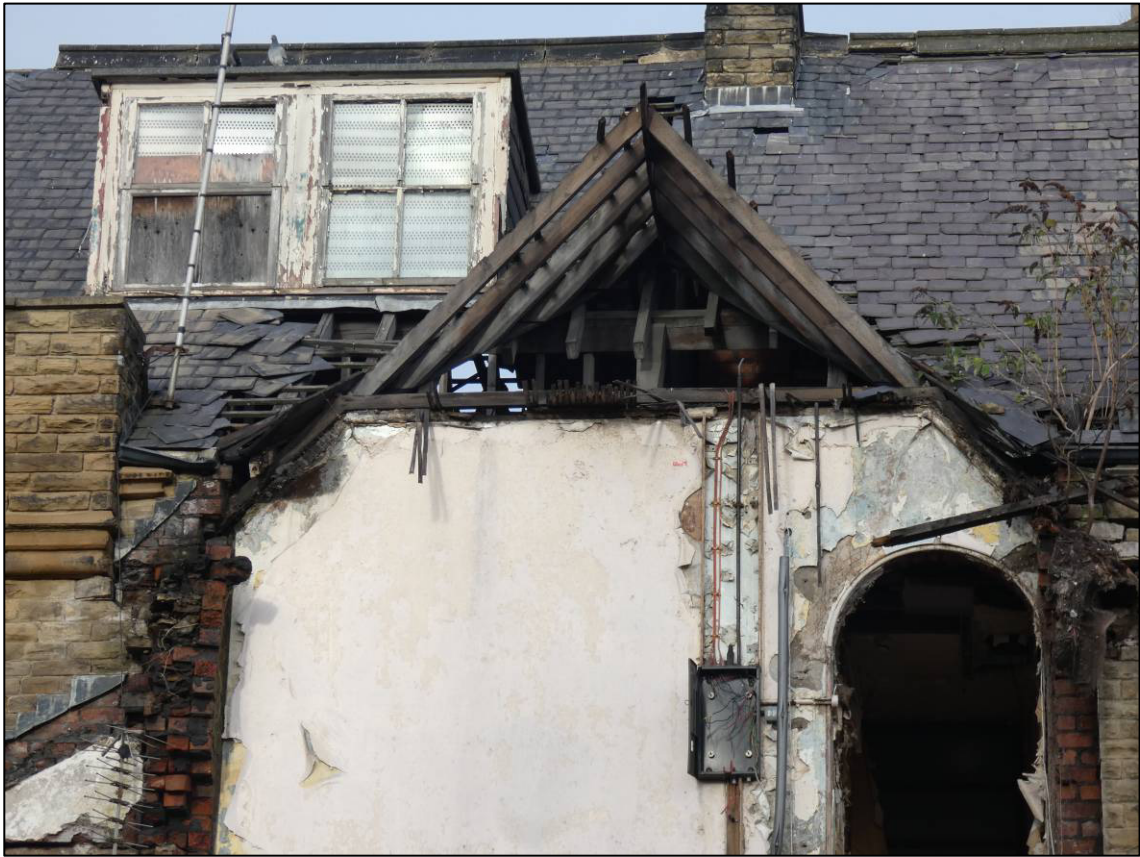
Plate 23: South elevation after demolition, former two storey part of service wing, attic, looking N (photo 2/198).

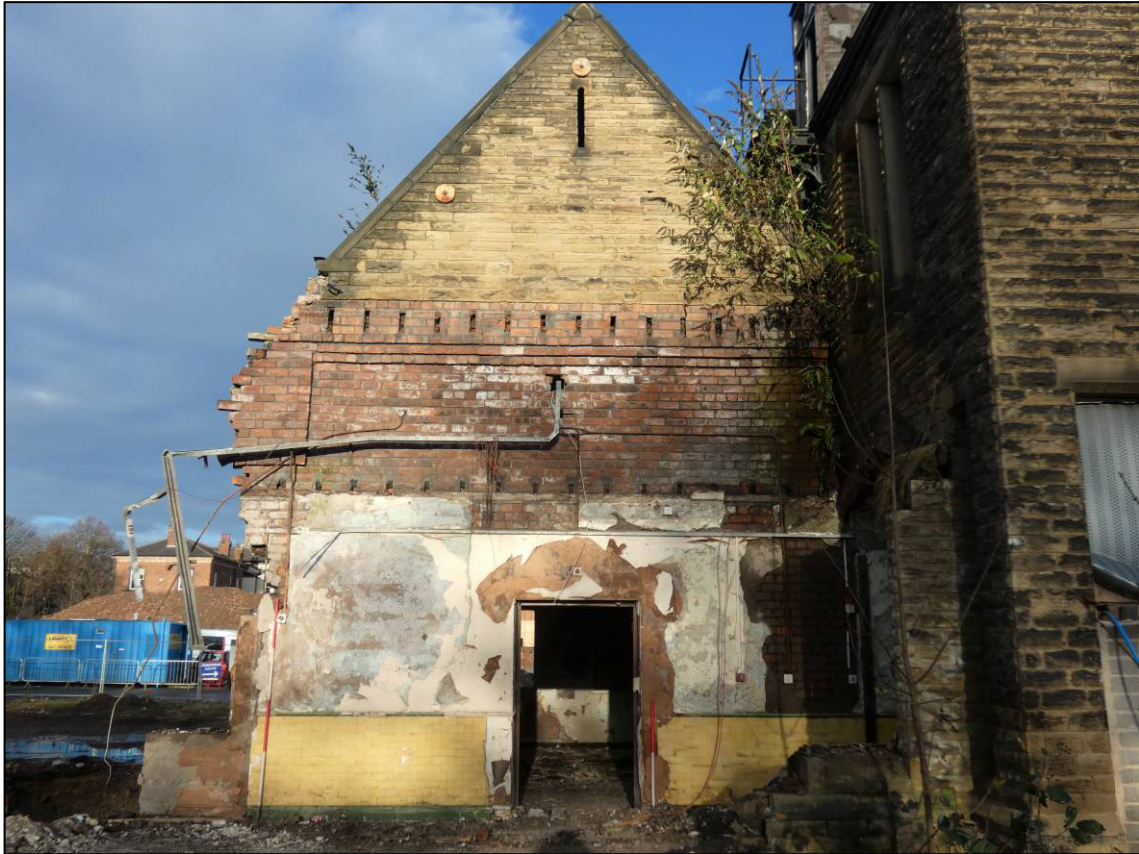
- 5.16 The corridor (G1) was tiled to dado level with mustard-yellow rectangular wall tiles, manufactured by the Craven and Dunhill Tile Works at Jackfield, Shropshire [2/157]. The green ceramic dado was probably by the same maker, with the walls plastered and painted above this. Above the lath and plaster ceiling, the corridor had a simple single-pitch softwood roof structure, sloping downwards from north to south. After demolition, only the north and east walls of the corridor remained. The corridor's north wall retains the tiles to dado level, and is plastered and painted above. There is a single centrally-placed doorway, that led into the Board Room (G2). Above the plaster, there is a line of recesses for the raking struts of the former corridor roof structure, and then a band of blank brickwork. This brickwork rises to three corbelled courses, which formerly supported the principal rafters of the corridor roof structure. Above the corbelling rises the south gable of the Board Room. This has a narrow slit to the gable apex and stone coping; there are also three circular cast-iron wall-tie plates [2/151-2/154] (see plate 25).

Plate 25: West elevation after demolition, former north wall of corridor (G1) with Board Room (G2) behind, looking N (photo 2/151).
