CONSERVATION FABRIC REPAIRS,
BUTTERTON BRIDGE, PICKING GILL,
SAWLEY, NORTH YORKSHIRE

ARCHAEOLOGICAL AND ARCHITECTURAL
OBSERVATION, INVESTIGATION AND RECORDING

Report no: 2020/620.R01
Version: Final
Date: May 2021
Author: Shaun Richardson & Ed Dennison

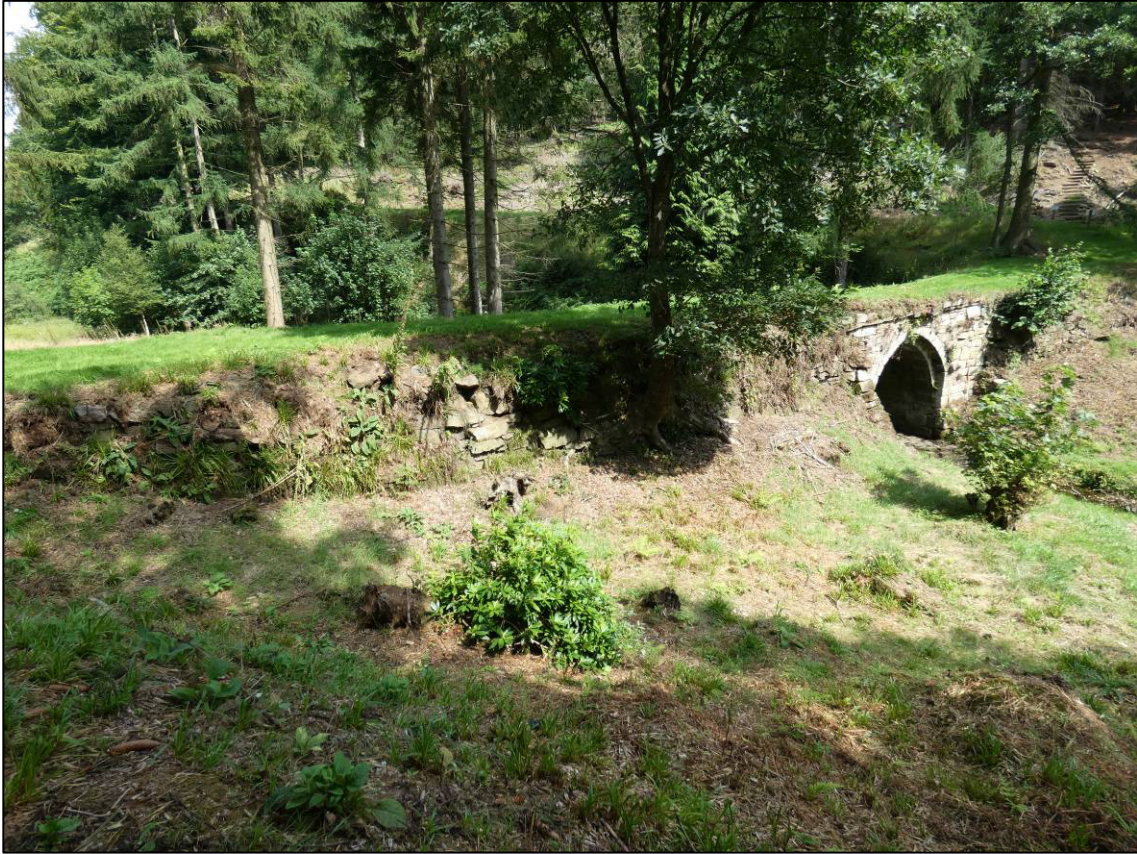
Plate 6: View of south elevation and west abutment, prior to repairs, looking NE (photo 1/896).

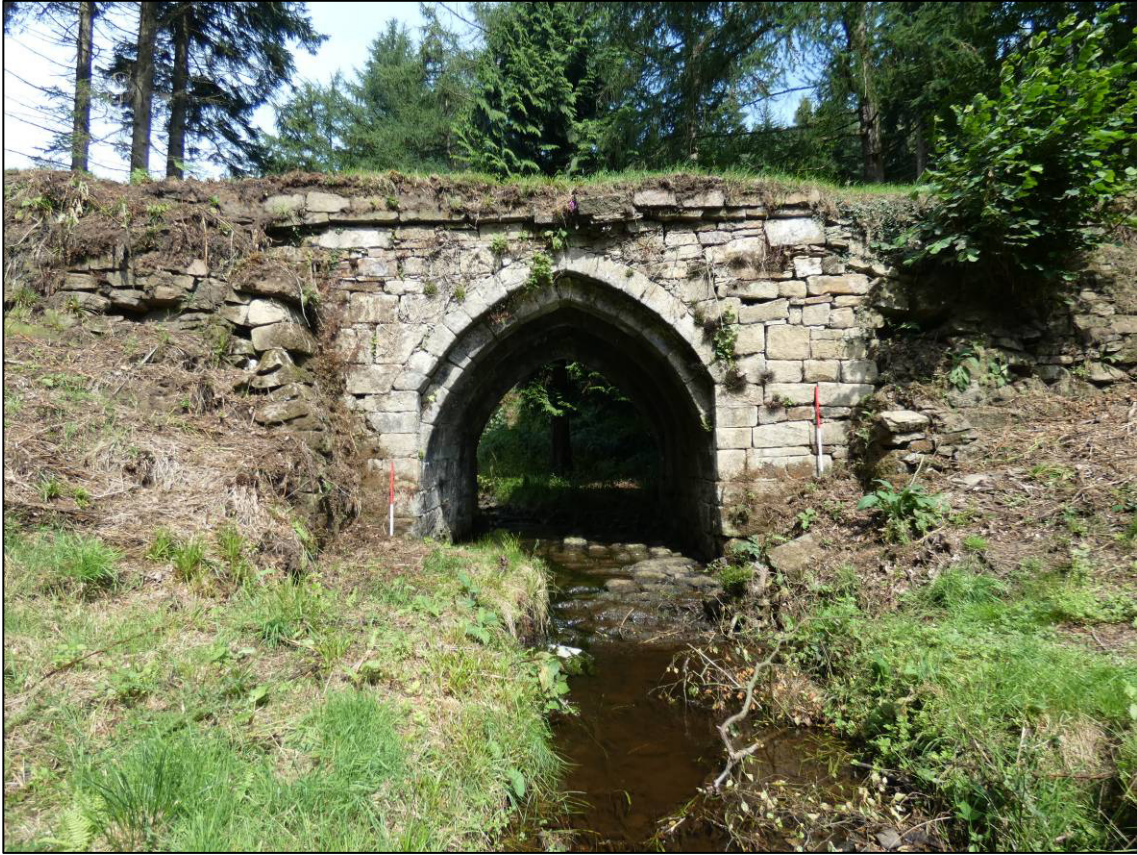
- 1.15 For the south elevation of the bridge, either side of the archway, much of the stonework was seen to be bulging out and would need rebuilding, especially the western section. The upper section of wall face was to be dismantled and rebuilt with two skins, the core behind being consolidated and secured with 1m long stainless steel rods. Other stainless steel rods would be used to set stainless steel plates behind outer face stonework to tie both the south and north faces of the bridge together. Elsewhere, deep tamping and repointing, including of the arch facing stones, would be done.

Plate 8: South elevation, prior to repairs, looking N (photo 1/883).

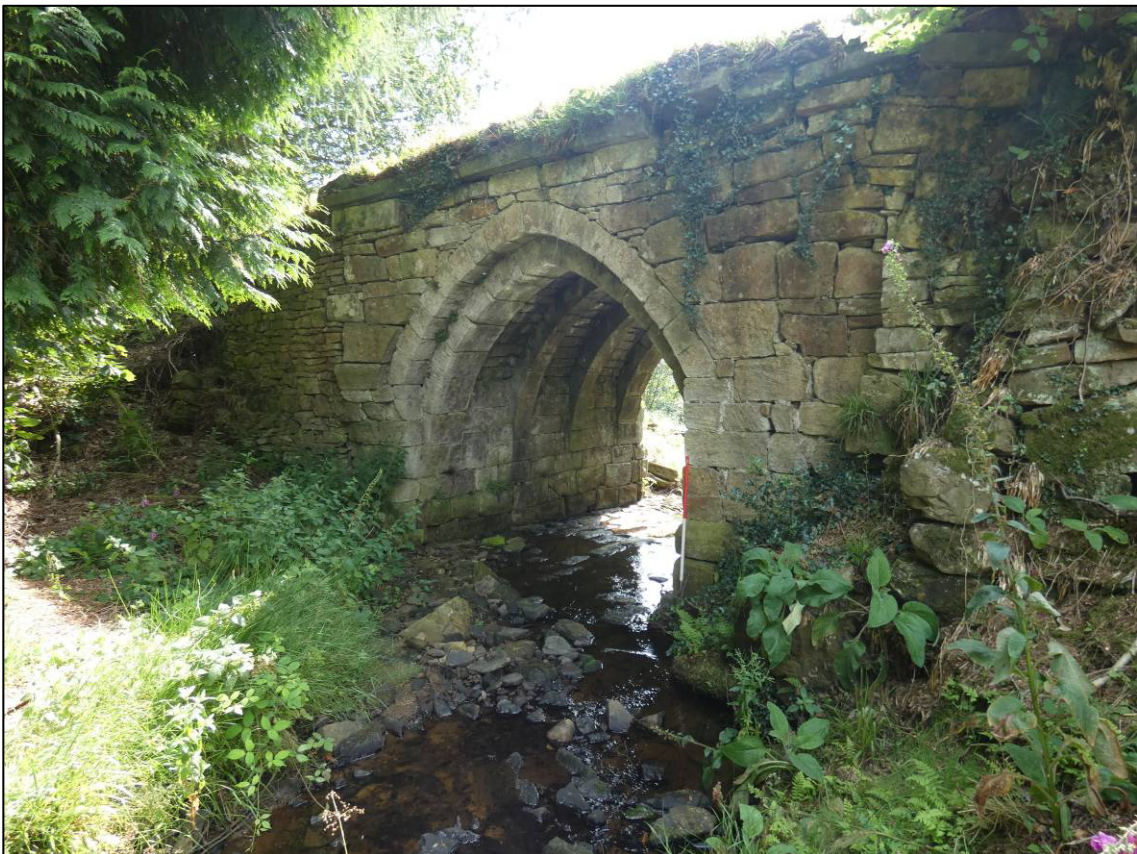
- 1.17 Similar dismantling and rebuilding work would also be done to the north elevation. Parts of the eastern buttress appear to have been added later and are not fully toothed in. Much of the western buttress will also need to be rebuilt. It was difficult to assess the condition of the eastern embankment, but it was assumed that the retaining wall survives and will need to be stabilised.

Plate 9: North elevation, prior to repairs, looking SE (photo 1/907).

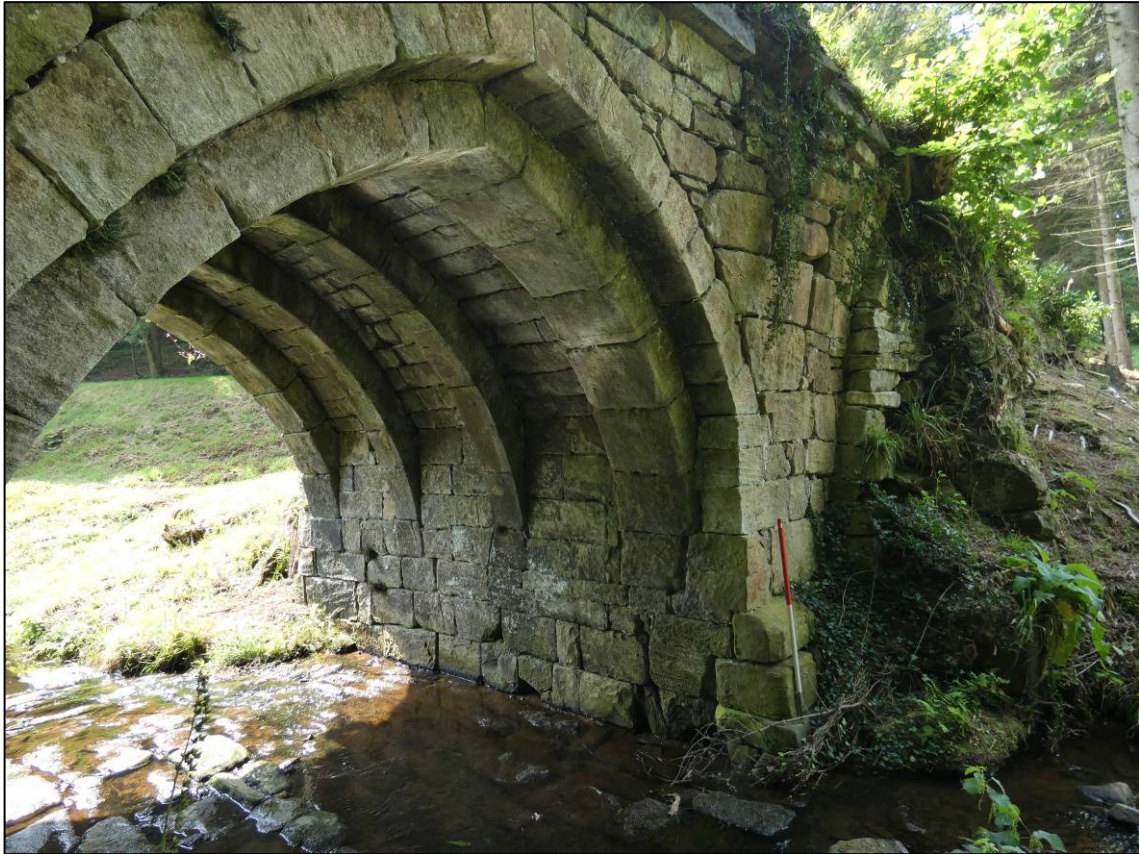
of the vault arch are more thinly coursed [1/891, 1/909, 1/912, 1/913; 3/296, 3/297, 3/301, 3/303, 3/304] (see plate 10). On either side, the lowest course of the vault projects very slightly, and rests on a bed of smooth rectangular stones or cobbles, laid north-south along the bed of the beck; a section of east-west laid stones on the south side of the bridge may represent a later repair. The northern edge of these stones corresponds with the north face or elevation of the bridge, and so they were almost certainly laid to form a base upon which to erect the structure, rather than forming the remains of an earlier ford, for example. Beyond the south face of the bridge, the stones are again set north-south, and slope gently downwards away from the bridge to form a small weir. No masons' marks or putlog holes were noted on the bridge during the course of the archaeological field work, although there are several recesses or sockets in the vault, set above the level from which the ribs spring, which may once have housed the wooden centring or form over which the vault was constructed.

Plate 10: North side of arch and ribs of vault, prior to repairs, looking SW (photo 1/912).

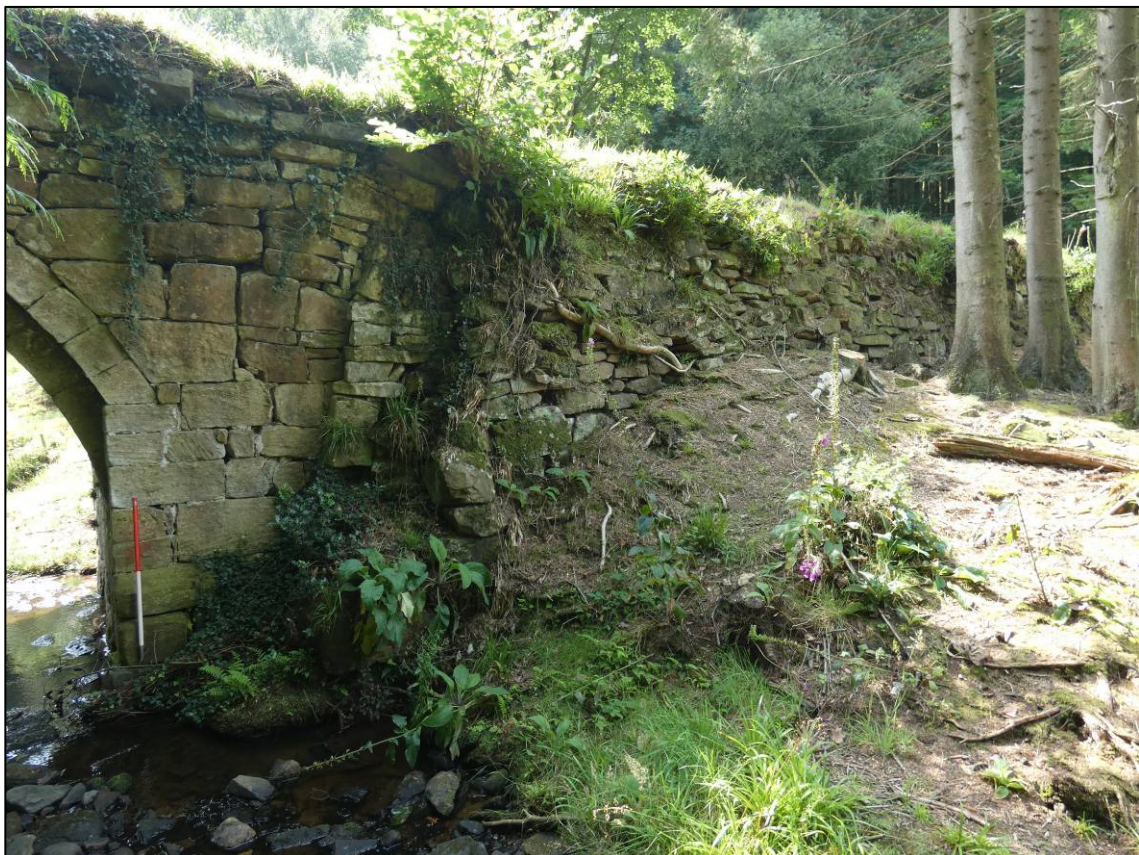
Plate 11: North elevation, west buttress/return and abutment, prior to repairs, looking SW (photo 1/906)

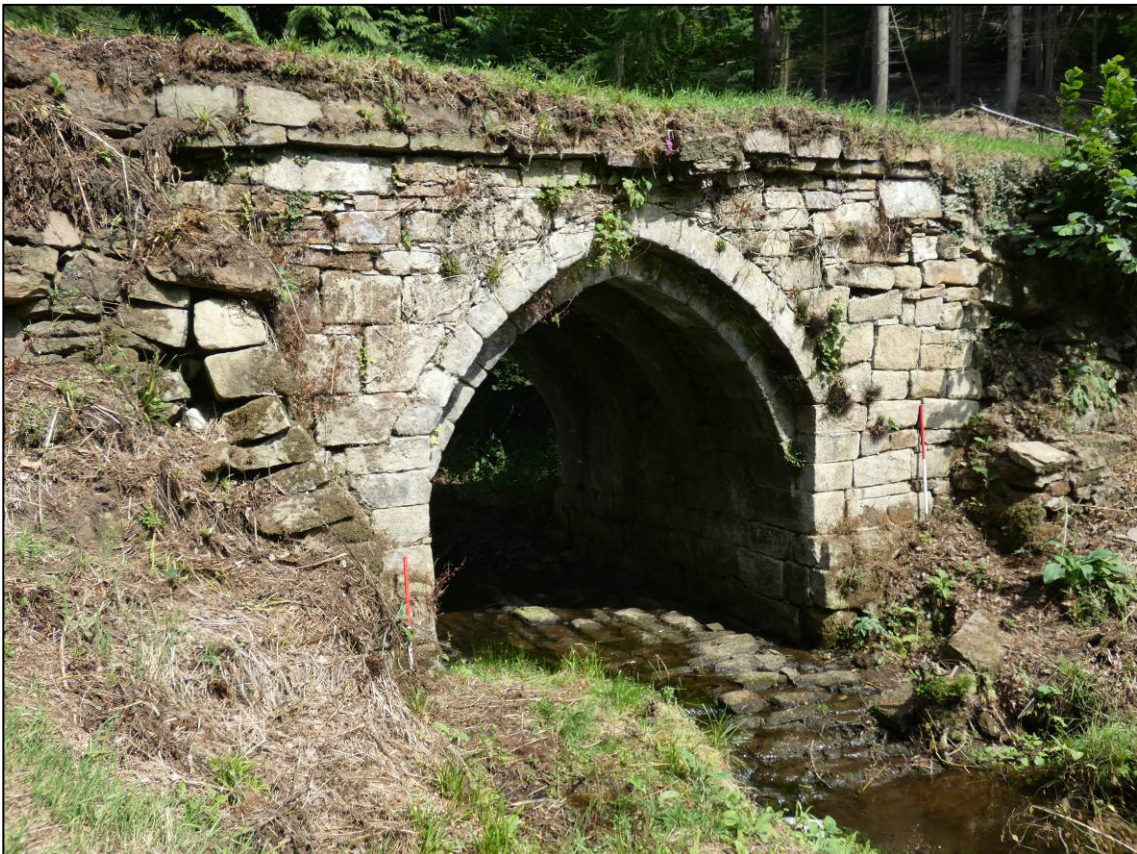
- 1.16 This south elevation also contains the remains of two buttresses, to the east and west of the central arch, which would require substantial rebuilding, and the replacement of fallen or missing stone work. A section of the western buttress would need rebuilding with large stones, whereas more rebuilding was required to the eastern buttress where only the base remained. Deep tamping and pointing would be undertaken throughout. Moving further out from the central arch, the eastern embankment is eroded quite badly, and the western one is held together by tree roots. Their stabilisation and repair is desirable, and would be undertaken if funds allowed.

Plate 13: South elevation and west buttress/return, prior to repairs, looking NE (photo 1/893).

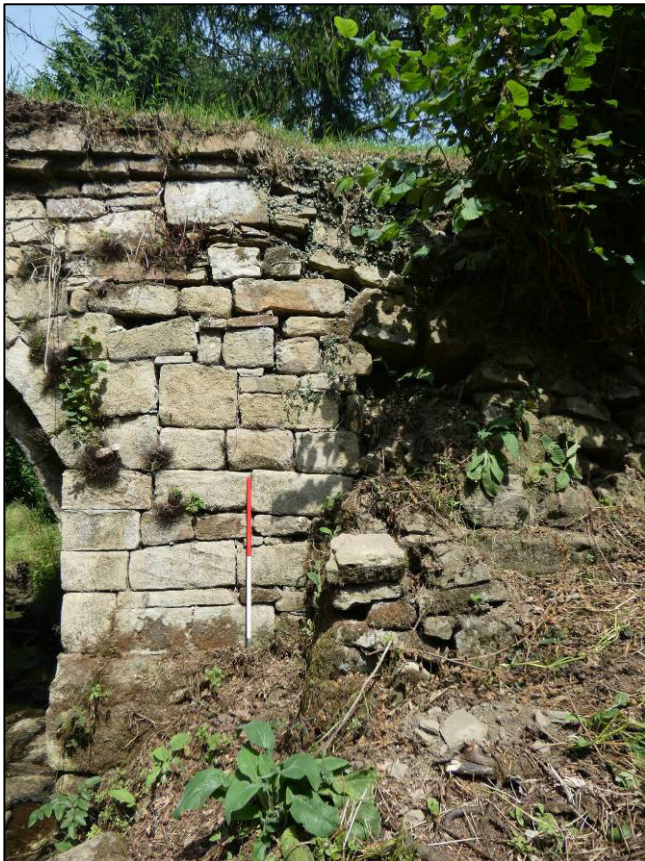
Plate 15: South elevation, east buttress/return, prior to repair, looking N (photo 1/903).

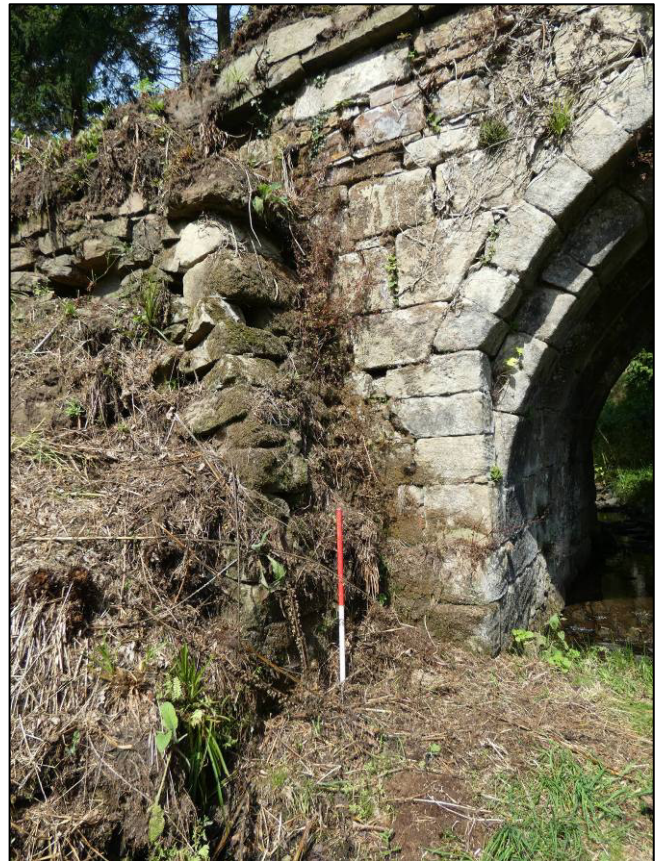
- 4.17 There is a better preserved buttress/former return to the west of the arch, although it is in poor structural condition and is poorly tied into the wall face. This buttress/return projects up to 0.50m from the adjacent wall face of the arch and has a battered east face, rising to a visible height of c.3m [1/898] (see plates 13 and 16). To the west of the buttress/return, the facing of the west abutment is built of roughly coursed and squared stone rubble, largely without mortar, partly collapsed and partly overgrown [1/899]. Generally, the stones are better coursed to the west of a large tree [1/900], whilst further to the west again there are some large stones up to 0.80m long incorporated into the abutment facing [1/901, 1/902; 7/059, 7/060; 8/573, 8/574-8/577] (see plate 18).

Plate 16: South elevation, west buttress/return, prior to repair, looking NW (photo 1/898).

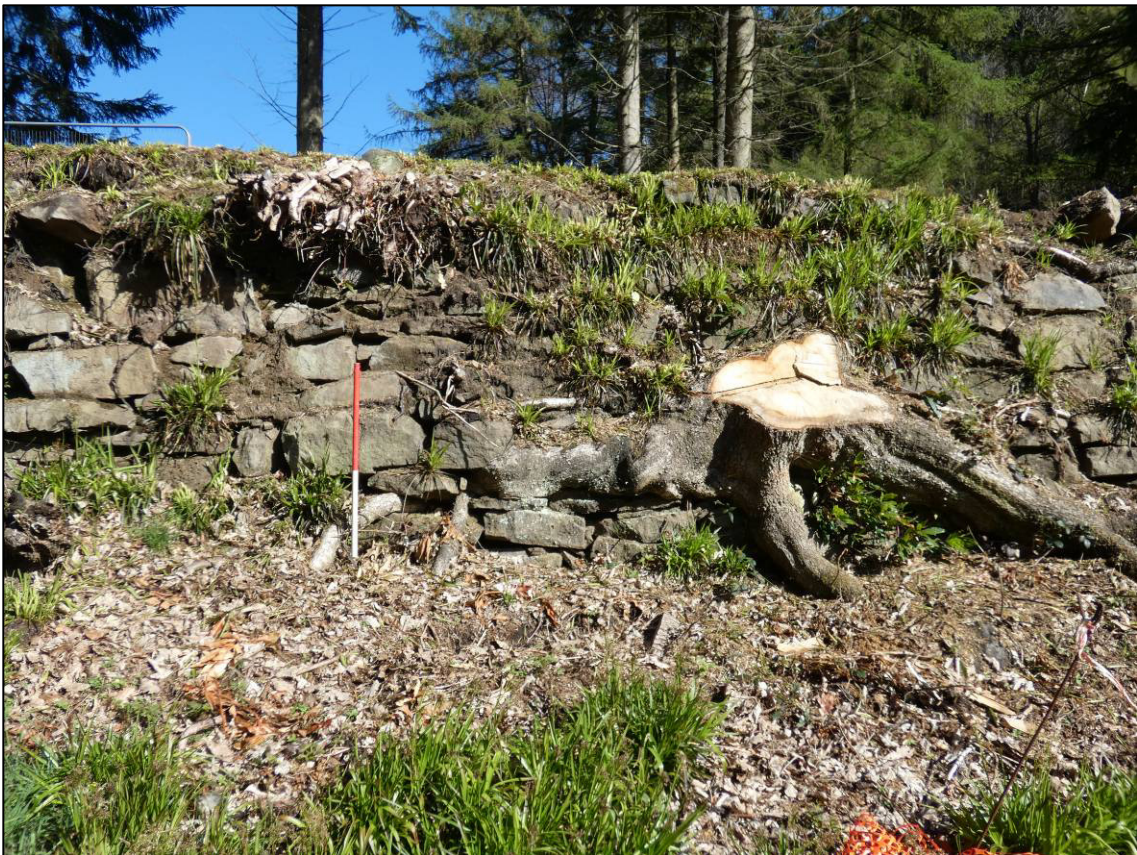
Plate 18: South elevation, section of west abutment, looking N (photo 8/574).

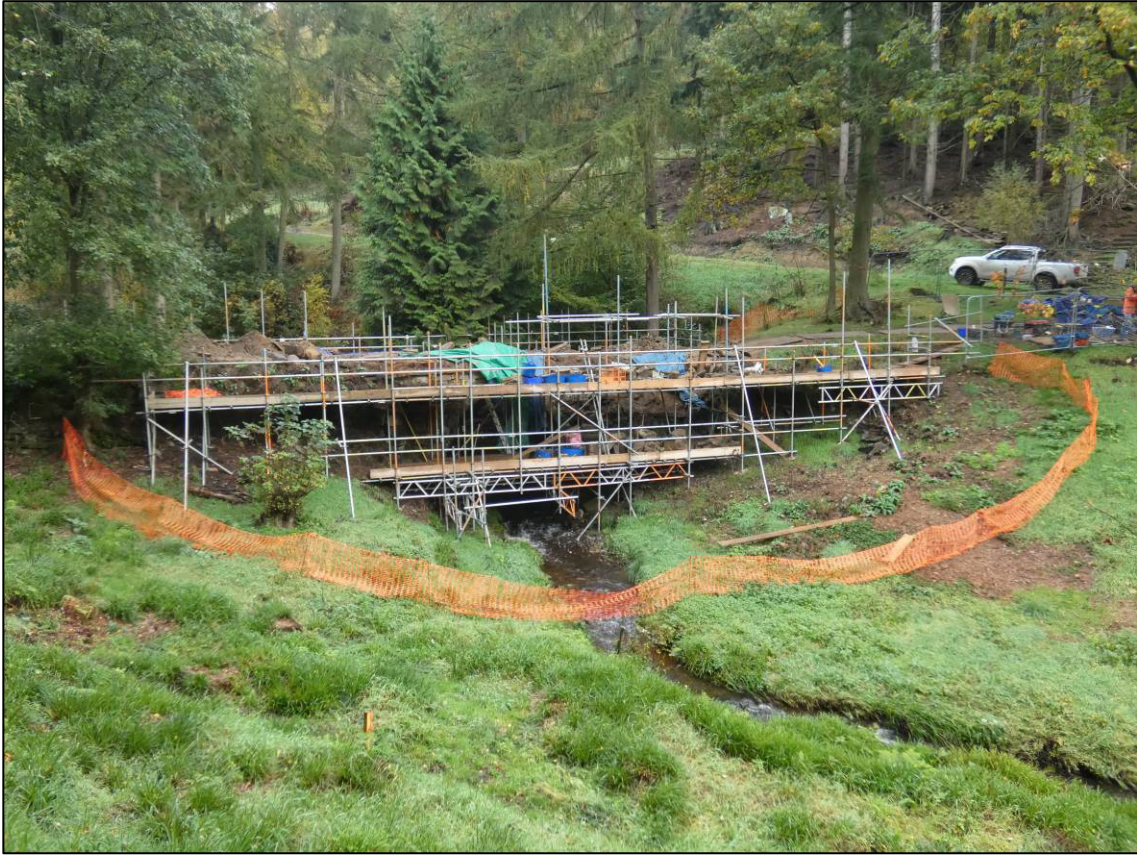
- 5.1 At the start of the repair and consolidation works, both elevations of the entire bridge structure were scaffolded to allow close working access [3/313, 3/314, 3/316, 3/317] (see plate 19). However, this made detailed archaeological recording, and in particular photography, difficult as it was not possible to view exposed sections and stonework from any distance. Recording, and indeed the repair and consolidation work generally, was also problematic on occasions due to very wet weather.

Plate 19: South elevation undergoing repair, looking NE (photo 3/316).

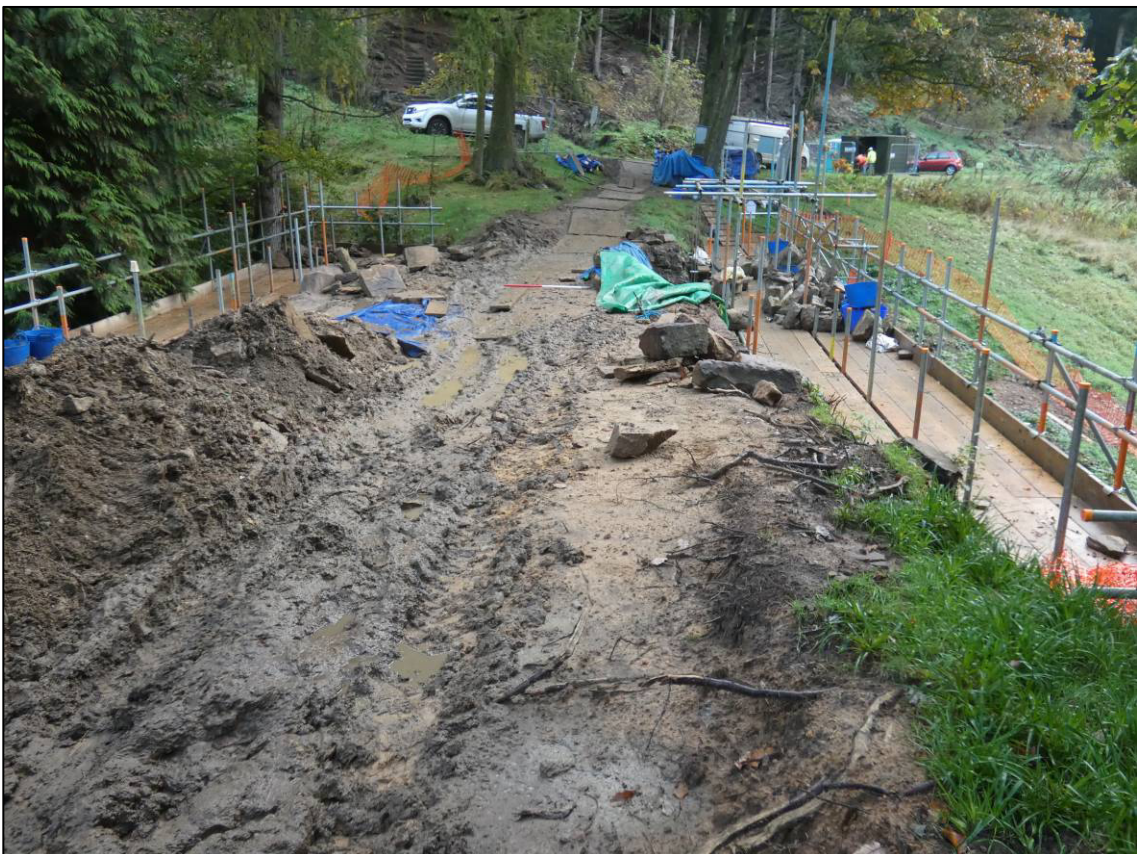
- 5.2 Initially, the ground surface of the causeway across the central 18m of the bridge and abutments was reduced by an average depth of 0.30m below ground level (BGL), and the exposed surface was then boarded to allow a mini-digger to access the sides of the structure; dismantled stonework was also stacked along the sides of the newly-exposed surface. The reduction in ground level revealed a clean, compacted mid-brown/orange sandy silt, but no finds or any traces of metallurgy or any other kind of surface were uncovered [3/286, 3/287] (see plate 20).

Plate 20: Surface of bridge after ground reduction, looking E (photo 3/287).

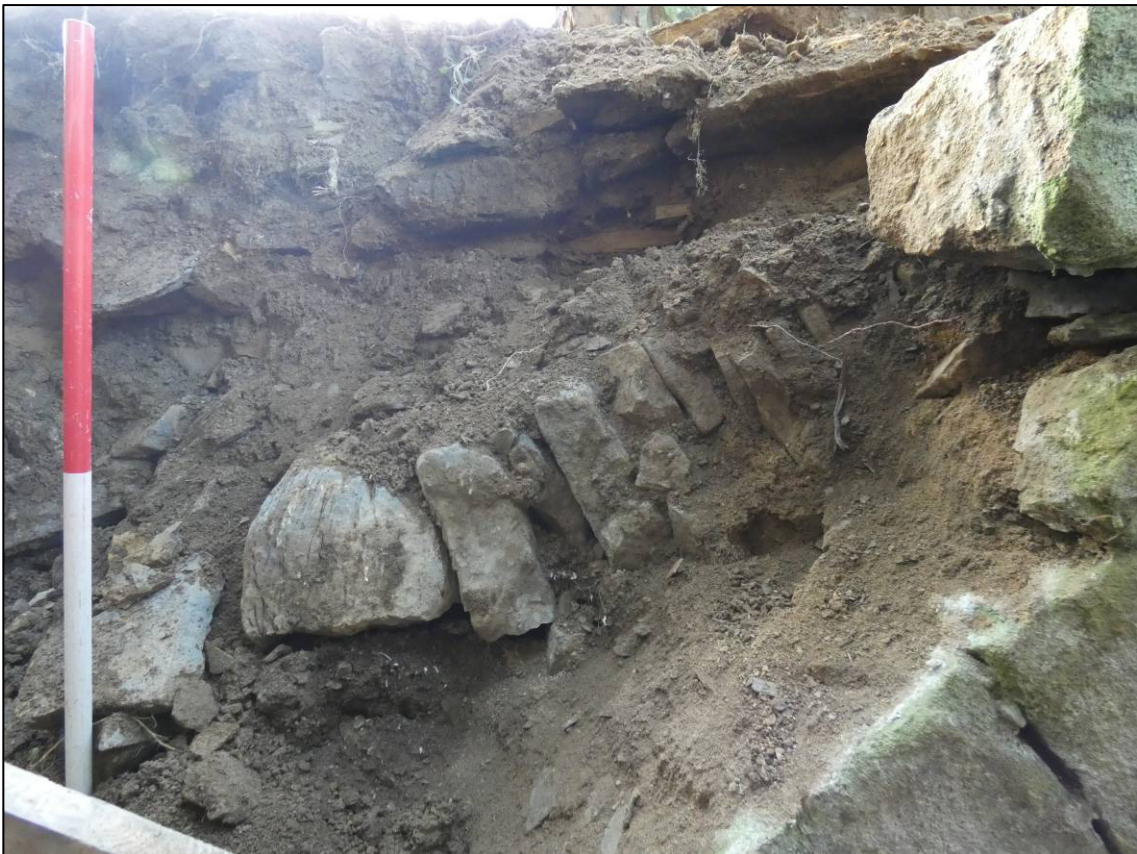
Plate 22: North elevation, area east of arch during clearance, showing section of relieving arch in section, looking S (photo 2/118).

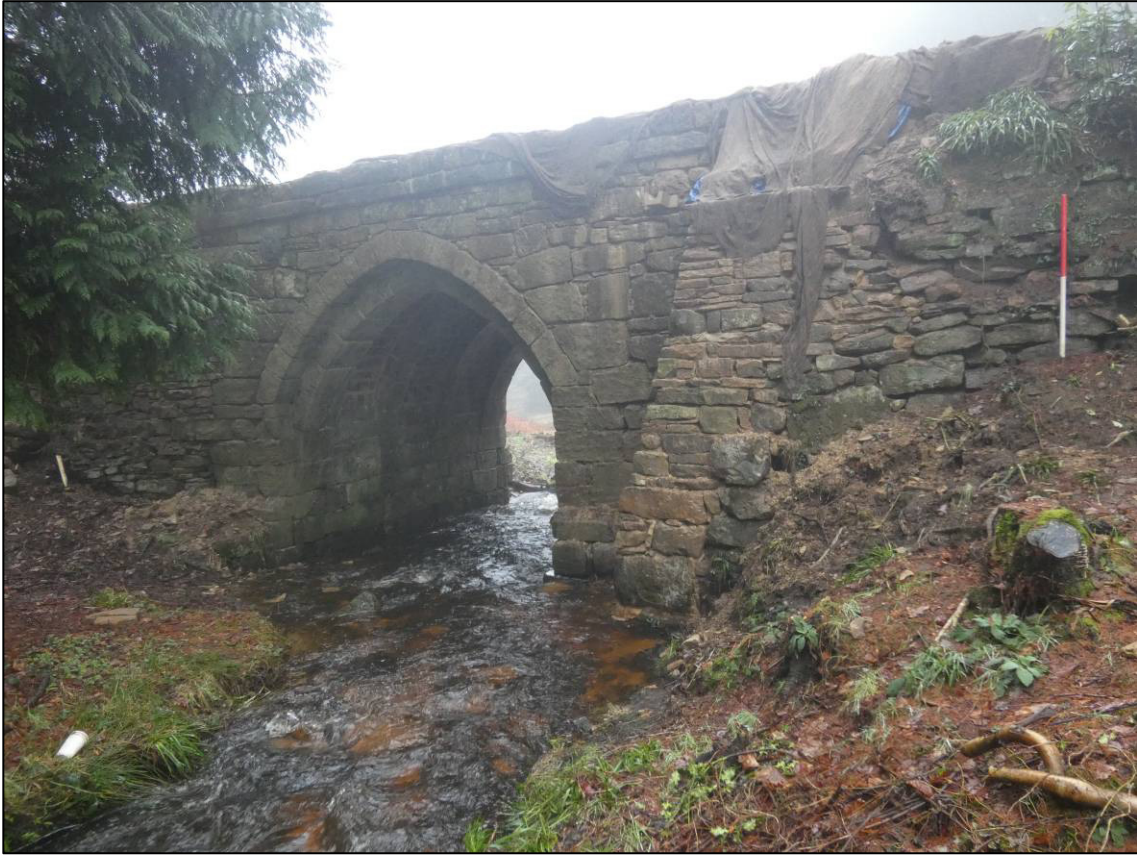
Plate 23: North elevation after repairs, showing rebuilt west buttress/return, looking SE (photo 7/068).

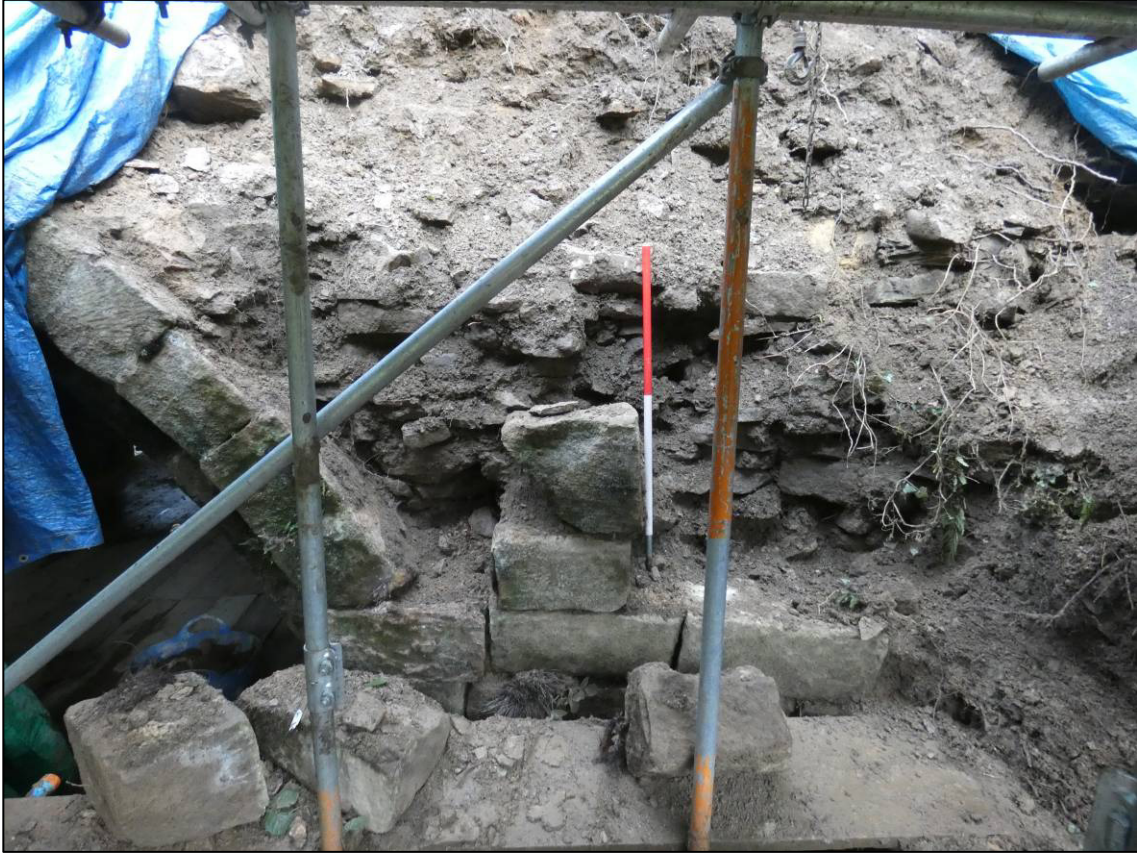
- 5.6 In total, a c.6.25m long section of the facing stone of the south elevation, to the east side of the arch, was removed to a maximum height of c.3.00m below the reduced causeway ground surface, including the buttress/former return here. The core behind was then cut back for an average depth of c.0.50m from the former wall face, and any collapsed core was consolidated and secured with lime mortar grout. This operation showed that the facing stones had an average depth of 0.50m back from the wall face. Behind these facing stones, both the bridge and the abutment had a core of roughly coursed and squared dry stone rubble, more neatly 'laid' than that seen to the north elevation [3/291, 3/292]. Within the rubble, there were at least two 'courses' of deeper stones, set c.0.50m apart vertically [3/293] (see plate 25). Further cleaning showed that this rubble was laid over the well-cut arch stones of the bridge.

Plate 25: South elevation, area east of arch under repair, showing central core, looking N (photo 3/293).

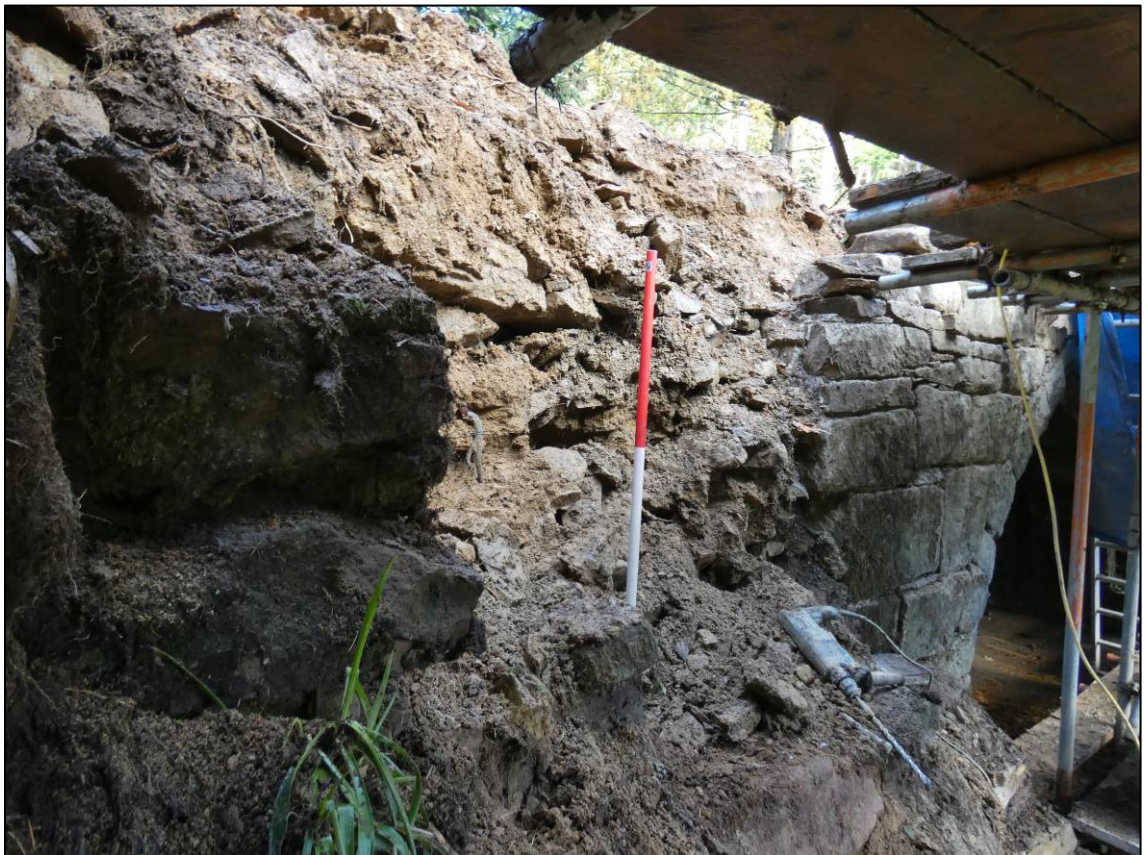
- 5.8 During the dismantling of the facing stone to the west of the arch, the building contractor noted what he thought were either several possible different phases of construction, or perhaps different elements of a single phase, and this was discussed with EDAS on site. However, due to heavy rainfall creating muddy conditions on site, and the loose nature of much of the material immediately behind the facing stones, it was difficult to ascertain the exact relationship of these exposed features to one another. Behind the facing stones, there was what

Plate 26: South elevation, area west of arch under repair, showing possible internal faces to core, looking E (photo 4/441).

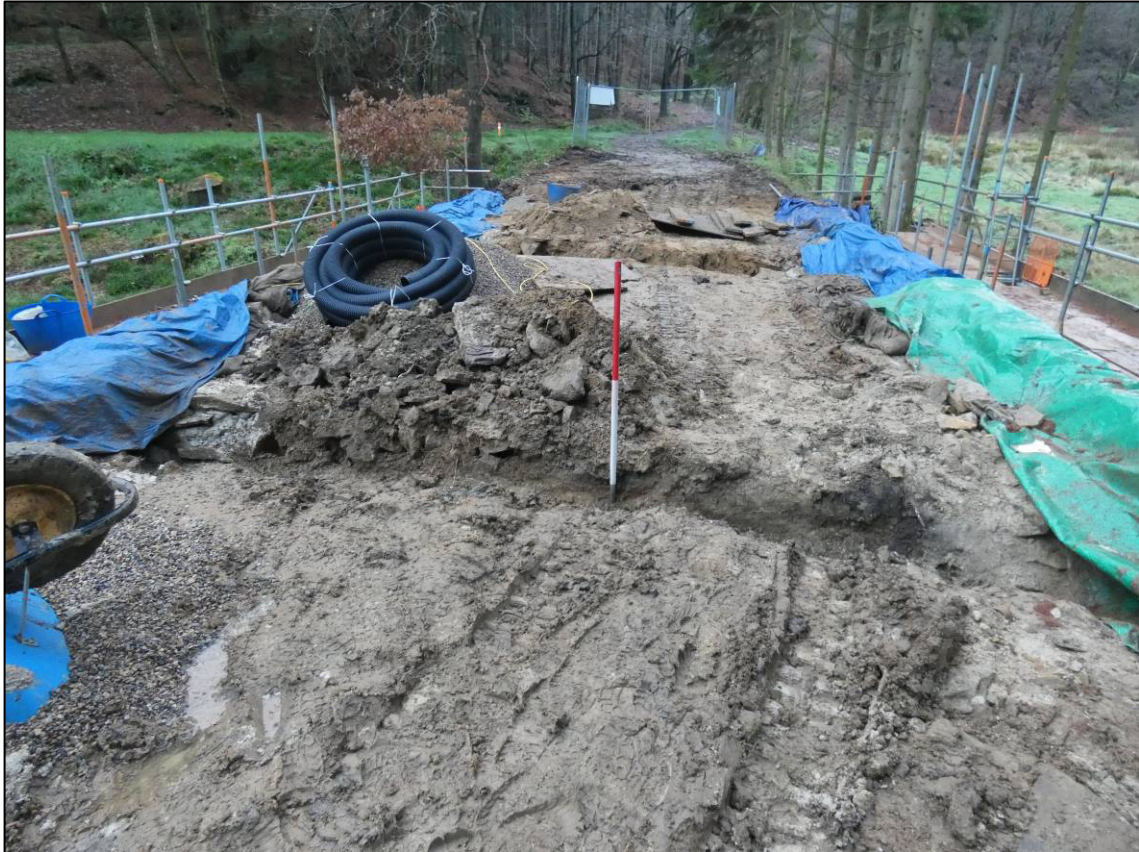
- 5.11 Two cross-trenches were excavated across the previously reduced causeway surface of the bridge, in order to facilitate the laying of two drains and the laying of two tie-bars with plates (see figure 8 plan) [6/775, 6/778]. These drains fed into spouts which projected beyond the external elevations to ensure water was shed away from the wall faces.

Plate 31: Excavated east trench (Trench A) across bridge top, looking W (photo 6/780).

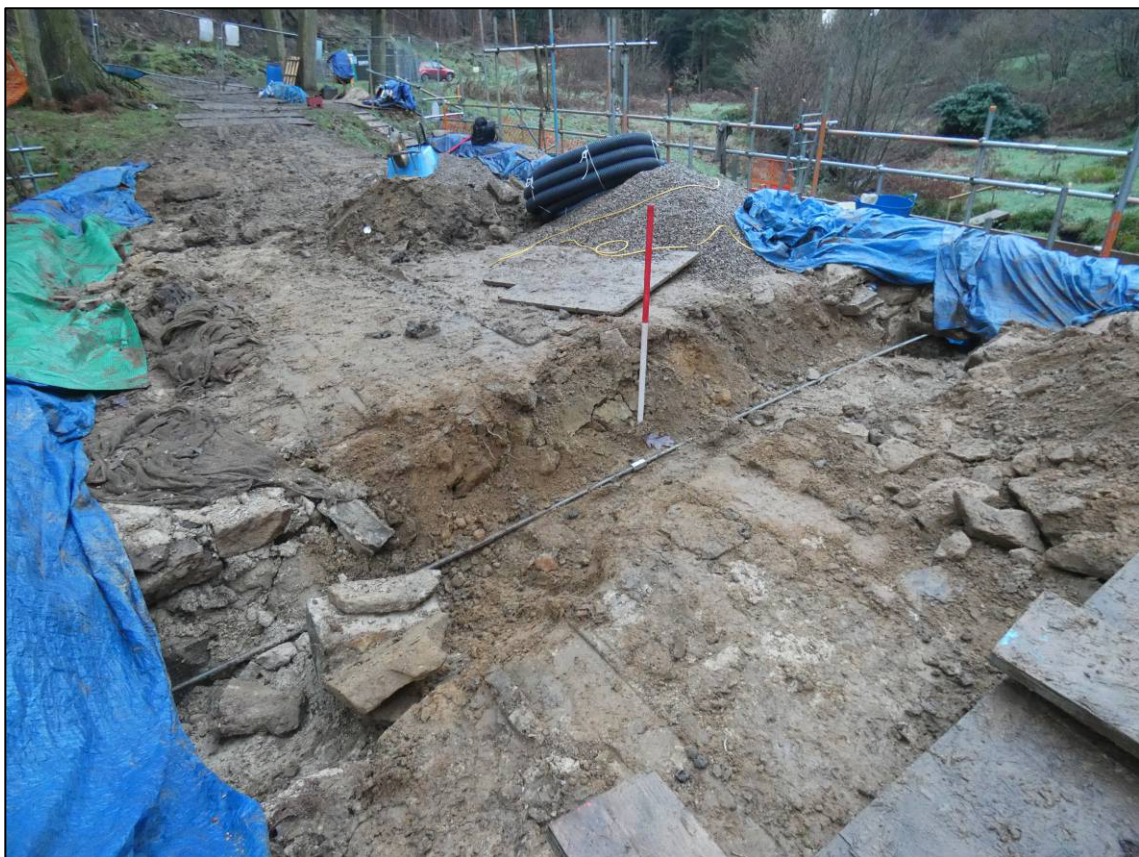
- 5.14 The tie-bars and drains were laid into the two excavated trenches [6/777] (see plate 32) which were then backfilled. Chutes were also placed into the parapet walls to allow water to be shed from the wall faces below [5/635; 7/053; 8/582, 8/585, 8/586]. The top of the causeway was re-surfaced with road stone and topsoil, and then re-sown with grass seed, restoring the ground surface to approximately the same level it had been prior to the start of the works [7/069].

Plate 32: Excavated west trench (Trench B) across bridge top, with tie bar inserted, looking W (photo 6/777).
