CONSERVATION FABRIC REPAIRS (PHASE 2),  
BUTTERTON BRIDGE, PICKING GILL,  
SAWLEY, NORTH YORKSHIRE

ARCHAEOLOGICAL AND ARCHITECTURAL  
OBSERVATION, INVESTIGATION AND RECORDING

Report no: 2021/641.R01  
Version: Final  
Date: November 2021  
Author: Shaun Richardson & Ed Dennison

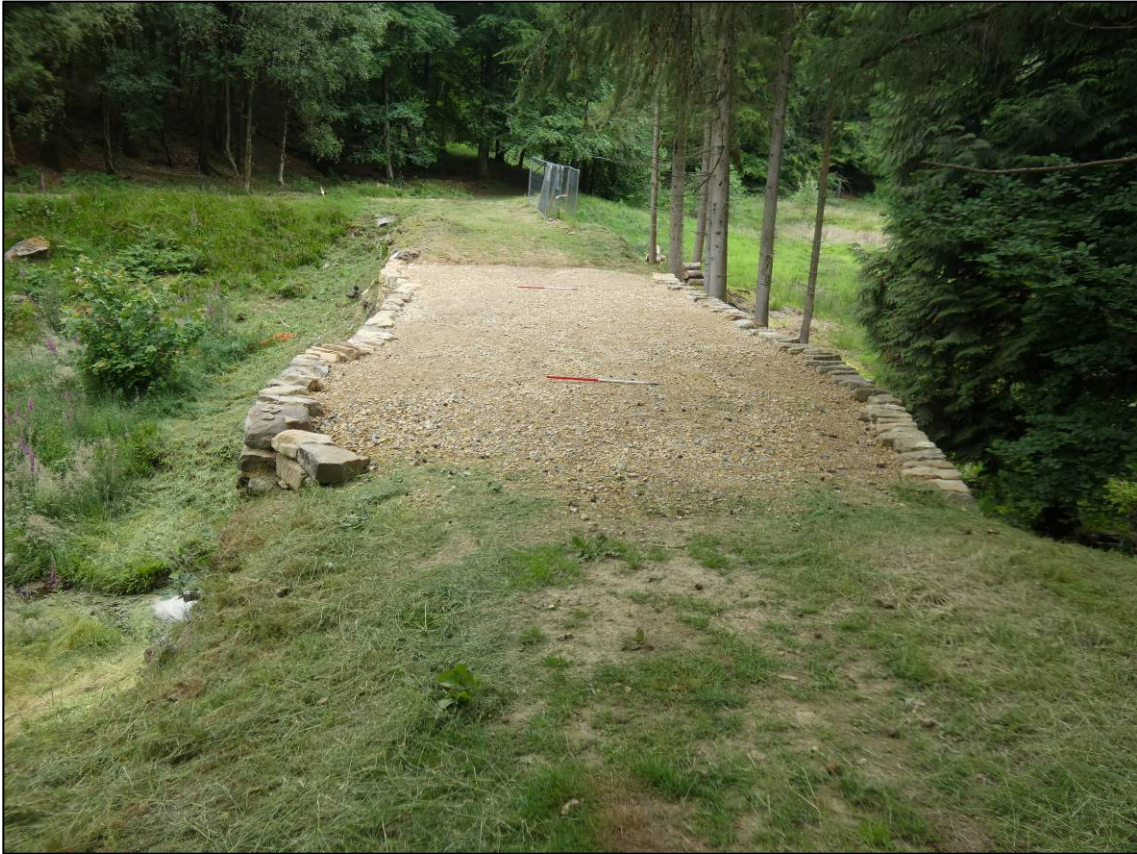
abutment only accounts for almost 32.0m of this; the abutments give the appearance of a raised causeway. At the start of the 2021 watching brief, the bridge section was covered with a compacted surface laid down as part of the Phase 1 works [1/823-1/825] (see plate 1).

Plate 1: Bridge and abutment surfaces before start of Phase 2 works, looking SW (photo 1/823).

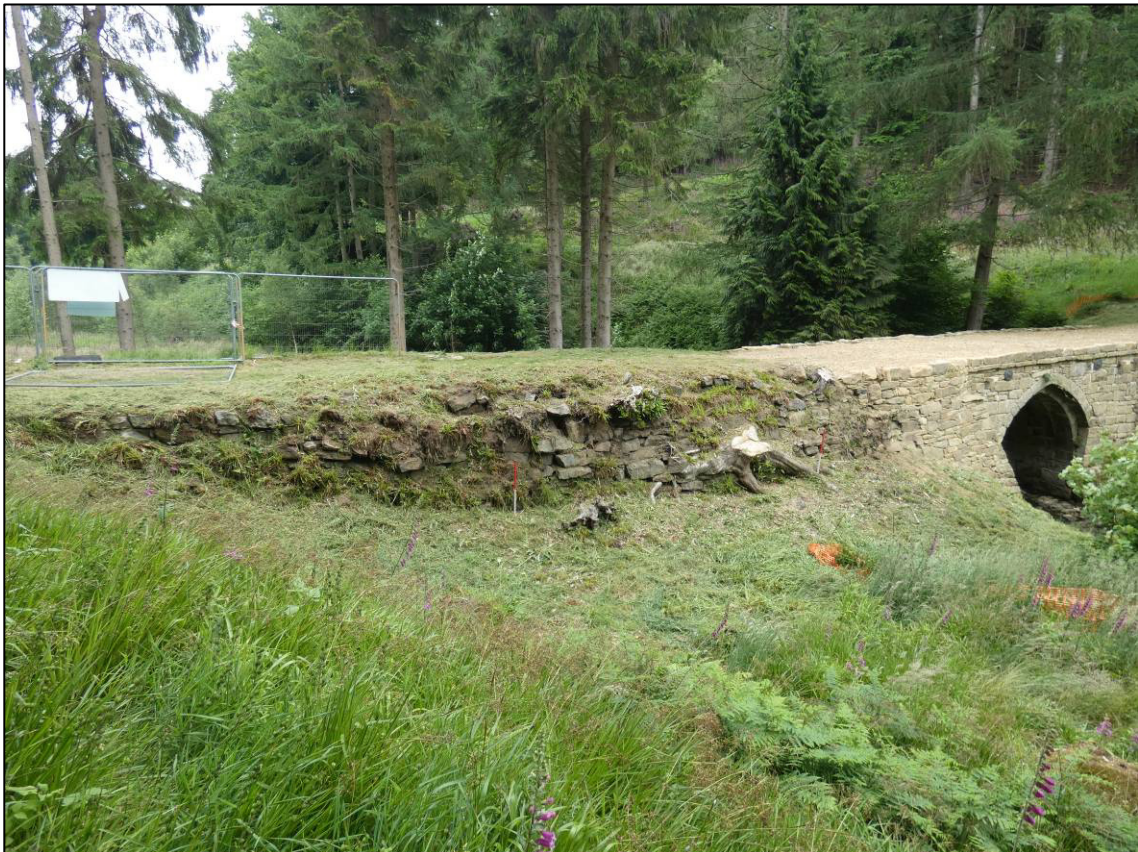
Plate 2: West abutment, south elevation, before start of Phase 2 works, looking N (photo 1/826).

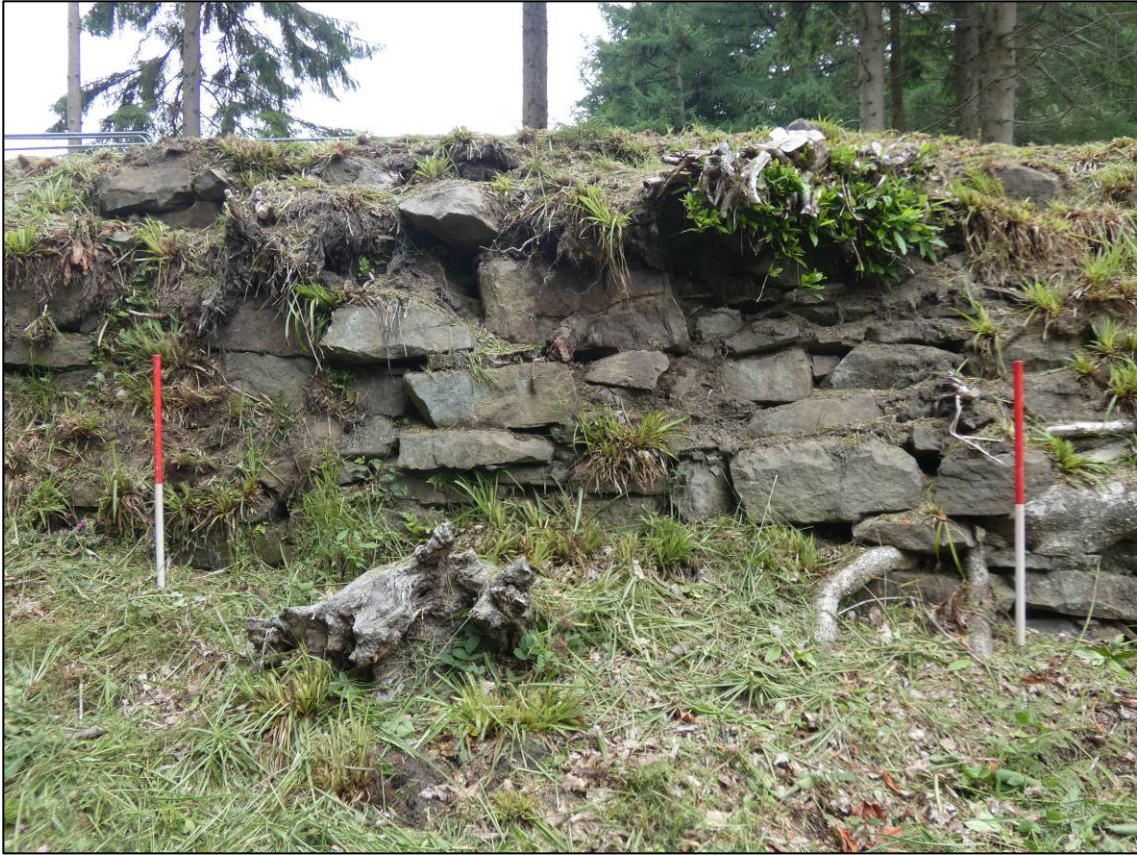
Plate 3: West abutment, south elevation, central section, before start of Phase 2 works, looking NW (photo 1/830).

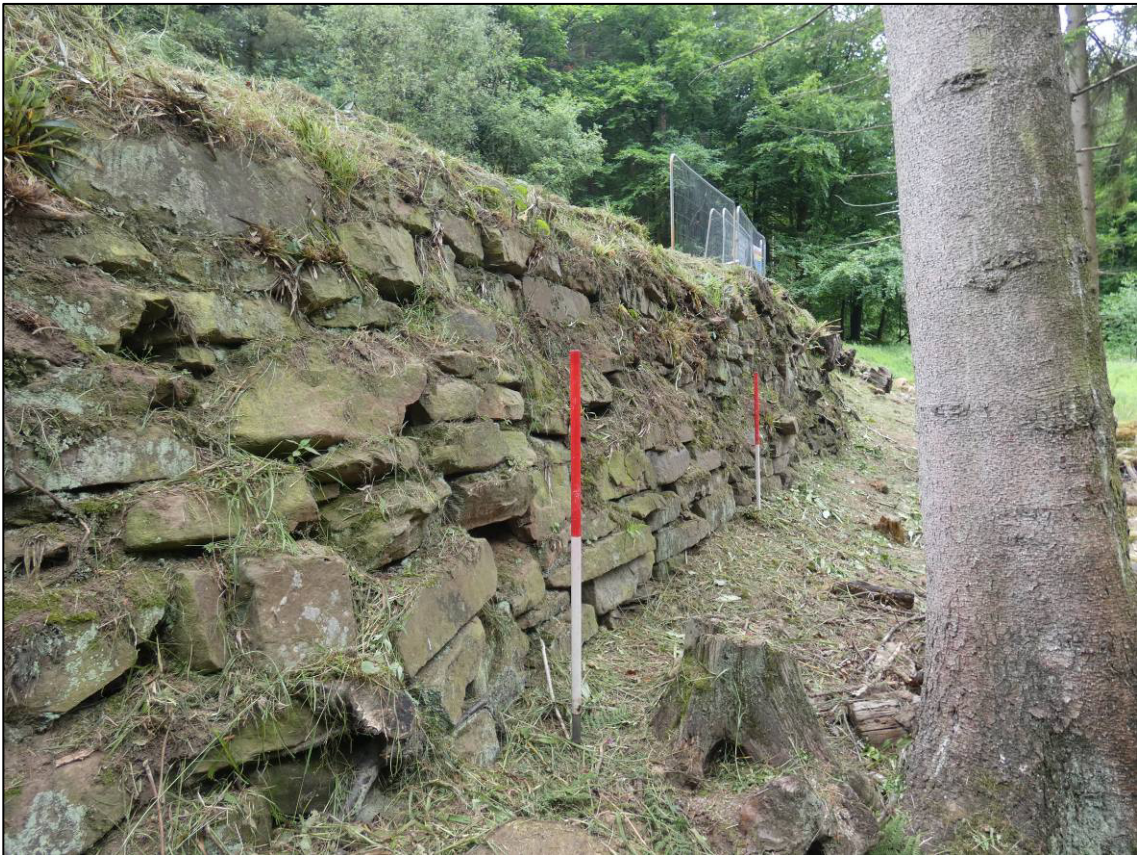
Plate 4: West abutment, north elevation, before start of Phase 2 works, looking SW (photo 1/834).

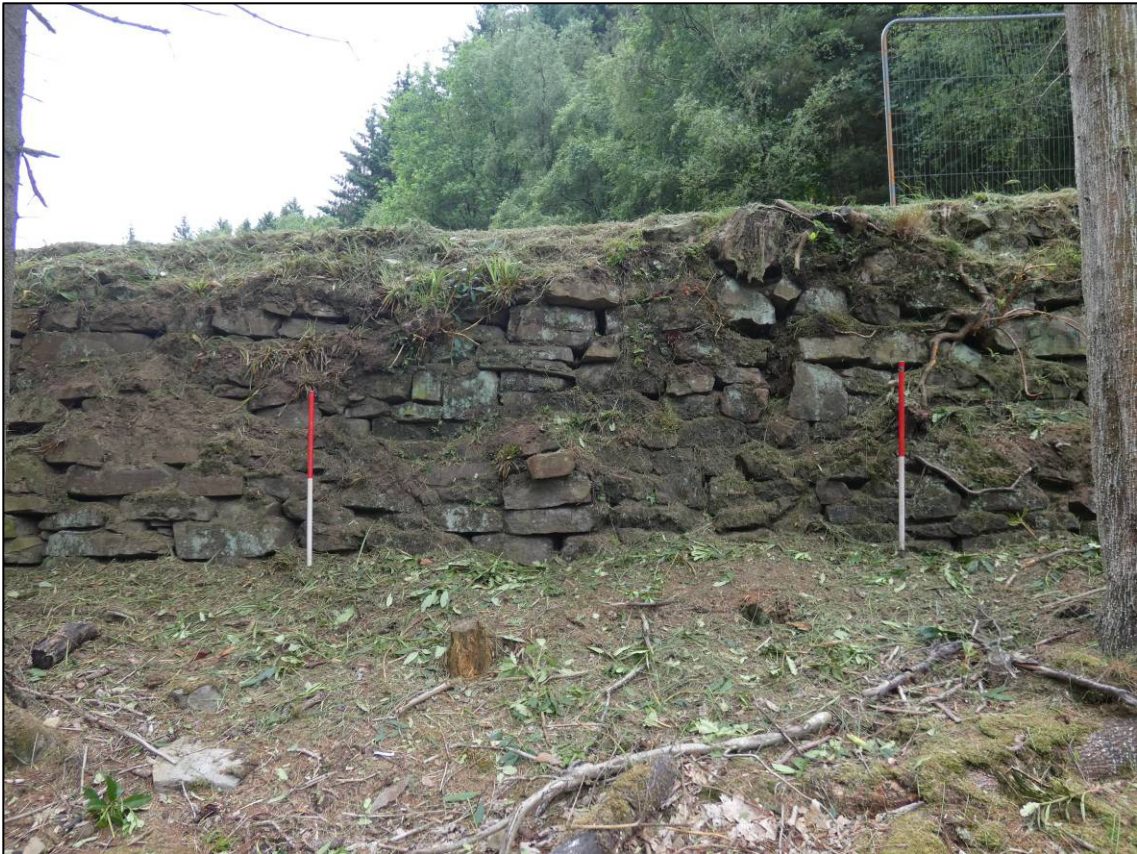
Plate 5: West abutment, north elevation, central section, before start of Phase 2 works, looking SE (photo 1/838).

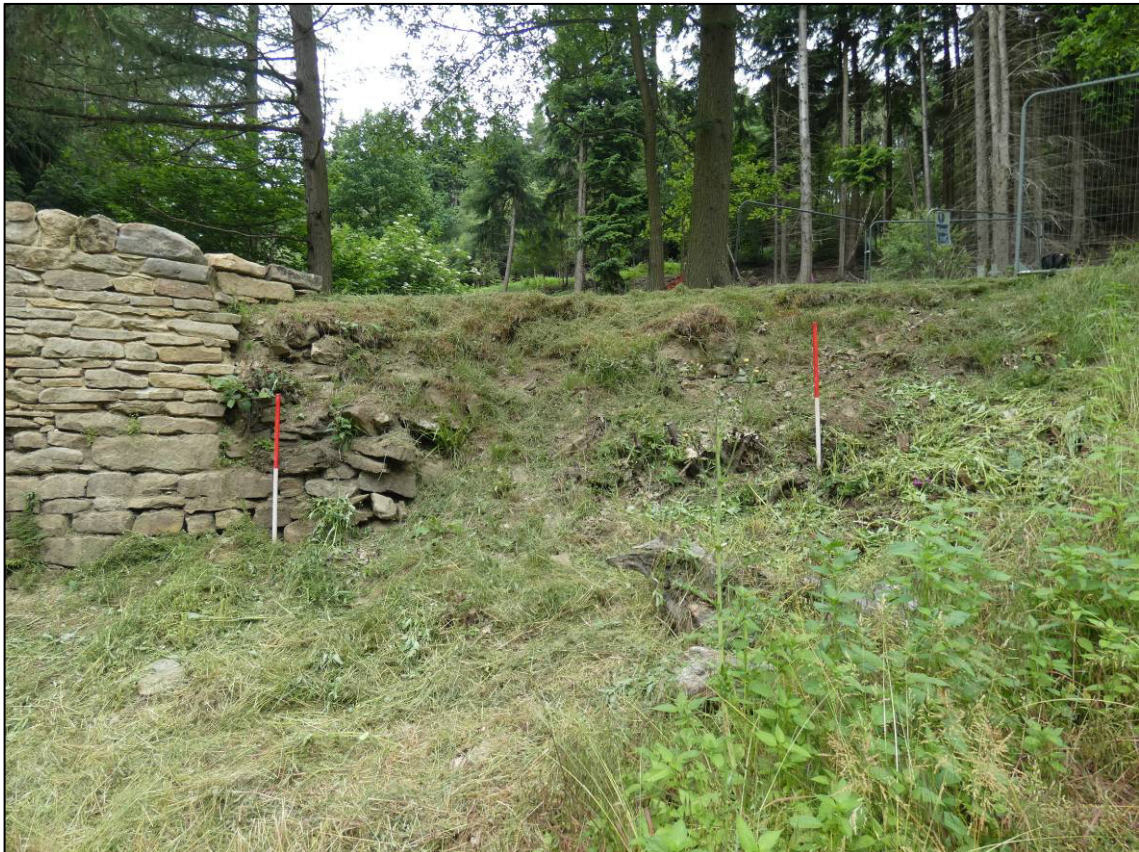
- 4.7 As noted above, no works were undertaken to the north side of the eastern abutment, as this had been covered by the previous Phase 1 works. The south elevation, immediately to the east of the bridge arch, was relatively well coursed and squared for a short distance only, and was rebuilt as part of the Phase 1 works. To the east of this, the well-vegetated facing was in very poor condition, partly collapsed and largely formed by un-mortared rubble with no obvious coursing visible [1/850-1/852] (see plate 6).

Plate 6: East abutment, south elevation, before start of Phase 2 works, looking N (photo 1/850).

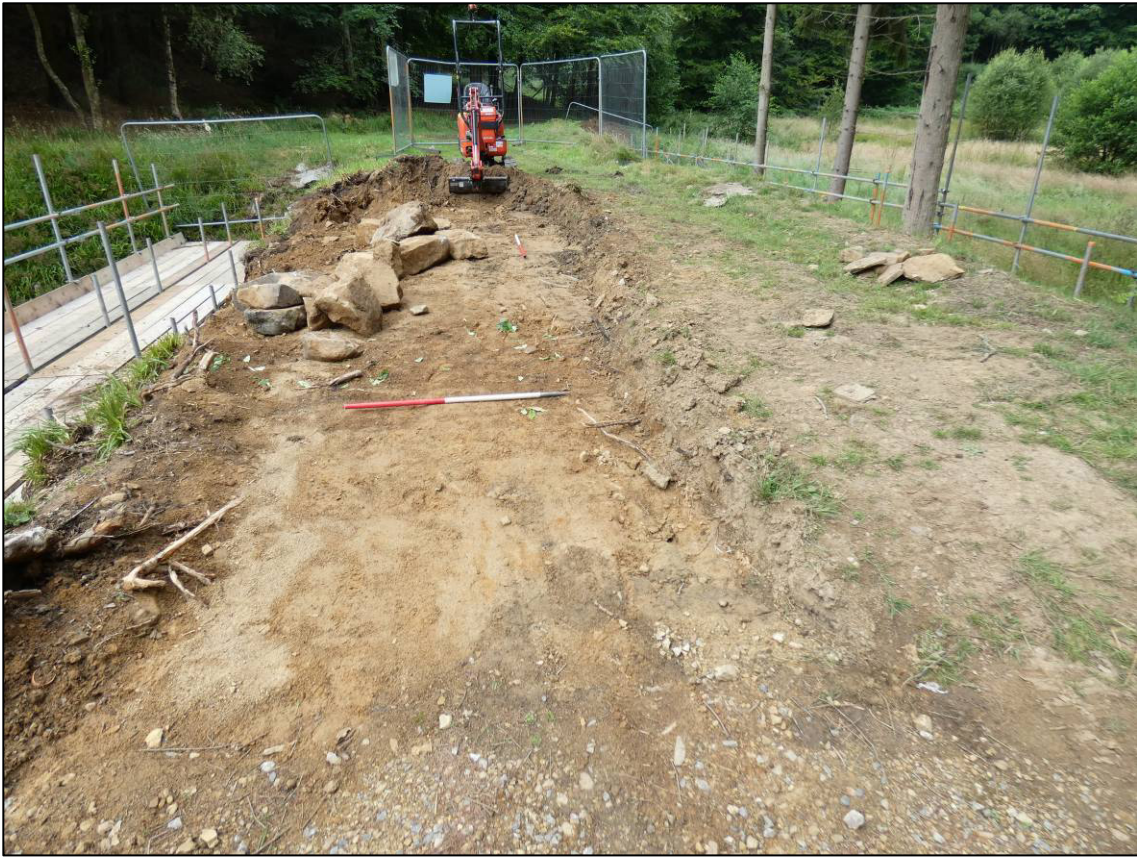
Plate 7: West abutment surface, reduction in ground level, looking SW (photo 2/331).

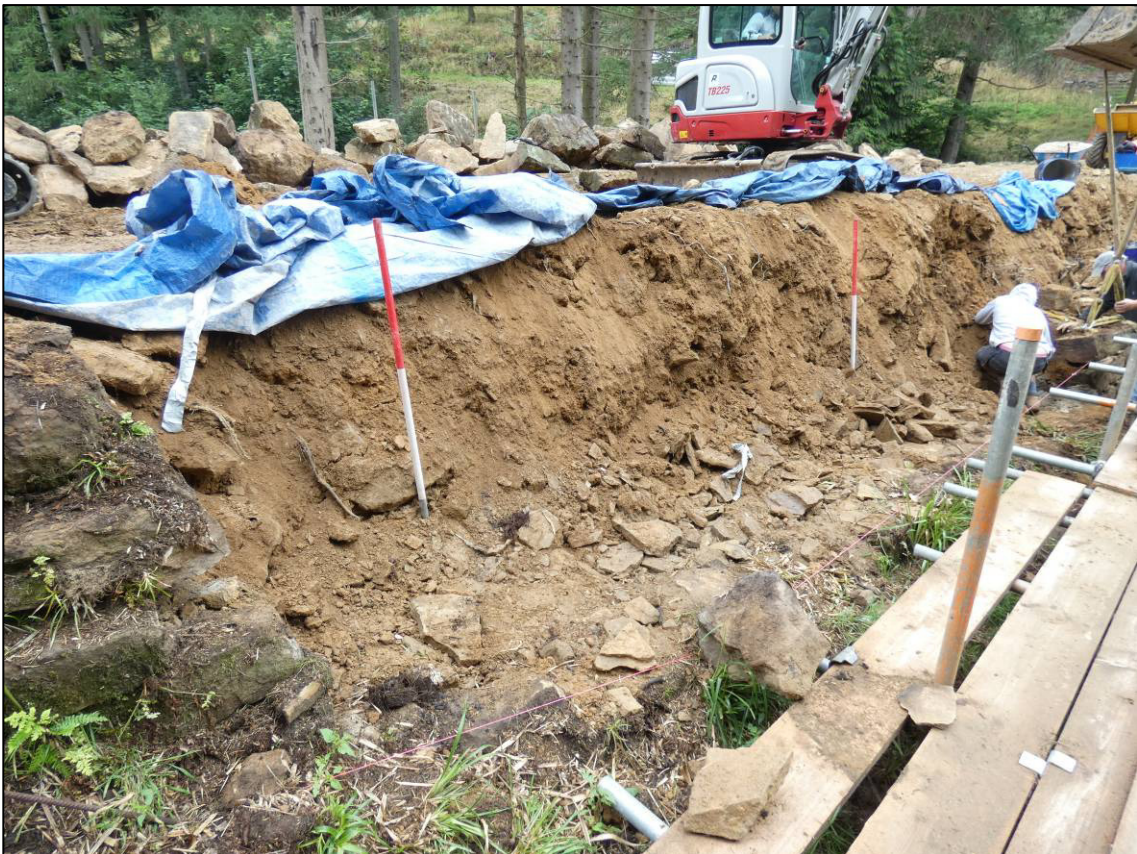
- 4.9 On 17th August 2021, a second visit was made to view the south side of the western abutment after the facing stone had been removed. The facing stone was cut back on average 1.0m from the original alignment, and to an average depth of 1.2m below the reduced ground level of the abutment's surface. This revealed the same un-mortared drystone rubble core as had been observed further to the east during the Phase 1 works. There was a possible 'levelling course' of larger stones, up to 0.50m long, set at between 0.75m and 1m BGL, although this was only visible between areas of collapse [3/461-3/463] (see plate 8).

Plate 8: West abutment, south elevation, during repair, looking NE (photo 3/461).

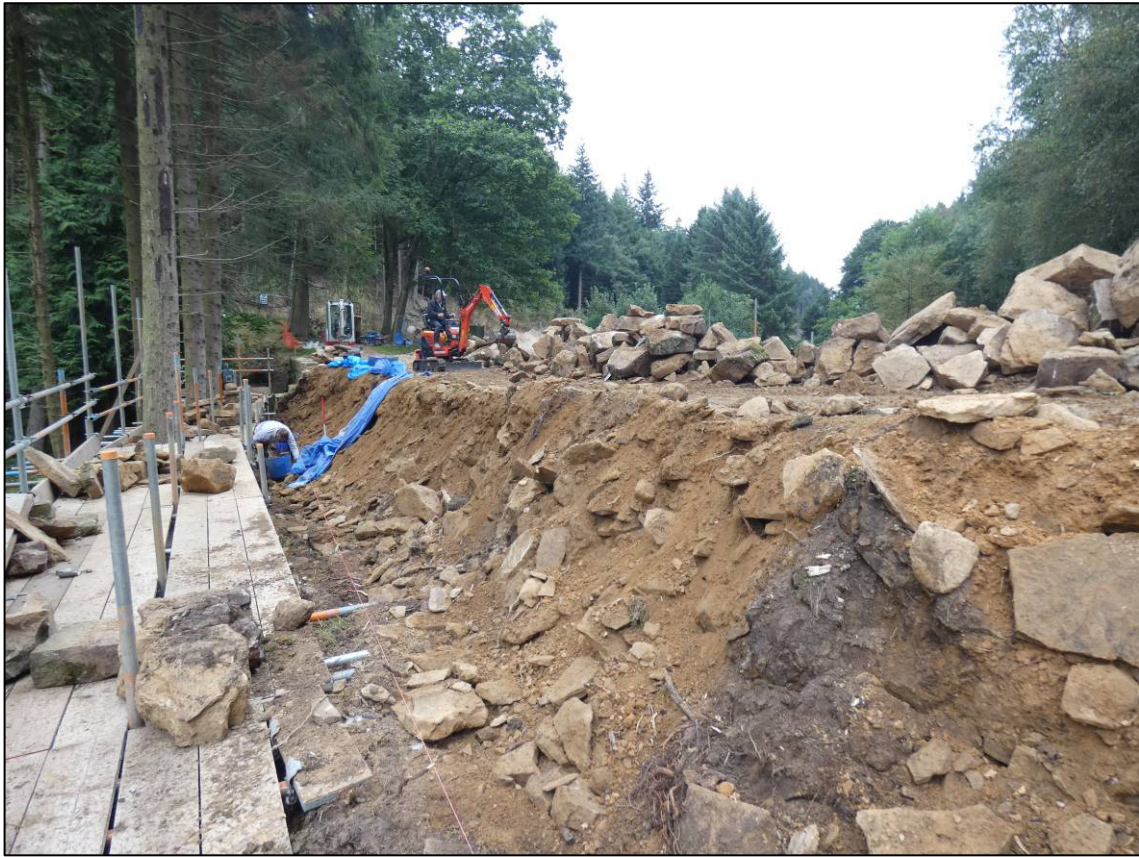
- 4.10 A further visit was made on 14th September 2021, to view the north side of the western abutment after the facing stone had been removed. The face was cut back on average 1.40m from the original line, and to an average depth of 1.30m below the reduced ground level of the abutment's surface. The removal of the facing stone revealed the same un-mortared drystone rubble core as was noted further to the east during the Phase 1 works [4/634-4/638], although some area of rubble appeared more regularly 'laid' towards the western part of the exposed section [4/639-4/641] (see plates 9 and 10).

Plate 9: West abutment, north elevation, during repair, looking E (photo 4/634).

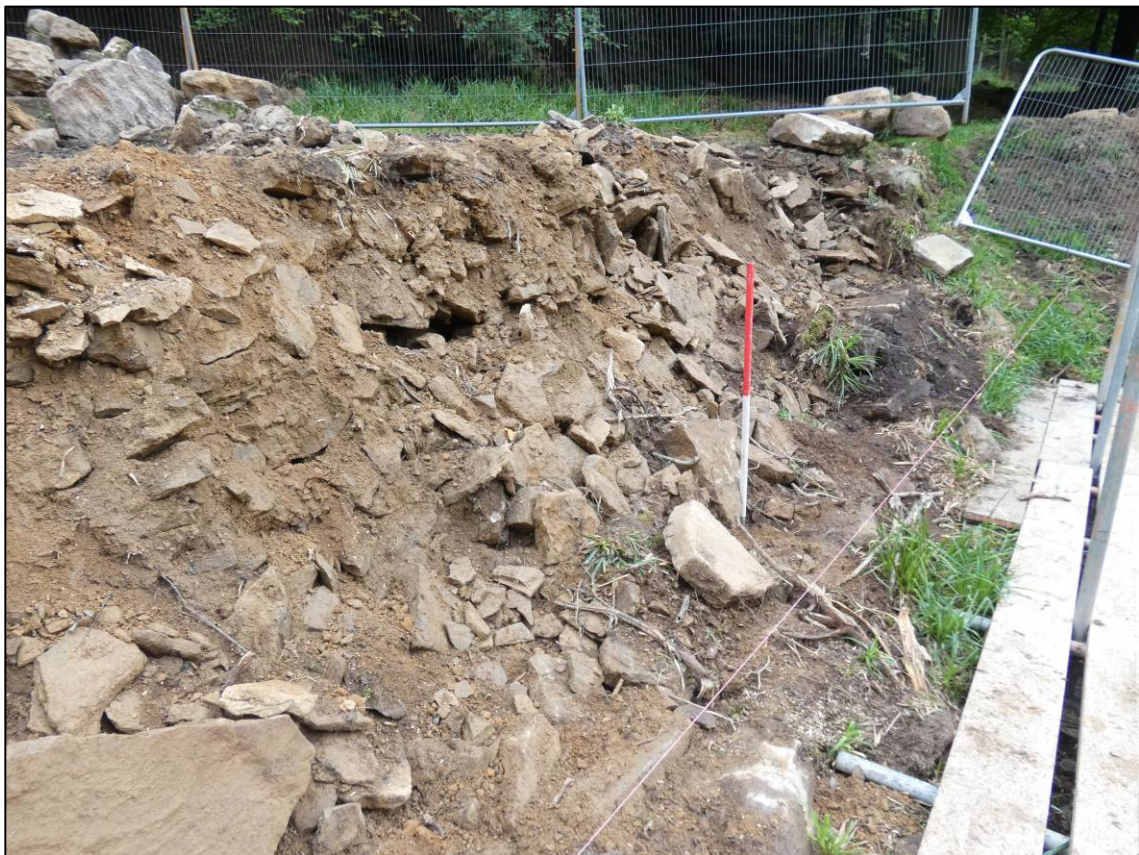
Plate 10: West abutment, north elevation, west section, during repair, looking SW (photo 4/639).

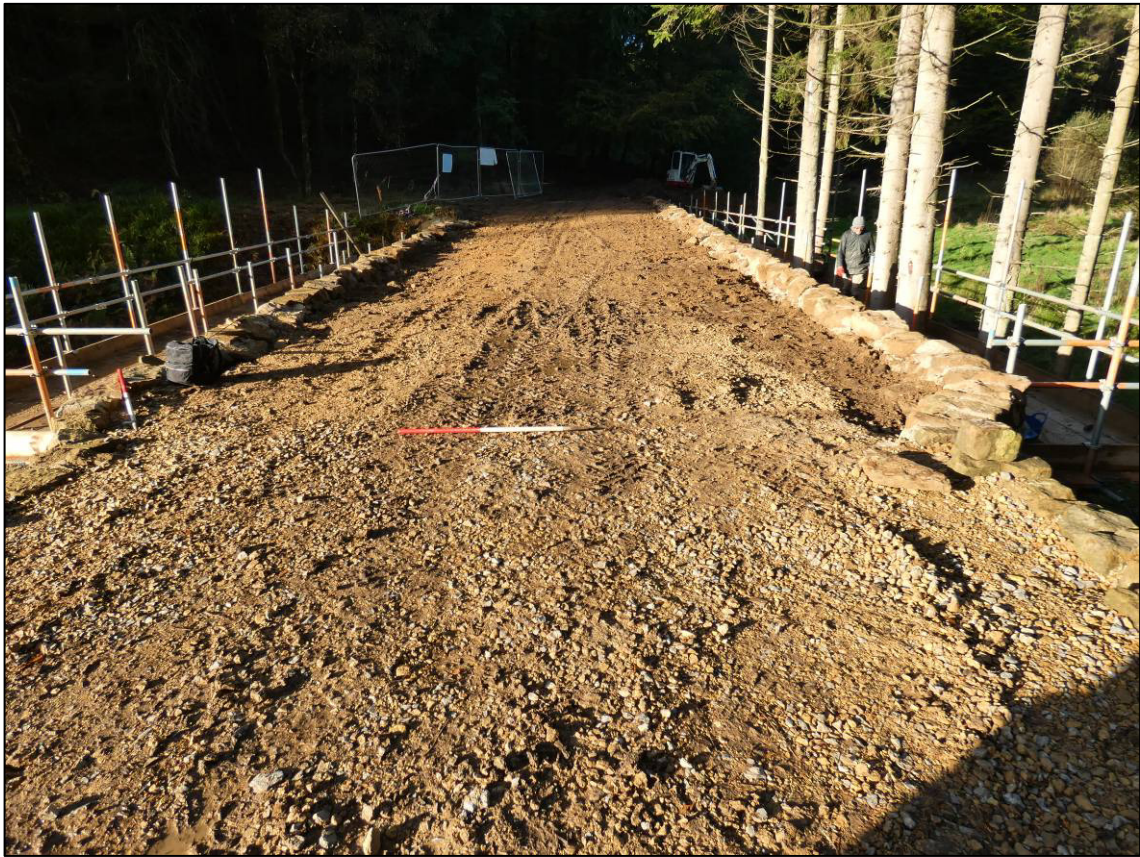
- 4.11 A final watching brief visit was made on 21st October 2021, to view the south elevation of the eastern abutment after the facing stone and soil had been removed. The facing stone was cut back on average 1.2m from the original line, and to an average depth of 1.3m below the reduced ground level of the abutment's surface. This revealed the same un-mortared drystone rubble core as was observed during the Phase 1 works [5/769-5/771]. The top surface of the abutment had also been partly restored by the same date [5/772] (see plate 11).

Plate 11: Abutments and bridge top surface after repair, looking SW (photo 5/772).

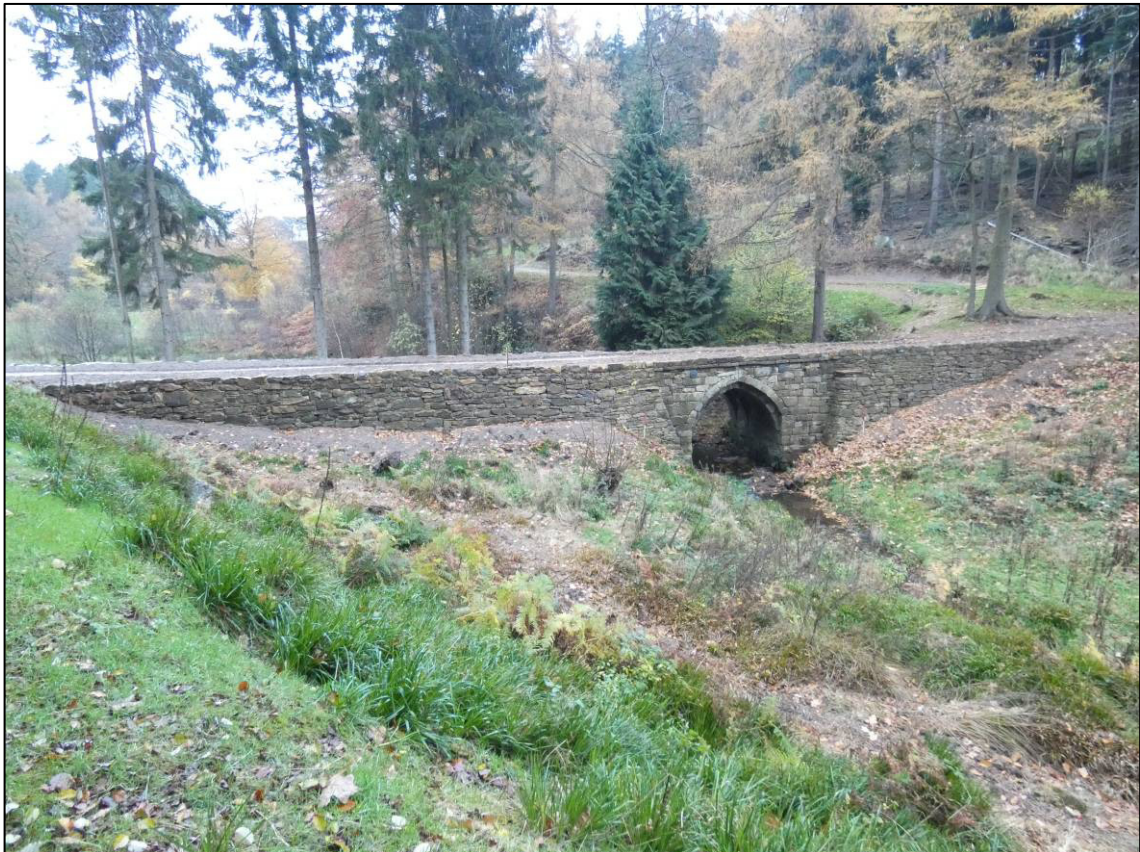
Plate 12: South elevation after repair, looking N (photo 6/007).

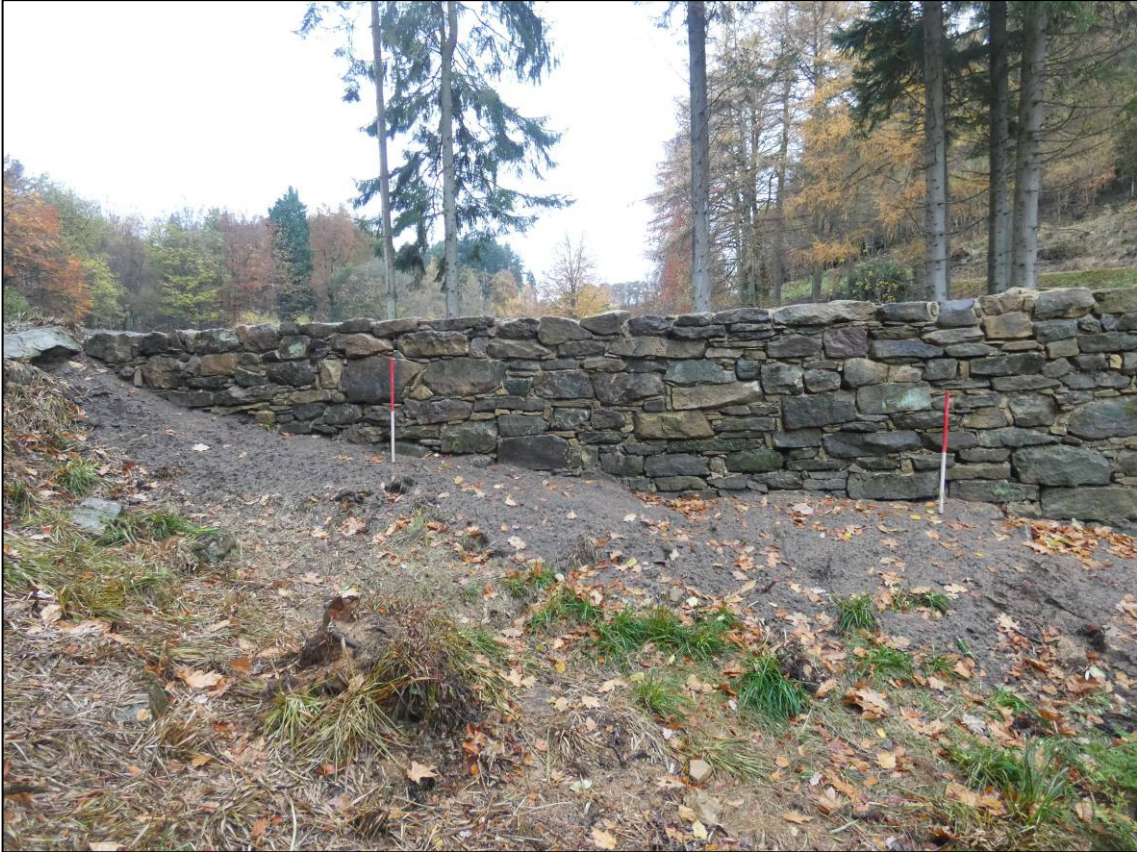
Plate 13: West abutment, south elevation, west section, after repair, looking NW (photo 6/025).

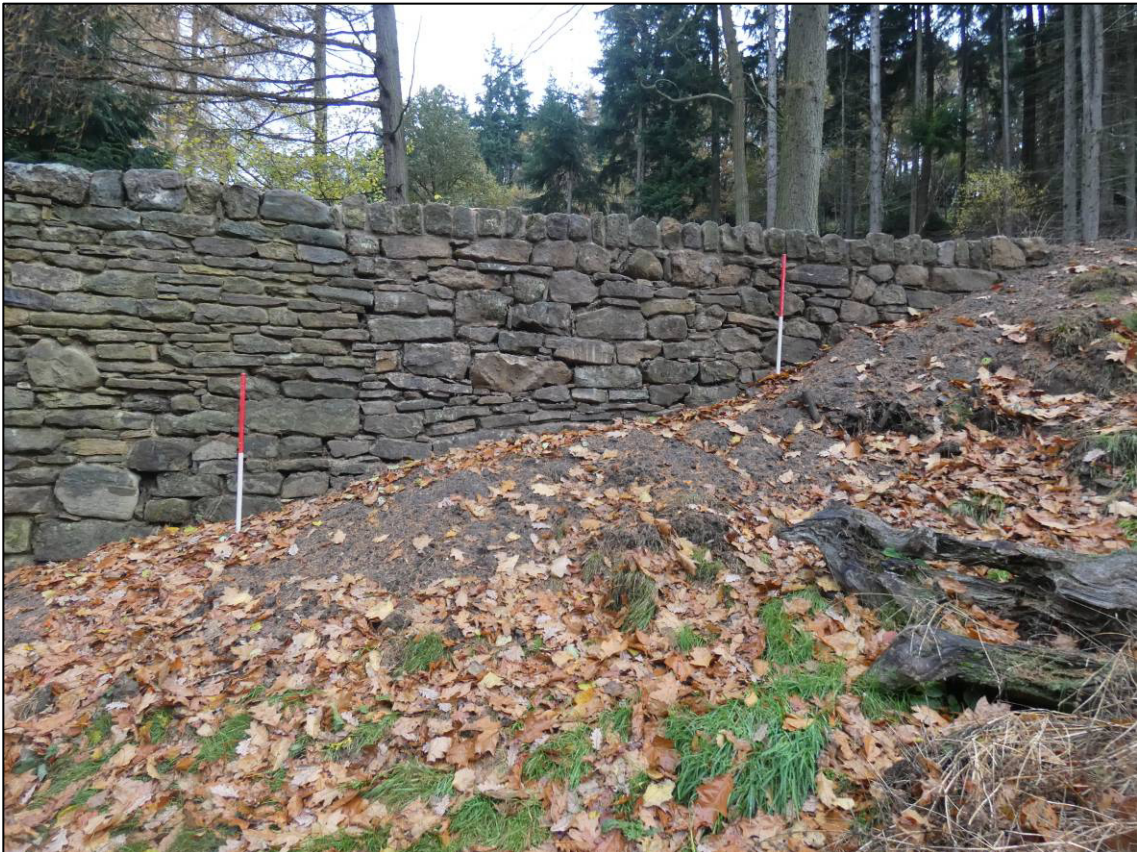
Plate 14: East abutment, south elevation after repair, looking NW (photo 6/019).

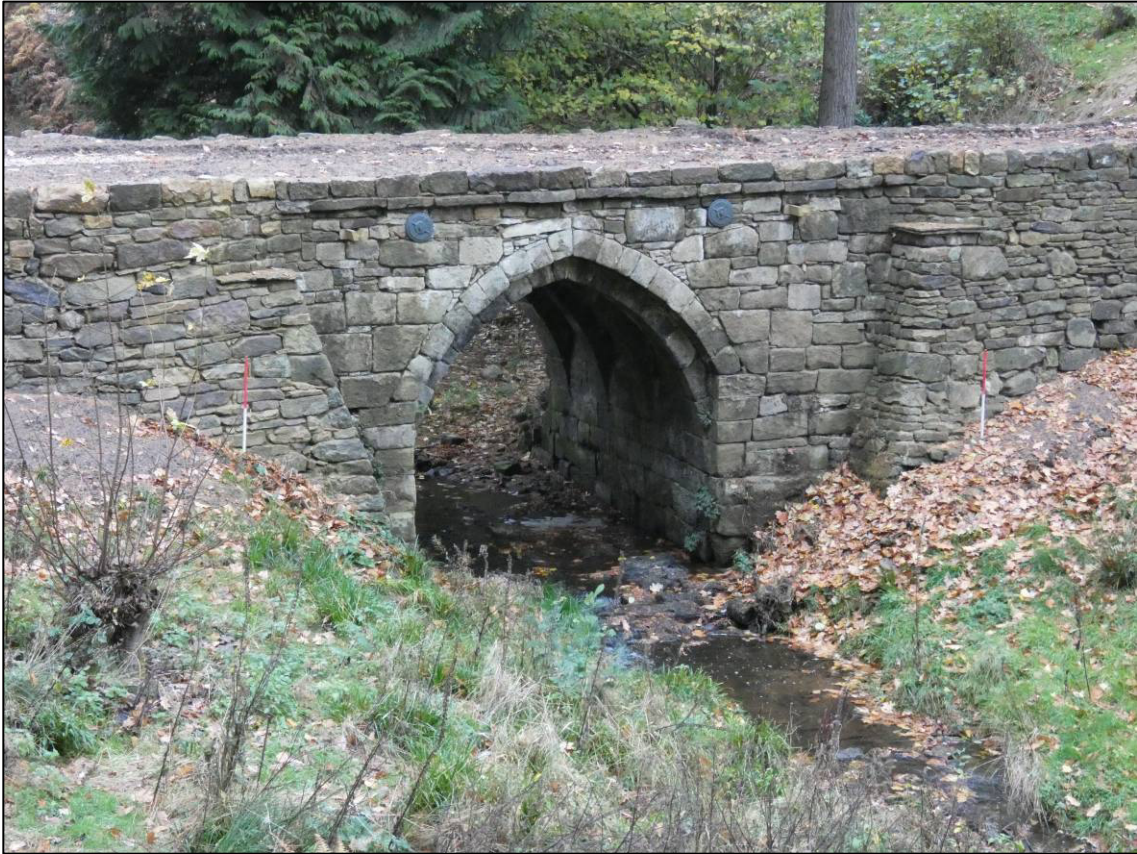
Plate 15: South elevation of main bridge structure, after initial Phase 1 repairs, looking N (photo 6/009).

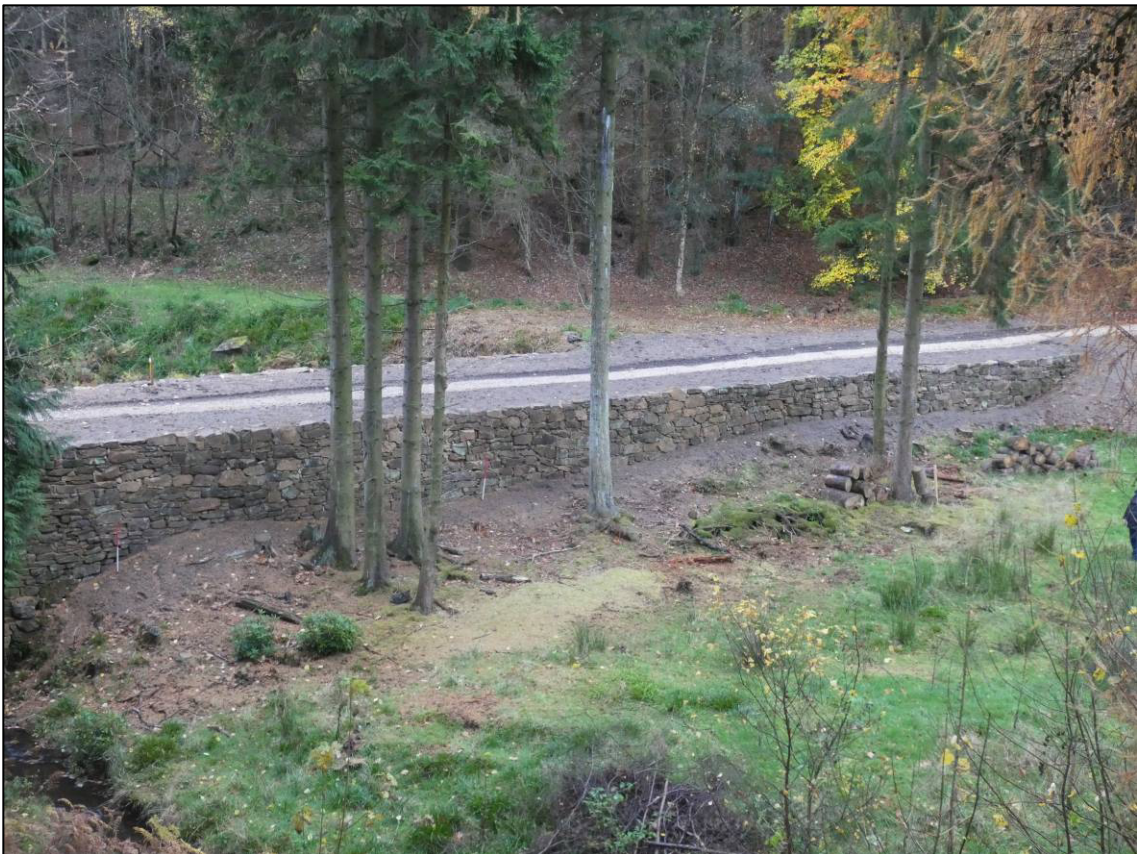
Plate 16: West abutment, north elevation after repair, looking S (photo 6/028).

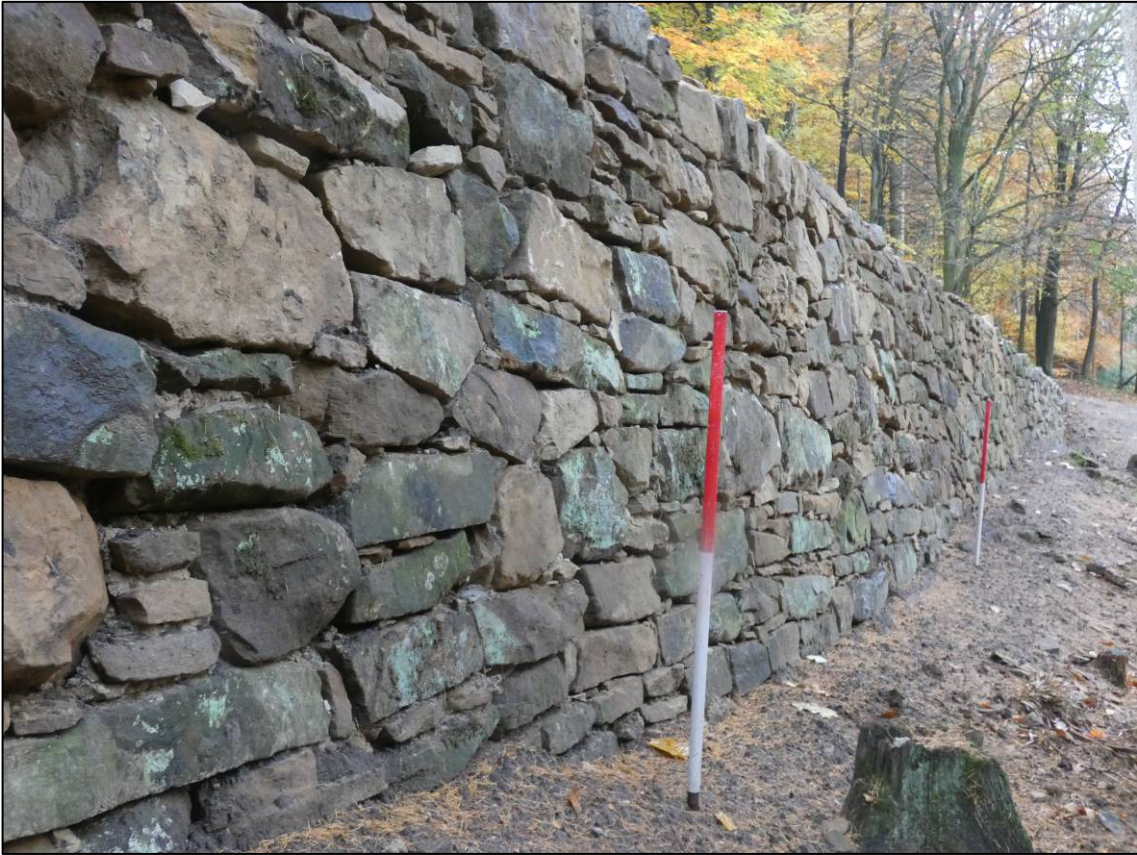
Plate 17: West abutment, north elevation after repair, looking SW (photo 6/032).

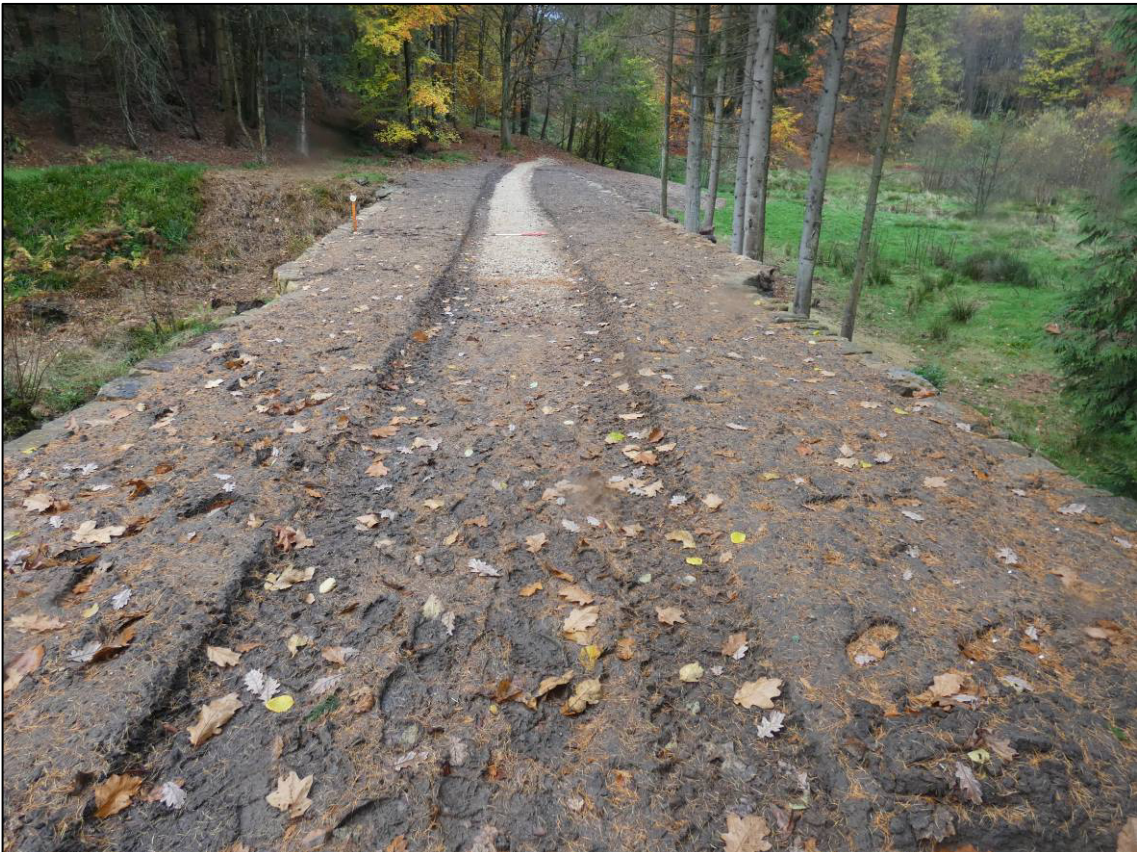
Plate 18: Bridge and abutment surfaces after resurfacing, looking SW (photo 6/044).
