FABRIC REPAIRS TO JERVAULX ABBEY,
EAST WITTON, NORTH YORKSHIRE

ARCHAEOLOGICAL OBSERVATION,
INVESTIGATION AND RECORDING

Report no: 2018/570.R01
Version: Final
Date: February 2021
Author: Ed Dennison & Shaun Richardson

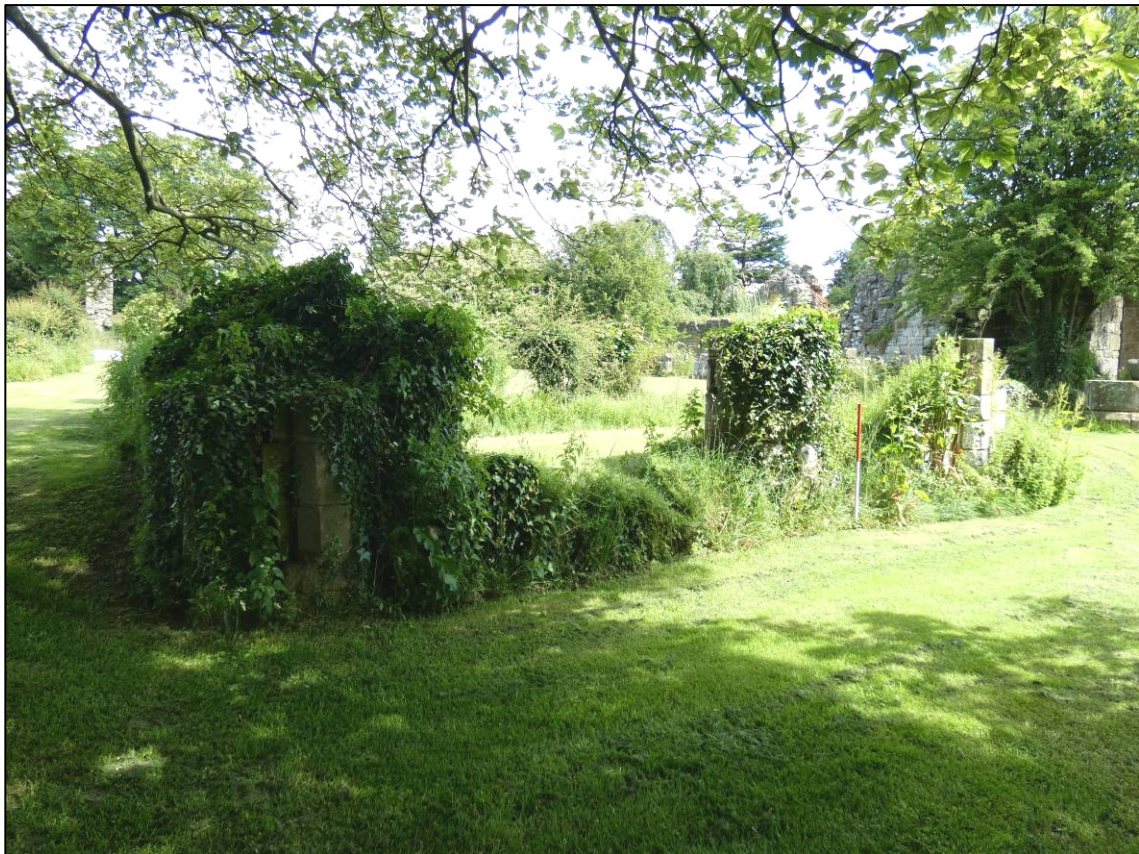
Plate 3: Area 2: Lay brothers' rear-dorter, south external elevation of south wall, before clearance, looking NE (photo 1/257).

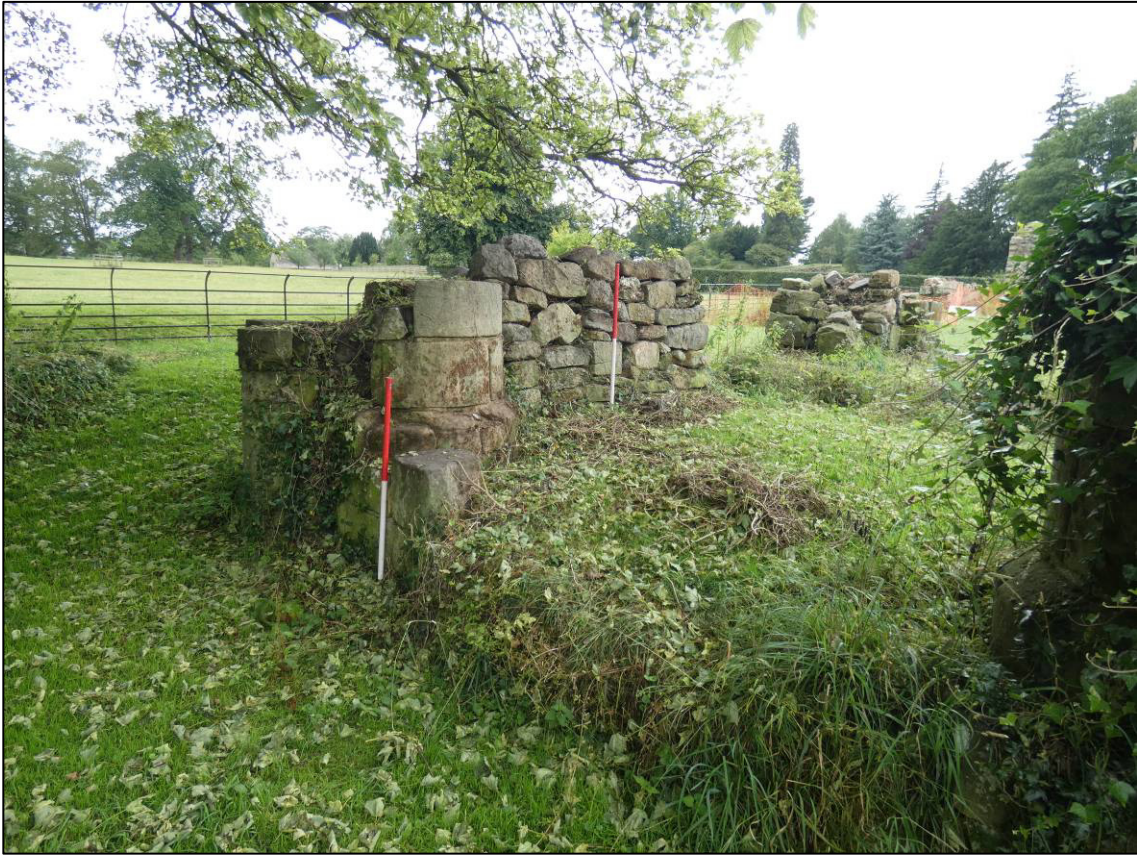
Plate 4: Area 2: Lay brothers' rear-dorter, east return of south end of west wall, showing column base, after clearance, looking NW (photo 2/453).

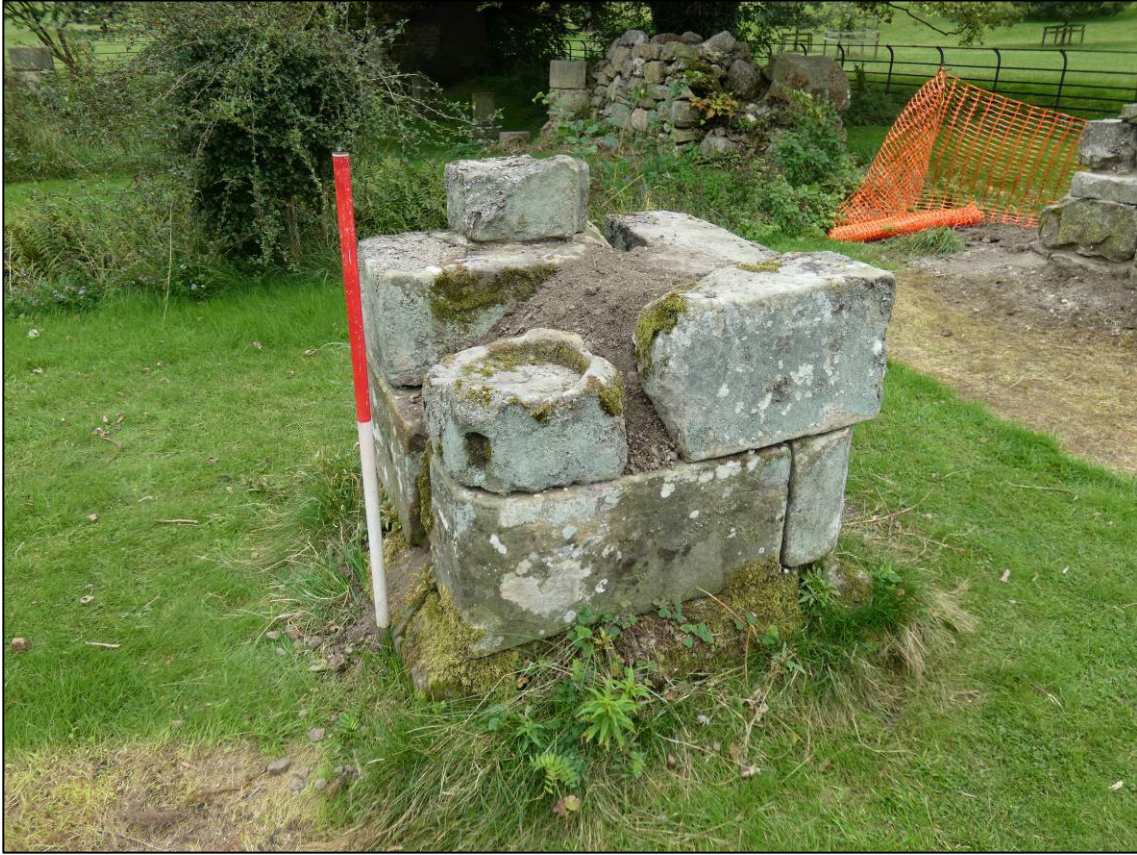
Plate 6: Area 2: Lay brothers' rear-dorter, west pier in north wall, during repair, looking S (photo 3/576).

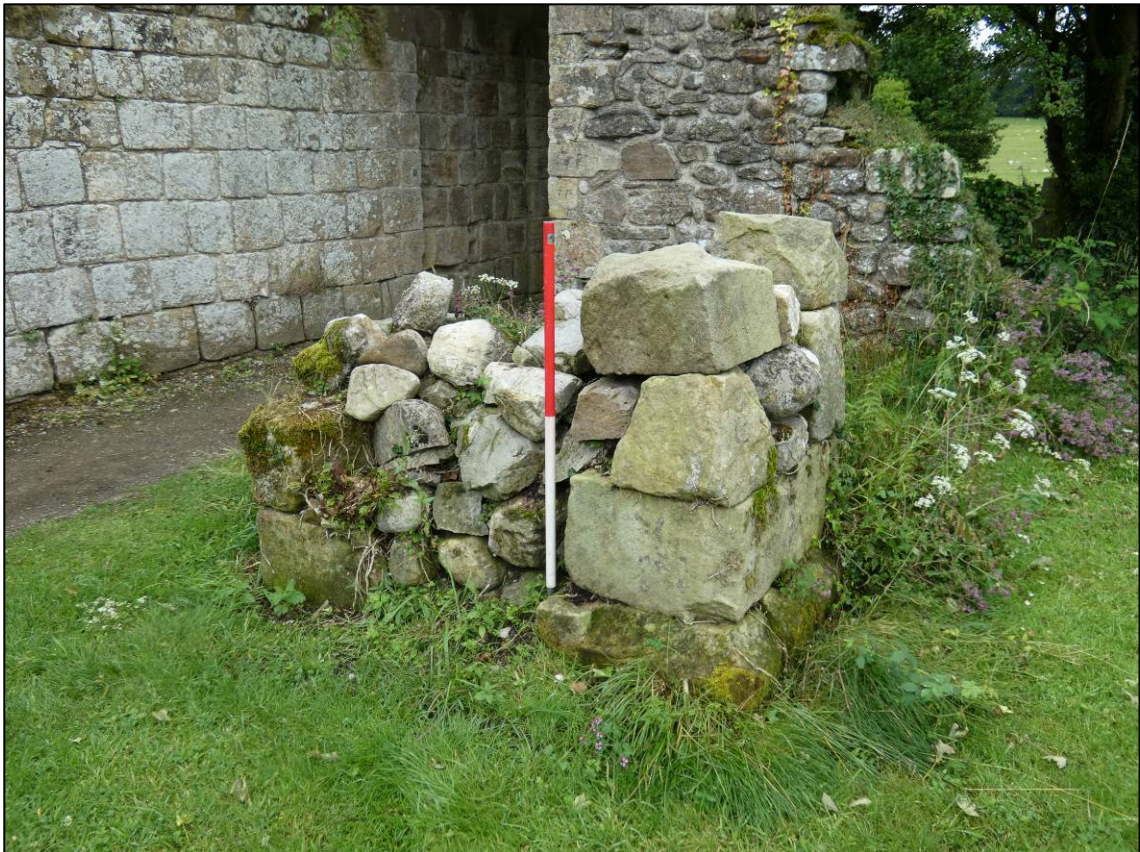
Plate 7: Area 2: Lay brothers' rear-dorter, east end of north wall, after clearance, looking E (photo 2/463).

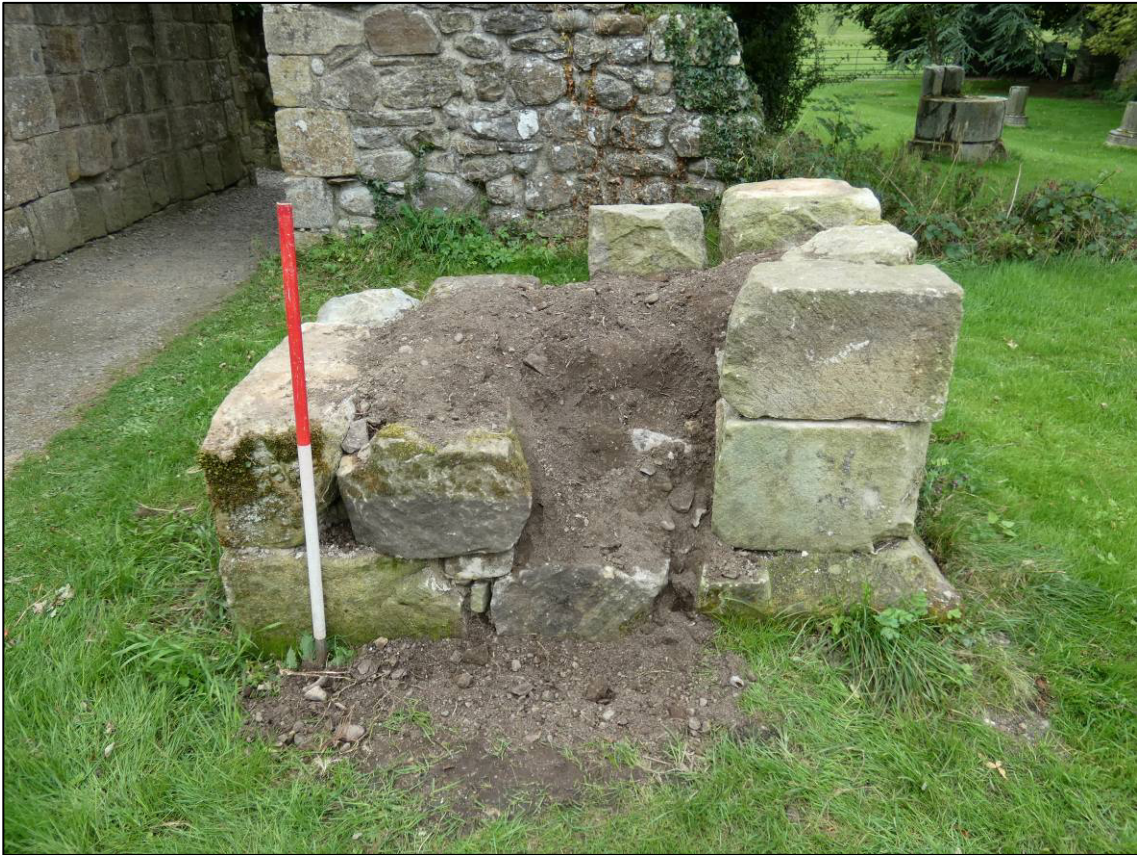
Plate 8: Area 2: Lay brothers' rear-dorter, east end of north wall, during repair, looking E (photo 3/578).

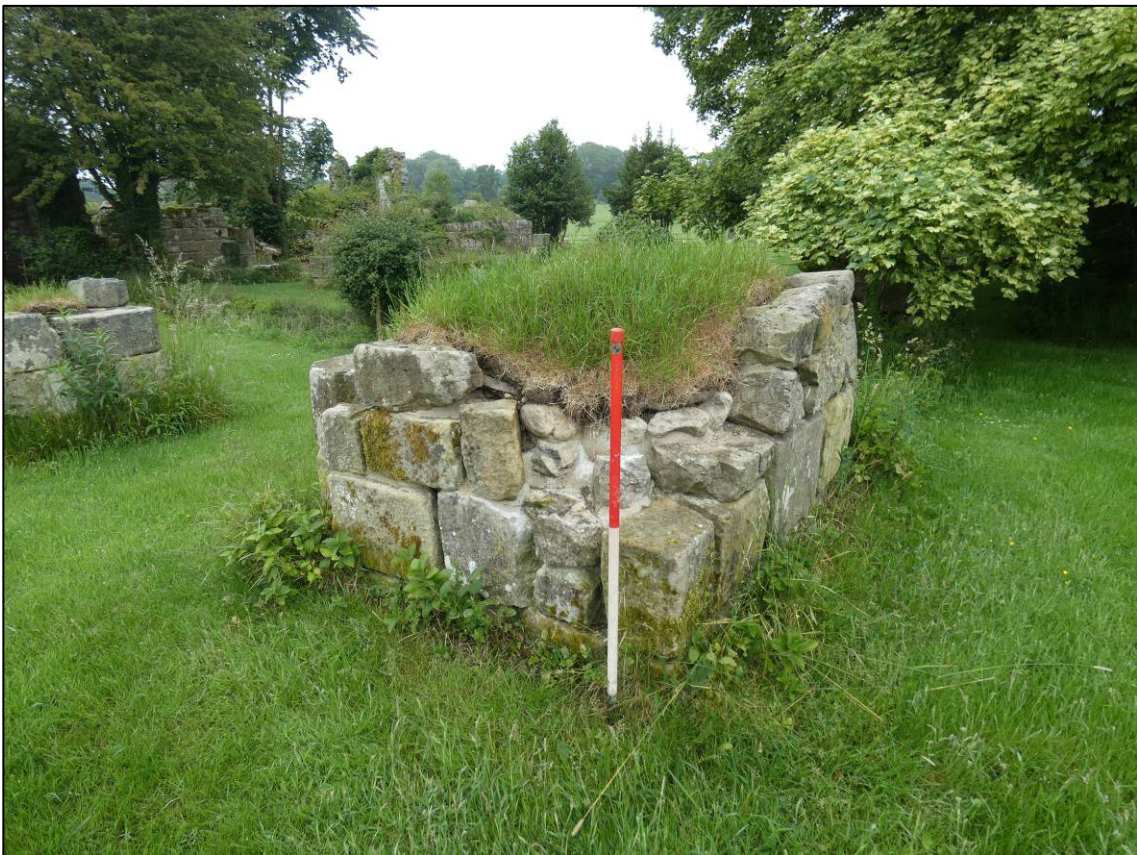
Plate 9: Area 2: Lay brothers' rear-dorter, east return to west wall, after repair, looking SE (photo 6/666).

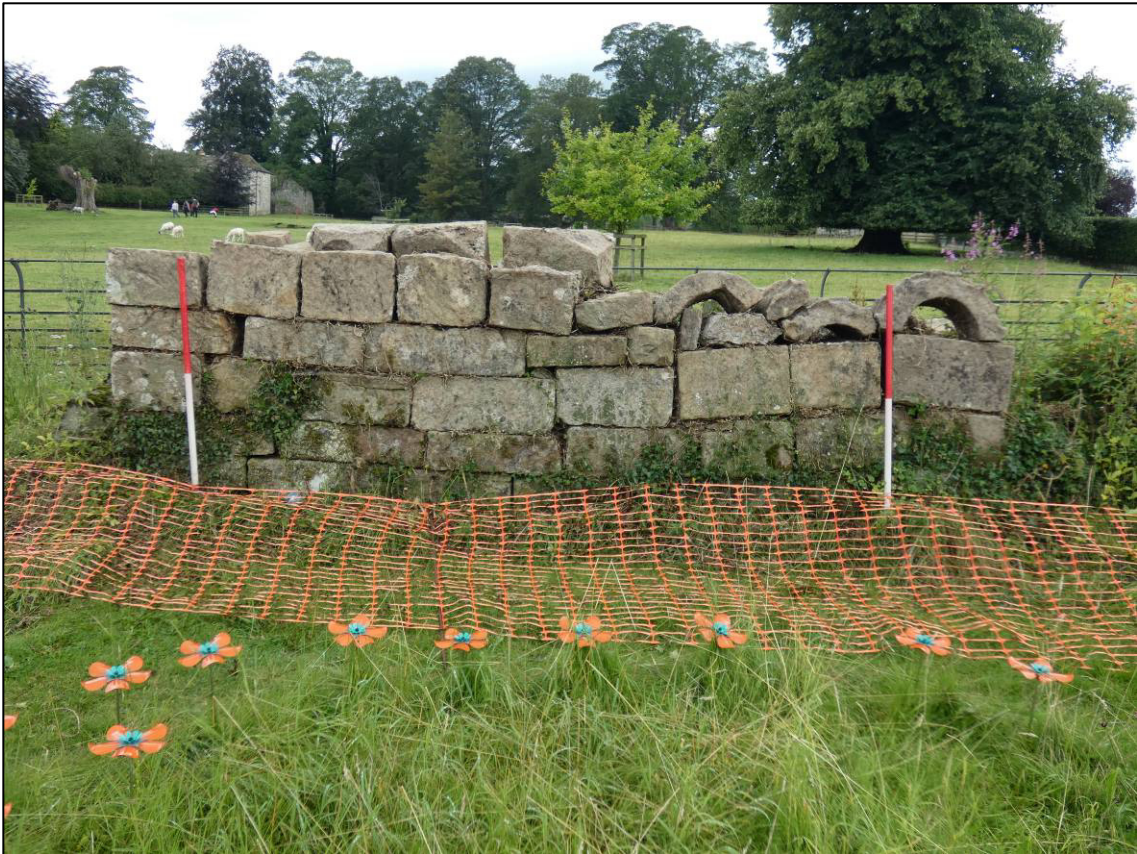
Plate 10: Area 3: Lay brothers' guest house, east internal elevation of west wall (north part), after clearance, looking W (photo 2/466).

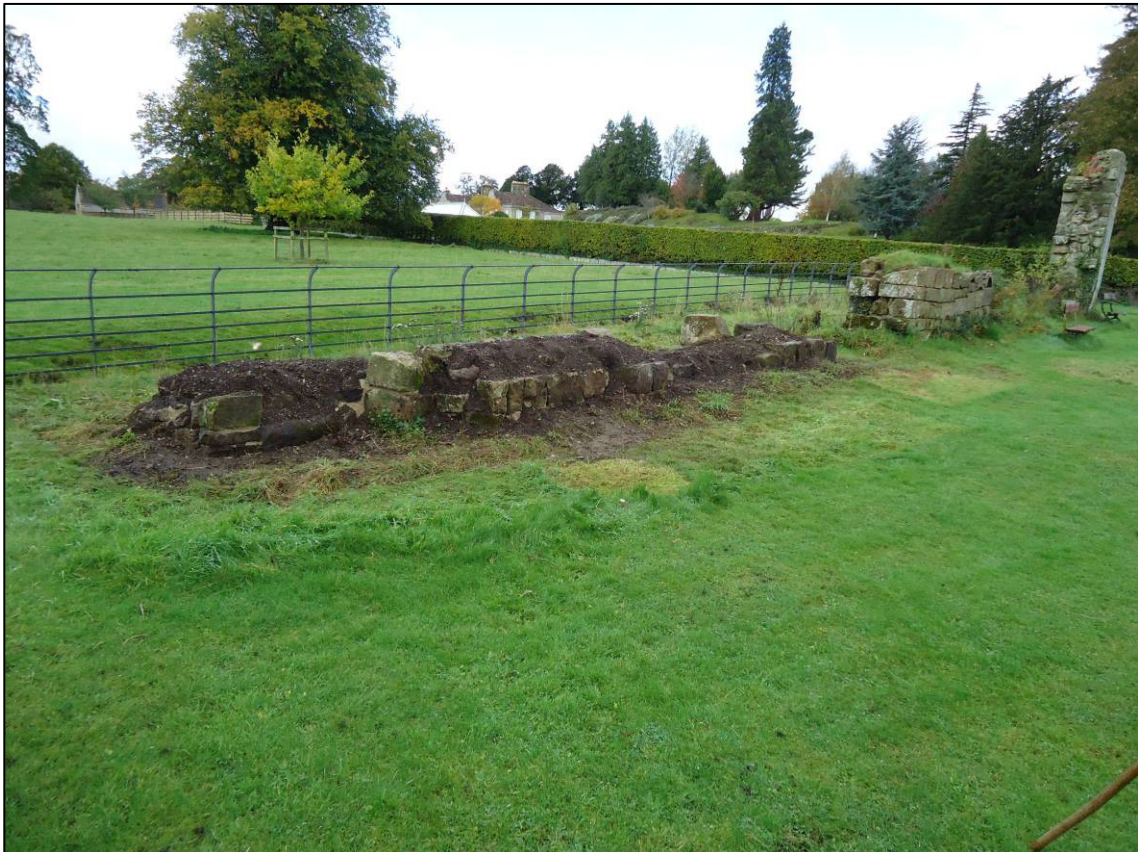
Plate 11: Area 3: Lay brothers' guest house, west wall, during repair, looking NW (photograph courtesy Peter Pace).

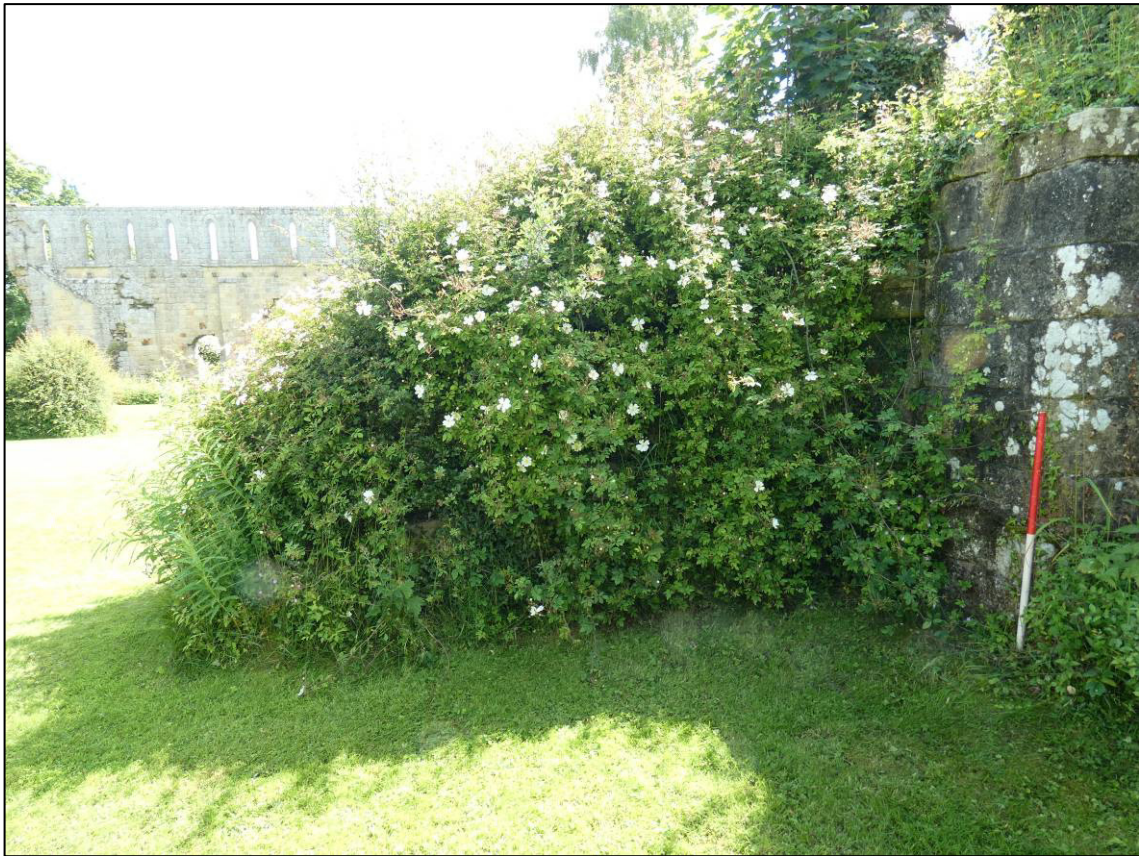
Plate 12: Area 4: Lay brothers' quarters (frater), west internal elevation of east wall (south end), before clearance, looking E (photo 1/278).

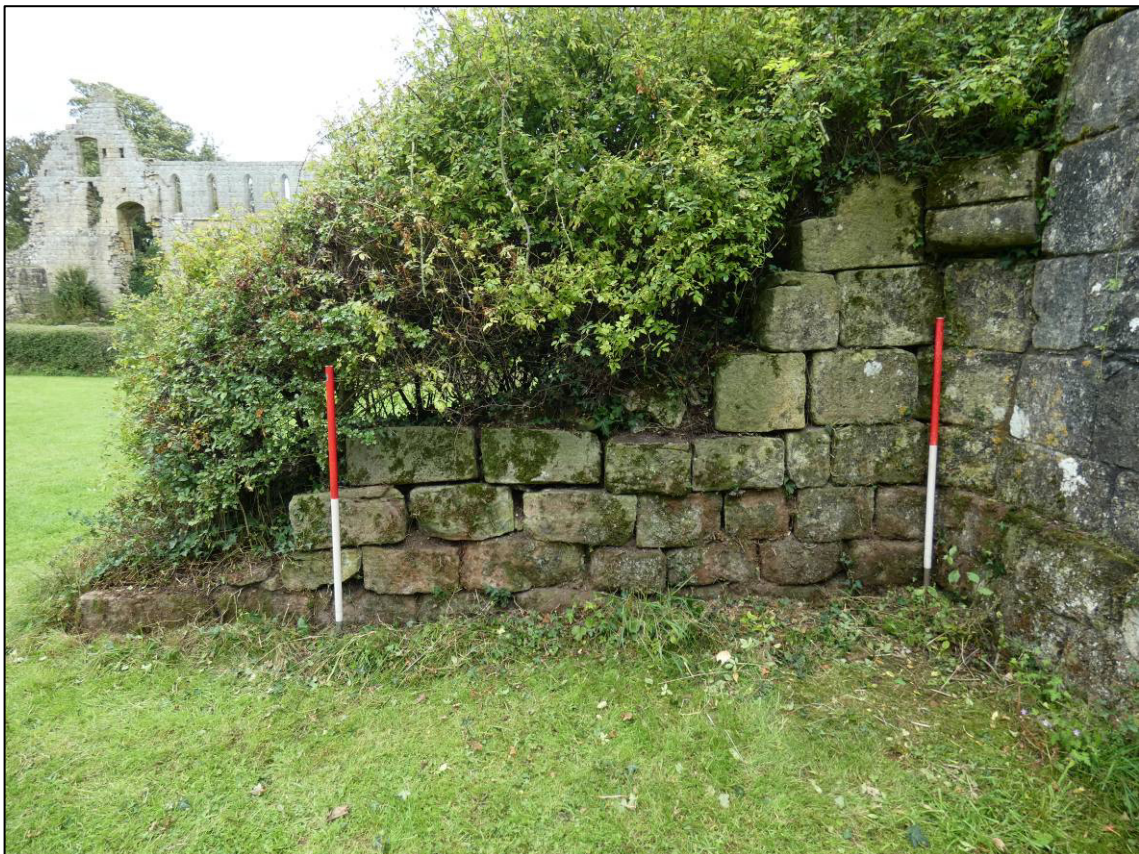
Plate 13: Area 4: Lay brothers' quarters (frater), west internal elevation of east wall (south end), after clearance, looking E (photo 3/580).

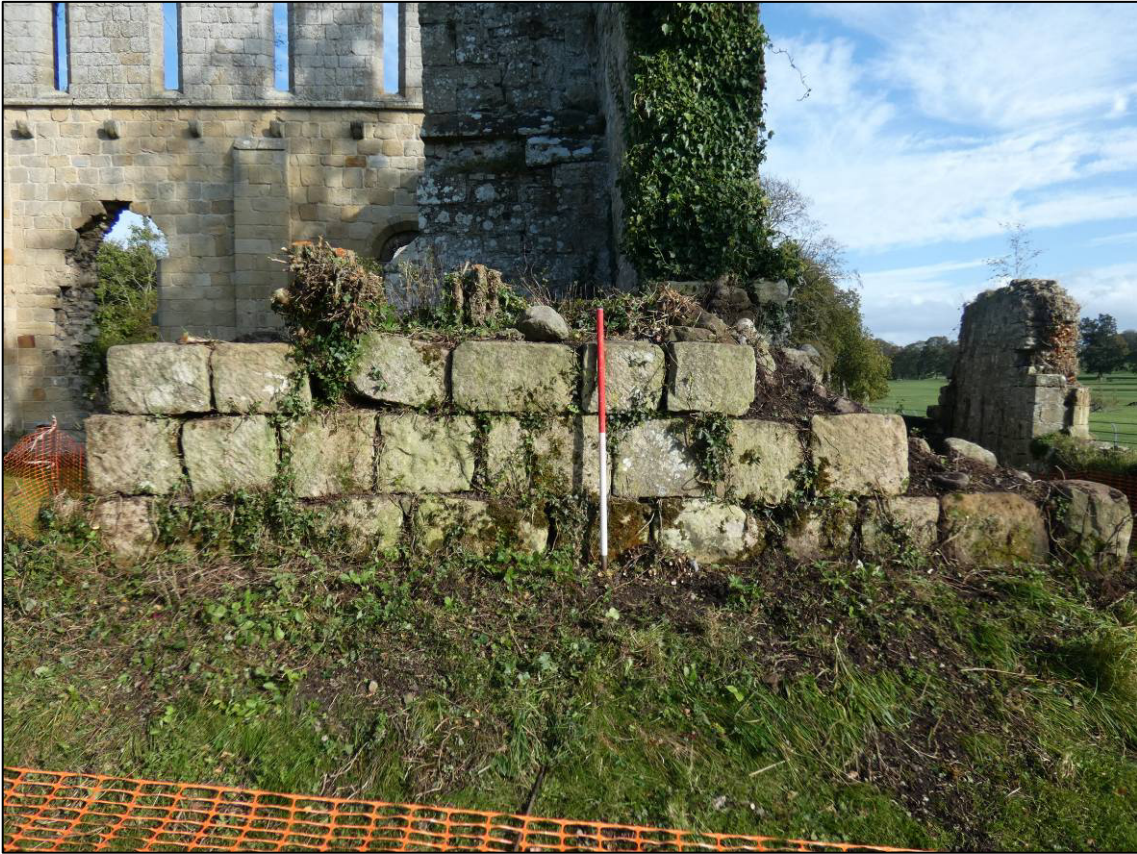
Plate 14: Area 6: Monks' frater, west internal elevation of east wall (south end), after clearance, looking E (photo 4/191).

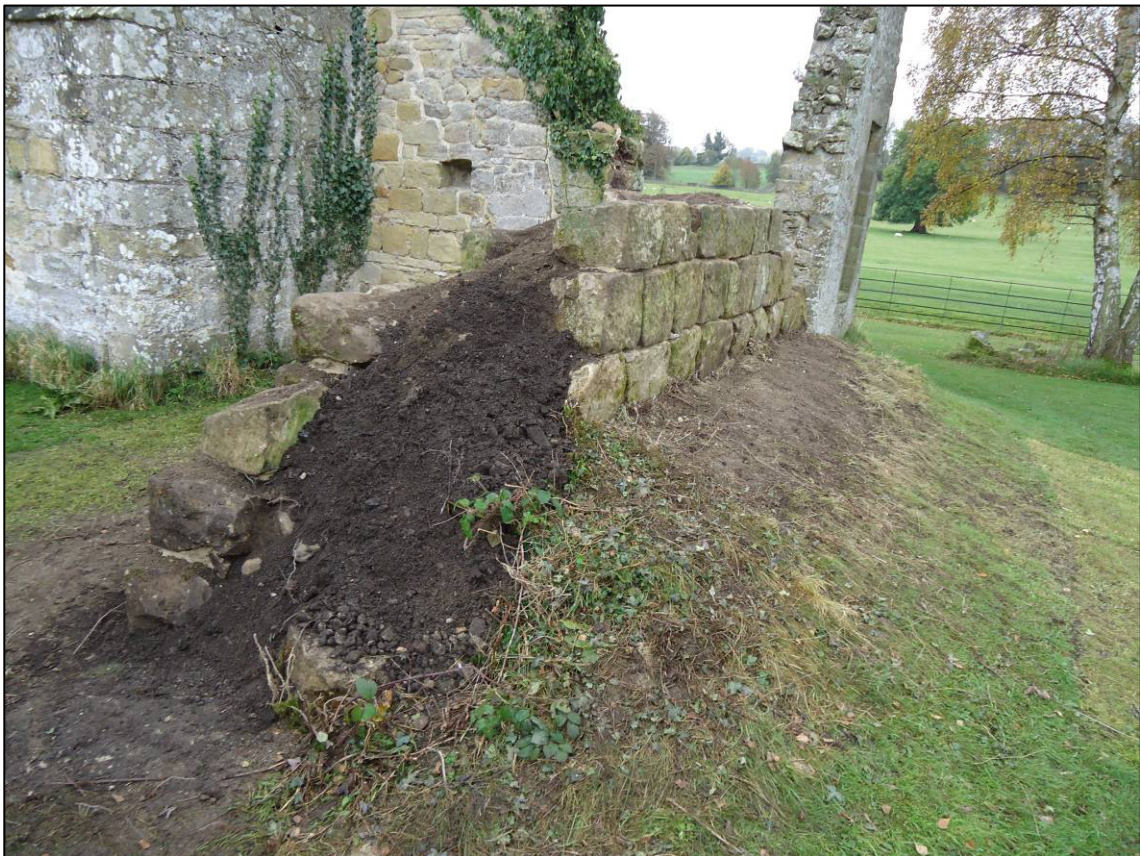
Plate 15: Area 6: Monks' frater, west internal elevation of east wall (south end), after repair, looking SE (photograph courtesy Peter Pace).

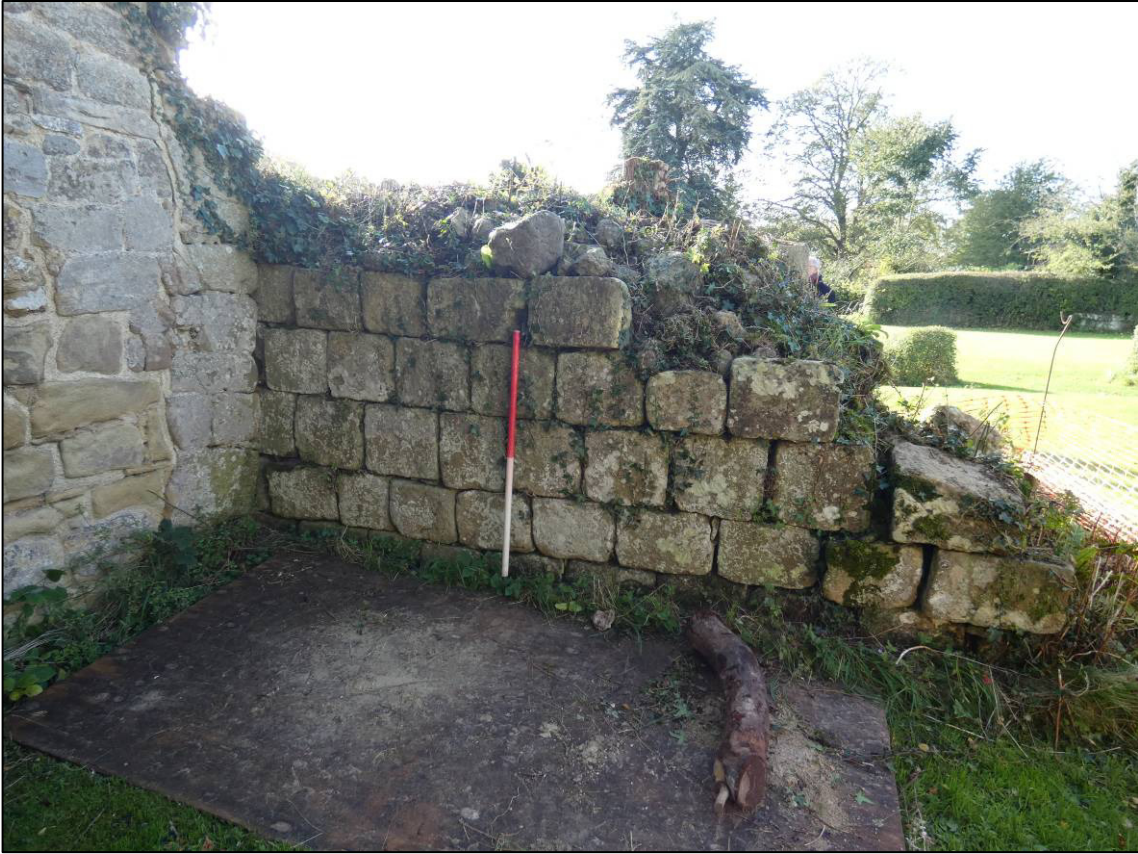
Plate 16: Area 6: Monks' frater, east external elevation of east wall, north of misericord, after clearance, looking W (photo 4/188).

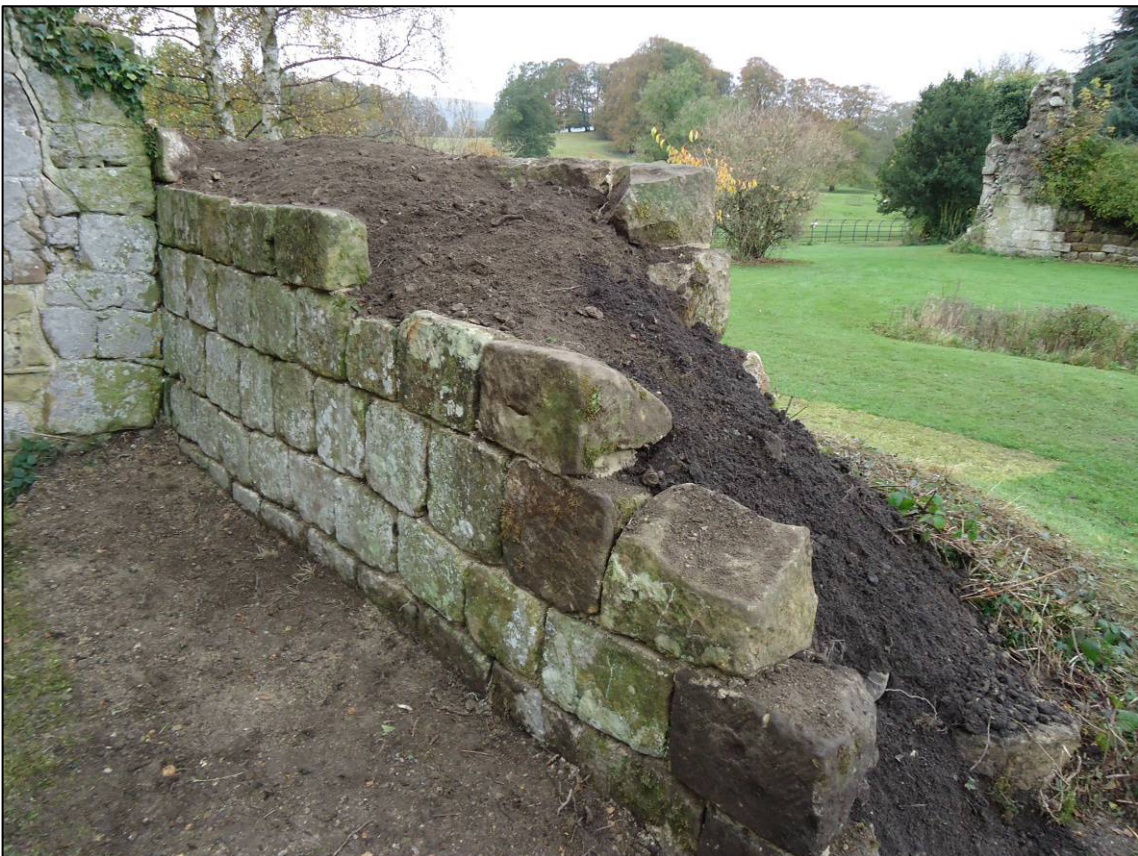
Plate 17: Area 6: Monks' frater, east external elevation of east wall, north of misericord, after repair, looking SW (photograph courtesy Peter Pace).

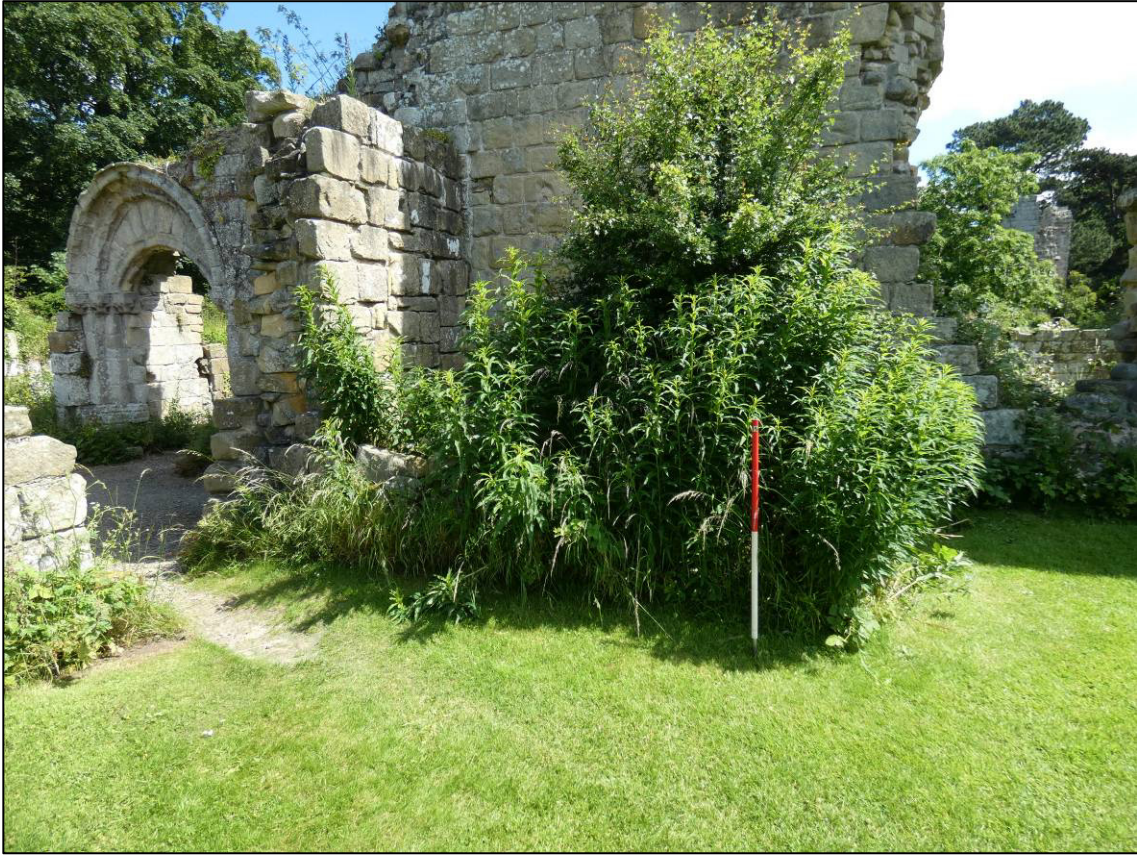
Plate 18: Area 7: Warming house, remains of dorter stairs, before clearance, looking NE (photo 1/298).

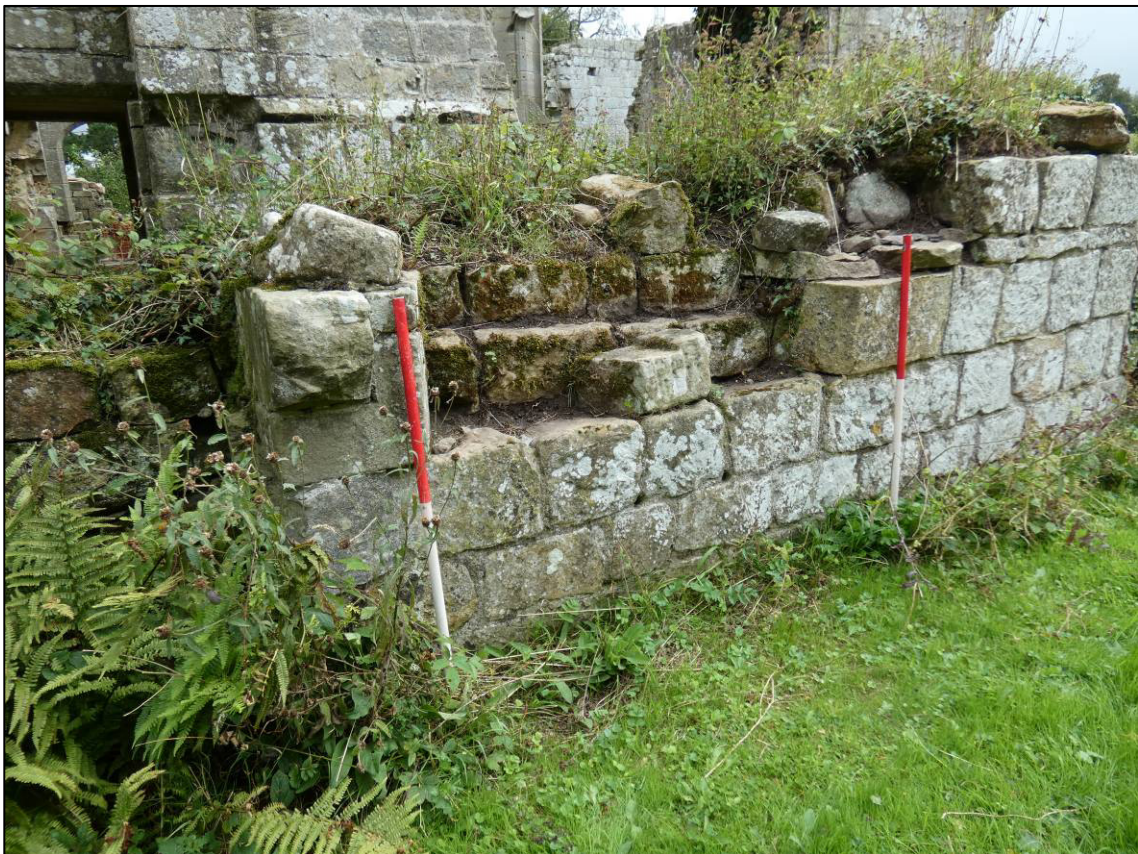
Plate 21: Area 9: Monks' dorter, window in west internal elevation of east wall (south part), after clearance, looking SE (photo 3/556).

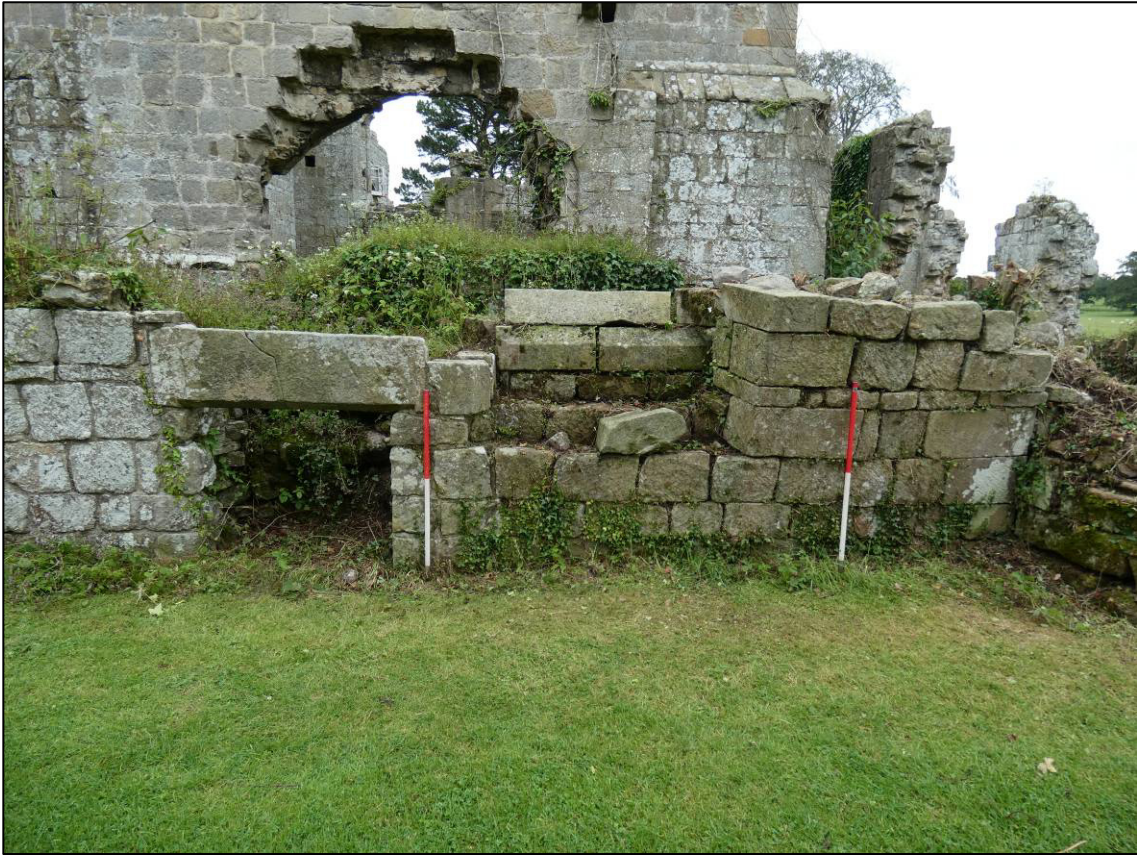
Plate 22: Area 9: Monks' dorter, fireplace and window in west internal elevation of east wall (south part), after clearance, looking E (photo 2/477).

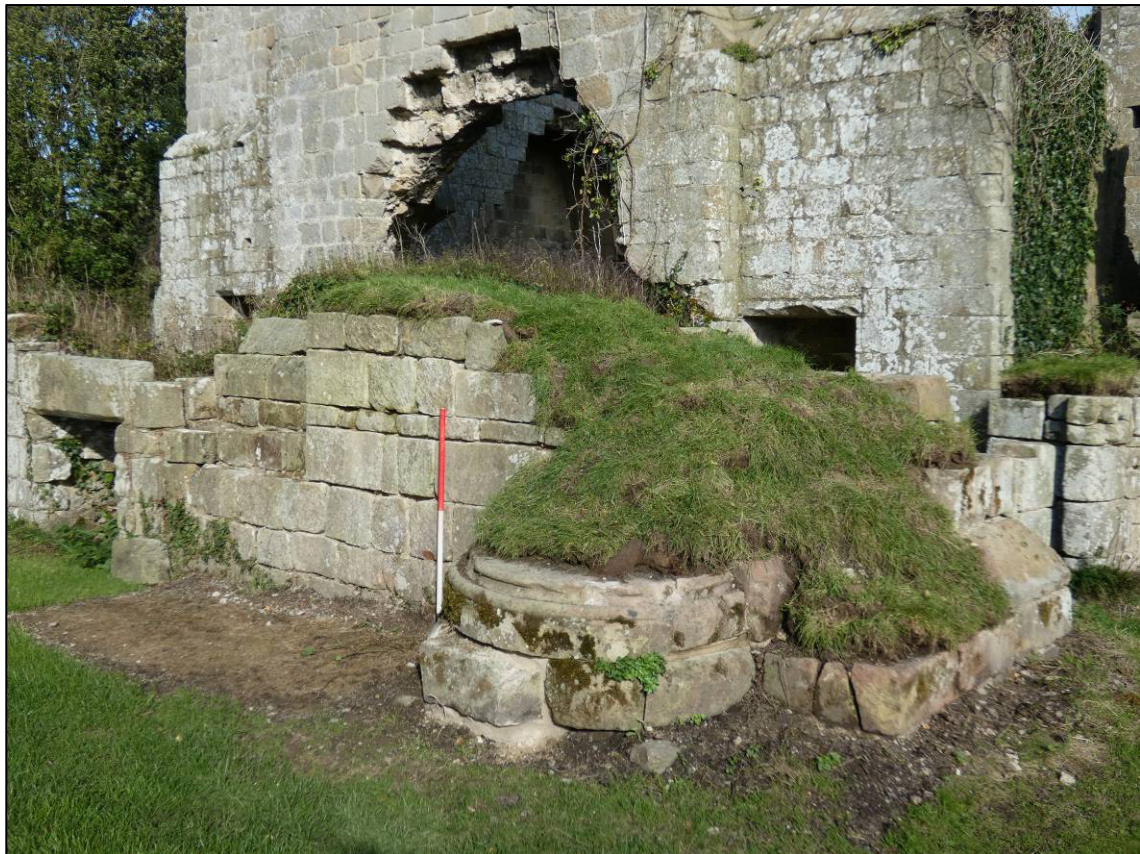
Plate 27: Area 9: Monks' dorter, pier base and west internal elevation of east wall (south end), after repair, looking NE (photo 4/185).

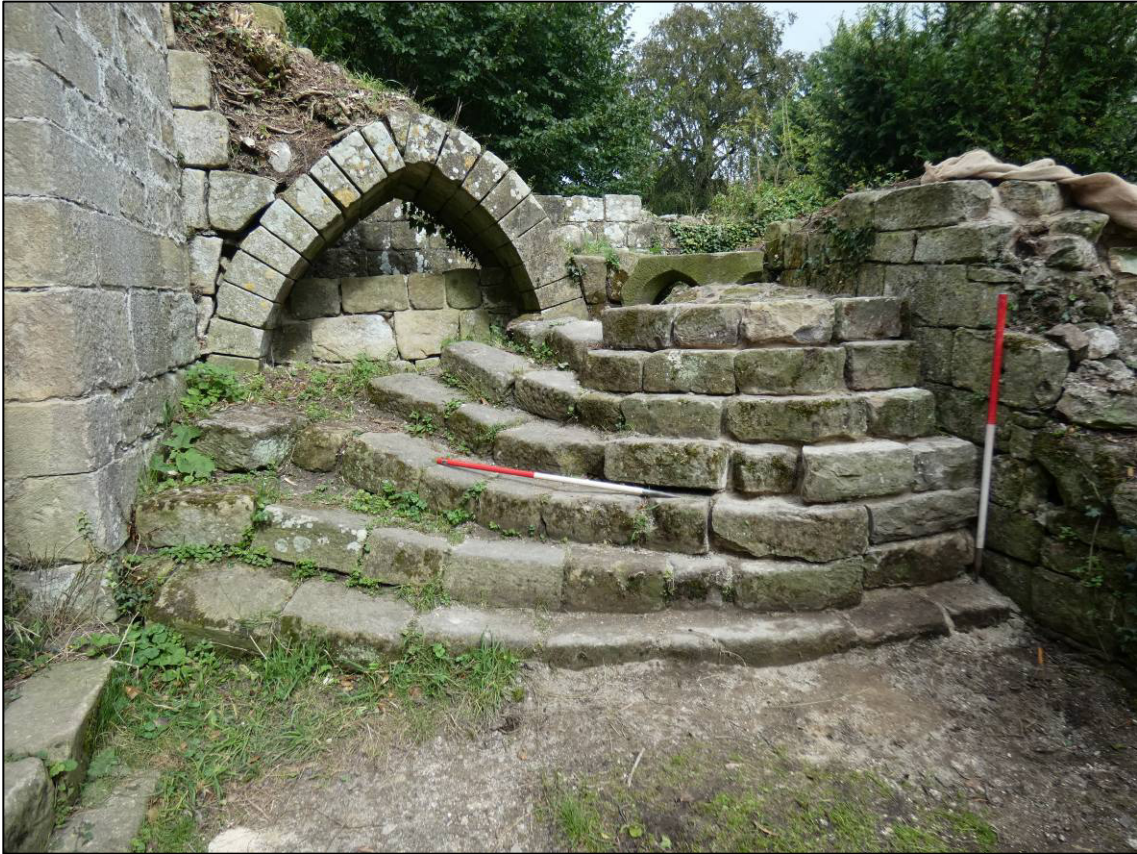
Plate 34: Area 12: Staircase between abbots' lodging and monks' rere-dorter, after repair, looking N (photo 3/557).

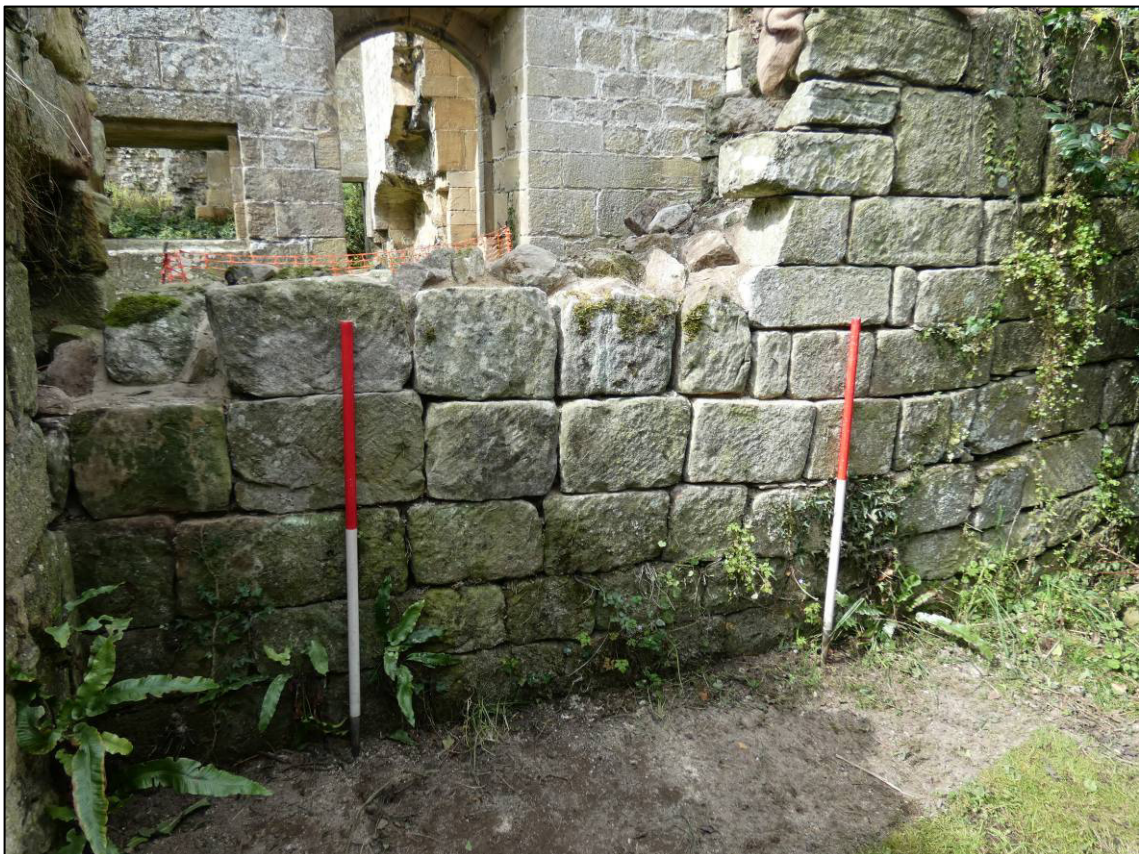
Plate 35: Area 12: Staircase between abbots' lodging and monks' rere-dorter, east elevation of wall to the east, after repair, looking W (photo 3/562).

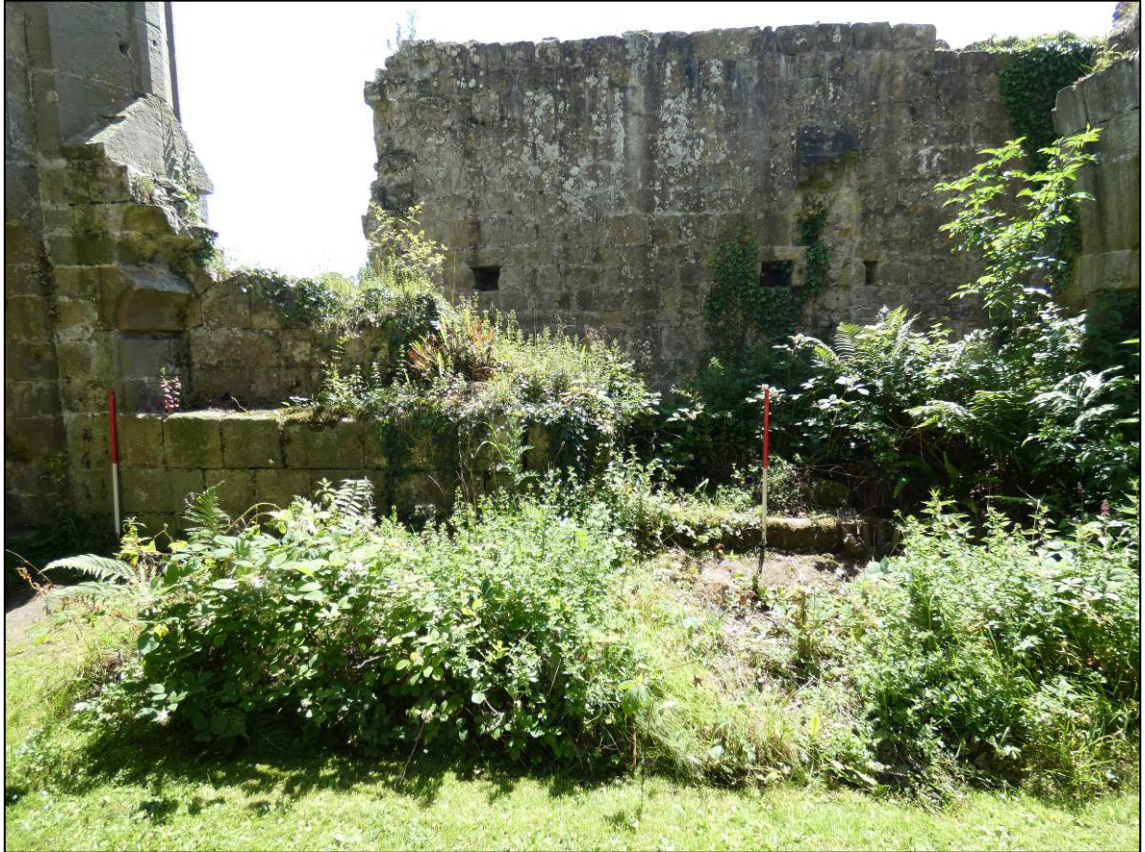
Plate 36: Area 13: Meat kitchen, north internal elevation of south wall, before clearance, looking S (photo 1/330).

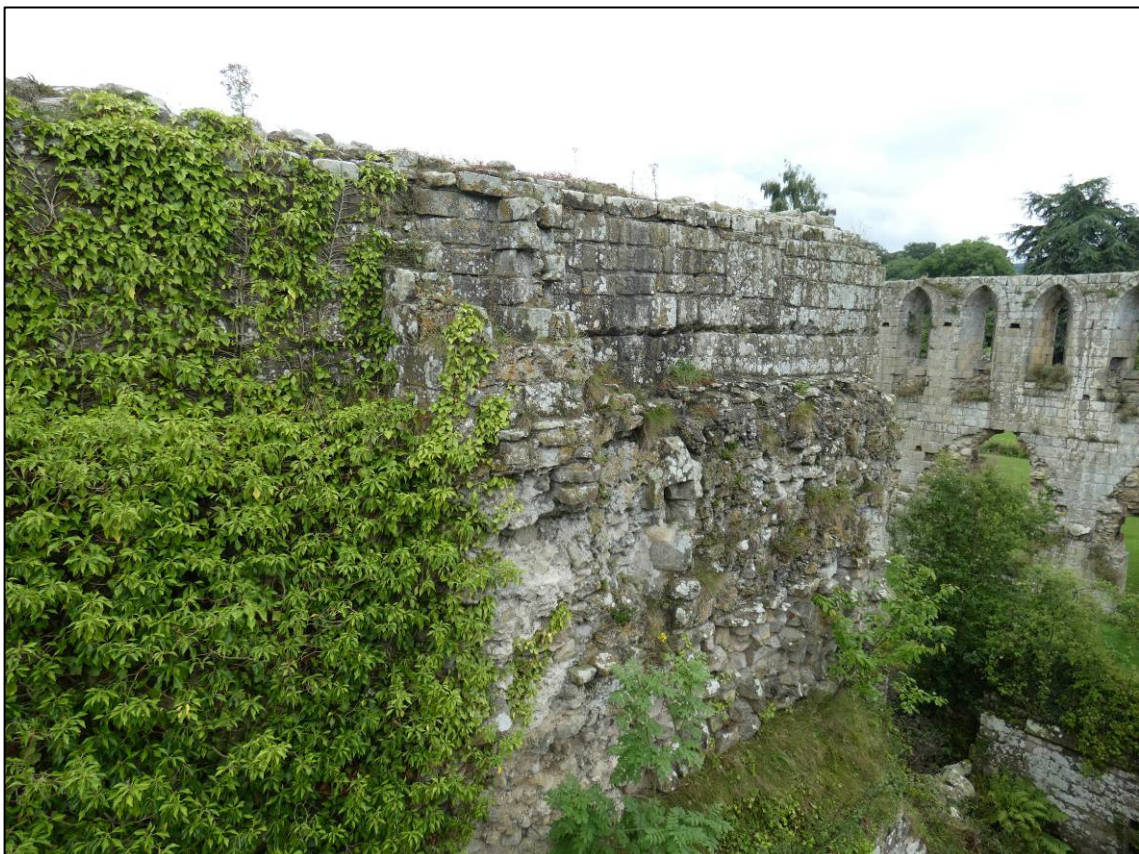
Plate 41: Area 14: Monks' rere-dorter, north internal elevation of south wall (upper level), showing chimney flue from meat kitchen and cut line of former rere-dorter roof, looking SW (photo 2/493).

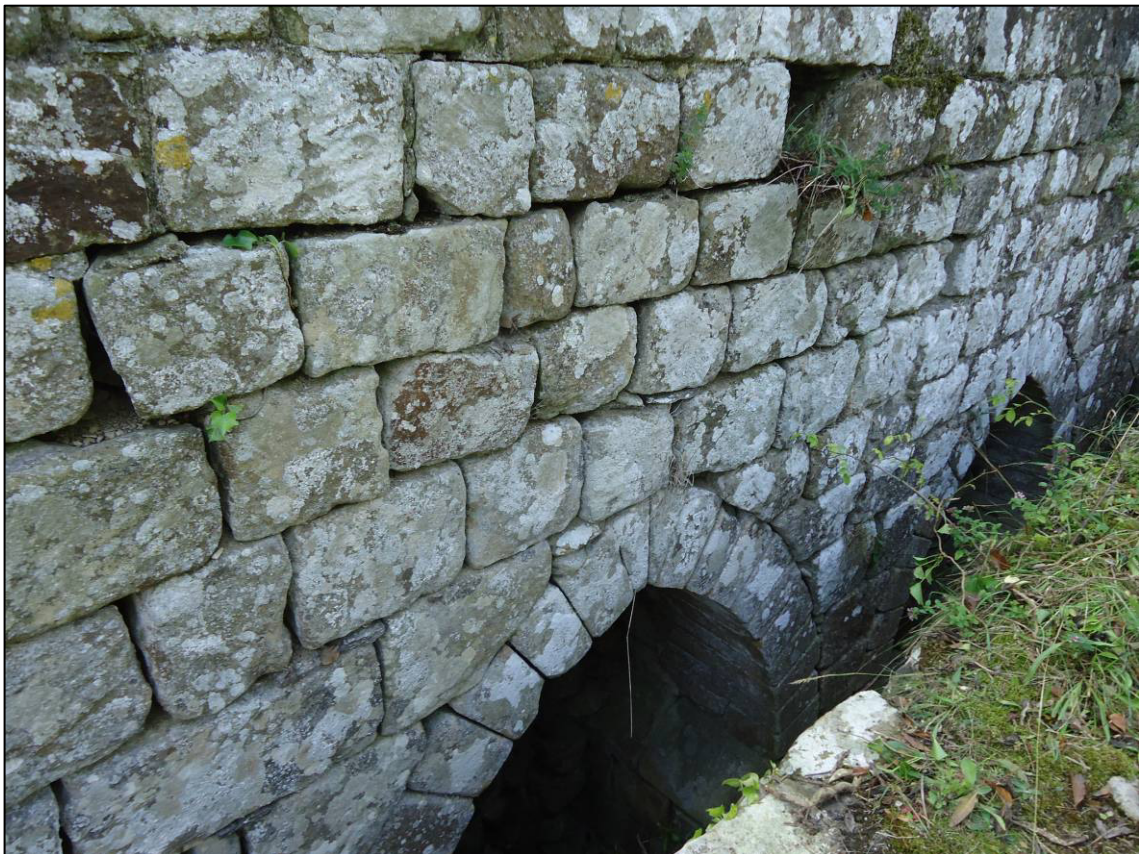
Plate 43: Area 14: Monks' rere-dorter, south internal elevation of drain, looking SW (photograph courtesy Peter Pace).
