FABRIC REPAIRS TO JERVAULX ABBEY,
EAST WITTON, NORTH YORKSHIRE

ARCHAEOLOGICAL OBSERVATION,
INVESTIGATION AND RECORDING

Report no: 2018/570.R01
Version: Final
Date: February 2021
Author: Ed Dennison & Shaun Richardson

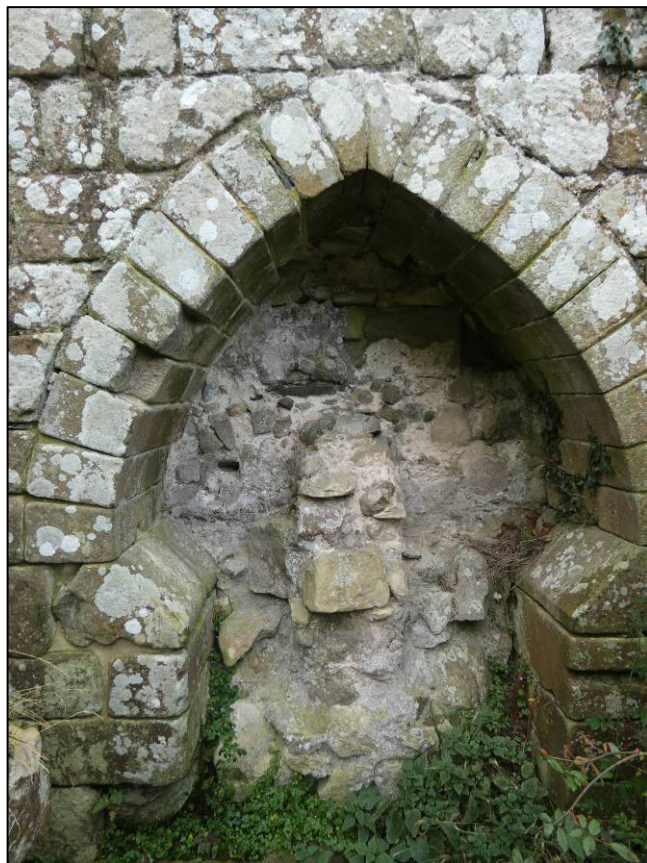
Plate 45: Area 14: Monks' rere-dorter, south internal elevation of drain, western arch after repair, looking S (photo 7/619).

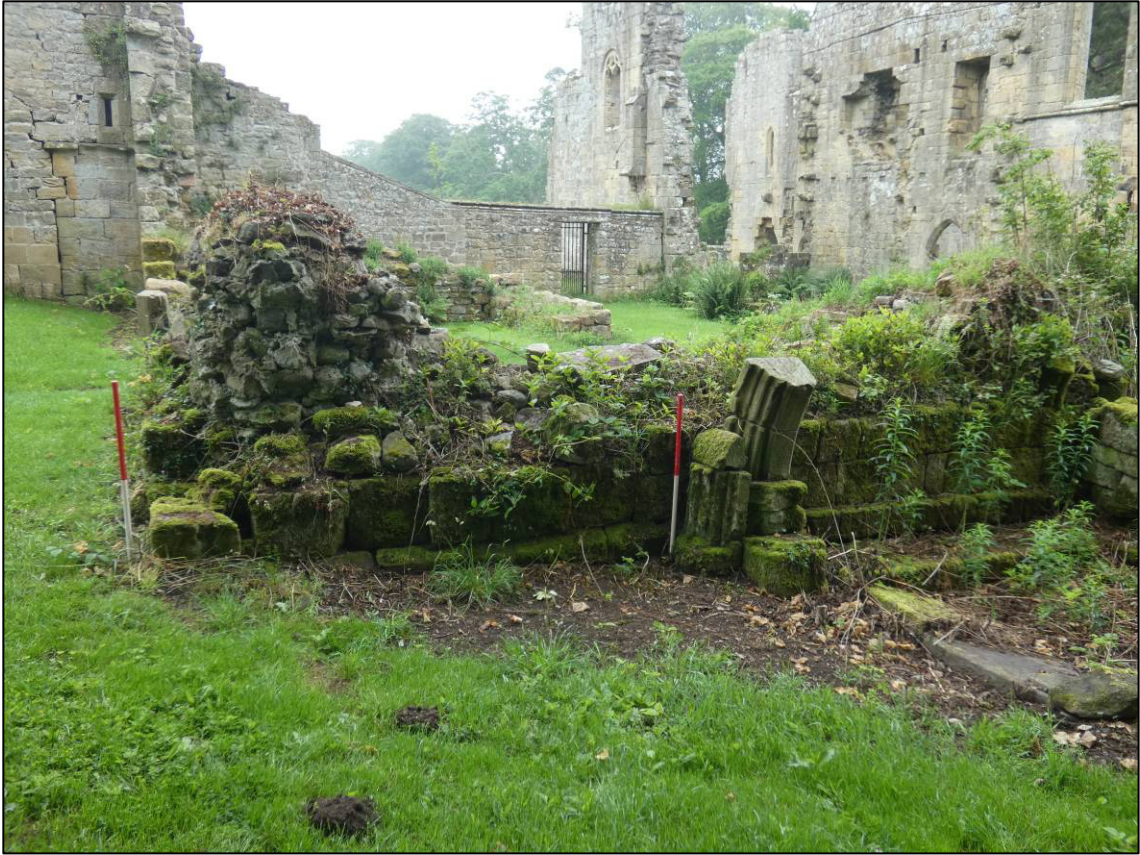
Plate 47: Area 15: Infirmary's lodging, west external elevation of west wall, before clearance, looking E (photo 6/642).

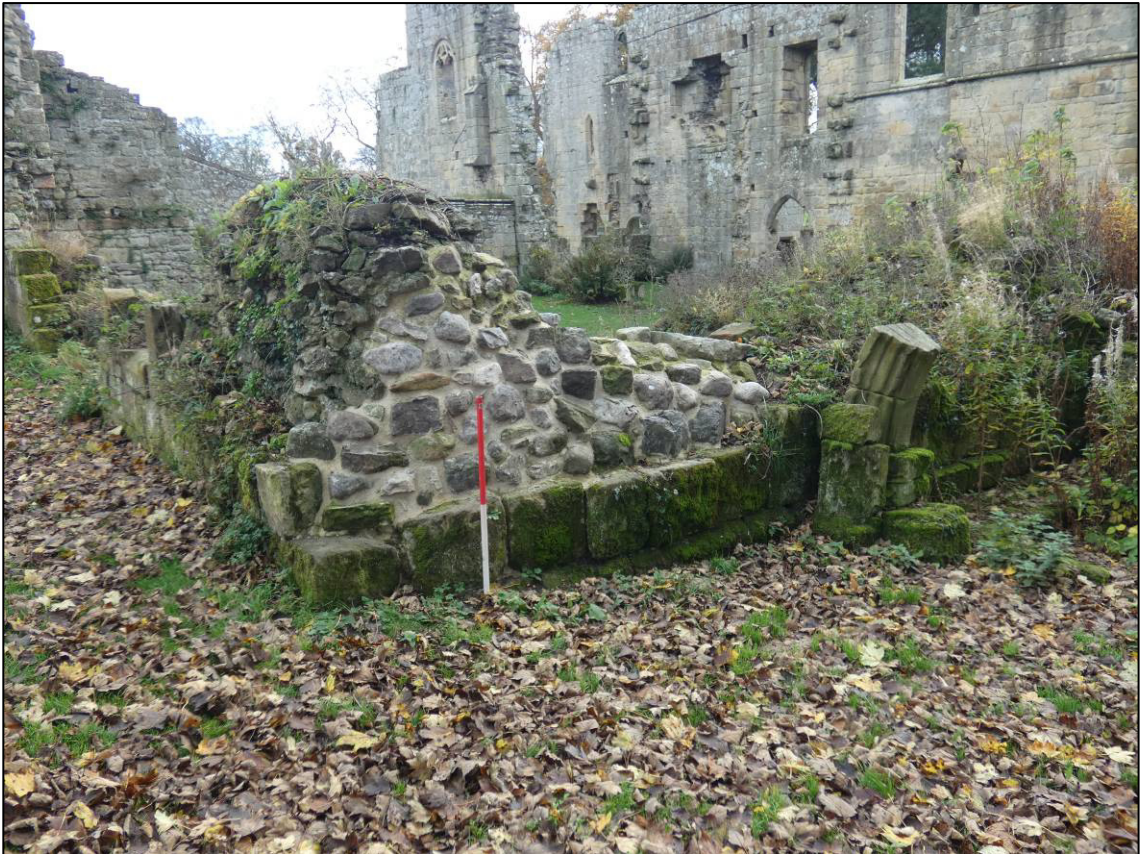
Plate 48: Area 15: Infirmary's lodging, west external elevation of west wall (north end), after repair, looking SE (photo 7/616).

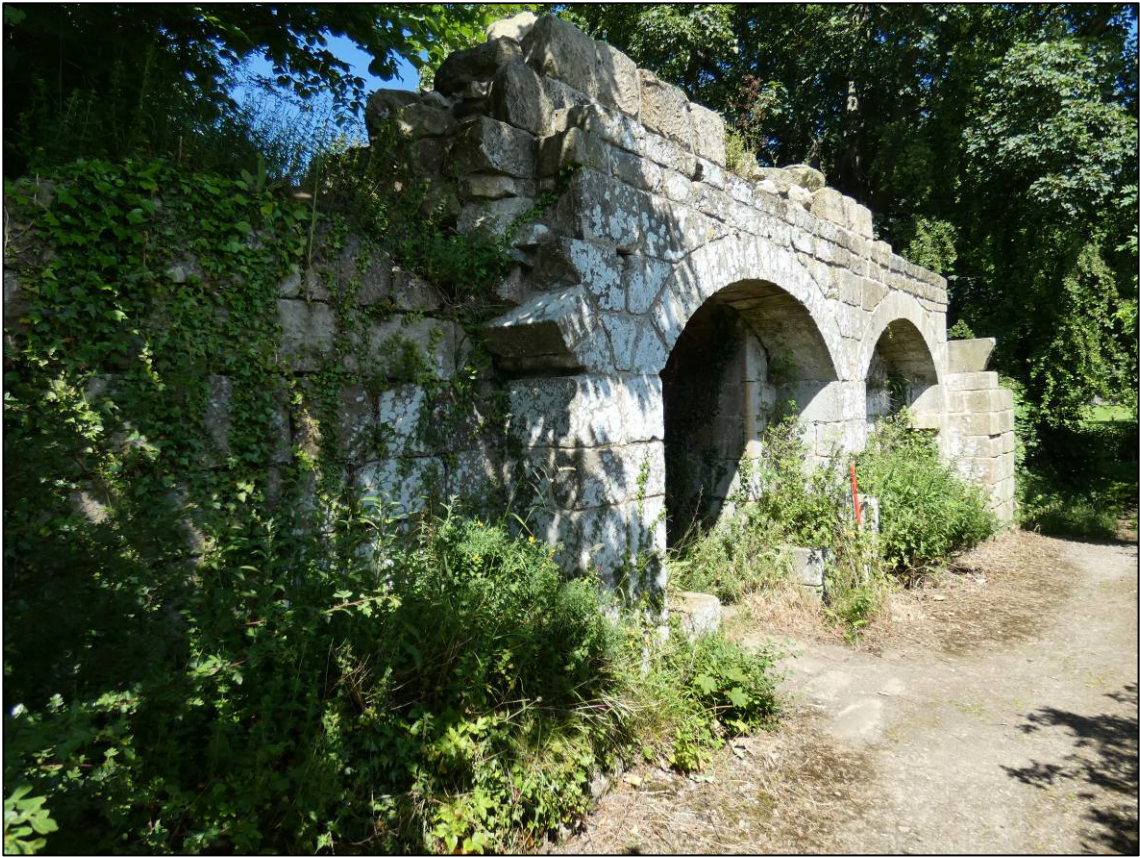
Plate 49: Area 16: Vestry, south internal elevation of north wall, before clearance, looking NE (photo 1/390).

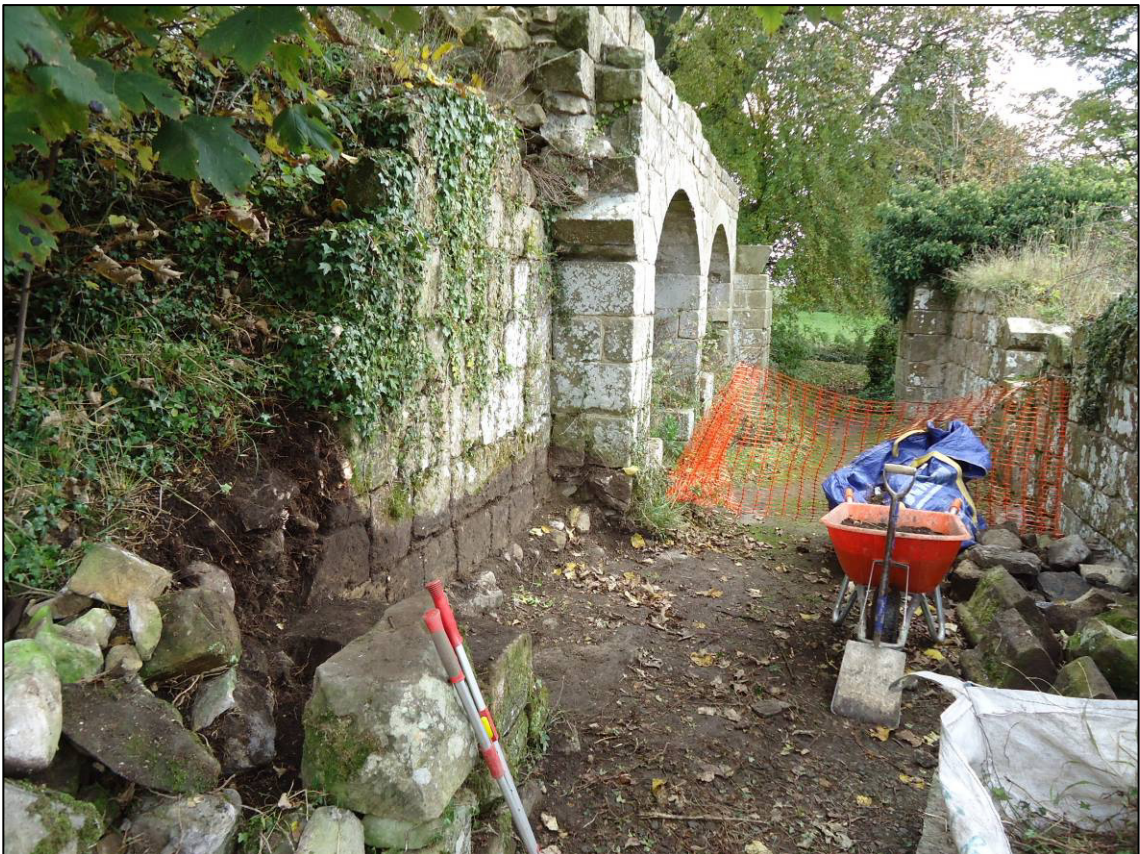
Plate 50: Area 16: Vestry, south internal elevation of north wall, during repair, looking NE (photograph courtesy Peter Pace).

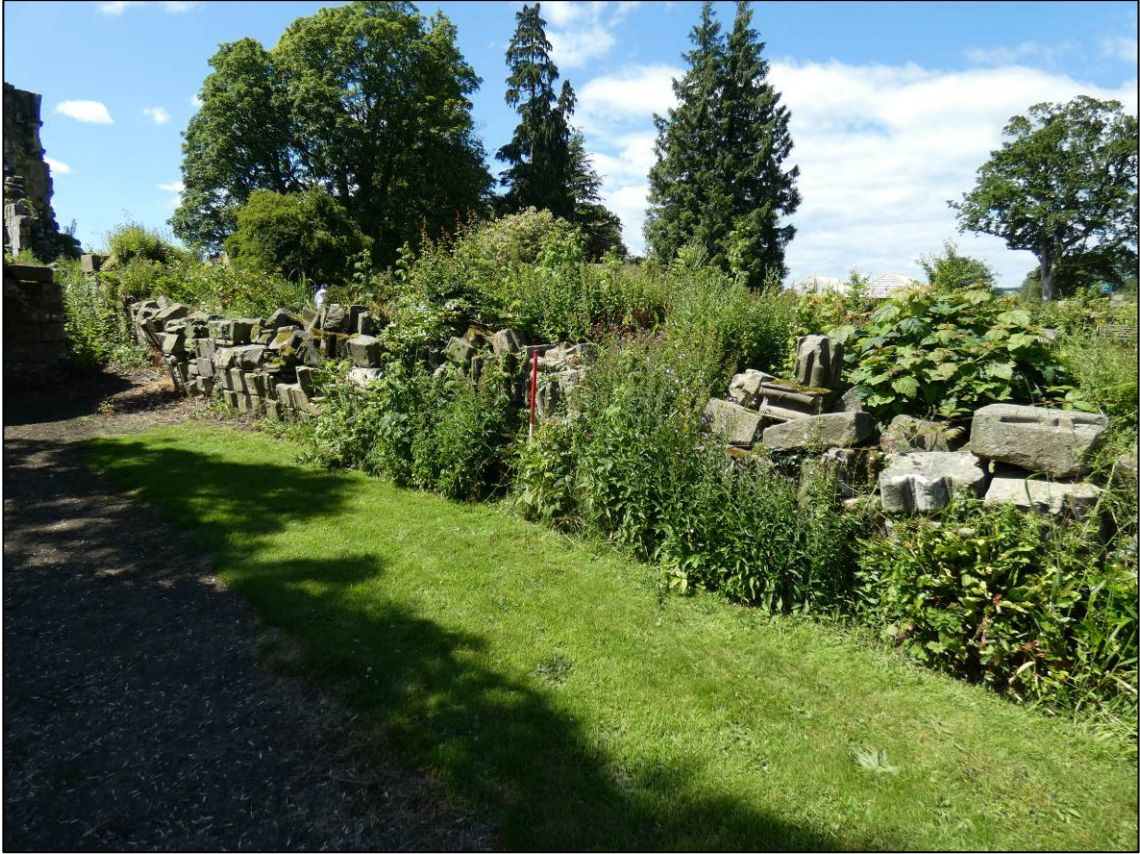
Plate 53: Area 18: Abbey church, lay brothers' quire, south external elevation of south wall (central part), before clearance, looking NW (photo 1/368).

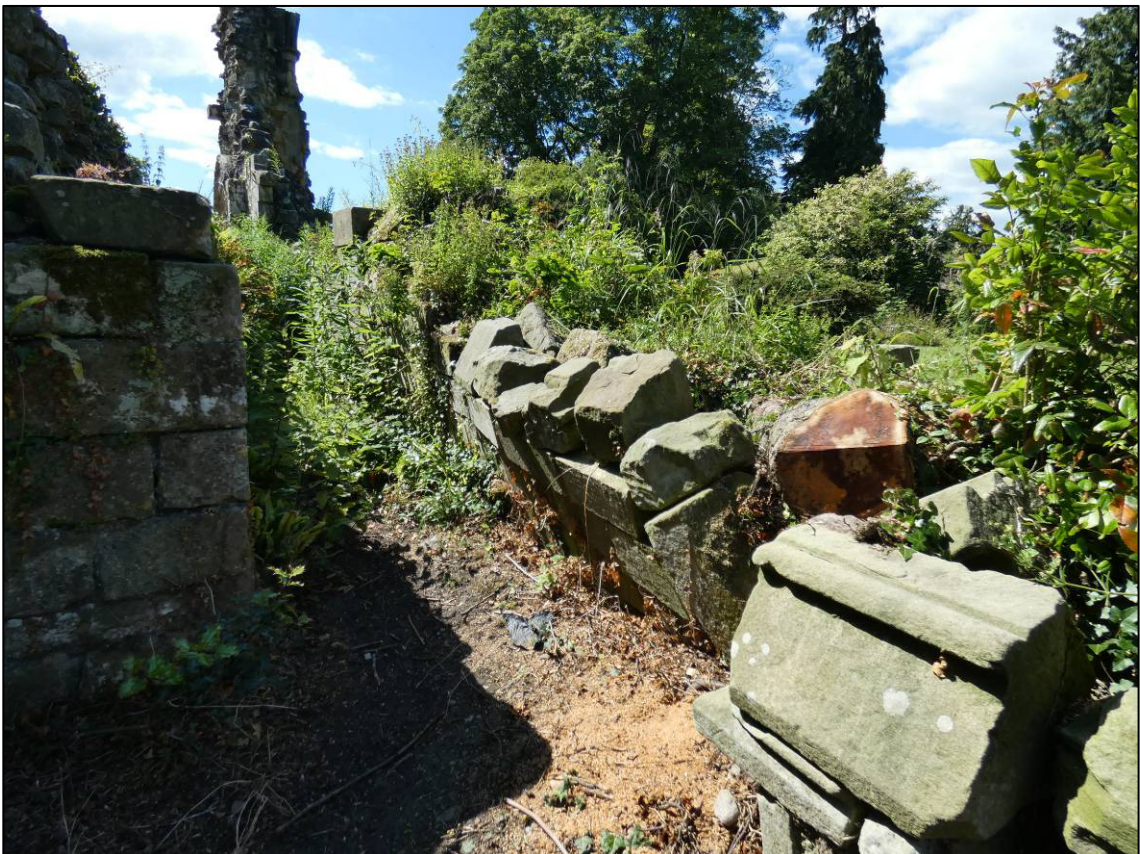
Plate 54: Area 18: Abbey church, lay brothers' quire, south external elevation of south wall (west part), during clearance, looking NW (photo 1/402).

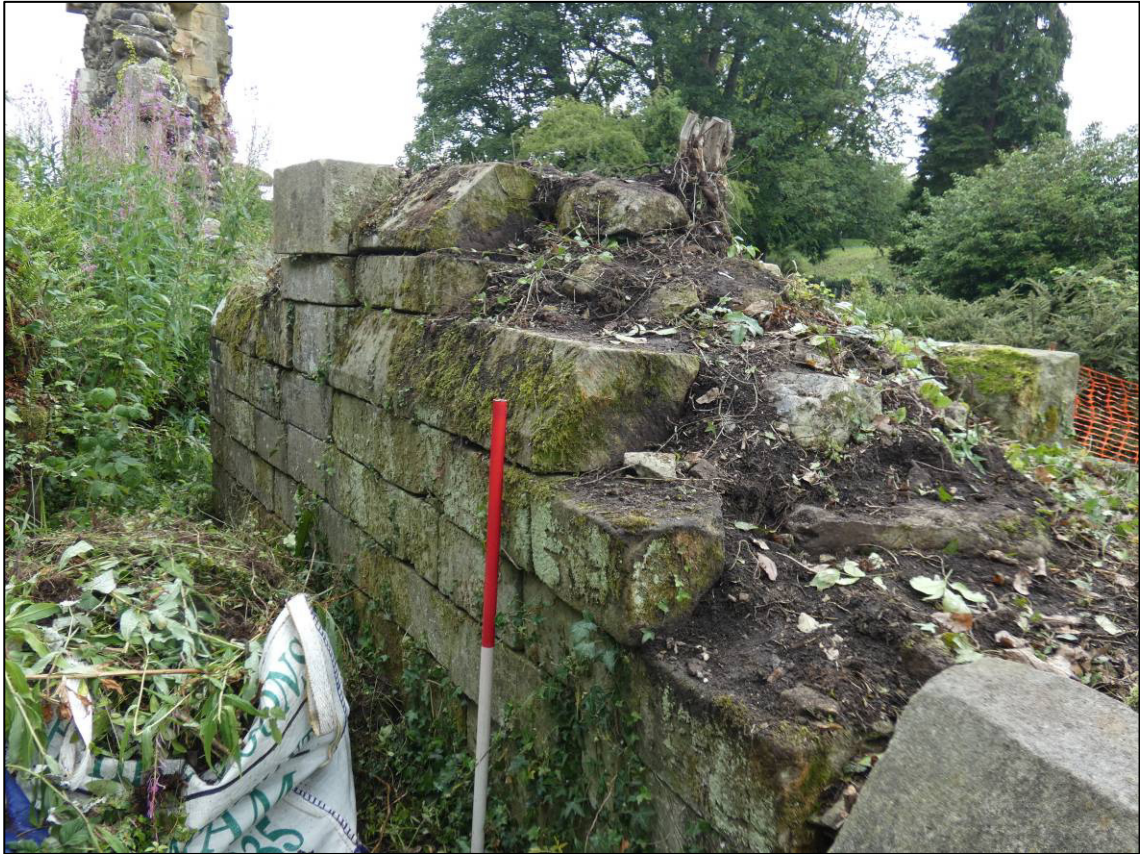
Plate 55: Area 18: Abbey church, lay brothers' quire, south external elevation of south wall, (west part) during clearance, showing base of window base, looking W (photo 2/473).

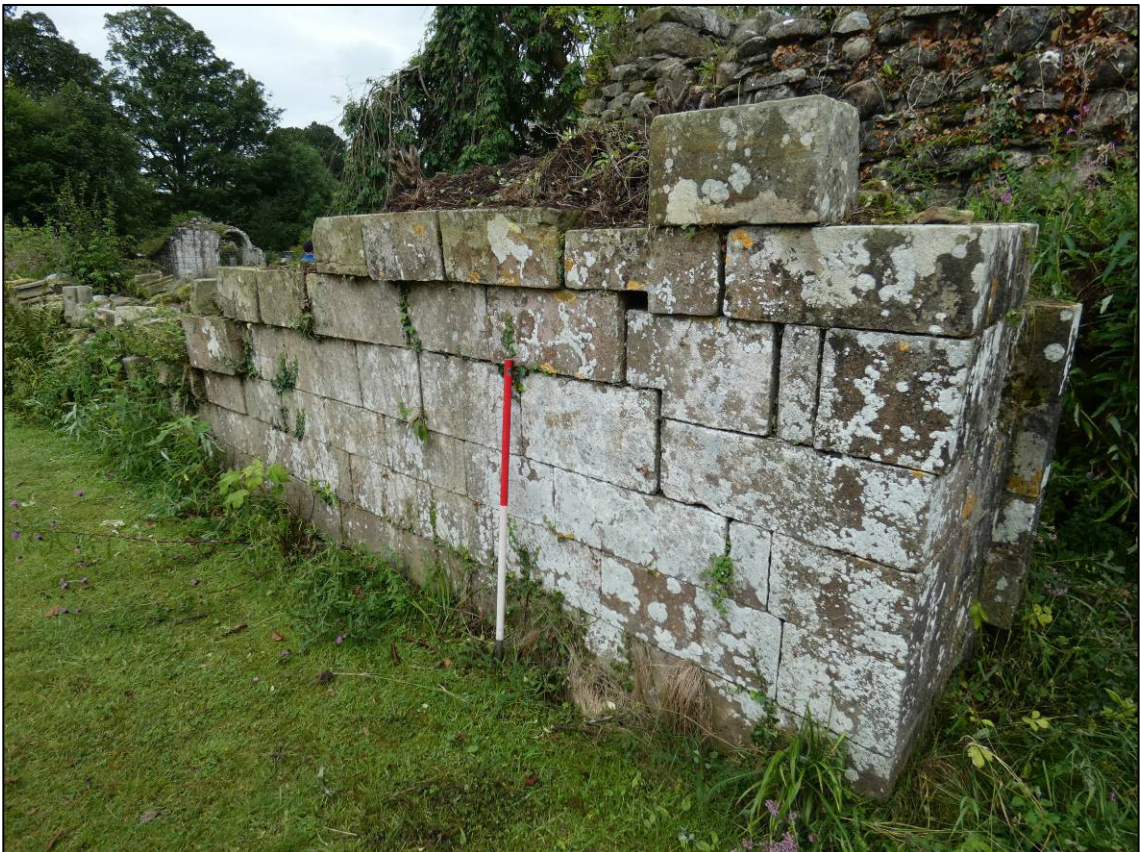
Plate 56: Area 18: Abbey church, lay brothers' quire, north internal elevation of south wall (west part), during clearance showing doorway opening, looking SE (photo 2/475).

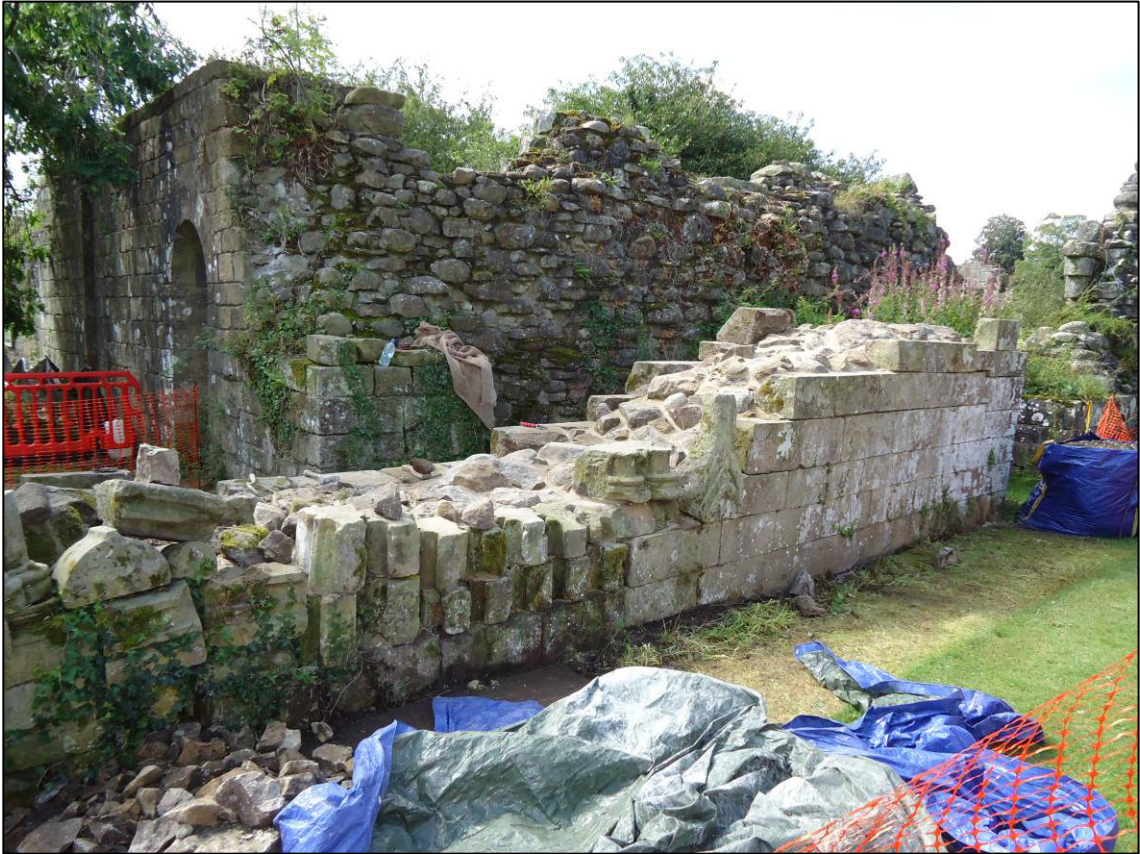
Plate 57: Area 18: Abbey church, lay brothers' quire, north internal elevation of south wall (west part), during repair, looking SW (photograph courtesy Peter Pace).

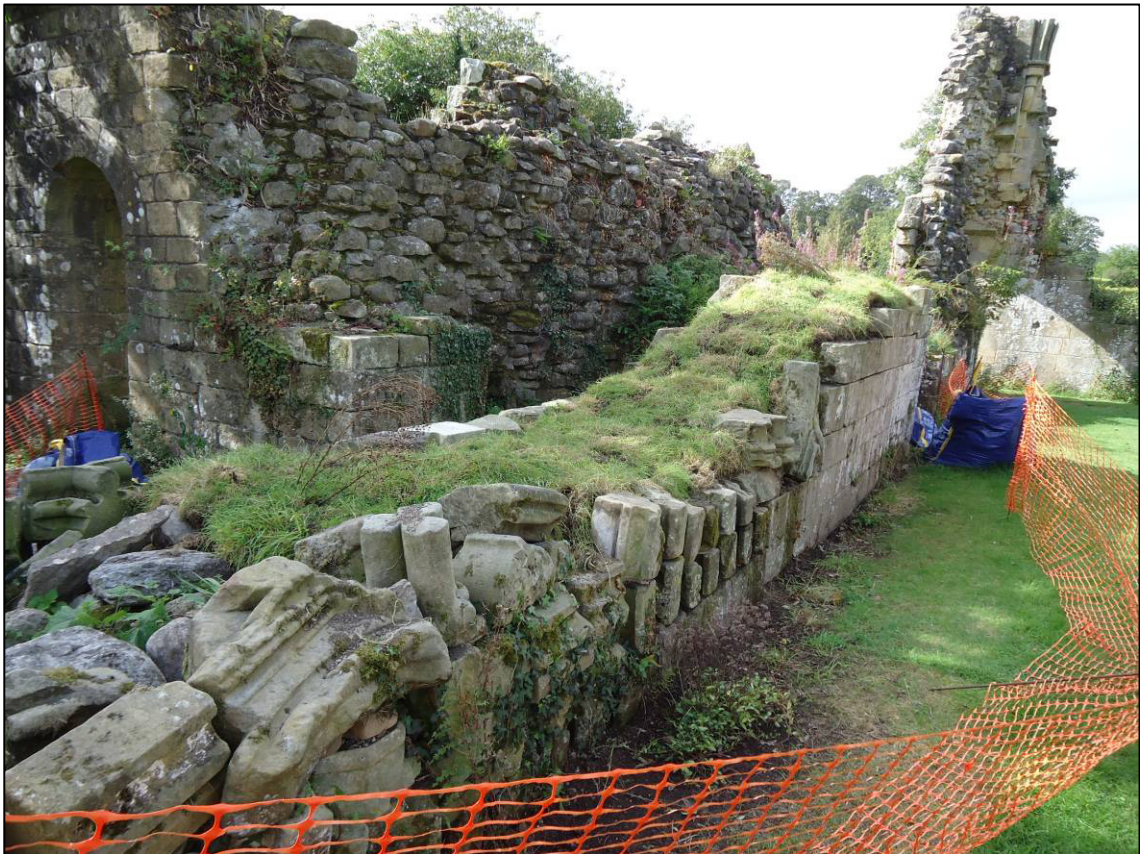
Plate 58: Area 18: Abbey church, lay brothers' quire, north internal elevation of south wall (west part), after repair, looking SW (photograph courtesy Peter Pace).

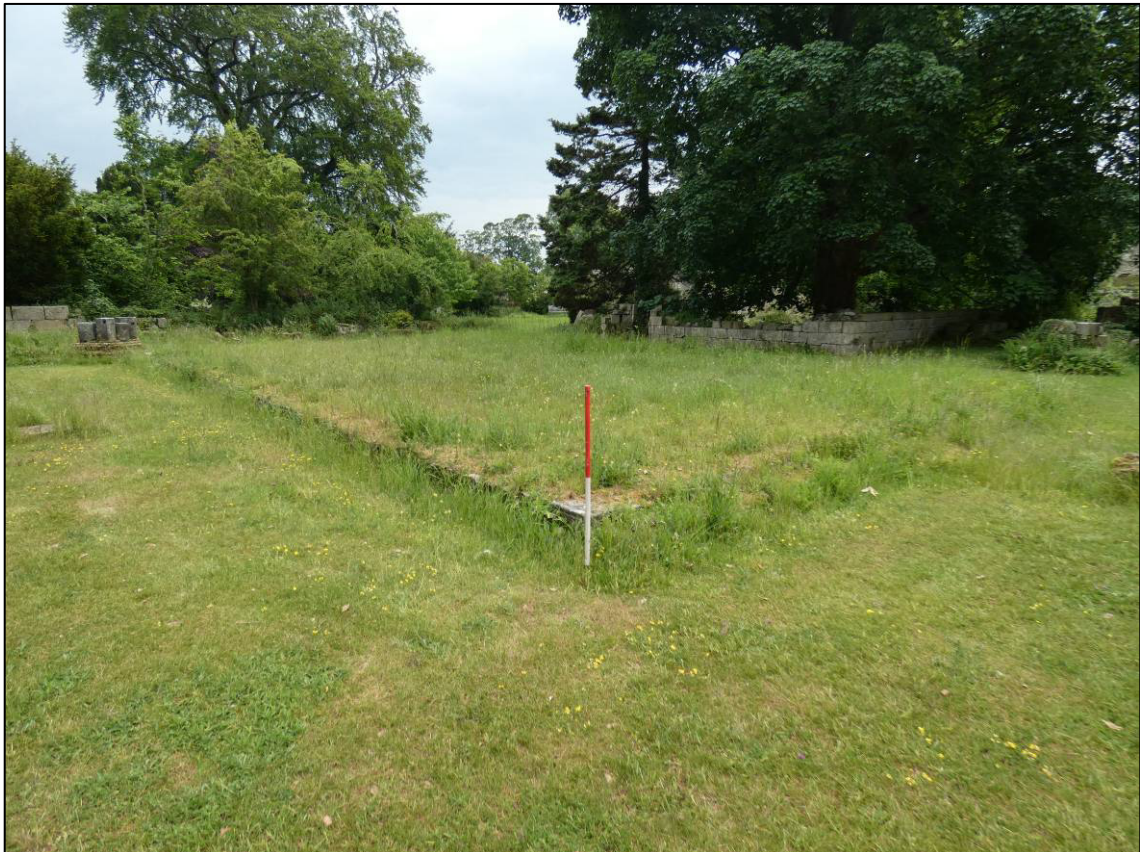
Plate 60: Area 19: Abbey church, central crossing platform, before repair, looking SE (photo 5/615).

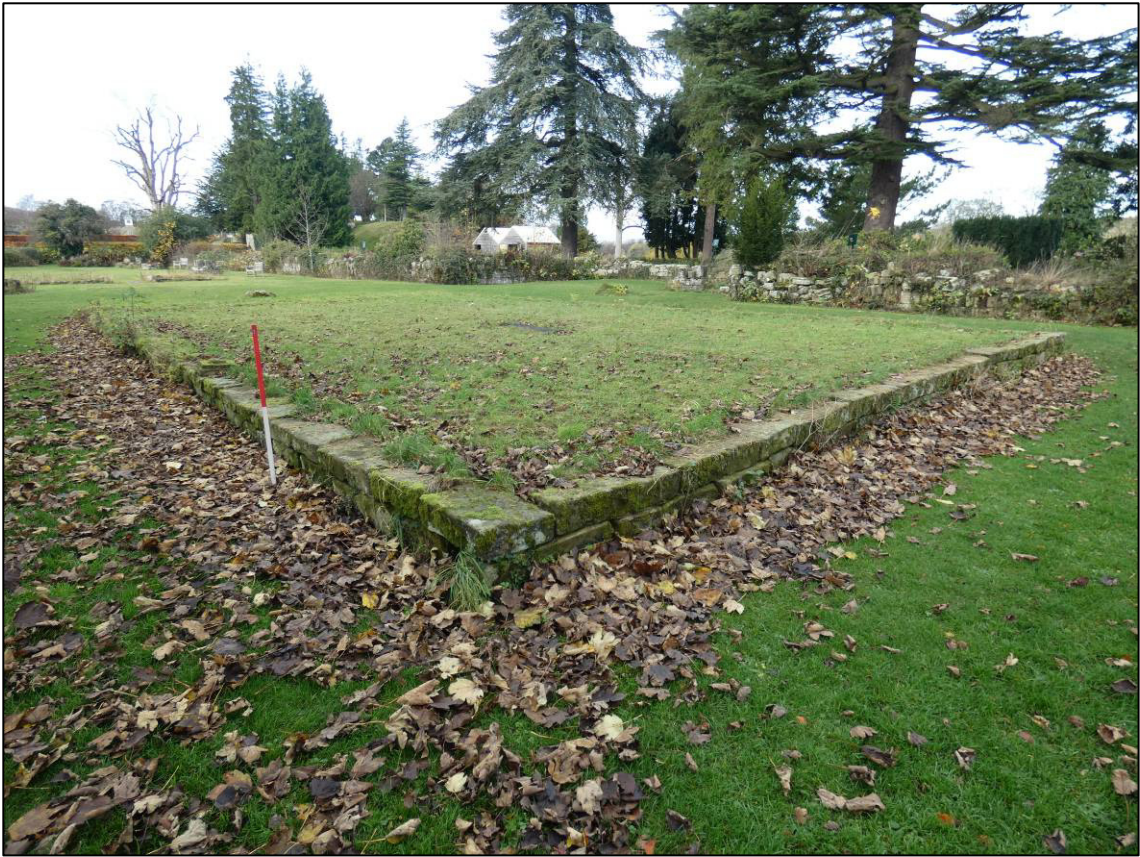
Plate 61: Area 19: Abbey church, central crossing platform, after repair, looking NW (photo 7/613).

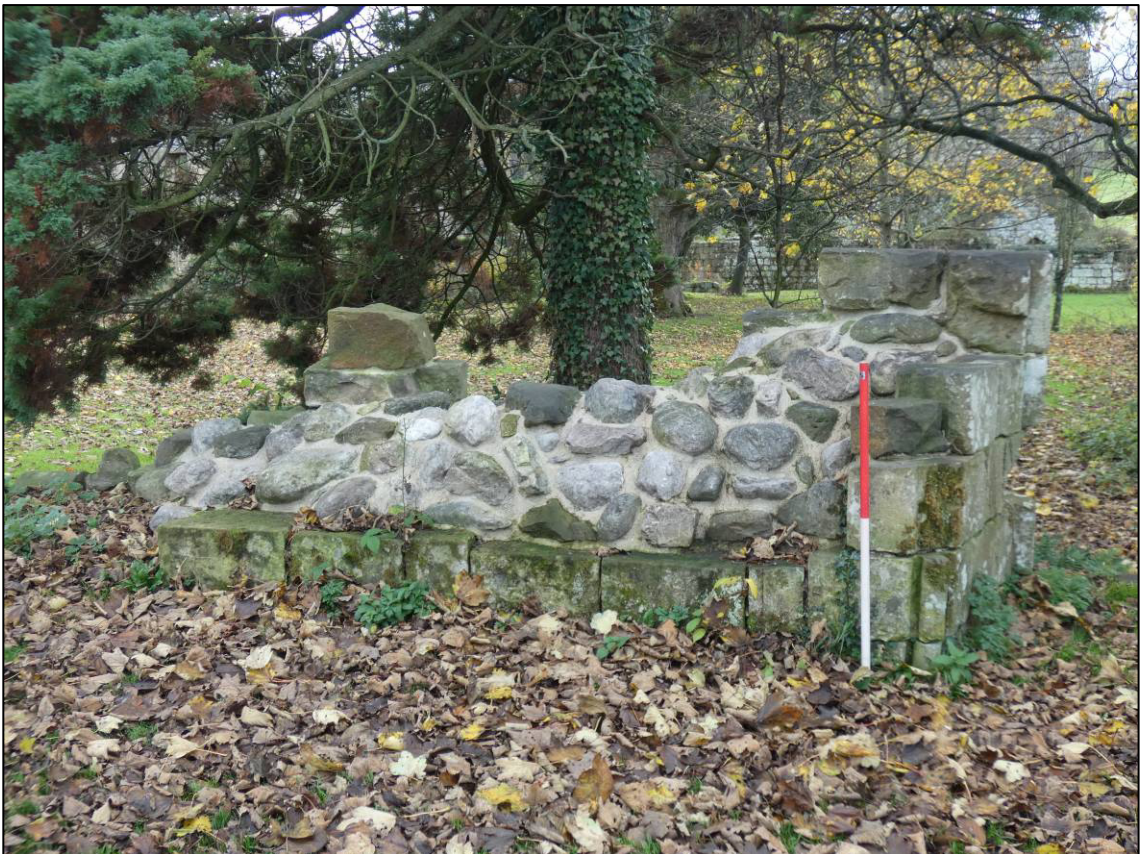
Plate 62: Area 19: Abbey church, presbytery, south internal elevation of south wall, after repair, looking S (photo 7/612).
