ST HELEN'S CHURCH,
BARMBY ON THE MARSH, EAST YORKSHIRE

ARCHAEOLOGICAL OBSERVATION,
INVESTIGATION AND RECORDING

Report no: 2021/635.R01
Version: Final
Date: October 2021
Author: Ed Dennison, Shaun Richardson & Richard Coates

Friends of Friendless Churches
St Ann's Vestry Hall
1 Church Entry
London
EC4V 5HB

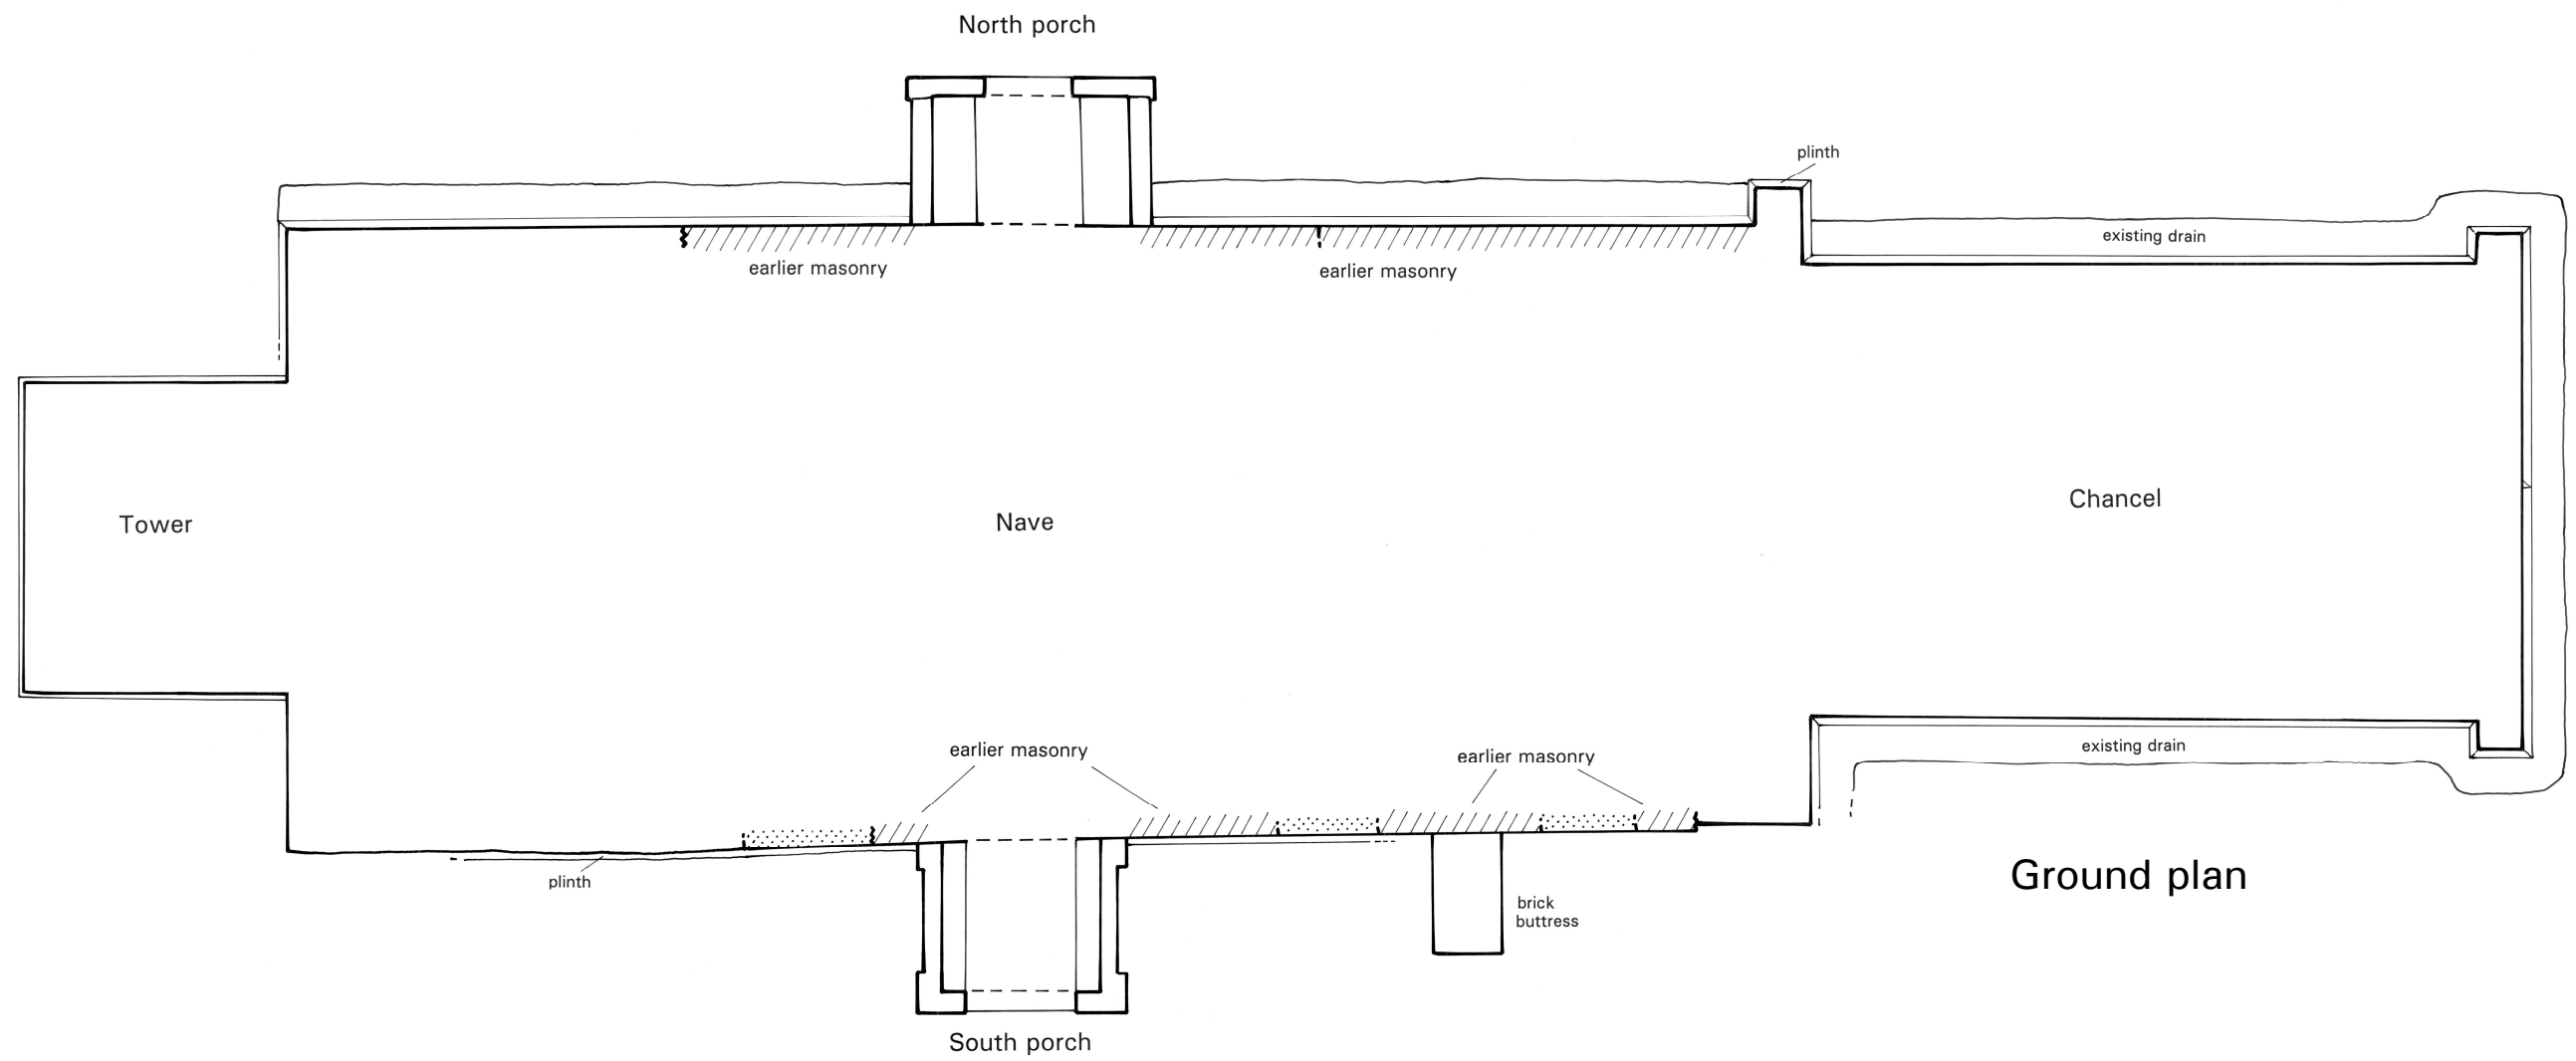
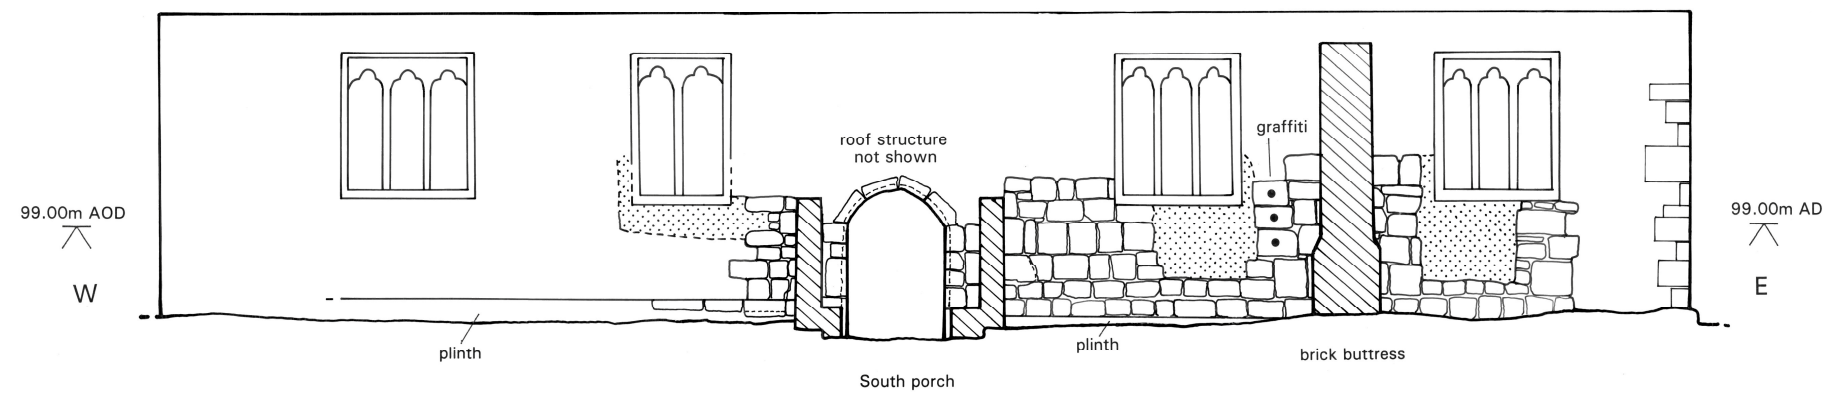
- 5.5 The south elevation of the nave was drawn at a scale of 1:50, as well as being photographed, as the earlier masonry here incorporates more recognisable structural features than on the north elevation. Much of the nave's south elevation also rises from a chamfered plinth, although towards the west end of the elevation, it appears to have been cut back and the wall face rendered over. It is also noticeable that, in plan, this part of the nave's south wall does not appear to run quite parallel to the opposite, north, wall. The plinth is set at a slightly higher position to the west of the south porch than to the east, and, where the wall face below the plinth is visible, it is constructed from rubble.

- 5.6 For c.12m of the elevation, either side of the south porch, there are what appear to be the remains of an earlier, smaller nave structure. As with the north elevation, much of this is built from dressed limestone blocks (including Magnesian limestone), generally neatly coursed, rising to c.1.80m above the top of the chamfered plinth, but additionally incorporating several openings blocked with rubble. Above the limestone blocks, and to the west end of the elevation, the nave is built of roughly coursed rubble; at the east end, it is built of very similar small coursed limestone as that seen to the chancel, and so it is assumed that this part of the nave was also rebuilt in 1870-71. The limestone blocks only extend c.0.55m to the west of the south porch, but below the window here there may be an opening blocked with rubble which is at least 1.65m wide; the base of the opening is set c.0.75m above the chamfered plinth (see plate 8).

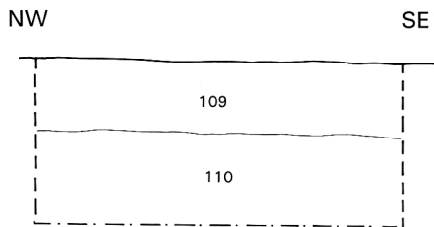
Section 5: north side of Trench 6

- 5.19 The excavation of Trench 6 was also monitored. It started at the west end of Trench 4 and ran west for c.11.00m, following a slightly curvilinear route and turning north at the western end to join an existing salt-glazed drainage pipe (see plate 19). The trench was an average 0.40m wide and was excavated to a maximum depth of 0.45m BGL at the western end.
- 5.20 The uppermost deposit encountered, forming the ground surface at between c.99.77m and 99.80m AD, was the same loose dark grey sand topsoil (109) with few inclusions, typically 0.20m thick, as seen in Trench 5; this deposit also contained some fragments of disarticulated animal bone and modern pottery and tile. It again overlay a loose mid-dark brown silty sand subsoil (110), at least 0.25m thick, which continued below the base of the trench (see Section 5 on figure 6).

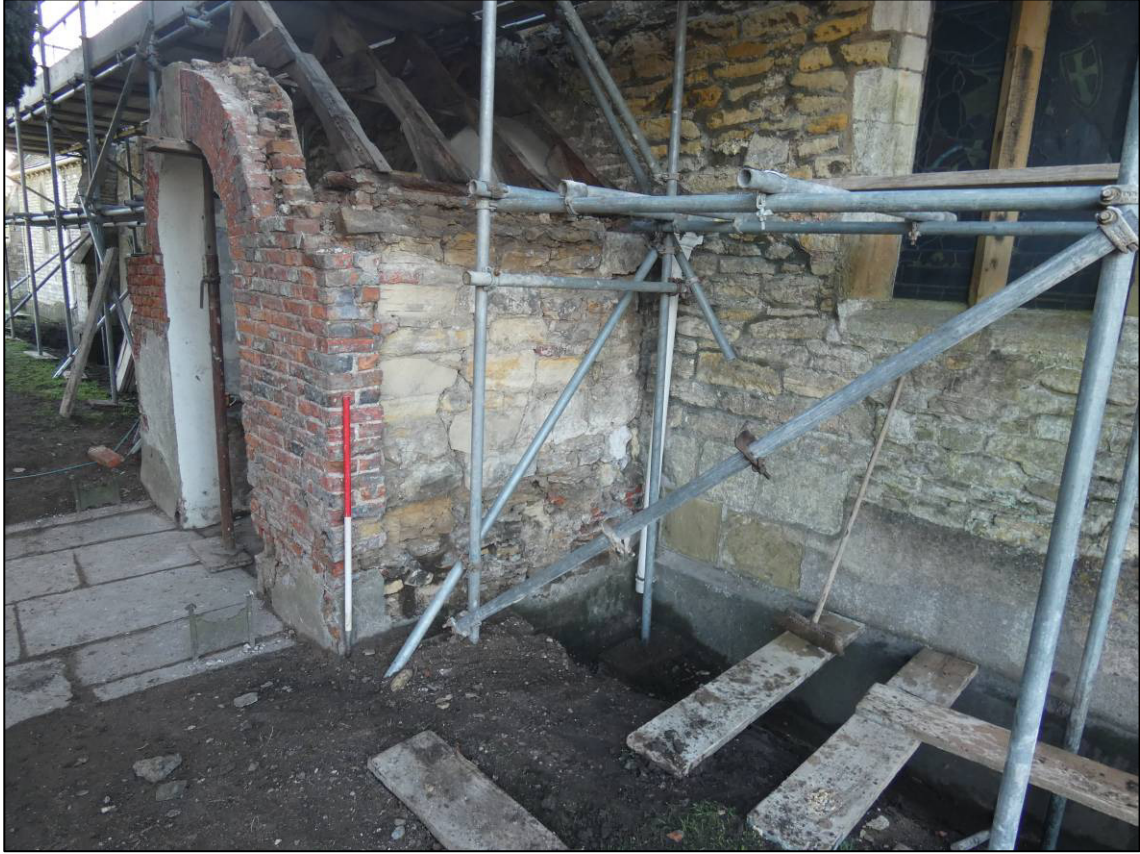
Plate 5: North porch after removal of stucco plaster, showing different fabrics, looking SE.

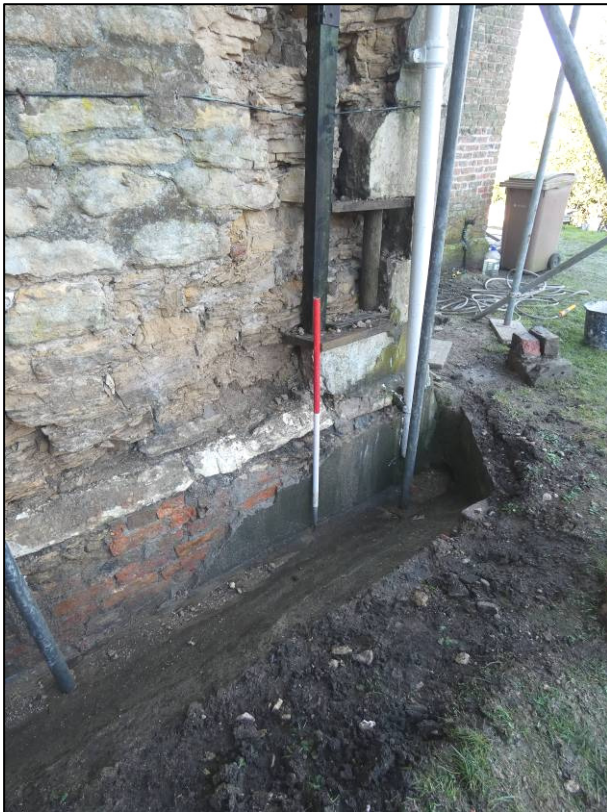
are dressed limestone blocks (including Magnesian limestone) rising to c.1m above the top of the chamfered plinth; above the blocks, the elevation is generally built of less-well squared rubble. The limestone blocks are sometimes well coursed, although often they are not (see plate 4). Some 2.10m to the east of the north porch, there appears to be a straight joint within the dressed blocks. The removal of the stucco plaster to the north porch, built in 1785, also revealed some interesting detail. The front of the porch is of brick, although the west and east sides are built of both rubble and pieces of dressed stone (see plate 5); presumably the front has a brick 'skin' because it is the more visible elevation through which people entered and left the church. To the west of the porch, the limestone blocks rise on average to c.0.50m above the chamfered plinth. They appear to end c.2.80m to the west of the porch, where there may be a staggered joint. At the west end of the elevation, where render has been removed or fallen off, the plinth can be seen to be of brick, beneath the chamfer (see plate 6).

Plate 6: Brick plinth at west end of nave, looking SW.

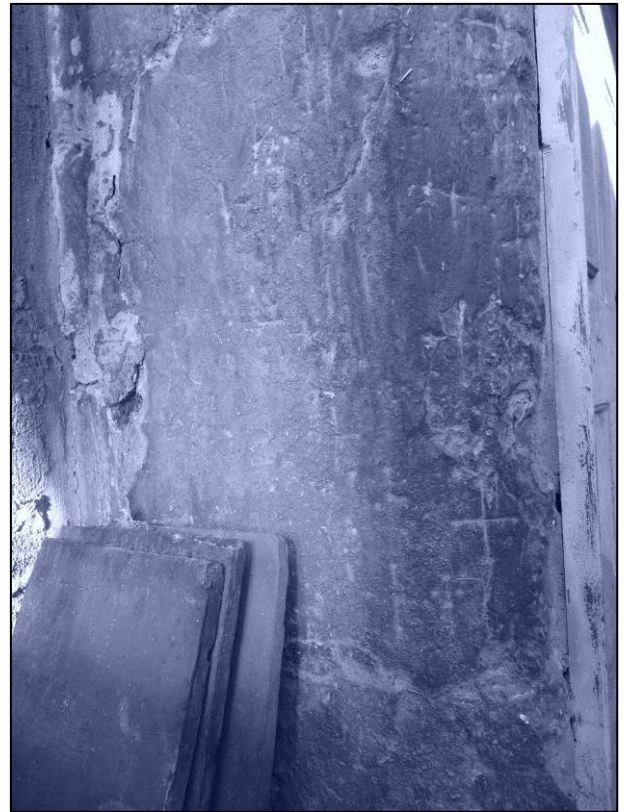
- 5.7 The south porch, built in 1785, is built completely of brick (see plate 9). It covers an earlier doorway with a segmental head - the quoins to the west jamb of the doorway retain a number of carved crosses (see plate 7). Such crosses are often found around the south door or porch of a church, and are fairly ubiquitous in terms of their distribution throughout the country; no clear interpretation for their presence has been found, although they may well be associated with recording agreements or ceremonies, or the movement of people and burials through the church doorway (Champion 2015, 63-69).

Plate 7: Carved crosses to west jamb of south doorway within porch, looking N.

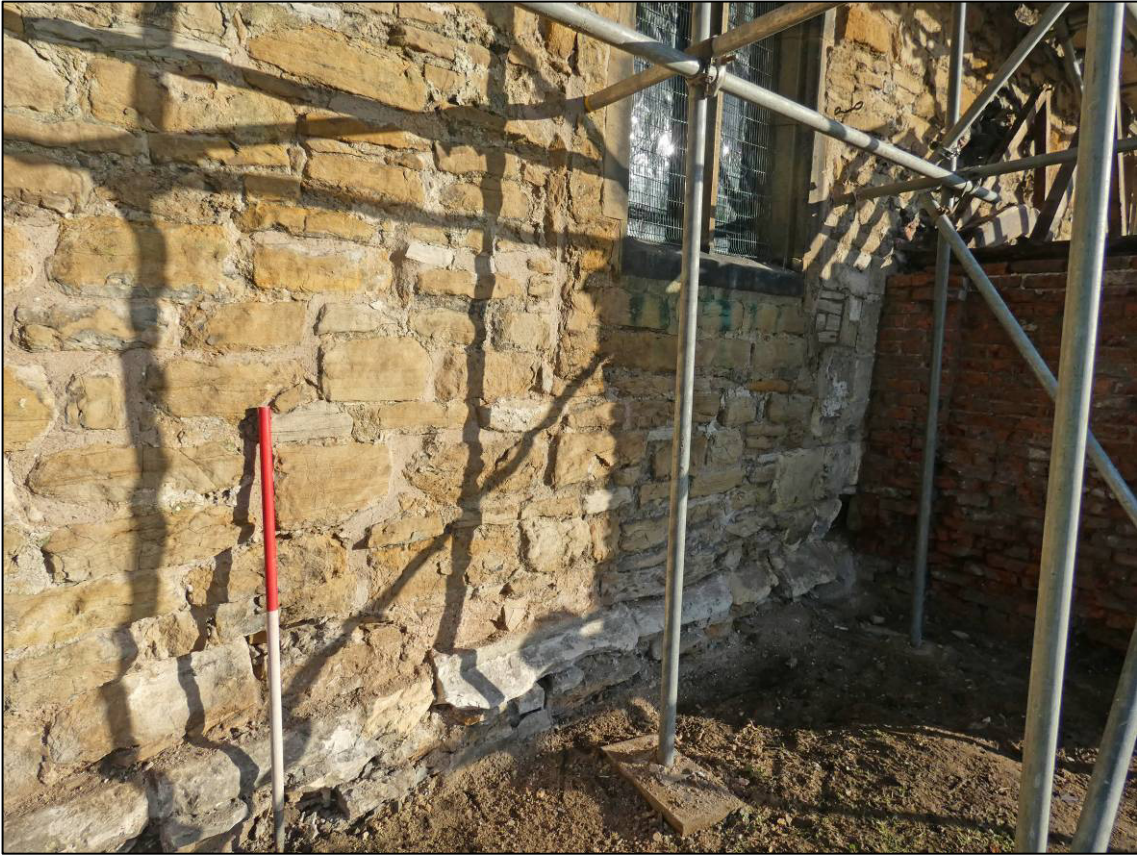
Plate 8: Earlier masonry and blocked opening to south wall of nave, west of south porch, looking NE.

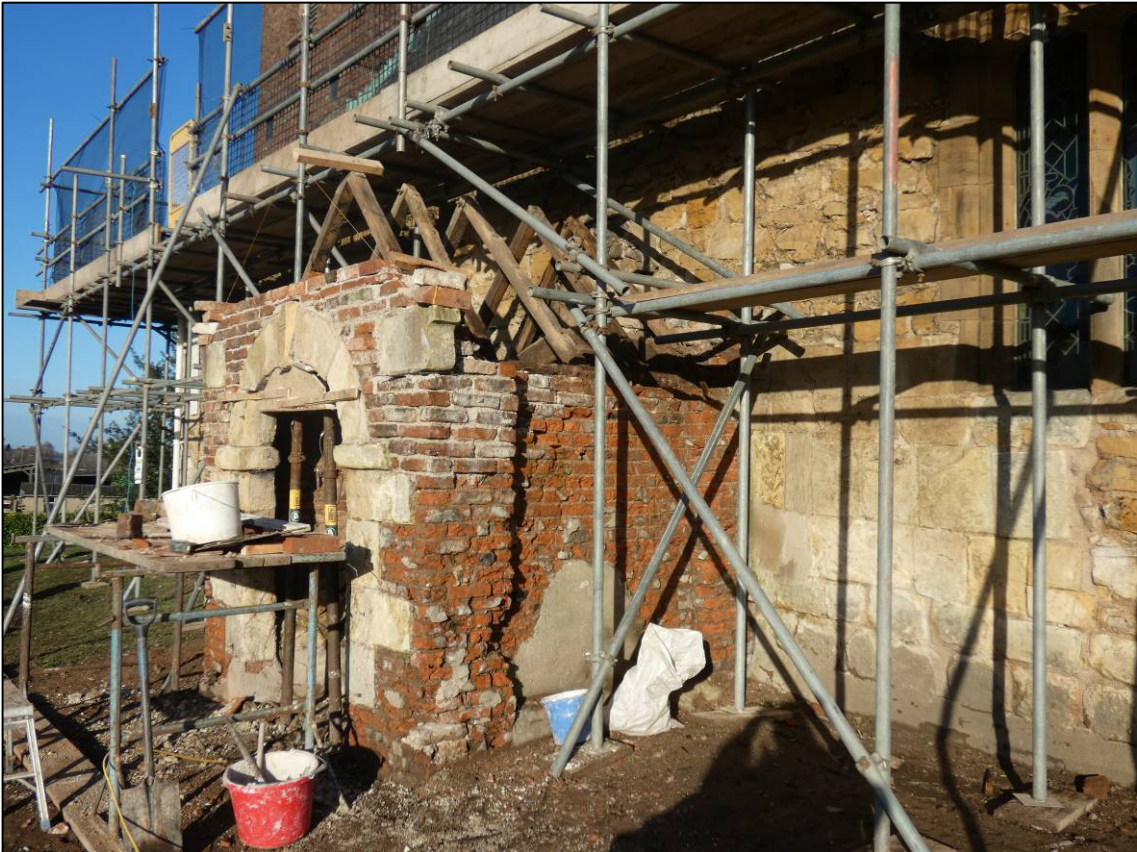
Plate 9: South porch, with stucco removed and undergoing repair, looking NW.

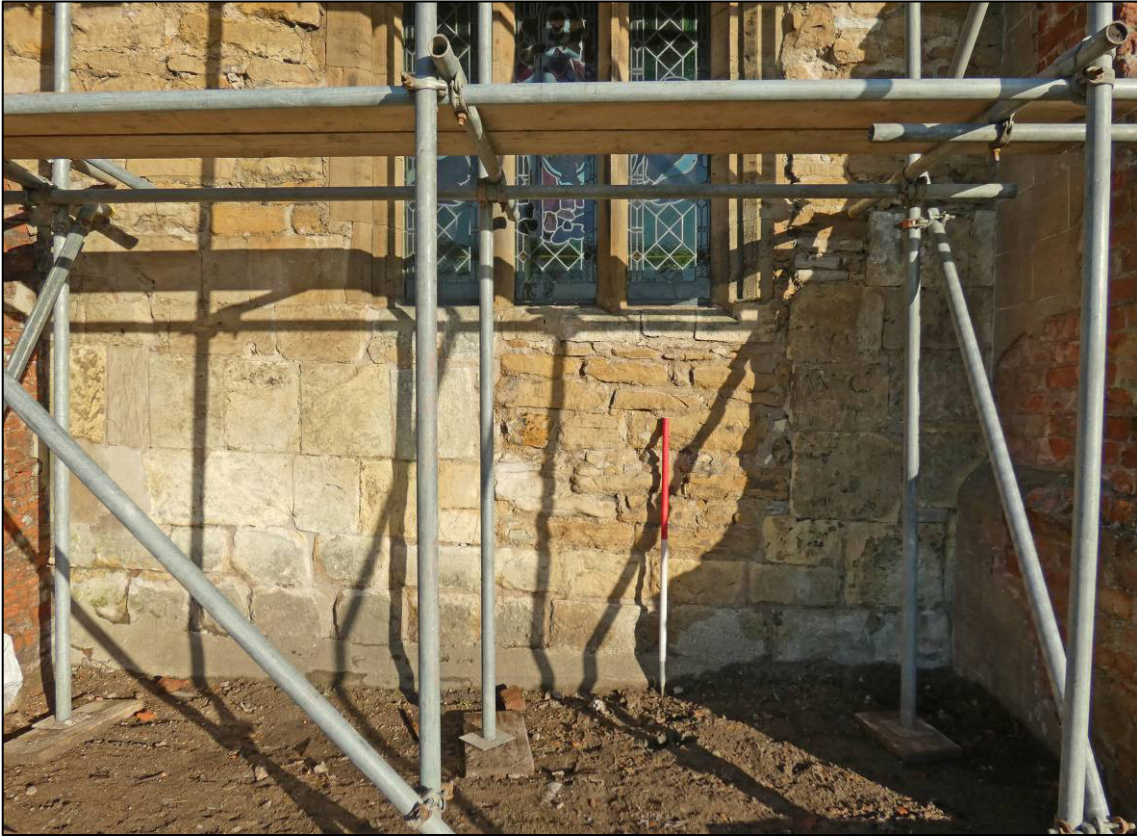
- 5.8 To the east of the porch, the limestone blocks of the south wall of the nave contain two openings, blocked with rubble, set beneath the existing windows either side of a later brick buttress; the blocked openings have an average width of 1.25m, with bases set c.0.50m above the chamfered plinth (see plates 10 and 11). The three stones forming the east jamb of the western opening retain much graffiti, almost all in the form of initials, none of which appears significantly earlier than the late 18th or 19th centuries. Some of the graffiti that can be read are 'G Comb 1830', 'W G', 'E B', 'I W' and 'J P', although most are now illegible (see plate 12).

Plate 10: Earlier masonry and blocked opening to south wall of nave, east of south porch, looking N.

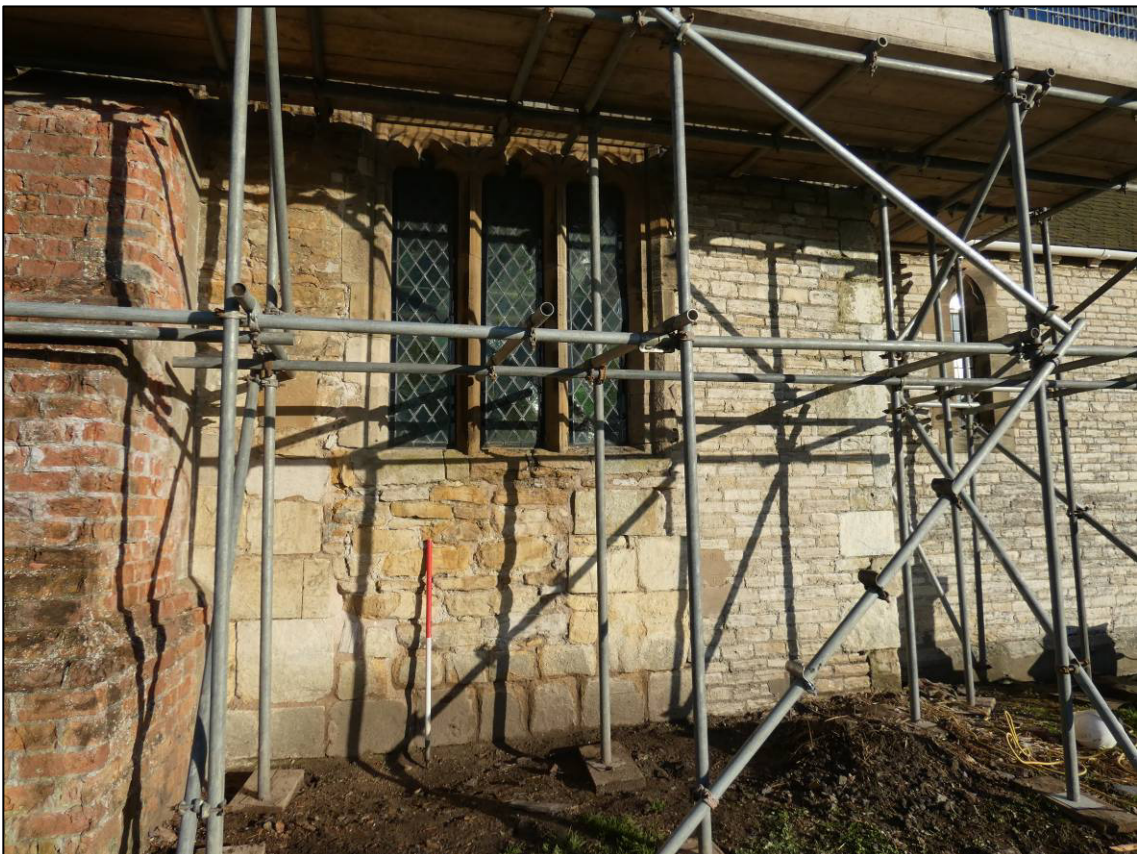
Plate 11: Earlier masonry and blocked opening to south wall of nave, east of brick buttress, looking N.

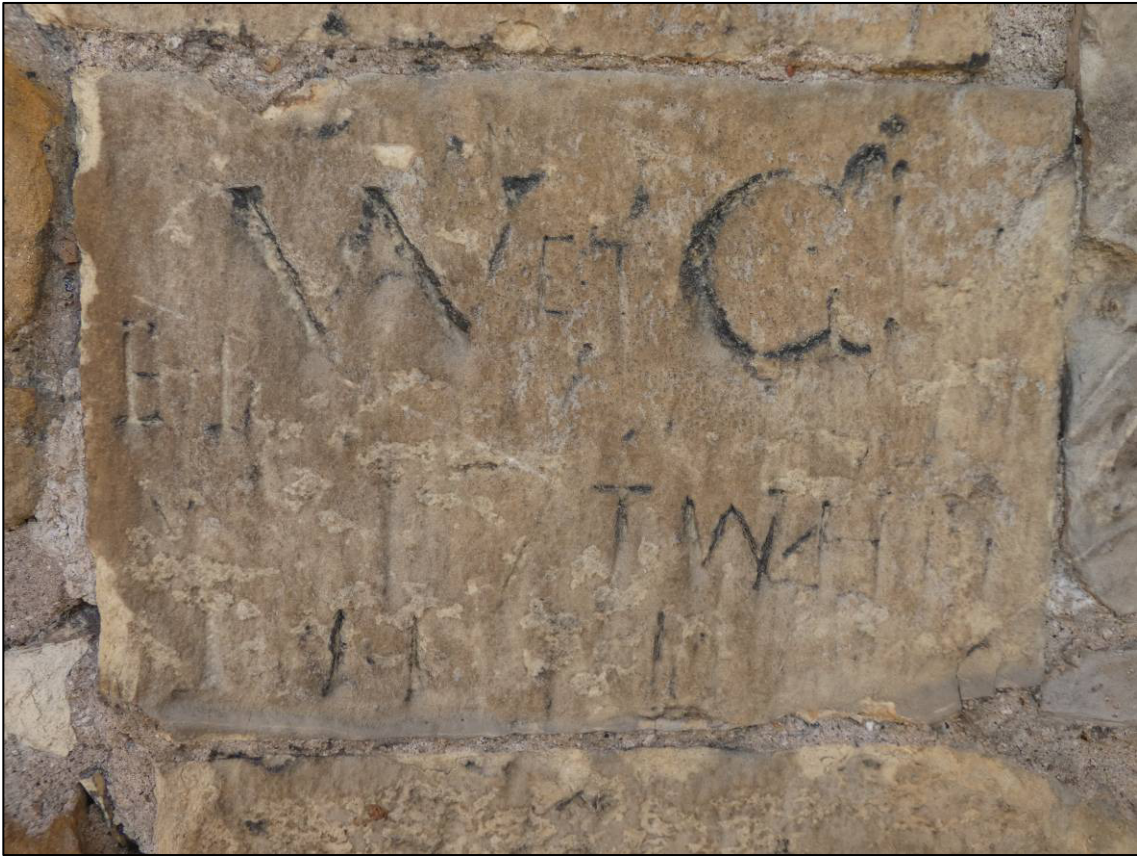
Plate 12: Graffiti on earlier masonry to south wall of nave, east of south porch, looking N.

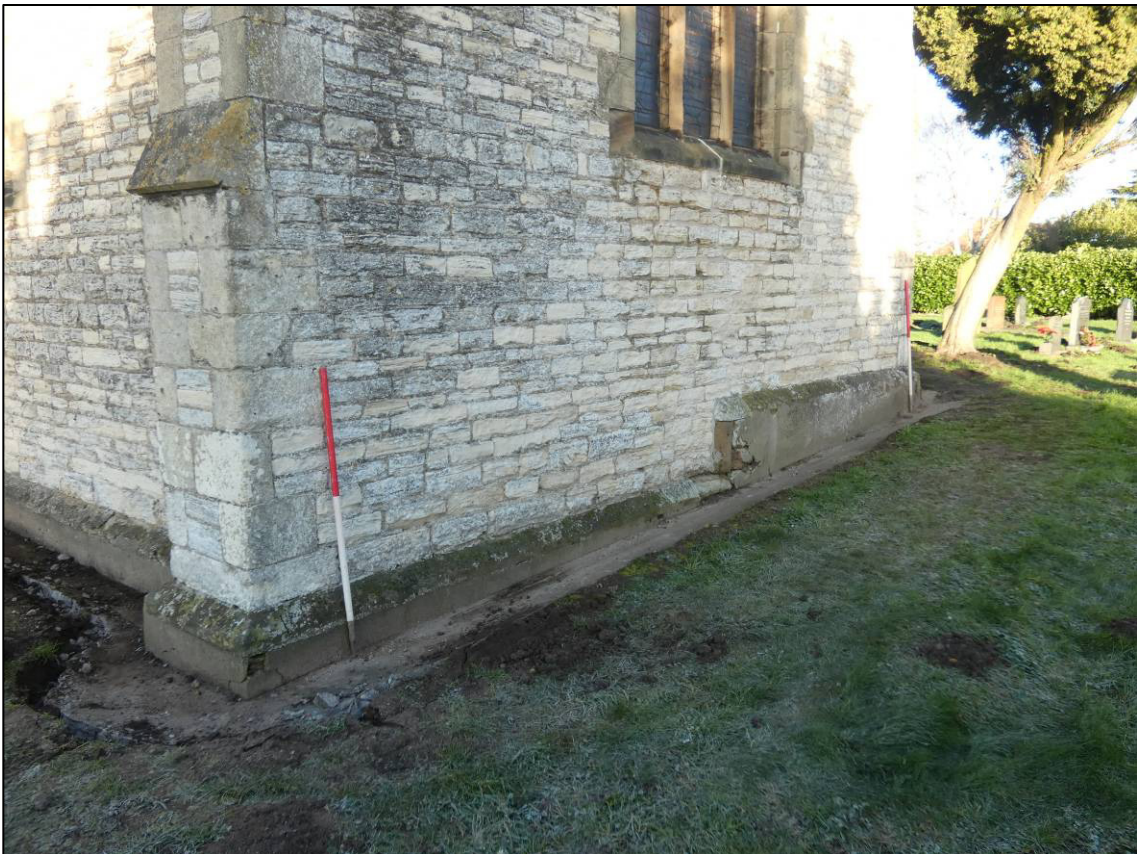
- 5.9 Prior to the start of the watching brief, the majority of the areas where the drains were to be excavated were formed by narrow, concave, concrete surfaces which sloped down towards existing surface drains (see plate 13). These were broken out and removed before any excavation could take place. However, to the west of the south porch, the alignments of two trenches (Trenches 5 and 6) were to be excavated through a grassed surface. There was little overall variation in the ground level around the church - at the north-west corner of the nave, it was 100.03m AD, at the south-west corner of the nave 99.89m AD, at the north-east corner of the chancel 100.40m AD and at the south-east corner of the chancel 99.72m AD; these heights are all relative to the 100m AD temporary bench mark placed outside the north porch. All the trenches were backfilled with gravel once the works had been completed.

Plate 13: Existing drainage channel along east side of chancel, looking NW.

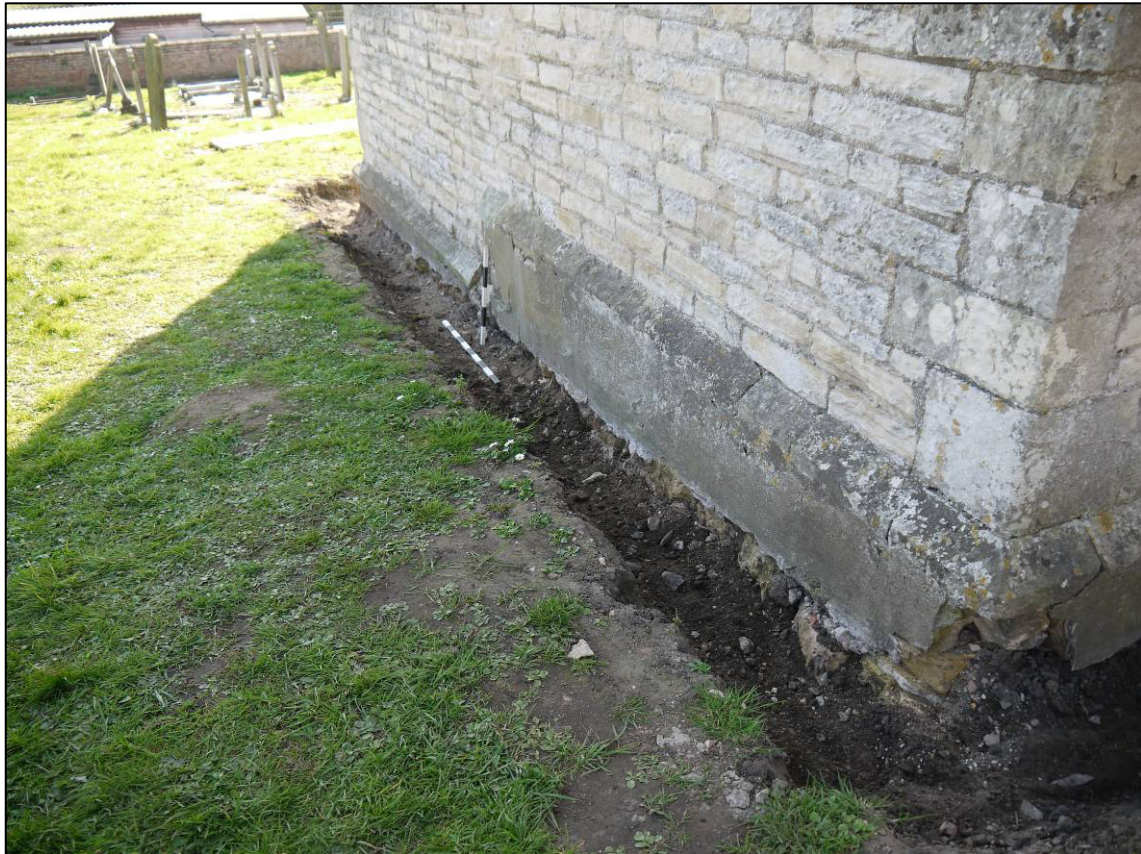
- 5.12 Trench 2 ran for 7.60m along the east wall of the chancel, its north and south ends connecting with Trench 1 and Trench 3 respectively; it was 0.40m wide and was excavated to a maximum depth of c.0.40m BGL. Once again, this trench was inspected immediately after excavation. The uppermost deposit, forming the ground surface at between 100.11m and c.99.72m AD, was the same loose dark grey-black friable clayey sand topsoil (101) seen in Trench 1, and this continued beyond the base of the trench (see plate 14).

Plate 14: Excavated drainage channel (Trench 2) along east side of chancel, looking SW.

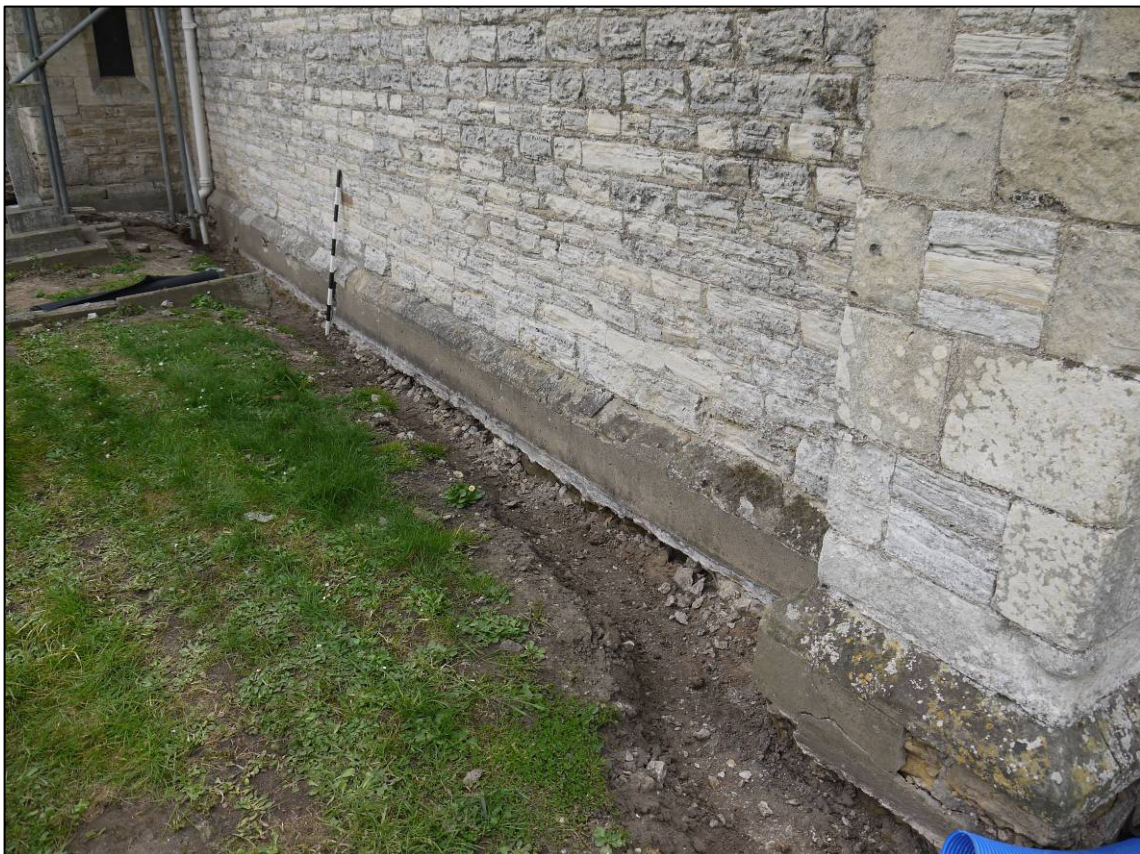
- 5.14 The uppermost deposit, forming the ground surface at an average of c.99.64m AD, was the same dark grey-black friable clayey sand topsoil (101) observed in Trenches 1 and 2 (see plate 15). This had an average depth of c.0.44m, and contained frequent building debris, occasional post-medieval and modern pottery, a small unmarked modern glass jar, and a very small assemblage of disarticulated animal and human bone fragments. At the west end of the trench, an existing salt-glazed drain ran along the southern return; this was subsequently removed. In this area, the previously cement-rendered limestone rubble footings (105) and underlying sandstone footings (106) of the south wall of the chancel were revealed, and the slightly greater depth of excavation showed that they were bedded on a layer of firm yellow-brown clay (107), at least 0.14m thick, which extended below the base of the trench (see Section 2 on figure 6). At the south-east corner of the nave, the footings extended for a similar depth, but also projected outwards from the face of the plinth by c.0.40m (see Section 3 on figure 6) (see plate 16); the footings (106) extended to the base of the trench here and incorporated a large block of flint (108). It is possible that this projecting section represents the footings of the south-east corner of the nave or a buttress, before this area was re-built in 1870-71.

Plate 15: Excavated drainage channel (Trench 3) along south side of chancel, looking NW.

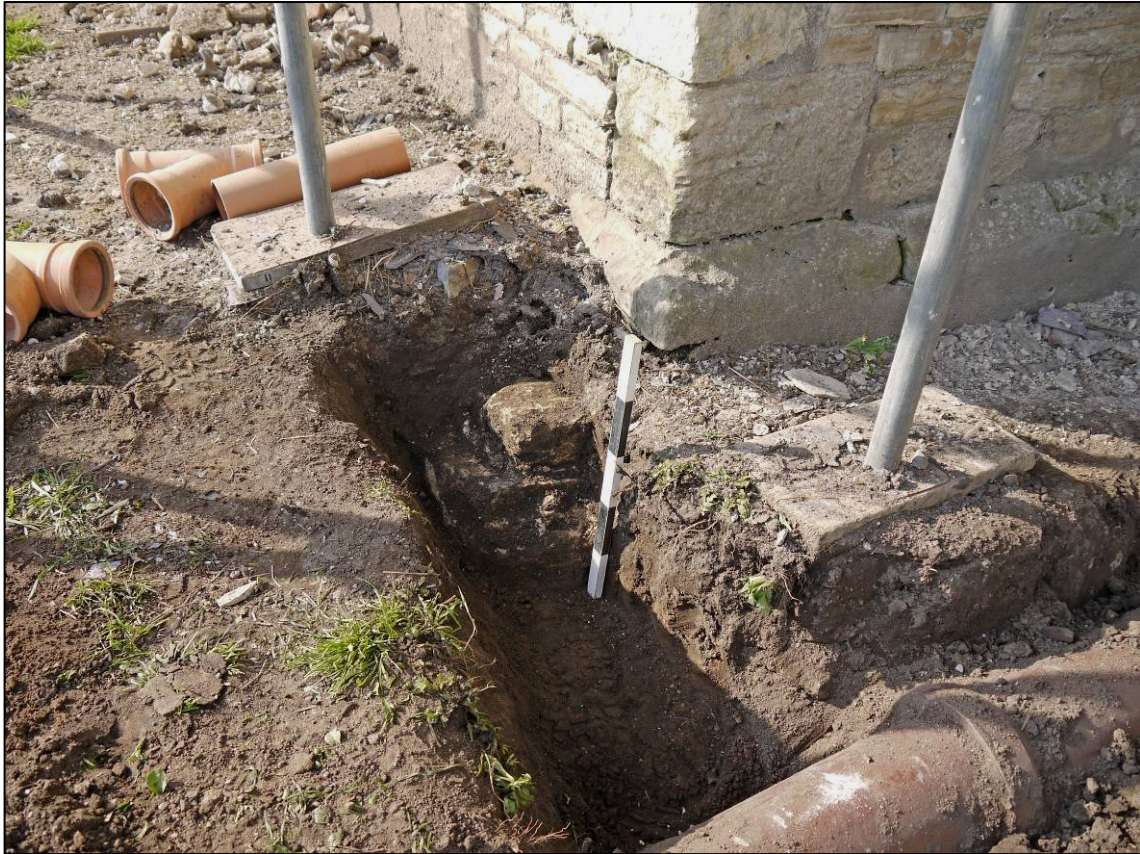
Plate 16: West end of Trench 3, showing projecting footings of south-east corner of nave (106), looking W.

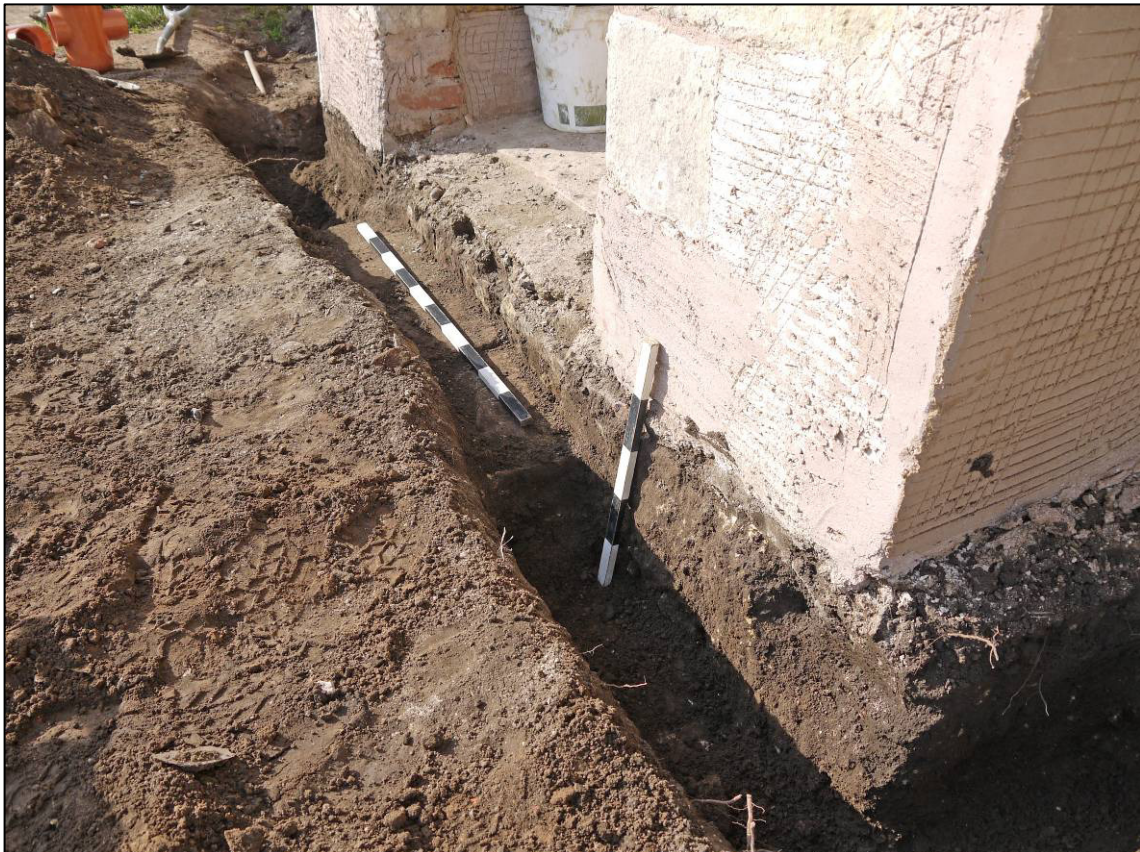
- 5.15 This trench was monitored as it was being dug. It had a total length of 3.20m and ran across the front of the south porch, before continuing west as Trench 6. The trench was 0.30m wide and was excavated to a maximum depth of 0.40m BGL.
- 5.16 The uppermost deposit encountered, forming the ground surface at an average of c.99.75m AD, was the same dark grey-black friable clayey sand topsoil (101) observed in Trenches 1, 2 and 3. In the north end of the trench, this deposit was at least 0.40m thick and continued below the base of the trench. Outside the south door, at a depth of 0.20m below ground level, were three dressed paving stones, 0.12m thick, which were laid over a consolidated deposit of dark grey-black clayey sand containing some small brick fragments and other building debris (112) (see plate 17).

Plate 17: Excavated Trench 4 in front of south porch, showing paving stones (112), looking NW.

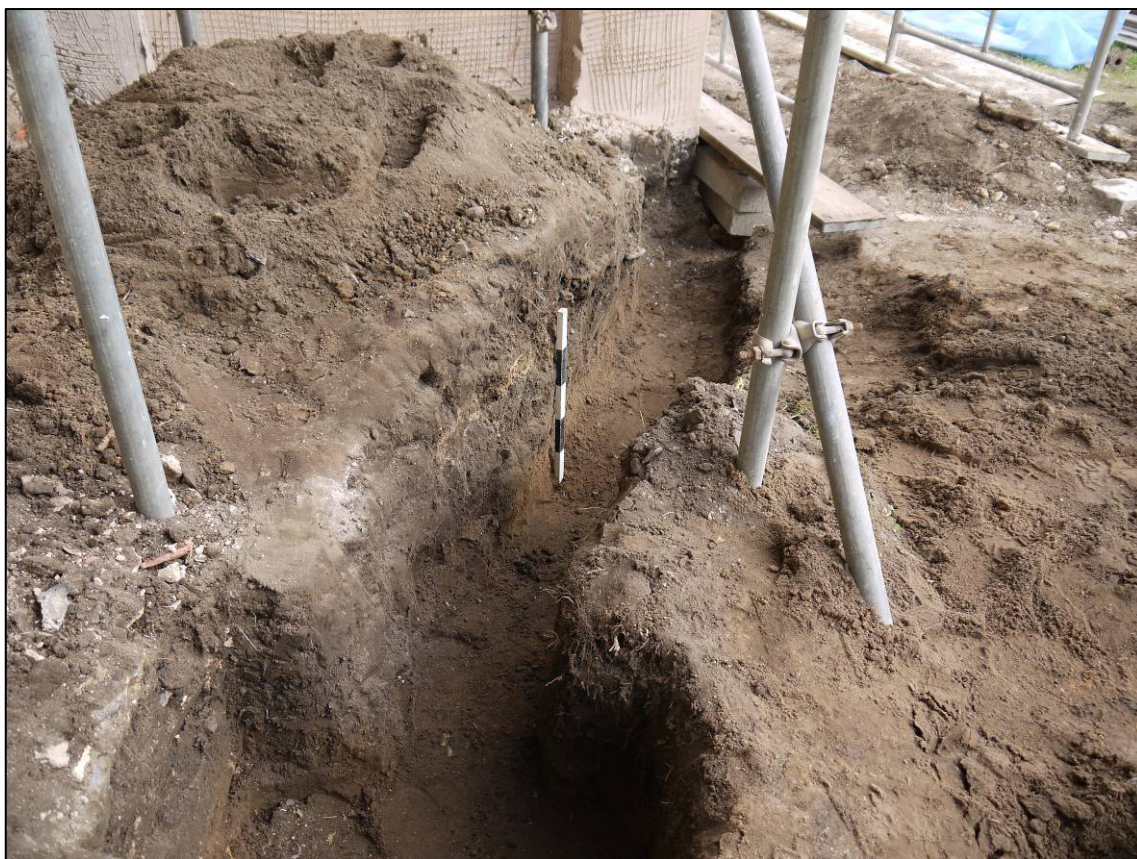
Plate 18: East end of excavated Trench 5, looking SE.

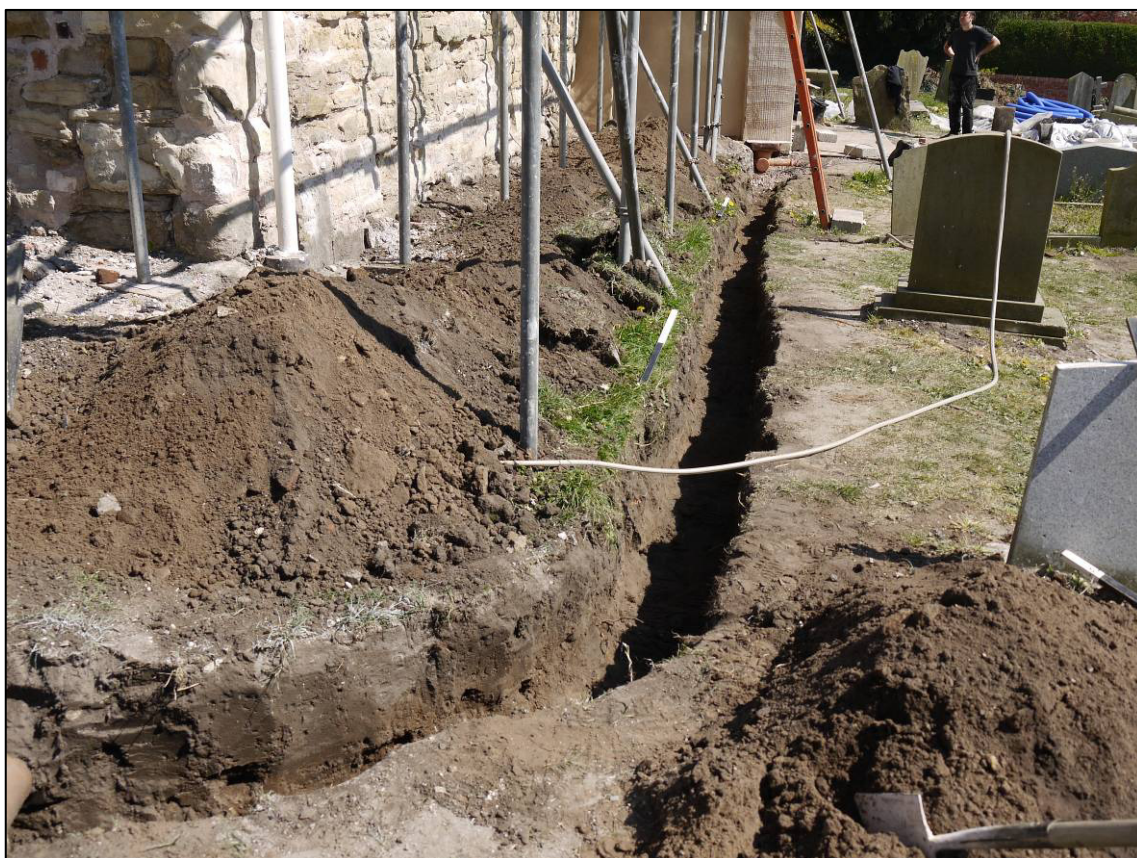
Plate 19: Excavated Trench 6, running west from south porch, looking E.
