THE OLD VICARAGE, STONEGATE,  
THORNE, DONCASTER DN8 5NP

HISTORIC BUILDING RECORDING  
AND ARCHAEOLOGICAL INVESTIGATION,  
OBSERVATION AND RECORDING

Report no: 2020/614.R01  
Version: Final  
Date: July 2022  
Author: Shaun Richardson & Ed Dennison

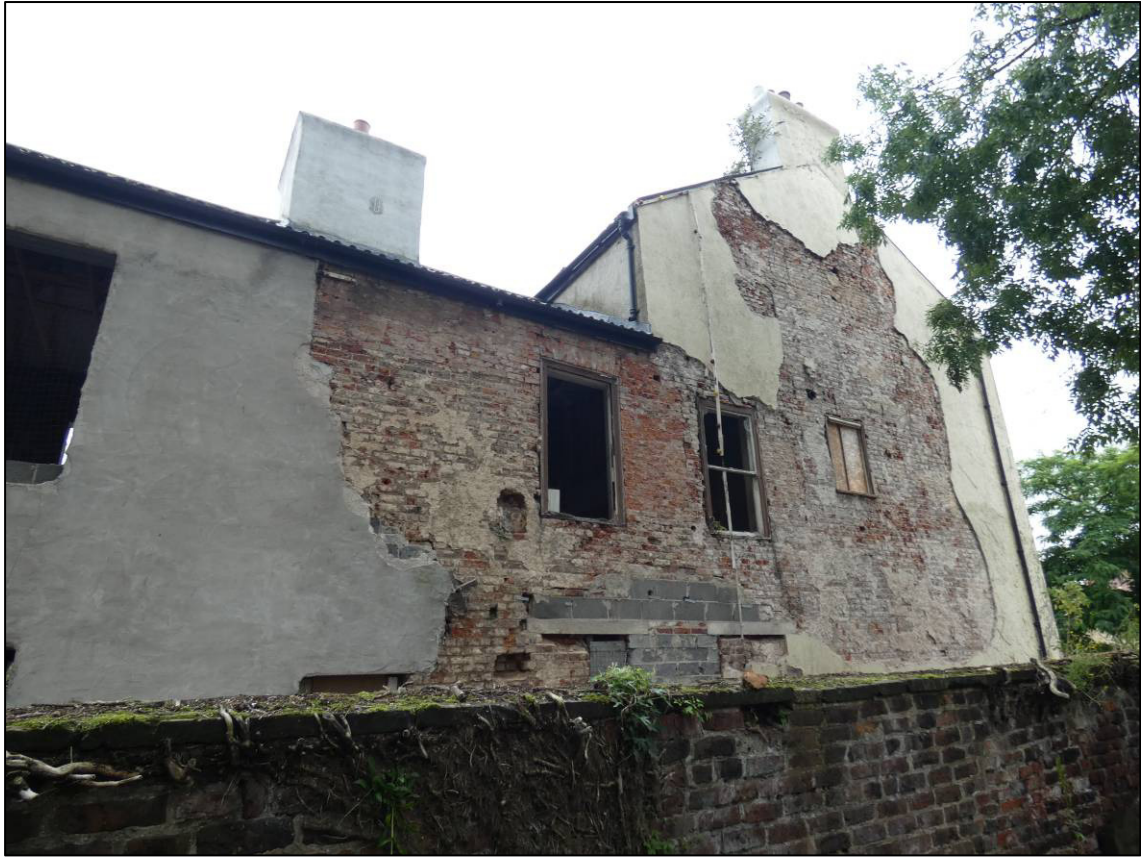
Plate 6: North elevation of rear wing, during removal of render, looking SW (photo 1/014).

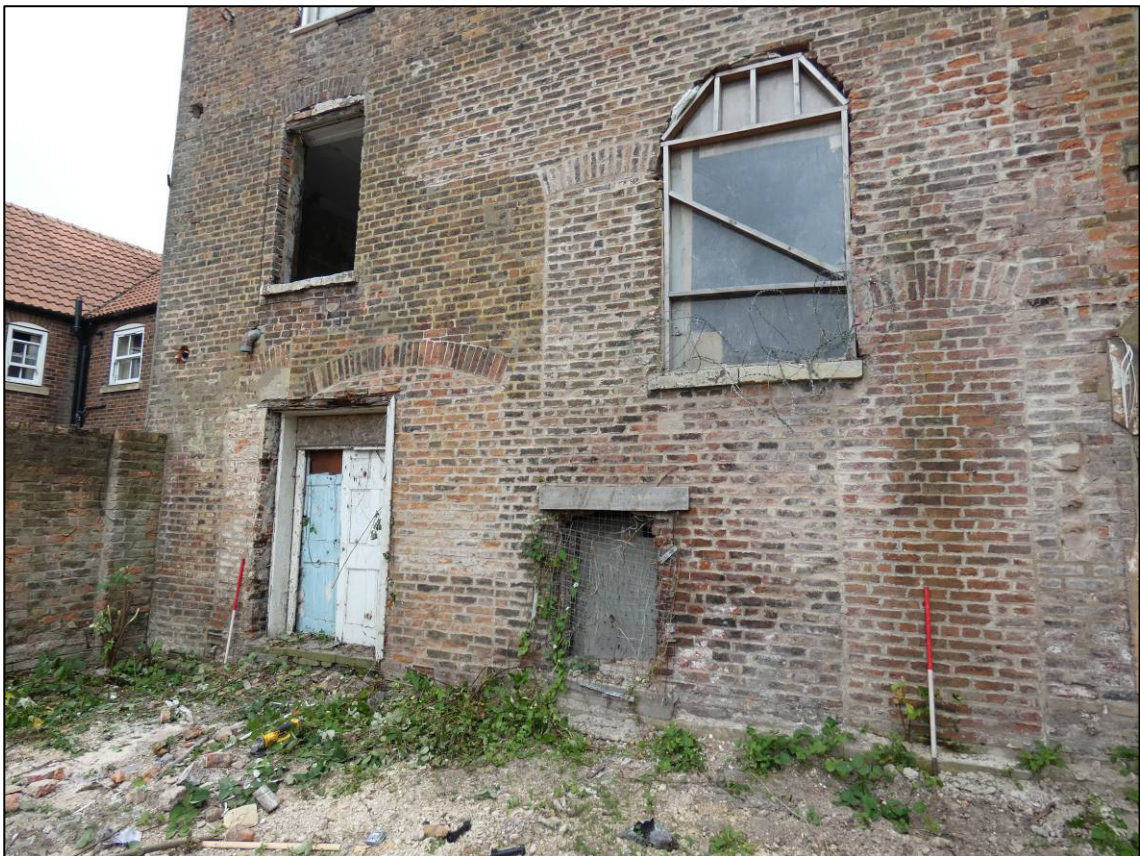
Plate 9: East elevation, south end, showing blocked openings, looking SW (photo 1/035).

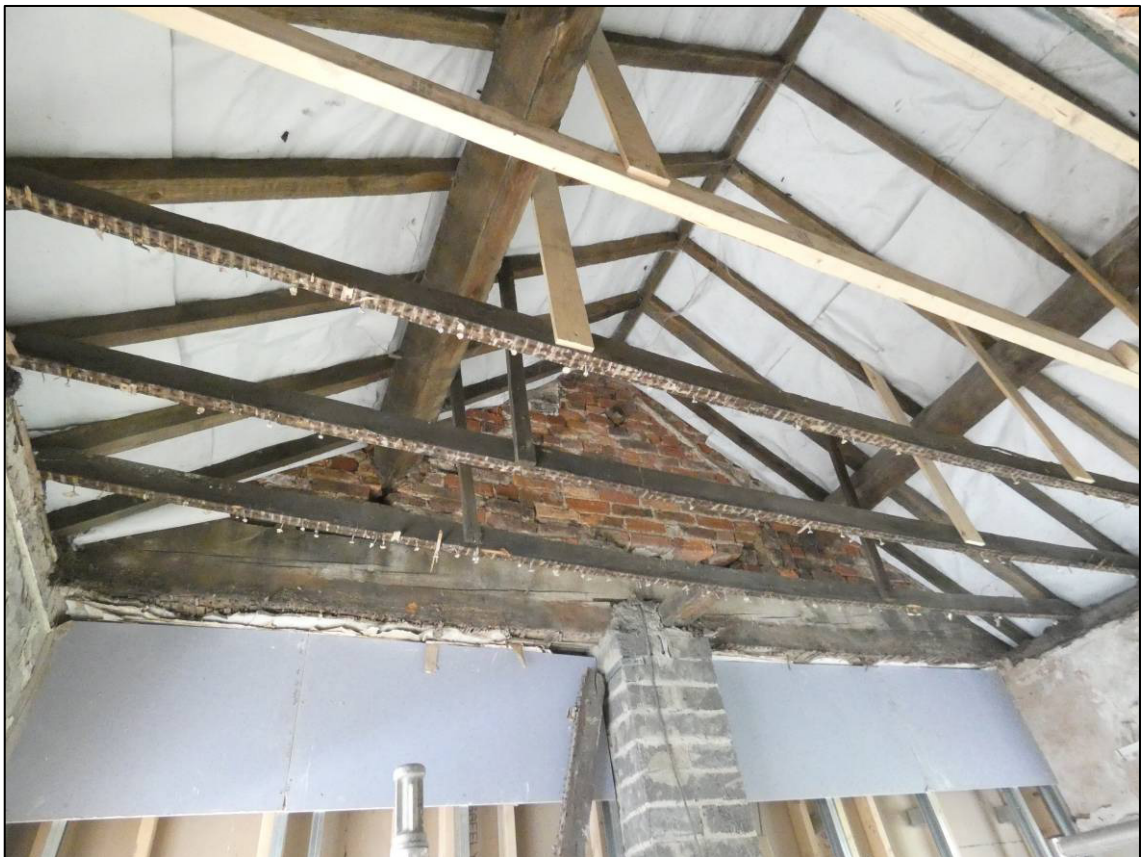
Plate 61: Rear wing first floor, east space (1F8) roof structure after stripping out, looking W (photo 4/517).

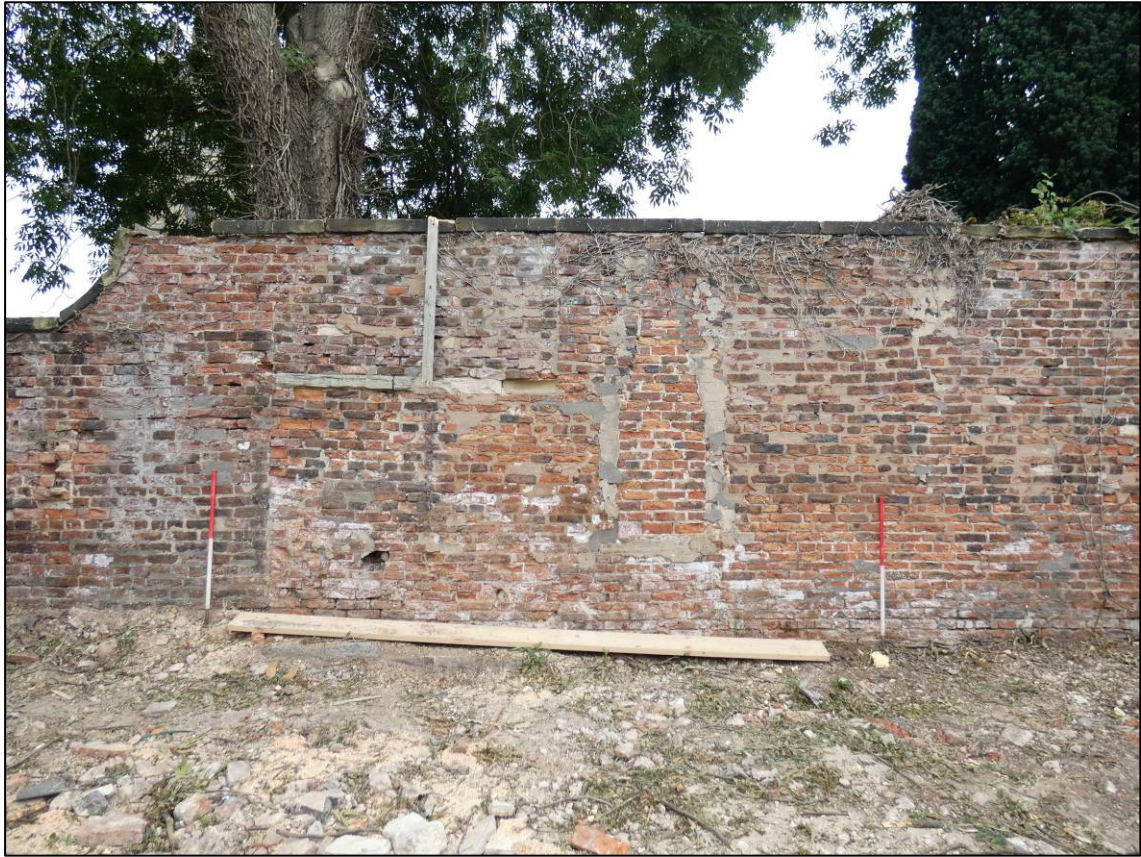
Plate 68: Rear yard, central part of north boundary wall, showing areas of blocking and repair, looking N (photo 1/965).

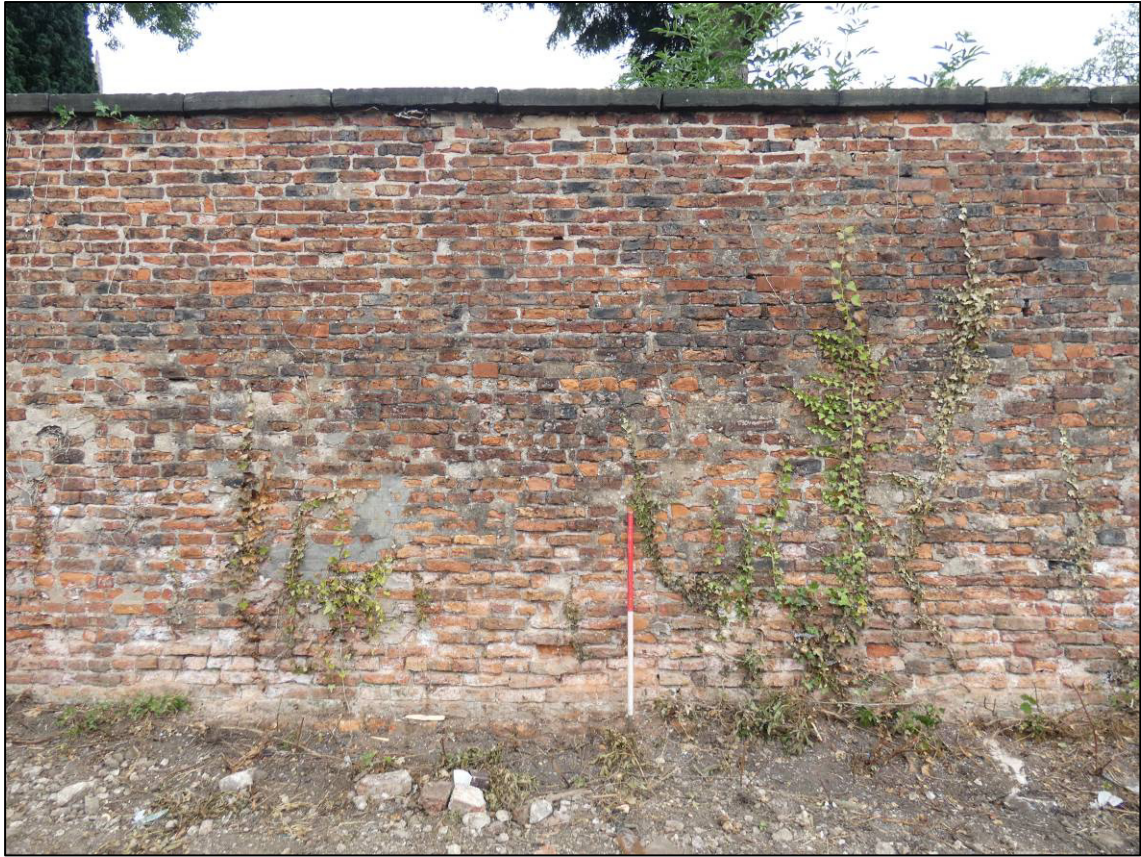
Plate 70: Rear yard, east part of north boundary wall, showing changes in build, looking N (photo 1/963).

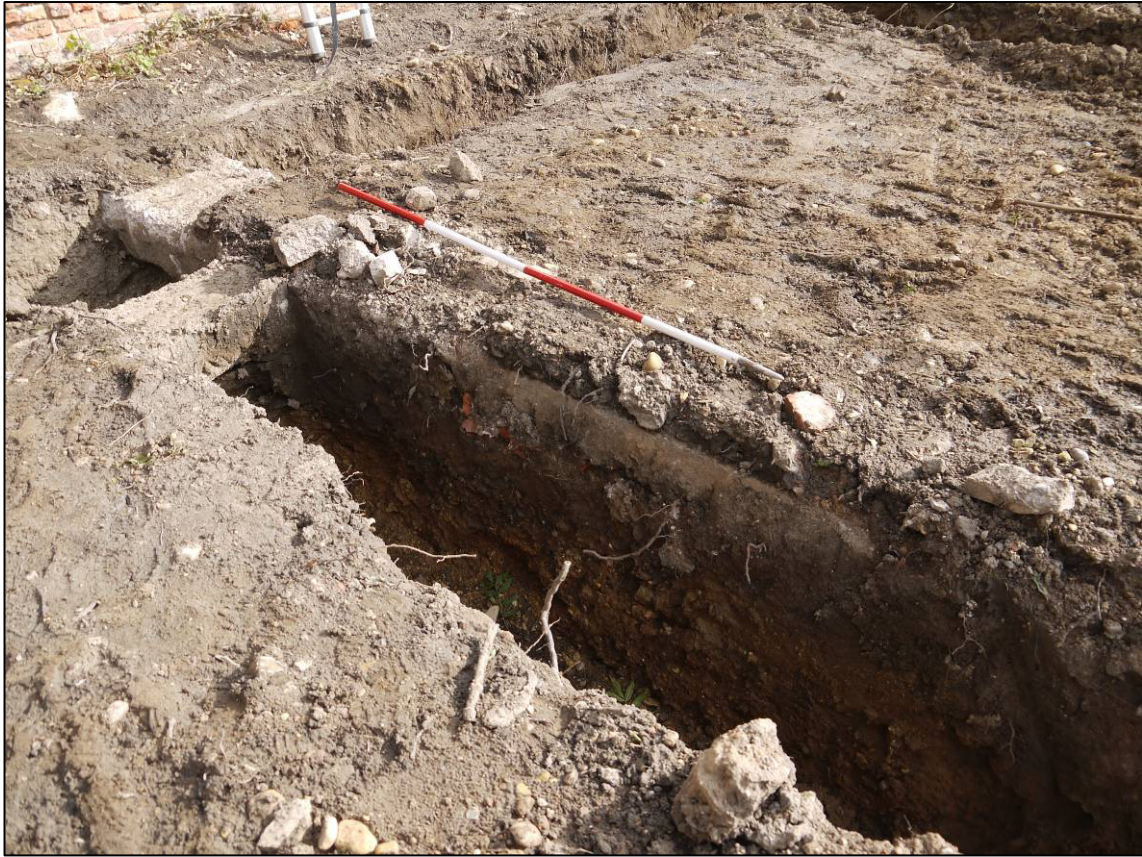
Plate 83: Concrete foundations (103) exposed at junction of Trenches 1 and 6, and along Trench 6, looking NE.

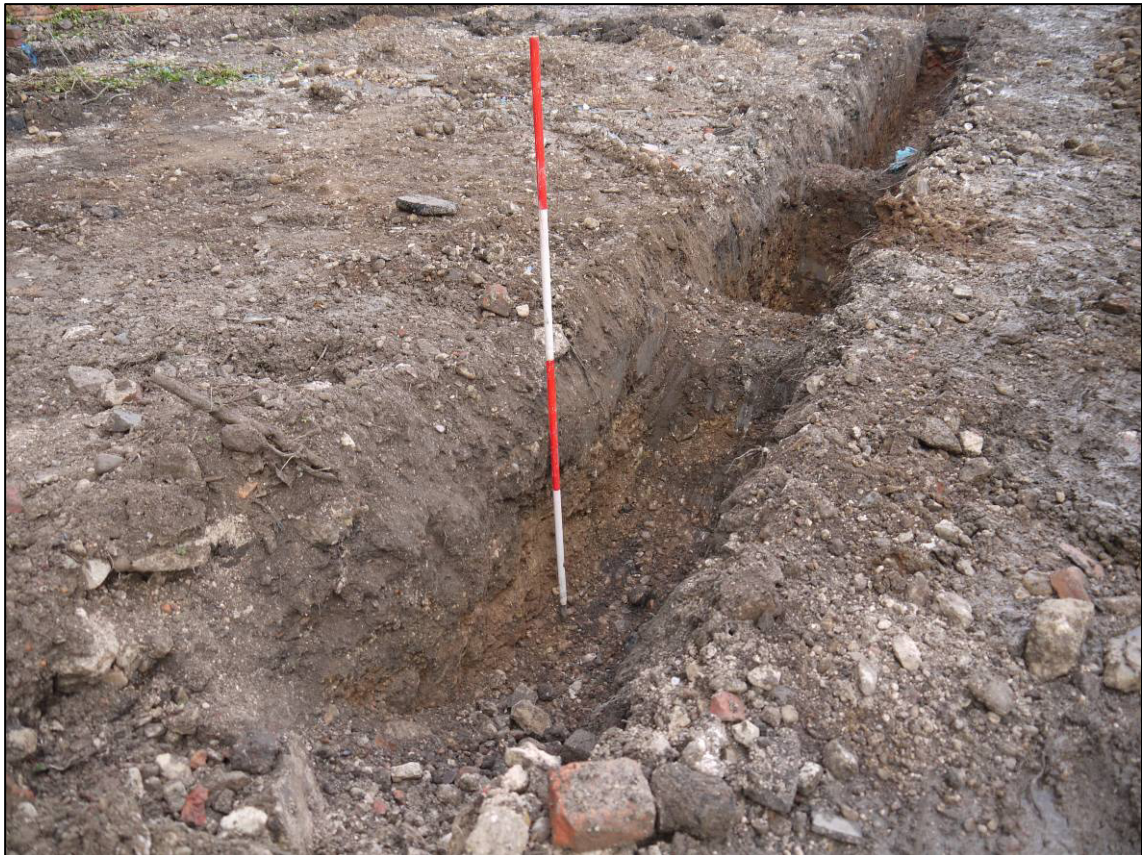
Plate 84: Concrete foundations (103) exposed in west end of Trench 2, looking E.

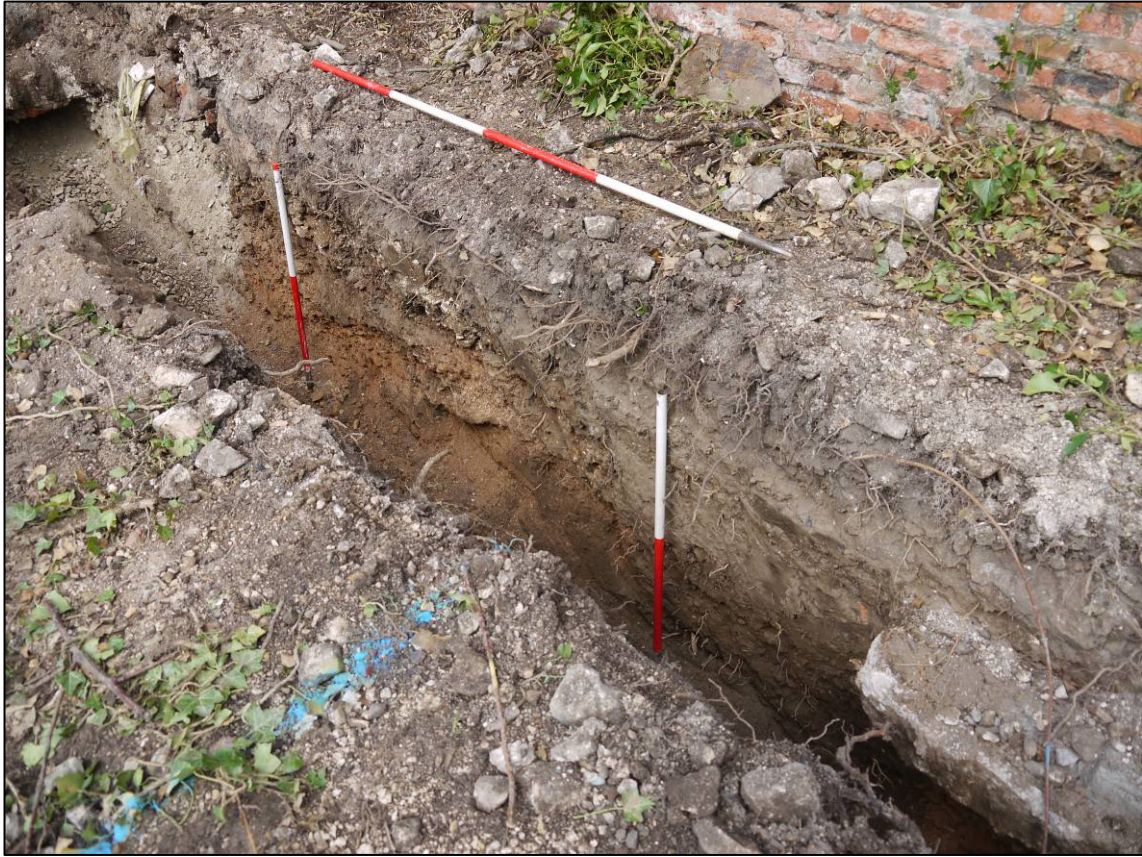
Plate 85: Possible pit or ditch (109/110) seen in north side of Trench 1, looking NW.

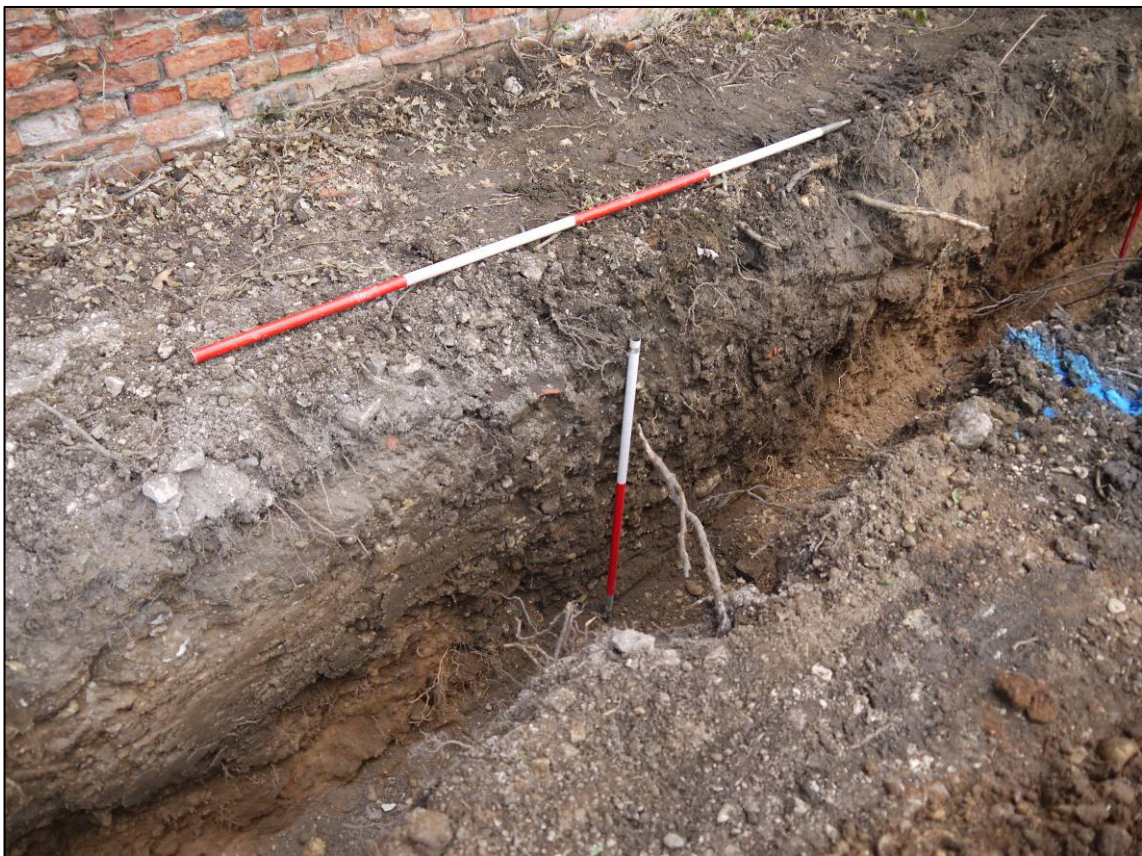
Plate 86: Possible pit or ditch (111/112) seen in north side of Trench 1, looking NE.
