BOLTON PERCY GATEHOUSE,
BOLTON PERCY, NORTH YORKSHIRE

INITIAL ARCHITECTURAL AND
ARCHAEOLOGICAL ASSESSMENT

Report no: 2009/346.R01
Version: Final
Date: May 2009
Author: Shaun Richardson & Ed Dennison

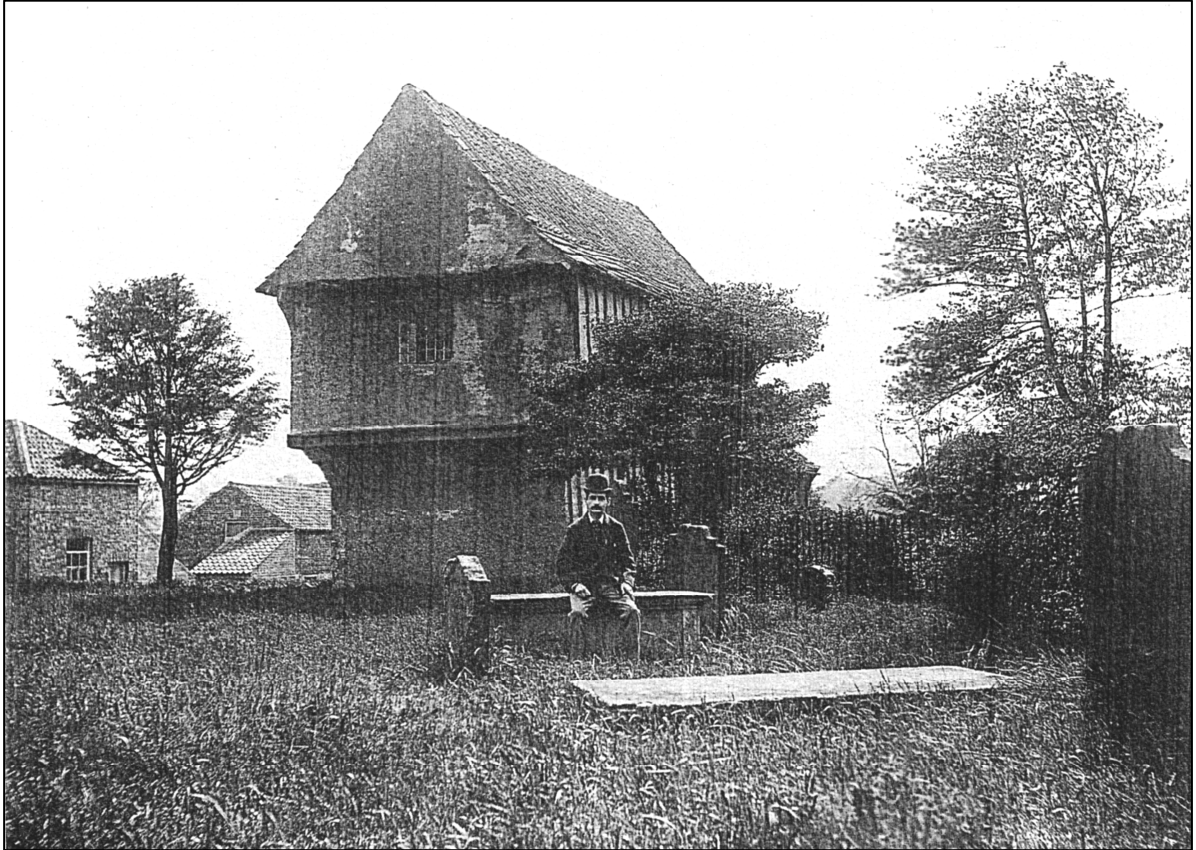
- 2.5 Due to this encroachment, and changes in ground level, it is now difficult to appreciate the former striking appearance of the gatehouse as it was when first completed. Some idea of this original setting can be gained from early surviving photographs of the gatehouse, such as that reproduced by Harrison (2000, 132), which show the building when the existing yews were still relatively small. Interestingly, when this photograph was taken in c.1900, the timber-framing of the east gable was plastered over externally (see plate 1).

Plate 1: Bolton Percy Gatehouse, c.1900, looking south-west
(Source: Harrison 2000, 132).

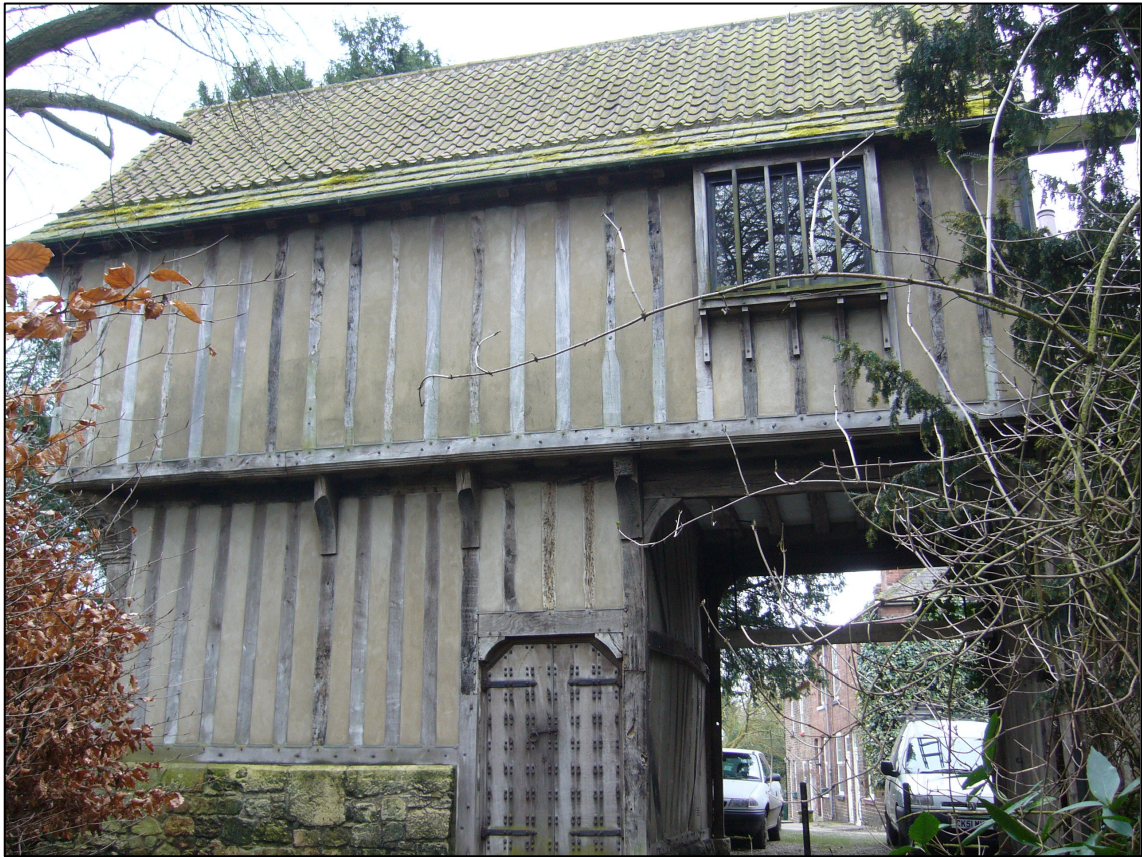
Plate 3: Bolton Percy Gatehouse, north elevation, looking south-east.

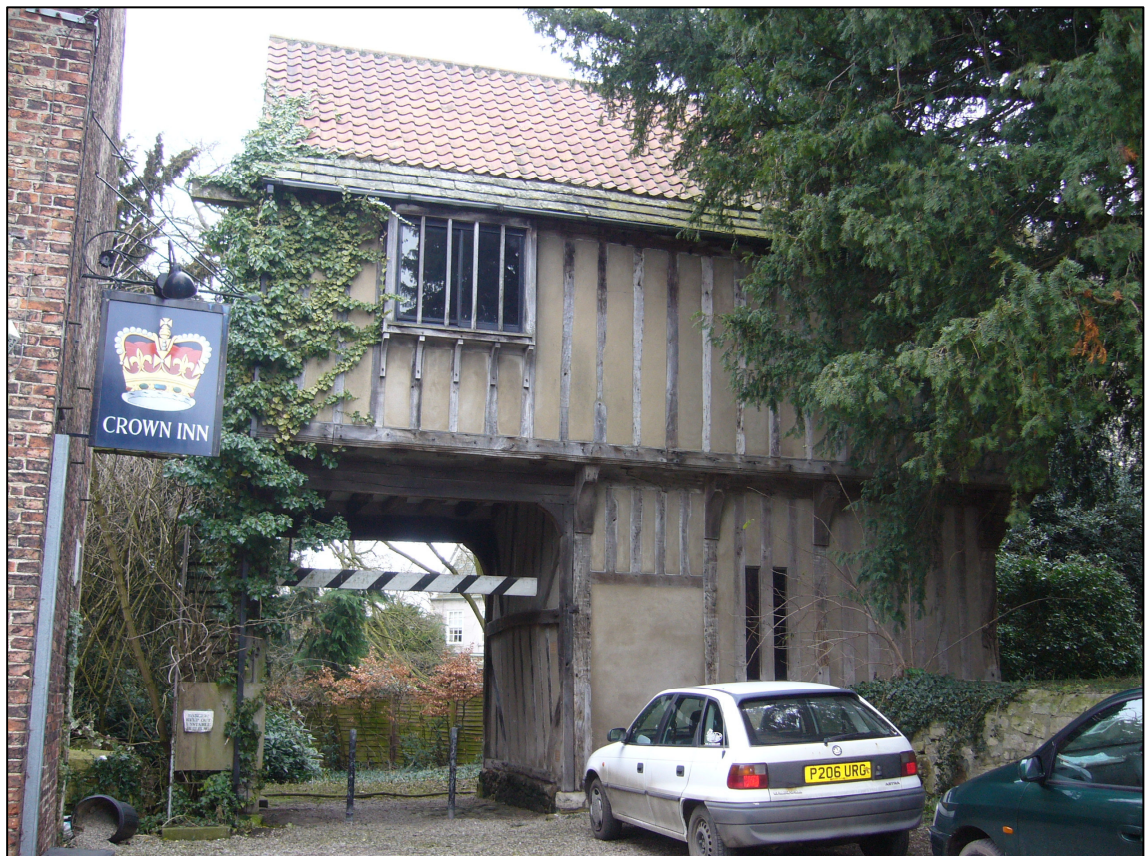
Plate 4: Bolton Percy Gatehouse, south elevation, looking north-west.

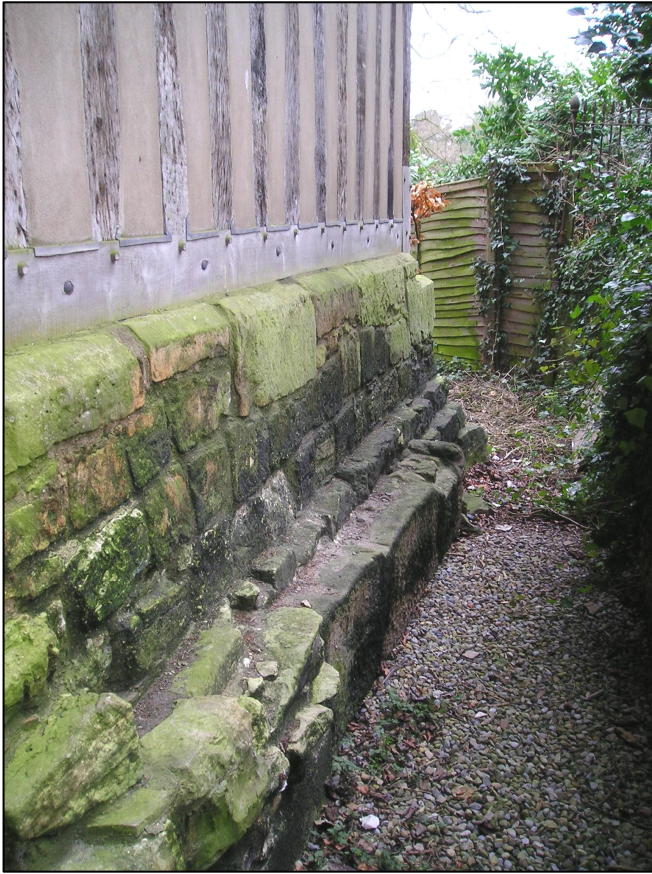
- 3.4 As has been noted above, both parts of the gatehouse formerly rose from a chamfered stone plinth. To the surviving east part of the building, the plinth is built of both roughly coursed and squared stone and also some larger, better dressed pieces (see plate 5). The chamfer is set at a slightly higher level to the east gable than to the north and south elevations, and is crudely stepped outwards towards the base. Above the chamfered plinth, sill beams support the ground floor close studding, the studding being more closely spaced at the eastern end of the building. Elsewhere, to the external faces that were not as highly visible, such as the internal sides of the passage, use is made of two storey posts, mid rails and downward braces. At the south end of the passage, above the west side, one of the original harrs which held the upper pivot of one of the leaves of the large external gates still survives. There are also iron pintles set approximately half-way up the posts at both ends of the passage, which appear to be later introductions, but a wrought-iron eye set into the west side may be an early feature, perhaps used to secure a gate leaf here. An original doorway with foliate spandrels at the north end of the passage's west side gave access to the ground floor space to the west of the passage (see plate 6). The passage is floored with cobbles in some places, although a line of bricks running across it in plan may represent the blocking described in 1938. When the outer gates were closed, access through the gatehouse was via what appears to be a cross-passage on the west side of the east part. There is also a small high window to the east gable's ground floor, presumably in the same place as an original.

Plate 5: Chamfered plinth, east end of gatehouse, looking NE.

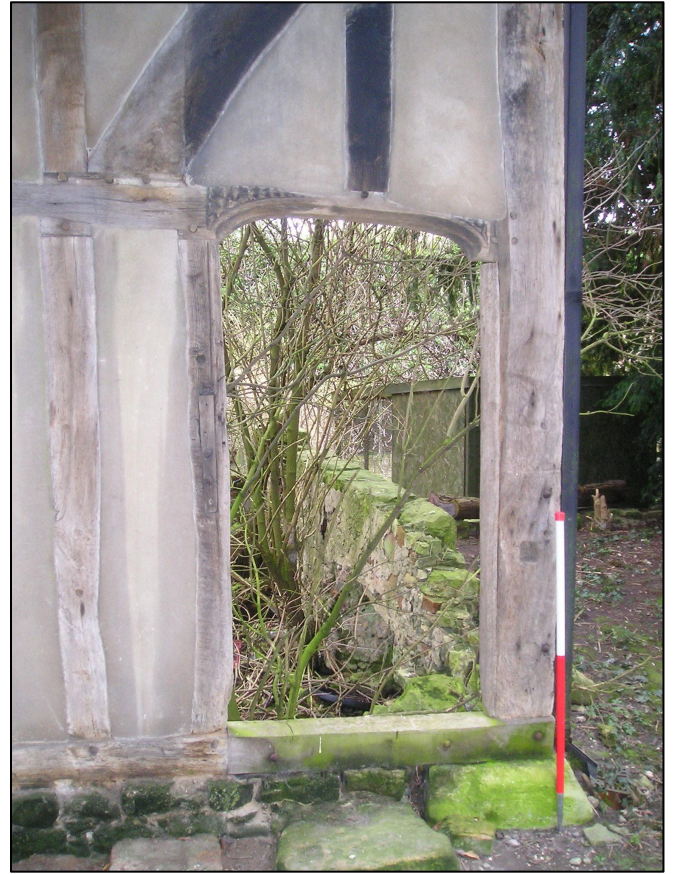
Plate 6: Doorway at north end of west side of passage, looking west.

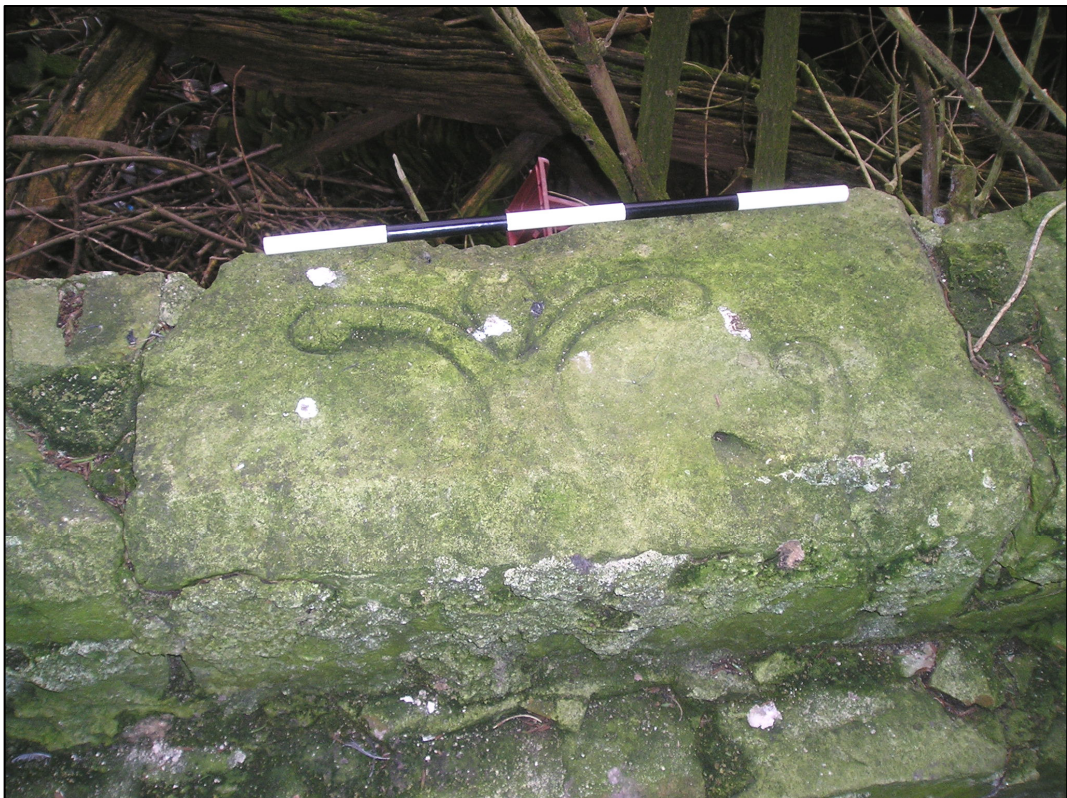
Plate 7: Reused coffin lid fragment on north plinth wall, west side of gatehouse.

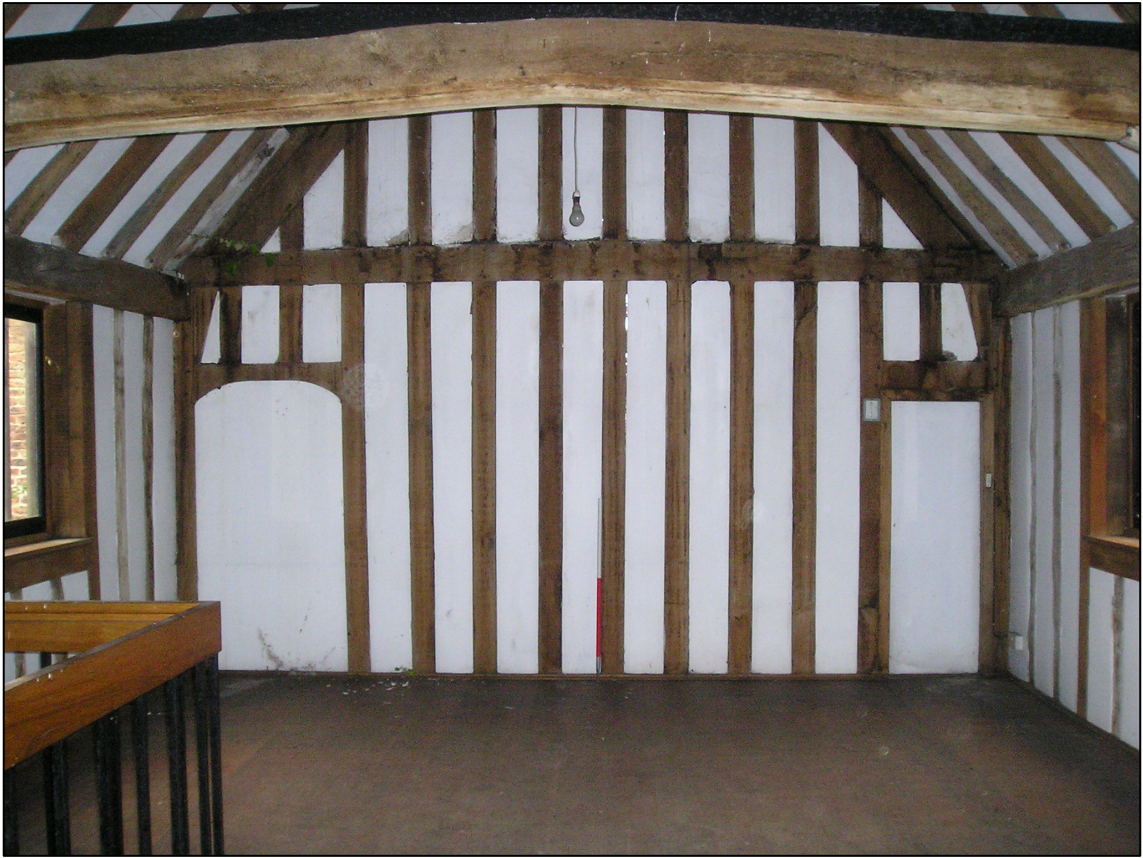
Plate 8: West end of first floor of gatehouse, looking west.

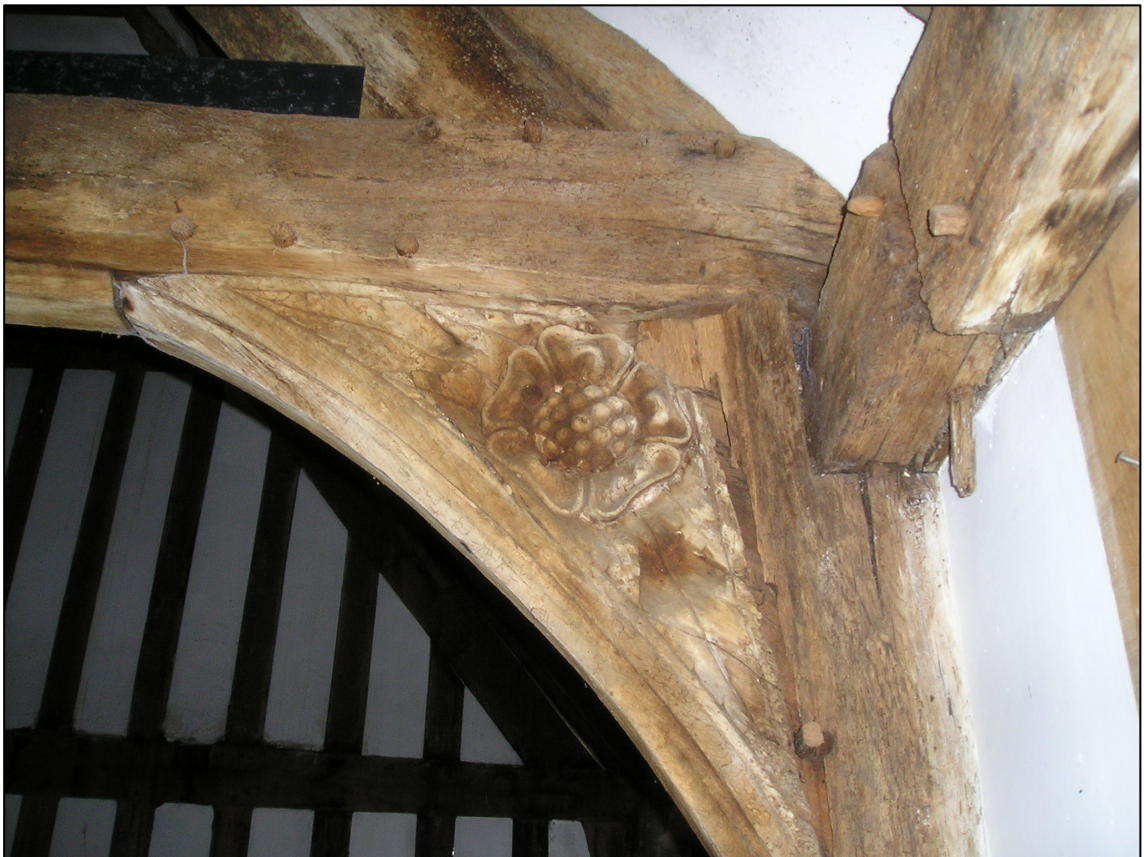
- 3.11 The 1970s stairs lead up to the first floor chamber, although originally this may have been accessed via a doorway in the west wall formerly leading through into the first floor of the gatehouse's west part. The first floor chamber is an impressive space, of three bays and crossed by two trusses of post and tie-beam construction, with short principals, a collar purlin and side purlins (see plate 8); Michelmores likens the roof construction to surviving examples in York and Lincoln dating to between 1450 and 1550. The cambered tie-beams are moulded, as are the posts. The knee-braces between the posts and tie-beam retain carved decoration. To the east face of the east truss, the south brace has a thistle and the north brace three berries surrounded by leaves, while the west face has a flower and an acanthus leaf in the same positions. To the east face of the west truss, the south brace has three berries with foliage and the north brace a rose (see plate 9), while the west face has five berries with foliage and a thistle in the same positions. A small number of carpenters' marks were noted on the first floor timbers, and there are scarf joints of several different types visible in the wall plates (see plate 9).

Plate 9: North knee-brace, east face of west truss, looking west.
