**CANONSLEIGH BARTON
BURLESCOMBE
DEVON**

**HISTORIC BUILDING APPRAISAL
OF REDUNDANT FARM BUILDINGS**

December 2011

Project CBB206/2011

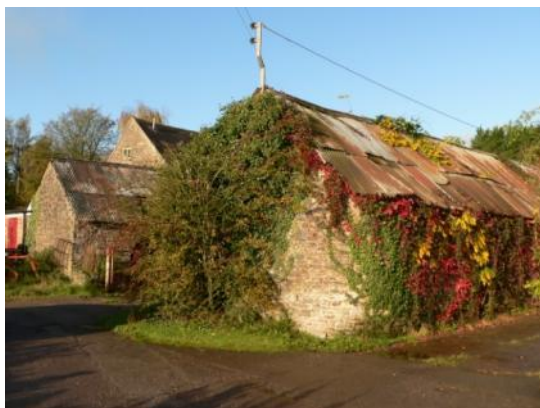
South east corner of east range

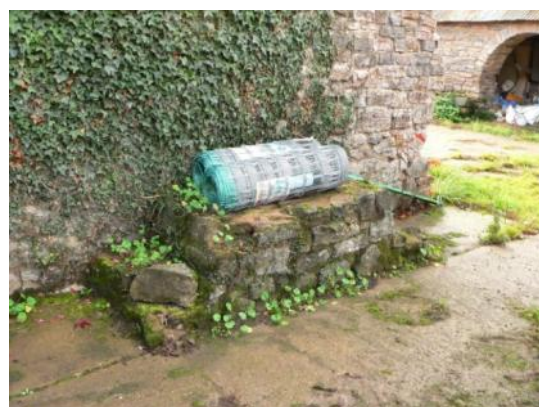
Mounting block at north end of east range

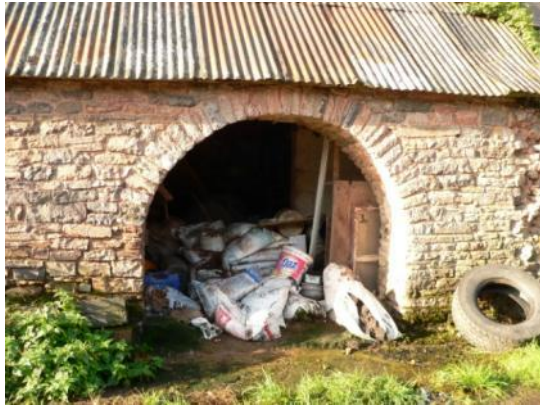
Arched opening, bay 3, west range

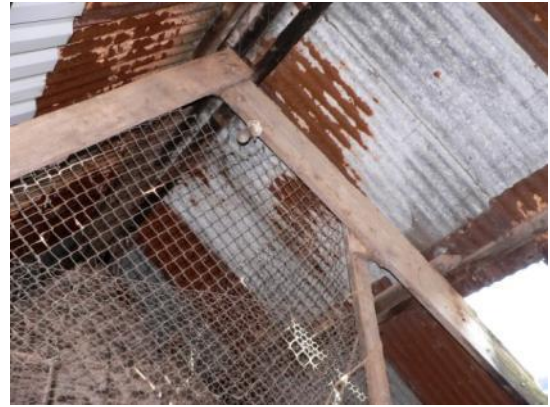
Bay 1 (south) has a raised concrete floor divided into two animal pens by a concrete blockwork partition. The stone walls are whitewashed. A modern lightweight roof structure has replaced the original structure, with a central triangular softwood frame, with purlins carrying corrugated metal sheet. The wall head on the west side has been built up with plasterboard and foam.

Modern roof structure, bay 1, west range

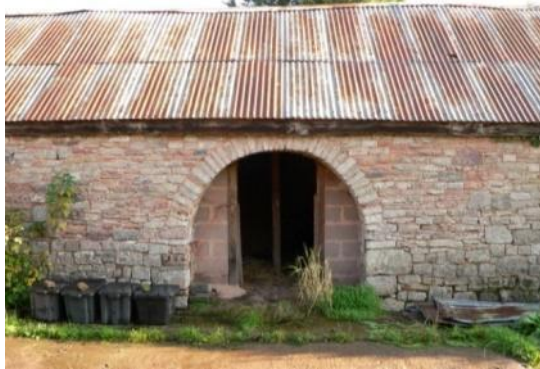
Bay 2 (middle) has a concrete floor sloping down to the yard. The arched opening has been partly closed in blockwork, timber and plywood, with a modern stable-type door. The walls are whitewashed. The roof truss has a tie beam and a collar pegged to the south face of principals. There is a clear panel forming a skylight in the cladding on east slope at the north end of this bay. On the west side, the rafter feet are carried on a projecting timber plate, the same as that on the west range, but a gutter board has been nailed to the projecting edge of the plate.

Arched opening, bay 2, east range

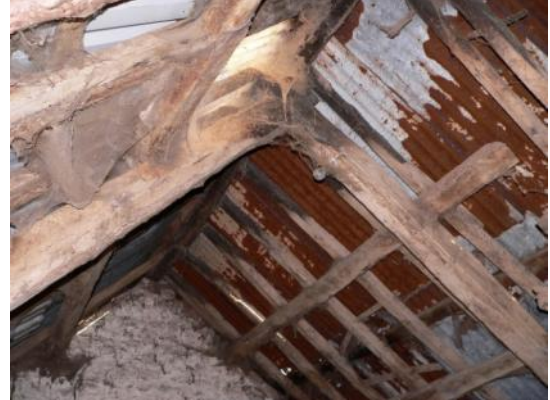
The original roof truss survives, comprising a tie beam 17cm deep x 15cm wide, which bears above centre of arch on yard (east) side and on top of rear wall, on which the feet of the principals sit. The form of joint between the tie beams and principals was unclear. The principals are of rustic appearance, being sparingly converted from small trees (hardwood), lapped and notched at the apex. There are two rows of purlins to each slope; the purlin timbers are in short sections splay-scarfed together and run over the backs of principals. There are remains of common rafters and some battens, the slopes being clad with corrugated metal sheeting, with a clear plastic panel close to the ridge on the west slope. The lower part of the west slope has been repaired with plasterboard and foam.

Original roof structure, bay 2, west range

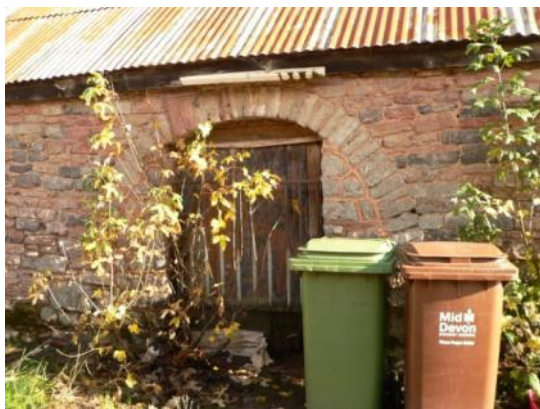
Infilled doorway, bay 3, east range

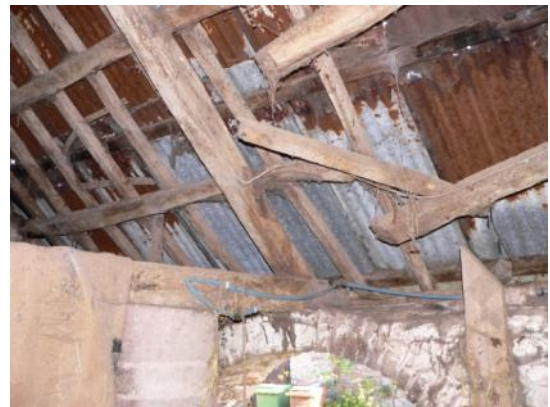
Roof structure, bay 2, west range

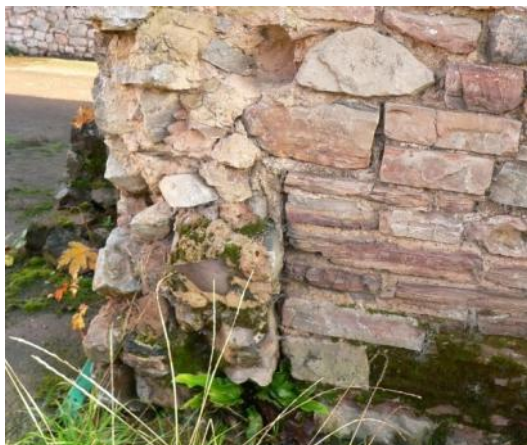
Gatepost scar, NW corner of east range

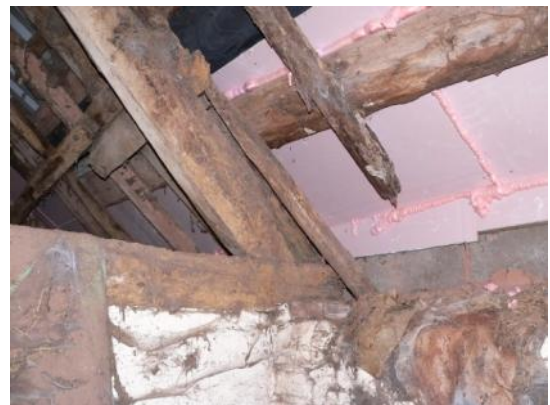
Tie beam and principal foot, rear bay 2, W

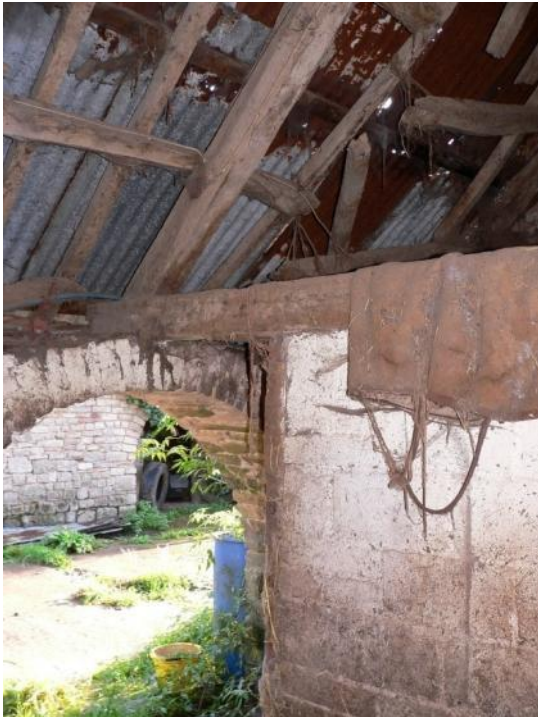
Blockwork infill and roof structure, bay 2, W

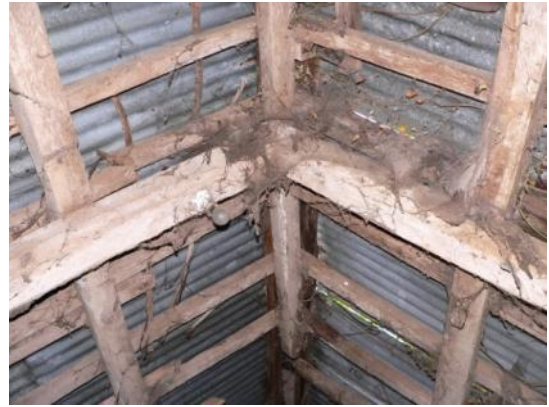
Principals and rafters, bay 1, E

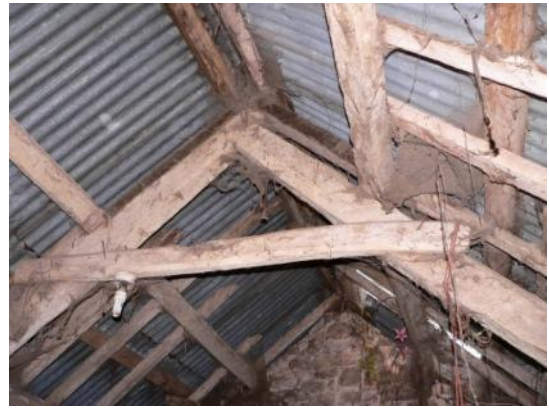
Truss with collar, bay 2, east range

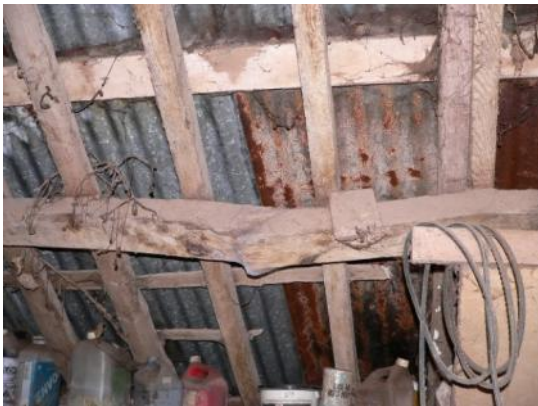
Purlin scarf joint, bay 3, west range

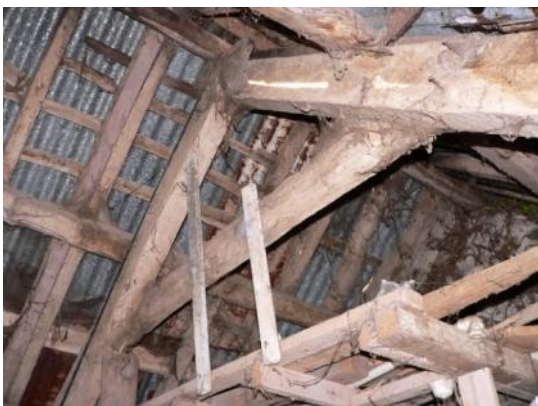
Truss with collar, rafters and battens, and loft platform, bay 3, west range

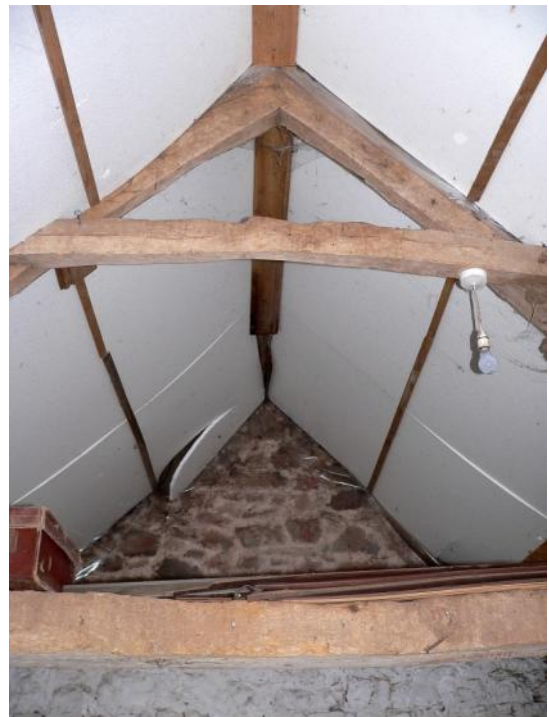
Bay 3 (north) has a modern galvanized pipe gate on the outside, hinged on the north side, with a tongued, grooved and v-boarded door in a timber frame. The arched opening has again been partly closed, externally with squared stone blocks, with blockwork internally. The walls are whitewashed. The floor of this bay is covered with fibre board. The roof truss is similar to that in bay 2, with a tie beam and a collar nailed to north face of principals. Both roof slopes are insulated and lined with foam board.

Roof structure, bay 3, east range
