**WELLAND DOWN FARM,
SANDFORD, DEVON**

**HISTORIC BUILDING RECORDING
OF LINHAY**

December 2013

Project 236

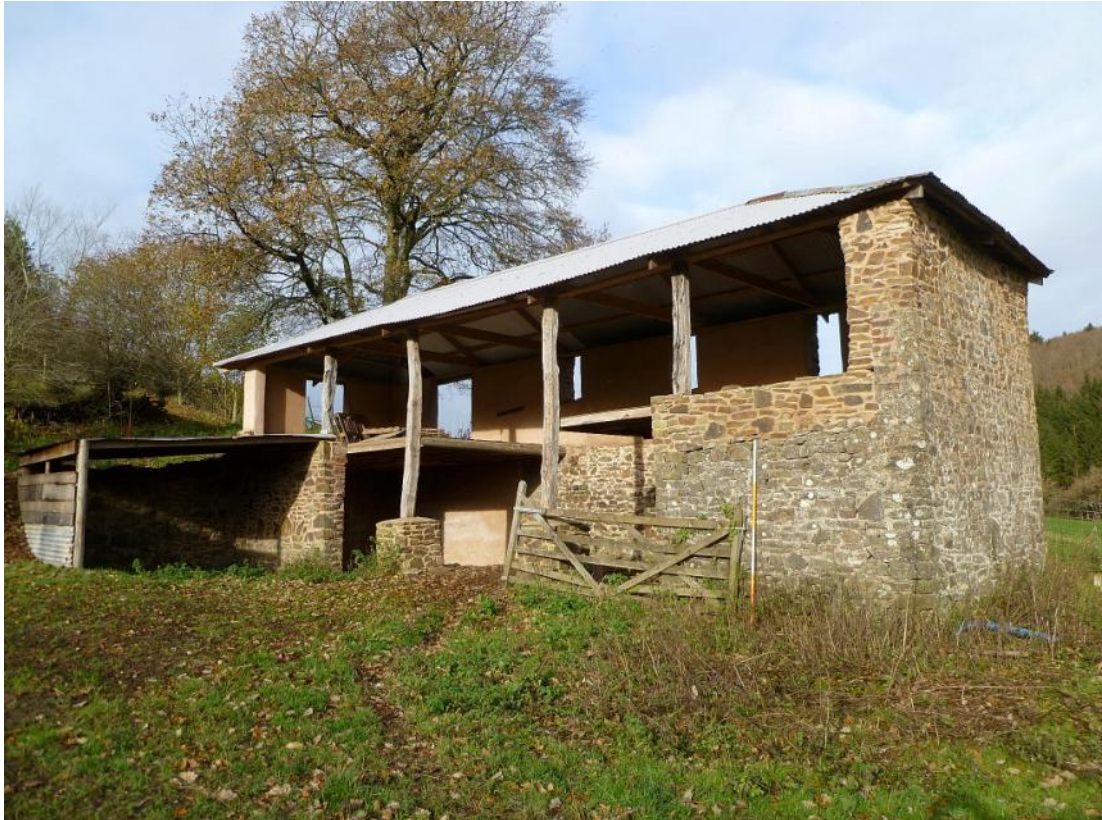
Westercombe linhay from the south east. Note areas of rebuilt masonry

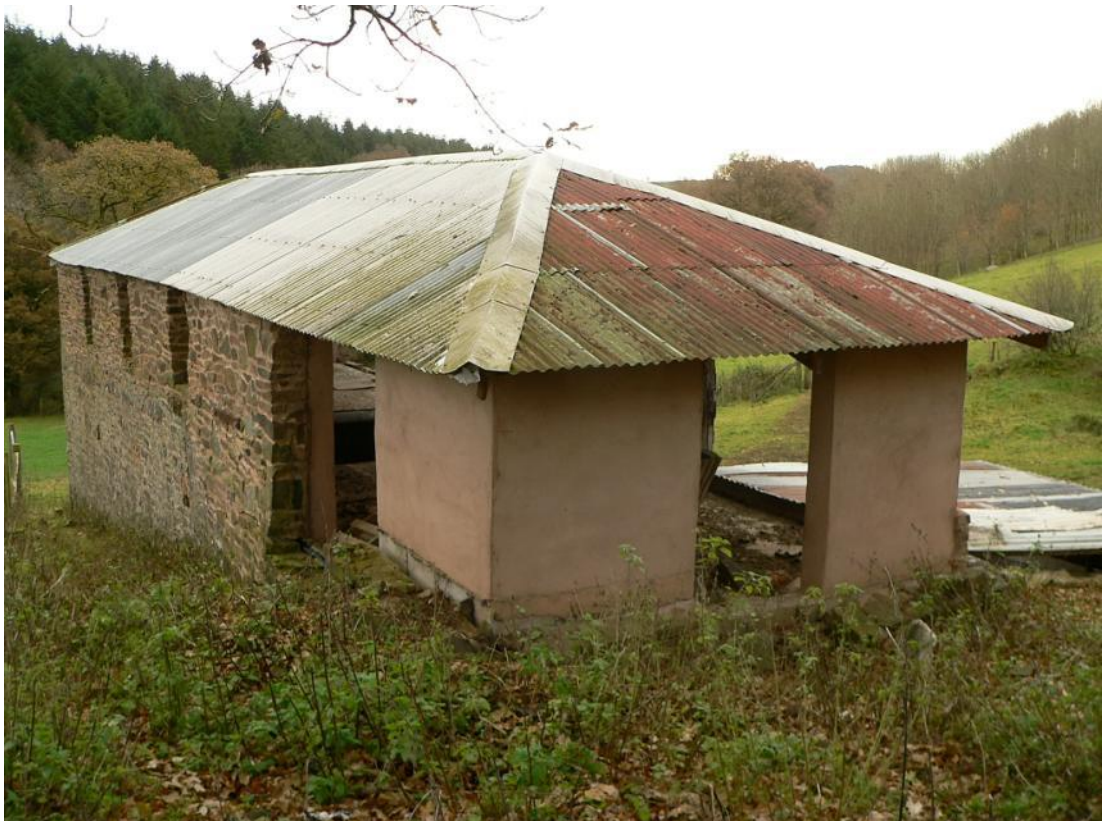
Linhay from the north west, showing extent of rebuilt rendered concrete block walling

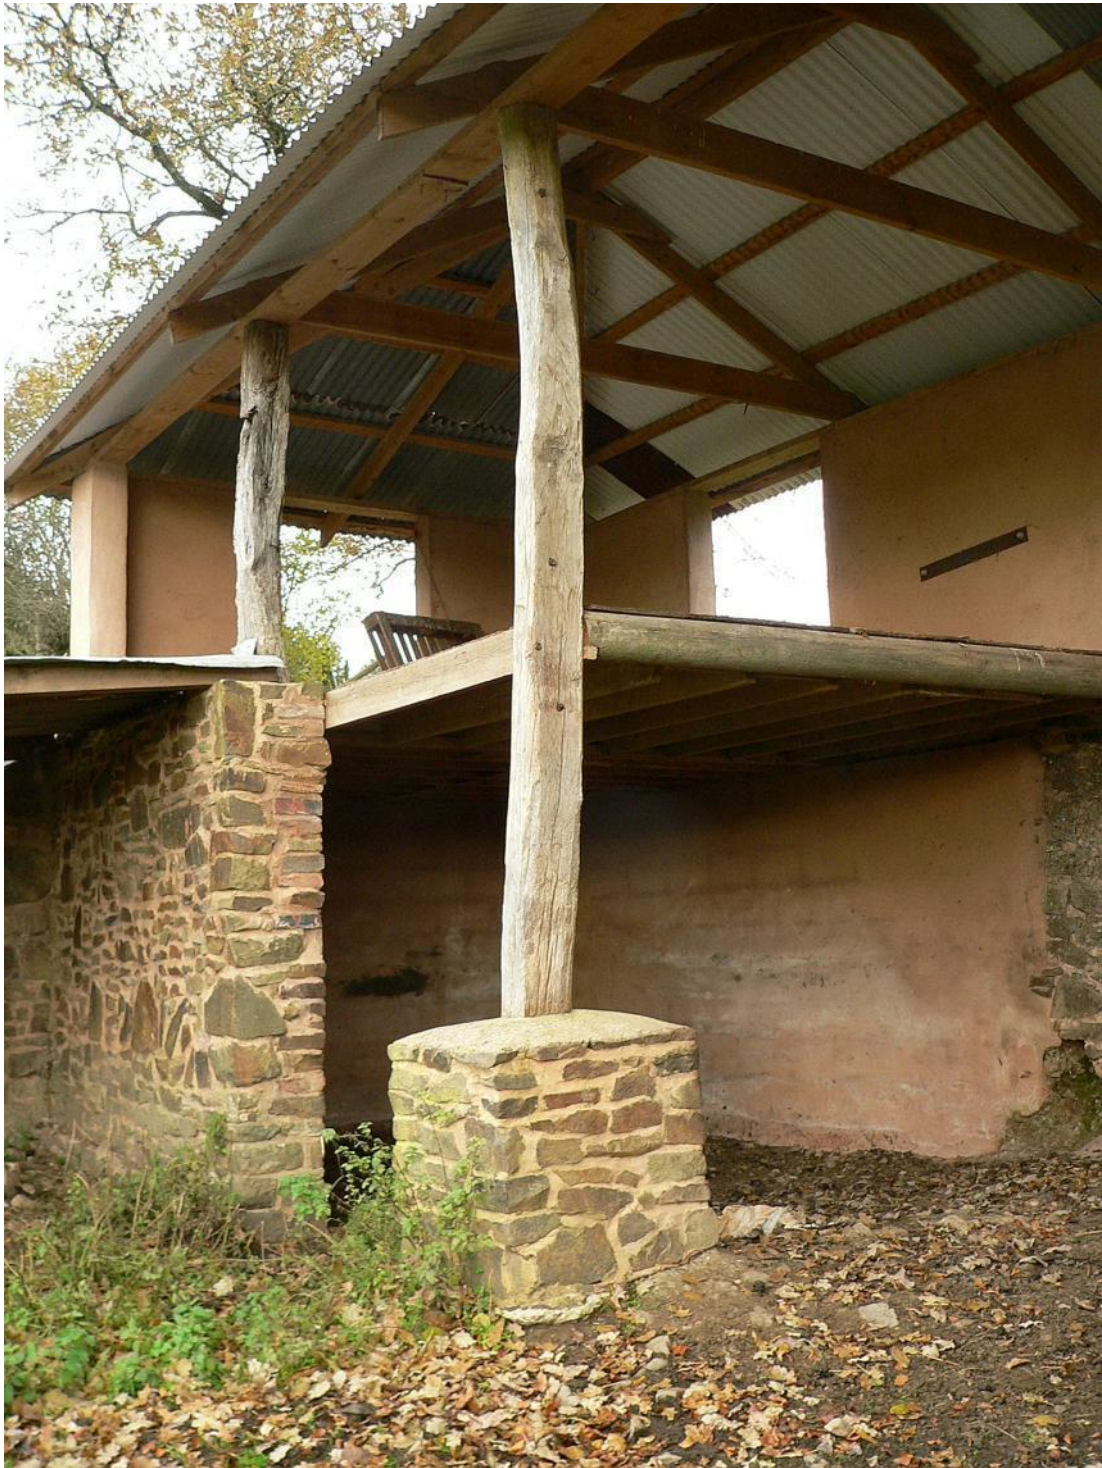
Linhay, looking north-west through centre bay, showing rebuilt and new stonework and rendered interior walls

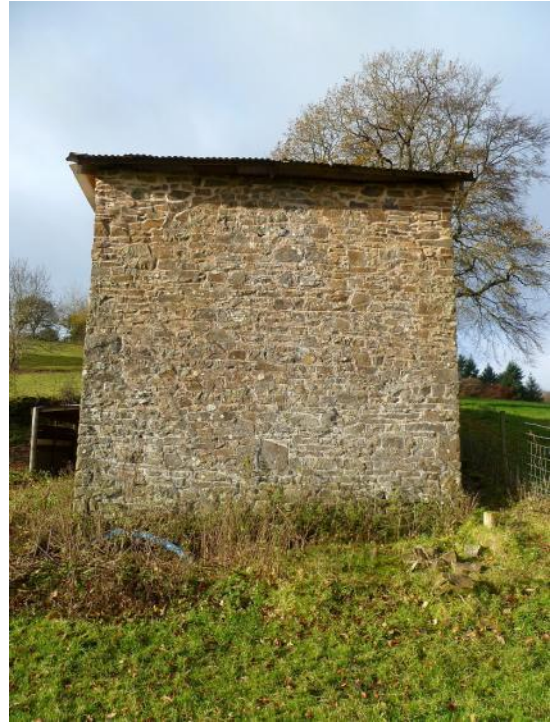
The east gable is of rubble stone to full height, with repairs to the masonry at the top of both corners at eaves level. There are remains of the stone footings of the walls of a small building about 2.3m square in the ground adjoining east gable. About 1.3m of stonework along the top of the north wall has been rebuilt, with three window openings and a 1.3m wide doorway to the rear of the first bay from the west. The outer rubble stone walling has also been rebuilt with an inner skin of rendered hollow concrete blocks. Because of the extent of rebuilding it is not possible to tell if the openings in the north wall are original (see discussion below).

East gable end; note rebuilt masonry

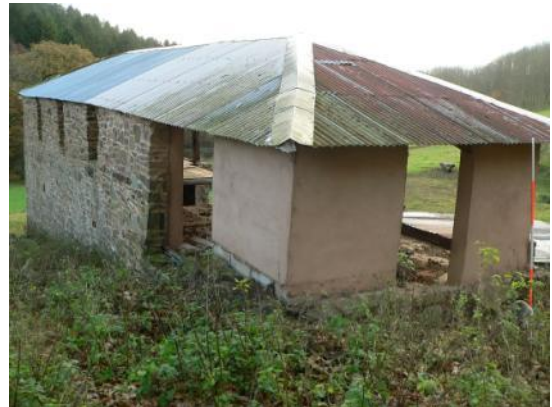
At the west end, where the linhay is built into the slope, some stonework remains above the higher ground level, but the existing gable end is of rendered hollow concrete blocks, the outer stone skin having not been rebuilt. There is much stone, presumably from the north wall and west gable, lying on the ground to the north-west of the building. As well as the wide doorway in the north wall of bay 1, there is another doorway through the west gable; both give access directly onto the loft floor. Again the amount of rebuilding makes it difficult to tell if these are new or reflect original openings.

North wall - top of stonework rebuilt - and west gable, rebuilt in rendered concrete block

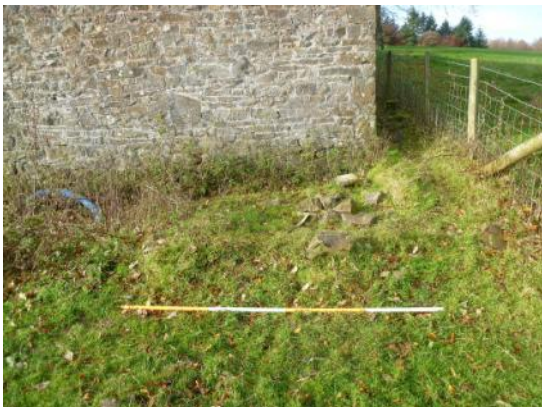
Extension footprint by east gable

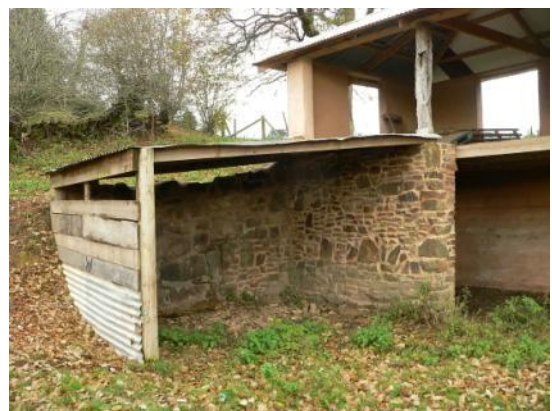
A single storey lean-to, about 4.1m wide (north-south) and 3.1m deep (west-east) projects from the south wall of bay 1. Its west wall is built into the bank and it has an open front to the east. Internally the west wall contains some massive stone blocks and has been substantially rebuilt, with cement pointing and some concrete repairs. The south wall is formed of corrugated iron sheets and wooden boards supported on timber posts, including a reused telegraph pole. The lean-to roof is of corrugated metal sheets on a lightweight timber structure.

Lean-to extension, with rear (west) wall built into bank

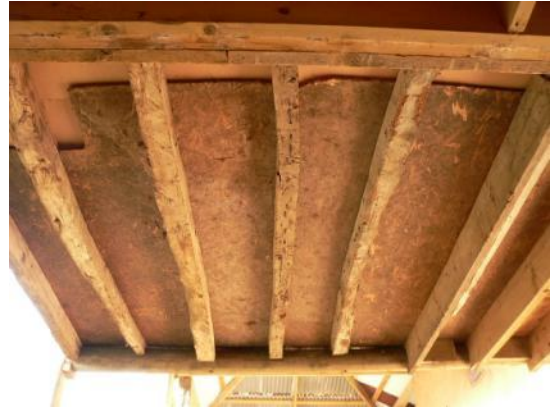
Reused floor joists in bay 4 from west

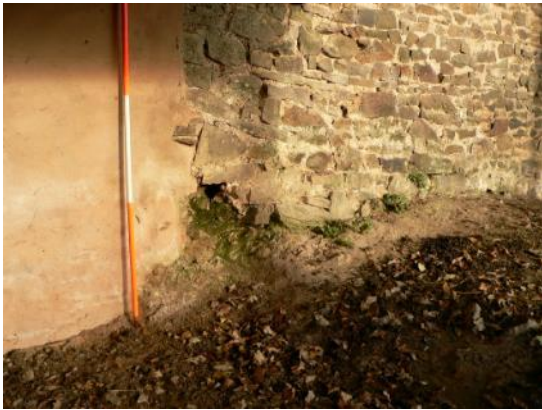
Bedrock exposed in rear wall of centre bay

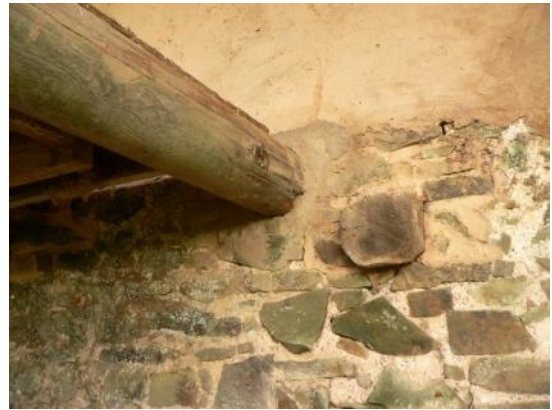
The first floor structure has been completely renewed and is set at a higher level than the original. There is some vestigial evidence of the original construction, with the ends of some of the principal cross beams which spanned from the front posts to the rear wall and defined the structural bays still built into the north wall. There is also some patching visible in the stonework where others were located. There are eight joist sockets in the stonework of the east gable wall, the tops of which are about 0.36m below the present floor level at that end. The new floor is carried on sections of telegraph pole which form two cross beams, one on either side of the central bay, and softwood beams and joists. The joists run north-south in the two end bays and west-east in the two inner bays, the central bay being open. The joists are of standard treated softwood, with noggings nailed between them at mid-span. All of the floor timbers are modern with the exception of a small area at the front (south) end of bay 4, where there are five reused joists. The floor is formed with sheets of OSB [oriented strand boards] laid on the joists. The west, north and east walls at

Original cross beam end and replacement first floor beam in rear wall of centre bay

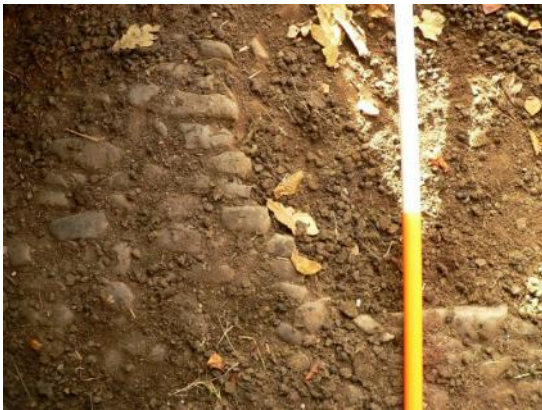
Cobbled floor surface at east end

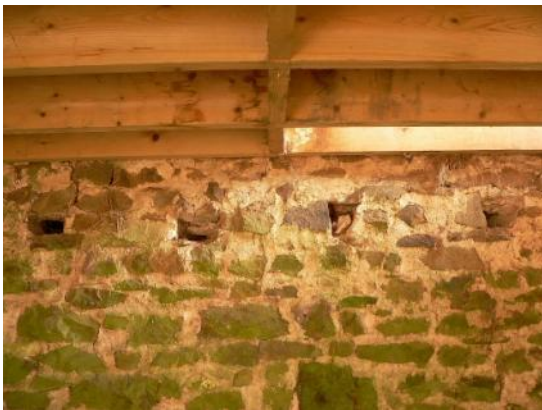
Joist sockets in east gable wall

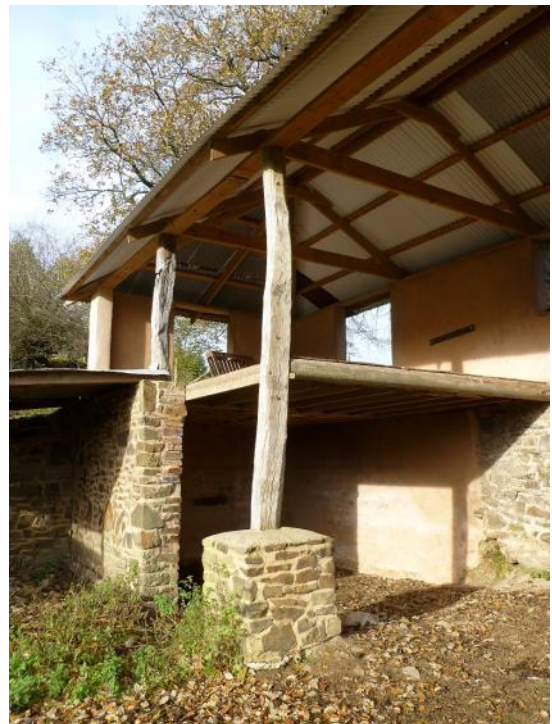
Centre bay, looking north-west, showing front posts and rendered concrete blockwork internal wall lining

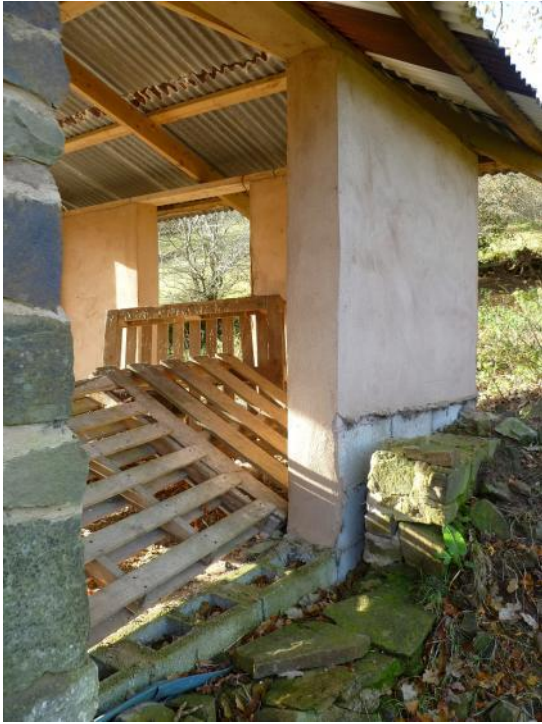
Doorway in north wall, bay 1 from west

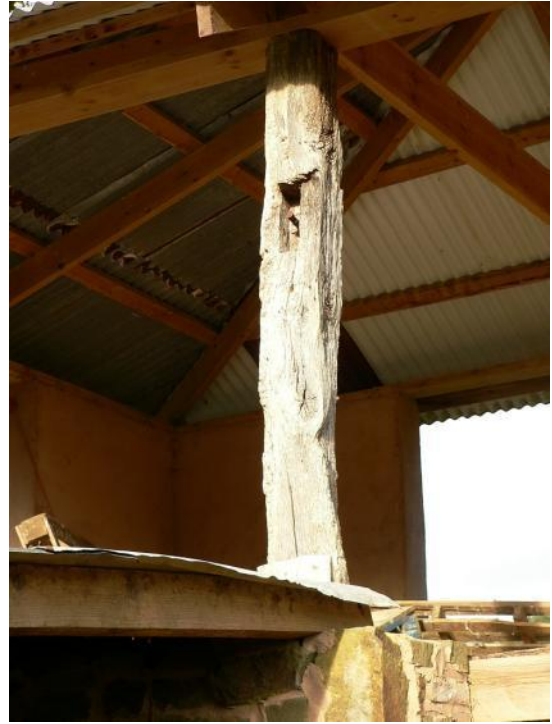
The partially open south front has two short posts which stand on the heads of the walls closing the two end bays and two longer posts which stand on rubble stone bases. The two short outer posts are both re-used timbers, which appear to have been cut down from the original front posts. They both have through mortises with angled shoulders (although now positioned upside down), to which the outer ends of the main cross beams carrying the loft floor would have been joined. The tenons on the ends of the original beams presumably passed through the mortises and were pegged across the faces rather than through the posts. The two taller inner posts are of different character, but are also reused timbers, having a number of redundant apparently random peg holes in them. Some of the faces of these timbers show evidence of hewing. Both of the taller posts sit on new rubble stone bases, which are about 0.75m square by 0.8m high with concrete capping.

Re-used front post between bays 1 and 2

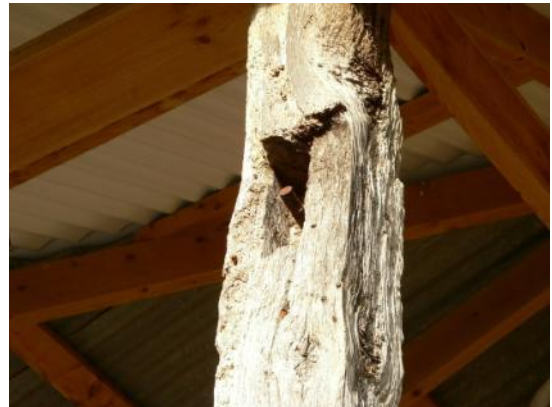
Detail of shoulder and mortice (upside down) on re-used front post

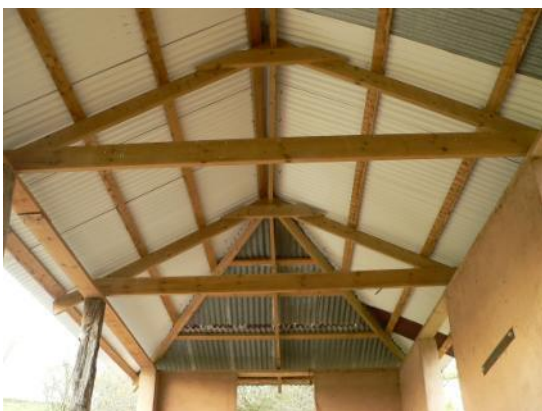
The roof is also new, being constructed of standard section treated softwood timbers nailed together. There are full length wall plates, of 190 by 50mm section, all round the heads of the walls and on the tops of the front posts and four lightweight trusses. The tie beams are 190 by 50mm section, the principal rafters 150 by 50mm section, with two rows of 100 by 50mm purlins on each slope and a vertical ridge board. Both the west and east ends of the roof are fully hipped and the slopes and hips are clad with corrugated metal sheets, some modern, some of older profile and finish.

New roof structure, looking to west end
