**HEDDON MILL,
GEORGEHAM, DEVON**

HISTORIC BUILDING EVALUATION

February 2014

Project HMG239

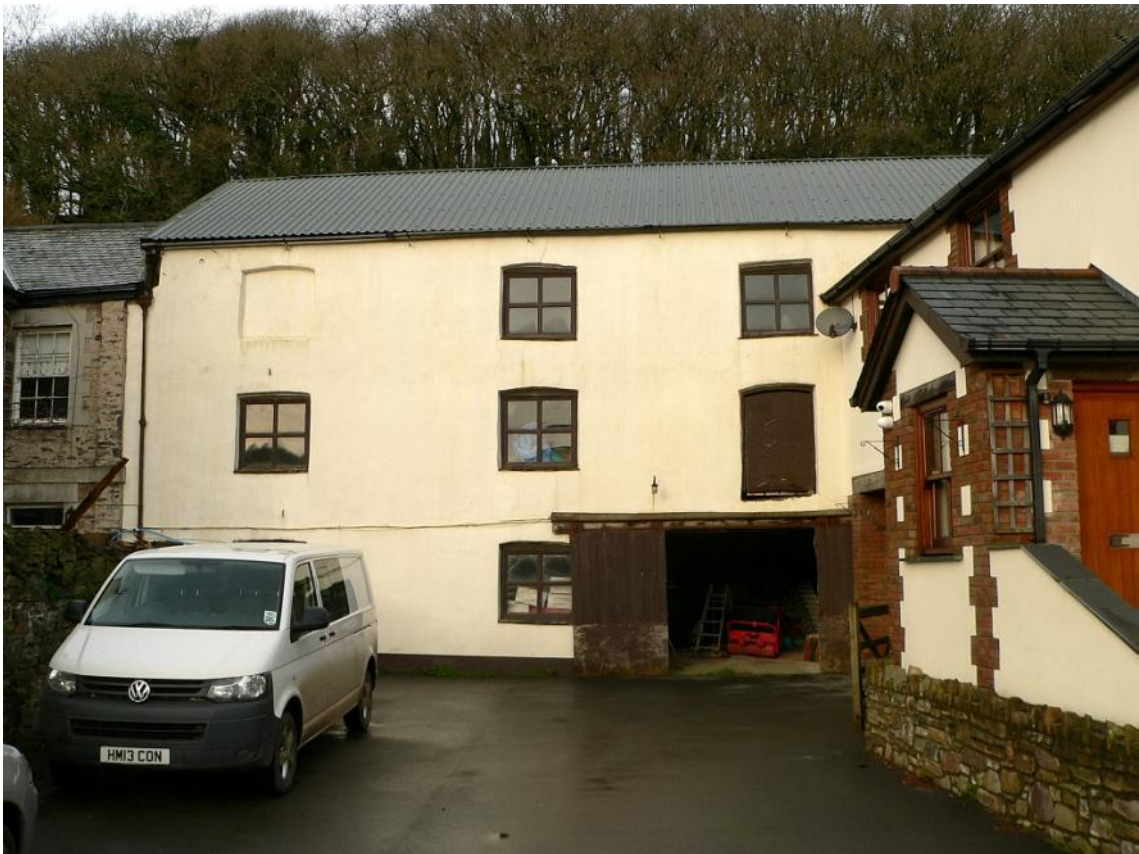
The window and door openings have arched heads and all of the windows frames on the east elevation have been replaced in timber and have cills made of roofing slates. At ground floor level there is a timber boarded door towards the south end of the east elevation and a wider opening with a pair of sliding timber doors, which appears to be an enlargement of an earlier door opening, towards the centre of the elevation. Above this opening is a first floor loading door, now closed with a plain panel. The window openings on the west side are now without frames and the windows in the gable ends, which lit the loft gallery, are blocked.

Heddon Mill: east elevation

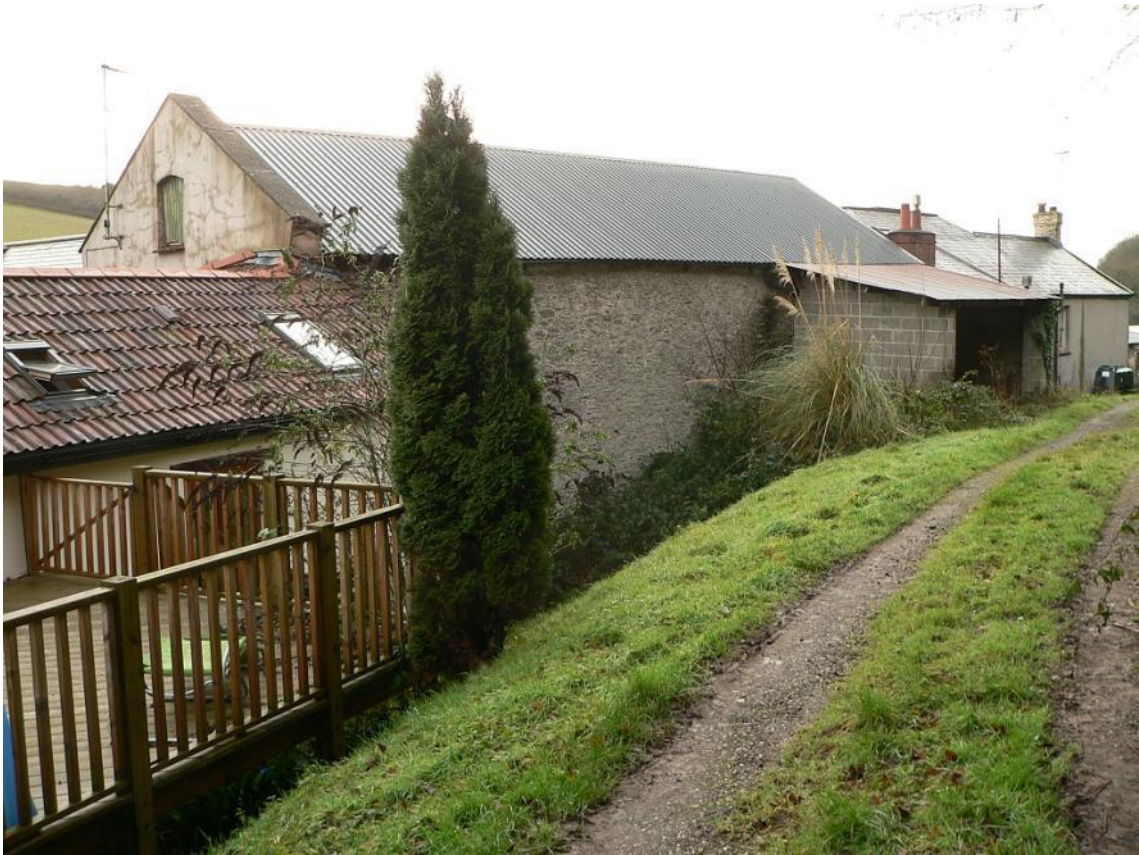
The walls are of random rubble stone, with a gable roof now clad with corrugated metal sheeting. The principal front elevation (east) is cement rendered and colour-washed cream with a black painted base. The rear (west) elevation, which is built alongside, rather than directly into, the bank which carried the leat, is rubble stone. Only the upper parts of the gable ends are visible above the adjoining buildings; the north gable is rendered with a concrete capped verge and the south gable has some exposed rubble stone and is rendered above the level of the villa roof.

Heddon Mill: west elevation, from north-west, showing level of former leat bank

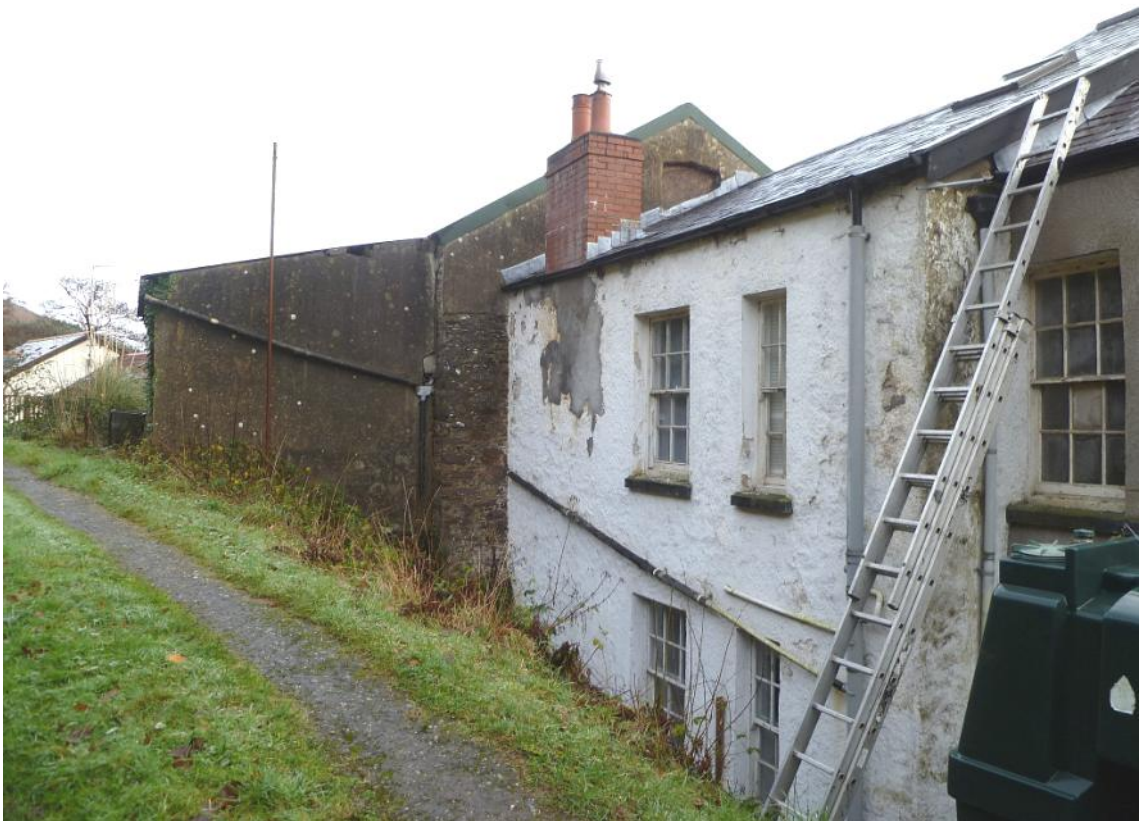
Heddon Mill: rear of villa and mill, showing south gable and extension over intake pit

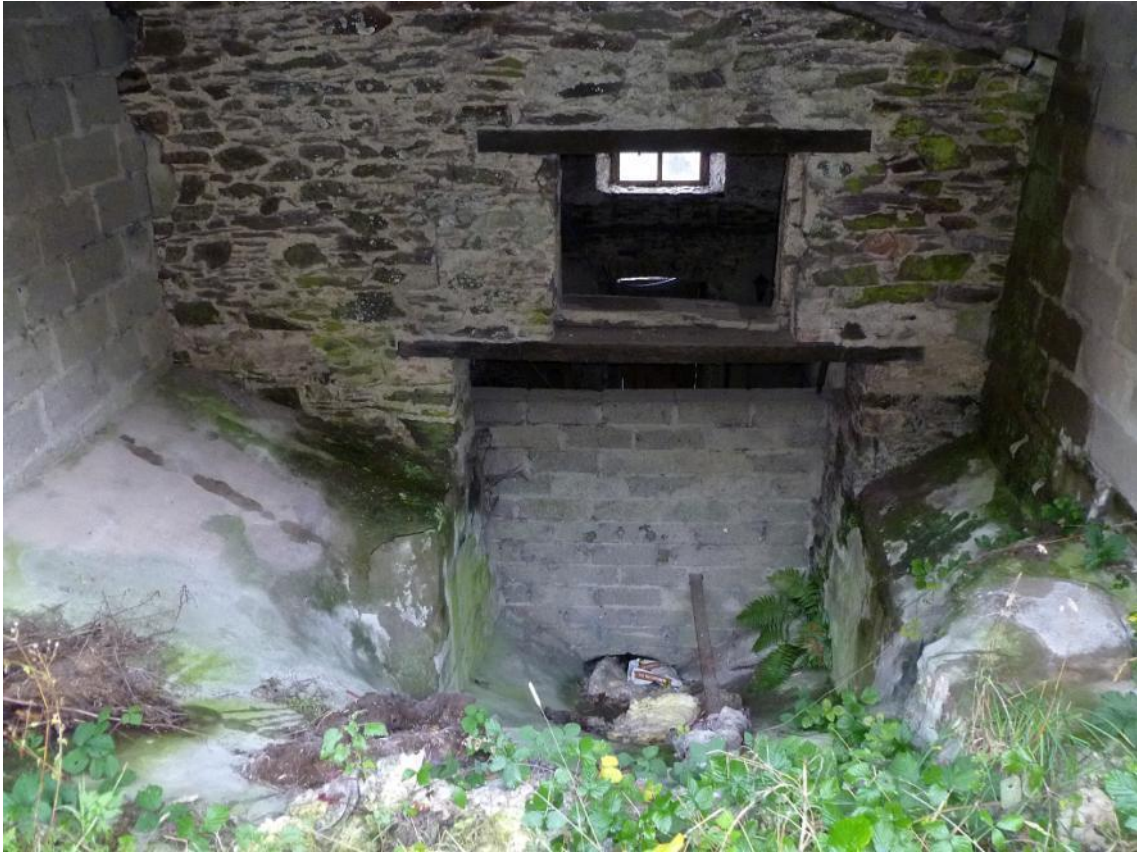
Projecting from the west side is a concrete block-walled extension, rendered externally on its south side only, with a lean-to roof clad with corrugated sheet. This encloses a concrete hopper-shaped intake pit, which was built to take grain tipped into it from the leat bank level. This structure partly occupies the position of the former launder which fed the internal waterwheel.

Intake pit on west side

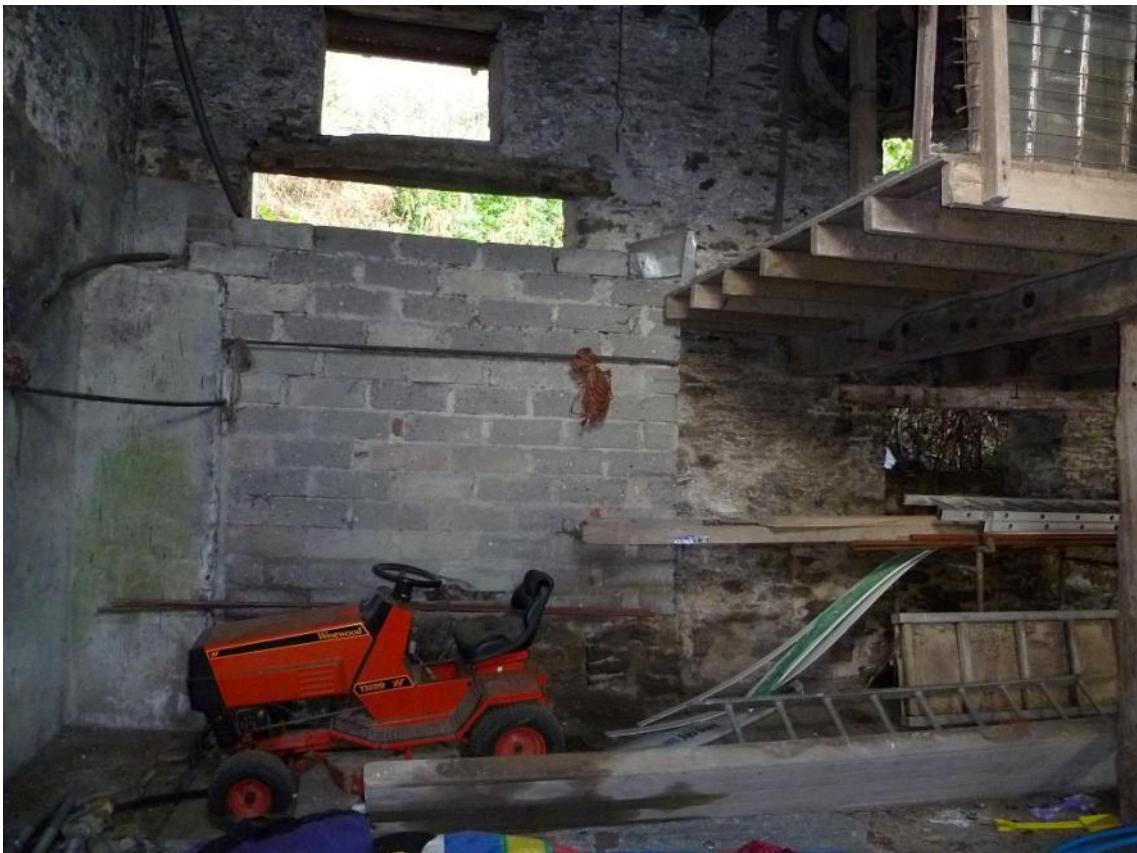
Interior view of blockwork wall to intake pit, south end of ground floor looking west

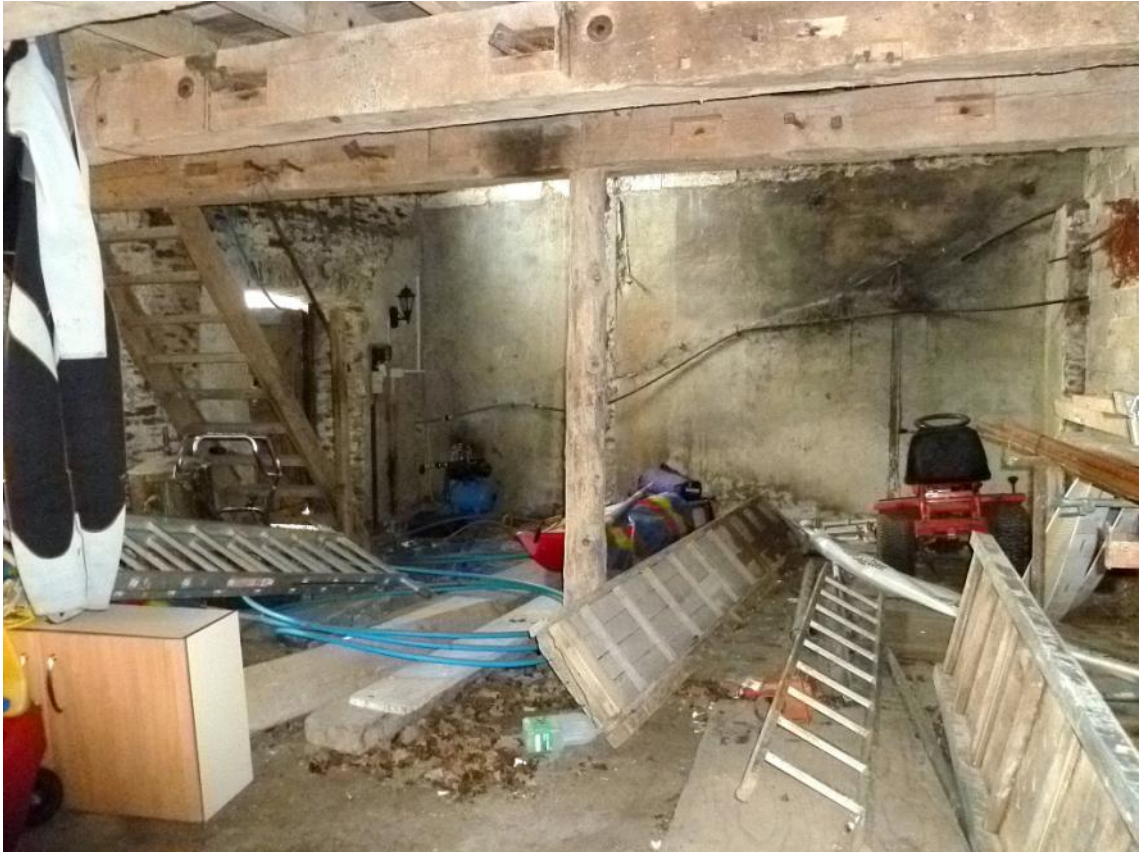
The first floor is open at the south end, over the pit, and at also at the north end. The central section has a suspended timber floor, with three principal cross beams to the north of the pit area which retain clear evidence in the form of mortises and fixings where the stone beams - the timber beams that supported the lower millstones - were located. There appear to have been three pairs of millstones conventionally arranged around a central vertical shaft (see Figure 8 and discussion). Some lubricant throw on the north face of the southernmost beam indicates the position of this shaft. There are also housings and some bolts through the beams, where vertical bridge posts were fixed. The central of the three beams has an inclined slot cut out at its west end, close to the wall. This was for a belt to pass from the wide pulley on the layshaft at first floor level down to the ground floor. The remaining first floor structure is not in bays, the floorboards being laid on deep softwood joists, of 280 x 80mm section at 0.44m centres., which span the width of the building. Some herringbone strutting remains between the joists in places and some of the timbers, which are of imported softwood, have quality or shipping marks visible on them.

Ground floor looking south, showing ceiling beams with mortises and positions of timbers that formerly supported three pairs of millstones

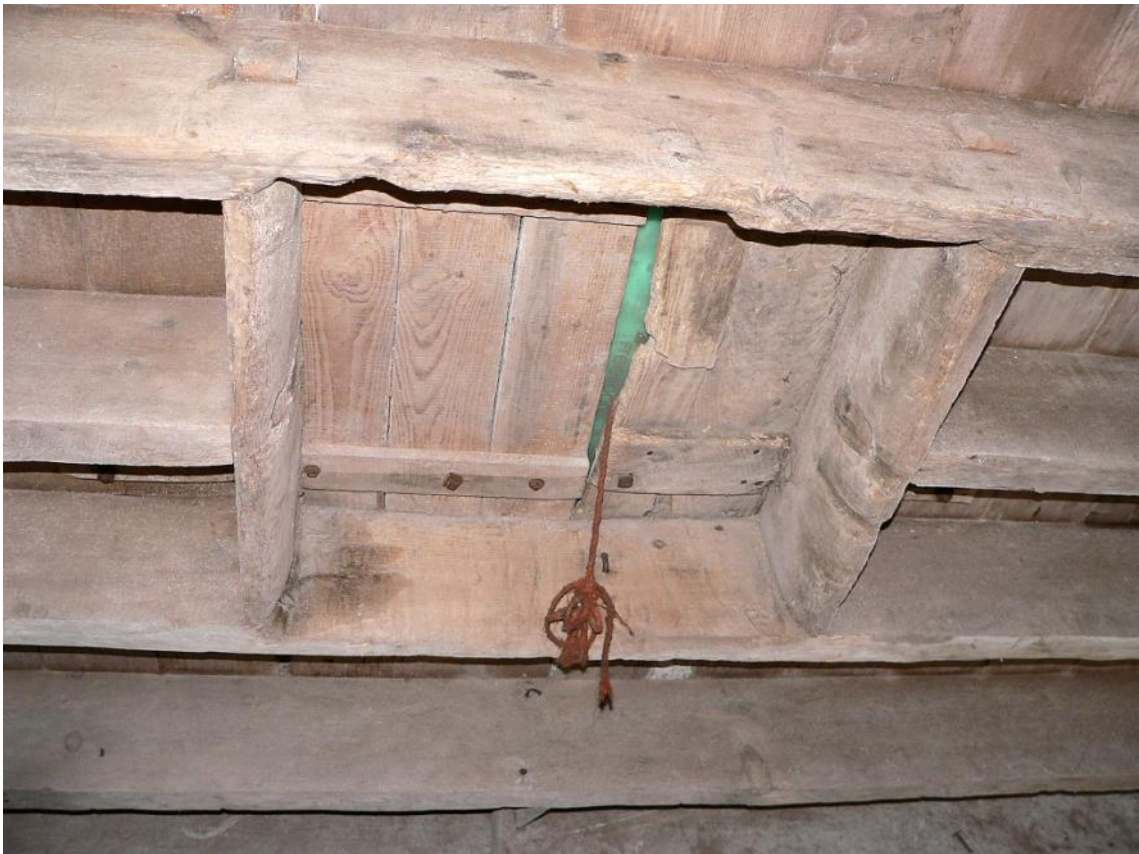
The circular shaft runs in two bearings, one just inside the west wall and the inner on a cast-iron hanger bolted to a timber which is hung from the underside of second floor joists. There are sack traps set in the floor, the trimmed joists around the opening below showing signs of abrasion from the hoist chain.

Sack trap opening in first floor. Note chain abrasion on trimmers

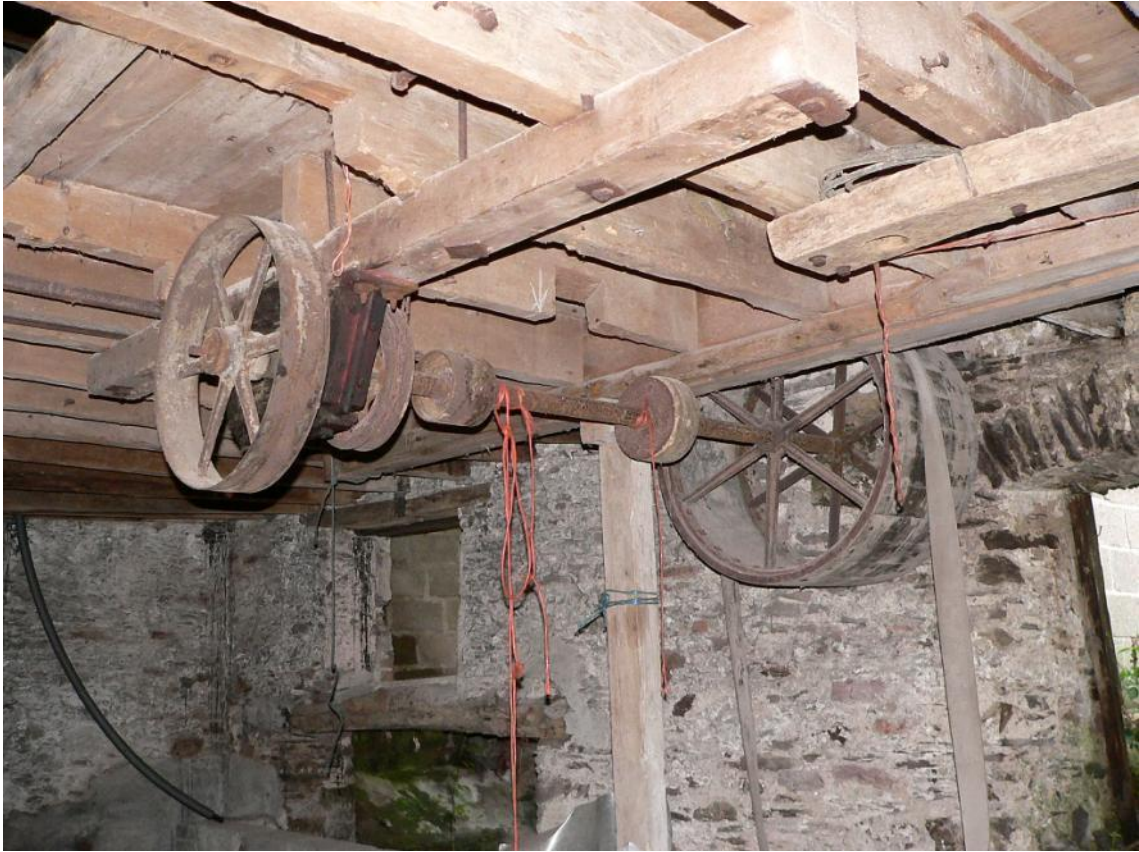
The first floor is reached by a set of steps which rise from the solid floor at the downstream end of the pit. This is not considered to be their original position. On the west side at the head of the steps is a short layshaft, running east-west, which carries four belt wheels and a chain drive wheel, from the west as follows:

The layshaft at first floor level, although in the right position to have been driven by the water-powered machinery to work the sack hoist and ancillary equipment at first floor level, appears to have been modified, as there is no provision for a gear drive as would be found with a conventional spurwheel drive layout implied by the positions of the millstones (see Figure 8). In the 1821 advertisement, a 'bunt' (a sifting machine for making fine flour) and a large grindstone (used for sharpening the tools for dressing the millstones, for example) are referred to and these would have been located at first floor level, driven by belt from a layshaft. The cut out in the end of one of the main beams, to allow a drive belt to pass down through the first floor, may be a later alteration so that the layshaft could be driven from an engine or motor located on the ground floor.

Layshaft and pulleys below first floor ceiling

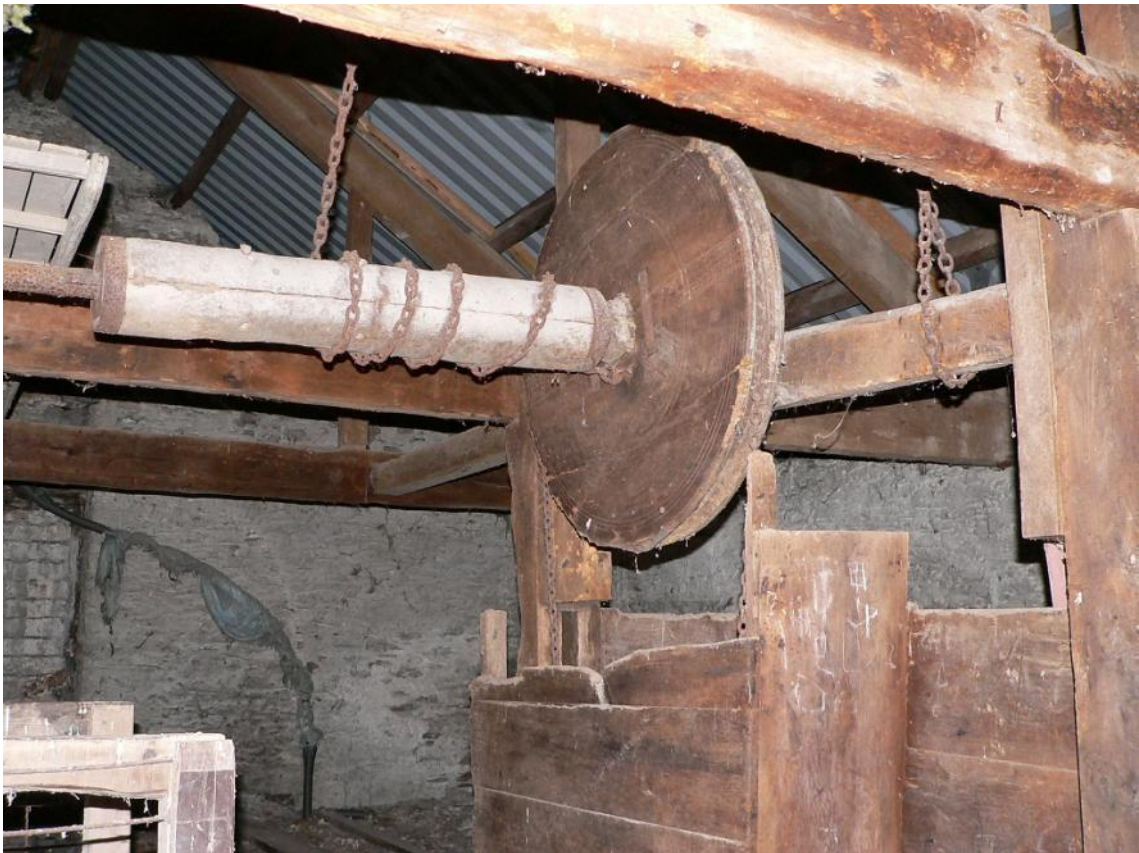
the bay. The hoist chain, with guide sheaves below the ridge, and the control lever which raised the chain drive wheel and drum to engage the hoist, are still in place. The sack hoist well is boarded up to tie beam level on three sides, being open on the south side. There are the remains of a central walkway or gallery set on top of the tie beams between the queen posts, from which bins (no longer surviving) on both sides of the loft would have been fed from sacks of grain raised to the upper level by the hoist. High level windows in both gable ends formerly lit the walkway; these are now blocked.

Sack hoist drive wheel and drum in loft

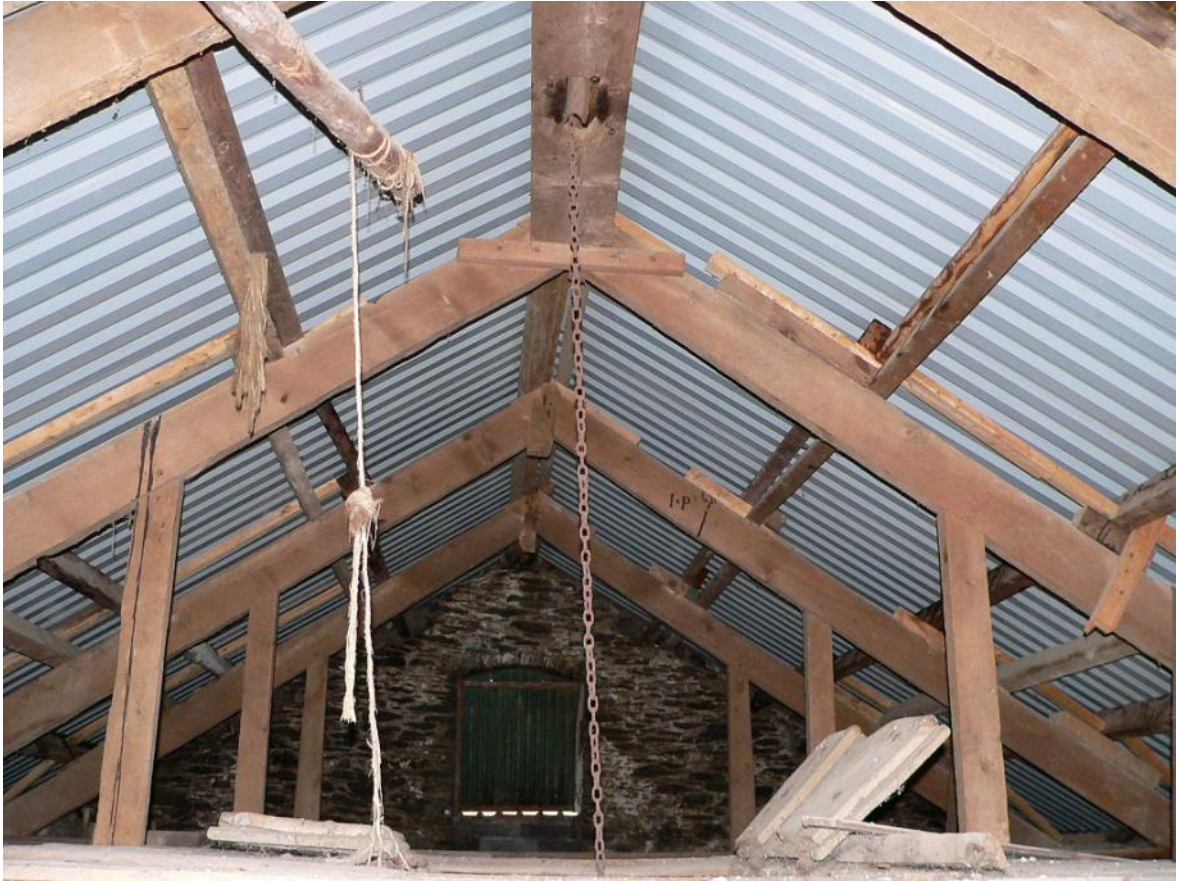
The gable roof is of eight bays, defined by seven queen post trusses. The tie beams are built into the wall heads on both sides, and are 230 x 100mm section imported softwood timbers. The principal rafters are 230 x 80mm section and the queen posts 130 x 80mm, set 2.8m apart. There are several rows of purlins randomly spaced across the backs of the principals on both slopes, and a pair of ridge purlins. Some of these timbers appear to have been renewed, presumably when the corrugated sheet cladding was put on. Three of the tie beams, on the south sides of bays 4, 5 and 6, have a cut-out arched relief close inside the east wall, either to provide working headroom or for some equipment or machinery to be located there.

Roof structure, looking north, with sack chain to centre above gallery floor

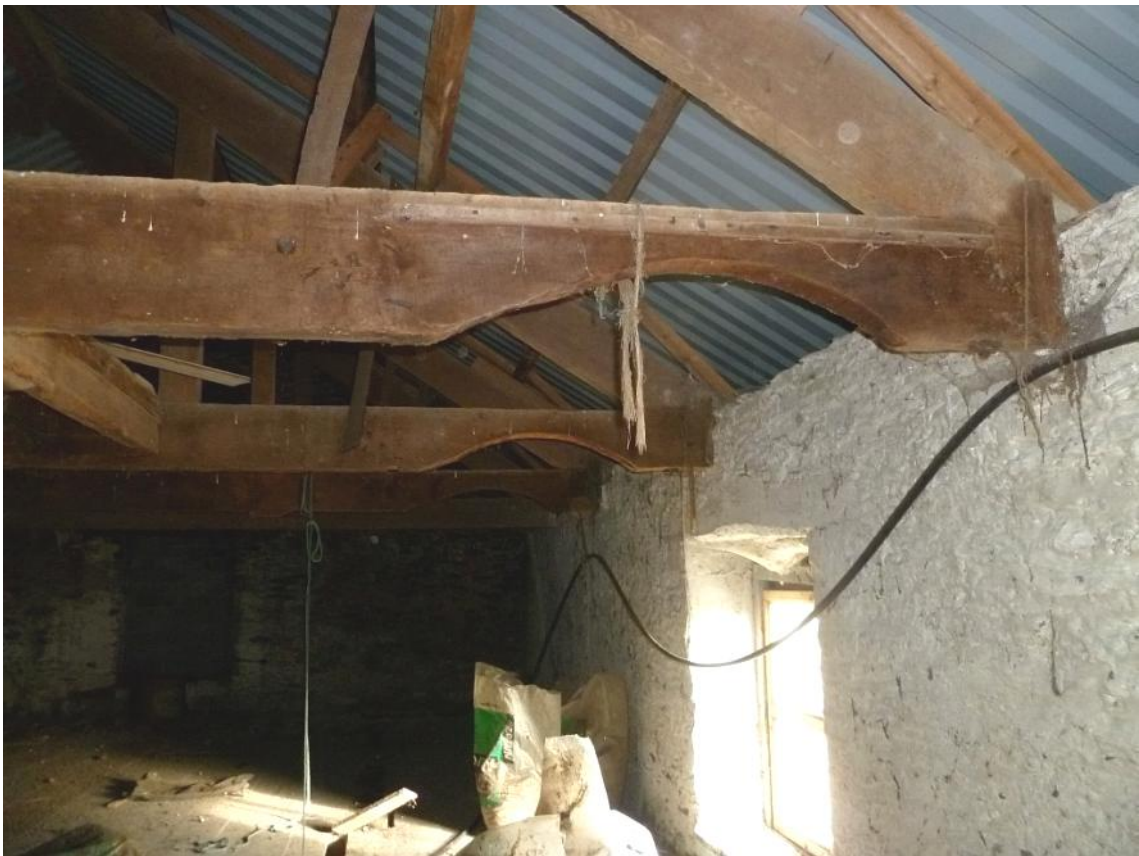
Cut-outs in roof truss tie beams, looking north-east
