LINHAY AT LOWER WESTOWN HEMYOCK, DEVON

HISTORIC BUILDING RECORDING

June 2015

Project LWL254

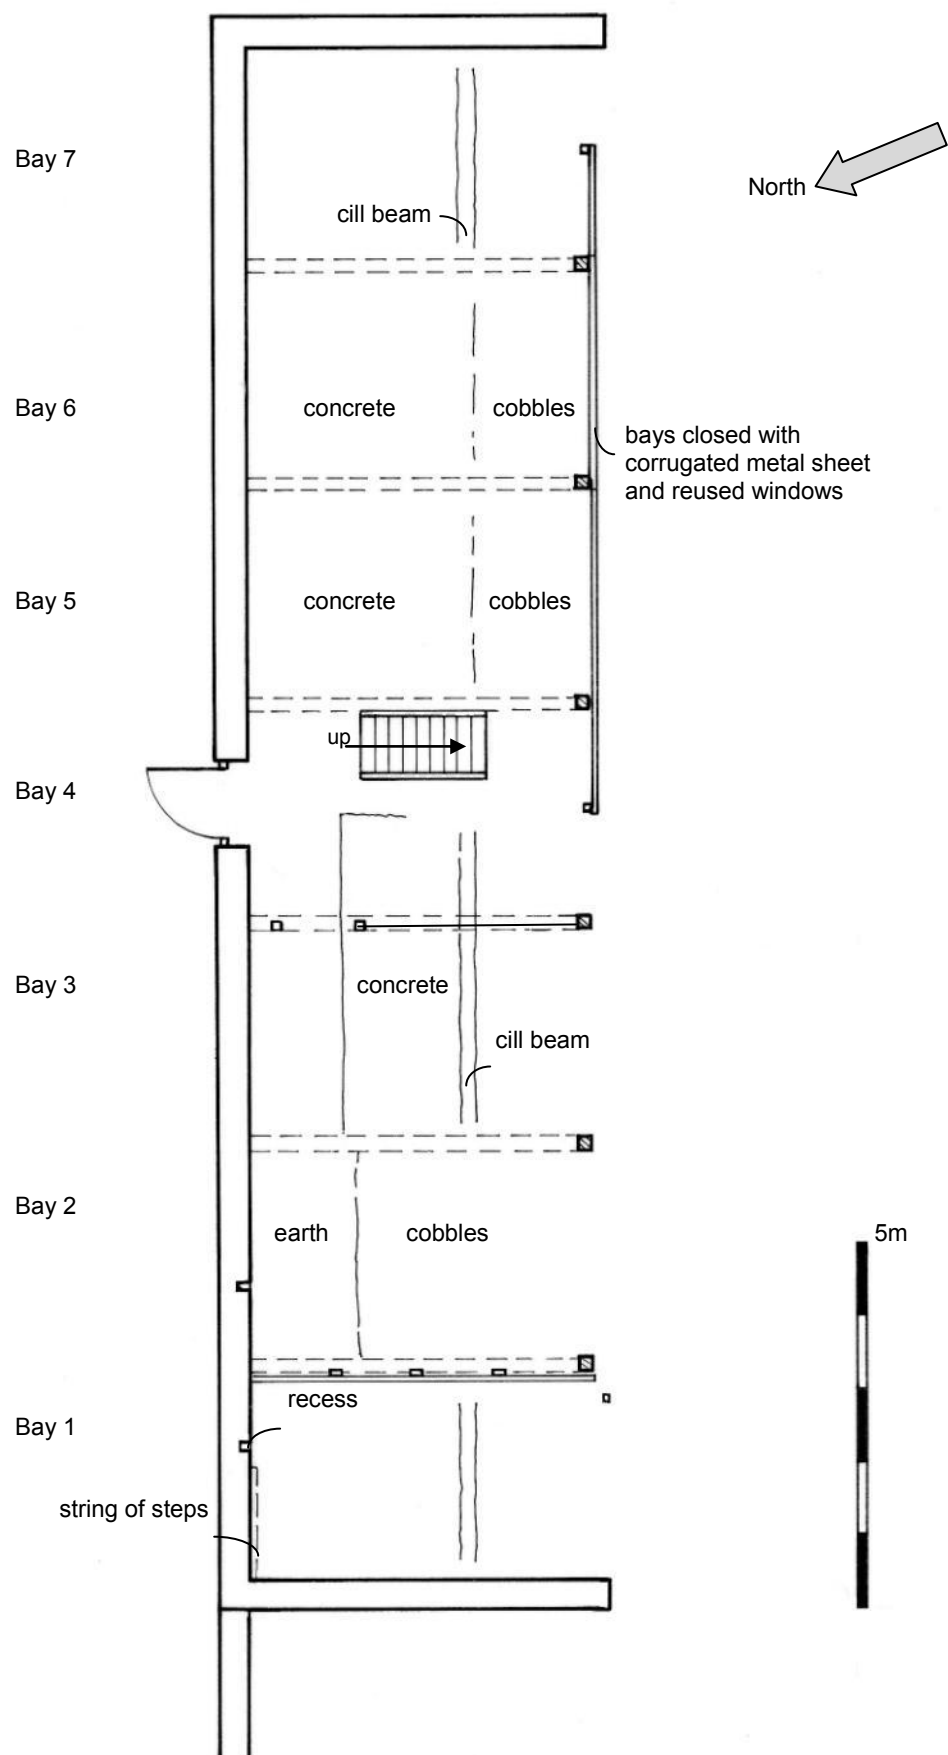
Figure 5: Lower Westtown linhay: ground plan

The principal features of the ground floor are shown on the plan (Figure 5) and the roof construction on the section (Figure 6). For the purposes of this report the bays are numbered from west to east and described as follows:

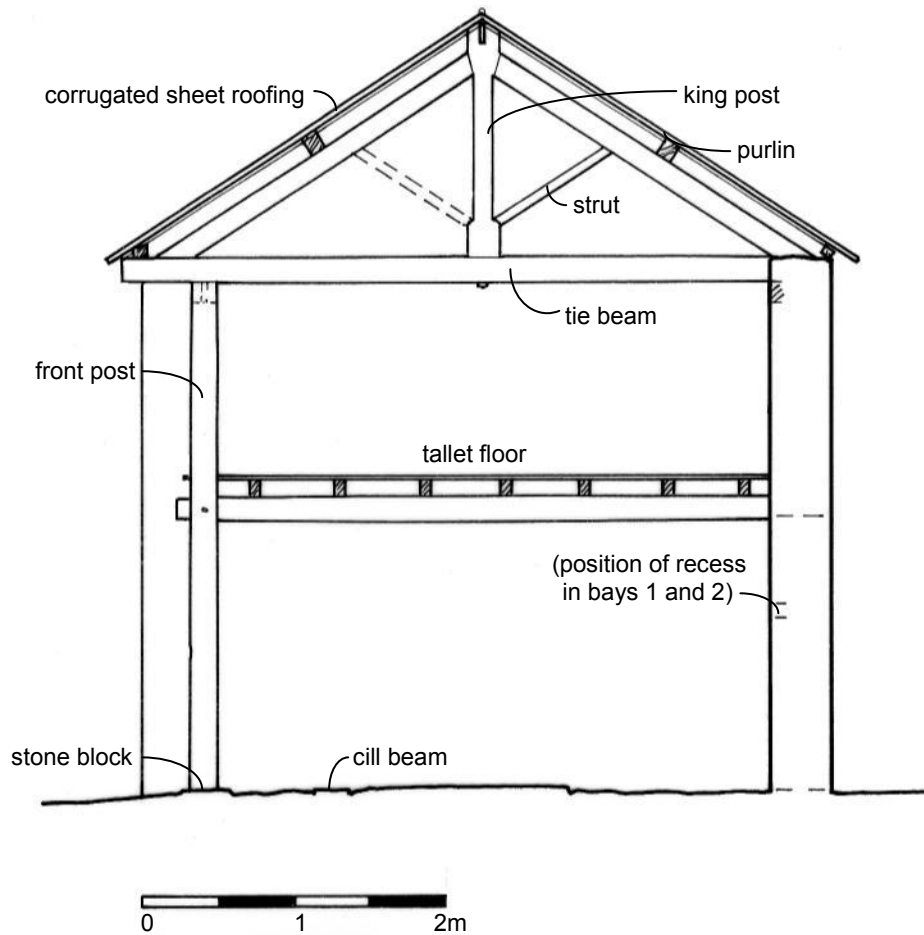
Figure 6: Lower Westown linhay. North-south section, looking west

The roof is carried on six trusses which are all of similar construction, with tie beams, king posts, struts and principals, the feet of which are tenoned into the tops of the tie beams. The timber used is a mixture of hardwood, oak and possibly elm and/or ash, with some pine. The roof pitch is about 33 degrees. Typical dimensions are: tie beam: 17cm by 10.5cm; king post: 21cm by 8cm at foot and head, shouldered down to 11.5cm by 8cm for the central part; struts: 5cm x 8cm; principals: 15cm by 9cm. The tie beams project beyond the heads of the vertical bay posts, which are tenoned into them, by about 0.5m. The heads of the front posts to bays 1-2 and 2-3 have both been heightened by about 20cm, with re-used timber pieces tenoned into them (see photograph). The raking struts, which were nailed to the sloping shoulders near the foot of the king posts and to the underside of the principals, were originally on both sides, but several are now missing. The original ridge appears to have been a single vertical board, now with timber plates added on both faces. The king posts are bolted through the tie beams with a vertical bolt and captive square nut set into the foot of the king post on the west side.

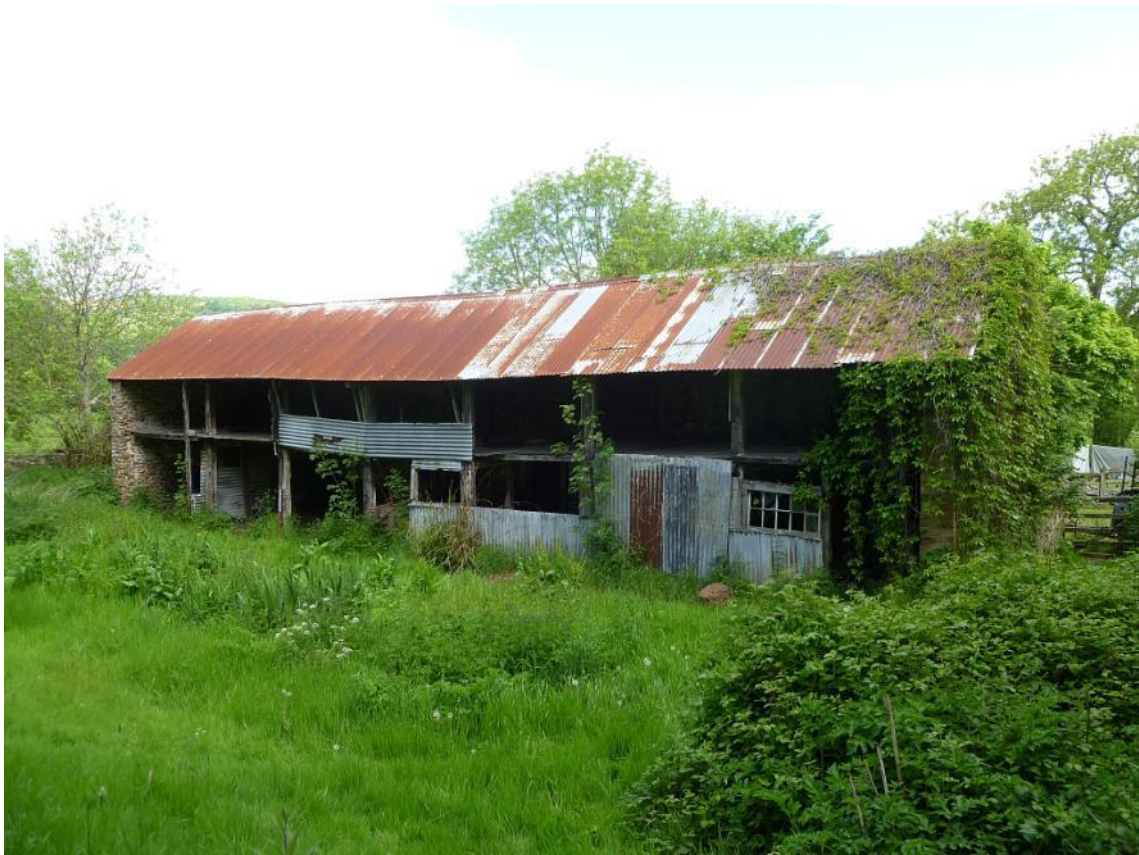
Lower Westown linhay, from the south

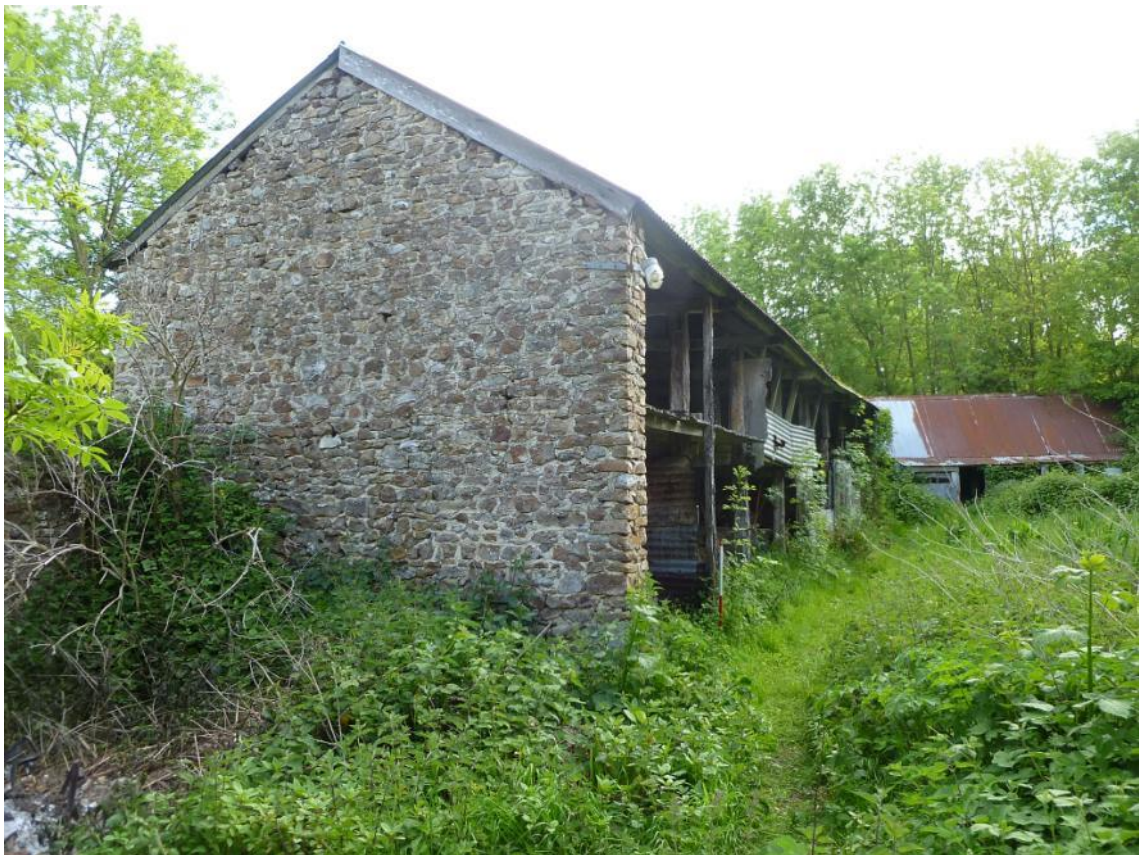
West gable end of linhay, with outbuilding to east

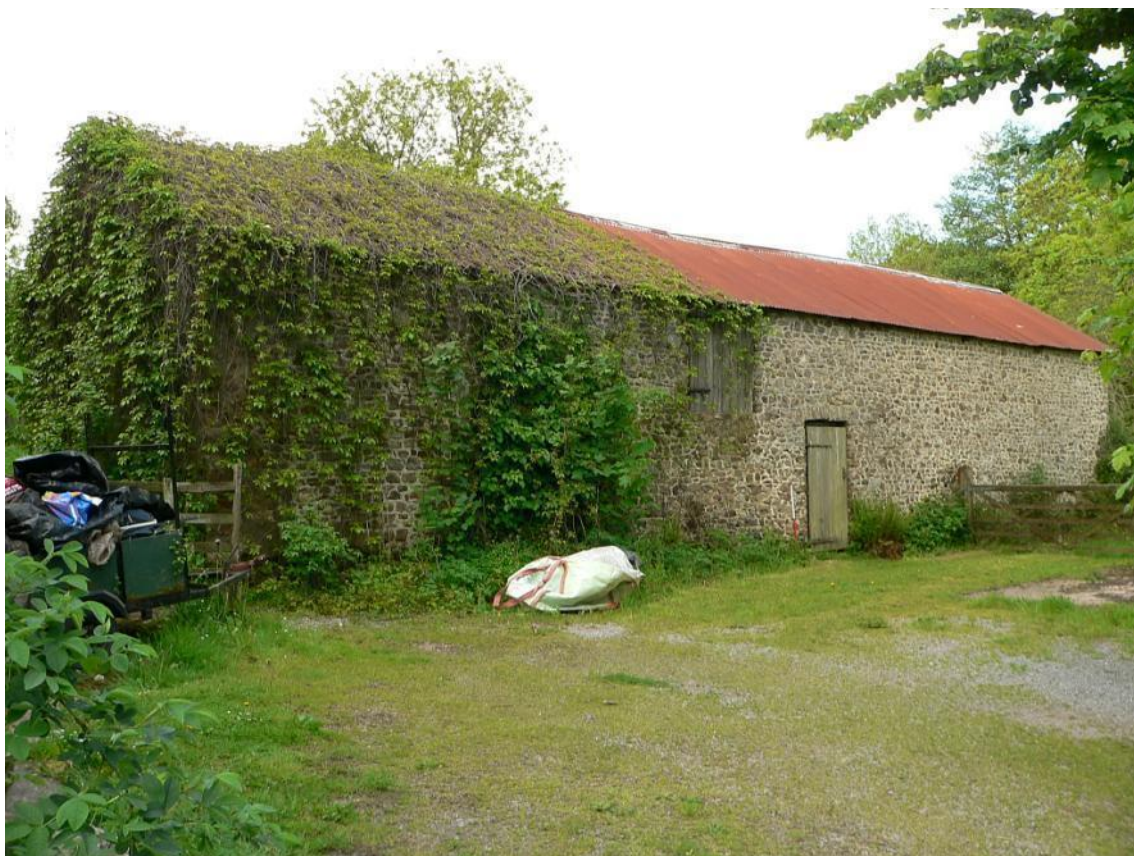
North elevation of linhay, from the north-east

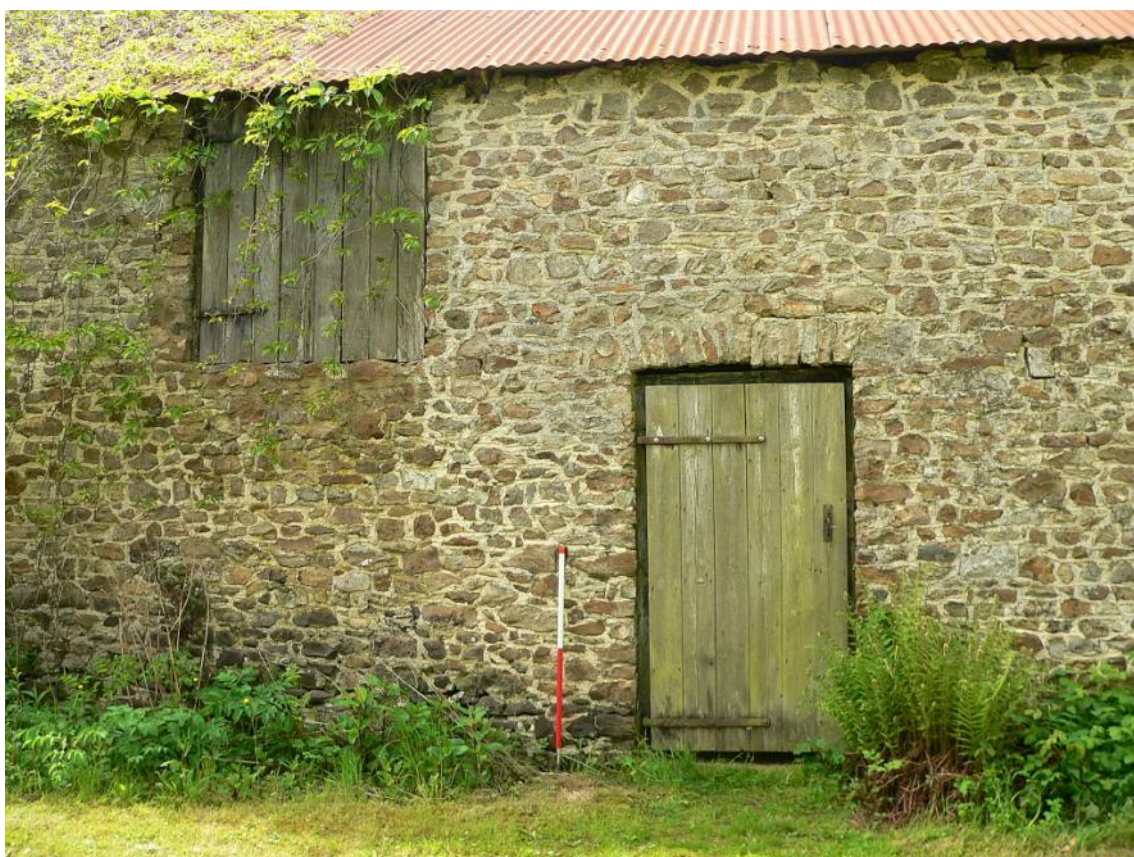
Doorway into central bay of linhay with loading door above to the left

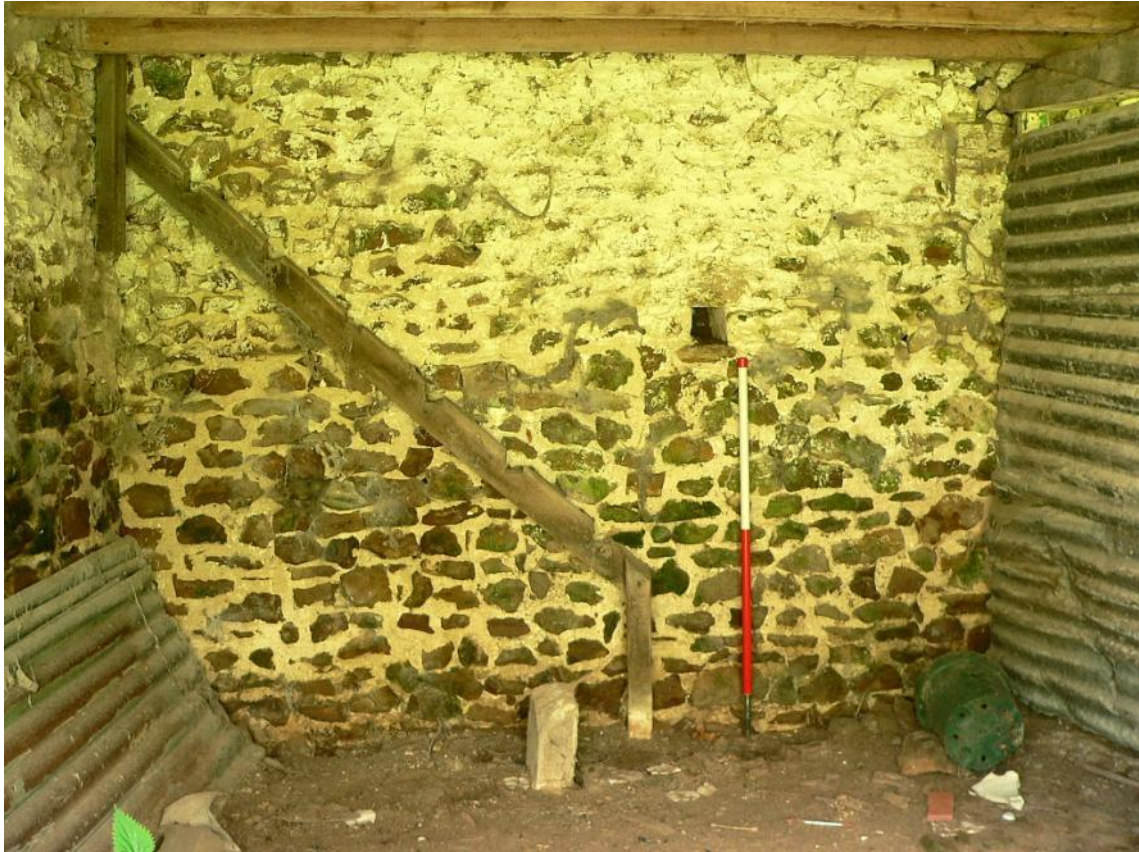
Bay 1: has the remains of a cobbled floor, with a timber cill beam set in floor 2.77m off the rear wall which forms a front edge to the cobbles. Fixed against the rear wall in the north-west corner is the string of a set of steps which led up to the tallet floor. The outer string is displaced and re-used as a prop against the partition between bays 1 and 2. There is a small recess in north wall, 10cm wide by 11cm high, 1.7m in from west gable (see photograph). The purpose of this is unclear. The tallet floor is carried on nine softwood joists of 10 by 5cm section, at about 40-50cm centres, the spacing and number of joists varying slightly from bay to bay. Some bays have an outer joist in front of the front posts. The joists have been renewed, their west ends being cemented into the gable wall.

Rear wall of bay 1, with string of steps up to tallet floor

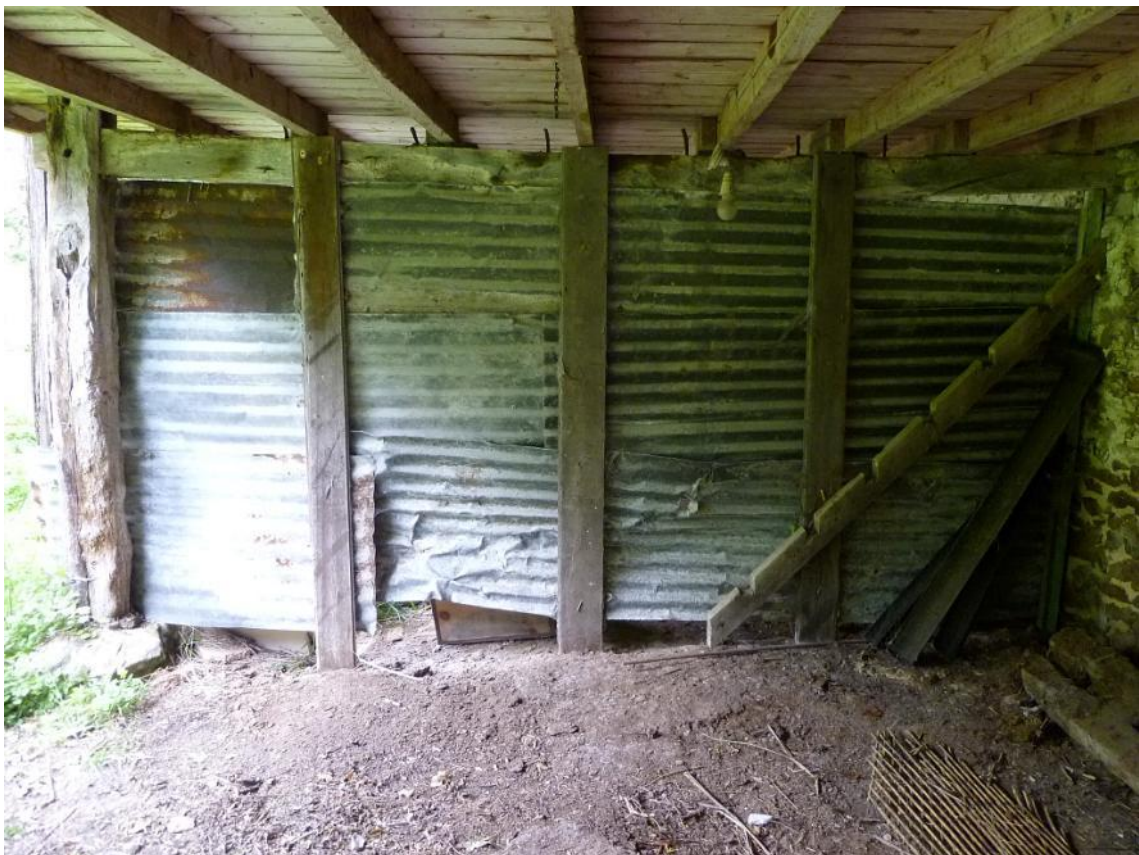
Bay 2: has the remains of a cobbled floor from about 1.5m off the rear wall. There is a small recess in the rear wall, 9cm wide by 10cm high and about 20cm deep, in a similar position to that in bay 1. A timber post and horizontal corrugated metal sheet partition has been inserted between bays 1 and 2. The beam between bays 2 and 3 has been scarf repaired at its north end and has a carpenter's mark 'l' on its west side near the front post. The tenon on the south end of the beam projects 13cm beyond front post, to which it is pegged with a single peg of about 2.5cm diameter (see photograph). The front post between bays 2 and 3 stands on a roughly squared stone block. It is a very wormy timber, with hinge pintles driven in for lower half doors to both bays. The top of the post has been repaired by a block tenoned into it, similar to the post between bays 1 and 2. The tallet floor is carried on seven joists over bay 2, the joists running over the tops of beams between bays 1- 2 and 2 - 3.

Inserted partition between bays 1 and 2, looking west, showing outer string of steps reused

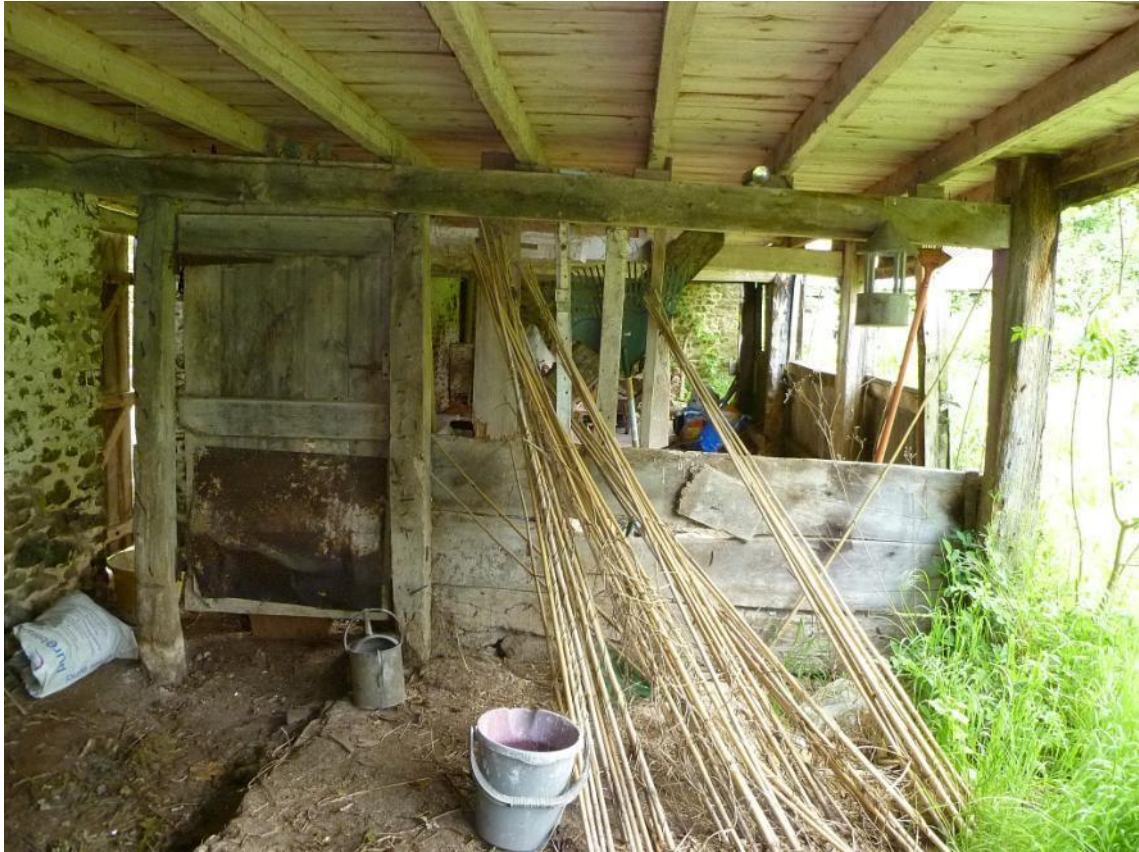
Bay 3: has concrete laid over the cobbles over part of the floor. It appears that the cobbled flooring has been deliberately removed along the rear (north) of bays 2 and 3, perhaps to create a passage with greater headroom. The beam between bays 3 and 4 has been renewed. There are two vertical timbers under it towards the rear, forming door posts for a re-used vertically-boarded door, and some horizontal timber boarding between this doorway and the front post. The tallet floor joists run over top of the beam, off which they are packed, with thicker packing towards the front as the beam falls slightly at its outer (south) end. The front post stands on a stone block, the top of which is set flush to the ground. The upper front parts of bays 3 and 4 have been partially closed with horizontal corrugated metal sheeting.

Inserted partition between bays 3 and 4, looking east

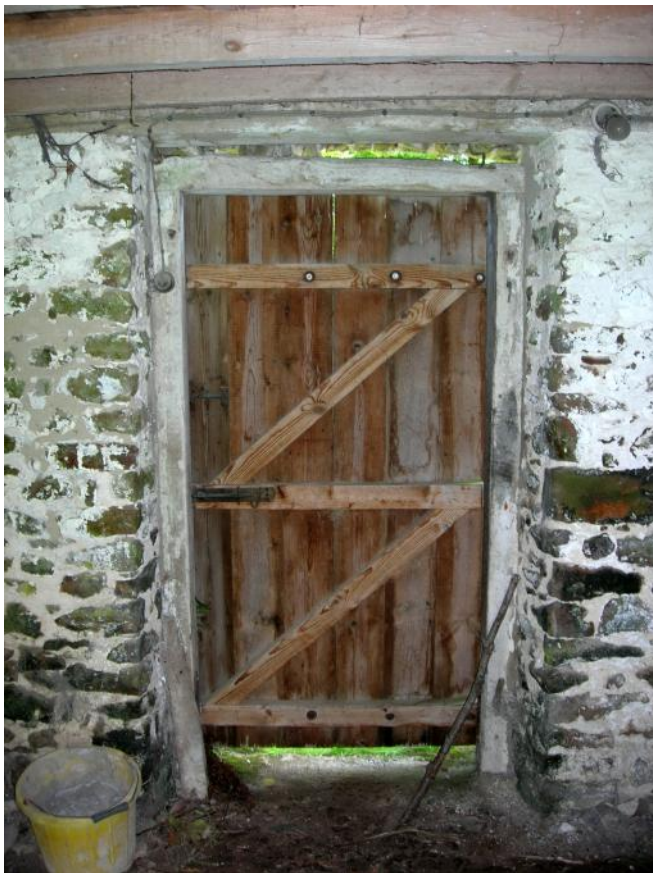
Bay 4: the concrete slab flooring in bay 3 extends into the west half of this bay, the remainder of the floor being uneven earth and some cobbles; the timber cill beam set in the floor along the southern edge of the cobbles is clearly exposed. This is the central bay of the building and has a door through the north wall. There is a ledged and braced vertically-boarded plank door hung in a plain pegged frame of hand-sawn sturdy 12 by 9cm oak timbers, the frame being older (?perhaps original) than the door. The door opening has an slightly arched head with stone voussoirs externally on the north side. Above the head of the door and along some of the beams are the remains of electric lighting cables with light fittings and several switches. On the east side of bay 4 is a set of steps which lead up to the tallet floor. The step strings and treads are made from sawn-down former railway sleepers. These steps are not in the original position (see bay 1 above). The beam between bays 4 and 5 has been renewed, similar to that between bays 3 and 4, its outer end falling slightly downwards. It is tenoned through the front post, with timber block under the tenon, and the peg hole for the original beam is now misaligned. There are nine joists with a trimmed opening for the steps. The south front of the bay is divided by a central vertical post. Vertical corrugated metal sheeting extends across the east half of this bay opening and also the front of bay 5.

Door in north wall of bay 4

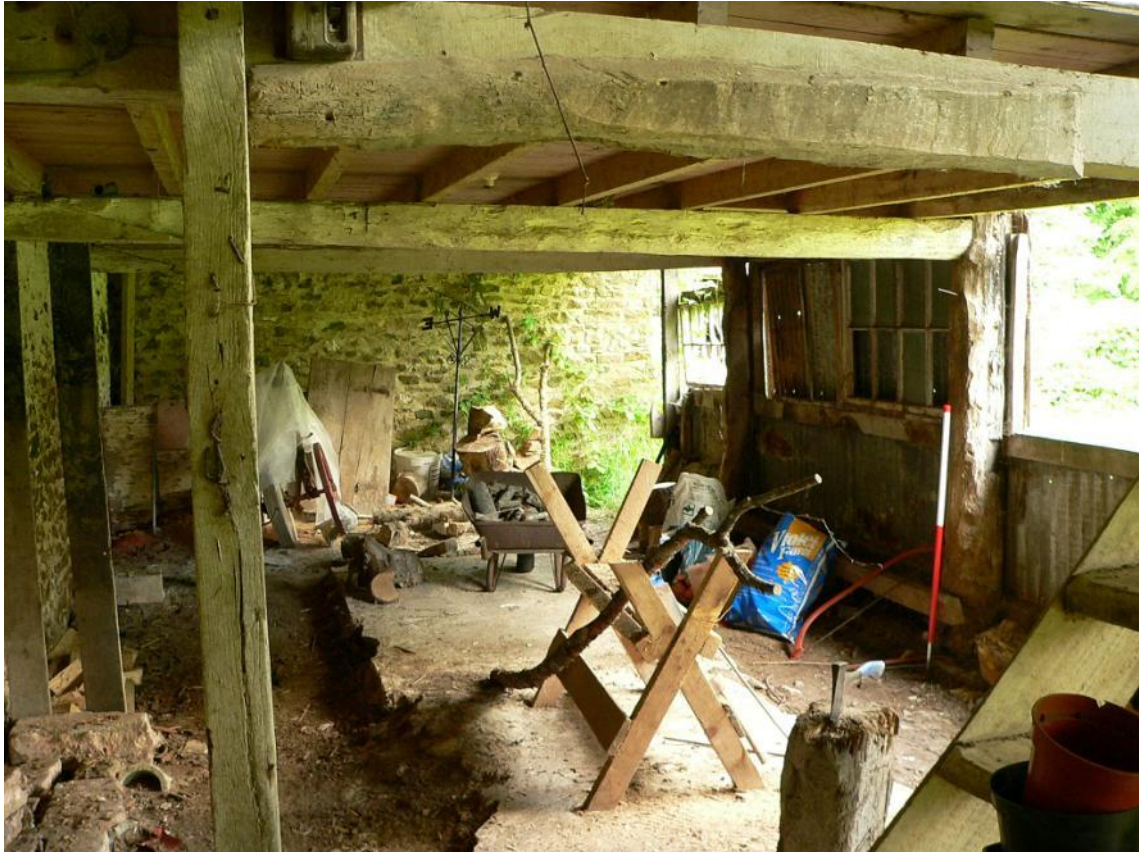
Ground floor interior at east end of linhay

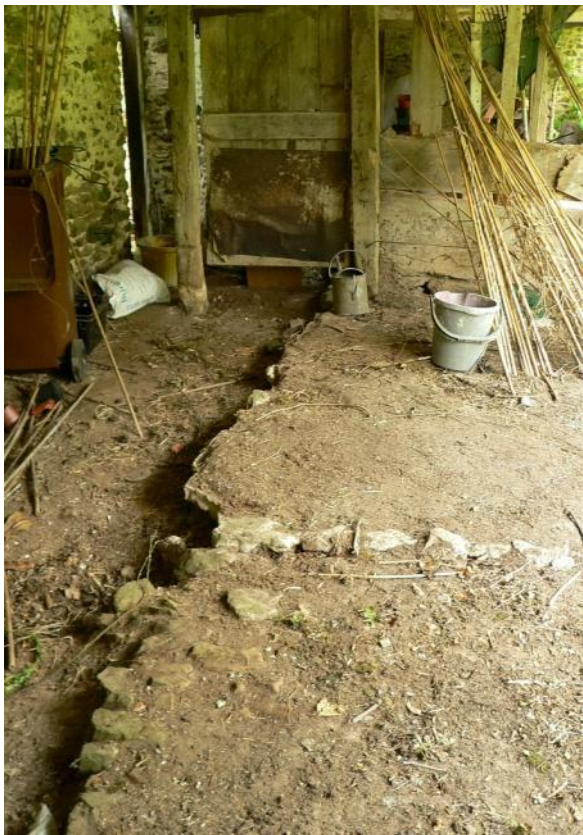
Floor in rear of bay 3, looking east

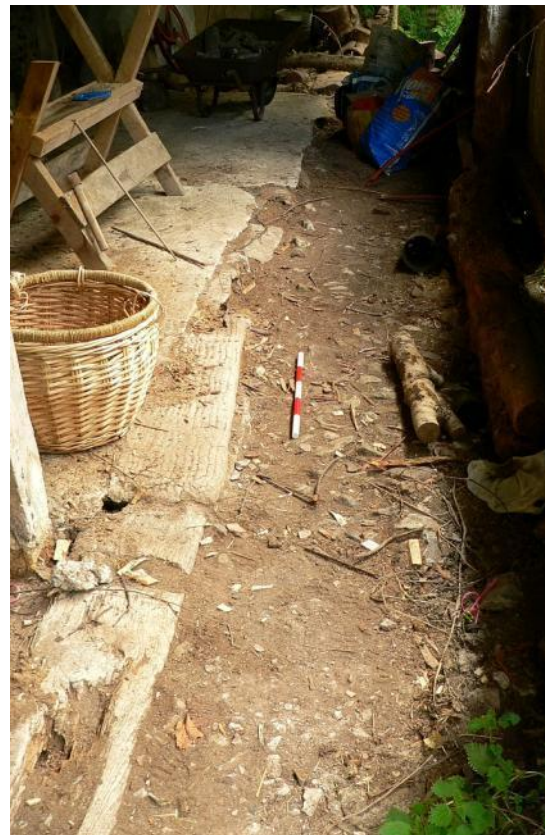
Bay 5: has a concrete slab across middle part of the floor with remains of the timber cill beam exposed. The floor is roughly cobbled floor between the cill beam and the south front of the bay. The beam between bays 5 and 6 has a scarf repair at its north end and the front end is tenoned and pegged through the post. This beam, which has a run-out chamfer on its east side, was white-washed. There is the possible remains of a carpenter's mark on its west side at the front. The front post is a very knotty squared timber standing on squared stone block.

Floor in bay 5, looking east, showing cill timber

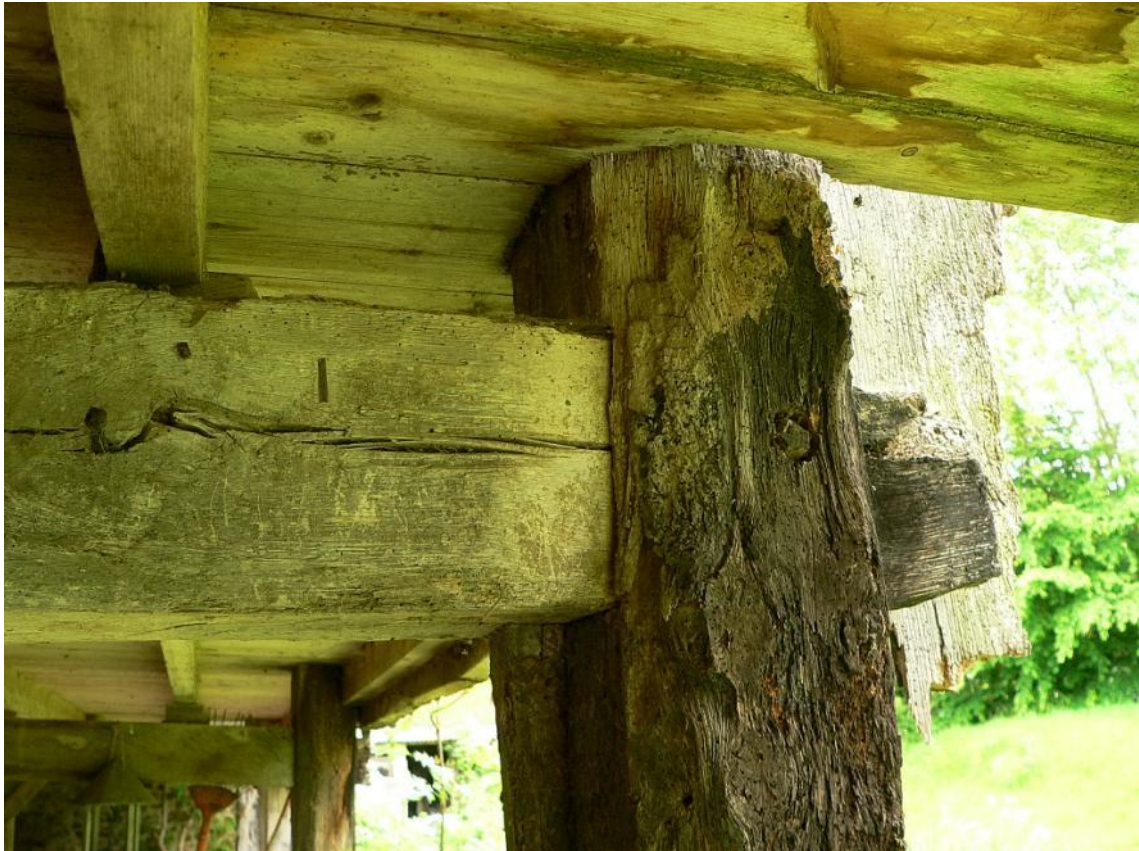
Bay beam, south end, showing carpenter's mark and tenon through front post, bays 2-3

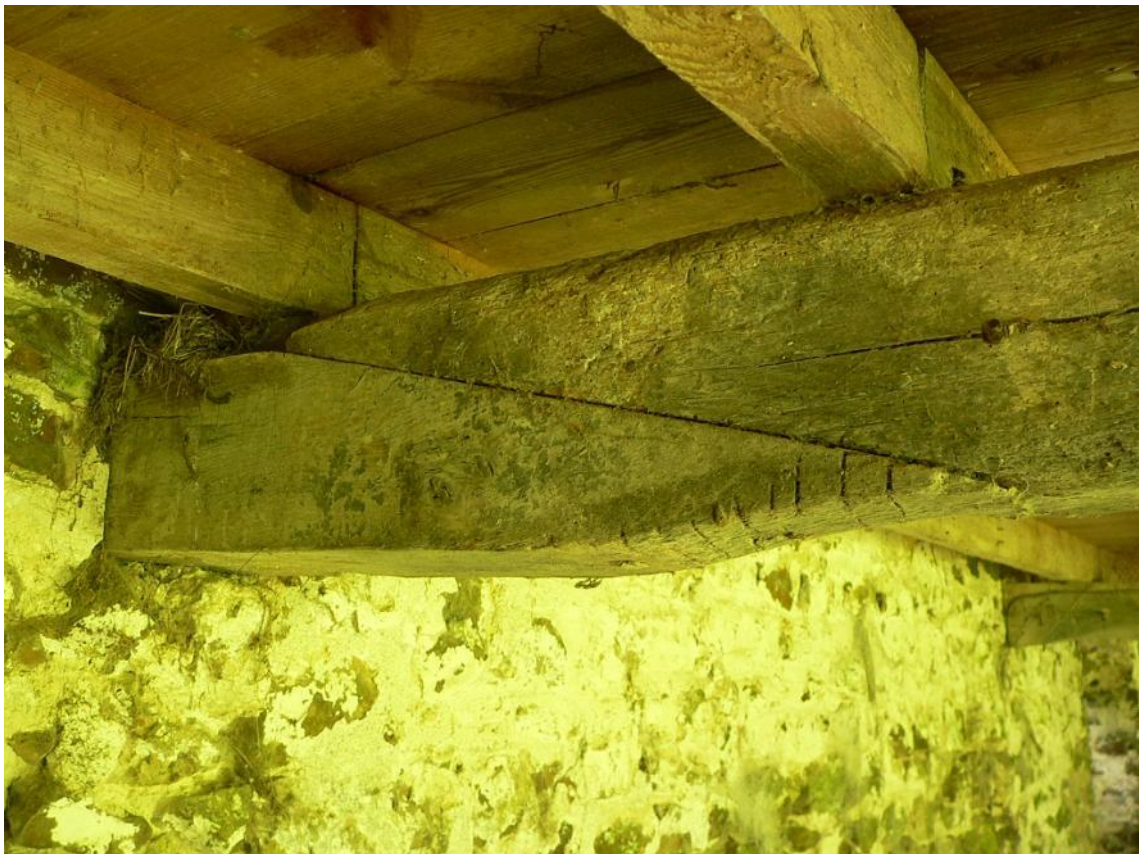
Scarf repair at north end of beam between bays 5 and 6

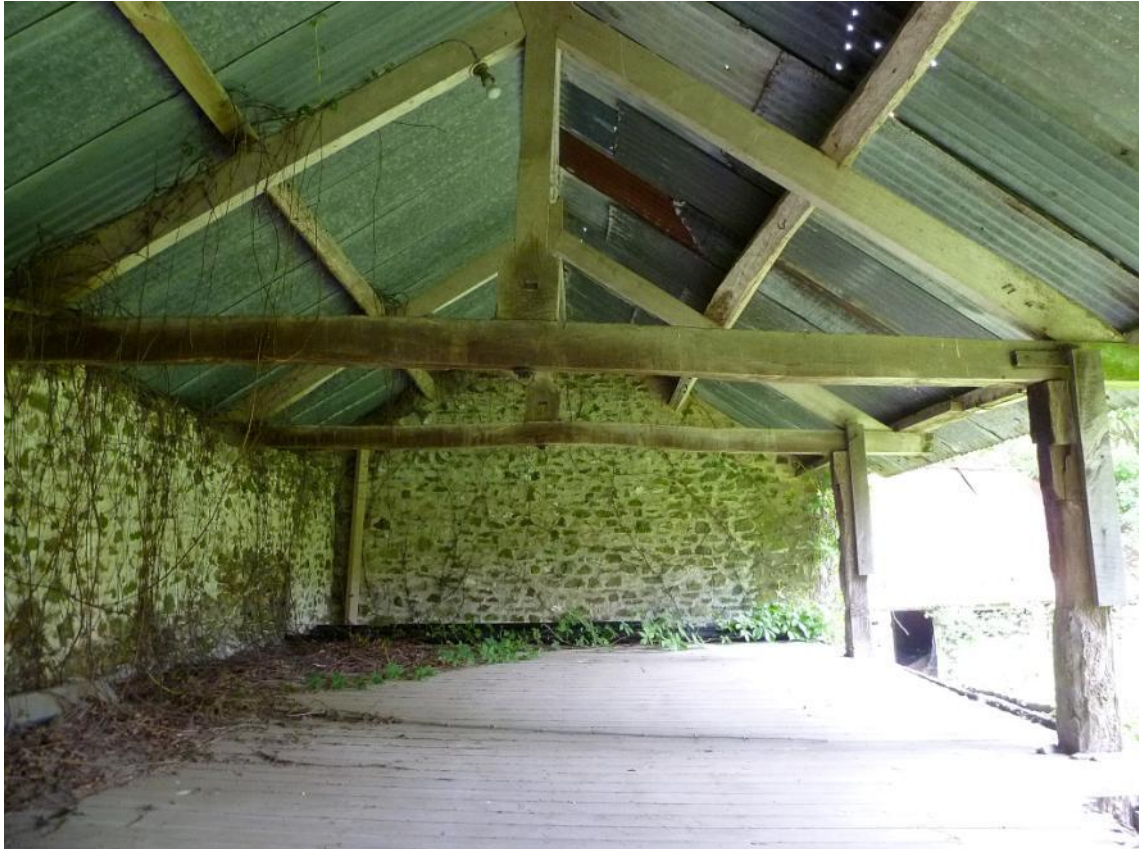
The tallet floor has been completely renewed with ex 18cm wide tongued and grooved boarding nailed to the joists. In the north wall of bay 5 is a loading hatch, with a relatively new vertically-boarded ledged and braced door hung in a plain pegged oak frame. The opening is square-sided, with some brickwork forming the reveals, to full height on the east

Tallet floor, looking east from stairway in bay 4

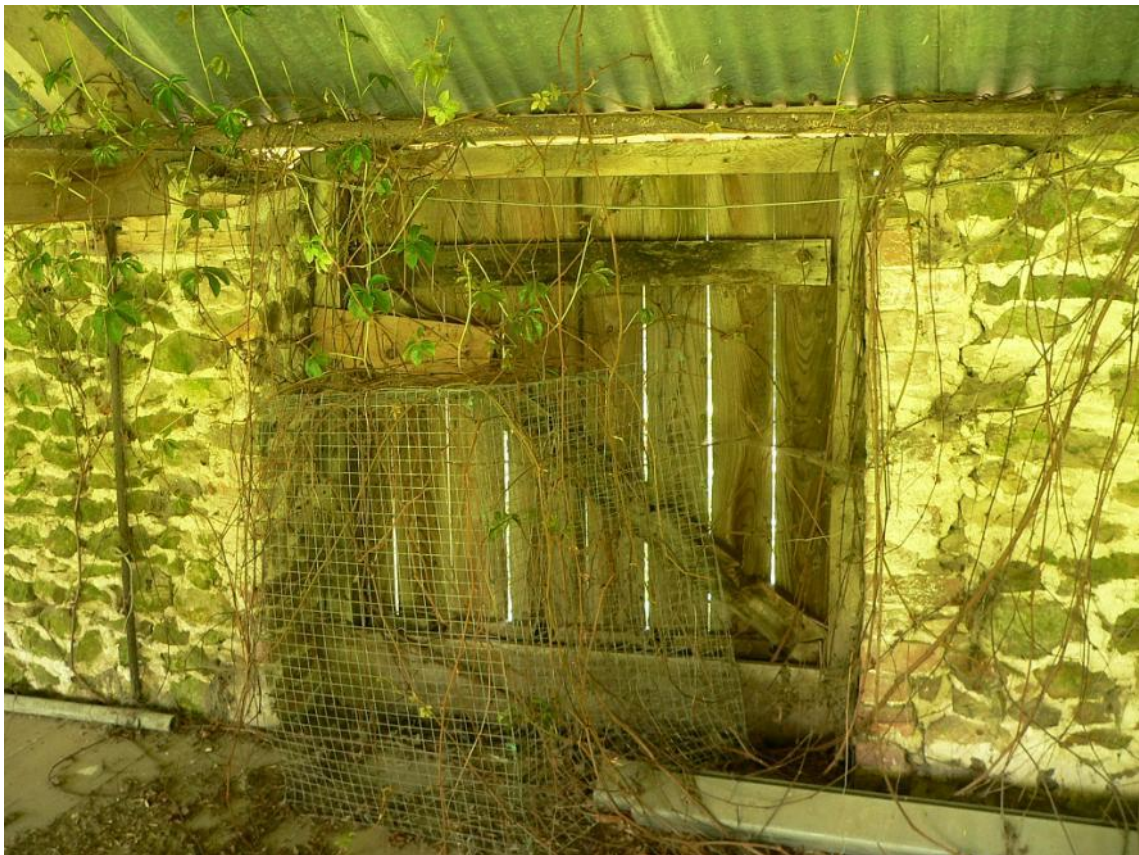
Interior of loading door in north wall of bay 5

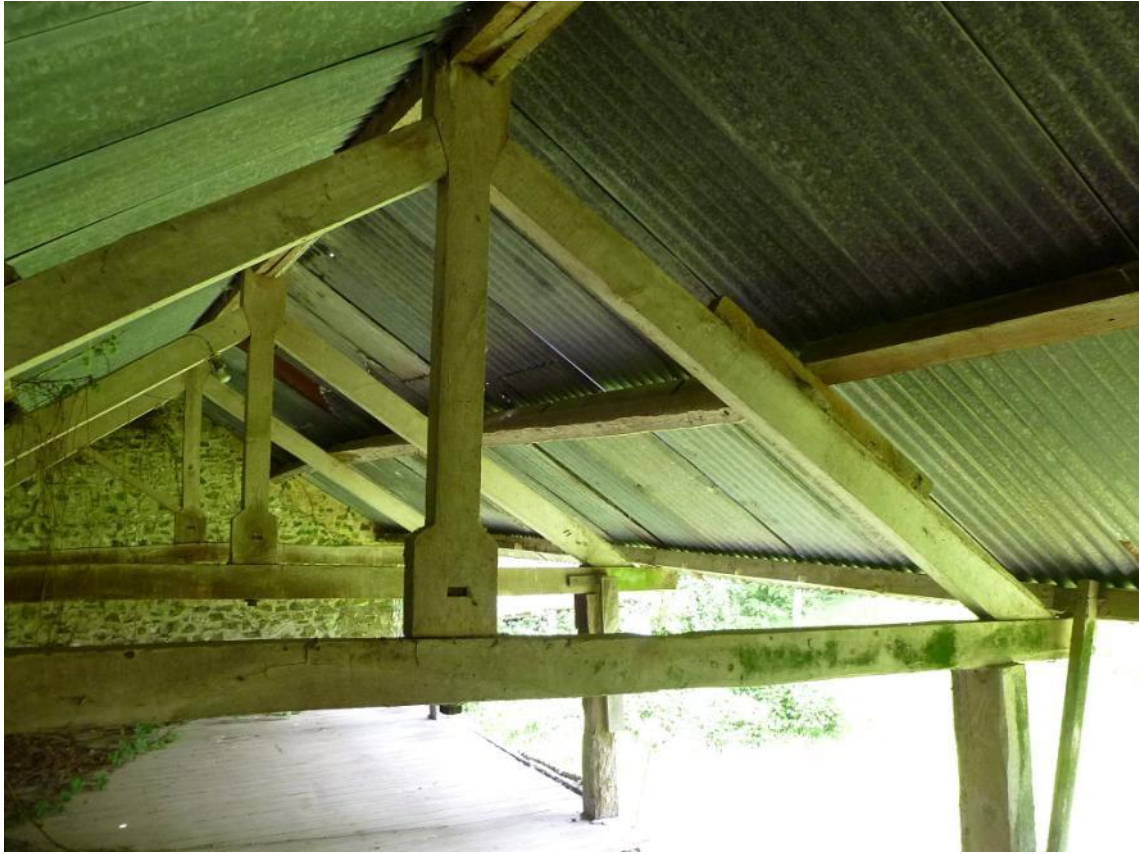
Roof trusses, looking east

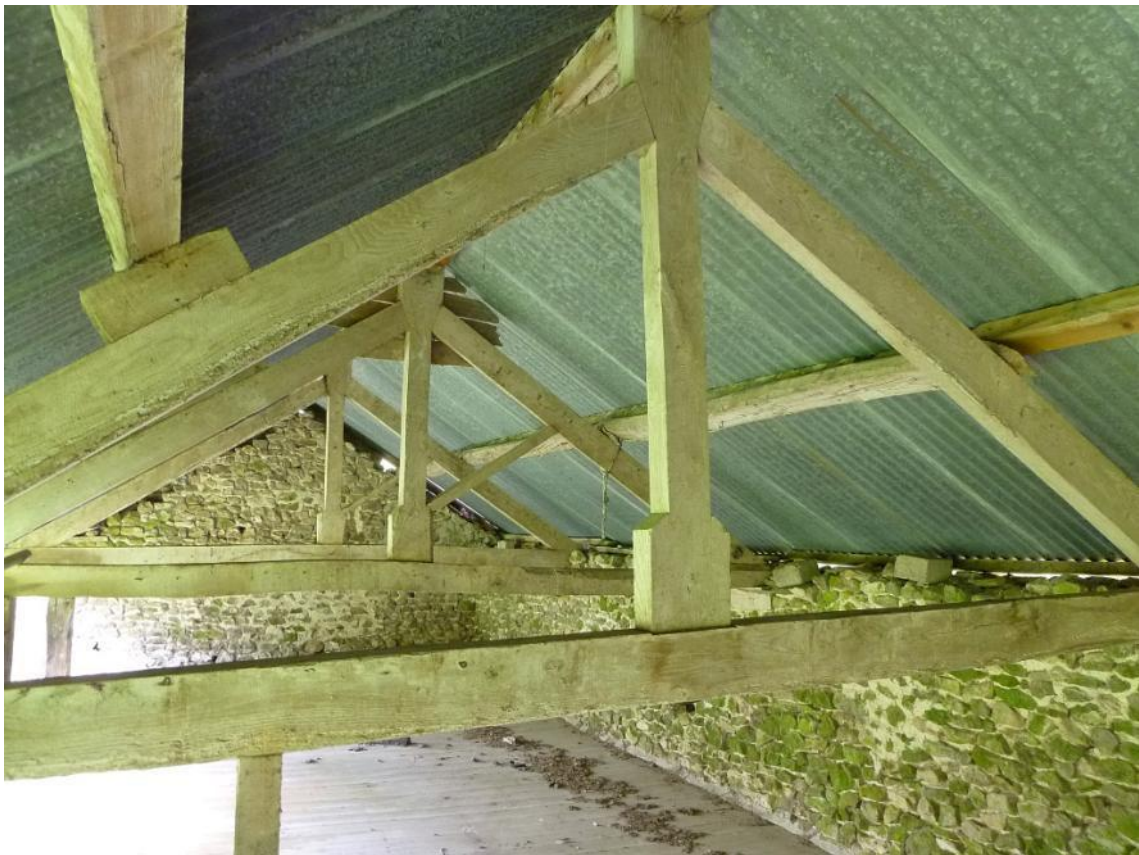
Roof trusses, looking to north-west corner

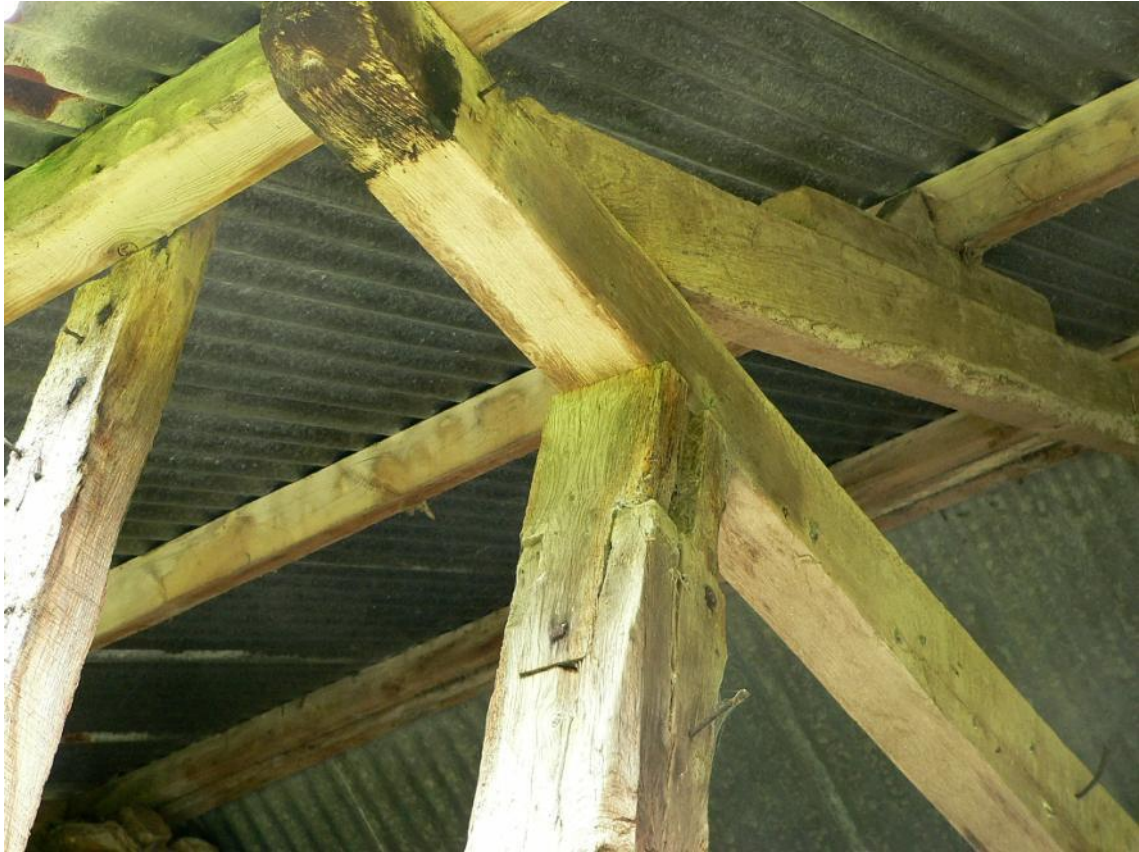
The beam between bays 1 and 2 has a scarf repair at north end. It is of oak, about 15cm square section, tenoned and pegged through front post. A carpenter's mark 'v' is cut into its west side close to the front post. The vertical front post is very knotty oak, approximately 21cm wide by 19cm deep, which stands on large roughly squared chert block. The head of the post has been repaired by the addition of top section tenoned onto it (see below).

Detail of head of front post with added top section and projection of tie beam

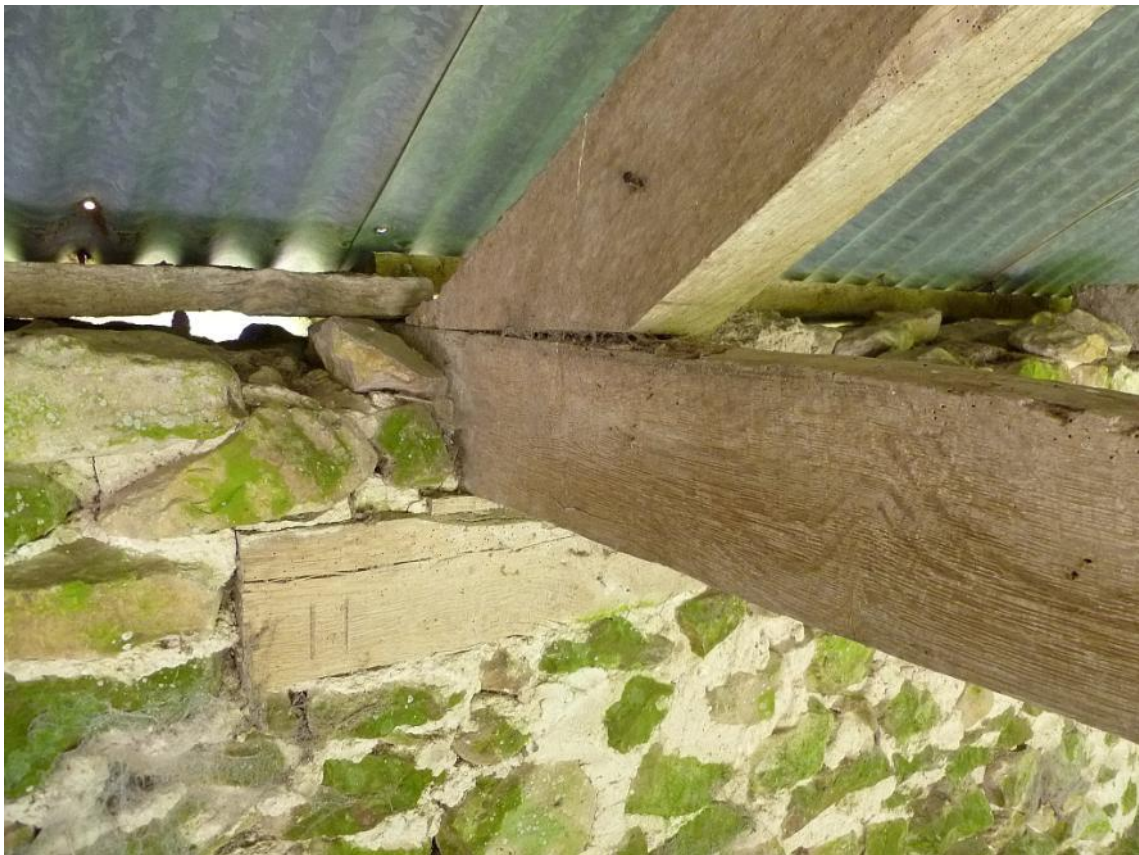
side. The northern wall head is roughly levelled, with timber blocks set in to support the ends of the truss tie beams. The block which supports the north end of the tie beam between bays 2 and 3 has 'II' cut into it.

Detail of tie beam bearing block with carpenter's mark built into north wall head

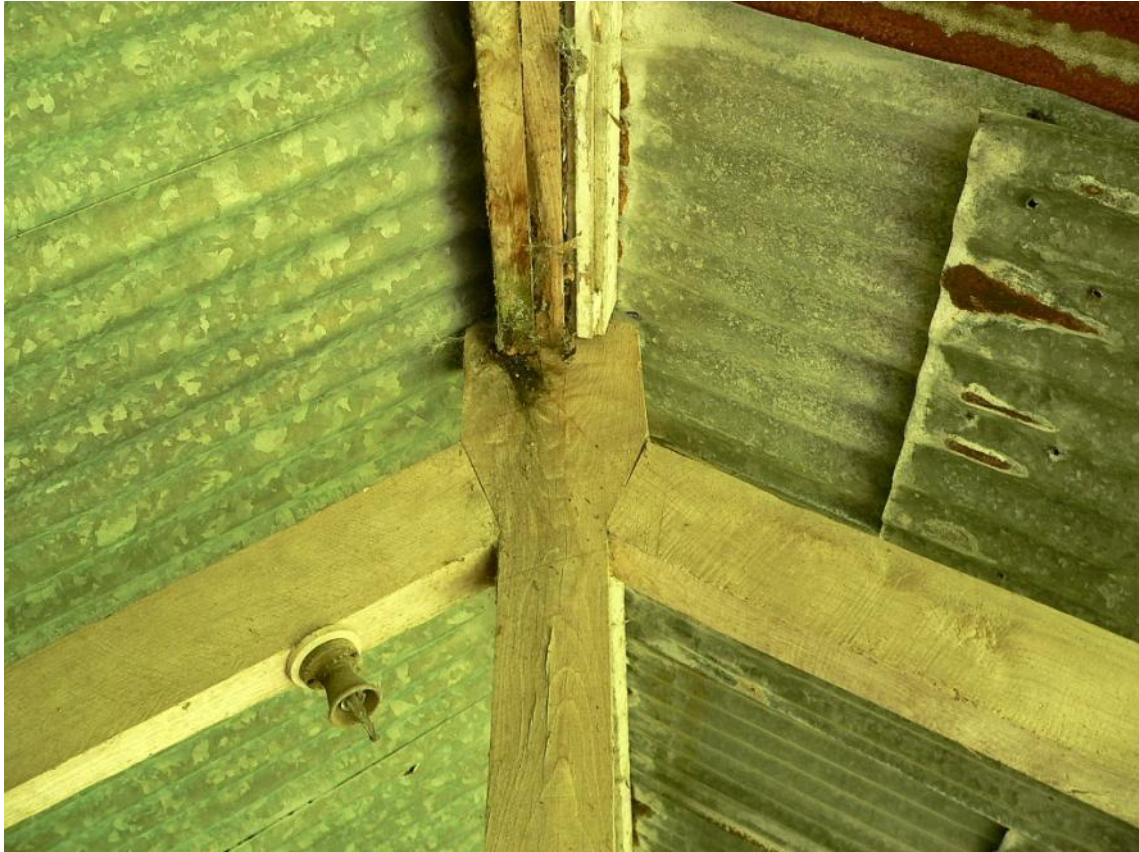
Apex of roof truss
