LINHAY AT LOWER WESTOWN HEMYOCK, DEVON

HISTORIC BUILDING RECORDING

June 2015

Project LWL254

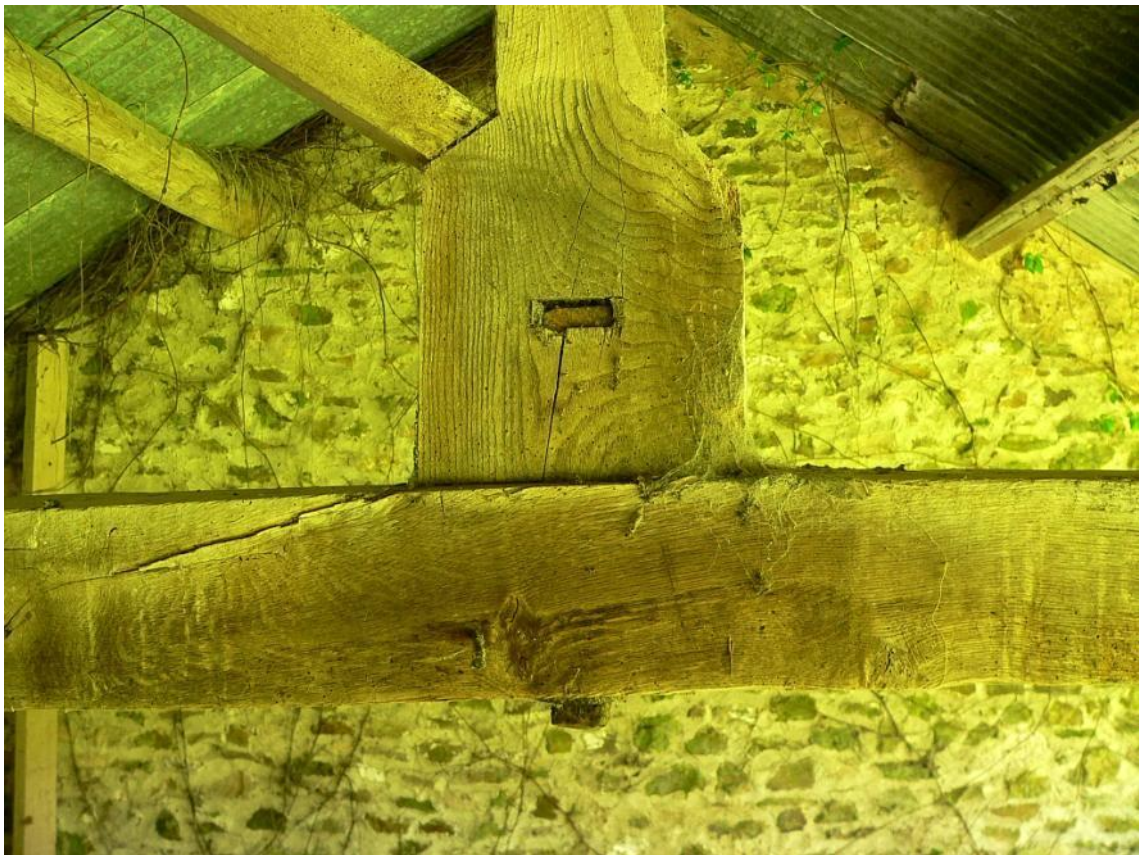
Foot of king post, showing captive nut and bolt fixing

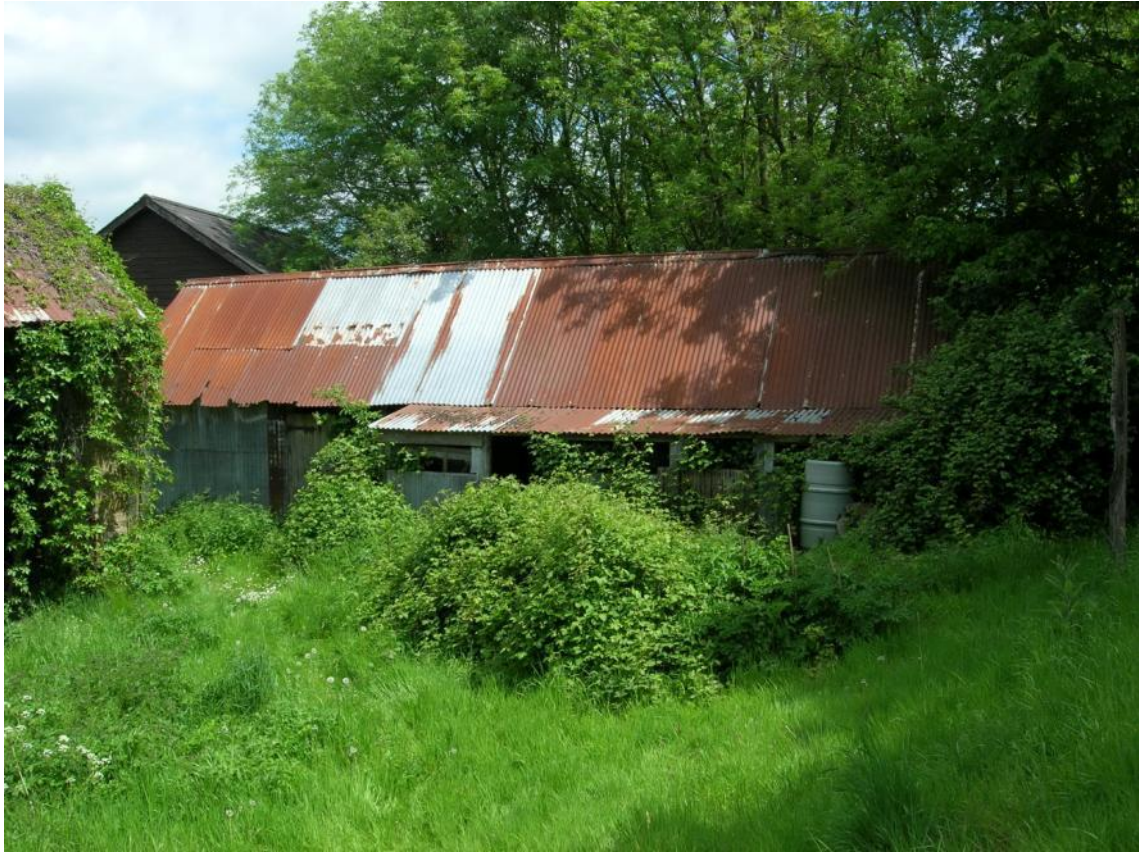
To the east of the linhay is a former agricultural building which is shown on the tithe map of c.1840. It is about 12m long by 2.5m deep internally, orientated about north-south, and of five bays. Bays 1 to 3 from the south were formerly extended forwards on the west side to form pigsties (see aerial photograph, page 10). The rear (east) wall is of rubble stone to a height of about 1.5m, with about 0.45m lift of cob above, forming the wall head. The south gable is of stone, extended outwards in concrete block, and north gable end has been rebuilt in concrete blockwork. The west front appears to have been open (perhaps formerly with doors closing the bay fronts), with timber posts defining the bays. The floor, which is mostly obscured with debris, is of concrete with some stone, which steps up in the three southern bays. There is a concrete feed/water trough in visible towards the rear wall in the north bay. The roof is quite steeply pitched (probably originally thatched), with simple rustic trusses. The principals are lapped and pegged at their apexes and their feet are tenoned and pegged into the tie beams. The trusses are numbered from the south with carpenter's marks clearly visible on the central truss (see photograph). There is a single row of modern timber purlins on both roof slopes and a vertical ridge board, the roof slopes being clad with corrugated metal sheet.

Outbuilding to east of linhay, from the west

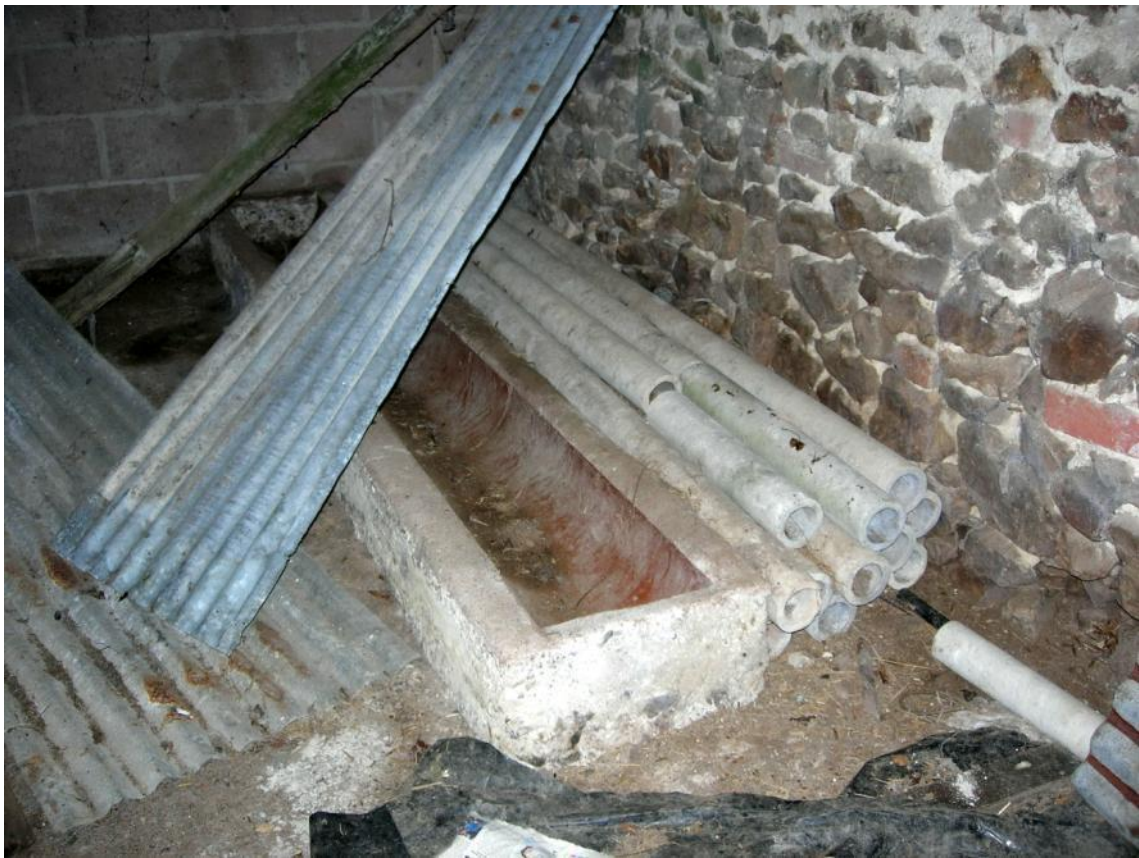
Feed/water trough in north-east corner of outbuilding

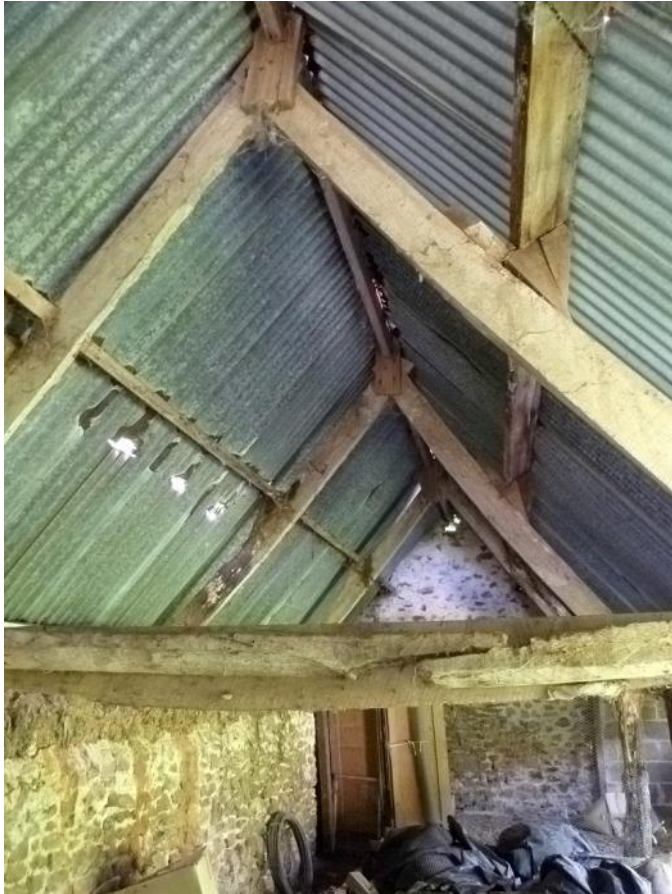
Outbuilding roof, looking south

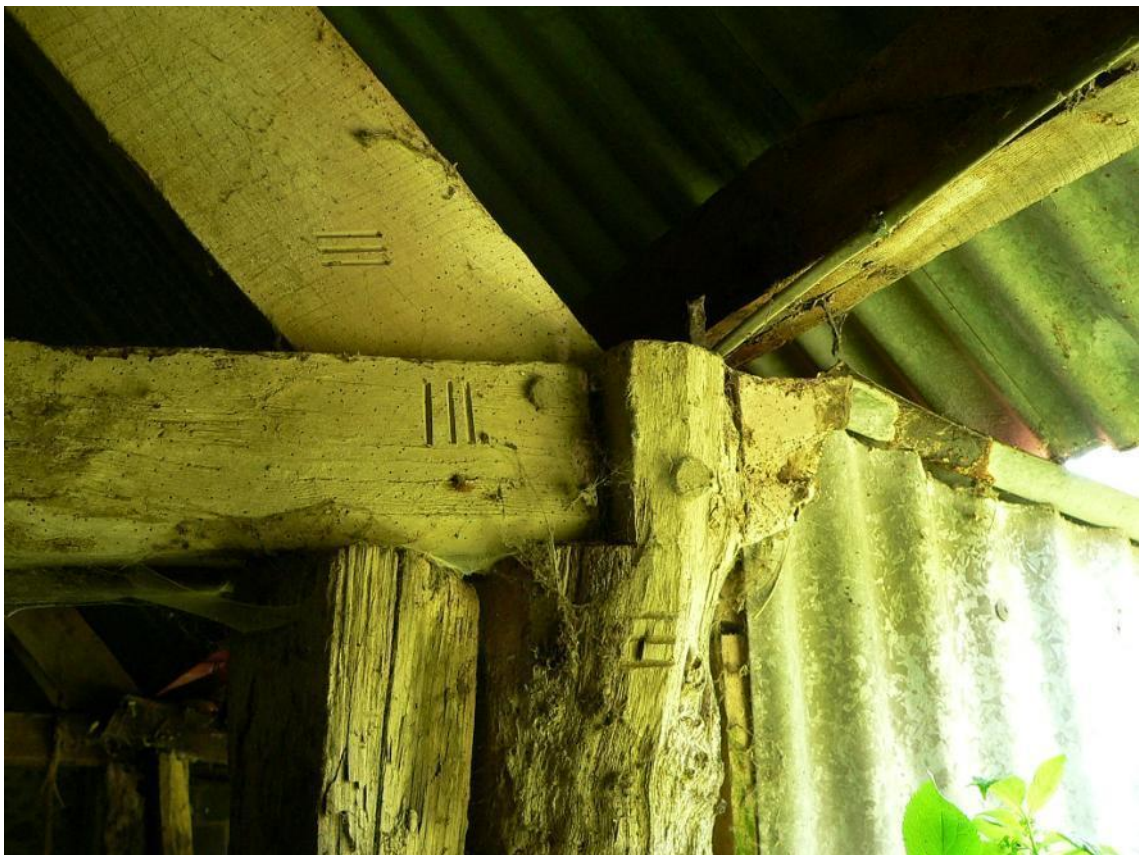
Detail of roof truss/front post on west side, showing construction and carpenter's marks
