**BISH MILL
BISHOP'S NYMPTON
DEVON**

HISTORIC BUILDING RECORDING

January 2017

Project BNM256

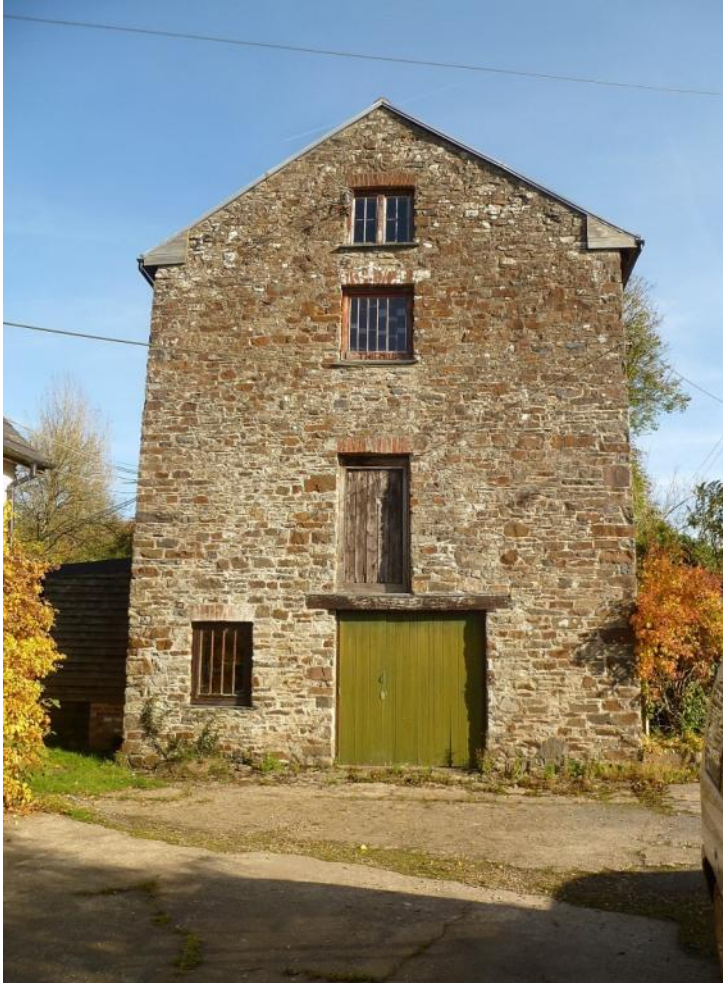
The west elevation has an enlarged doorway opening at ground floor level, with a squared timber lintel and three vertically-boarded door leaves. The north return of the doorway appears original, with quoins, while the south side has been rebuilt. From the symmetry of the elevation, it is suggested the original ground floor doorway was single leaf width. There are fragmentary remains of a cobbled surface immediately outside this doorway. A number

West gable end, from yard between mill and house

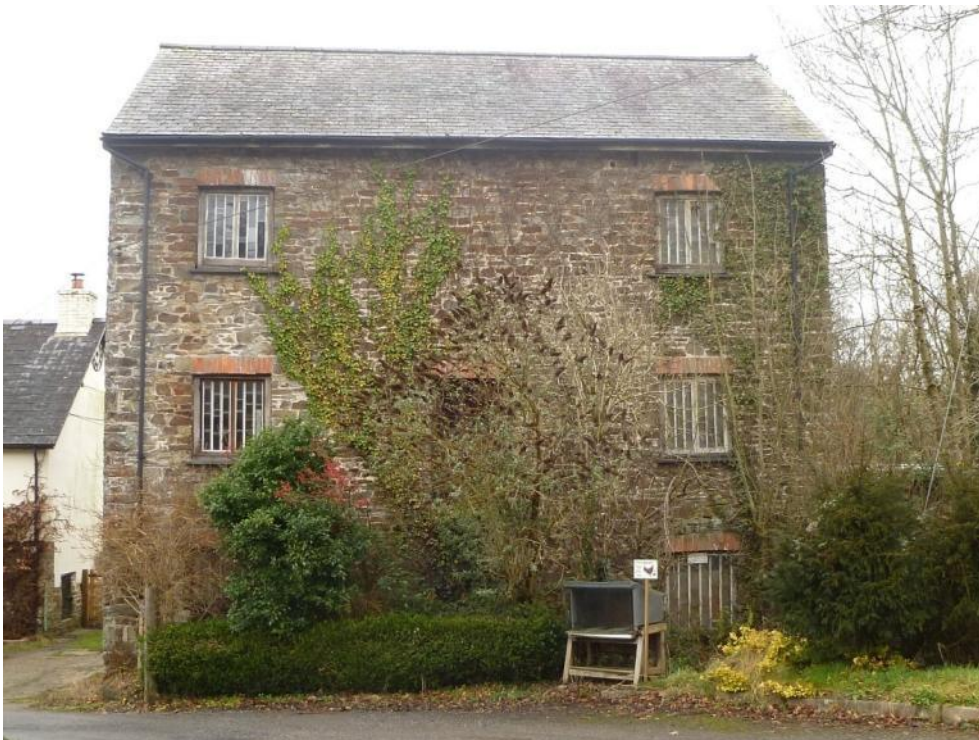
The south elevation is partly overgrown and inaccessible in places. The loading door at first floor level has two projecting oak timber cantilevers at floor level, presumably the remains of a platform which was used for unloading sacks of grain from the back of a cart or waggon.

South elevation. The first floor loading door is partially obscured.

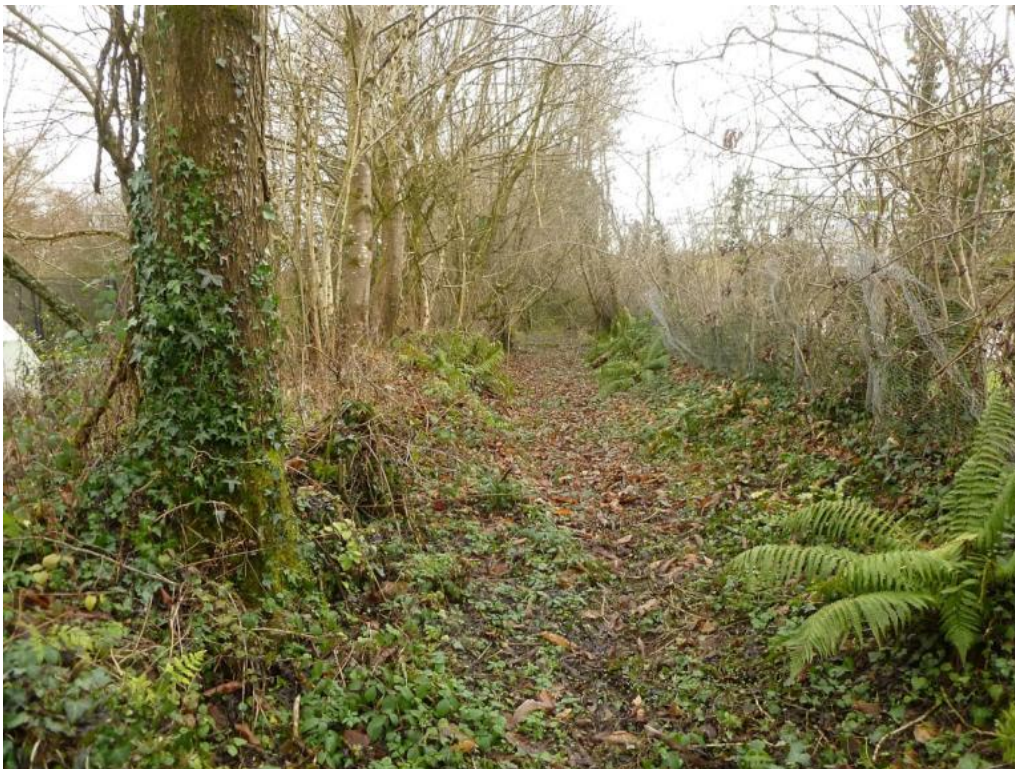
Silted section of leat to east of mill

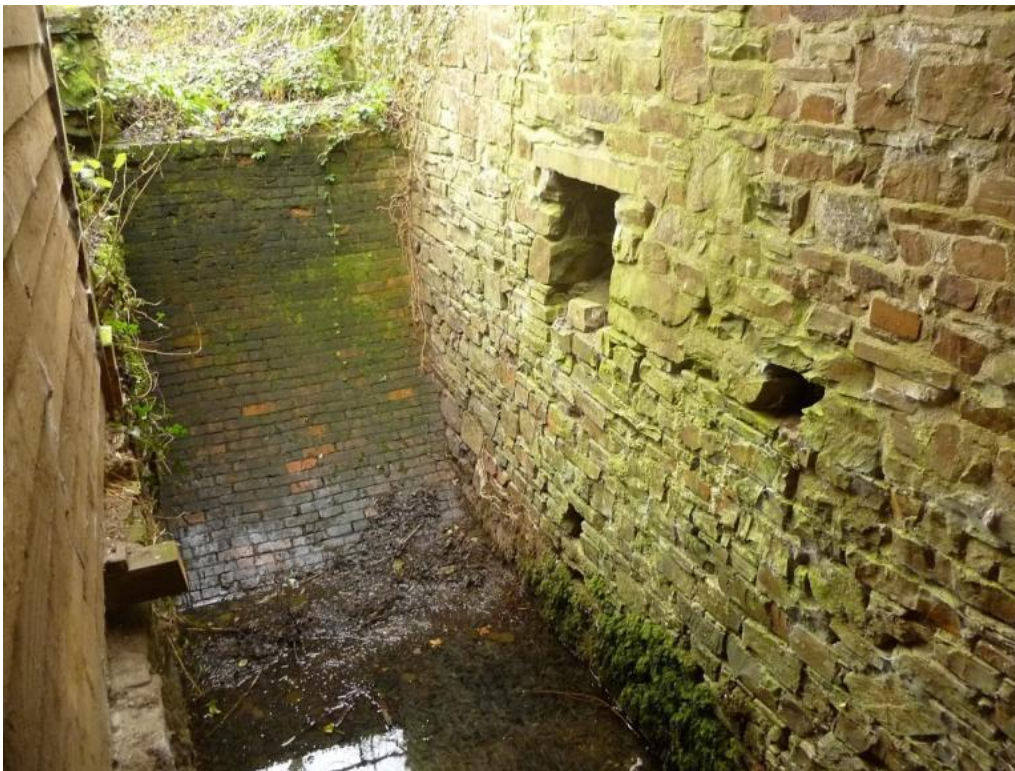
Wheelpit, showing curved brick breastwork at south end and wheelshaft opening

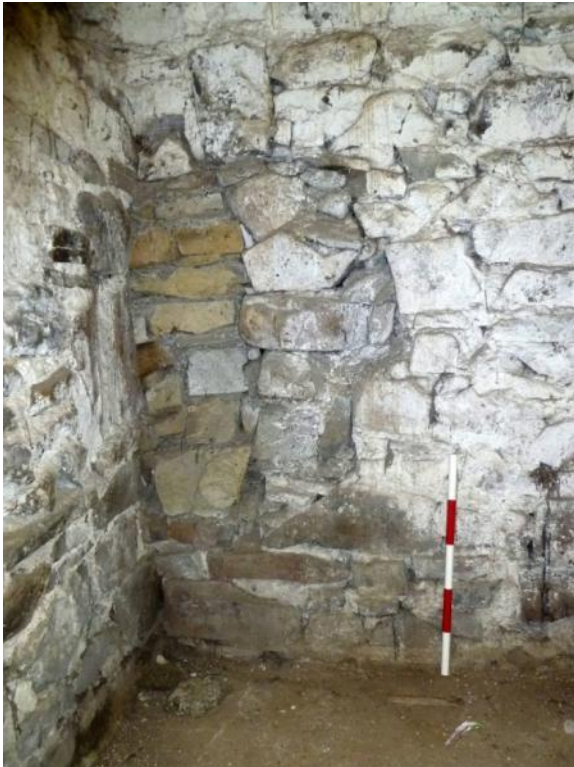
The inner face of the east gable wall has several interesting features. In the north-east corner is what appears to be a blocked partially circular opening. This is in about the same position as the exterior recess. Above the wheelshaft opening is an arc-shaped recess in the stonework, which would have allowed clearance around the horizontal spurwheel from which the drive to the millstones was taken from the vertical shaft (Figure 12). In the south-east corner is an angled timber, roughly squared and white-washed, with several holes bored in it, and a heavy metal forging, which formed the control handle by which the penstock (the sluice gate behind the waterwheel) was operated. The holes in the timber allowed the penstock to be opened and held in different positions, depending on the amount of water required to run the mill.

Blocked opening in north-east corner

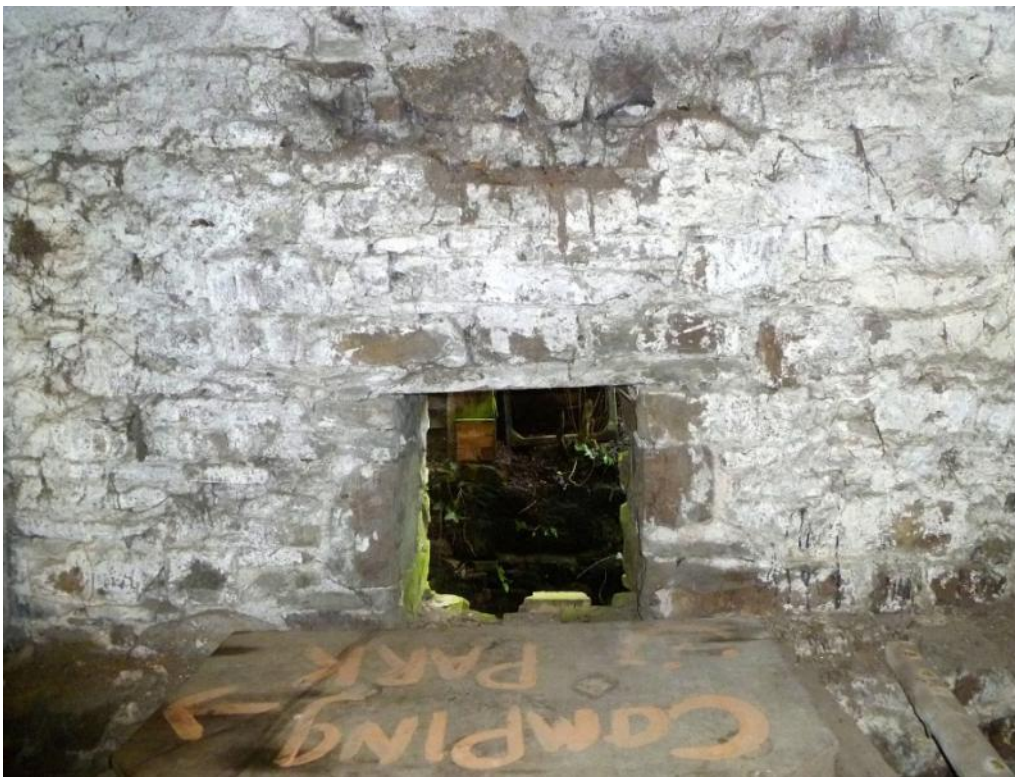
Waterwheel shaft opening through east gable end wall, with recess in wall over for clear rotation of spurwheel

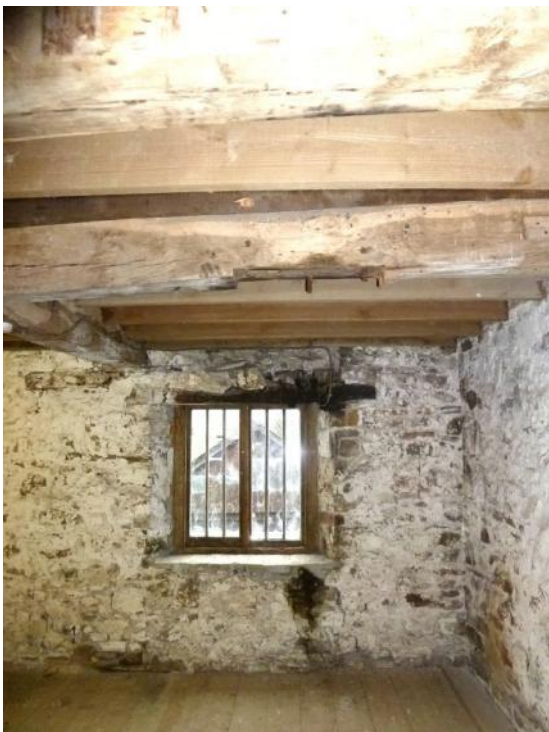
upright shaft extending to the first floor ceiling and carrying a crown wheel near its top, from which an ancillary drive layshaft was taken off the north side (see Figure 12). The position of the bearings for a horizontal shaft can still be seen, one on a beam close to the vertical shaft position and the other on the lintel over the window in the north-east corner (see first floor plan and photographs).

Layshaft bearing positions, hung from beam (centre) and on lintel over window
