**LINHAY AT LICKHAM BOTTOM,
HEMYOCK, DEVON**

HISTORIC BUILDING RECORDING

Project LBL262

HISTORIC BUILDING RECORDING OF A LINHAY AT LICKHAM BOTTOM, HEMYOCK, DEVON

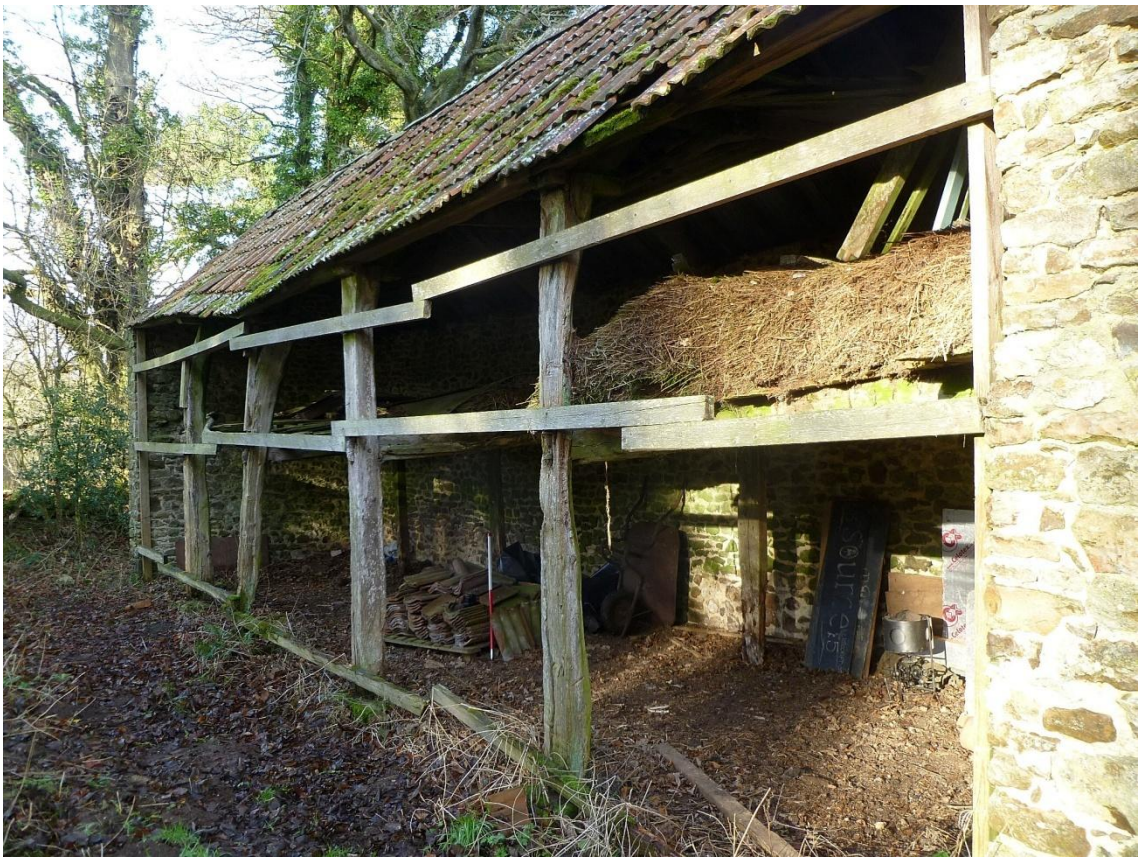
Secondary timber props have been inserted under the north ends of beams 1 and 2. There are also a number of sawn softwood timbers fixed horizontally across the front of the building, between the posts, in order to retain some stability, and additional vertical supports have been screwed (with modern screws) to the front faces of P1 and P2.

South front of linhay, looking west, showing modern bracing timbers

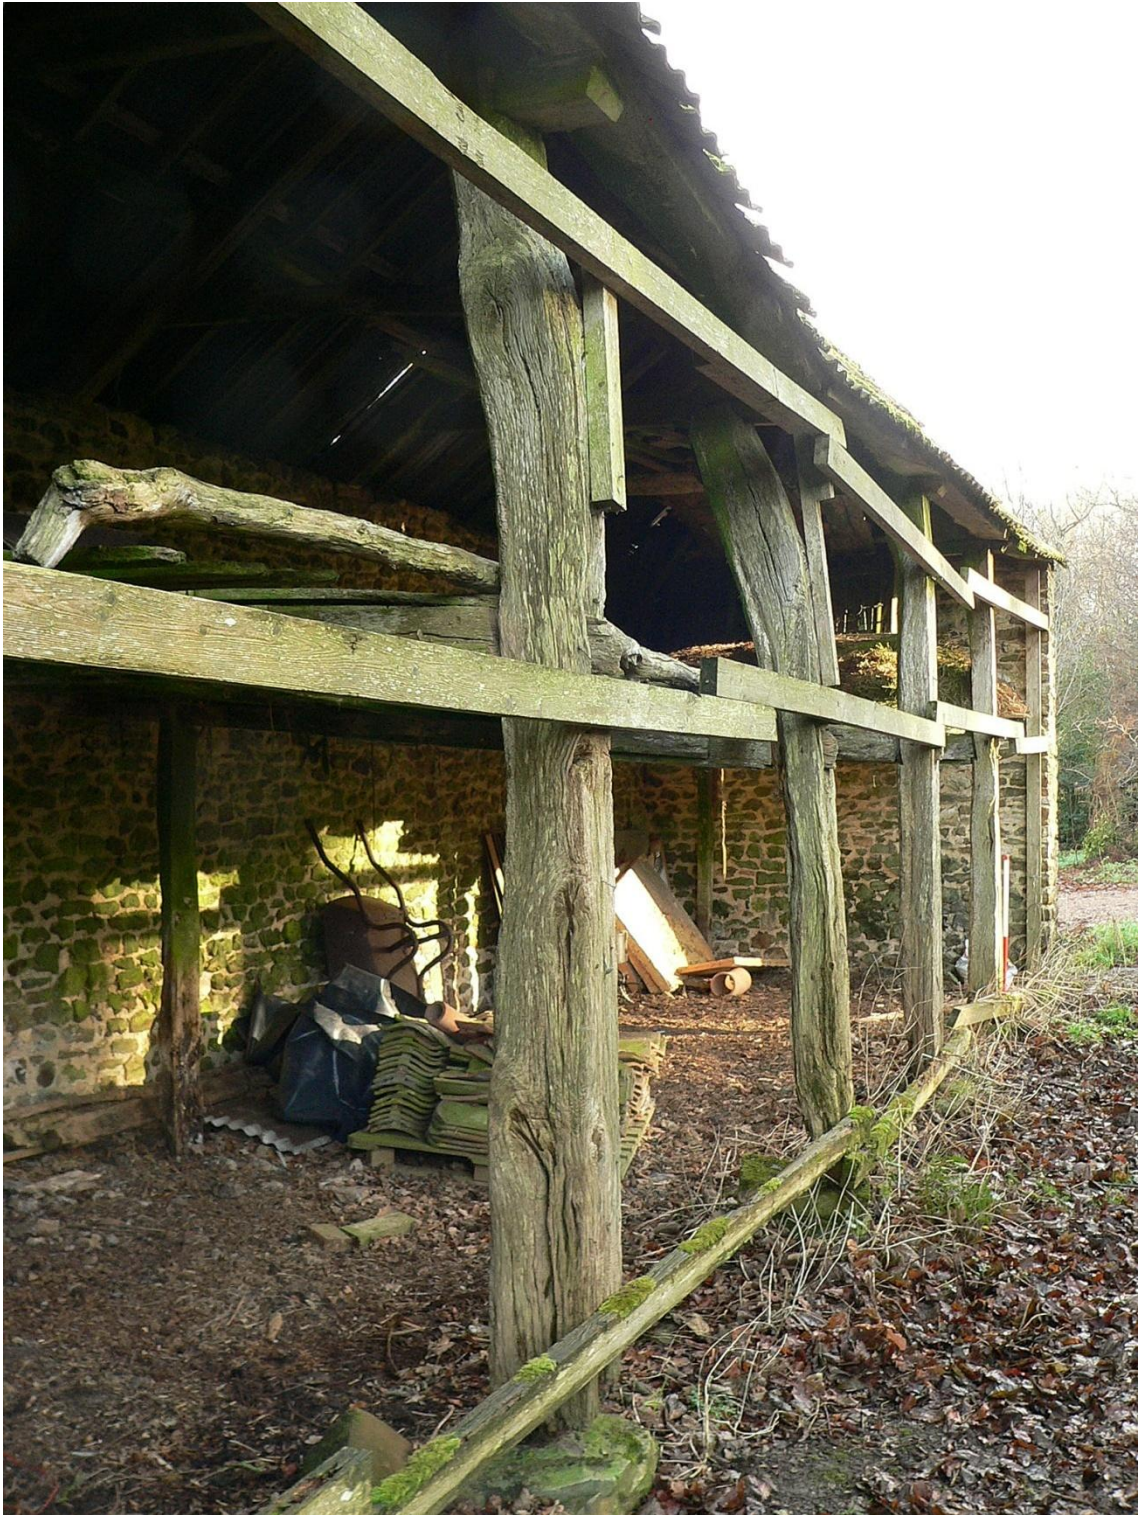
The four front posts sit on roughly shaped stone bases. Numbering from west to east, P1 and P2 are squared oak timbers which both have a natural curve inwards towards their tops. P3 is a squared timber with a slightly jowled top and P4 a straight squared timber. All of the posts are weathered and there is no clear evidence that any of them have been re-used; they are probably 'as found' timbers, sparingly converted from locally sourced trees. All four posts have a short, north-south aligned, timber plates notched into/over their heads. A single iron spike has been driven down through each pad on the of north side of the post head, presumably to stop it from moving outwards (see photograph).

South front of linhay, looking east, showing curved tops to P1 and P2

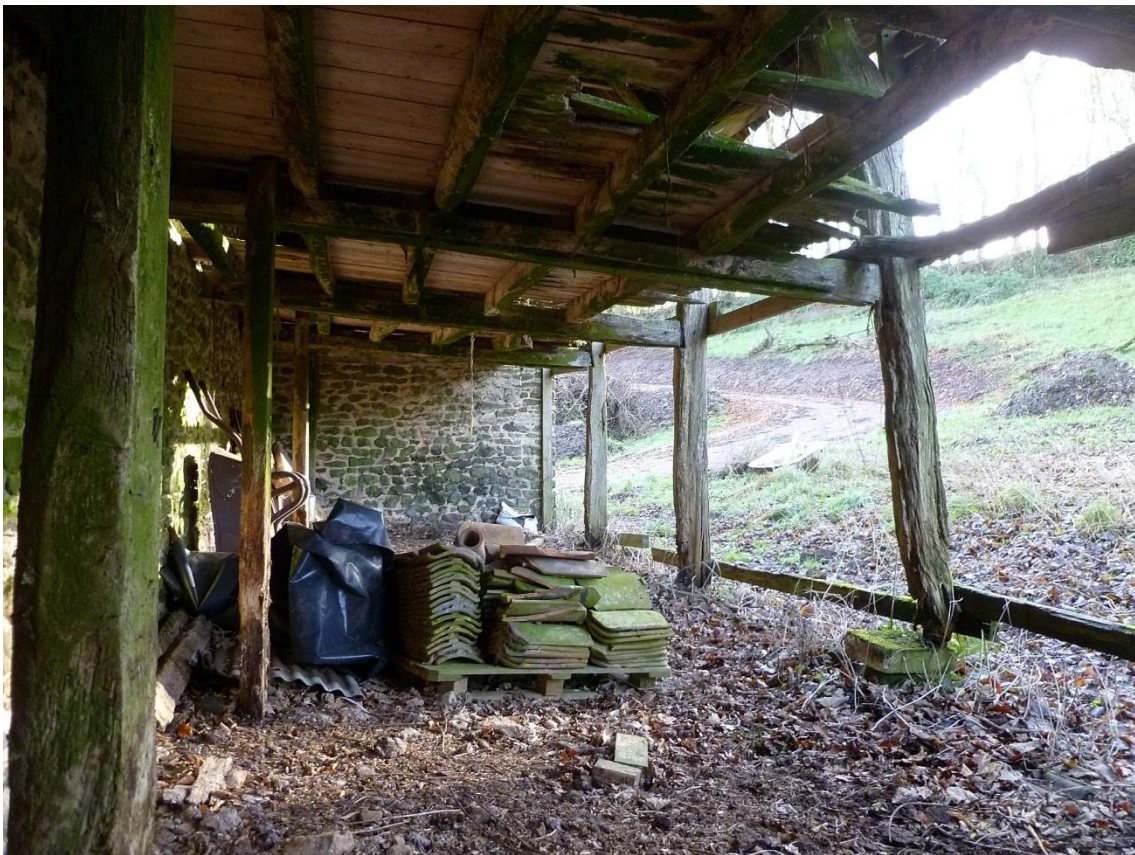
Interior looking east, showing tallet floor and secondary props under cross beams to left

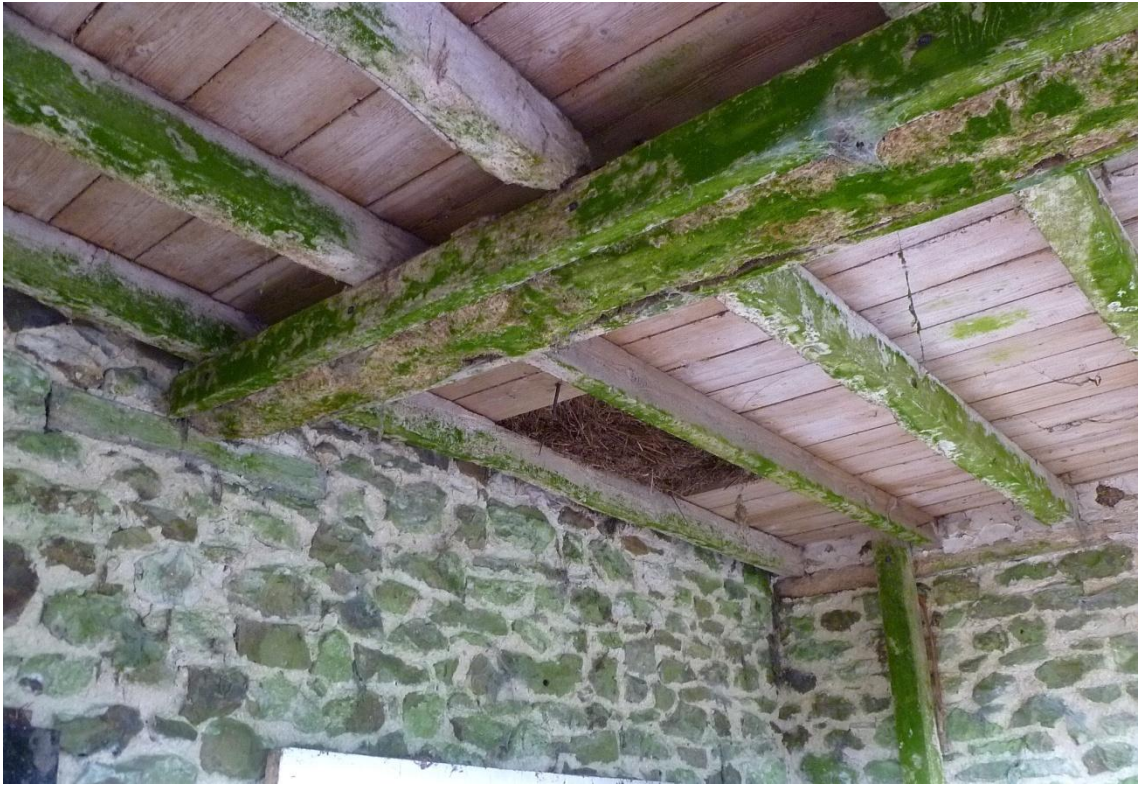
The cross beams have timber plates nailed to both faces which carry the ends of the floor joists. These span west-east and their ends are notched over the plates. The joists are generally simply converted, of about 11cm by 7cm cross-section, spaced at approximately 0.5m centres. There were originally six joists in each bay, but several are missing. In both the west and east bays the outer ends of the joists are carried on full length timber plates built into the walls.

Cross beam and joists on timber plates built into walls in north-east corner

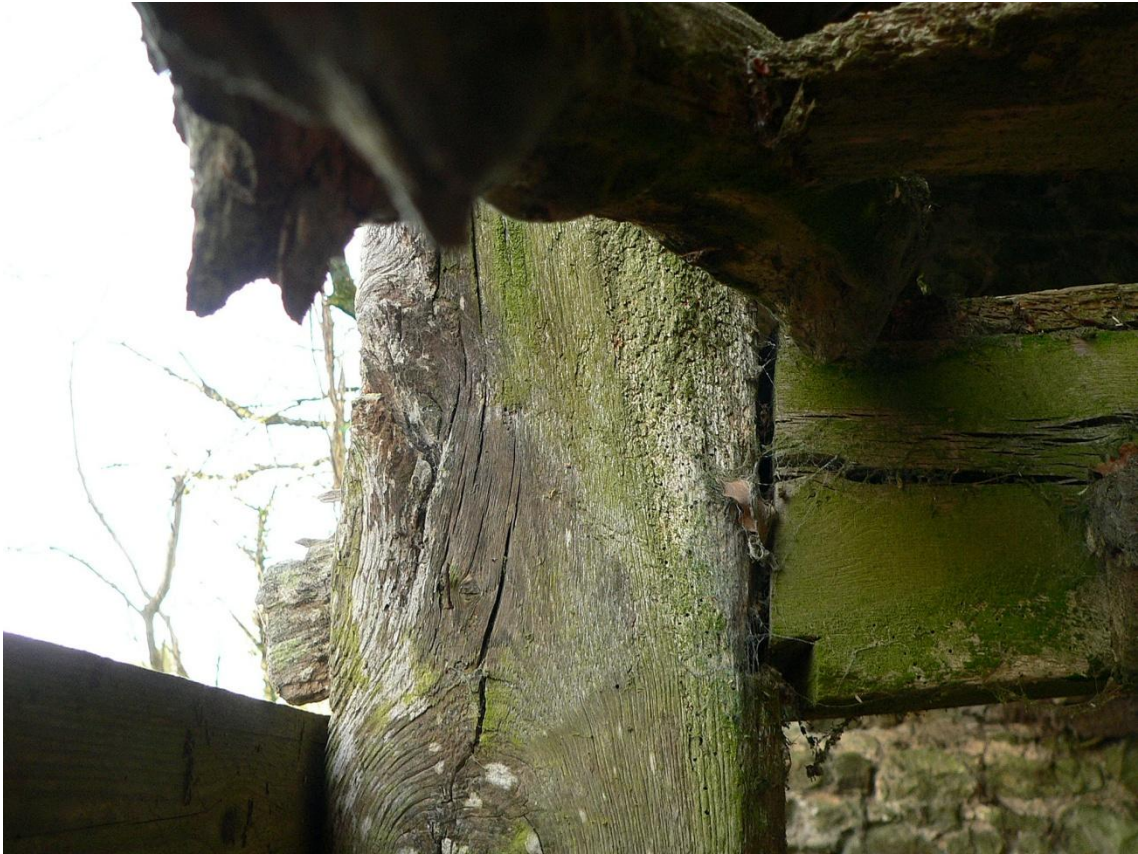
Detail of cross beam to front post joint, P1, east side

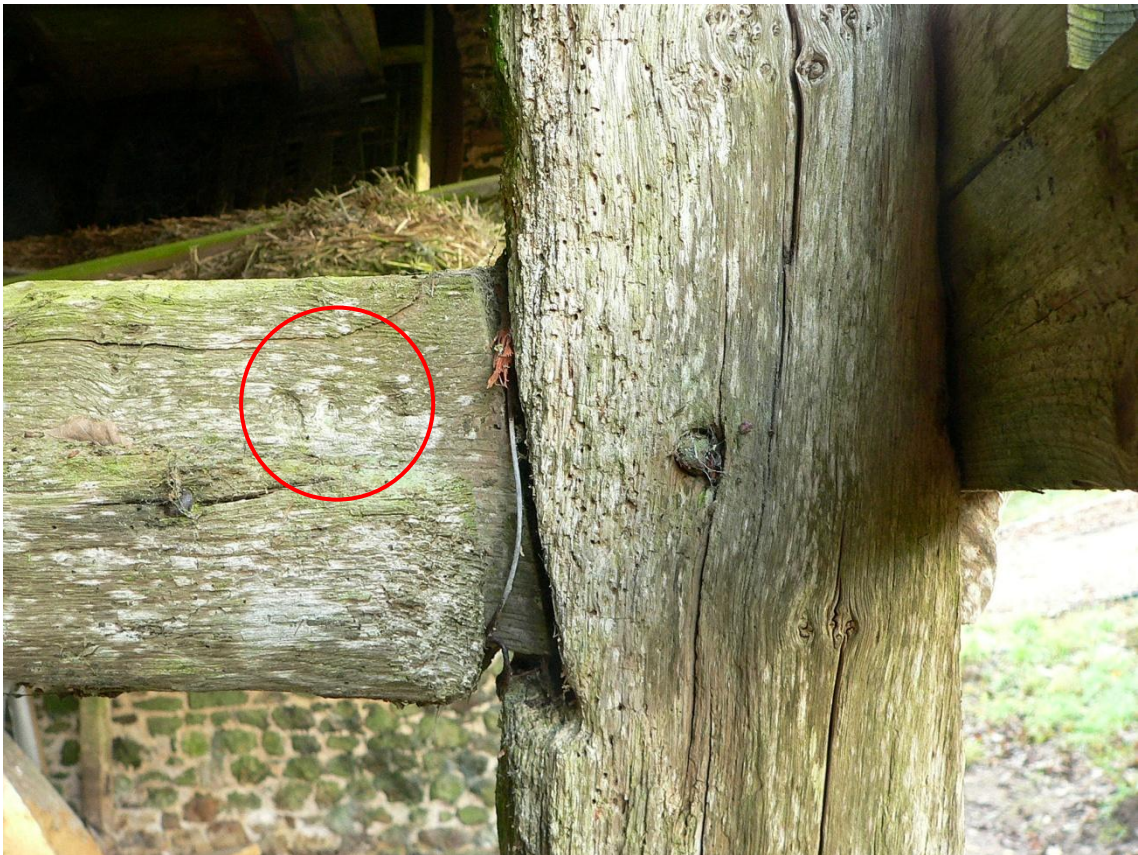
The cross beams which support the joists carrying the loft or tallet floor, are squared timbers, about 18cm square. From the west, numbers 1, 2 and 3 are marked for assembly with small circular indentations: 'o' 'oo' and 'ooo' close to where they are jointed to the posts (see photograph). No marks were visible on number 4, possibly due to weathering of the face of the timber. The south/front ends of the beams are tenoned through the posts, with a small notched shoulder on underside and the tenons of numbers 3 and 4 are pegged through the

Cross beam / post joint, pegged, P3, showing assembly marks

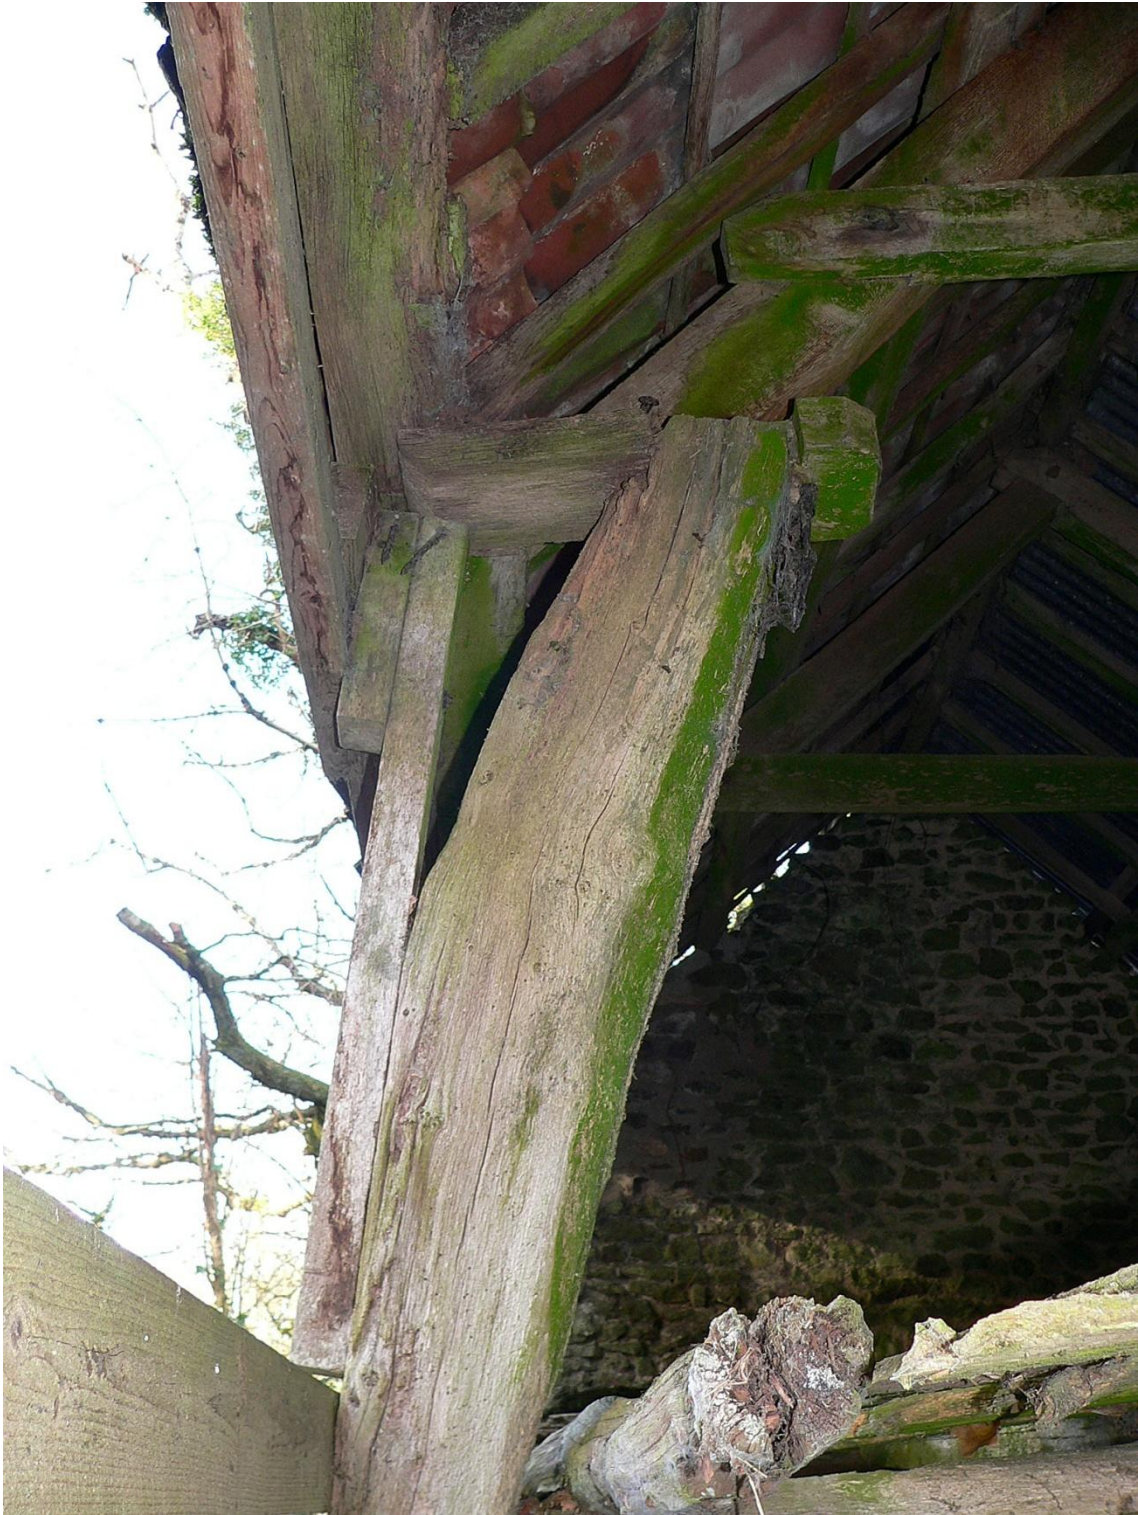
Curved head of post P1, east side, showing shaped timber plate carrying foot of principal

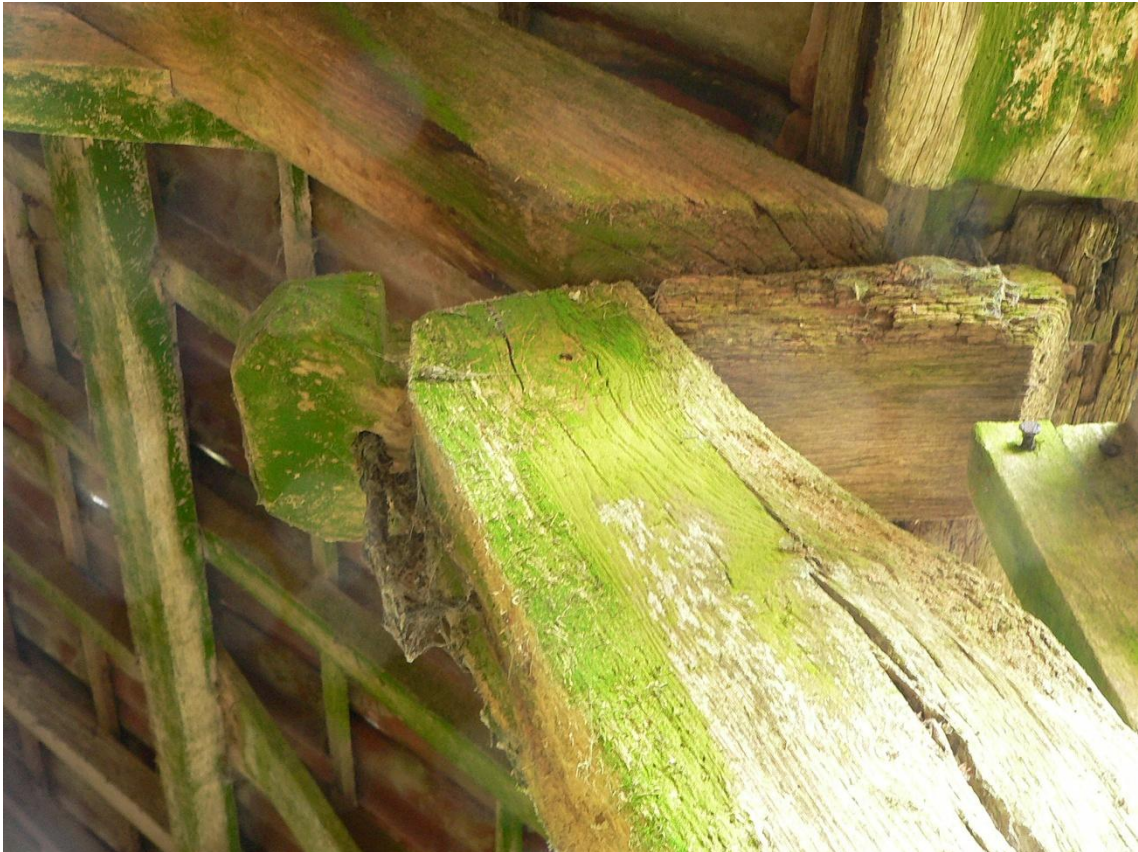
Detail of timber plate carrying foot of principal, P2, showing metal spike to left of post
