# **HUDLEY MILL CHARLES, DEVON**

## **REPAIR AND MANAGEMENT PLAN FOR THE WATERWHEEL, LEAT AND MILL POND**

**July 2010**

**Project HMC 183/2009**

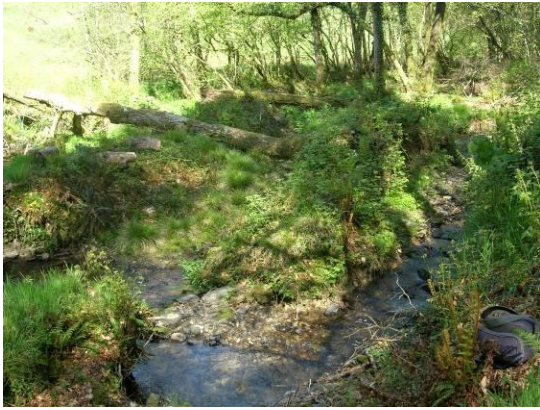
The entrance to the leat is now poorly defined, with islands of alluvial deposit and some fallen trees dividing the stream into several channels, obscuring the area where a weir structure would have been. There is no clear evidence of a weir, other than some large stones in the stream bed. A sluice is marked at the leat entrance on the 1:2500 Ordnance Survey map (Figure 3). Water was taken from the stream at a natural bend in its course, a familiar feature, which allowed the main flow of the stream to be directed straight into the leat entrance. The leat entrance channel, which is about 1.2 – 1.3m wide, is now silted up. Working downstream from the entrance, there is about 3m of stone revetment on the west side, then a stone reinforced post and plank structure for 2.6m, with masonry wall 0.8m thick behind. About 8m down from the entrance is a narrow pipe-like opening about 0.4m wide, through a stone wall which is about 1.2m thick. A smooth vertical groove on the west side of this opening suggests that it could have been closed with a vertical sluice,

Leat entrance, right, looking upstream

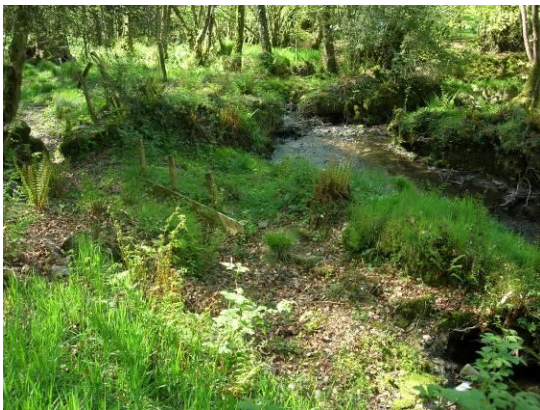
Leat entrance, foreground, and bend in stream

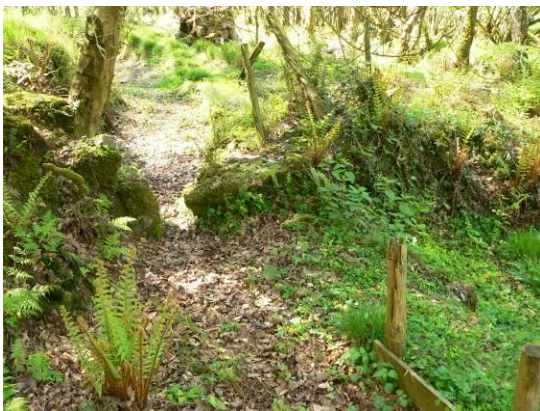
Revetted leat entry and sluice opening in wall

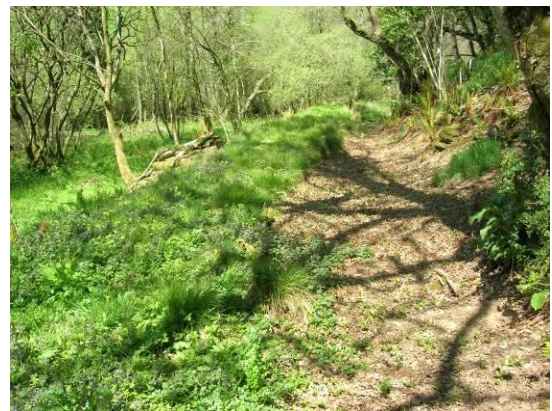
Eroded section of bank at bend in leat course

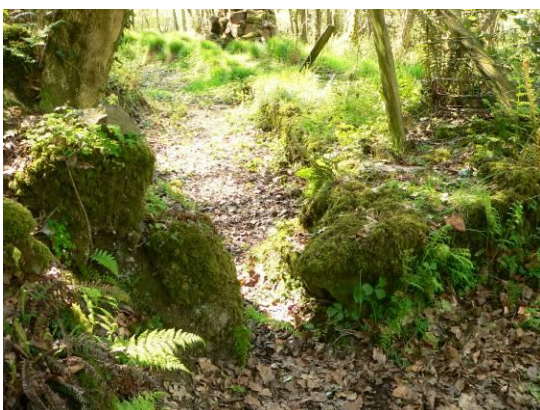
Sluice opening in wall, spill weir behind

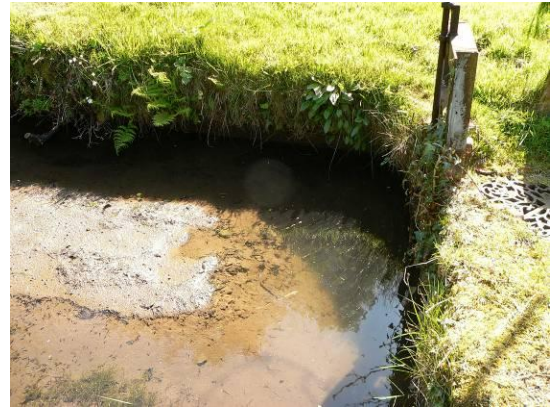
Silt and sluice at south end of mill pond

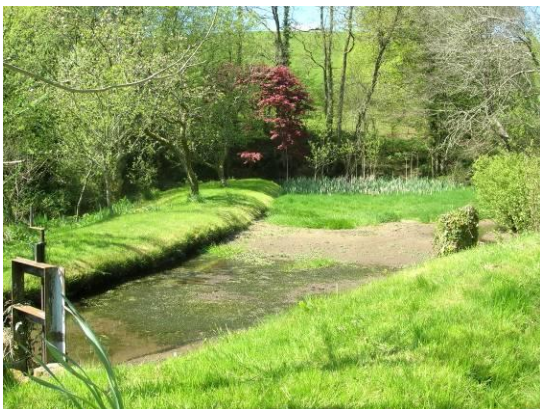
The mill pond is roughly triangular in shape, with its apex at the south (mill) end. It is about 20m wide by 40m long. It is heavily silted up, with grass and reeds growing out of a large silt island. There is vertically pitched stone walling at the north-west corner, where the bank of pond curves towards the leat entrance. The south-west side of the pond is defined by a well developed slightly curved top grassed bank. The mill end of pond is about 2.2m wide, with a single brick wall inserted across it, with a sluice gate, close to the side of the road. The sluice opening is 0.38m wide, with a vertical metal gate in a 7.5cm steel angle frame. The gate, which is a piece of steel plate, is raised and lowered on a single screw. It is in a reasonable condition. The water in the pond was standing to a depth of 0.65m over the cill of this sluice. This depth also reflects that of the silt at this end of the pond. Immediately downstream of the sluice gate is a decorative cast-iron grille set in the ground over the channel. It is understood that this was put in by the present owner.

Mill pond from south-east, showing silt build up

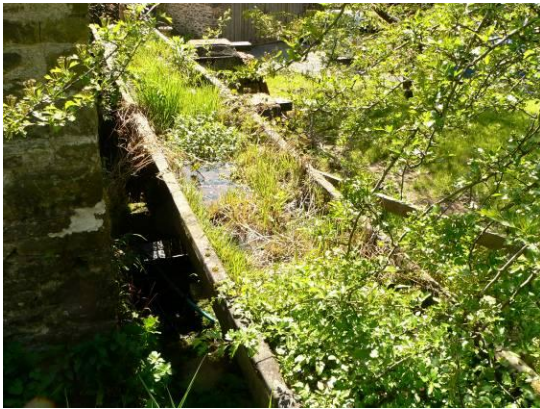
Overgrown launder

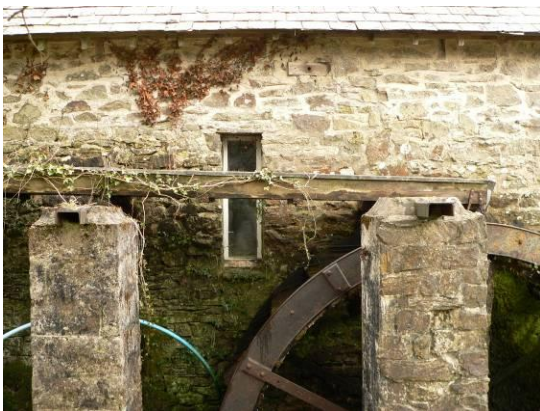
The present launder is a timber trough about 6m in length, which falls at a slight angle from the leat end to the top of the waterwheel. The trough is 0.7m wide overall with 18cm x 4cm timber sides, 15cm deep internally. It is made with single side boards nailed to 15cm bottom boards, which run lengthways. The launder is supported on 3 steel channels, 15 by 7.5cm section, the inner ends of which are built into the pit wall and the outer ends are supported by piers. The piers are of cast concrete; the outer and downstream faces of the lowest pier have been faced in stone (since 1990). Each of the three channels appears to be set at a slightly different height, so there are timber blocks between them and the underside of the trough. A small amount of water still runs along the launder, which has plants and moss growing in it. Although it has been lined with roofing felt to make it more watertight, the timber structure and packing is saturated and the steel channels are wet, but appear in fair condition.

Launder and supporting columns

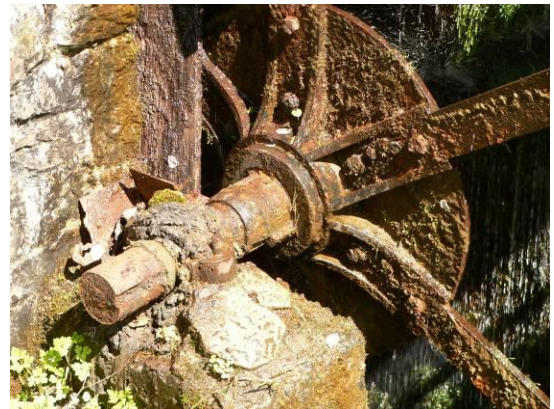
Detail of nave and outer wheelshaft bearing

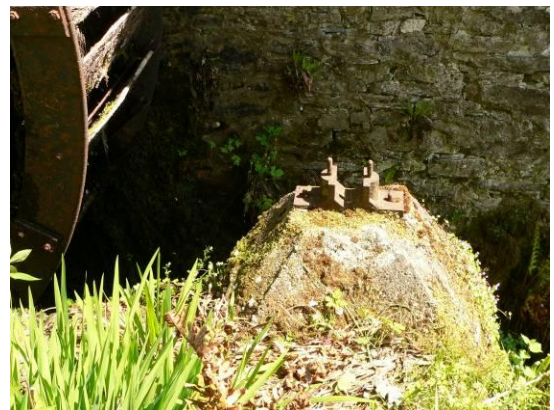
The wheelpit is about 1.25m wide. On the outer side, 0.92m downstream of the wheel, is a cast concrete bearing base, with part of a cast-iron bearing pedestal still loosely in place on it. The rubble stonework of the outer wall of the wheelpit has partially collapsed and there is a build up of silt in the bottom of the wheelpit downstream of the wheel. From the south end of the wheelpit the tailrace is culverted under the road, emerging under a low arched opening at the west end of the barn opposite. The tailrace course appears to run in a fairly straight line, water flowing back into the stream via an open channel on the downstream side of the road bridge. The condition of culvert was not examined, but a small amount of water appeared to be flowing freely through it.

Concrete bearing support downstream of wheel
