**REPORT
TO
SCOTTISH & SOUTHERN
ELECTRICITY NETWORKS AND
HISTORIC ENVIRONMENT SCOTLAND**

**EXCAVATIONS AT
DEMOLISHED STRUCTURE
AT CRAIGNAVAR TOWNSHIP,
GLEN ALMOND, PERTHSHIRE**

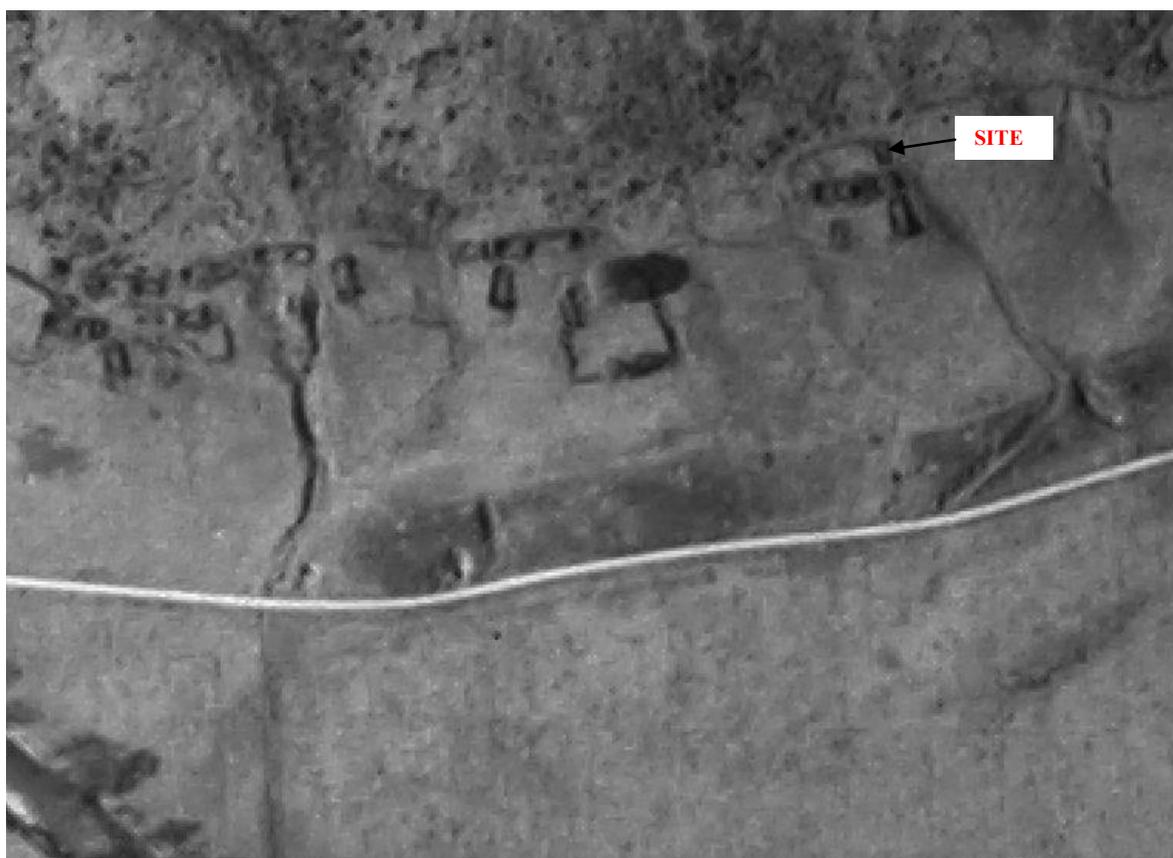
Aerial view of Craignavar from the south, showing the small demolished structure (labelled SITE) in its far north-east corner

The damage comprised the destruction of a small building (described here as Structure A) in the extreme north-east corner of the site (see photograph above). It was also thought that part of a nearby field wall, perhaps a head-dyke, was also damaged although it has been shown

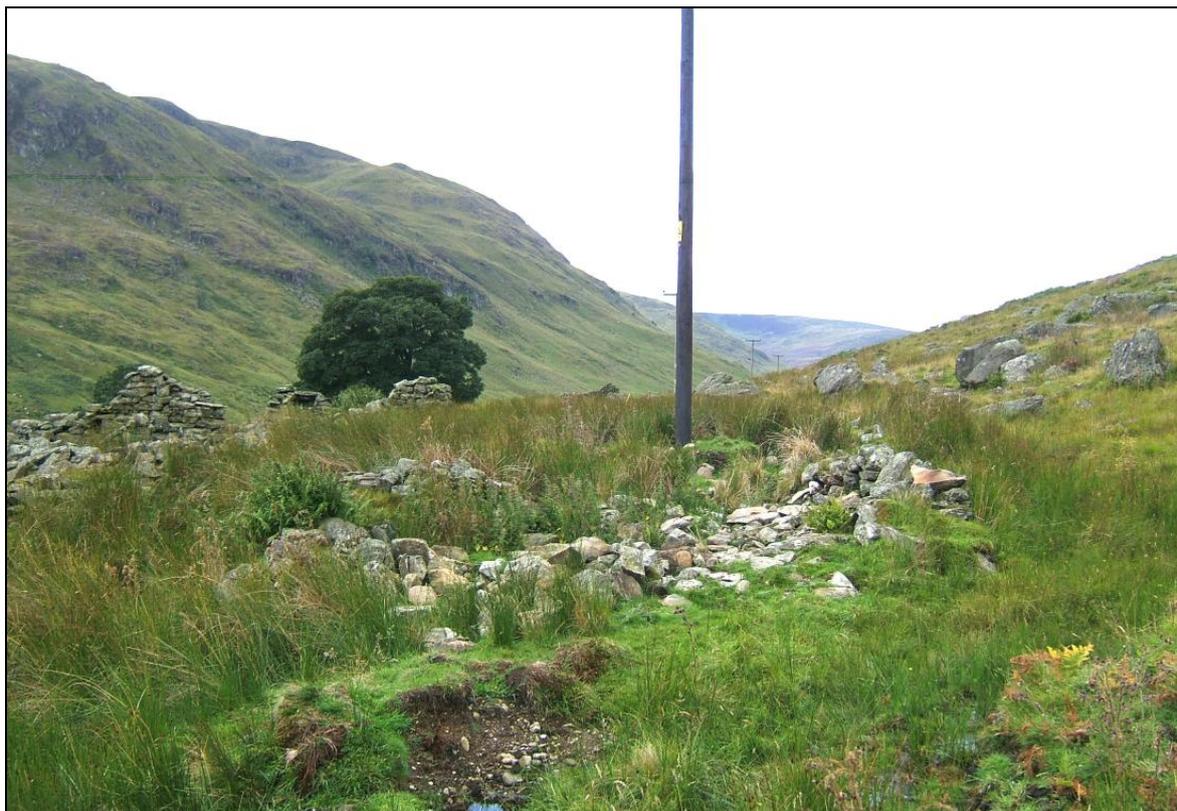
*View, from the east, of replacement Pole 107
with demolished Structure A in the foreground*

Following a meeting on 10 May 2018 between Richard Heawood of HES and John Lewis of Scotia Archaeology, acting on behalf of SSEN, it was decided that the exposed remains of Structure A should be protected. This will be achieved by covering the floor of the building with a geotextile membrane which will be concealed by a thin layer of aggregate (type 1) over which some of the excavated rubble will be replaced. This work is to be carried out carefully under archaeological supervision.

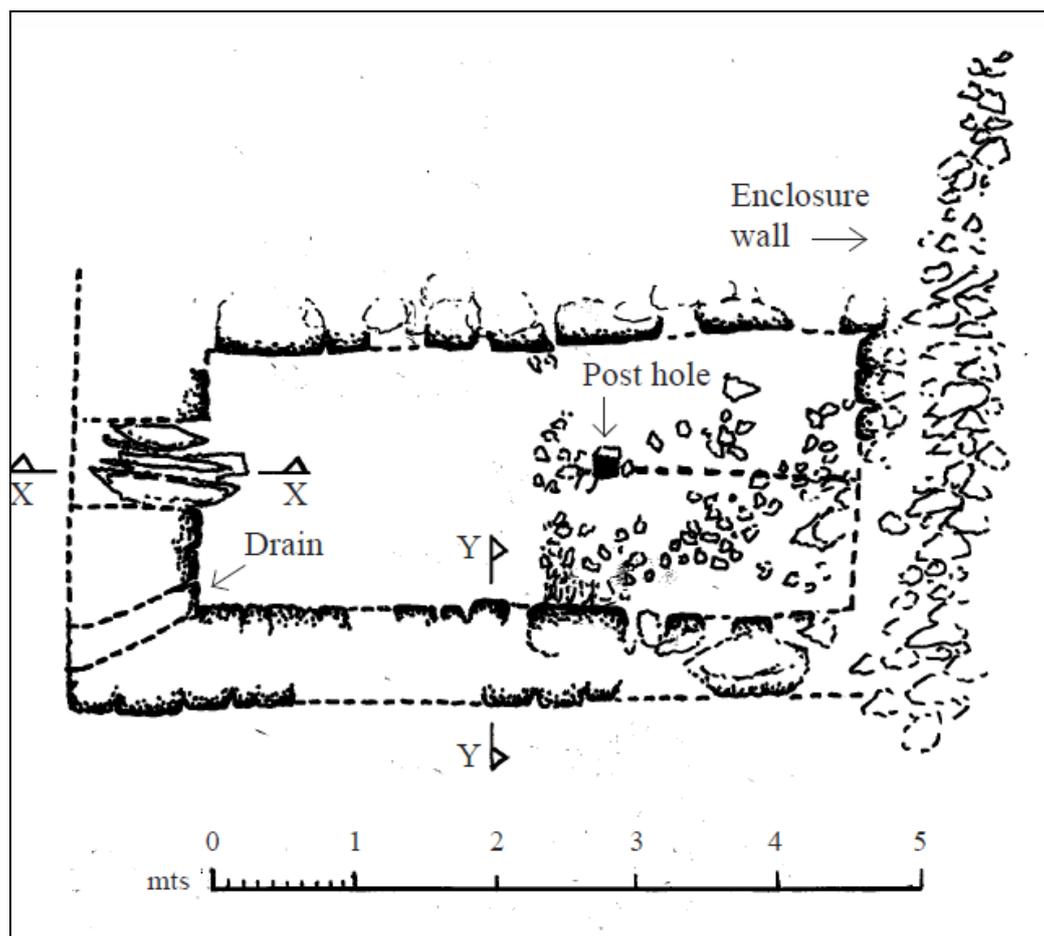
Structure A showing excavated features

Set into the cobbles, 1.8m from the north wall and midway across the building's width, was a small socket, 140mm square and 50mm deep. It would have carried a timber upright probably supporting a partition dividing the north end of the building into two stalls. The presumed position of this division is shown as a broken line in the plan of Structure A.

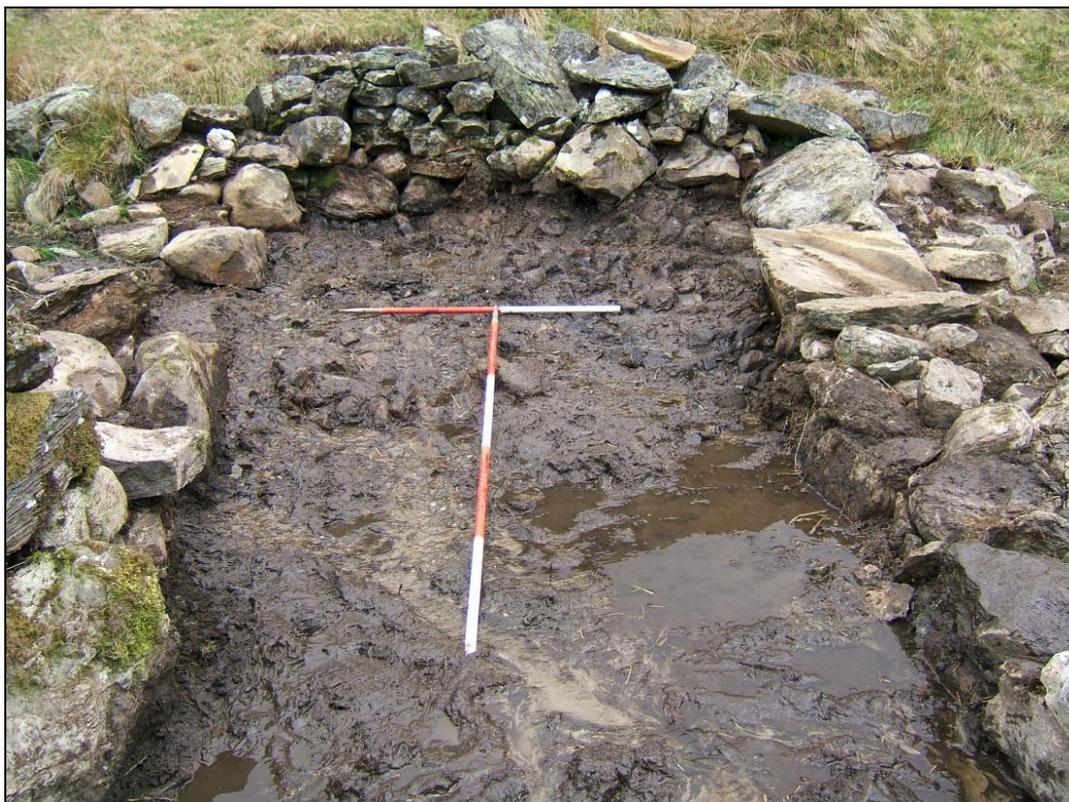
The remains of a cobbled floor, set into the underlying glacial till of orange sand and gravel, survived in the north half of Structure A but was absent elsewhere. Probing in the south half of the building, which continued to fill with water, failed to identify anything that could be construed as a stone floor.

North end of Structure A showing some of the cobbled floor in situ

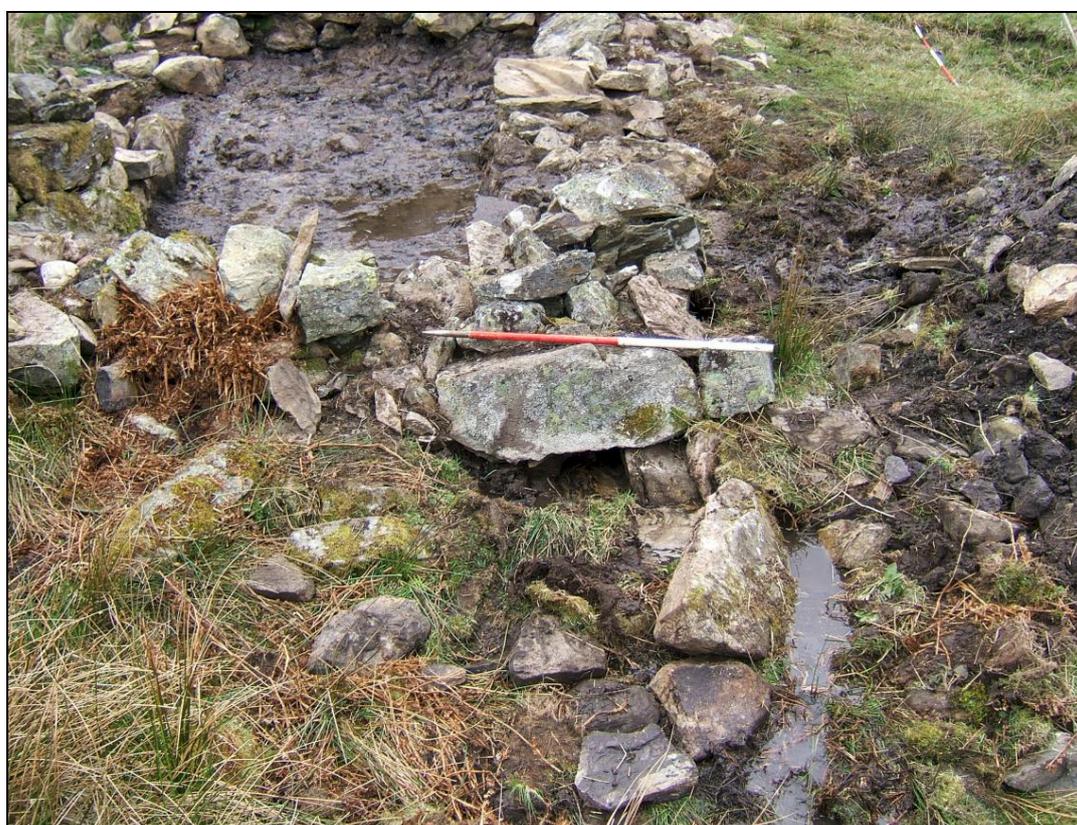
Running through the south-east corner of Structure A was a drain, 300mm wide, presumably to remove fluid waste from the interior of the building. Its function would have been enhanced by the natural north to south slope within the building. Unblocking the drain during the excavation helped alleviate flooding but this action could not prevent water flowing into it from the north.

Drain exiting from the south-east corner of Structure A

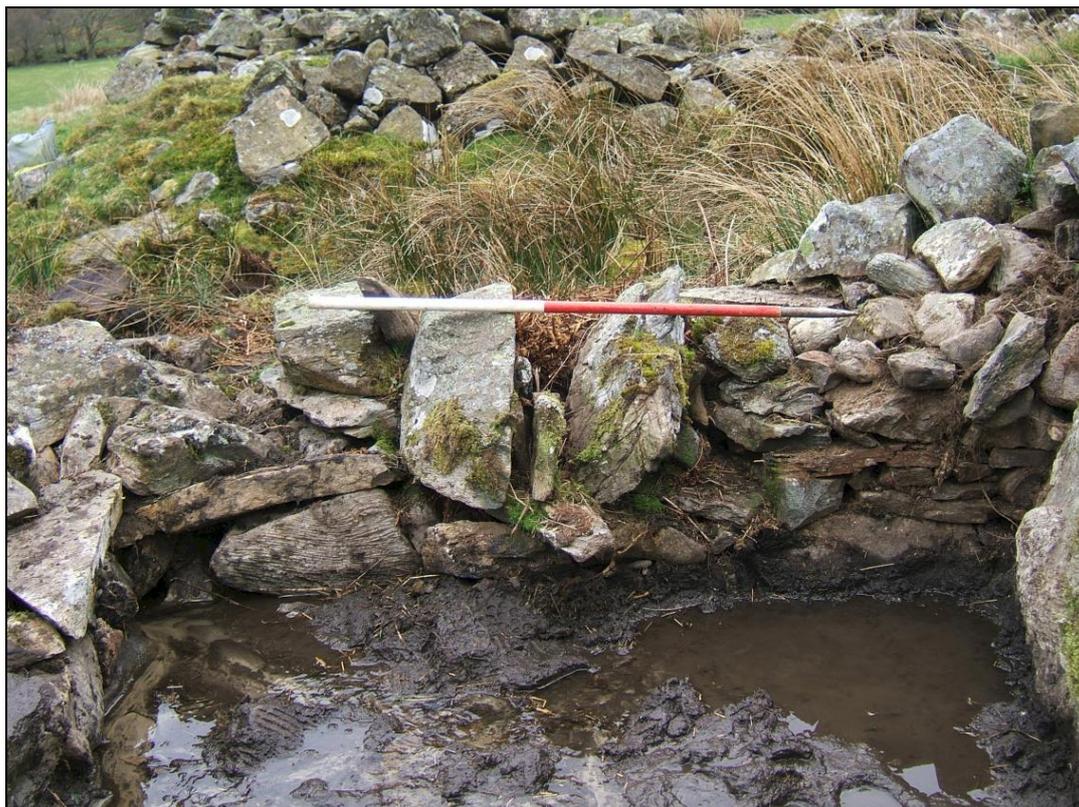
Blocked doorway in the south wall

There was an opening, 0.7m wide, in the south wall that had been blocked at some stage. This doorway, with a step midway through it, gave access to a passage leading into the east side of the enclosure. It is not obvious why the opening was blocked.

In addition, HES requested that the blocking in the south wall opening should be replaced. Following these operations, SSEN will remove any remaining spoil from the site.

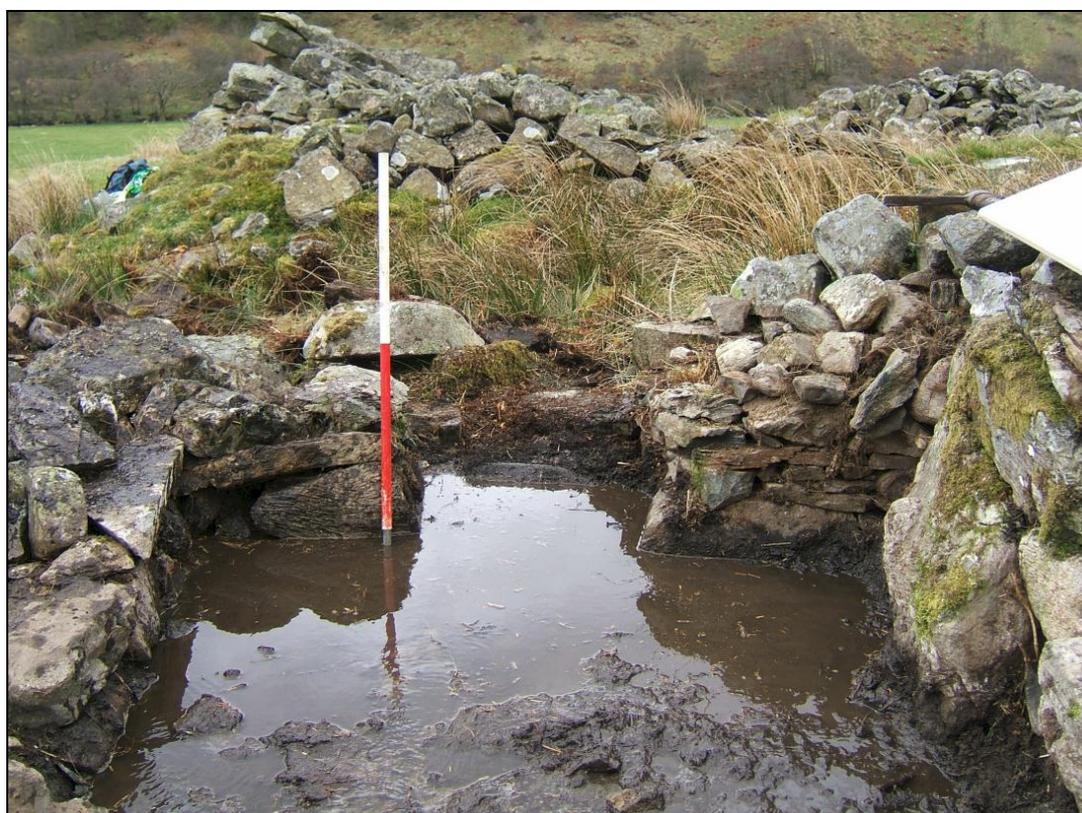
The unblocked doorway in the south wall
