ST. MARY'S CHURCH
EASINGTON
COUNTY DURHAM

~ ARCHAEOLOGICAL WATCHING BRIEF ~

REPORT ON AN ARCHAEOLOGICAL WATCHING BRIEF

Grid Reference: NZ 41430 43445
Client: St. Mary's Easington PCC
Date of fieldwork: 2nd – 4th July 2019
Project Code: AP 19/12
Oasis Number: thearcha2-386097

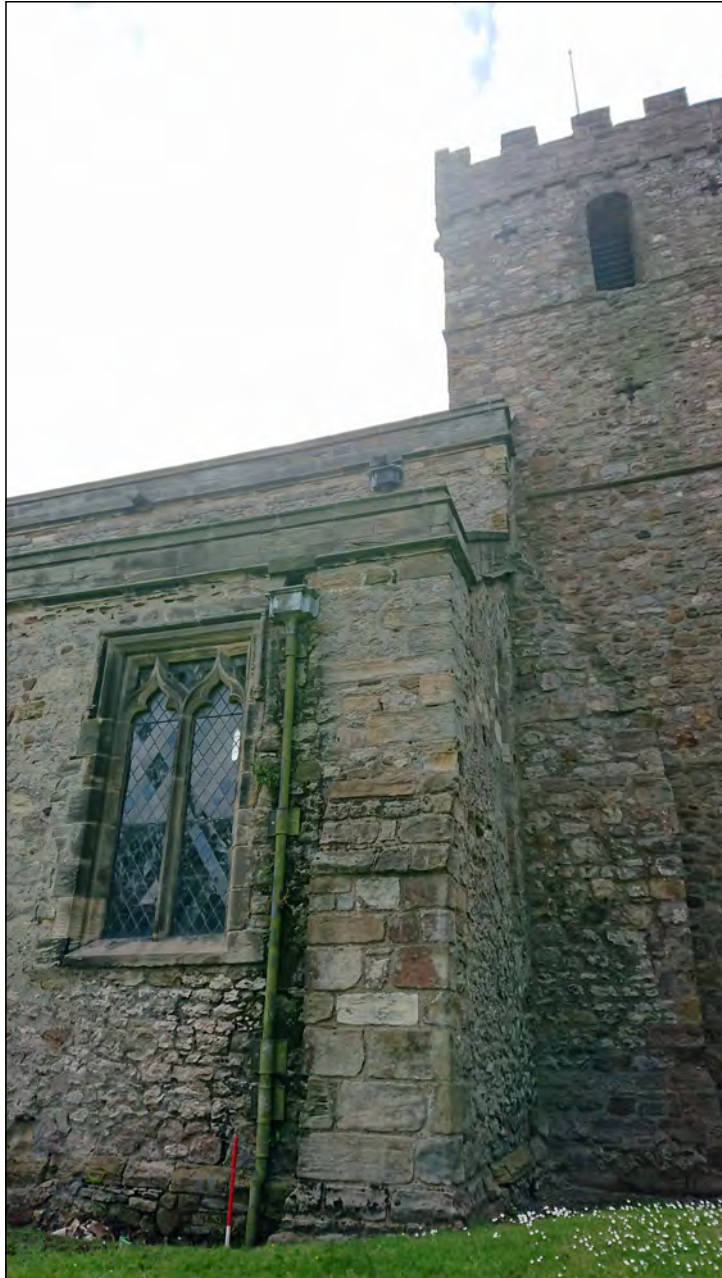
Below the topsoil [101], an existing salt-glaze ceramic drainpipe was revealed [102] of probable 19th century date. No archaeological remains were observed.

Photo 01. Broad view looking south towards Drainage excavation GY01.

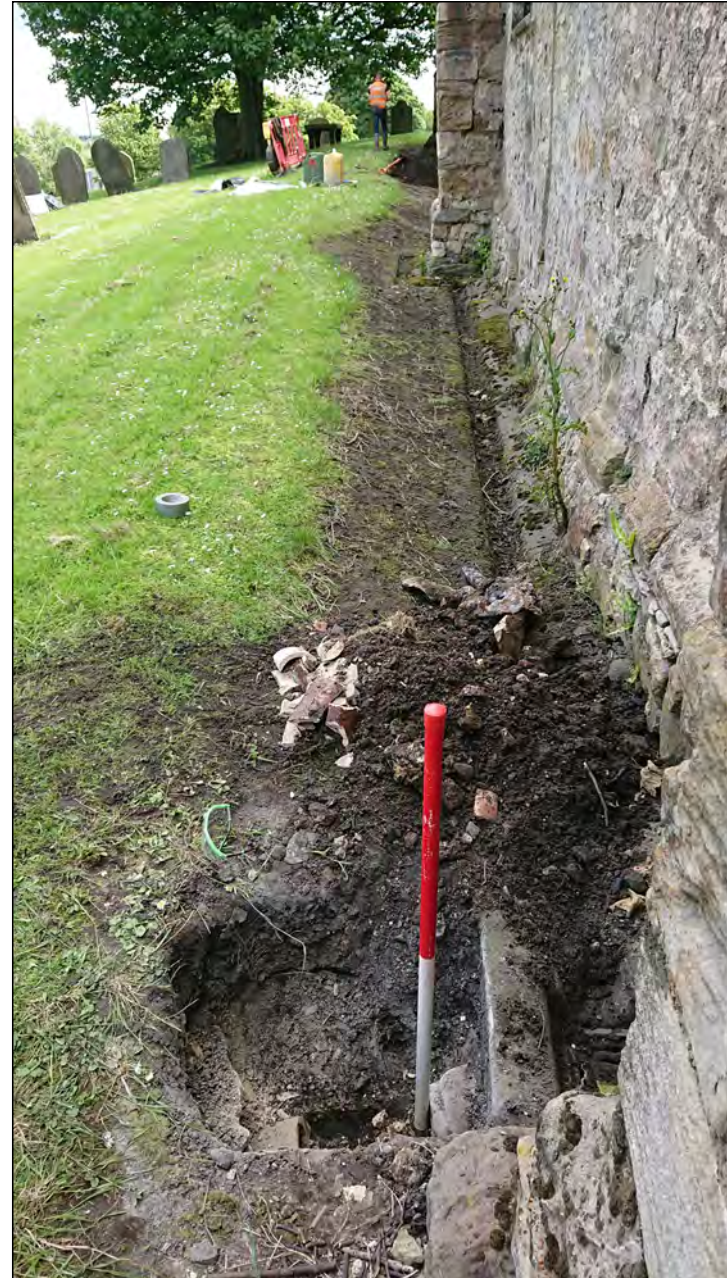
Photo 02. View looking east at Drainage excavation GY01.

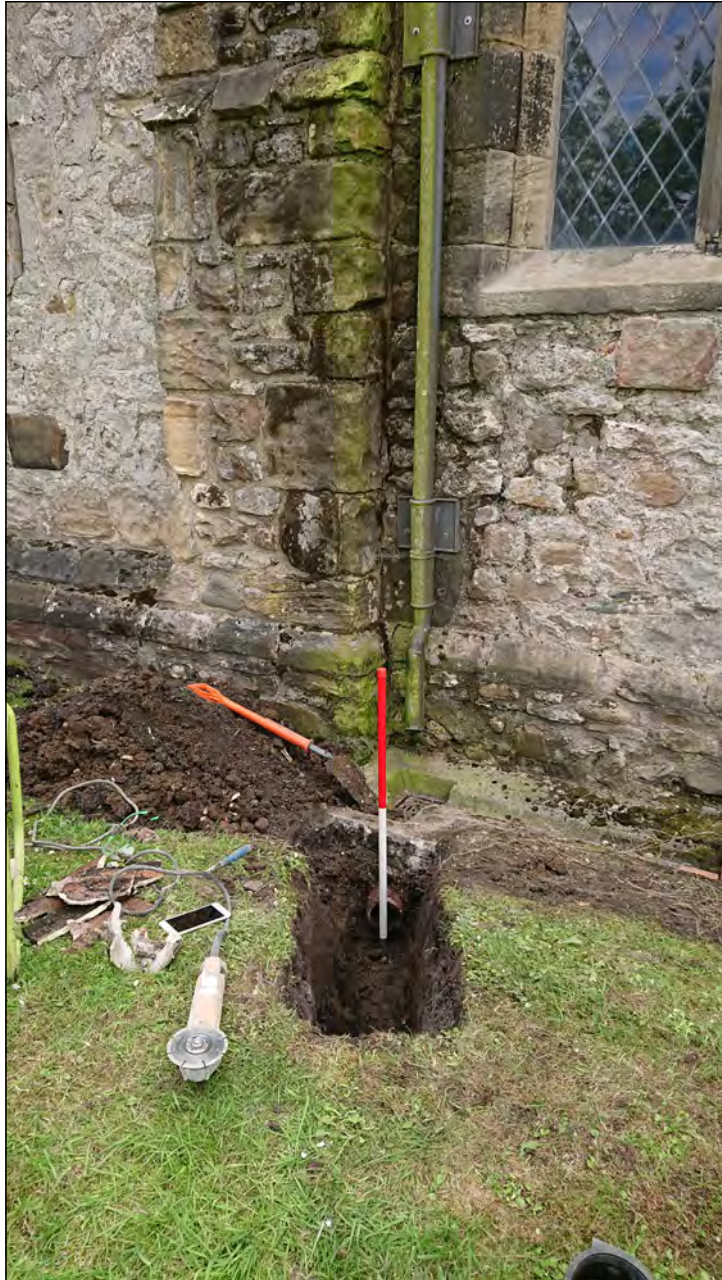
Below the topsoil [201], an existing salt-glaze ceramic drainpipe was revealed [202] of probable 19th century date. The north end of the sondage was a little deeper, following the line of the existing drainpipe, with some hard-core back-fill observed above it [203]. Some disturbed disarticulated human bone was scattered randomly in the topsoil. No archaeological remains were observed.

Photo 03. Broad view looking southeast towards Drainage excavation GY02.

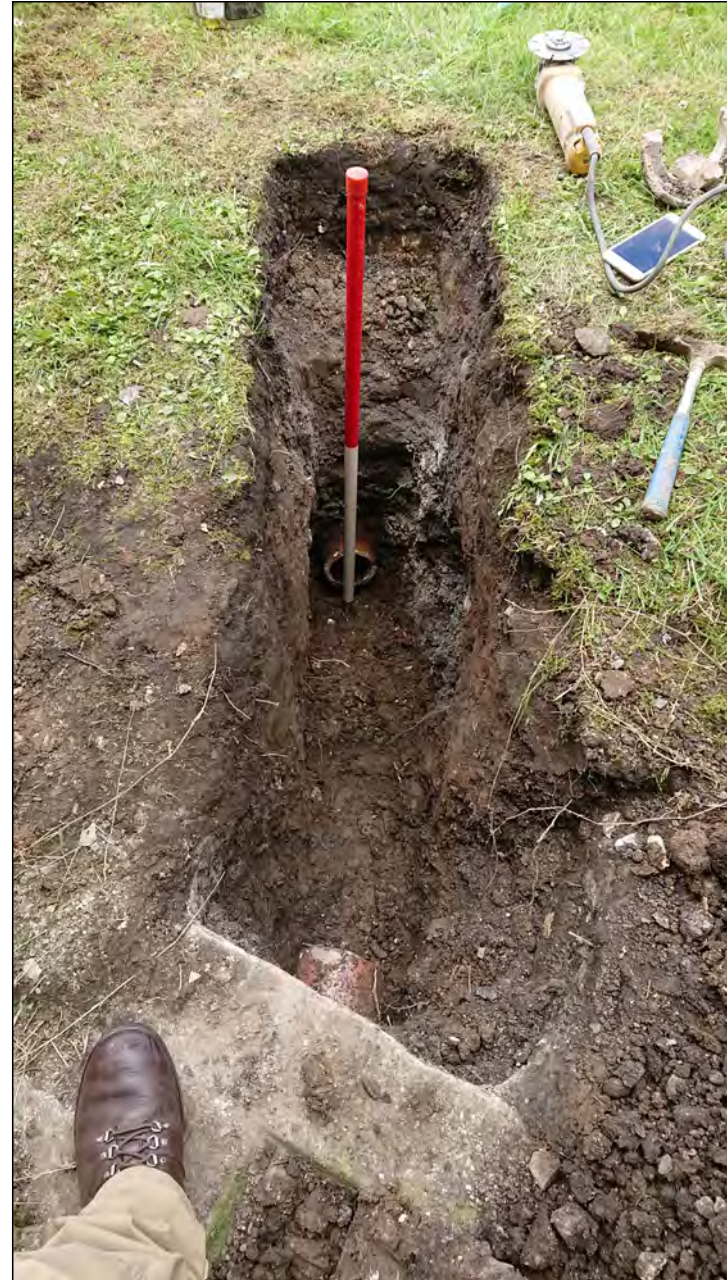
Photo 04. View looking northwest along Drainage excavation GY02.

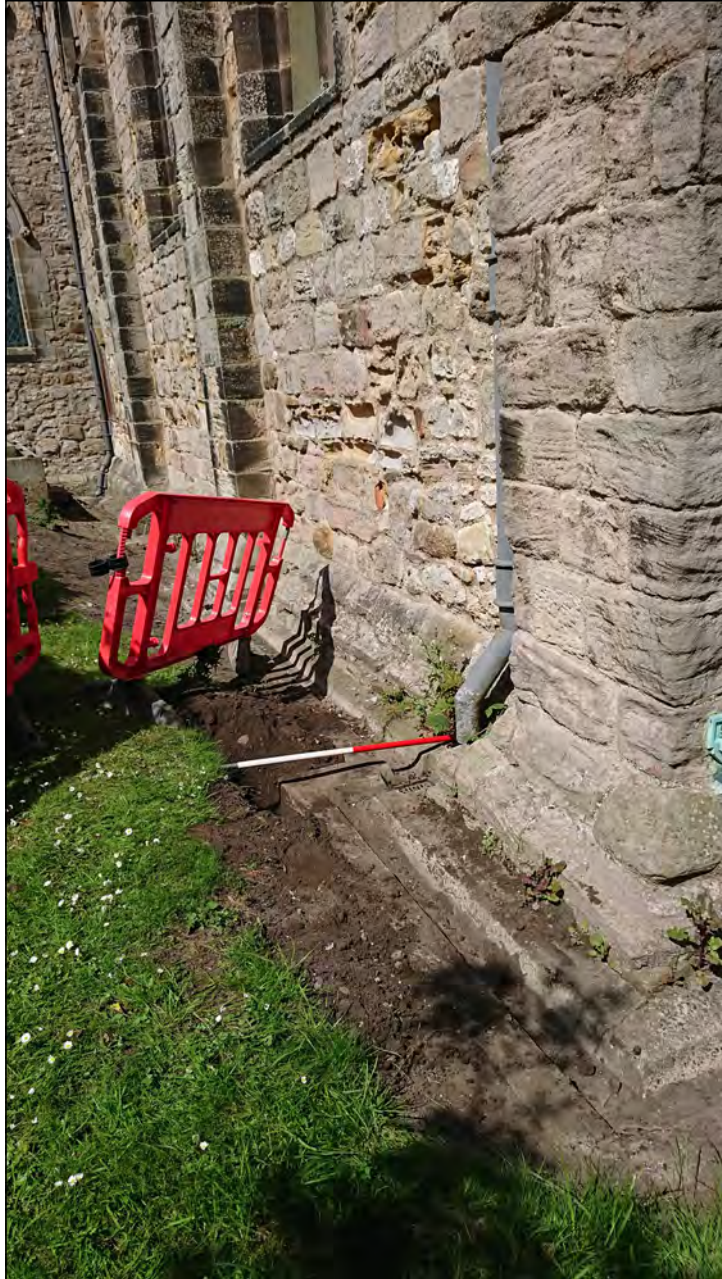
Within the topsoil [501], an existing ceramic drainpipe was revealed [502] of probable 19th century date. No archaeological remains were observed.

Photo 05. Broad view looking west towards Drainage excavation GY05.

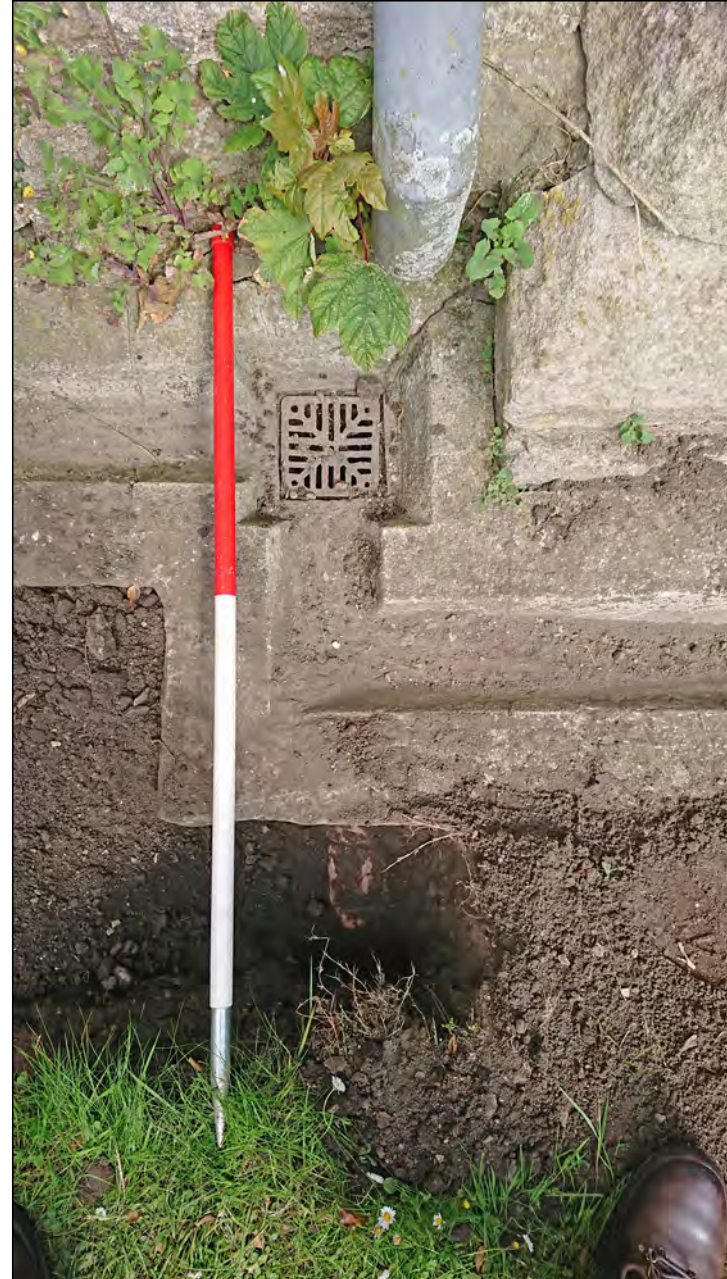
Photo 06. View looking north at Drainage excavation GY05.

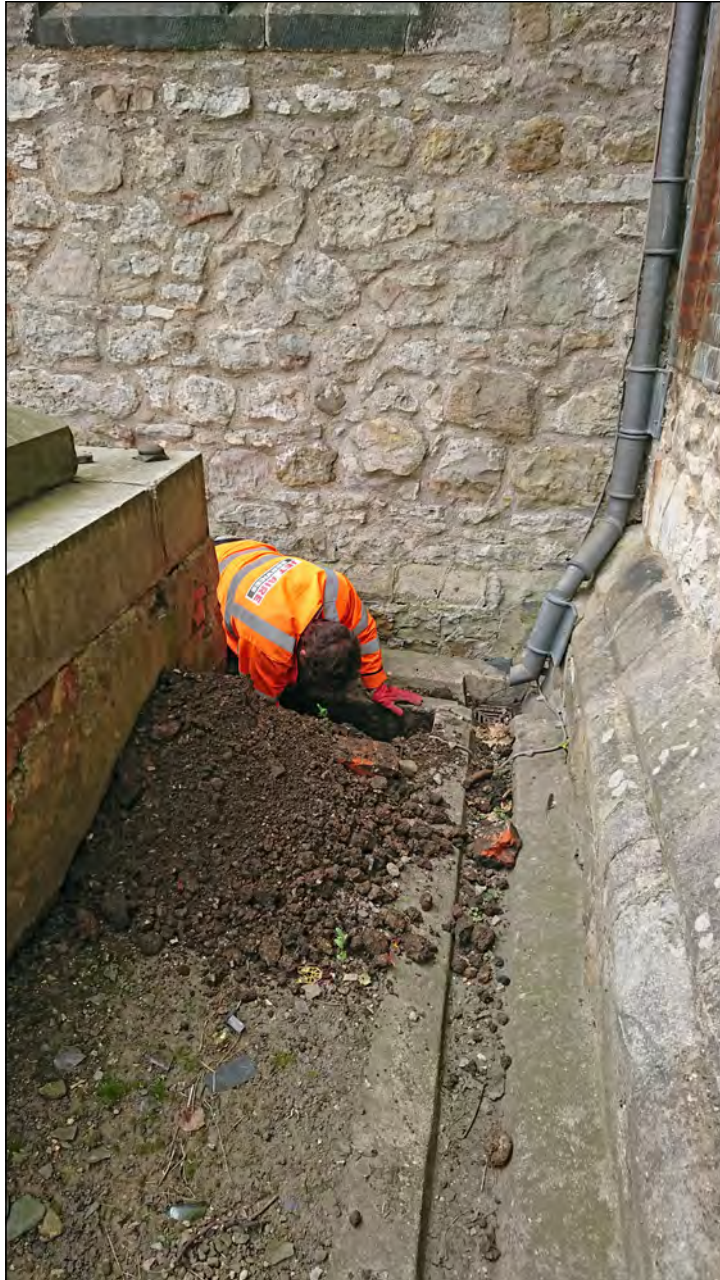
An existing ceramic drainpipe was exposed [602] after breaking out a portion of modern concrete [601]. No archaeological remains were observed.

Photo 07. Broad view looking west towards Drainage excavation GY06.

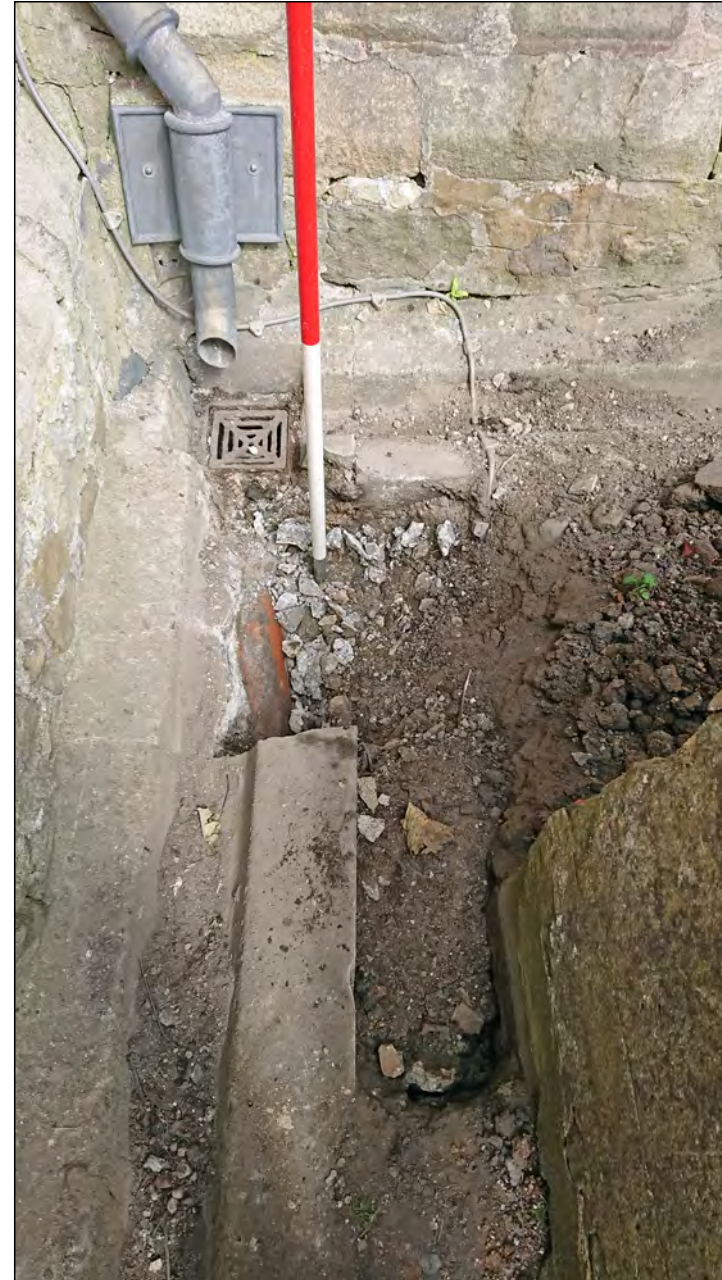
Photo 08. View looking north at Drainage excavation GY06.

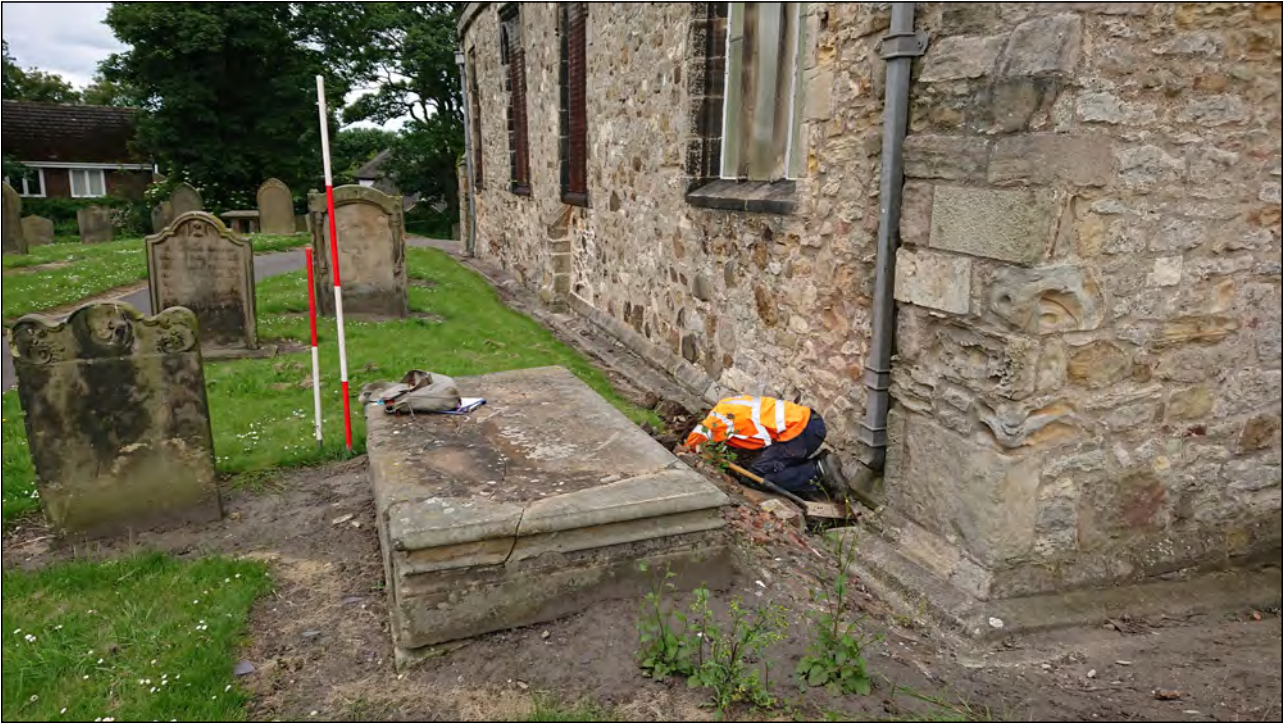
Below the topsoil [701] - which contained some disturbed disarticulated human bone, a very small rubble-based wall [702] protected double salt-glaze ceramic drainpipes [703-4] of probable 19th century date. A vandalised chest tomb was observed abutting the east end of the sondage but was not affected by the drainage works.

Photo 09. Broad view looking west towards Drainage excavation GY07 and Tomb Chest 'A'.

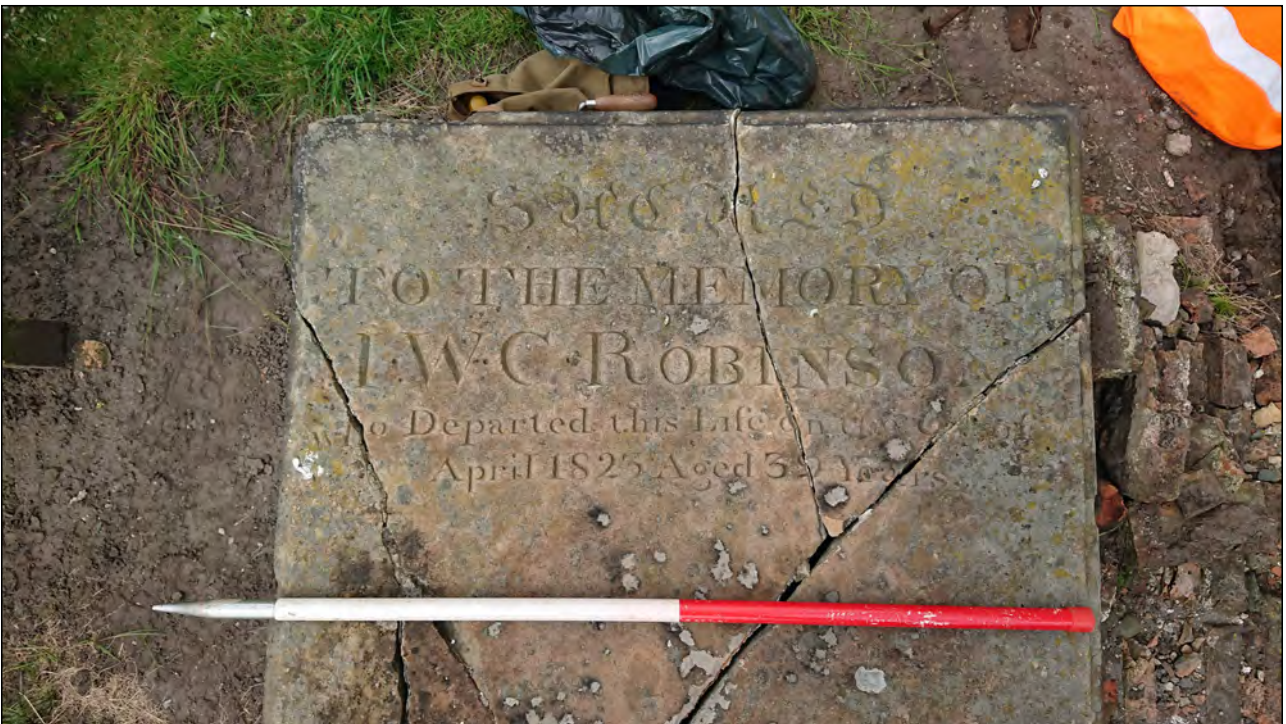
- [701] Topsoil, comprising of fairly-firm, mid grey-brown silt-loam, some disarticulated human bone.
- [702] Small rubble-based wall above ceramic drainpipe [703] measuring 0.18 m (width) x 0.32 m (depth), aligned WSW-ENE, parallel to nave south wall.
- [703] Existing salt-glaze ceramic drainpipe, aligned WSW-ENE.
- [704] A second salt-glaze ceramic drainpipe parallel to the first [703].
- [705] East end of sondage abuts a brick-built vaulted chest tomb (see photos 09-10) of I.W.C. Robinson c.1825. Not affected by the drainage works but in need of repair and re-pointing, as recently subject to vandalism - with several bricks removed.

Photo 10. Dedicatory inscription on Tomb Chest 'A', with recently vandalised brick vault beneath.

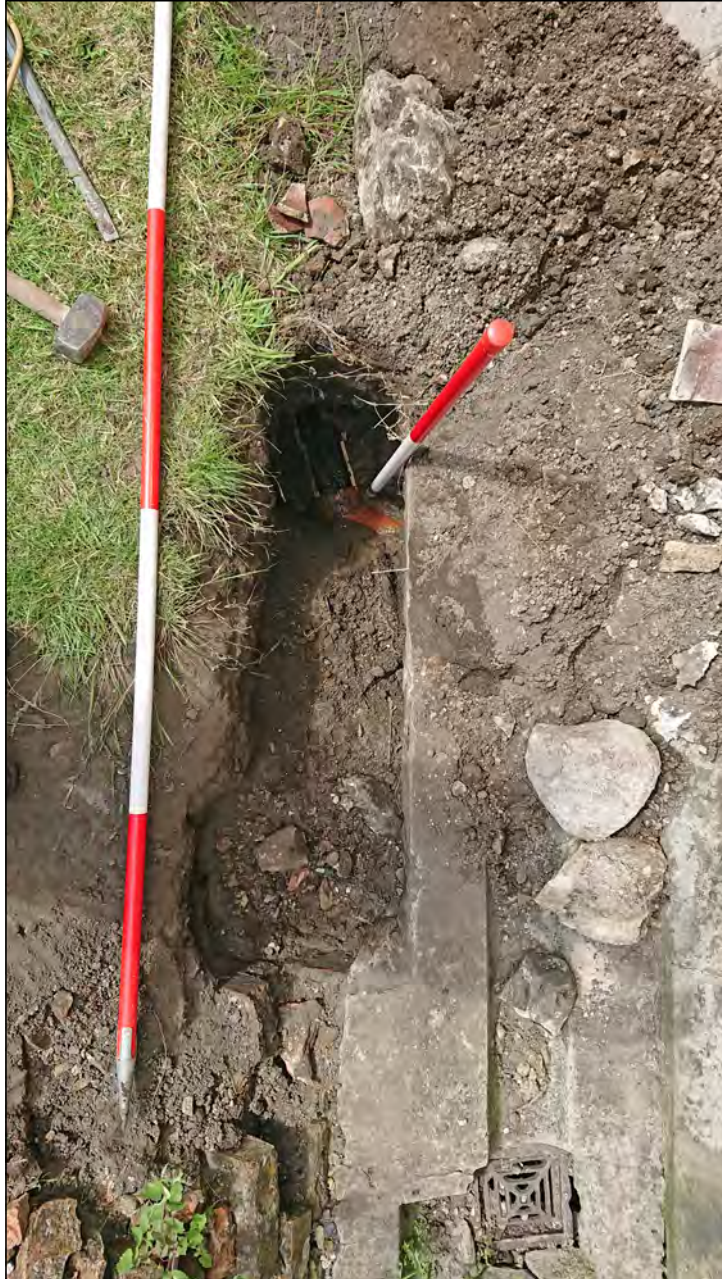
Photo 11. View looking west along Drainage excavation GY07.

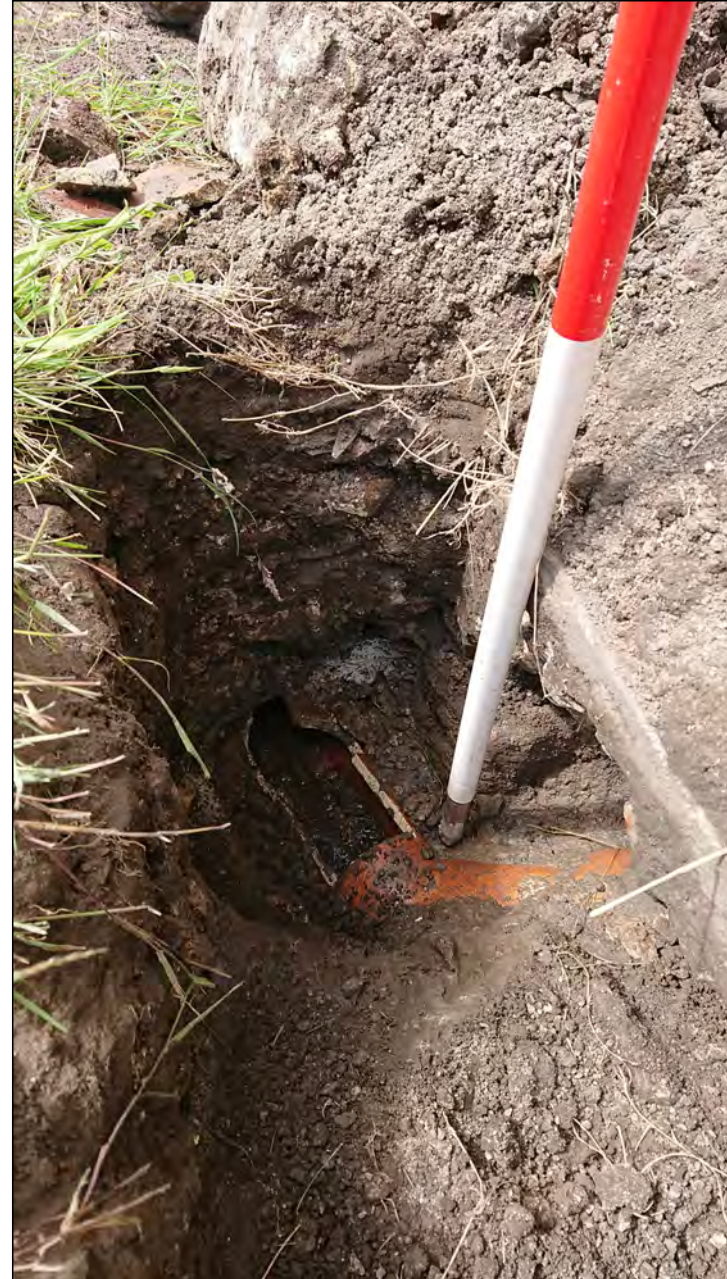
Photo 12. Detail of existing ceramic drain in GY07.

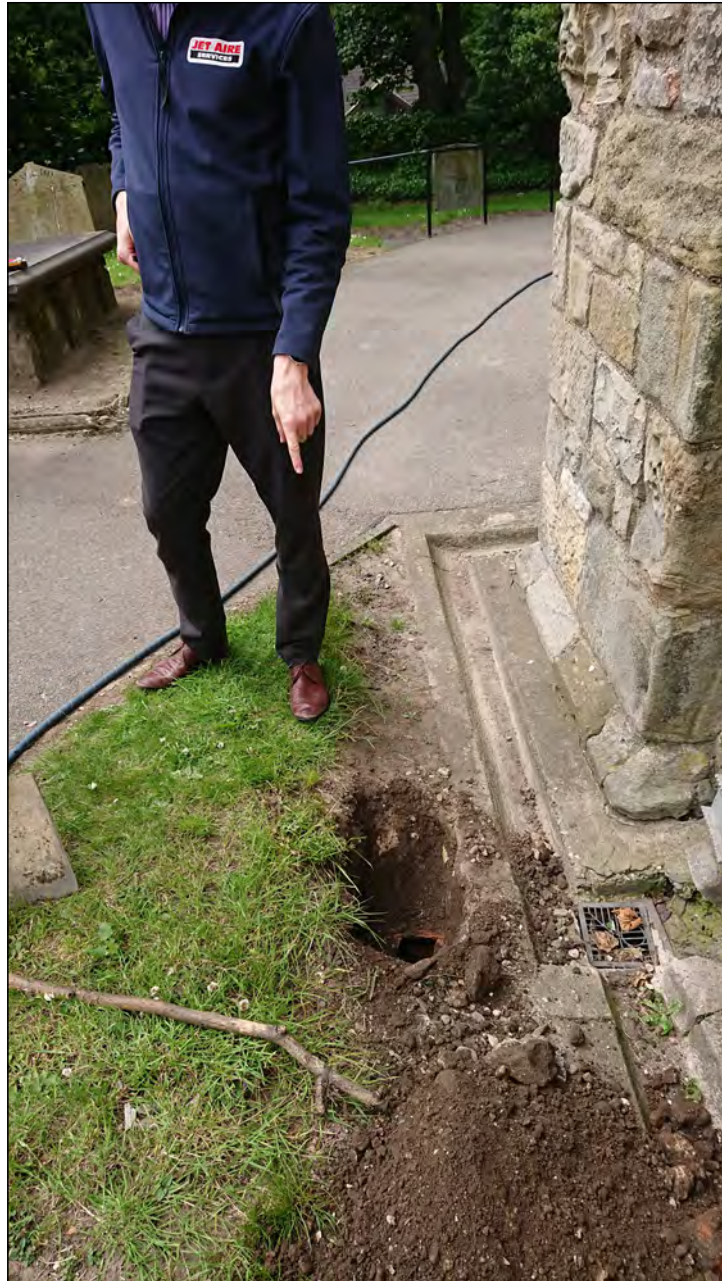
Within the topsoil [801], an existing ceramic drainpipe was revealed [802] of probable 19th century date. No archaeological remains were observed.

Photo 13. View looking west at Drainage excavation GY08.

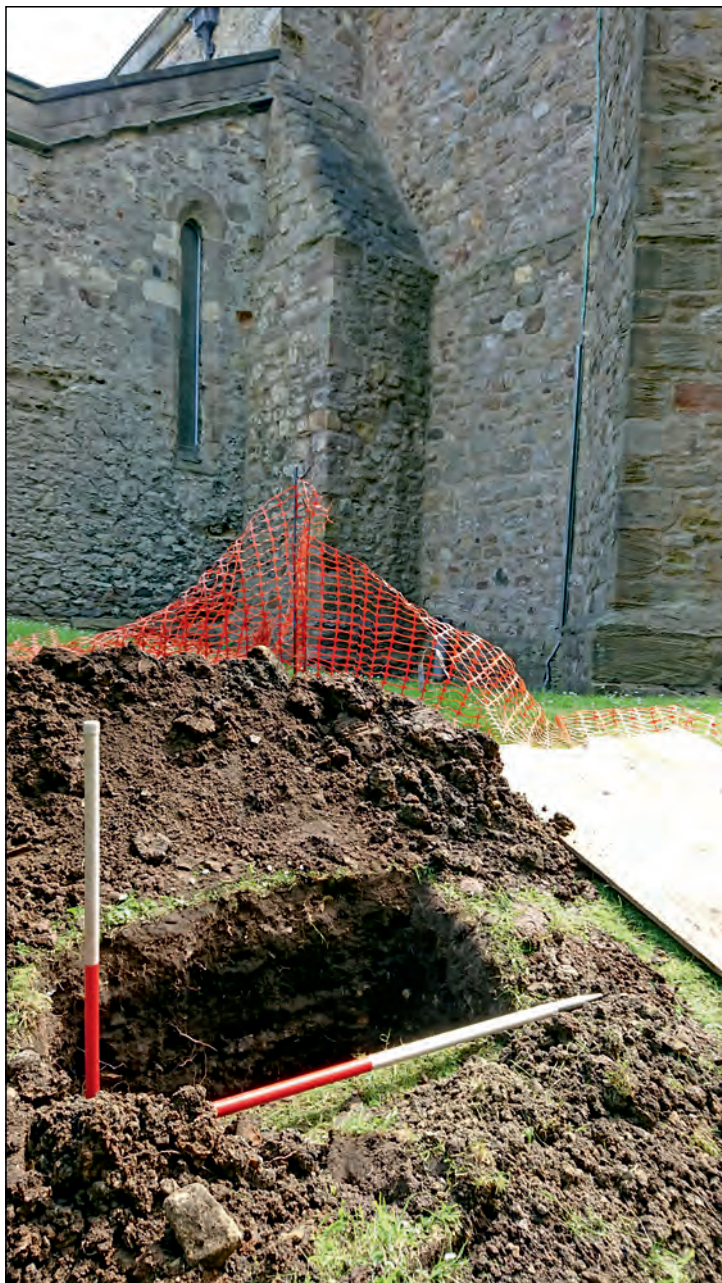
At the base of the topsoil [901] two small electricity cables were observed [902] running parallel to the churchyard path. Below this was a sandy-silt subsoil [903] followed by natural boulder-clay [904]. No archaeological remains were observed, nor was the existing manhole which the excavation sought to find.

Photo 14. Broad view looking west, showing the first excavation attempt to find Mh1 (MH1a).

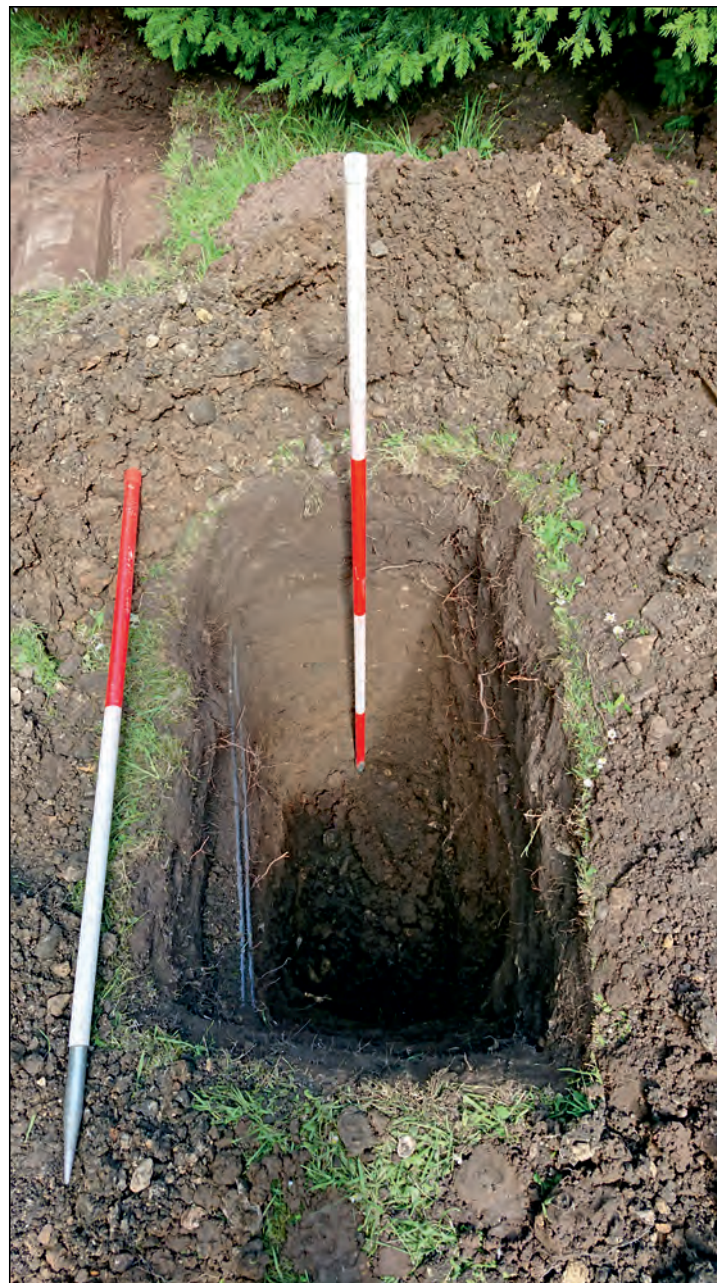
Photo 15. View looking north at the first excavation attempt to find Mh1 (MH1a) before being abandoned.

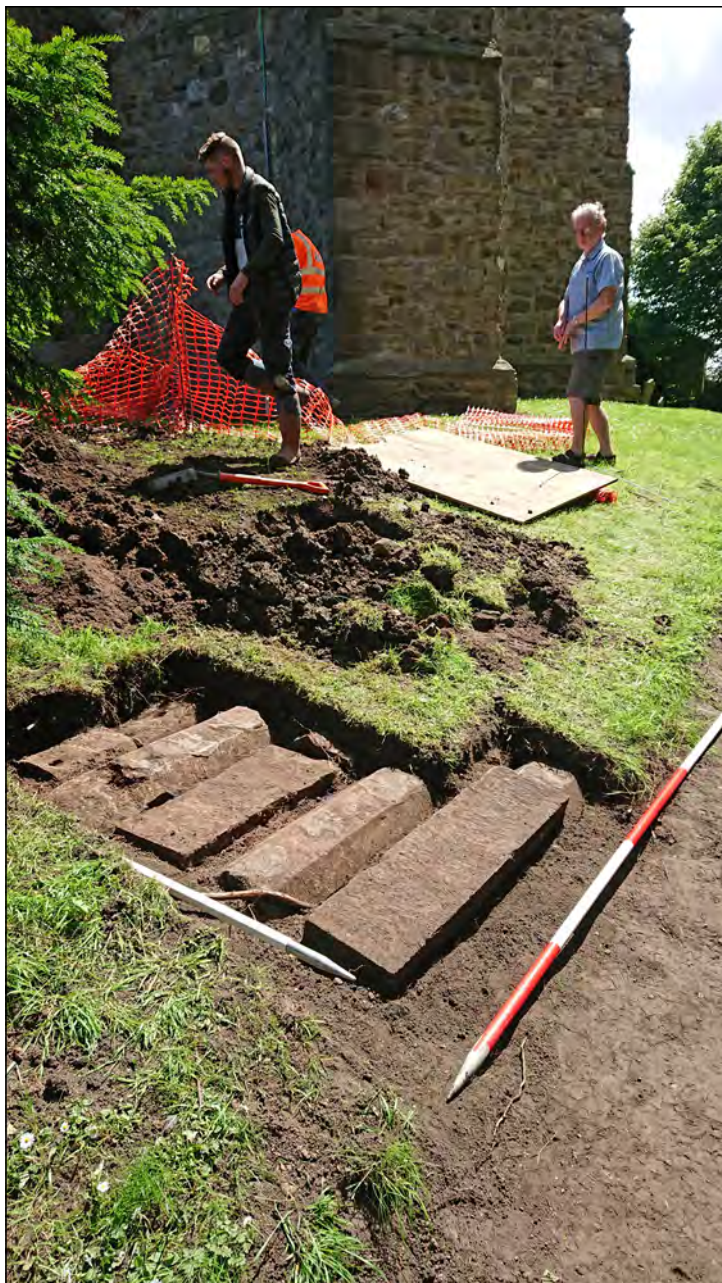
During the excavation of MH1a, a series of reused sandstone slabs were noted poking out through the topsoil, located 1.13 m to the northwest of MH1a, abutting the pathway retaining wall on a WSW-ENE alignment. The slab area measured 1.50 m (length) x 0.90 m (width). This feature was briefly explored and found to comprise at least five sandstone slabs, reused from the pedestal bases of (presumably fallen) gravestones. The feature has been interpreted as ad hoc revetting, probably constructed in the late 19th or early 20th century, to help stabilise the bank adjacent to the pathway retaining wall.

Photo 16. Broad view looking southeast, showing a row of stone slabs reused probably in the 20th century torevet the main pathway retaining wall.

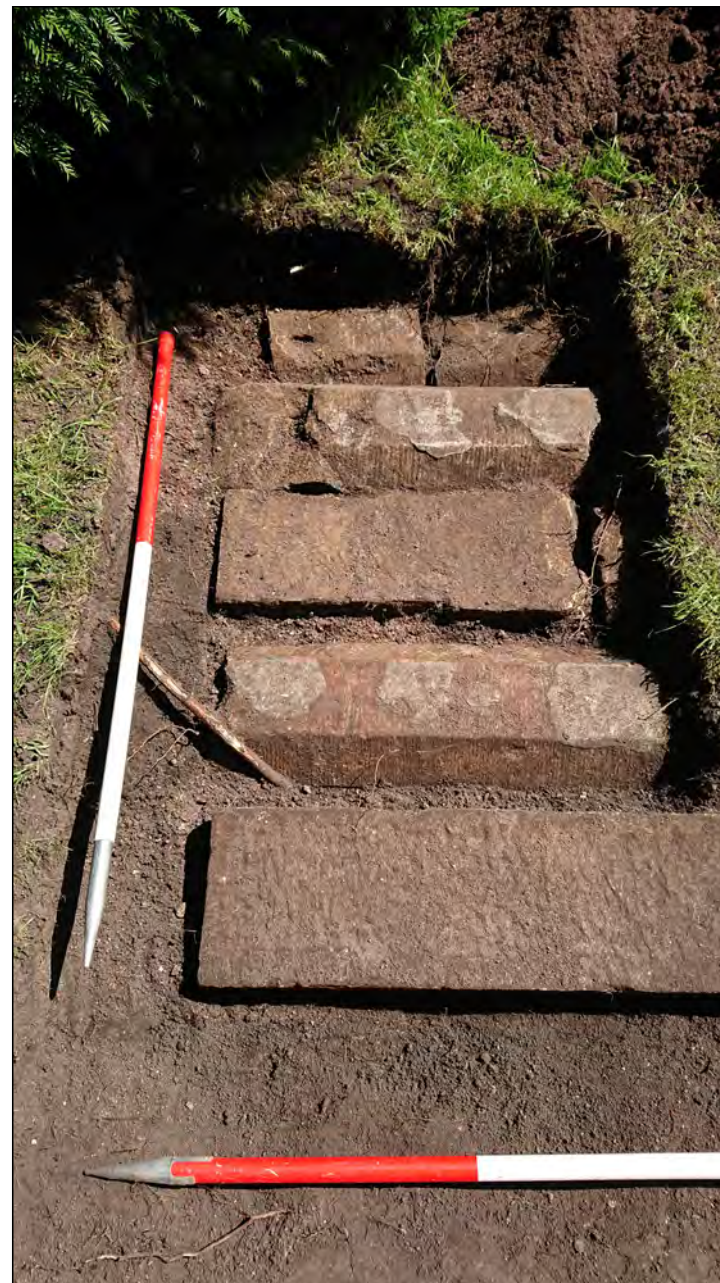
Photo 17. View looking east along row of stone slabs reused probably in the 20th century torevet the main pathway retaining wall.

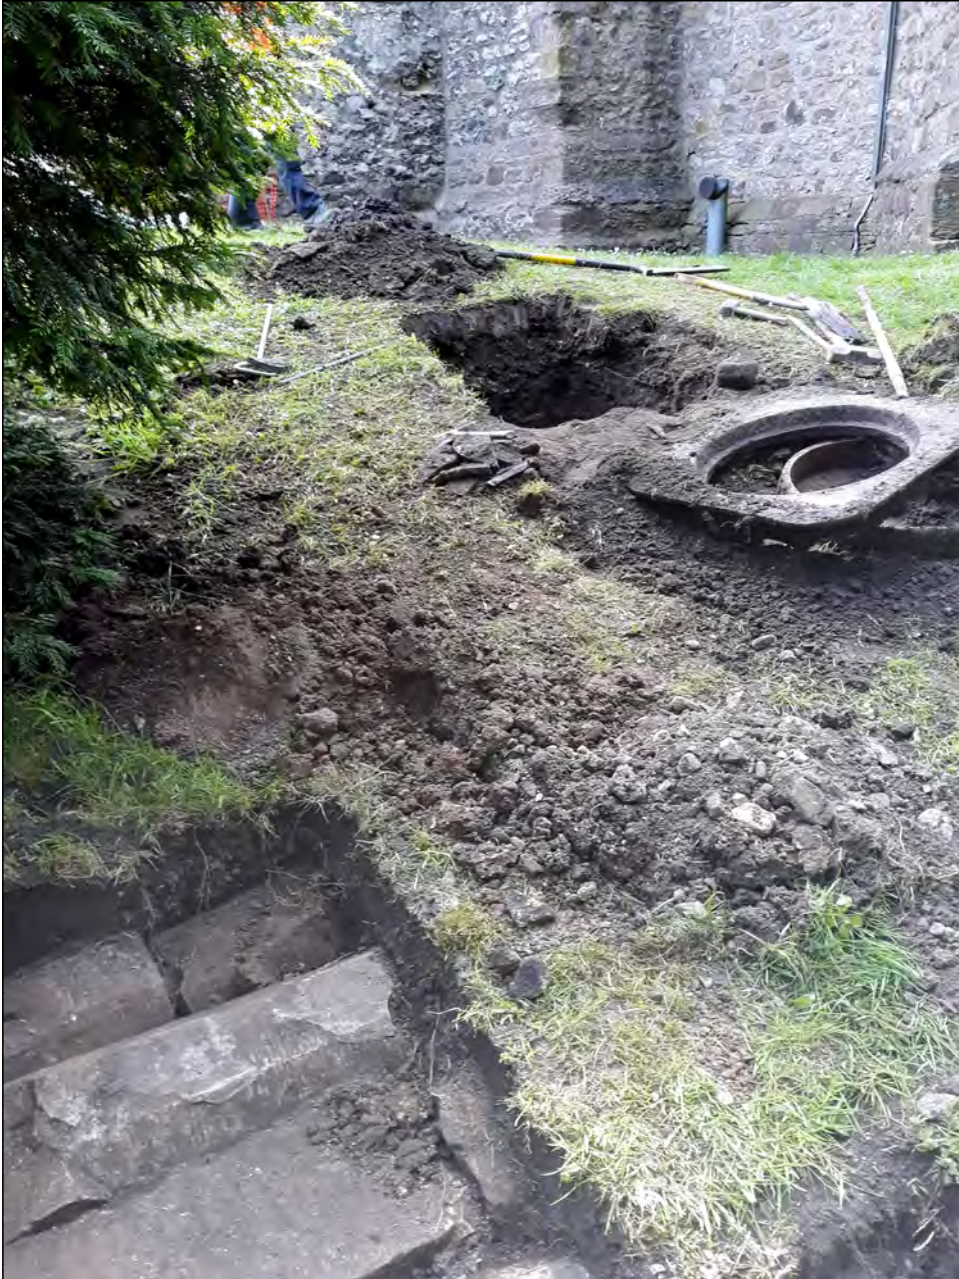
Below the topsoil [1001] and redeposited subsoil [1002], a square concrete manhole [1003]-MH1 was located at a depth of 0.50 m below ground level. No archaeological remains were observed.

Photo 18. Broad view looking approximately east at second (successful) excavation attempt to find MH1.

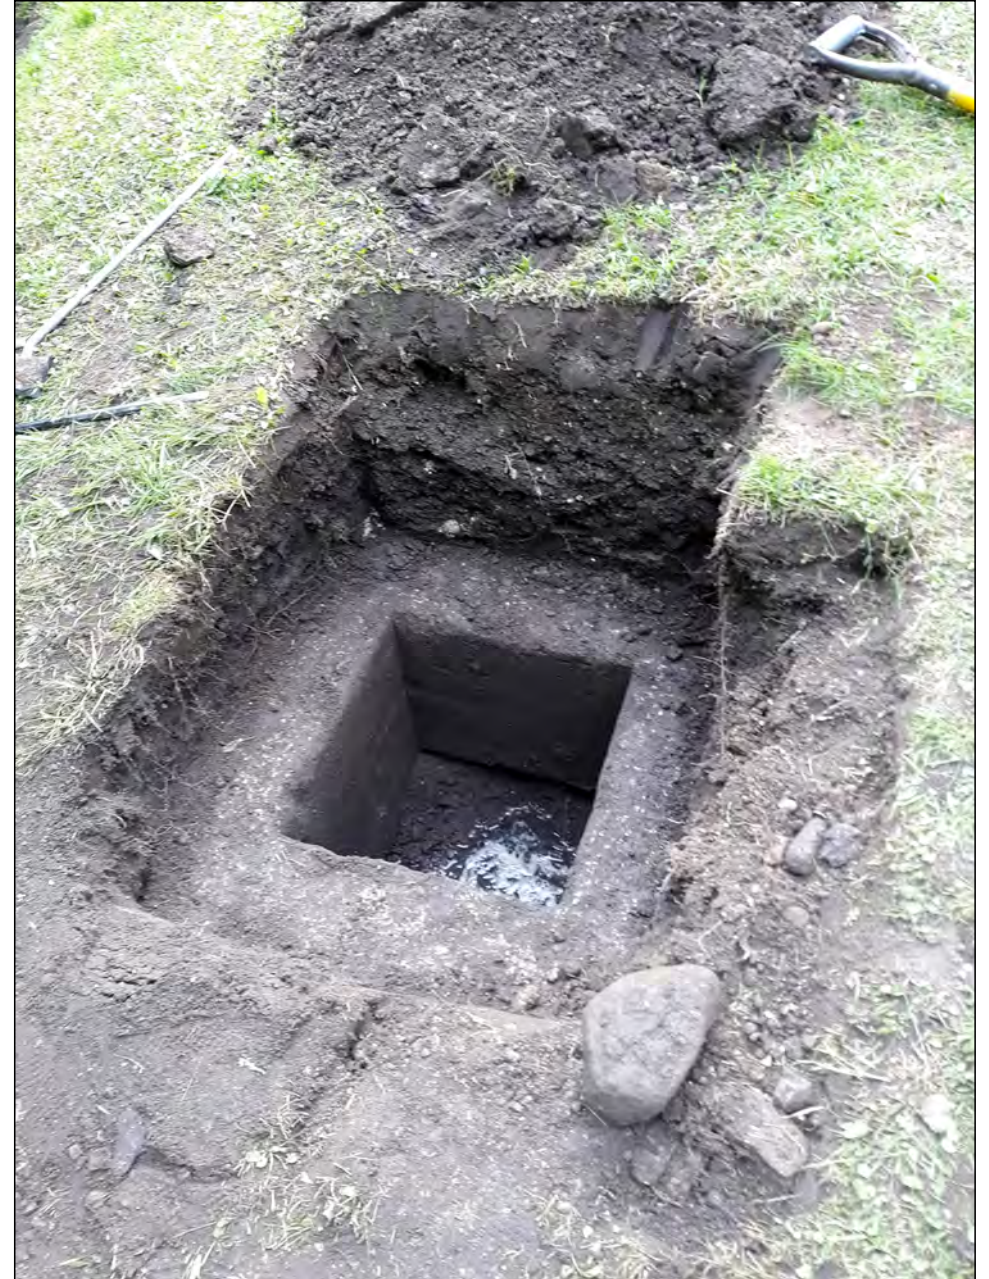
Photo 19. View looking ENE at second (successful) excavation attempt to find MH1.
