HAYDON OLD CHURCH,  
HAYDON BRIDGE,  
NORTHUMBERLAND

~ ARCHAEOLOGICAL WATCHING BRIEF ~

MAY 2021

REPORT ON AN ARCHAEOLOGICAL WATCHING BRIEF

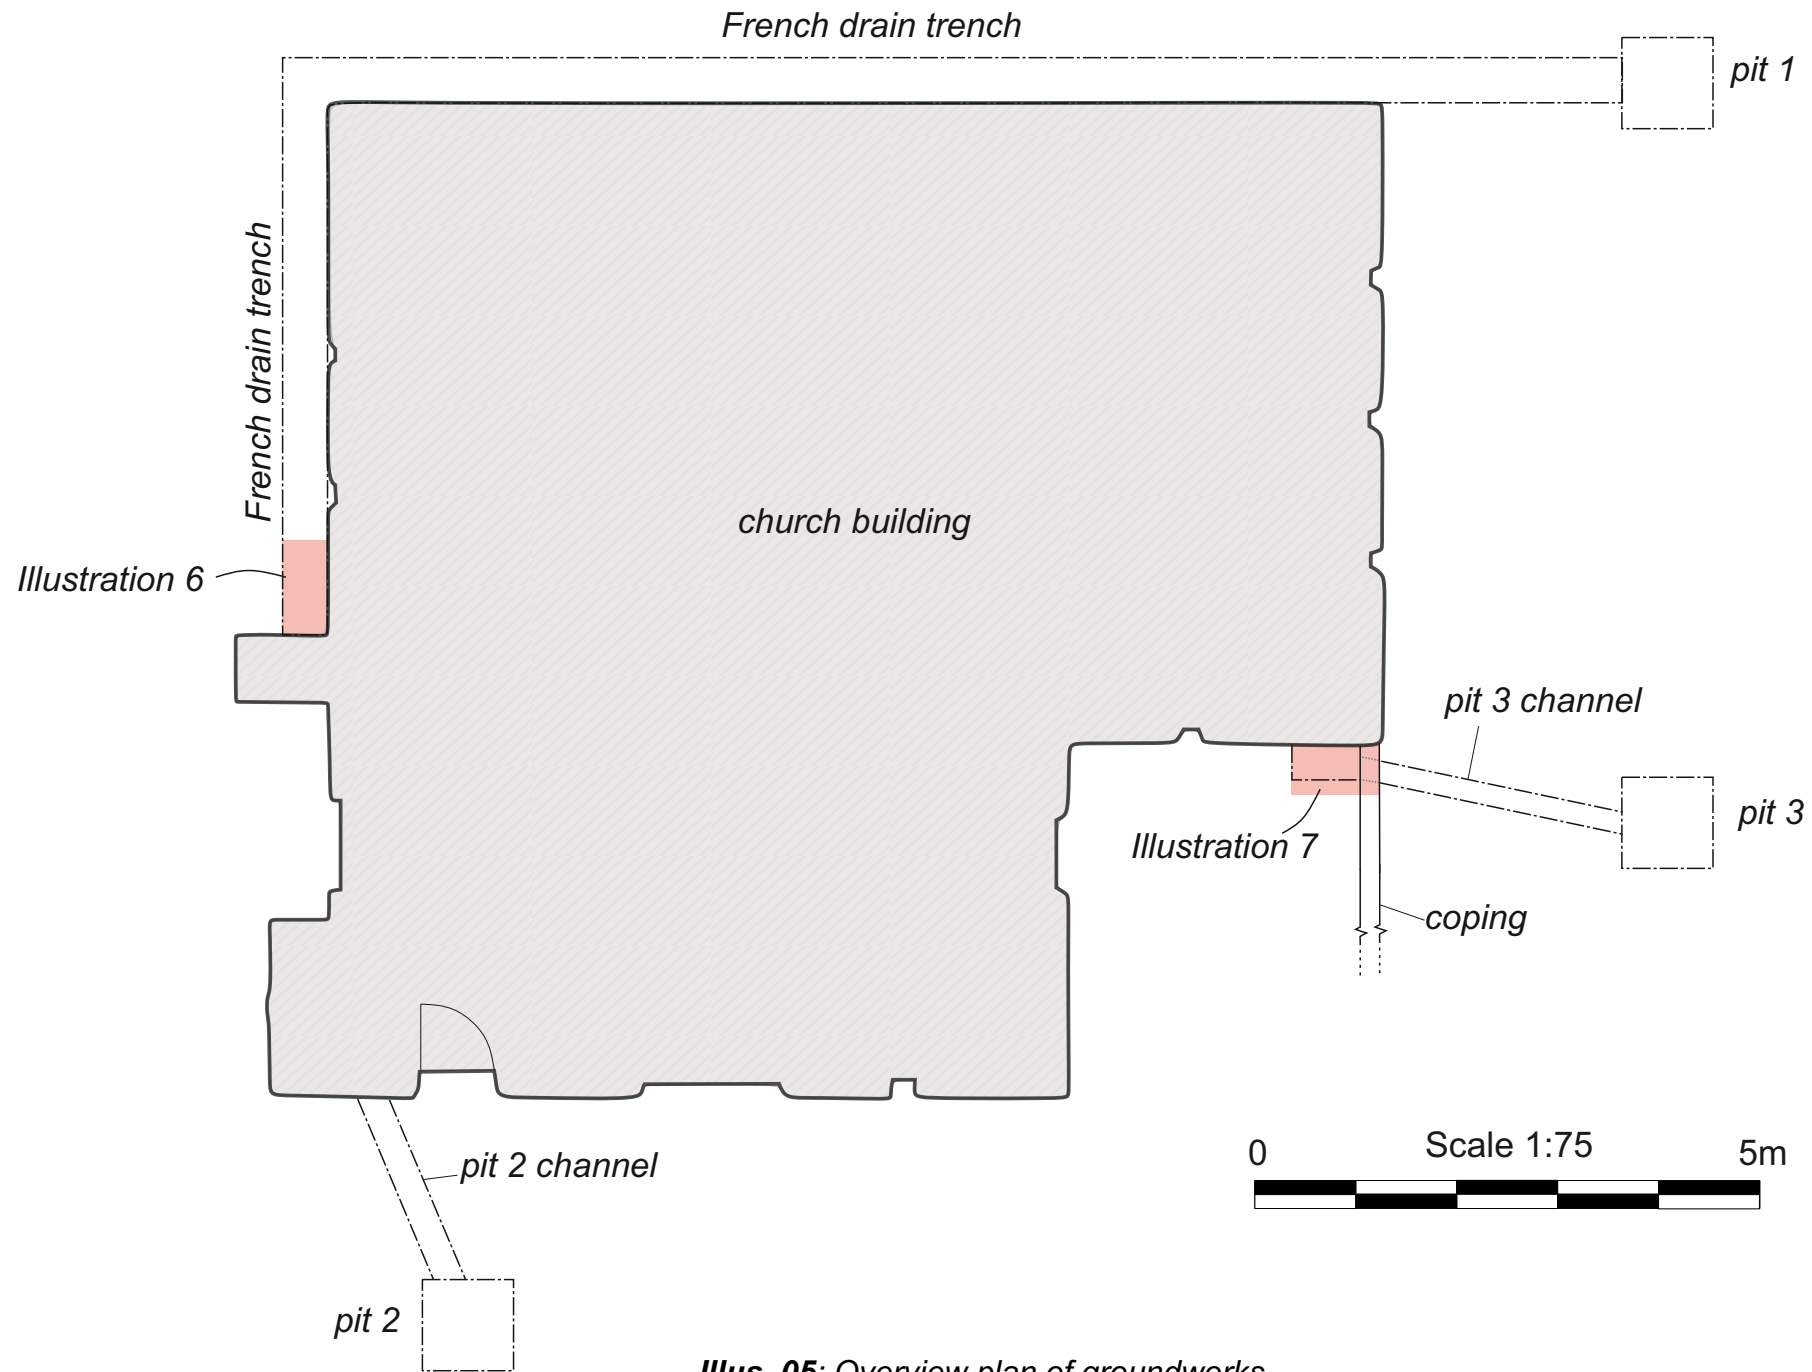
**Illus. 05:** Overview plan of groundworks.

Three soakaway pits were excavated in the churchyard to receive water from improved guttering (*see Illus. 05*). These pits, in order of excavation, were placed 2.40 m from the north-east corner of the chancel (pit 1), 2.40 m from the south-west corner of the chapel in front of the chapel door (pit 2) and 2.40m from the south-east corner of the chancel (pit 3). All pits were 0.90 m by 0.90 m in plan and were excavated to depth of up to 0.90 m.

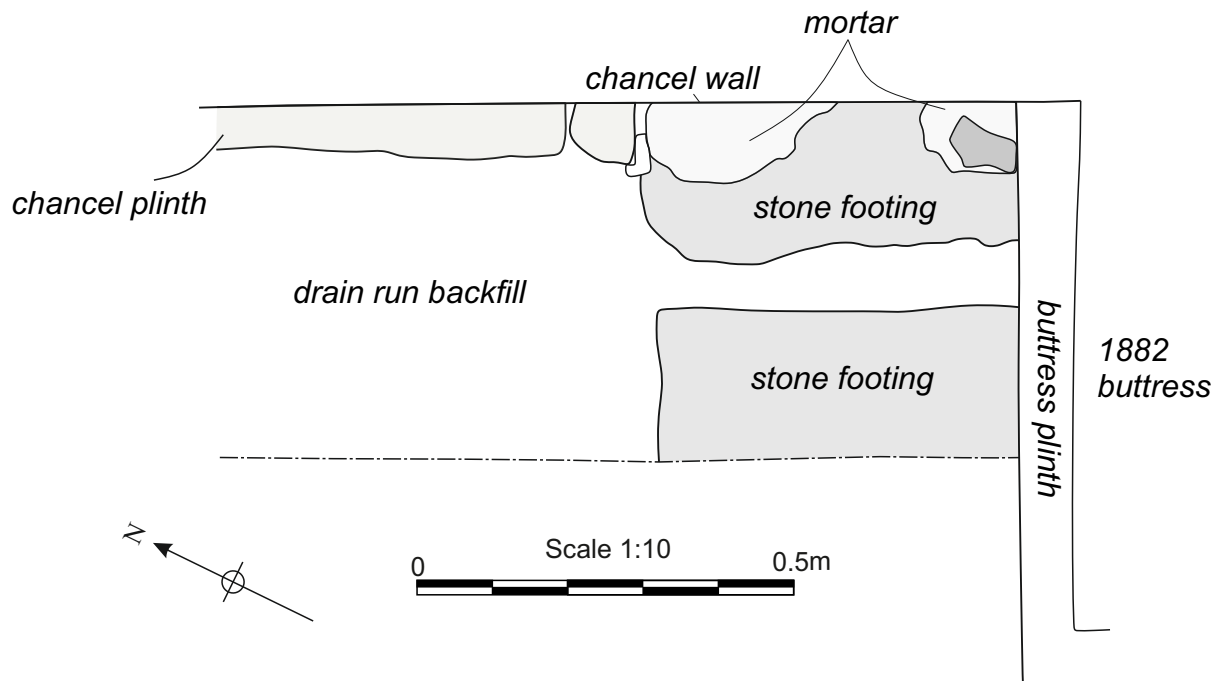
**Illus. 06:** Plan of stone footing on the west side of the chancel.

The only feature of note within this trench was a stone footing found in the base of the trench north of and adjacent to the extant 1882 buttress (*see Illus. 06*). This footing was likely for the large 1795 buttress referred to by Hodges, matching well with its projected position (Ryder 2011: 7). Just three fragments of disarticulated human bone were found during the course of these excavations. The material throughout the trench consisted dark grey-brown sandy soil with frequent gravel inclusions and represents backfill of the 19<sup>th</sup> or 20<sup>th</sup> century drainage run.

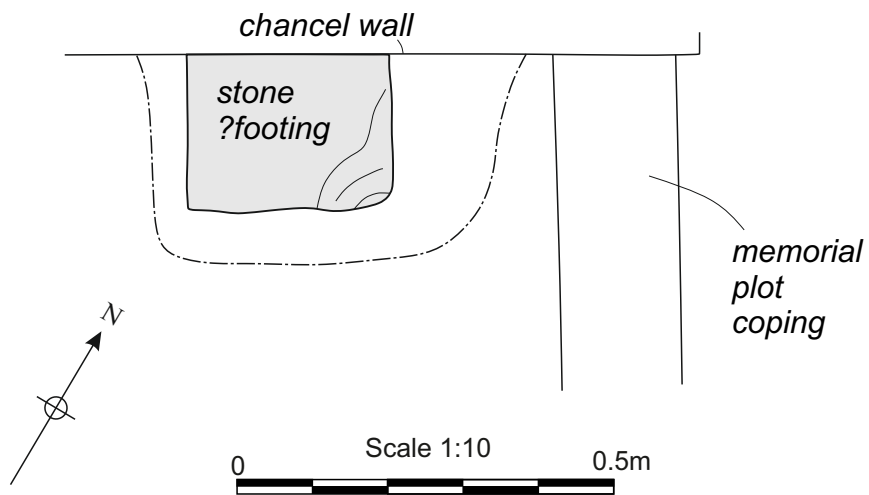
**Illus. 07:** Plan of possible stone footing on the south side of the chancel.

In the channel excavated from the chancel corner to the soakaway (pit 3), one piece of *in-situ* masonry measuring 0.27 m by at least 0.20 m in plan and with a depth of at least 0.10 m, was encountered on the south wall of the chancel, 0.28 m from the south-east chancel corner (see *Illus. 07, Photo 14*). The stone was overlain by the chancel south wall and may have represented a footing for a structure predating the 14<sup>th</sup> century chapel, although this is unclear. No further masonry or masonry fragments were encountered. More defunct 19<sup>th</sup> or 20<sup>th</sup> century drainage was present here, running though the coping of the memorial plot against the south wall of the chancel, which it post-dated – the coping had been roughly bored through below ground level in order for the drainpipe to pass under it.

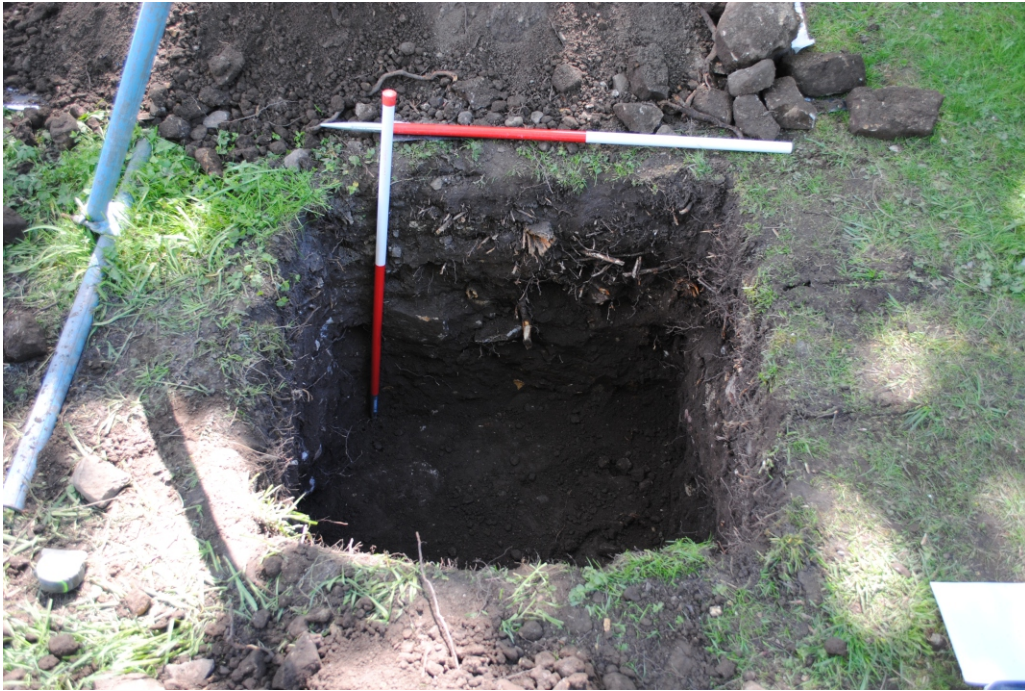
Pit 1 (*see Photo 01*) contained frequent masonry fragments, many of them large, presumably from historic demolition and refurbishment of the church buildings. No features or significant finds were encountered, and no disarticulated bone was found. The entire pit consisted of a dark grey-brown topsoil, with frequent roots.

**Photo 01.** Soakaway pit 1 looking south.

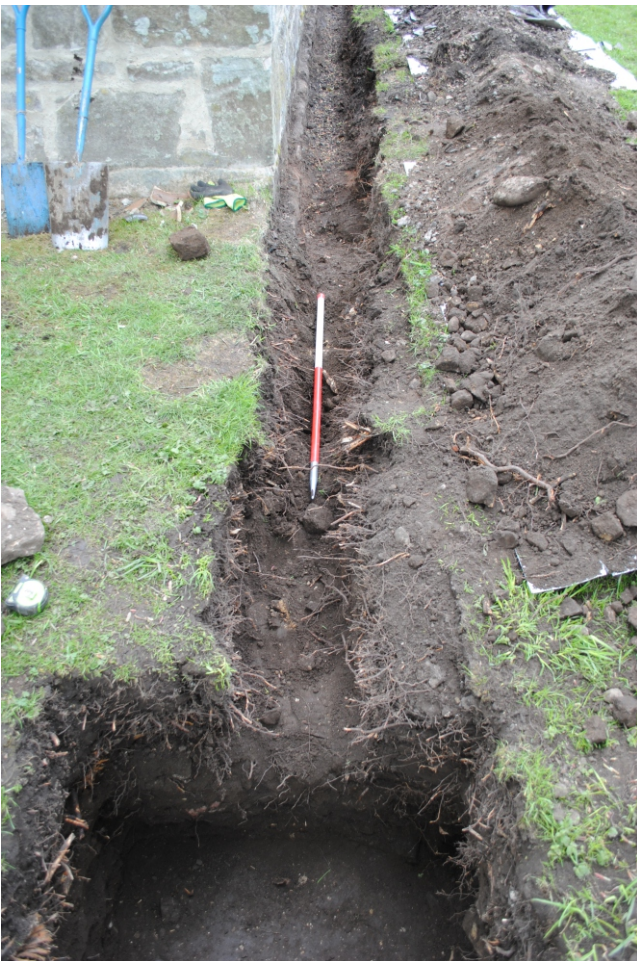
**Photo 02.** View looking west from soakaway pit 1 towards the excavations for the drain.

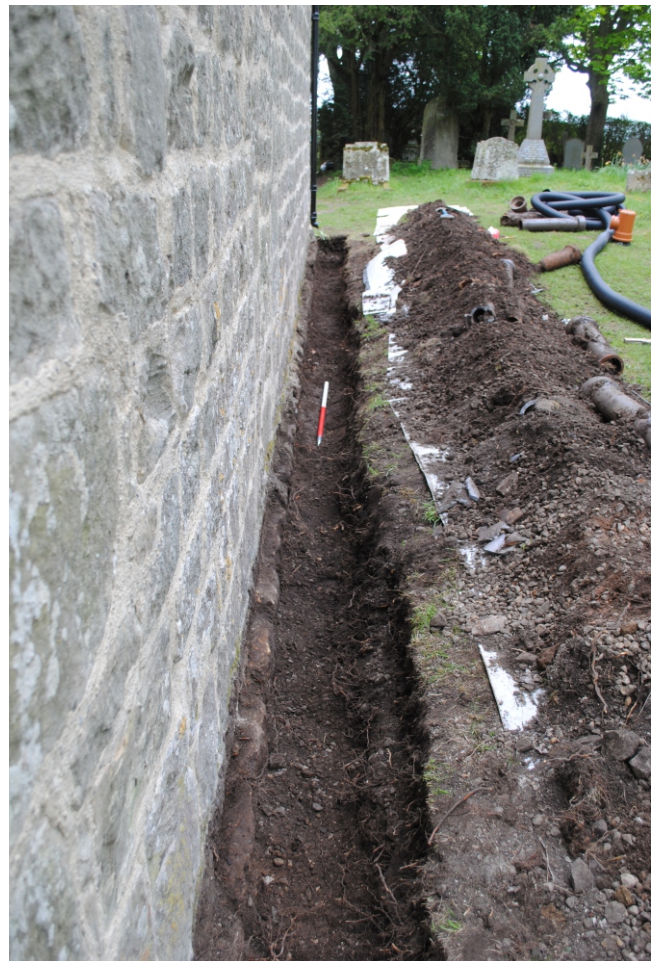
**Photo 03.** View looking west at excavations for the drain.

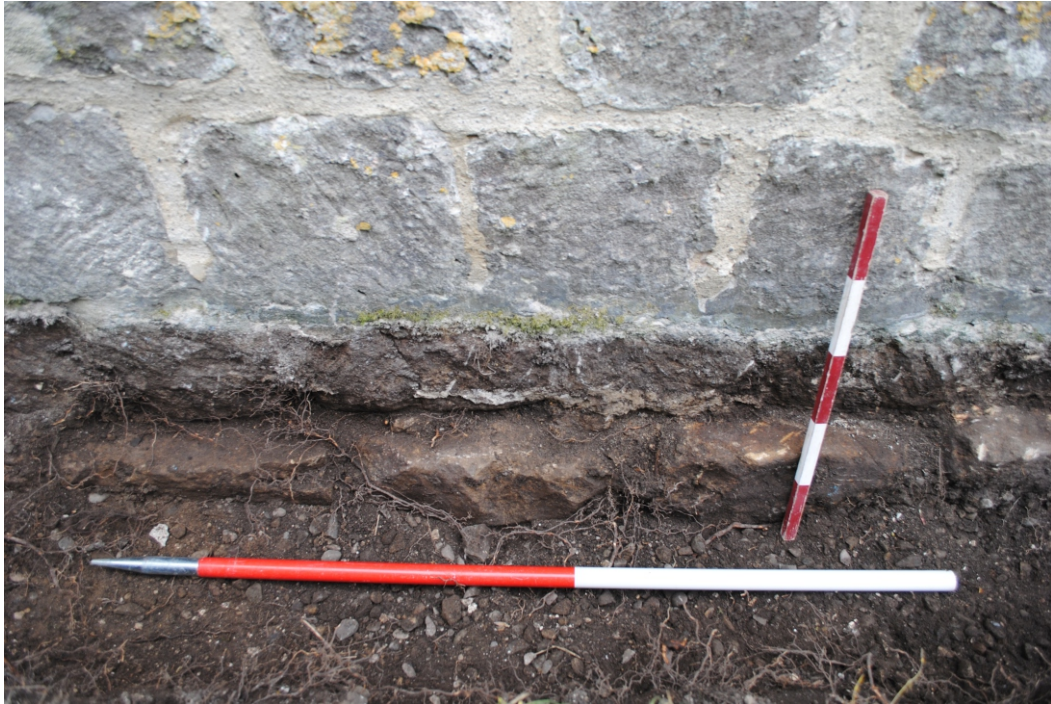
A trench 0.45 m wide and approximately 0.45 m deep was excavated along the north and west sides of the chancel wall (*see Photos 02-07*), revealing the chancel's plinth (*see Photo 04*). This trench extended from the 1882 (northern) buttress on the west wall via the north-west chancel corner to a soakaway pit 2.40 m from the north-east corner of the chancel building (pit 1, below). An *in-situ* drainage run was extant in the trench in roughly the same position as the proposed French drain on both lengths of the trench. It consisted of mismatched lengths of ceramic pipe, some glazed and some unglazed. The pipes were mostly blocked with organic materials and soil and likely date to the late 19<sup>th</sup> or early 20<sup>th</sup> centuries.

**Photo 04.** The chancel plinth revealed in excavations for the drain. South view.

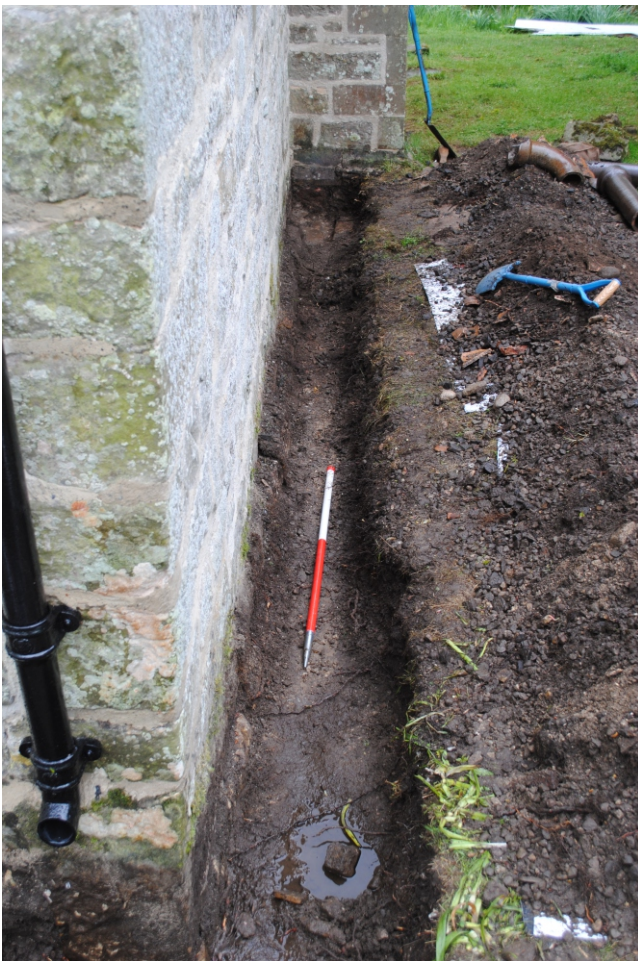
**Photo 05.** View looking south in the return of the trench for the drain.

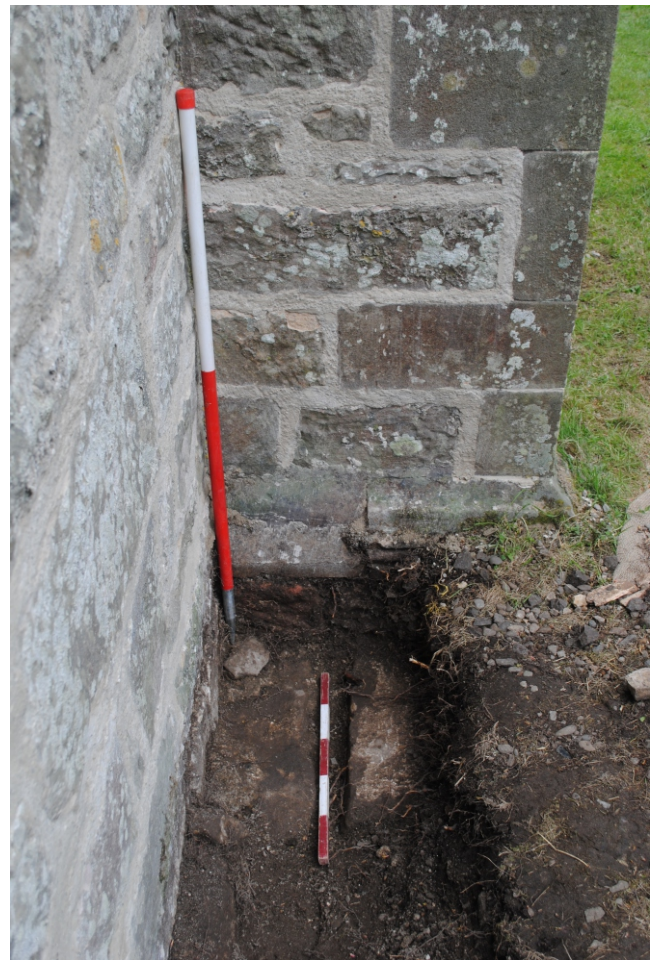
**Photo 06.** The foundations adjacent to the north buttress on the west wall. South view..

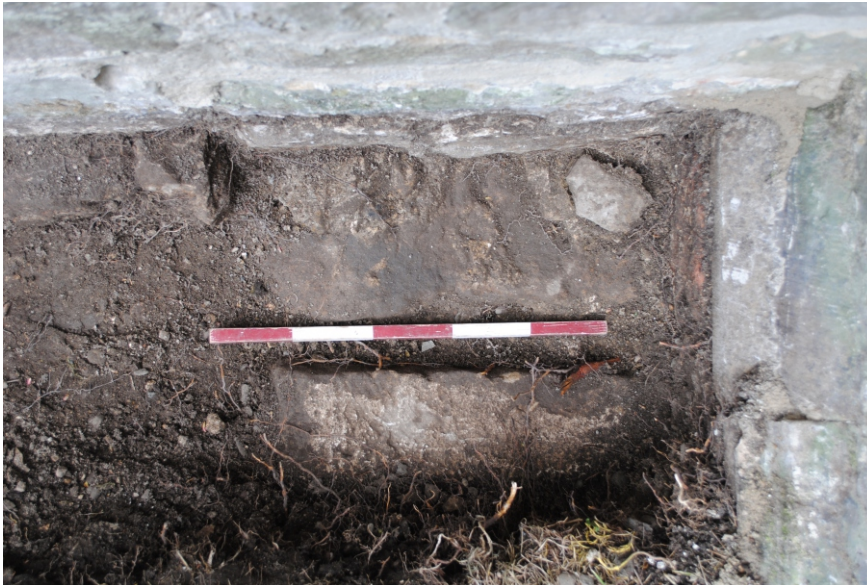
**Photo 07.** The footing adjacent to the north buttress on the west wall, photographed in plan

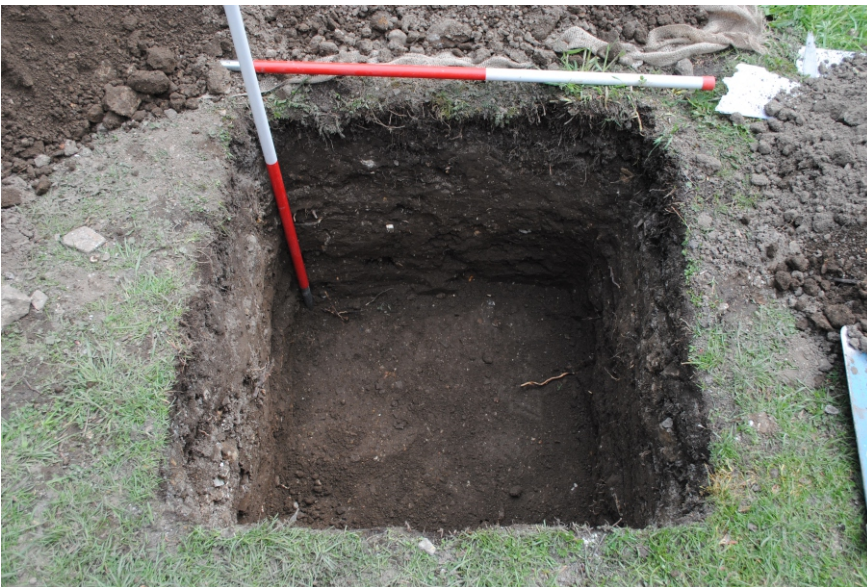
Pit 2 (*see Photos 08-09*) contained an initial layer of loose sandstone rubble overlying dark grey-brown topsoil. No cut features were encountered. Far fewer fragments of masonry were present in this pit, although a complete 'wrestler' ridge tile was found 0.45 m down from surface level. Pit 2 contained a large number of disarticulated and often fragmentary bones. The channel leading from the chapel corner to the soakaway pit (*see Photos 10-11*) was also devoid of features and finds, barring few fragmentary pieces of human bone.

**Photo 08.** Soakaway pit 2 looking south

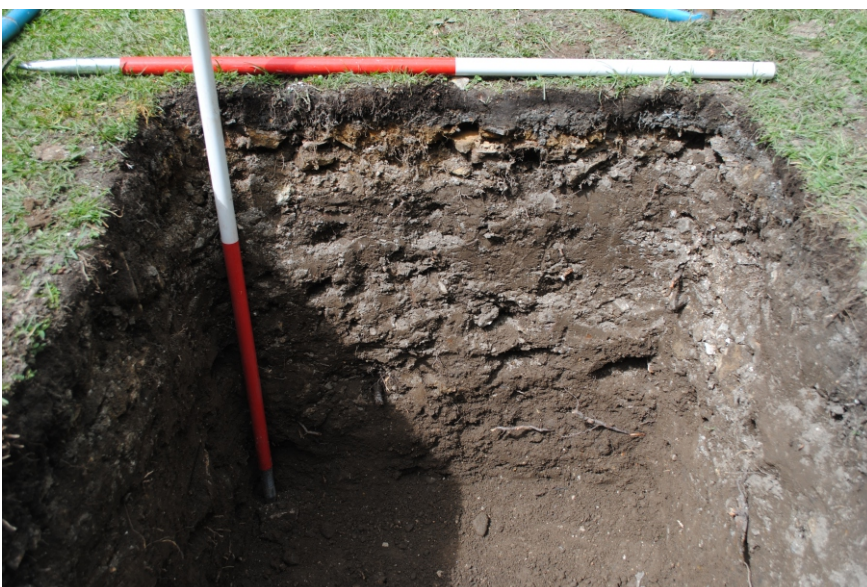
**Photo 09.** Soakaway pit 2 looking north, showing the layer of sandstone rubble

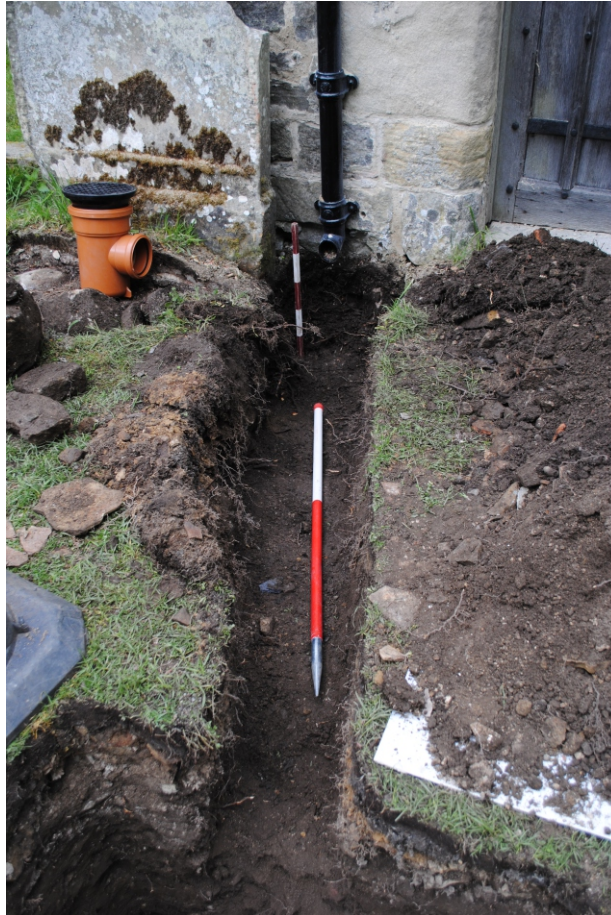
**Photo 10.** The channel leading from guttering by the church door to soakaway pit 2, looking north-west.

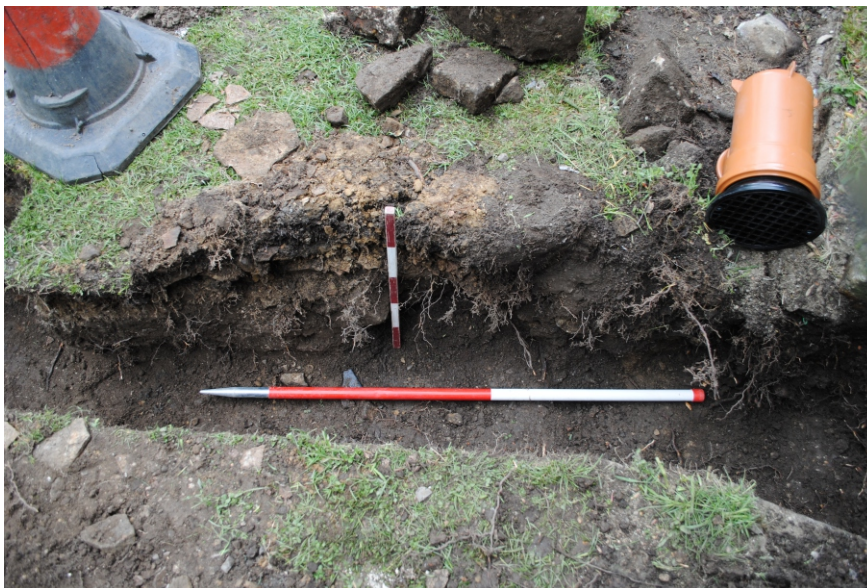
**Photo 11.** The channel feeding into soakaway pit 2 looking south-west, showing a layer of sandstone rubble.

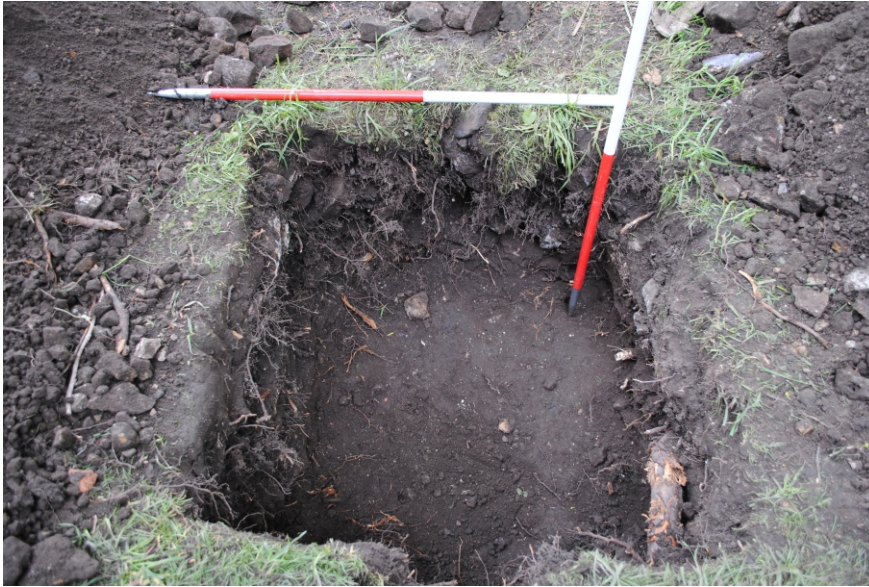
Pit 3 (*see Photo 12*) contained many masonry fragments, similar to pit 1. One notable large fragment found high in the pit was neatly chamfered (*see Photos 18-19*). A metal object, possibly a hanging fixture for candles or similar (*see Photo 20*), was also found within the top 0.45 m of the pit. No cut features were encountered. The earth in the pit was a dark grey-brown topsoil, consistent with that encountered in the other pits. Pit 3 was located between two headstones, but no articulated human remains were encountered, and less disarticulated remains were encountered than in pit 2.

**Photo 12.** Soakaway pit 3, looking east.

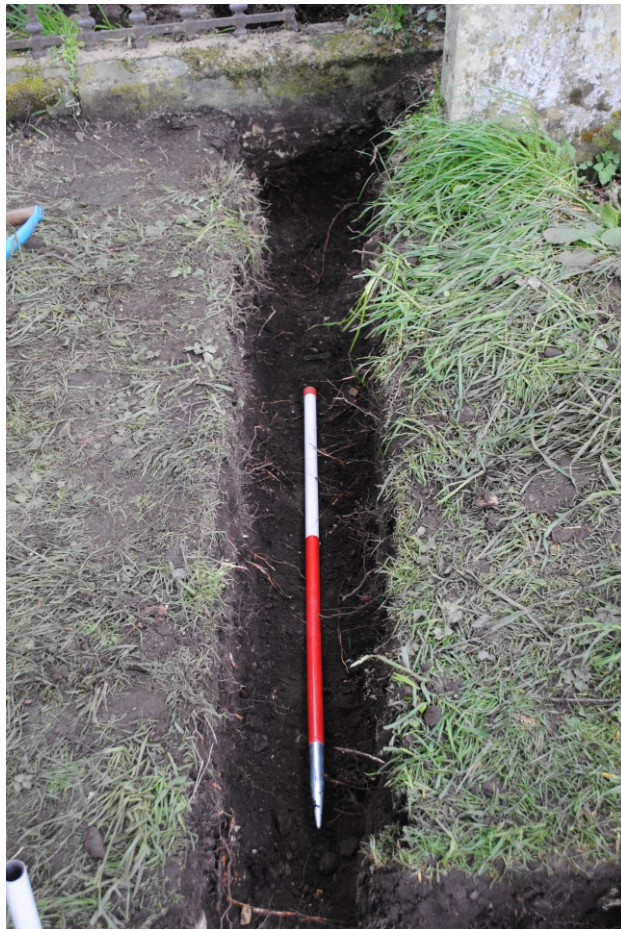
**Photo 13.** The channel feeding into soakaway pit 3 looking west, showing historical alterations to the memorial plot coping.

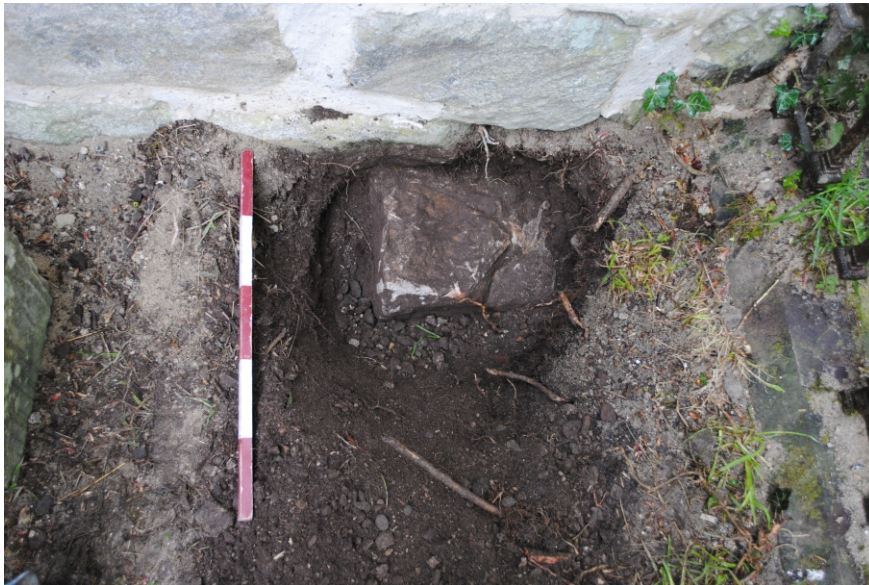
**Photo 14.** Possible footing in situ near to the south-east chancel corner. North view.

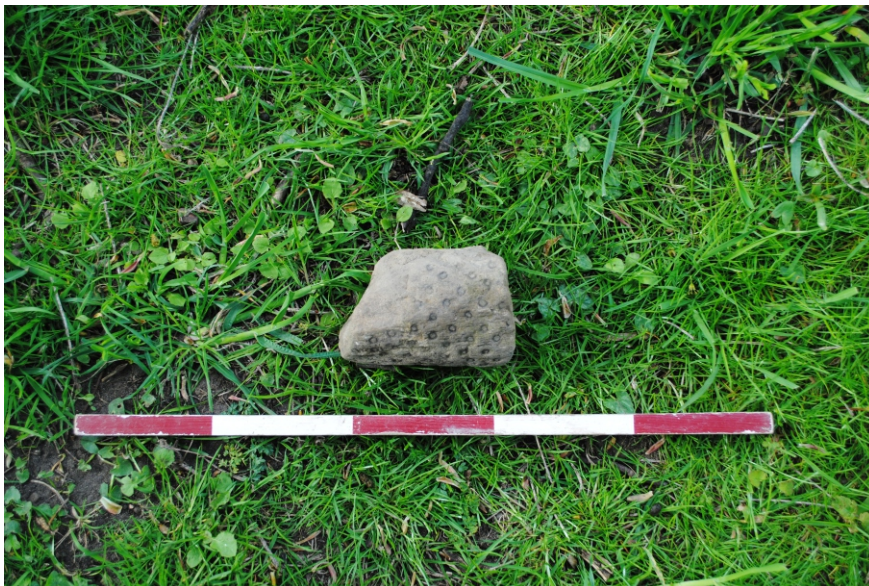
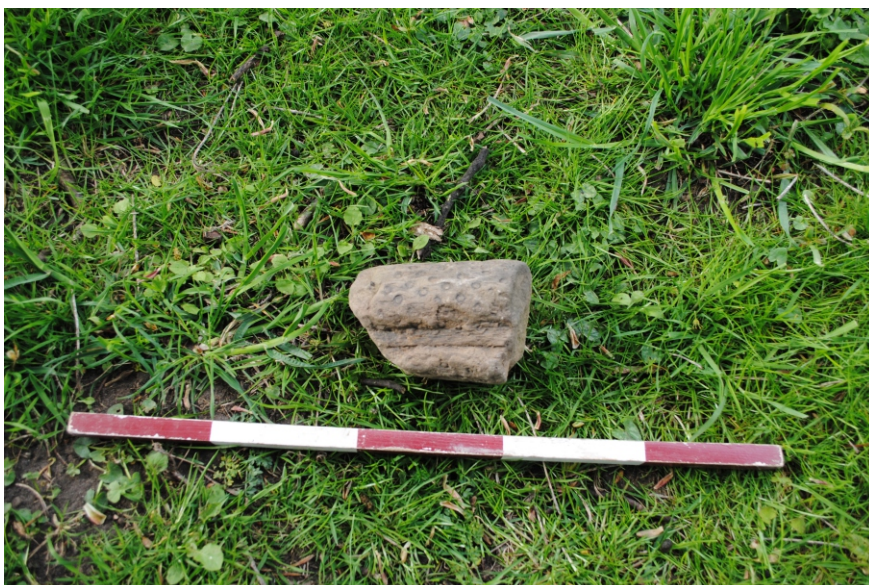
**1.4** The present churchyard appears to have piles of masonry rubble covered by earth in places, likely related to historic demolitions and refurbishments (*see section 2 below*). Ryder noted scattered stone north of the yew avenue when considering the location of the demolished nave and tower (2011: 7). More conspicuous upon site inspection in 2021 was the pile of earth and stone against the north-east corner of the churchyard retaining walls. Found on this pile was a loose piece of decorative masonry (*see Photos 15-16*).

**Photo 15.** Worked masonry found atop a pile of masonry rubble and soil adjacent to the east churchyard wall.

**Photo 16.** Worked masonry found atop a pile of masonry rubble and soil adjacent to the east churchyard wall.

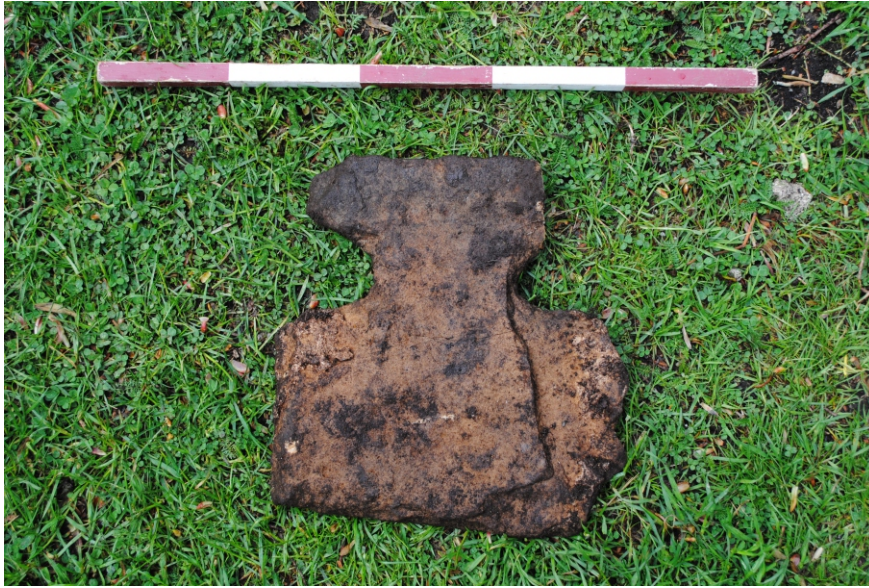
*Photo 17. A near complete 'wrestler' ridge tile from soakaway pit 2.*

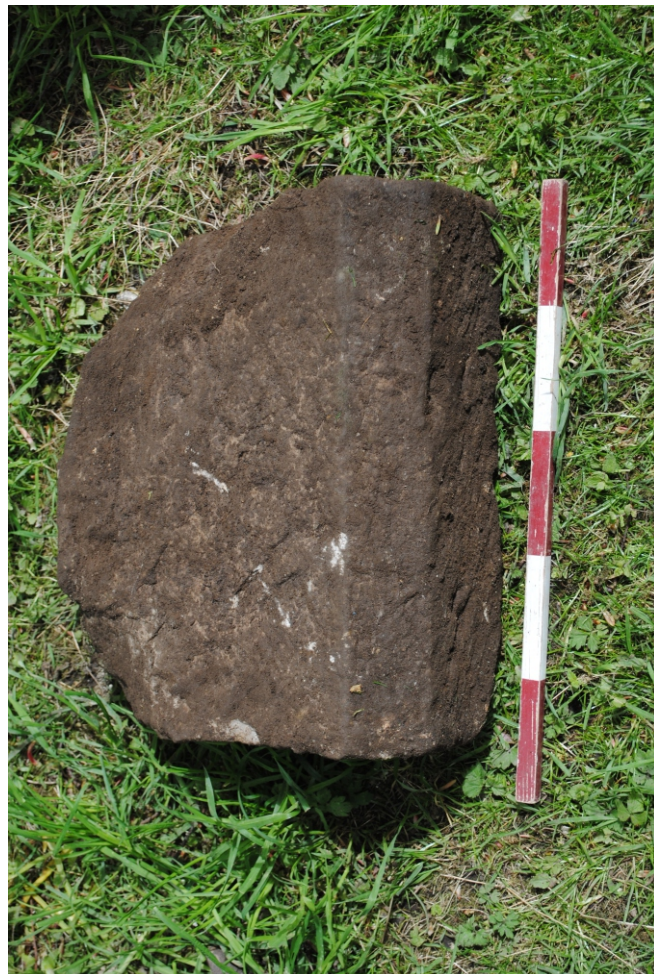
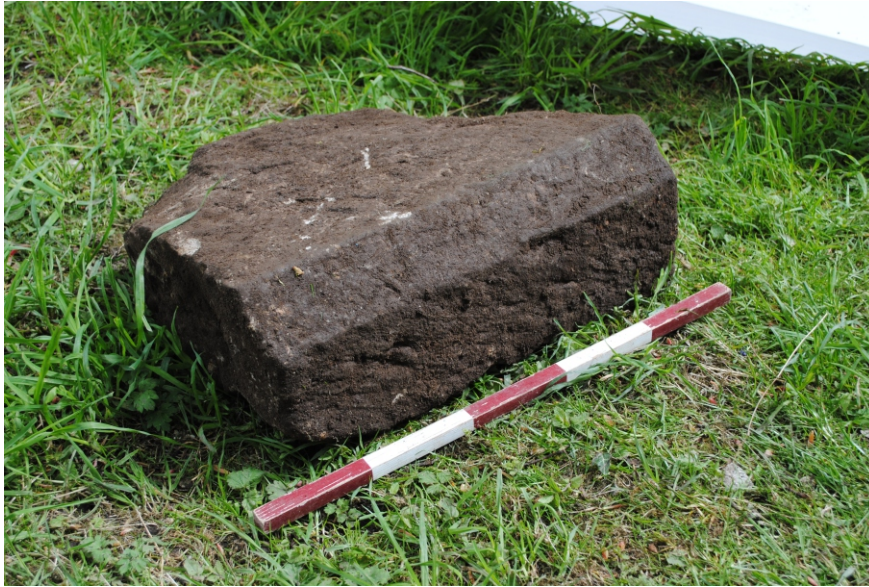
*Photo 18. A large chunk of chamfered masonry, recovered from soakaway pit 3.*

**Photo 19.** A large chunk of chamfered masonry, recovered from soakaway pit 3.

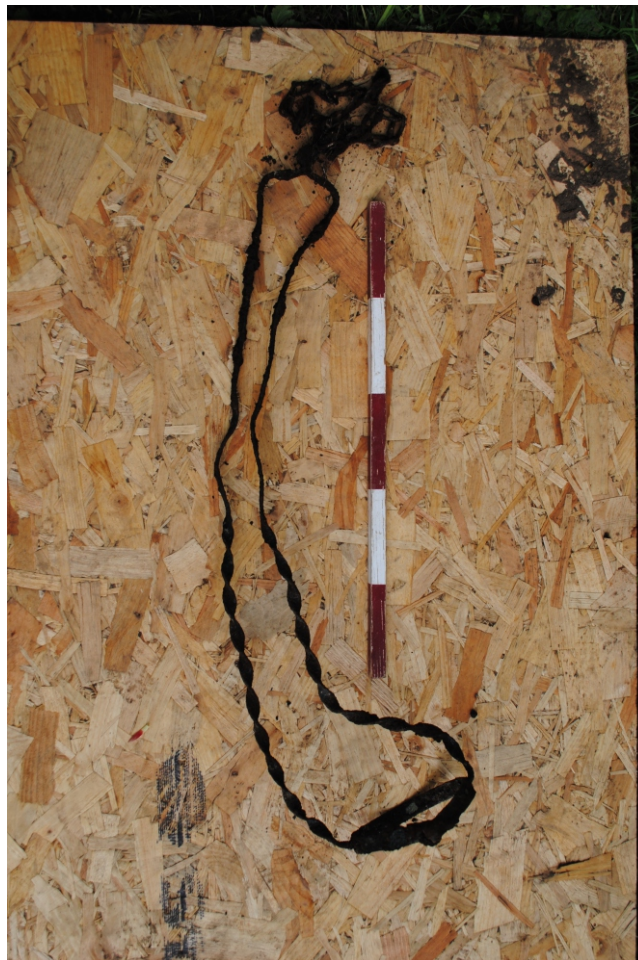
**Photo 20.** A metal object, possibly a hanging fixture, recovered from soakaway pit 3.
