# THE RABBIT 1-3 HIGH STREET WEST BISHOPWEARMOUTH SUNDERLAND

#### HISTORIC BUILDINGS RECORDING

### THE RABBIT, 1-3 HIGH STREET WEST, BISHOPWEARMOUTH, SUNDERLAND SR1 3EX

Report title:	The Rabbit, 1-3 High Street West, Bishopwearmouth, Sunderland.
	Historic Buildings Recording.
Stage:	Final
Project code:	AP 21/32
Compiled by:	Richard Carlton, Peter Ryder & Marc Johnstone
Control:	Alan Rushworth
OASIS ID:	thearcha2-511292
Date issued:	07/09/2022
Planning application:	N/A
Grid reference:	NZ 39246 57012 (approximate centre)
Client:	Sunderland City Council

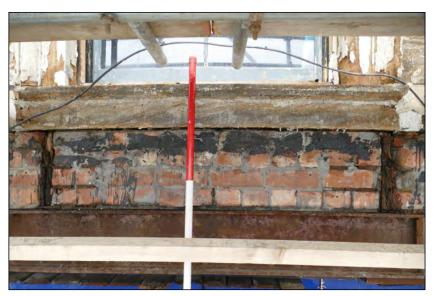
Photo 10. Interface between ground and first floors, view looking NNW at lower part of crumbling window architrave and lintel in the south wall, easternmost window of High Street West No. 1.

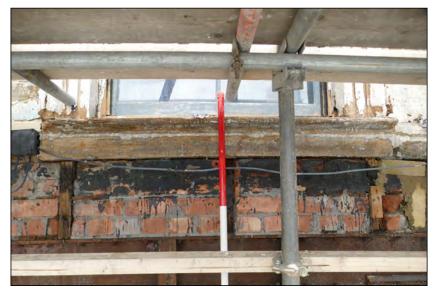
Photo 11. Interface between ground and first floors, view looking NNW at lower part of crumbling window architrave and lintel in the south wall, centre-east window of High Street West No. 1.

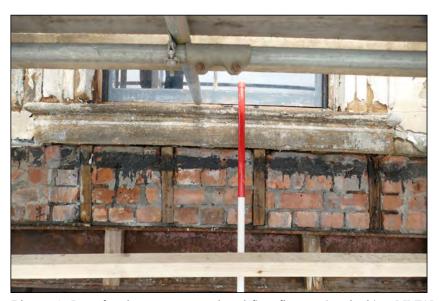
Photo 12. Interface between ground and first floors, view looking NNW at lower part of crumbling window architrave and lintel in the south wall, centre-west window of High Street West No. 1.

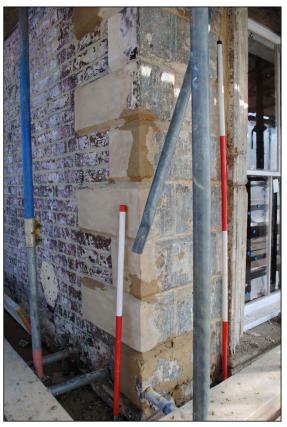
Photo 25. Exterior first floor, view looking NE at repair work to quoins in SW corner.

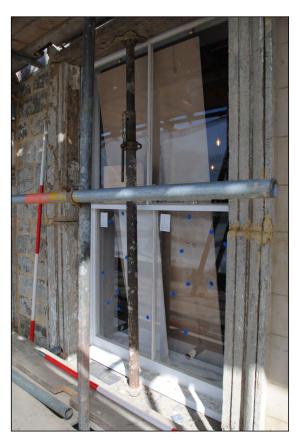
Photo 27. Exterior first floor, view looking NW at repairs to westernmost window in south wall.

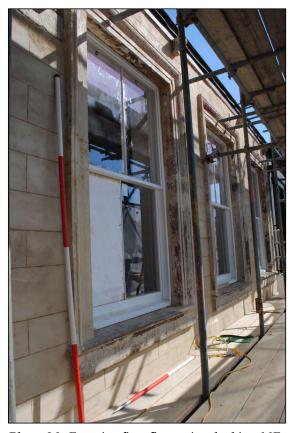
Photo 28. Exterior first floor, view looking NE at window repairs in south wall.

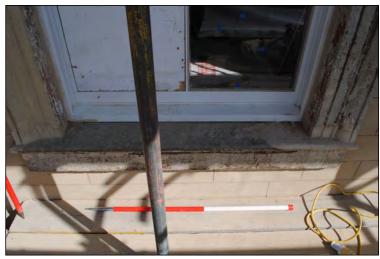
Photo 29. Exterior first floor, view looking NNW at sill and architrave repairs to westernmost window of No. 2 High Street West, south wall.

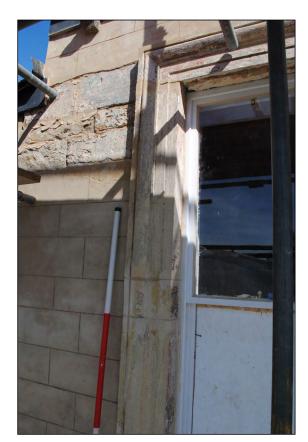
Photo 31. Exterior first floor, view looking NNW at detail of architrave repairs to westernmost window of No. 2 High Street West, south wall.

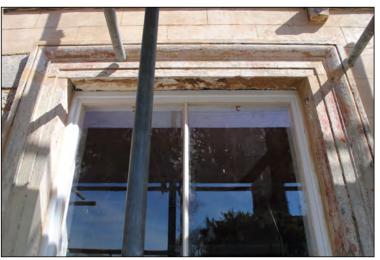
Photo 30. Exterior first floor, view looking NNW at upper architrave repairs to westernmost window of No. 2 High Street West, south wall.

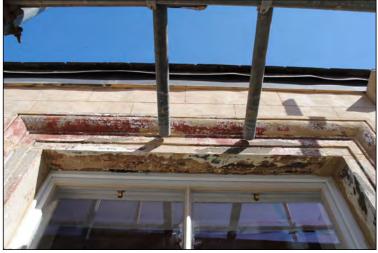
Photo 32. Exterior first floor, view looking NNW at upper architrave repairs to central window of No. 2 High Street West, south wall.

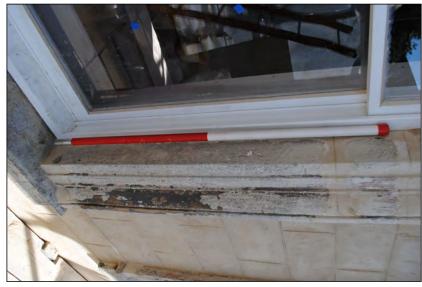
Photo 33. Exterior first floor, view looking NNW at sill repairs to central window of No. 2 High Street West, south wall.

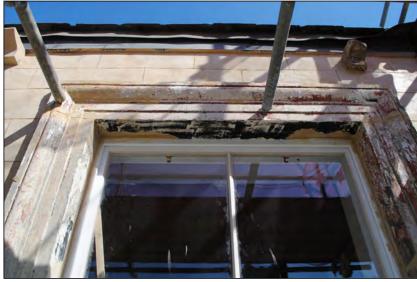
Photo 35. Exterior first floor, view looking NNW at upper architrave repairs to easternmost window of No. 2 High Street West, south wall.

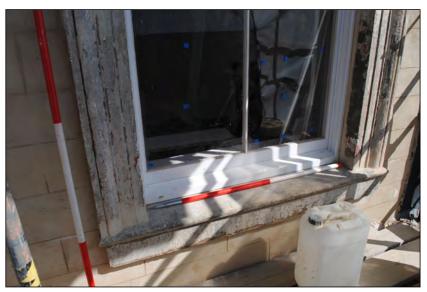
Photo 34. Exterior first floor, view looking NNW at sill and architrave repairs to easternmost window of No. 2 High Street West, south wall.

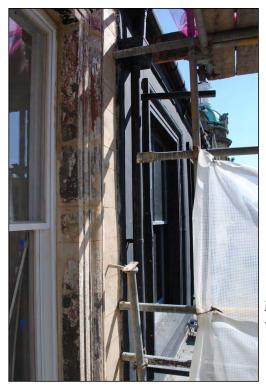
Photo 36. Exterior first floor, view looking NE at detail of architrave repairs to easternmost window of No. 2 High Street West, south wall.

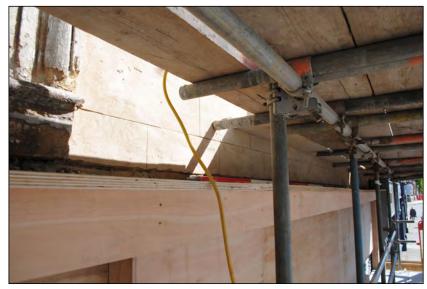
Photo 37. Interface between first and ground floors, exterior, south wall, view looking NE at repointed stonework.

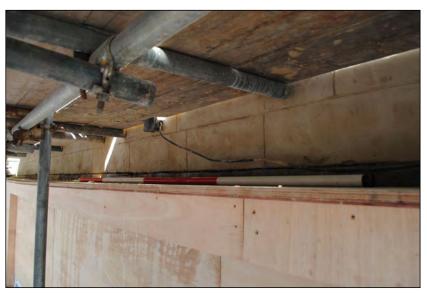
Photo 38. Interface between first and ground floors, exterior, south wall, view looking WNW at repointed stonework.
