*GOOSE HILL FORMER SCHOOL SITE  
MORPETH  
NORTHUMBERLAND*

ARCHAEOLOGICAL WATCHING BRIEF

REPORT ON AN ARCHAEOLOGICAL WATCHING BRIEF

<b>Grid reference (NGR):</b>	<i>NZ 20149 85752</i>
<b>Date of fieldwork:</b>	<i>April 2021; November 2021-August 2022</i>
<b>Client:</b>	<i>Northumberland County Council</i>
<b>Project code:</b>	<i>AP 21/31</i>
<b>Stage:</b>	<i>Final</i>
<b>Compiled by:</b>	<i>Adam Leigh</i>
<b>Control:</b>	<i>Richard Carlton</i>
<b>OASIS ID:</b>	<i>thearcha2-512446</i>

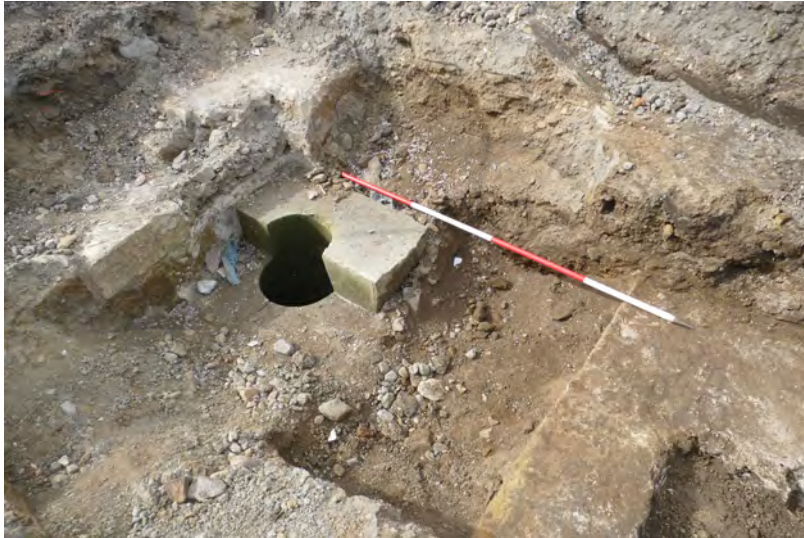
**Photo 01.** *The partially deconstructed latrine chute [101] W view.*

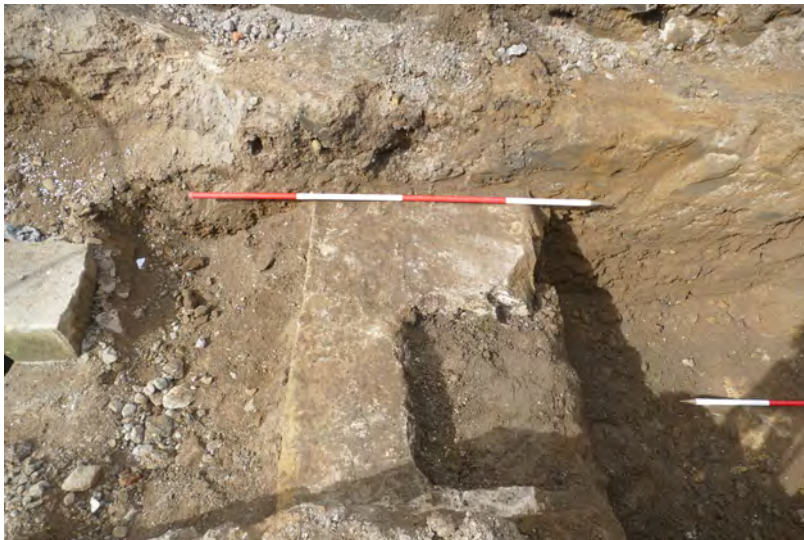
Possible wall [104] (*Photos 01-02*) was aligned north-west to south-east, parallel with wall [103]. The length of the structure exposed was 1.70 m, the width a maximum of 1.02 m. No joins were observed in this structure, although the northern part of its surface seemed to consist of mortar, possibly masking joins. An approximately rectangular 'gap' was present, measuring 0.93 m by at least 0.58 m in plan. It was filled with loose mid grey-brown silty sand with occasional lime flecks, presumed generic made ground backfill (111). The full extent of this shape was masked by the stepping down of the excavations down to the level of the culvert capstones to the north-east of possible wall [104], but it is possible that this rough rectangle represents the space formerly occupied by another chute, although no evidence either to support this or rule this out was observed during excavation of the trench to the east at lower height relative to [104]. Alternatively, [104] might plausibly represent a floor surface, or potentially the lower layer of a floor surface upon which flags might have been set.

**Photo 02.** *Possible wall [104], NW view.*

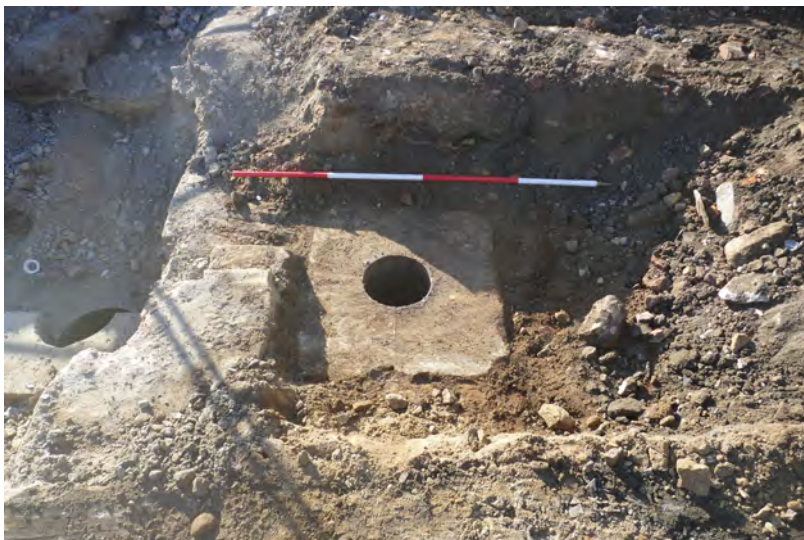
**Photo 03.** *Chute [102] SE view.*

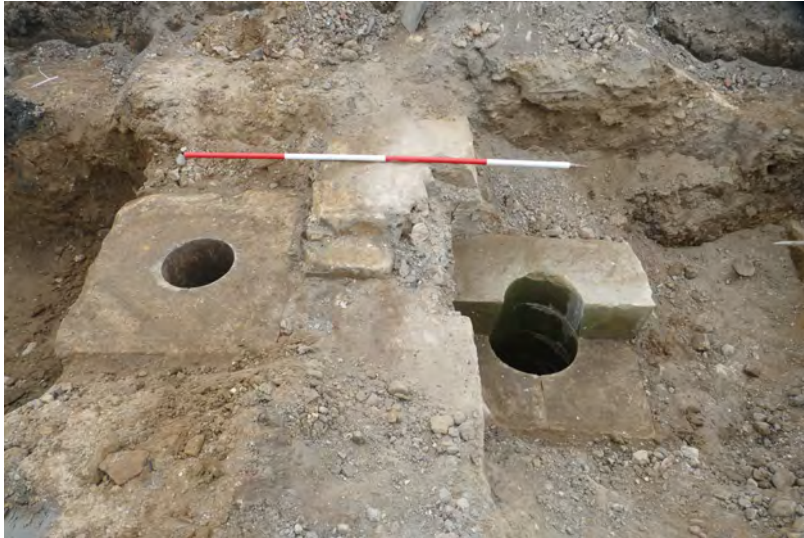
**Photo 04.** Latrine chutes [102] and [101], divided by wall [103] NW view.

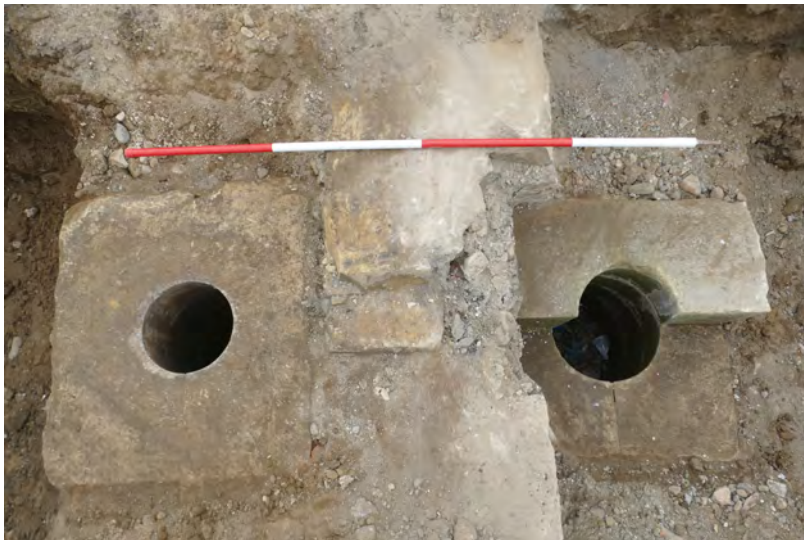
**Photo 05.** Vertical view of Latrine chutes [102] and [101], divided by wall [103].

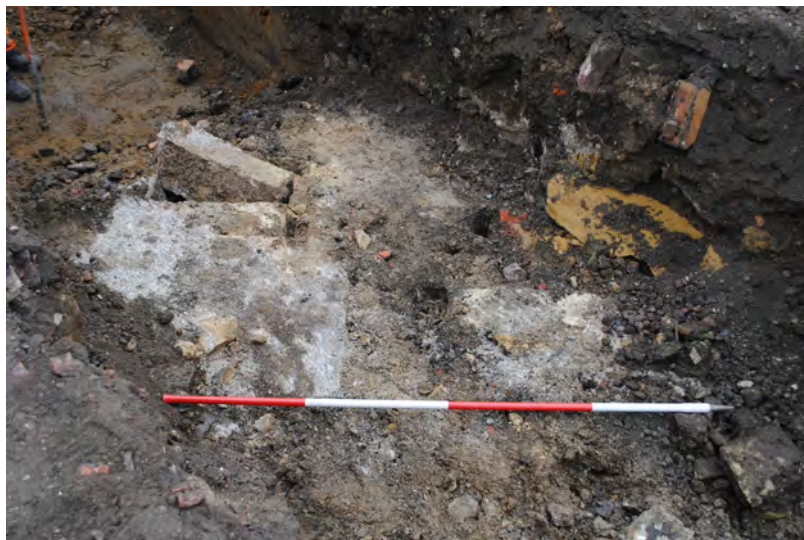
**Photo 06.** The surface of the culvert [115] in area 2, showing where it divided to collect waste water from another source. W view.

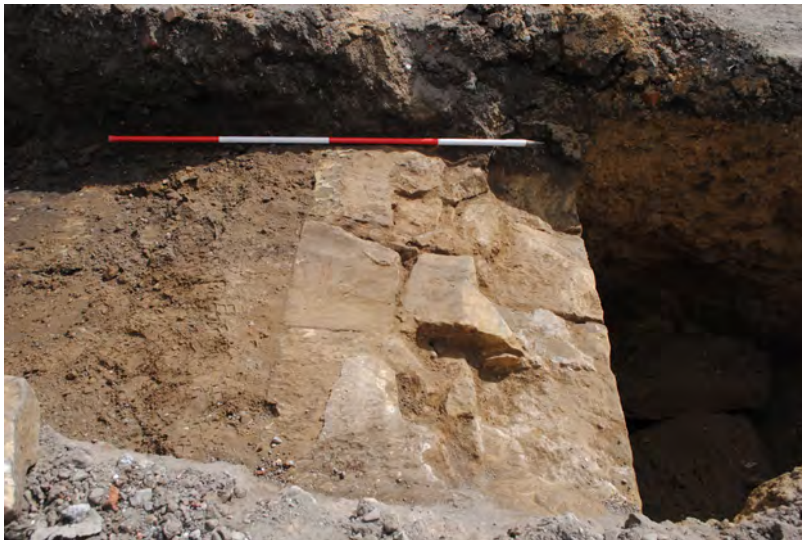
**Photo 18.** The male debtors' gaol yard wall [109] in area 5, SE view.

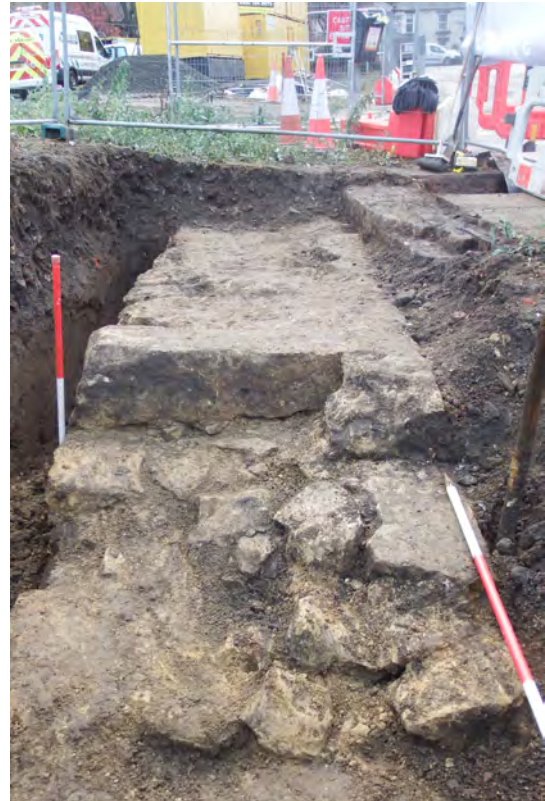
**Photo 21.** A close-up of the gaol perimeter wall [114] profile. SW view.

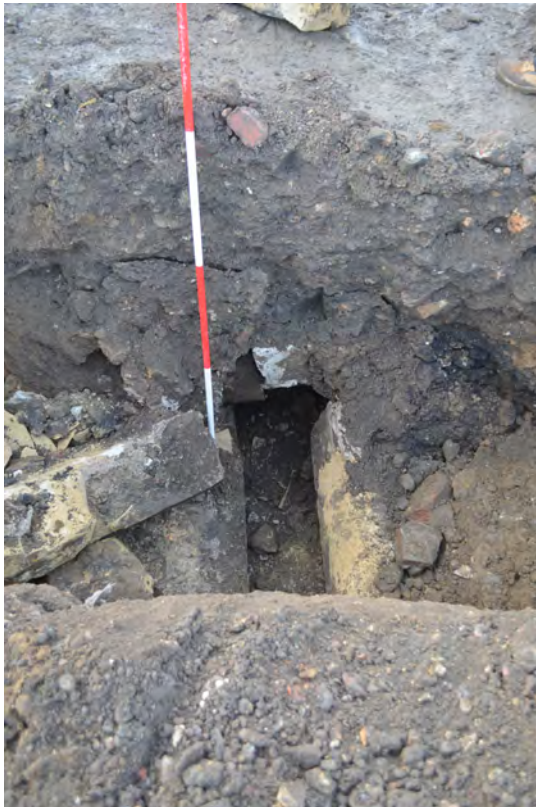
**Photo 24.** The culvert, with voussoirs for capping, exposed in a trial pit. S view.

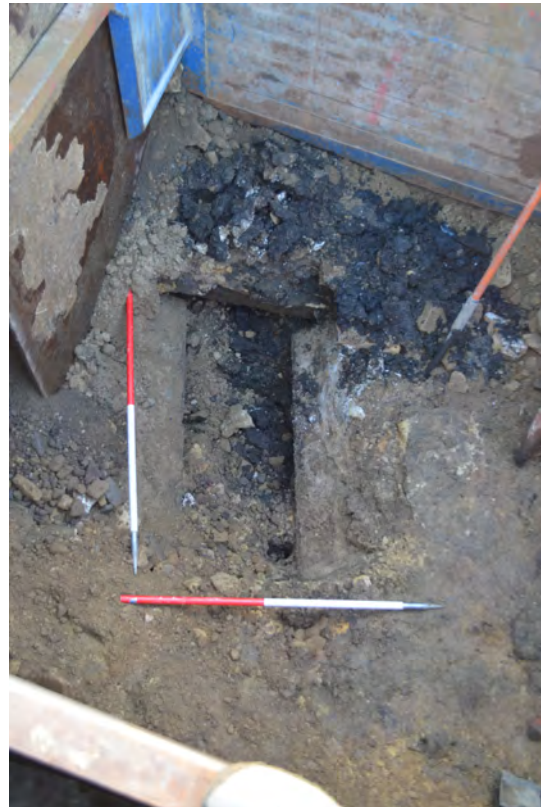
**Photo 25.** The culvert [115], as exposed in a trial pit in the eastern end of site. SE view.

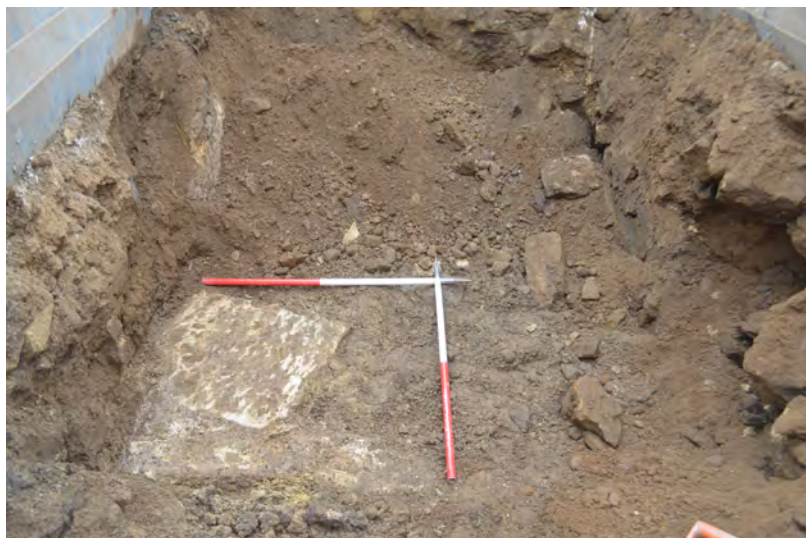
To the west of the above section of perimeter wall, in the drainage run between MH A and MH B, an apparently in situ stone was encountered at the base of the trench below sandstone rubble during excavation of the pipe run (*Photo 49*). This stone, possibly foundational, was likely a structural element of men's cell block and was encountered at a height of 23.56 m AOD.

**Photo 49.** Probable foundational structural remains associated with the corner projection of the men's cell line, SW view.

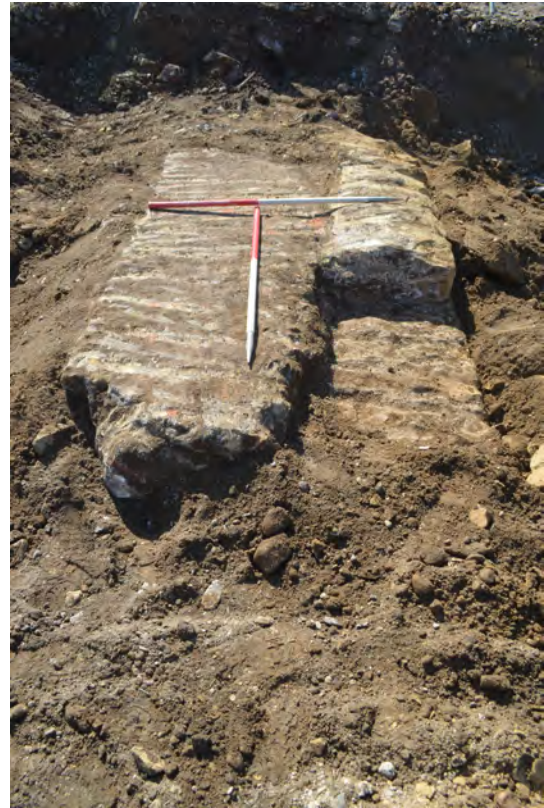
Initially, concrete was encountered at 25.10 m AOD running alongside a line of sandstone blocks resembling a wall (*Photo 51; Illus. 24*). Curiously, two lengthy railway or wagonway track segments were present overlying the concrete (*Photo 52*), although it was unclear to what extent they were part of the structure. It was suggested by a machine driver who had apparently seen similar usage that they might have been present in order to support a large door. It is however far from certain that they were fixtures of the structure or even precisely along the same alignment. They seem a rather rough and

**Photo 51.** The concrete structure [125] encountered during excavation of the roadway. SW view.

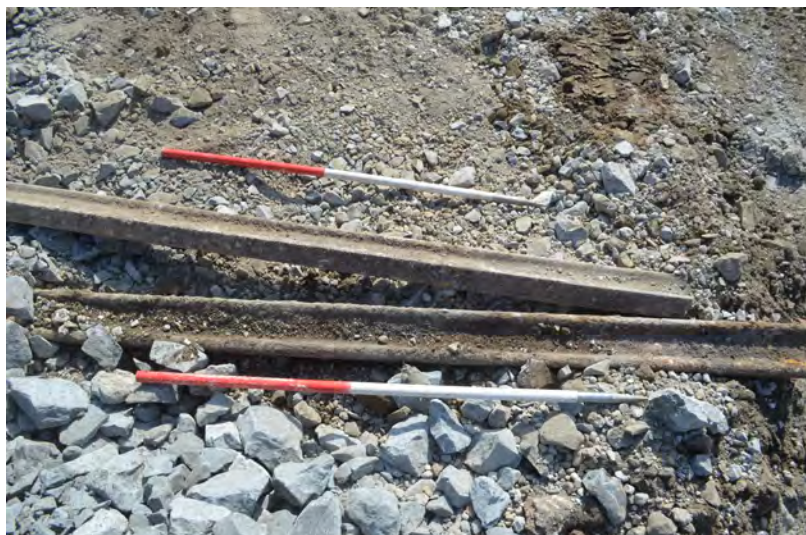
**Photo 52.** The rails observed on the top of concrete structure [125].

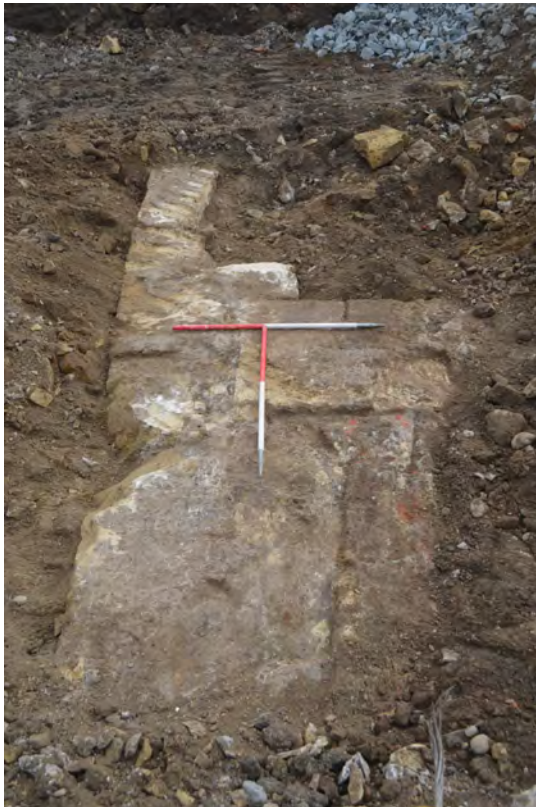
Once the above phase of construction was removed, a further layer of sandstone construction was encountered in the same place (*Photo 53; Illus. 24*). The structure was 4.75 m in visible length, and was encountered in the western side of the roadway. It did not appear to be present in the eastern half of the new roadway as it was not encountered despite excavations at the same level. It had visible concrete abutting it in the same alignment as that of the concrete encountered the level above. The concrete element, given the number [125], superficially resembled that used in the school foundations encountered during the evaluation, and appeared to have been laid after the sandstone blocks around it at this level, with an apparent triangular gap in the join between sandstone blocks filled with the concrete. The two likely origins of the concrete are that it was laid in the early 19<sup>th</sup> century to reinforce an element of the gaol construction, or it was laid for early 20<sup>th</sup> century construction of the school following along a convenient pre-existing line (i.e. courses of a surviving gaol wall). It is not clear which, although it should be noted that no similar concrete had previously been found in association with the gaol, with all bonding of gaol sandstone consisting of white or grey lime mortar with no obvious brick or sandstone aggregate.

The sandstone elements of the structure, given the number [126], consisted of large slabs in a broad line, although the easternmost slab appears to be either thinner or broken. Two slabs appeared to form some kind of return, heading south-east, at right angles to the general alignment of slabs. This structure might have formed a floor surface or a foundation for a wall – its location, when projected onto the 1859 OS Plan of the gaol, is at the northern side of the men's cells, which presumably would have consisted of a substantial wall. This structure was present at a height of 24.92 m AOD.

**Photo 53.** Sandstone structure [126], NE view.

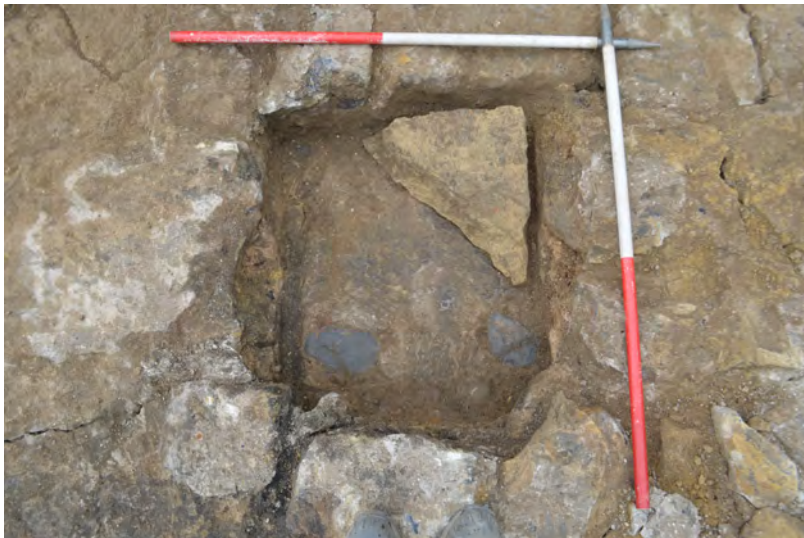
**Photo 57.** *The square pit feature [130] in plan.*

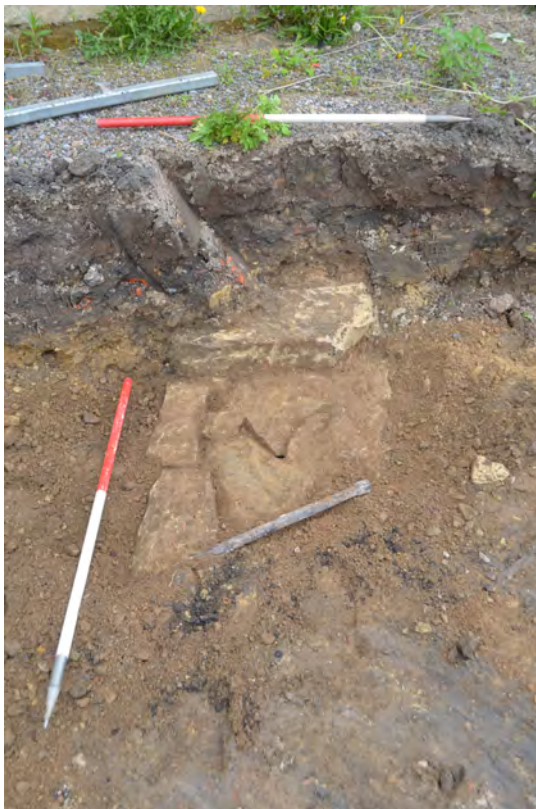
Further to the east, the stripping of the baulk revealed the eastmost of the arrangement of 'radial' yard walls (*Photo 60*) within the men's yards [118]. A length of around 0.95 m was revealed, with the wall's length beyond this having evidently been truncated by a modern service. The wall's width was 0.62 m, and two courses were visible, the lower course flush with the ground and containing more irregular stones – perhaps a more foundational course – and the upper consisting of a single block in the baulk, covering the entire width of the wall and 0.08 m in height.

**Photo 60.** The eastmost yard division wall, [118]. S view.

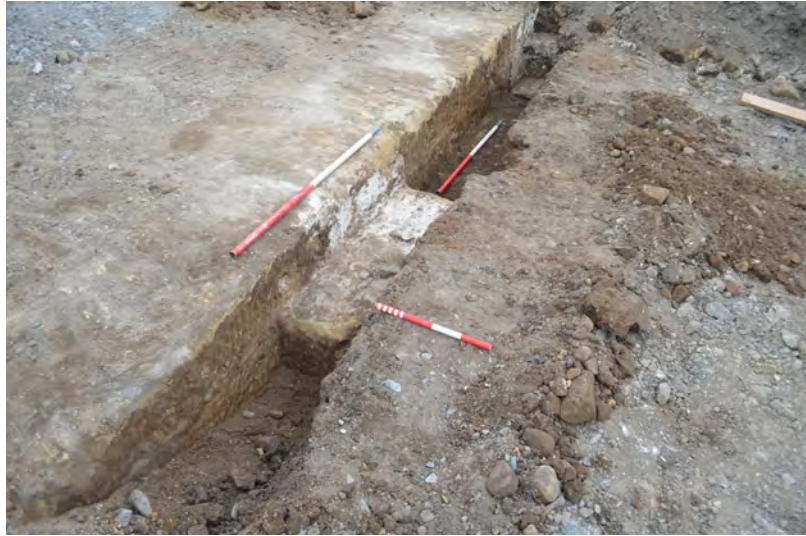
**Photo 62.** Oblique shot facing W, showing presumed cell walls [128] and [129] abutting wall [127].

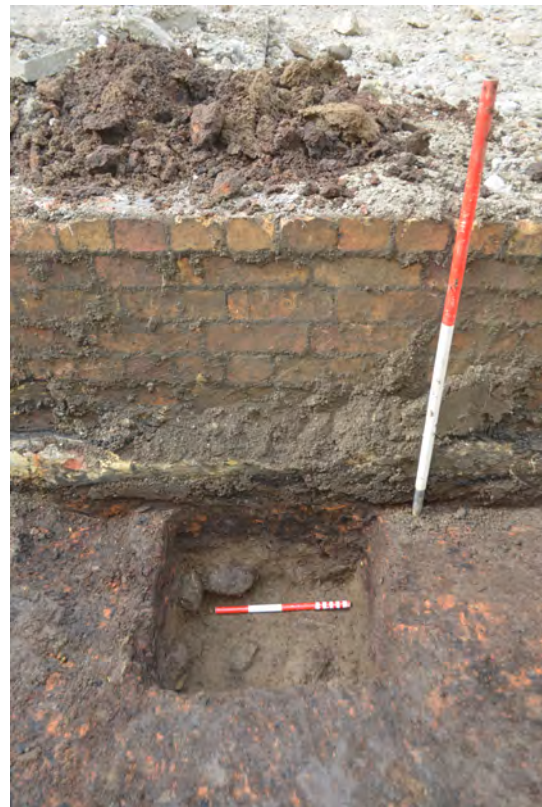
**Photo 64.** A small trial hole showing the depth of layer (132) below the school front wall foundations and overlying probable natural (135). NW view.
