*ST. CUTHBERT'S CHURCH
DARLINGTON
COUNTY DURHAM*

ARCHAEOLOGICAL WATCHING BRIEF

JULY 2022

*The Archaeological
Practice Ltd.*

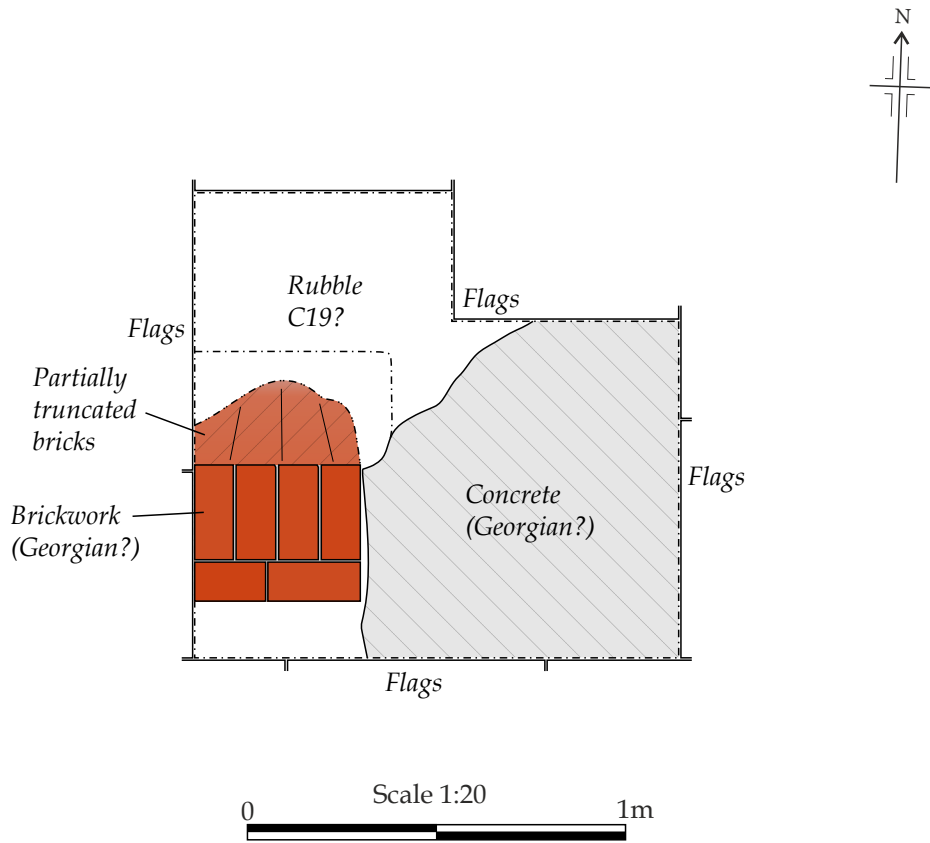
Illus. 09: Plan of archaeological features in Test Pit 1, St. Cuthbert's Church, Darlington.

Beneath the sandstone flagged floor [01] and underlying modern concrete [02], was a mixed rubble make-up layer [04] of C19+ date, observed to a depth of approx. 0.48 m below ground level across most of the test pit, but extending to 0.84 m in depth within the north-west corner.

In the eastern 2/3 of the test pit, an old concrete-type surface [05] was observed below the rubble make-up layer, probably of pre-Victorian origin. This appeared contiguous with a squared structural feature of hand-made bricks [06] of probable Georgian origin, observed in the south-west corner of the test pit. This brick-built feature was partially truncated on its north side as it headed toward the north pier in the crossing. The feature was recorded and left insitu, but a sondage was positioned along its truncated northern edge, in the north-west corner of the test pit, reaching a depth of 0.84 m. Both the brickwork and the rubble make-up [04] north of it, extended beyond the limits of excavation.

- [05] Old concrete-type surface observed in eastern 2/3 of test pit at 0.48 m below ground level. Extending eastwards and northwards beyond edge of excavation. Contemporary and associated with brickwork [06], of probable late-18th – early 19th century origin.

- [06] Hand-made soft red bricks of probable late-18th – early-19th century date (Georgian), forming a squared structural feature in the south-west corner of the test pit, observed at a depth of 0.46 m below ground level. Soft lime-mortar bond. Partially truncated on its north side as it heads toward the easternmost pier of the north aisle. These partially smashed bricks grade down by 0.14 m in depth to the north, reaching the max depth of excavation here at 0.84 m below ground level. Associated and likely contemporary with old concrete [05] which extend eastwards from the eastern edge of the bricks. On average the bricks measured approx. 0.24 m x 0.10.5 m x 0.08 m. Difficult to interpret due to limitations of excavation and partial truncation. Most likely, the structure represents an earlier sleeper wall or similar in this area of the crossing, pre-dating the 1862-5 re-ordering – which lowered the floor and rebuilt the pier, underpinning it and the aisle walls, probably resulting in the wall's truncation. A description of the works, specified by Pritchett*, indicates the Victorians excavated a great deal from the crossing area. He goes on to say that 15" of soil, with all the bones etc, were taken up from inside and wheeled into the churchyard. Also noted was the Allan vault, located in the North transept which was lowered by six feet and covered with two feet of concrete.

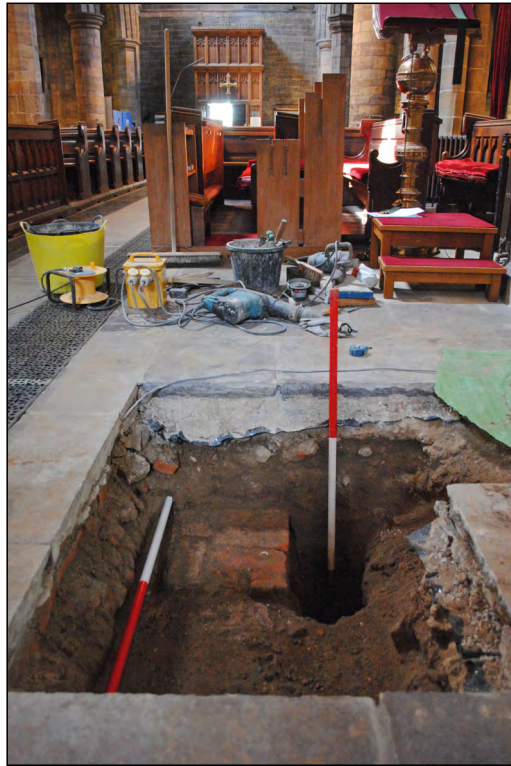
Photo 05. Test Pit 1, west view, showing east-facing section and partially truncated C18/19 brickwork and concrete below the floor.

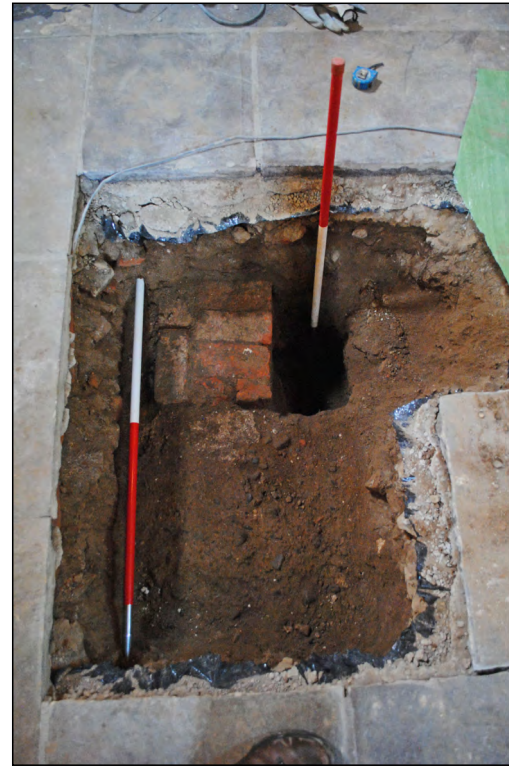
Photo 06. Test Pit 1, overhead west view, showing partially truncated C18/19 brickwork and concrete below the floor.

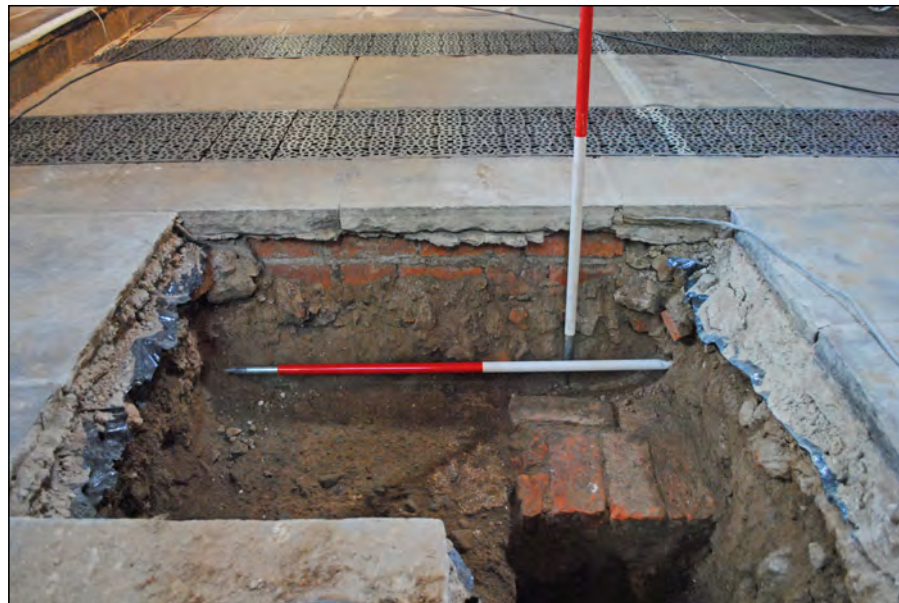
Photo 07. Test Pit 1, south view, showing north-facing section and partially truncated C18/19 brickwork and concrete below the floor.

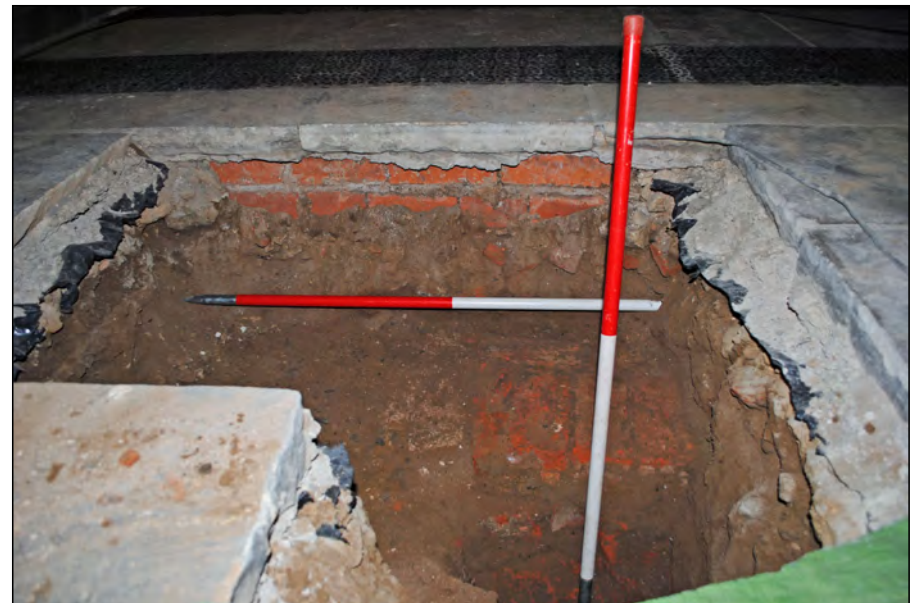
Photo 08. Test Pit 1, south view (with flash), showing depth of truncation in C18/19 brickwork and concrete below the floor.

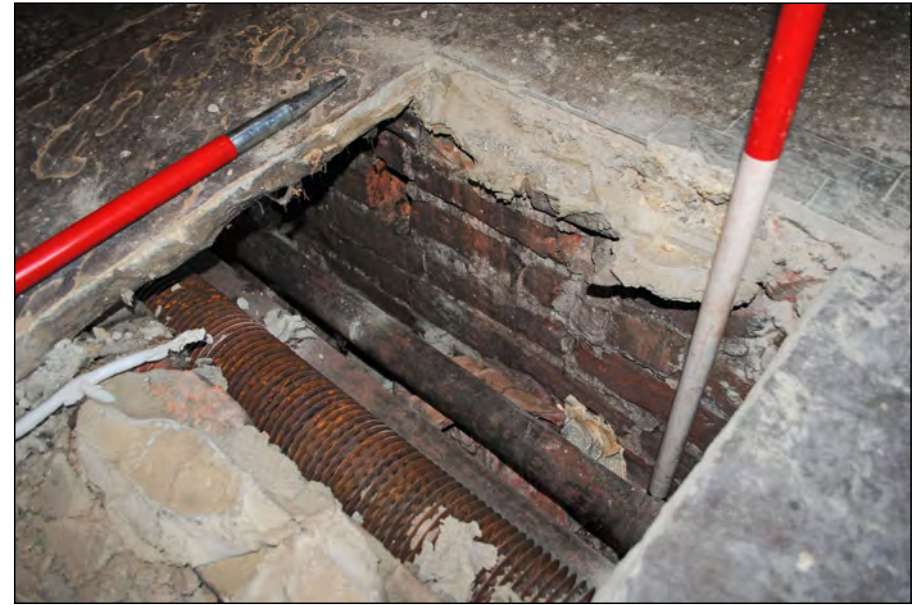
- [03] Brick-built sleeper walls of mid-late 19th century date, functioning to support the flagged floor [01] of the Church Nave, and forming the edges of two service ducts [02] running down the central aisle of the Church Nave. Four parallel walls in total observed within the test pit, built from at least five courses of pressed red brick with Portland cement bond, with each brick measuring approx. 0.05 m in width. The sleeper walls were observed from 0.10-0.29 m below ground level to the maximum depth of the ducts, which was 0.56 m.

Photo 14. Test Pit 2, view looking south-east at north-facing C19 brick sleeper wall and exposed pipework below the flags in the central aisle.

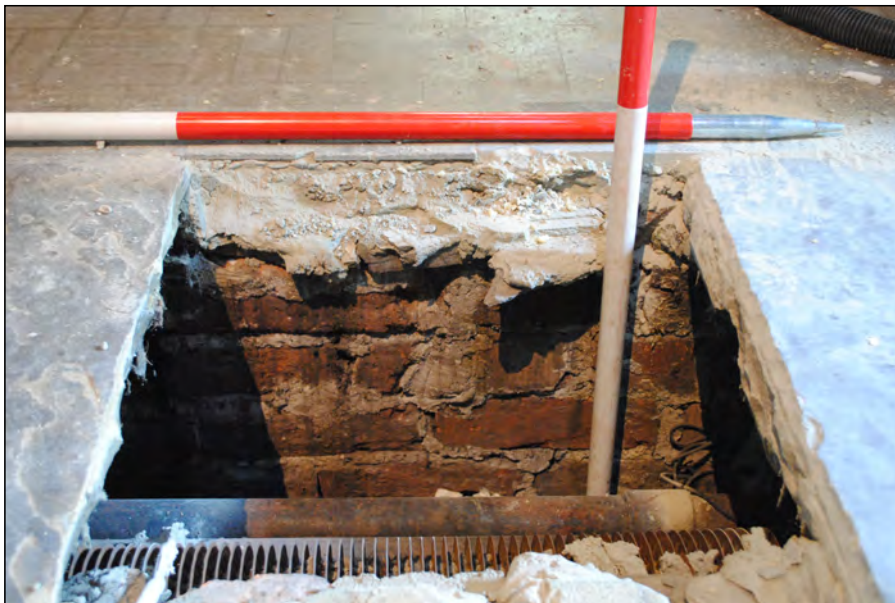
Photo 15. Test Pit 2, view looking south at north-facing C19 brick sleeper wall and exposed pipework below the flags in the central aisle.

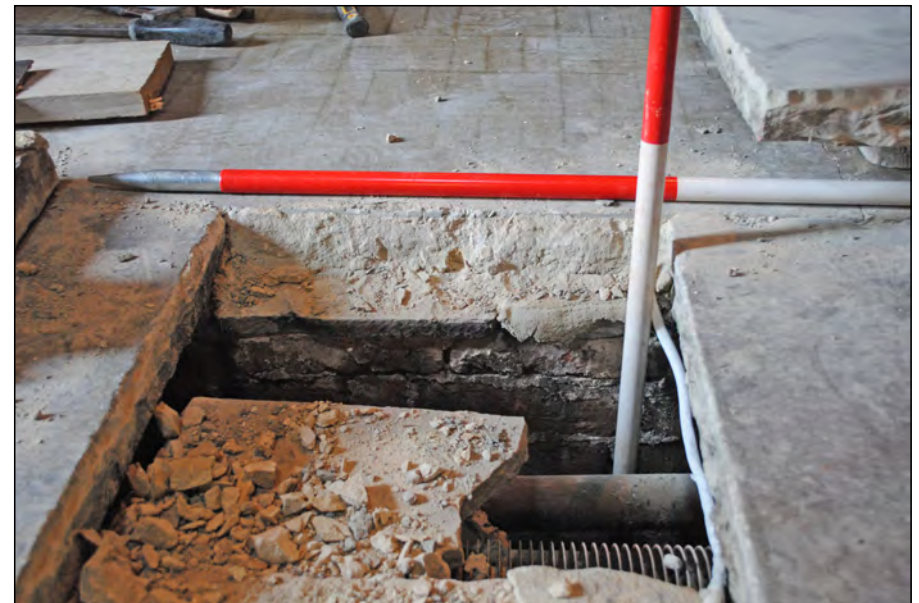
Photo 16. Test Pit 2, view looking north at south-facing C19 brick sleeper wall and exposed pipework below the flags in the central aisle.

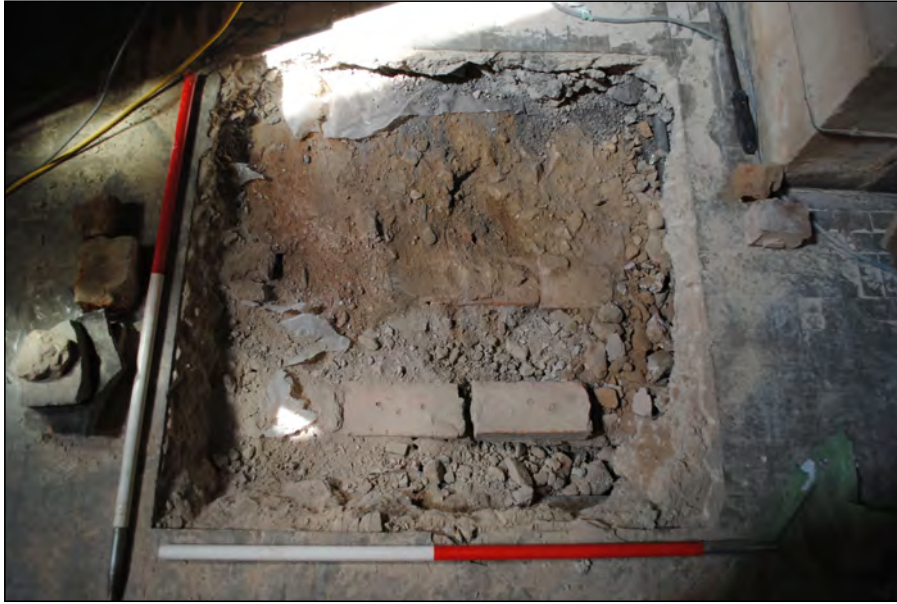
Beneath the modern parquet floor tiles [01] and modern concrete [02], was a redundant service duct [03] of probable mid-late 19th century date – built from single skinned red-brick walls, but with its cavity entirely infilled with cement rubble, some of which contained smashed fragments of medieval sculpted stone with cusped decoration (see *Photo 26*) and small quantities of disarticulated bone. Further cement rubble [04] filled the rest of the test pit, observed to the specified maximum depth of excavation. Service pipes were noted running N-S along the entire east section and running E-W in the north section.

Photo 21. Test Pit 3, view looking west, following removal of plastic membrane and some rubble backfill to reveal the top of a brick wall or piping conduit.

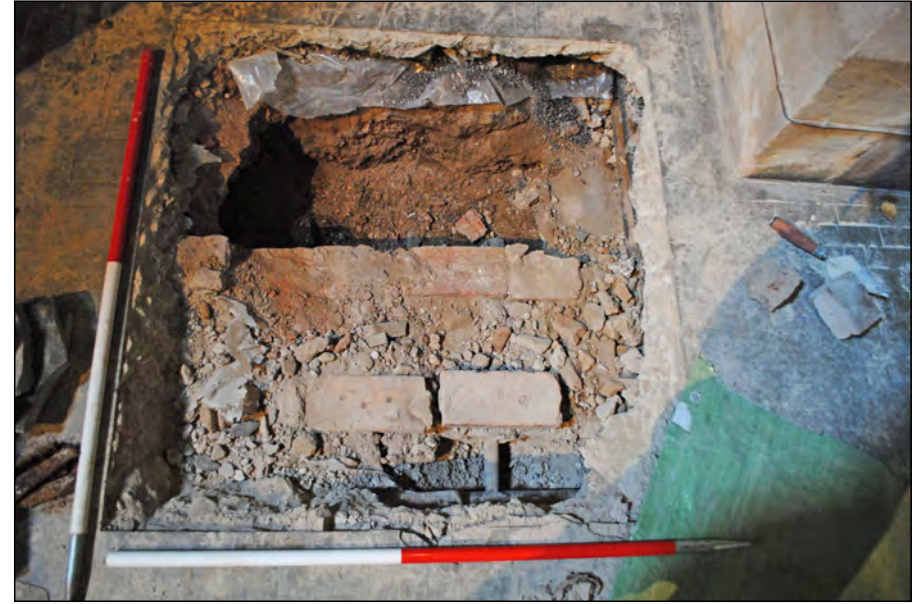
- [03] Two single-skinned red-brick sleeper walls forming a redundant service duct measuring 0.41.5 m in width, the cavity infilled with cement-based rubble. Aligned N-S, observed 0.15 m below ground level, and extending beyond the limits of excavation. Built from at least three courses of pressed red brick with Portland cement bond, with each brick measuring approx. 0.05 m in width. Probable mid-late 19th century date. Located in eastern part of test pit, approx. 0.47 m from and parallel to the western edge. A small E-W aligned iron pipe was observed to connect perpendicularly into the duct near the NE corner of the test pit, with no exit signs on the west side.

Photo 22. Test Pit 3, view looking west, following the removal of further rubble backfill, revealing some pipework and the aforementioned brick wall/conduit.

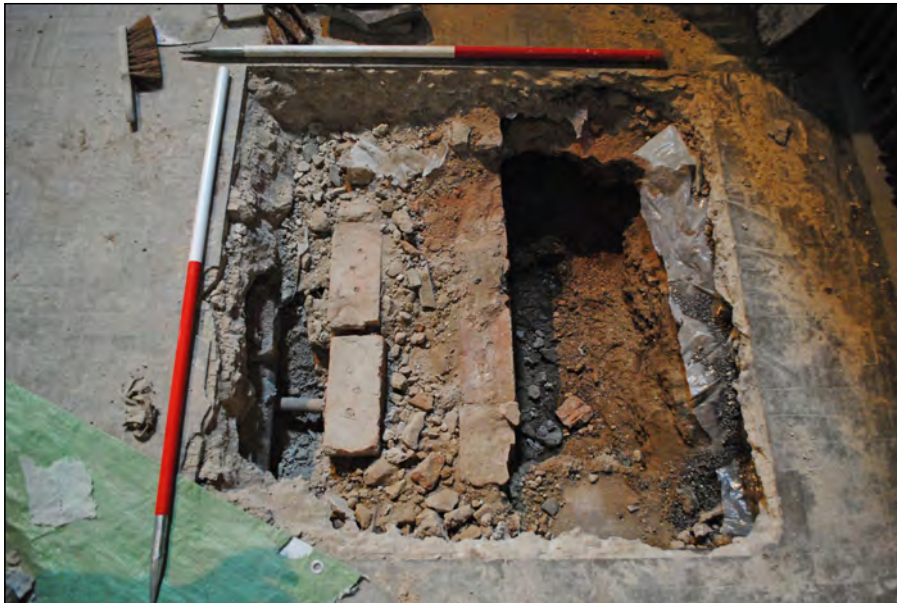
Photo 23. Test Pit 3, view looking south at exposed pipe running perpendicularly into brick wall/conduit.

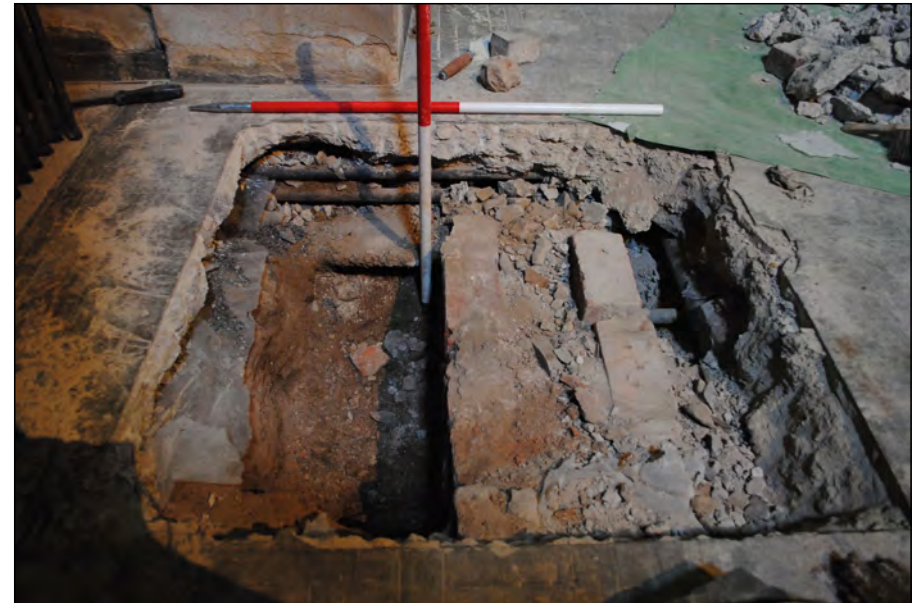
Photo 24. Test Pit 3, view looking north at exposed piping in south facing section and in NE corner of test pit running perpendicularly into brick wall/conduit.

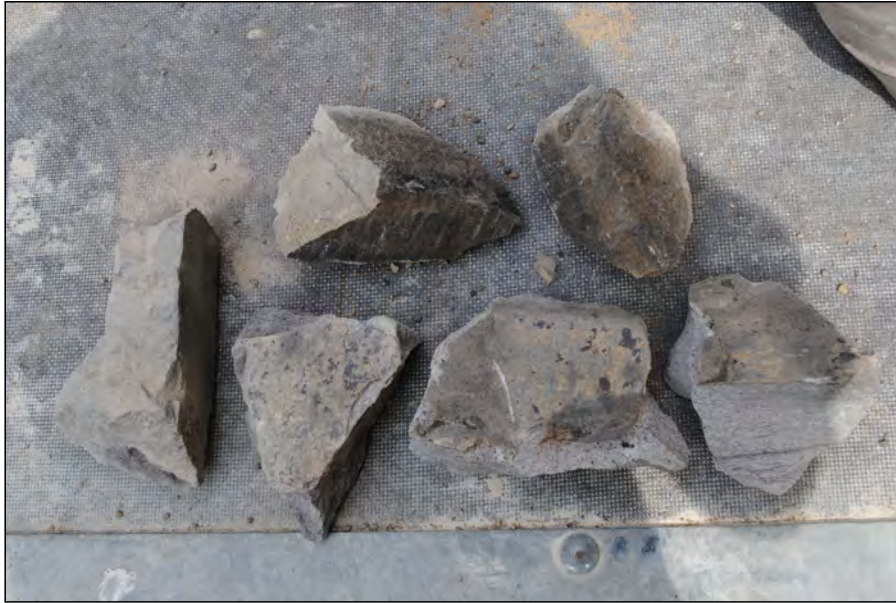
Photo 25. Several fragments from a medieval sculpted stone, observed within the rubble backfill encasing probable C19 brick walling/conduit and piping in Test Pit 3.

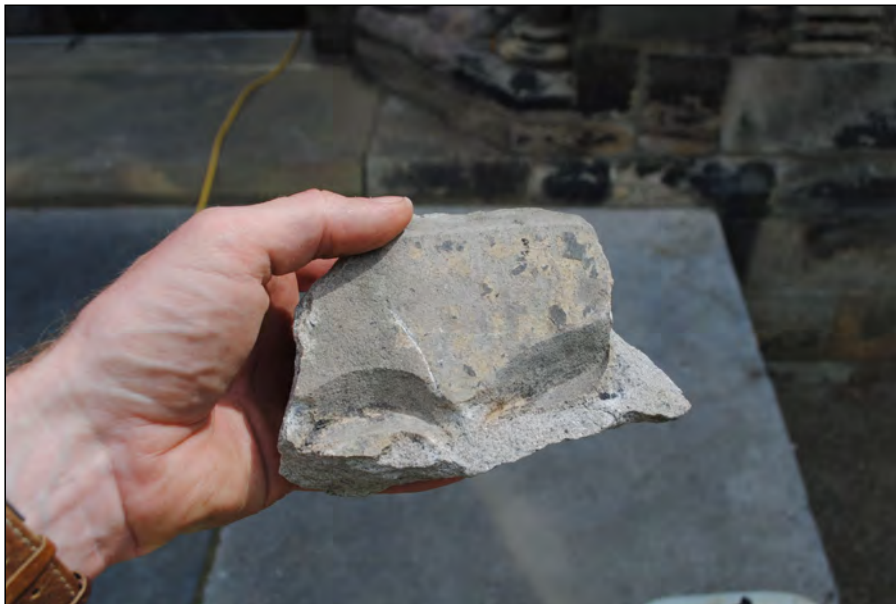
- [04] Cement rubble 'make-up' layer observed either side of redundant C19 duct [03] extending beyond the limits of excavation in every direction. Excavated to specified depth of test pit, but observed to get progressively siltier with depth. Contained a small quantity of disarticulated bone and several smashed fragments from a medieval sculpted stone, one of which had cusped decoration (*see Photo 26*).

Photo 26. Fragment of medieval sculpted stone with cusped decoration, observed within C19 backfill in Test Pit 3.
