**Standing Building Recording
Mains of Glasclune
Farmstead
BLAIRGOWRIE**

TB/BW03/March 2009

**STANDING BUILDING RECORDING
MAINS OF GLASCLUNE
BLAIRGOWRIE
BW03**

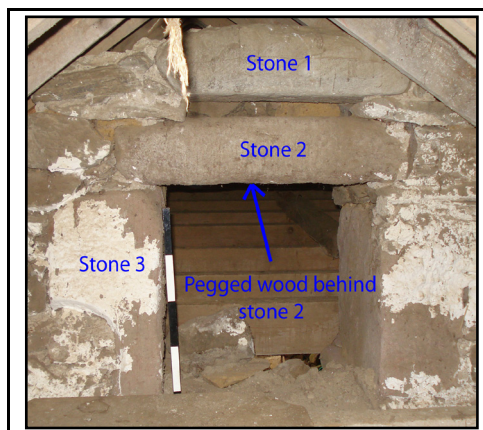
Photo showing location of re-used materials in the window/vent separating Units 1 and 2

Photo	Description	Dimensions	Interpretation
<p>Looking up</p>	<p>A short piece of wood serving no structural function sandwiched in between two stone lintels (stone 2 and another). The piece of wood is possibly slightly curved. There is a notch in the west facing edge and two pegs (roughly rounded) are protruding from the east facing side in line with the notch. Species of wood unknown but probably a hardwood. Bark was noted.</p>	<p>Cross-section roughly 14 x 11cm. Length could not be measured, but not more than 1m as this is the width of the top of the dividing wall at this point. Notch 3cm deep max, 18cm long.</p>	<p>As the surviving piece of wood is short, it is difficult to be precise about the function it originally served. However, it could have been one end of a tie beam with pegs attaching it to a wall plate. The piece of wood may be from the castle, particularly as it is pegged, but it could also be from an original roof of one of the farm buildings. Only dendrochronology could make this distinction.</p>

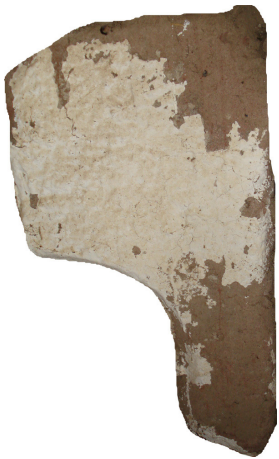
Re-used stone 3

<p>Looking west</p>	<p>A reddish stone (sandstone) forming the south side of the window/vent in Unit 1. This stone is large and rectangular with what looks like a concave region at the south-east corner - almost certainly carved out. Stone tooled on the east side.</p>	<p>Thickness (up down) 50cm, width (north-south) 25-12cm, depth (towards west) 69cm.</p>	<p>The tooling and concave region suggest this stone is re-used. It may be part of an opening to a gun hole from the castle. The openings to the gun holes on the castle are built from red sandstone and usually comprise an upper and a lower block of stone. It is possible that this stone is half of one of these blocks. Further interpretation is difficult because the stone is fixed into the wall.</p>

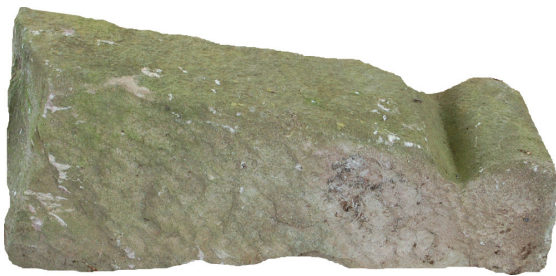
Re-used stone 4

<p>A wedge shaped stone with tooling on most faces. Stone carved into a newel at one end. Stone found loose in demolition rubble from Unit 3 or the west end of Unit 2.</p>	<p>Length 59cm, width 25cm, thickness 20.5cm. Newel end width 12cm.</p>	<p>This stone is a stair tread from a turnpike stair. It almost certainly comes from the castle.</p>
