THE BARN AT HIGHER CROW TREES FARM, TOCKHOLES, LANCASHIRE: AN ARCHAEOLOGICAL BUILDING RECORD

CS Archaeology

February 2012

Project Number: 90

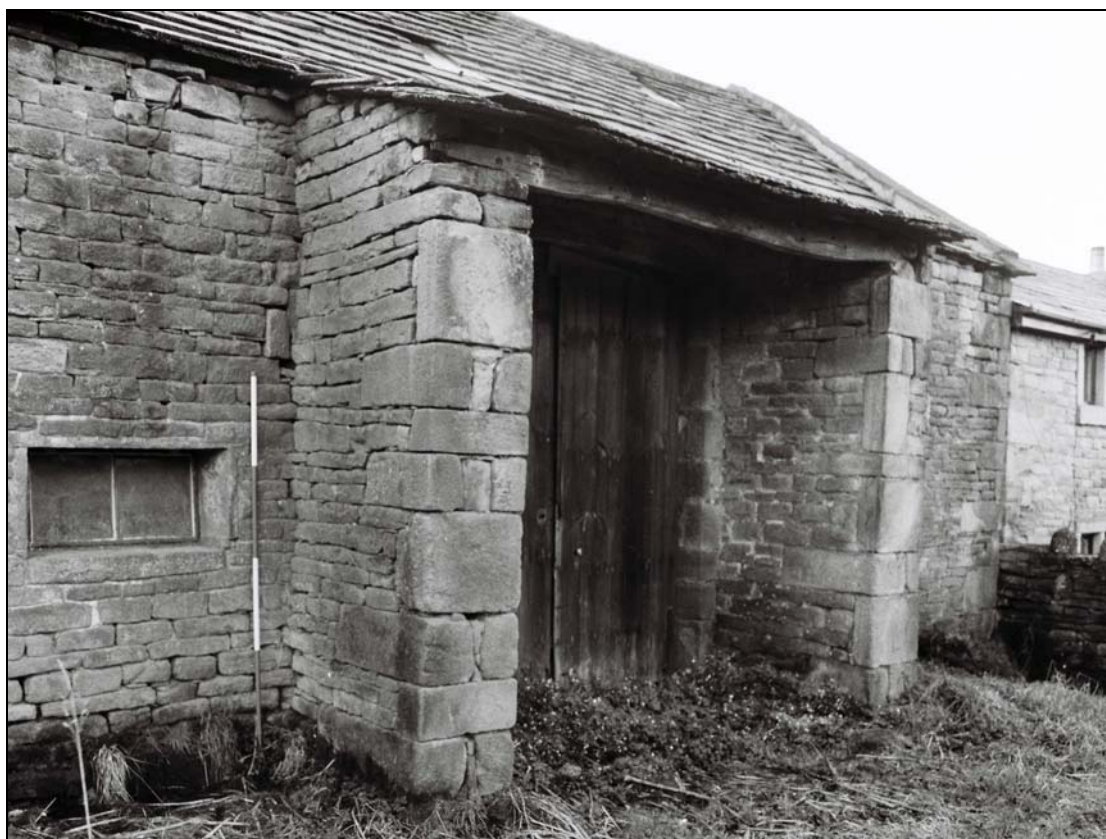
- 6.3 The barn (building 1) features two opposing barn doorways [4 & 8] which were positioned across the centre of the building. Architecturally this type of doorway is termed 'cheeked porches' (Brunskill 2000, 159) with almost monumental masonry to the quoin stones. Porches would have provided weather protection extending the internal threshing floor (**Plate 3**). The barn doorways [4] are square headed with exposed oak lintels. NB no evidence for any arches were noted, indicating that the oak lintels formed the original square headed arrangement. The barn door [4] still features internally opening, bi-folding, plank and battened doors, which are hinged via a pivot peg into the oak lintel and the stone thresh. The doors would appear to be later insertions, as evidenced by the removal of the adjacent jambs/quoins to facilitate the hinged doors. To the quoin stone's external faces of the cheeked porch, were at least three of type 1 mason's marks (**Figure 4**).

Plate 3, 37: Oblique view of the front porch [4], looking southwest

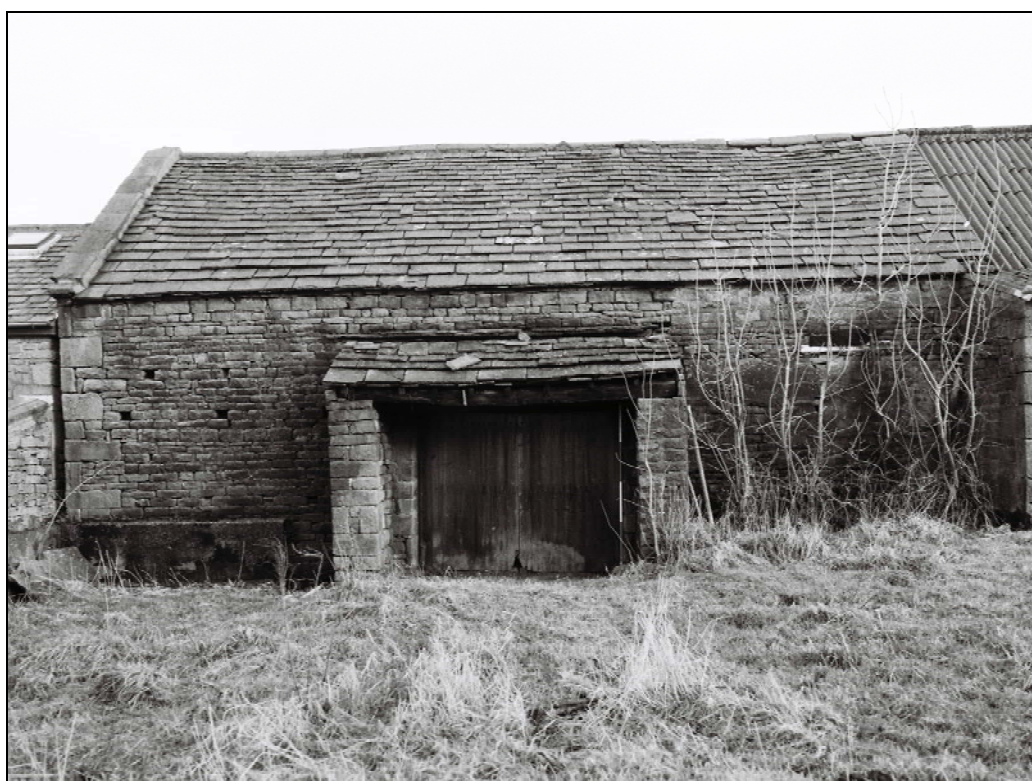
- 6.5 The *Southwest Elevation* is also largely original. It features a central barn doorway with a cheeked porch [8]. The original inner and outer barn doorways [8] are square-headed with exposed oak lintels (**Plate 4**). Left of the barn door is a series of blocked ventilators [7]. To the right of the barn door [8] ventilators are no longer evident but at least one was confirmed internally, this section of the elevation has been obscured by a cement render, the remnants of an abutting lean-to storeroom. Towards the southwest corner is a further type 2 mason's mark, depicting a 'P' (**Plate 5**), which suggests that the quoin-work may have been the product of two masons or that the type mark was a later addition. During the renovation work, building 2 had to be taken down and the revealed further type 1 mason's marks to the quoins to the southwest elevation (southern corner). Type 1 mason marks are also evident in the quoins stones at the adjacent Higher Crow Trees farmhouse.

Plate 4, 40: view of the rear southwest elevation with the lower cheeked porch [8] and graduated stone flag roof, looking northeast

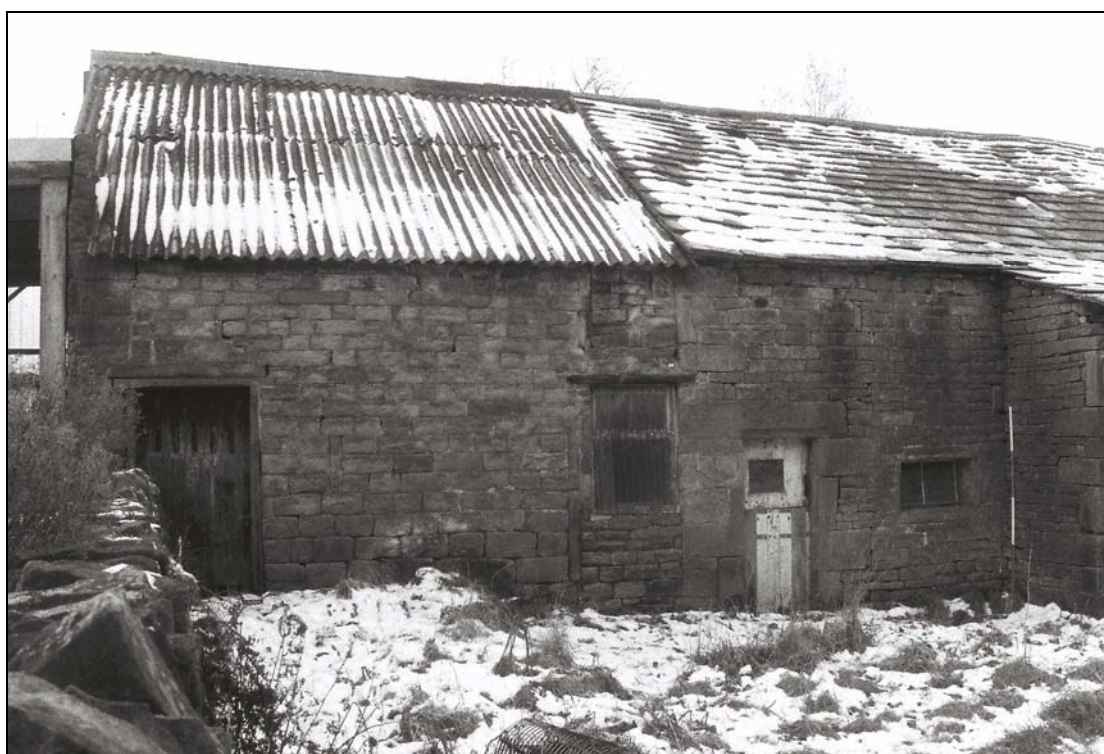
- 6.6 The southeast extension (Building 2: **Figures 4 & 5**) has also been historically re-roofed and features corrugated sheets. The rubble walls feature quoin-stones and original

Plate 6, 29: Oblique view of the shippon (Blg 1) with bay 1 of the barn (Blg. 2), looking southwest

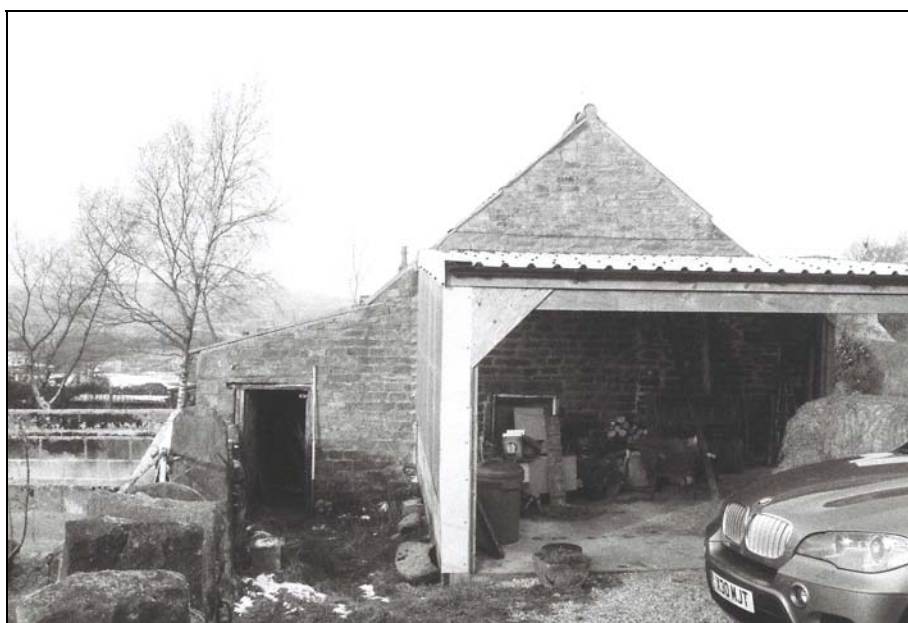
Plate 8, 3: The southeast gable obscured by later lean-to (Building 2), looking southwest

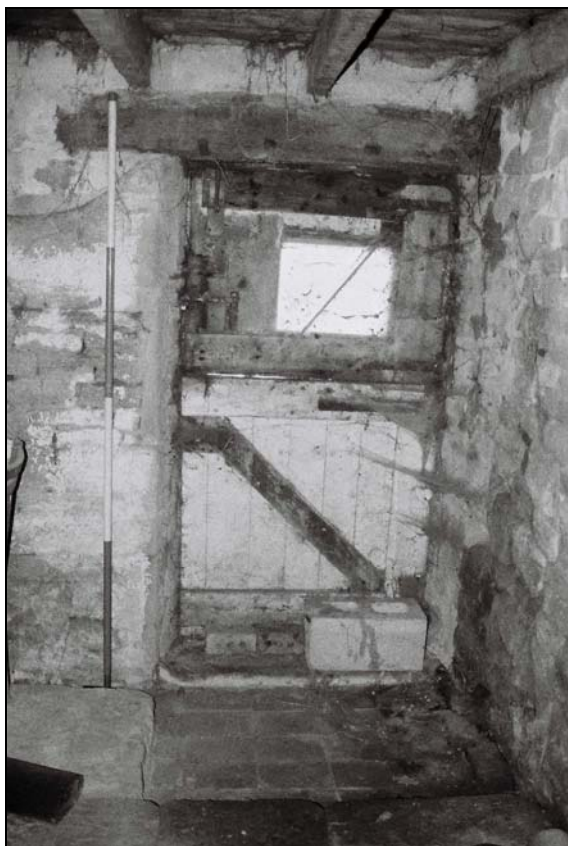
Plate 9, 16: Internal view of doorway [1] (Blg. 1, Rm. 1), looking north northeast

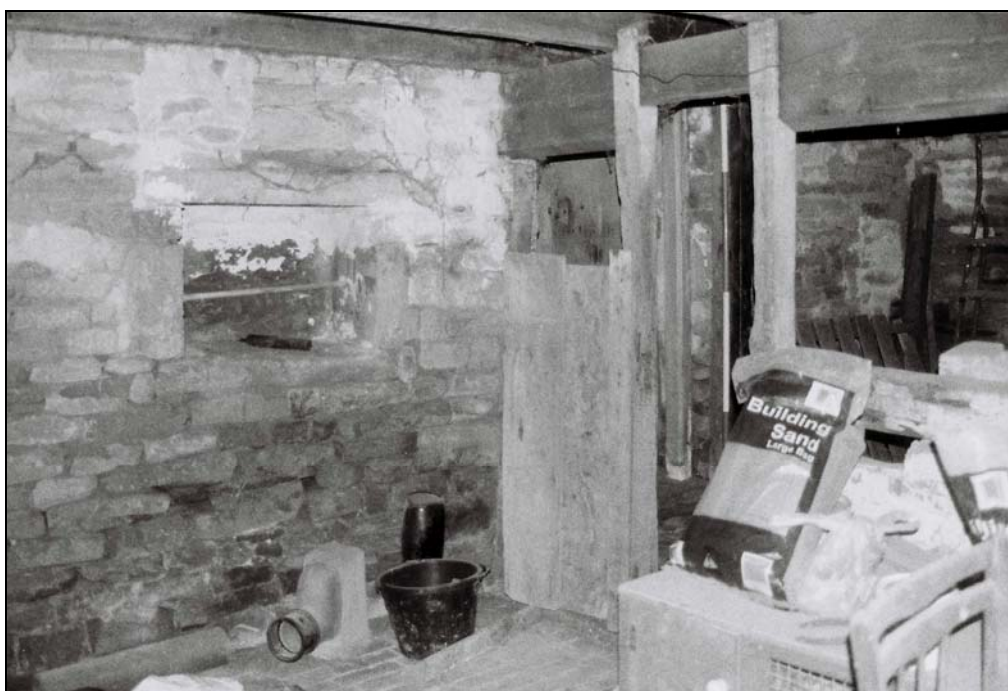
Plate 10, 14: general view with the recessed keep hole [14] in the southeast wall, looking south

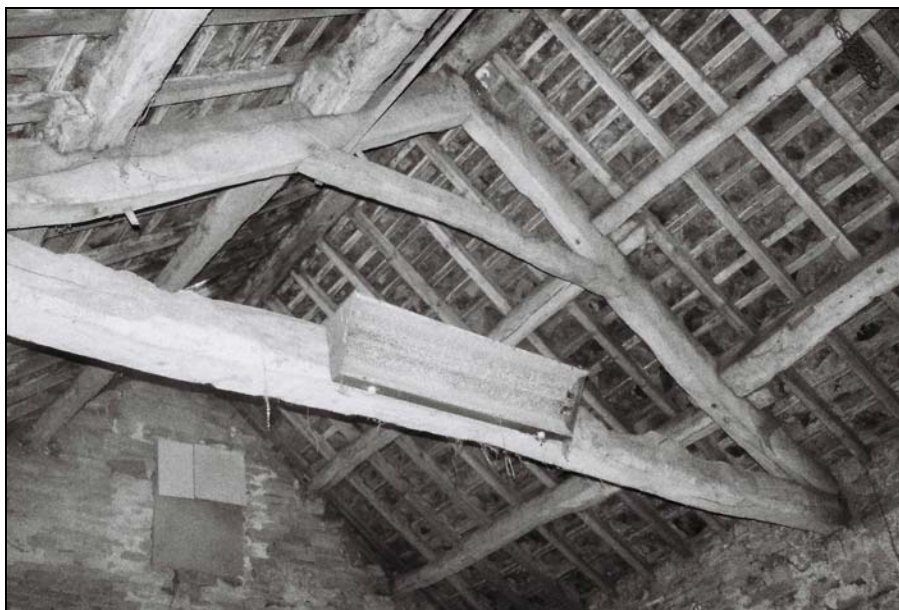
- 6.10 Rooms 2 and 3 are open to the exposed roof, which features a pair of tie-beam trusses (T1-2) with collar beams (**Plates 11, 25 & 12, 50: Figure 7**) and through purlins. Oak timber was used throughout the roof, (apart from the replaced rafters). The principal roof joints are rebated and secured with oak pegs, and the principal timbers are chamfered to the undersides. No evidence for carpenter's marks was observed, despite the ready access to the southern side of truss 2. Room 2 is dominated by the two opposing barn doors. Doorway [4] features mason's marks (M1) to the ashlar jambs and external cheeks (**Plate 13**, 24: **Figure 4**). In addition doorway [4] still retains its original door sockets for a batten, roughly set at chest height. Originally the threshing floor would have extended between the two barn doorways and these were invariably constructed from flagstones, resilient enough to withstand continual hand threshing using a flail. Brunskill (200, 158) notes that hand threshing was universal until the mid 19th century, and required sheaves of unthreshed corn to be stacked on one side of the threshing floor (Rm. 3) and the straw stored extramurally. Unfortunately the threshing floor is no longer in situ however there is evidence for it; a linear stone kerb and flagstone [15] beneath the rear barn door [8]. The kerb indicates that the threshing floor was probably confined between the inner doorways, and the chequered porches did not act as an extension to the threshing floor but were designed for weather protection. Doorway [8] also

Plate 11, 25: view of the original oak roof truss (2), looking southeast

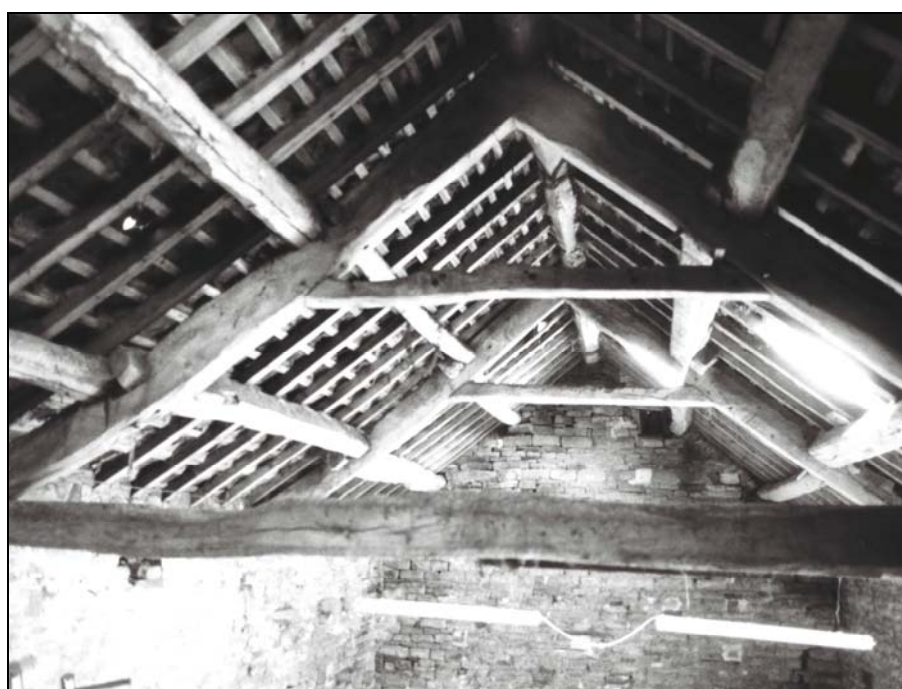
Plate 12, 50: view of the roof from the hayloft, looking northwest

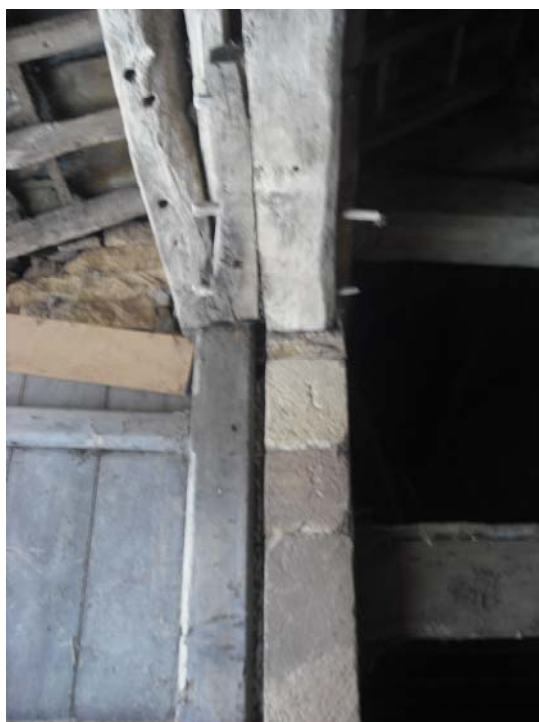
Plate 13, 24: View of the type 1 mason's marks and the inserted pegged timber for the hinge of the barn door [4], looking southeast

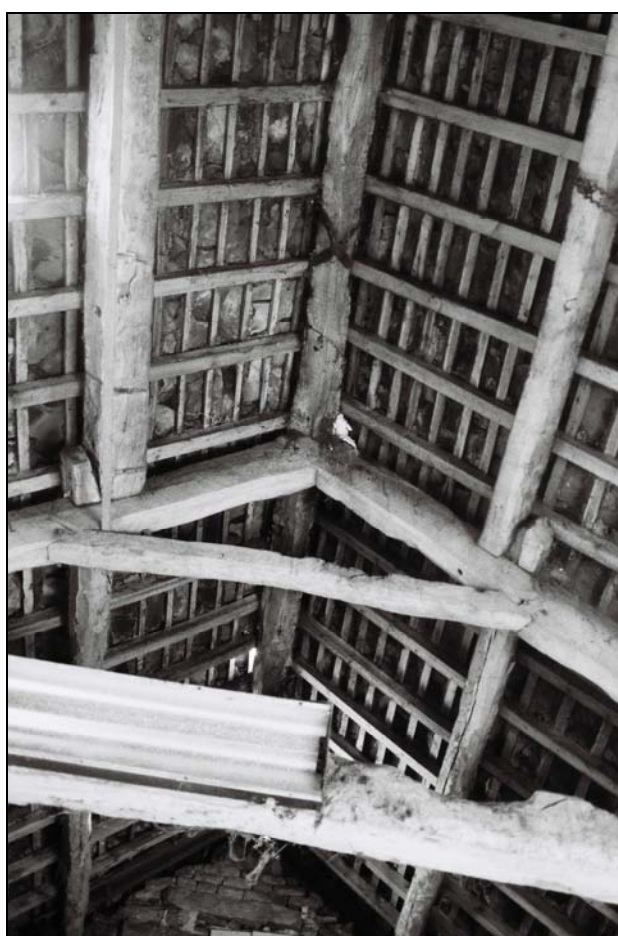
features mason's marks to the inner door jambs (M1) and was very similar in construction to doorway [4]. Further evidence for unloading was provided beneath the ridge purlin above the centre of the threshing floor, in the form of an iron cross-brace (**Plate 14**, 55). The brace would have secured a block and tackle to hoist sheaves off the cart as it passed through the barn. NB chains were also noted to the purlins and may have been fitted once the cross brace presumably failed.

Plate 14, 55: View of the roof collar and purlins (Truss 2) and cross brace to the ridge purlin, looking southeast
