TYTHE HOUSE BARN, BROOME, BROOME LANE, WORCESTERSHIRE: AN ARCHAEOLOGICAL BUILDING RECORD

CS Archaeology
June 2013

Planning Reference: WF/12/0599

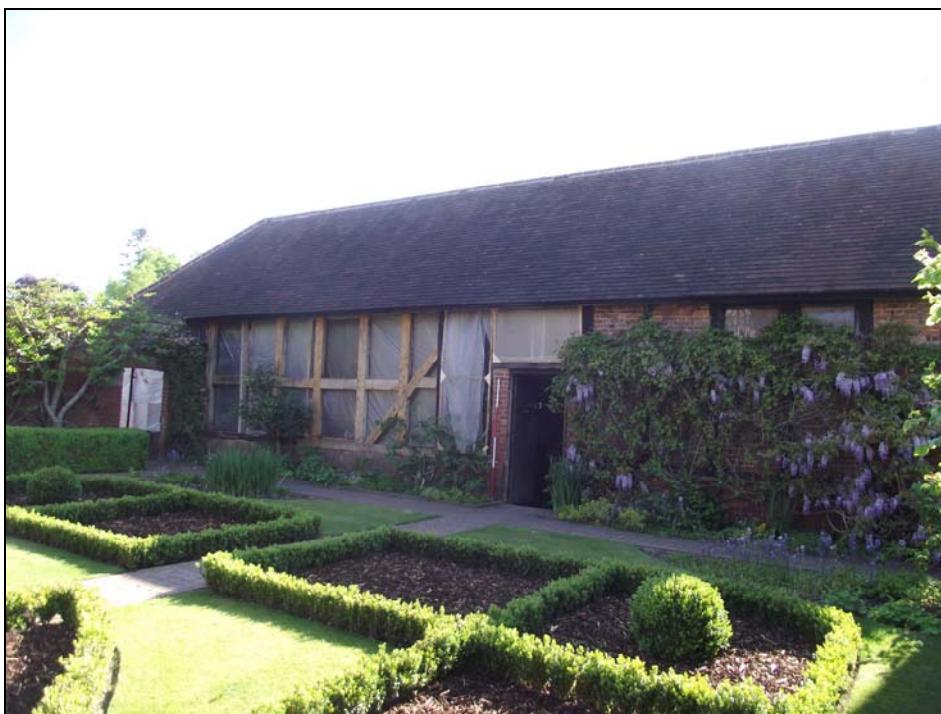
- 5.2 The West Elevation (l. c.19.24m x ht. 3.3m: **fig. 8**) has largely been rebuilt (**Plate 1, 8**), re-roofed and the structure has been stabilized ensuring its long term preservation. Sections of the sill beam remain in situ. The original square paneling to the northern end of the elevation remains in situ (bays 3-4) but was largely obscured by climbing plants. The infilling brick nogging was visible and features 18-19th century bricks. Bays 1-2 feature the modern oak framing onto of the original sandstone walling (**Plate 2, 7**), which is extant up to one and a half courses. The wall top is square-headed and flush with the sill beam, and was built with narrow joints and set in lime mortar. NB there is no evidence for a chamfer, compared to the east elevation. The wall extends across the 1st and 2nd bays, the 3rd bay features 18th century brick below the sill beam which continues in brick. Access to the barn is via a doorway to the centre of the 3rd bay (phase 2), which appears to have been inserted, as evidenced by the

Plate 1, 8: view of the west wall with partially rebuilt oak framing, from the southwest

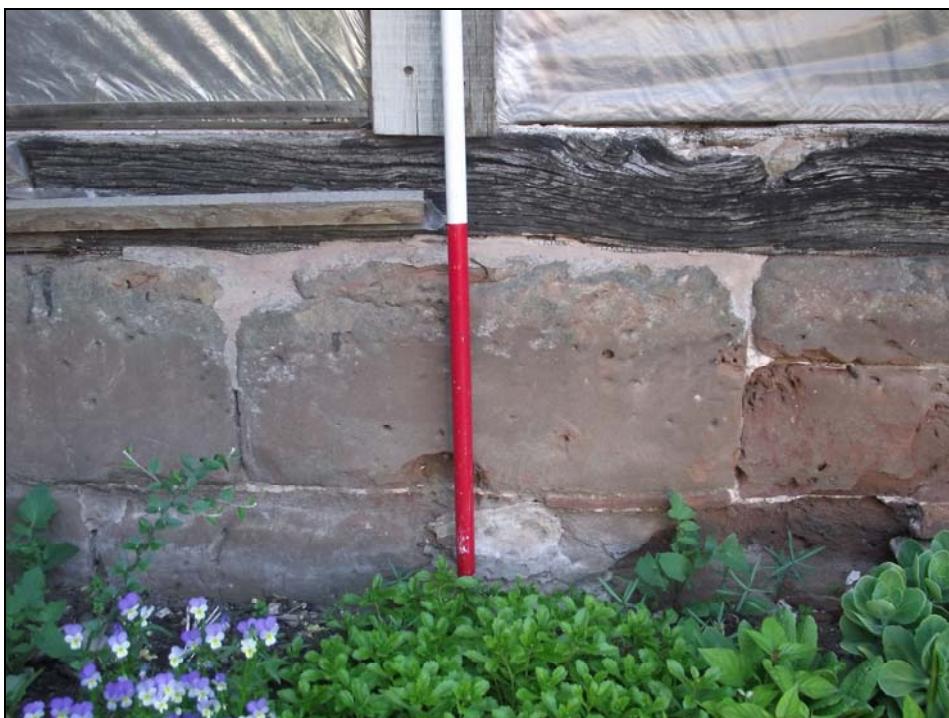
Plate 2, 7: detail of the red sandstone walling, from the west

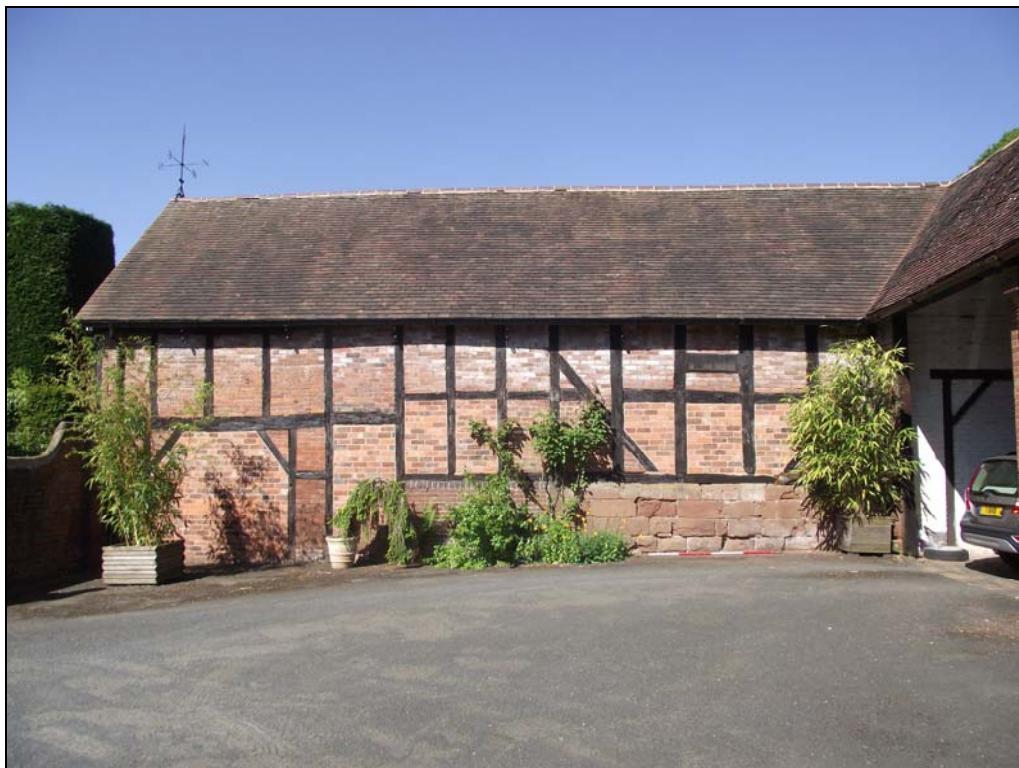
- 5.3 The east elevation (*l.* c.19.24m x *ht.* 3.3m: **Fig. 8**) provides the best opportunity to analyse the barn. The arrangement of the original square framing and the walling beneath indicates that the barn was constructed in two phases (**Plate 3, 19**). Presumably the walling to Bay 1 has been historically removed to facilitate the insertion of the wide cart doorway [1]. This probably occurred during the late 19th century when a hayloft was inserted as evidenced by the internal brickwork. Bay 2 is marked by the sandstone walling which survives up to four courses and features a continual top chamfer (**Plate 4, 21**) below the sill beam. Bay 3 features an off centre doorway which has been blocked with modern bricks with 18th century brickwork below the sill beam. Bay 4, features a raised beam defining a wide ground floor opening which was then remodeled to facilitate a carriage/garage door.

Plate 3, 19: view of the east elevation, from the east

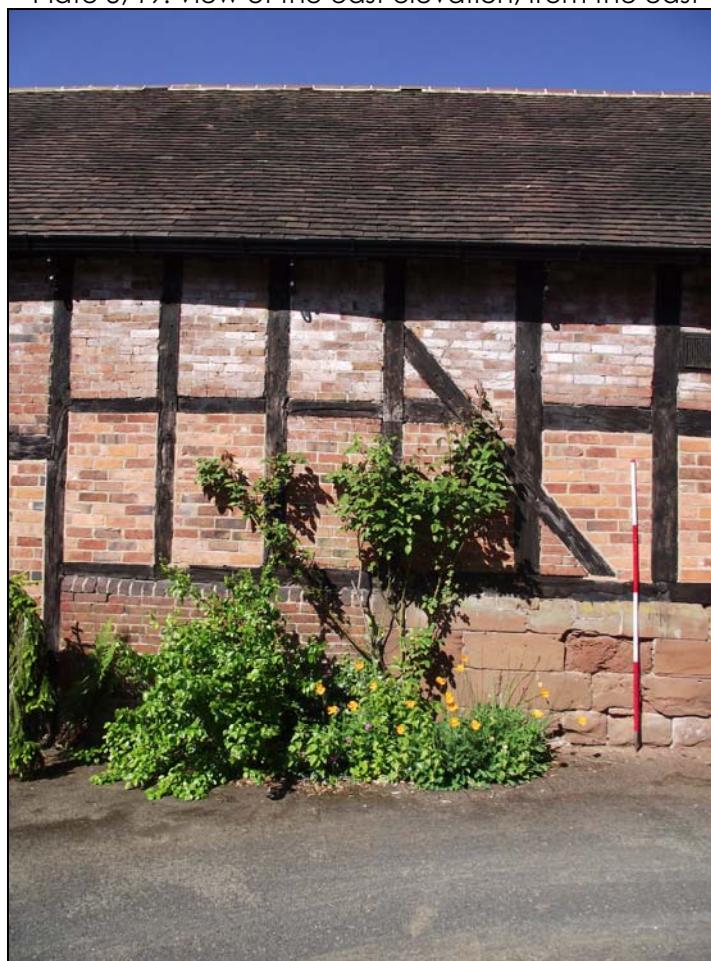
Plate 4, 21: detail of the east elevation (bays 2-3, phases 1-2), from the east

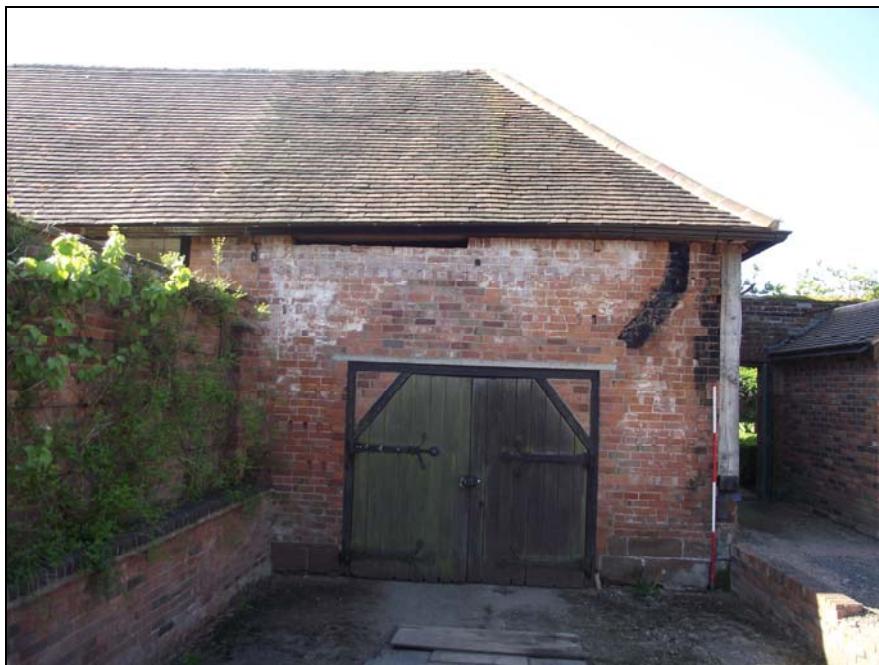
- 5.4 The north elevation has almost entirely been rebuilt with late 19th century brick work using a variation of the English bond with the header row incorporating a half brick sized ventilator, these are now mostly blocked (**Plate 4, 1: fig. 9**).

Plate 5, 1: view of the north elevation with inserted doorway and flue scars beneath the eaves, from the north

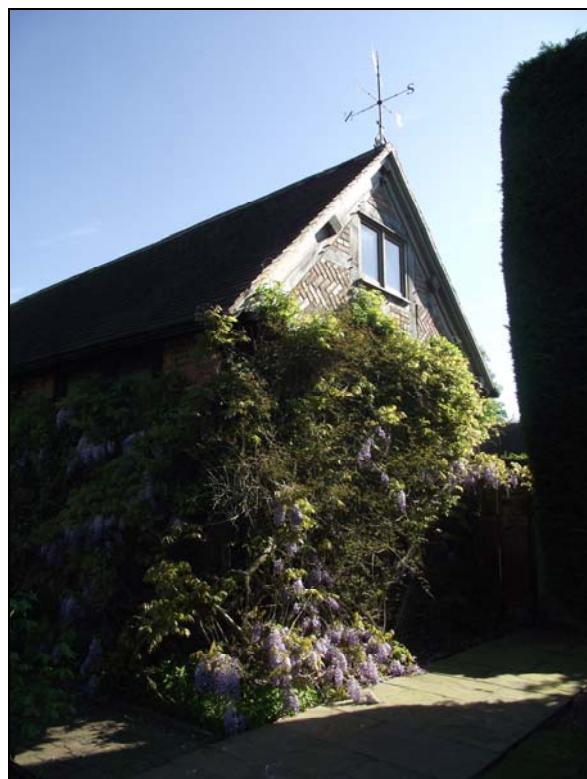
- 5.5 The south elevation ha been entirely reconstructed (**Plate 6, 10: fig. 9**) with herringbone brickwork to the upper gable wall.
- 5.6 Internally the Tythe Barn is divided into 4 rooms these correspond to the external bays. All the rooms (1-4) have now been linked by inserted doorways. This has re-organised the historic accesses to the building which were principally through the south elevation towards the adjacent house, The Rectory. Throughout the barn all the ceilings have been replaced with modern sawn timber joists and oak trusses (principal rafters and purlins). Where exposed the original oak timbers have been hacked or axed so that the lime plaster could key into the wall.

Plate 6, 10: view of the rebuilt gable wall, from the southwest

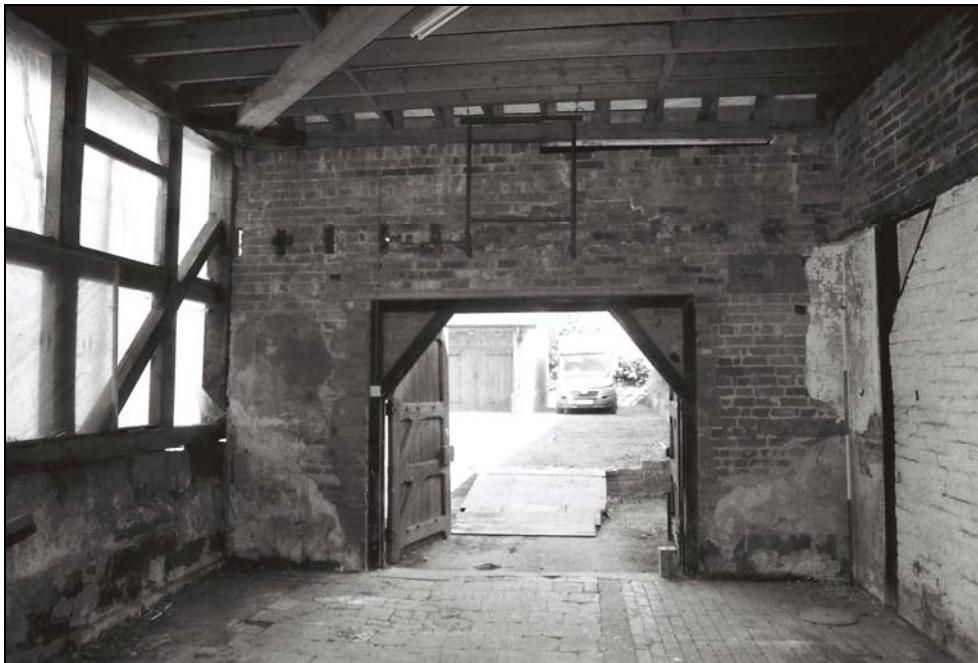
Plate 7, 17: Room 1, general view of the north wall with line of joist holes above the inserted doorway, from the south

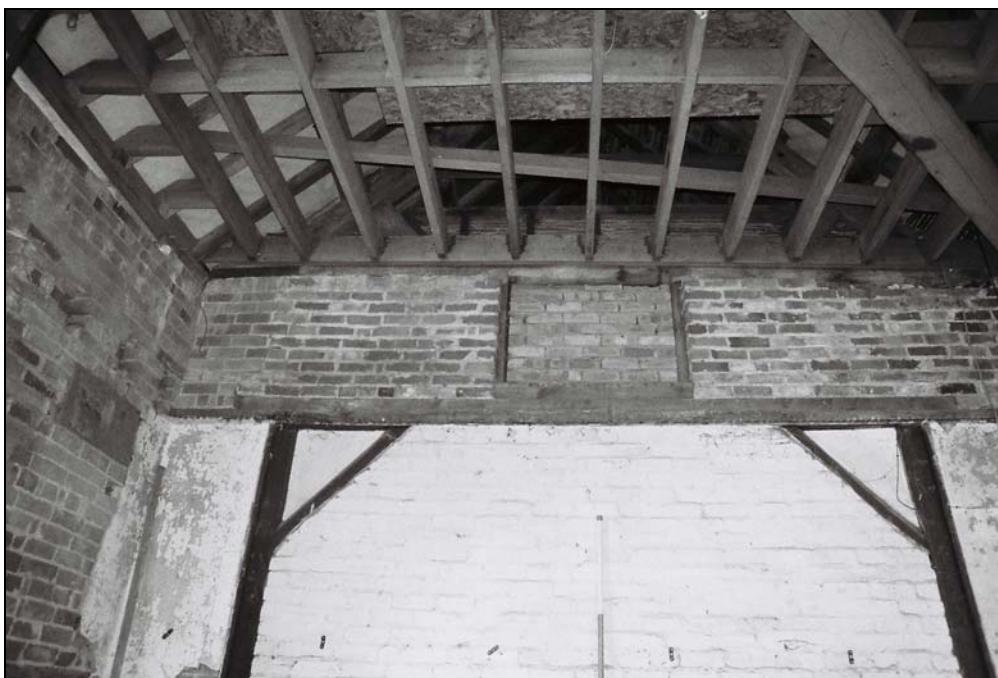
Plate 8, 15: view of the blocked opening [1] with pitching hole [2] above, from the west

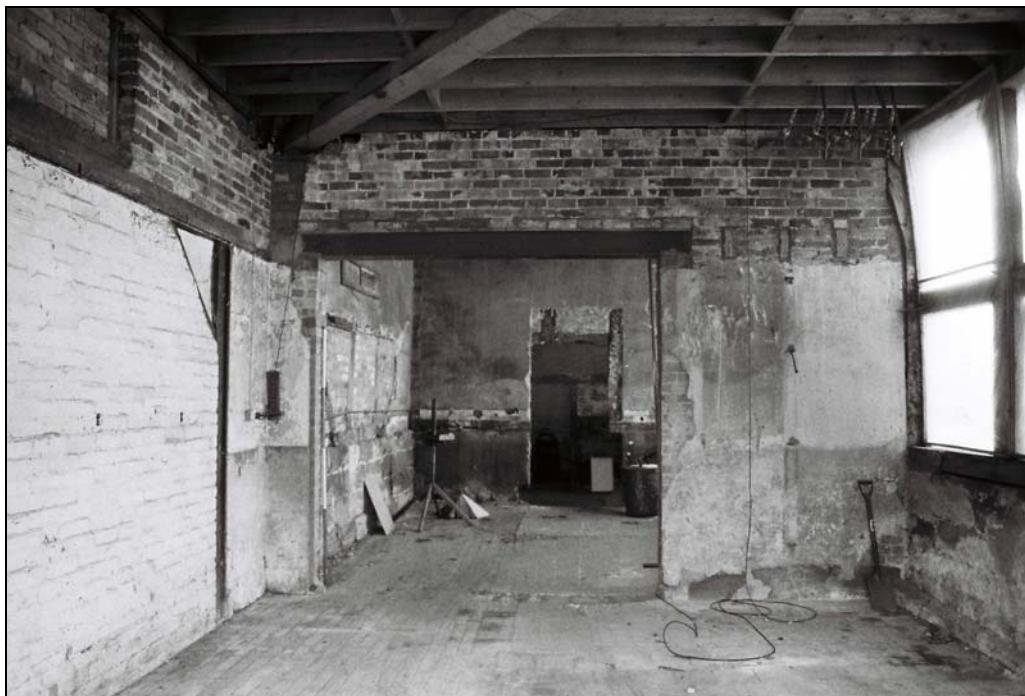
Plate 9, 13: room 1, general view of the south wall, from the north

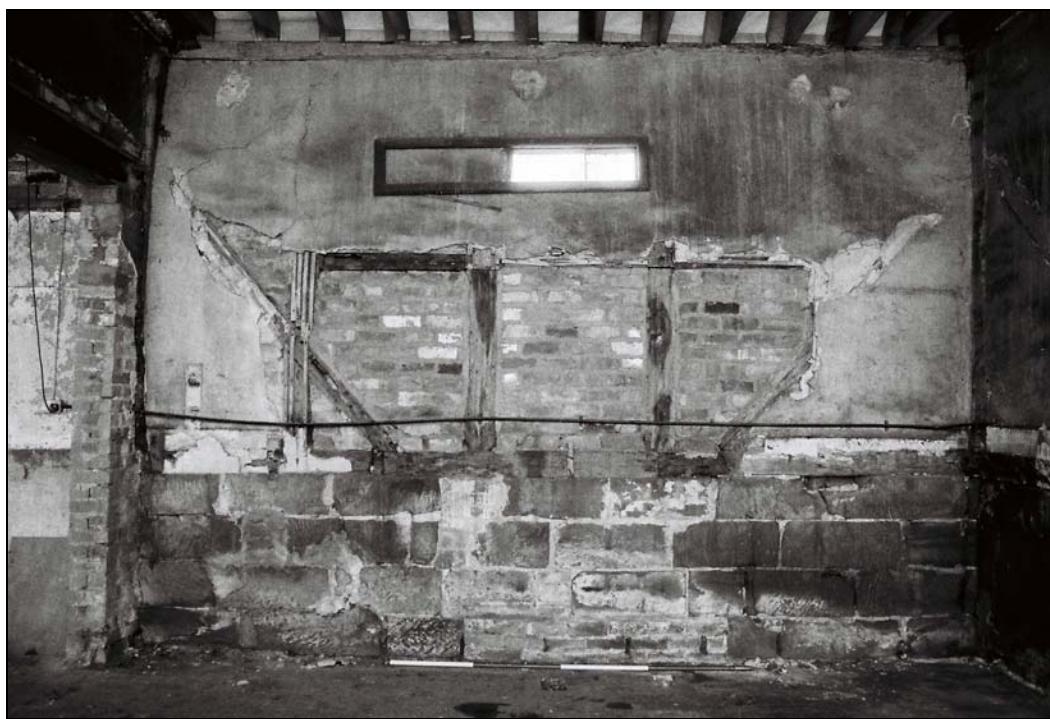
Plate 10, 25: view of the east wall with original oak walling with brick infill/noggin, from the west

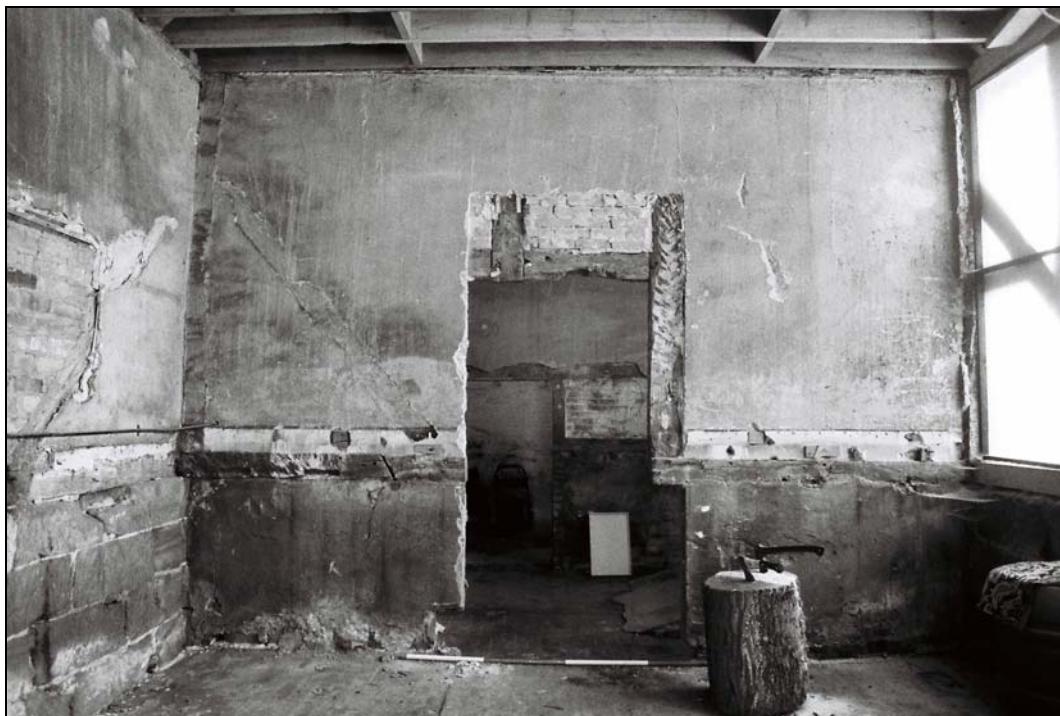
Plate 11, 24: View of the south wall with the straight braces of the framing visible below the plaster, from the north

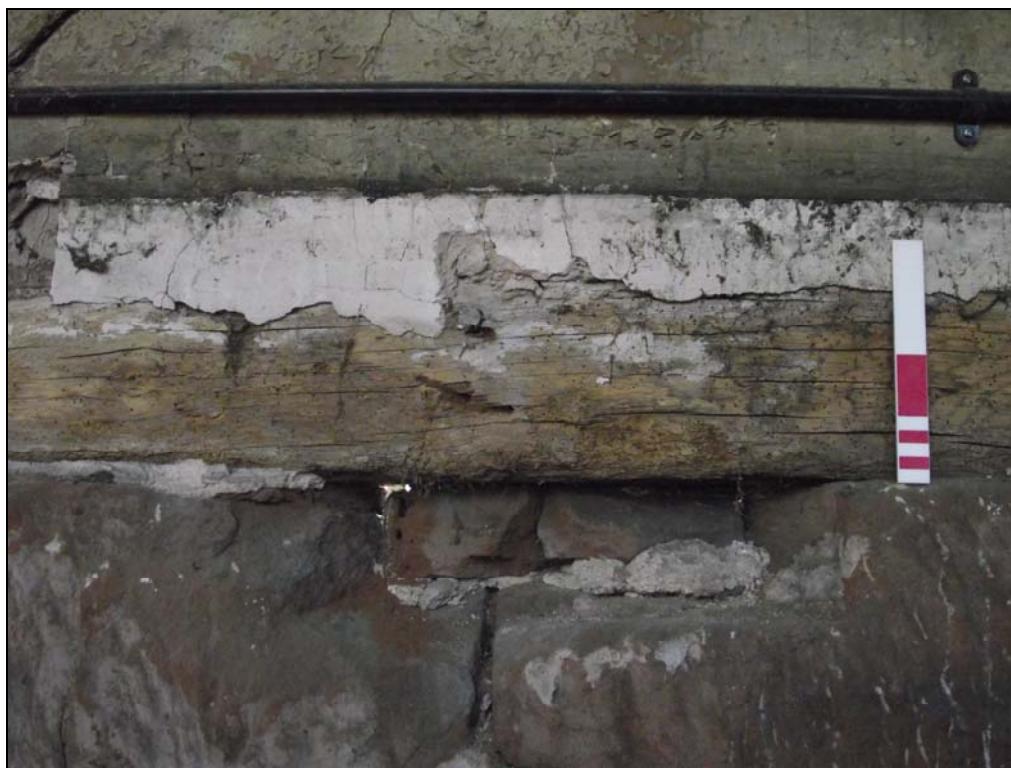
Plate 12, 52: Detail of the recess [3] to the east wall below the sill beam, from the west

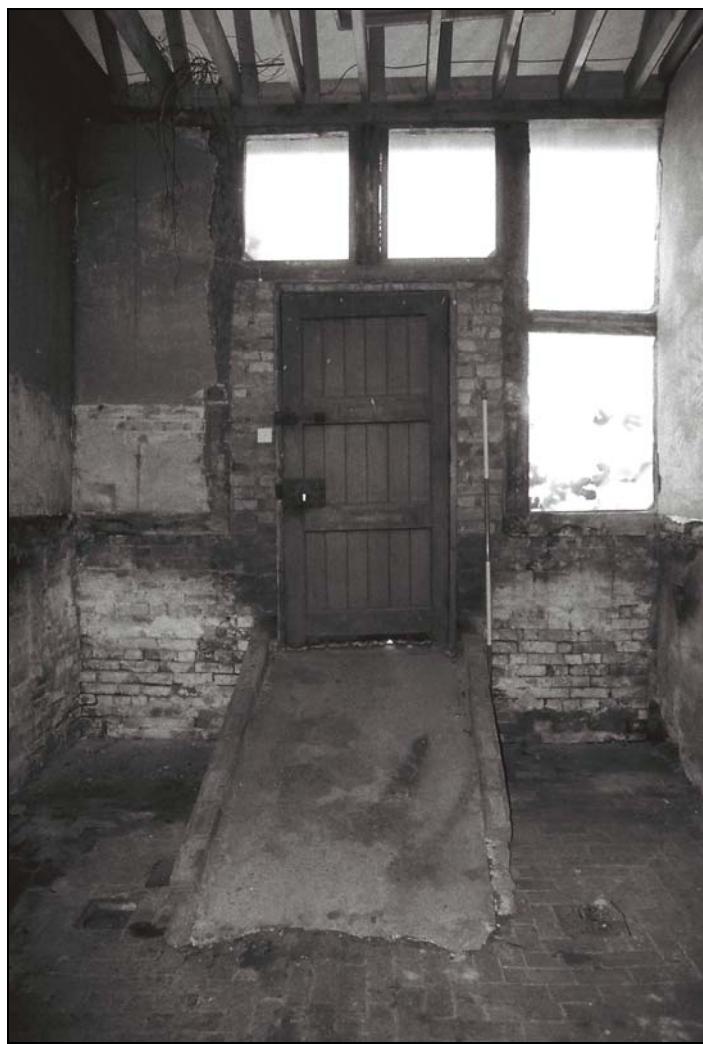
- 5.10 Room 3 (l. 5.2m, w. 3.54m & ht. 4.06m) now features a concrete ramp up to an inserted doorway in the centre of the west wall (**Plate 13**, 31). Most recently this room has been used as a storeroom for Tythe House but historically the room was accessed from the east (The Rectory). This access shift is reflected in the walls. The north wall has historically been breached to allow access and the historic doorway to the east wall blocked up with modern bricks. This inserted doorway has a concrete ramp, which overlies the brick floor. The floor level lies 0.3m below rooms 1&2, and has brick pavers in a three stall design, with corresponding square and a circular drain (**Plate 14**, 39). The north wall is particularly notable because, in contrast with all the other internal oak timbers, it has been historically weathered as evidenced by its blackened surface (**Plate 15**, 32). The sill beam features a chamfer to the once 'external' sill beam. The east wall (**Plate 16**, 34) is largely 'original' featuring the wall timbers (sill, post and rails), but there are notable differences in the construction compared to rooms 1 & 2. These differences include the absence of wall braces and sandstone walling, and indicates that this room belongs to a later building phase. The south wall (**Plate 17**, 35) features rectangular wall framing and at the mortice and tenon joint between the sill beam and posts are a series of carpenter's marks [9] in roman numerals (**Plate 18**, 37). This is the only place that carpenter's marks were able to be discerned, no doubt protected by subsequent plasterwork.

Plate 13, 31: view of the inserted doorway and the NW corner, from the southeast

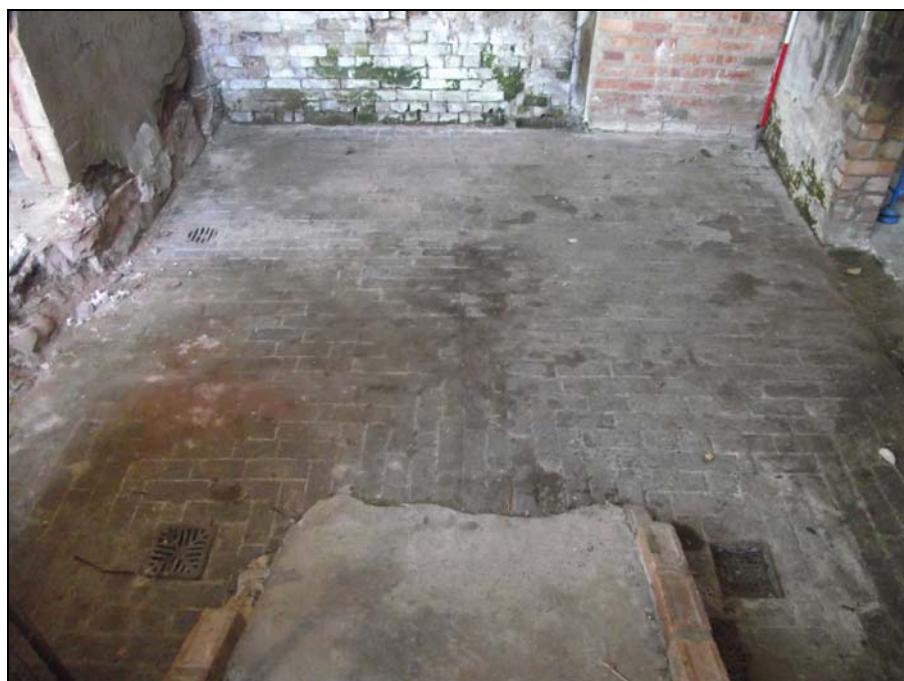
Plate 14, 39: view of the brick set floor with stall drains, from the west

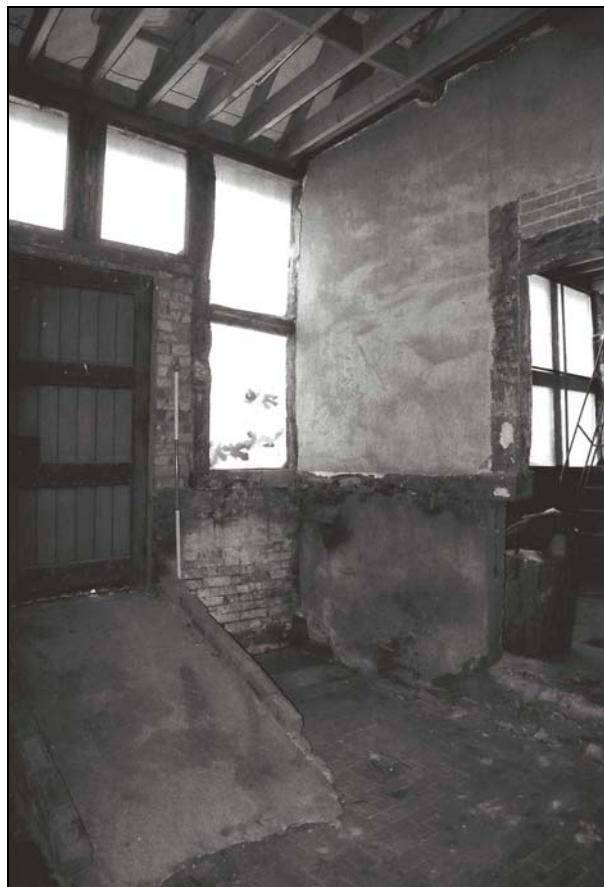
Plate 15, 32: view of the inserted doorway and the NW corner, from the southeast

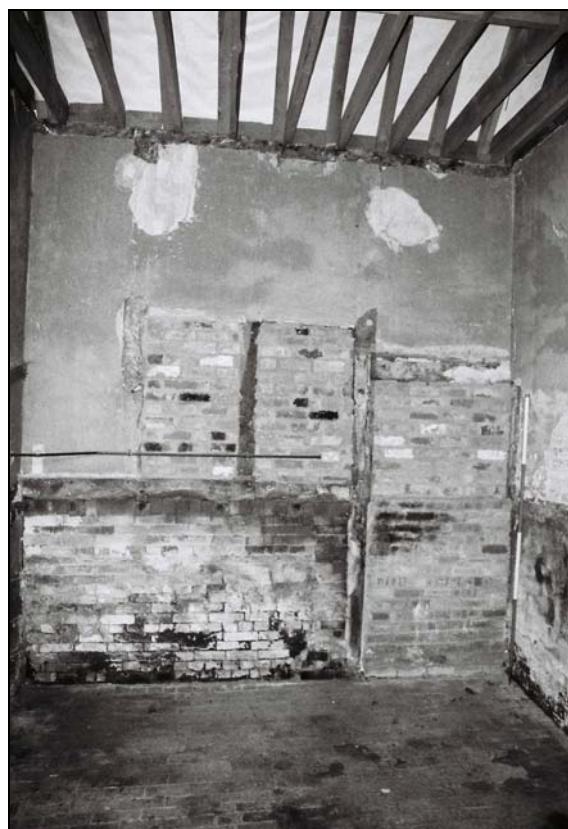
Plate 16, 34: room 3, view of the east wall with blocked doorway [4], from the west

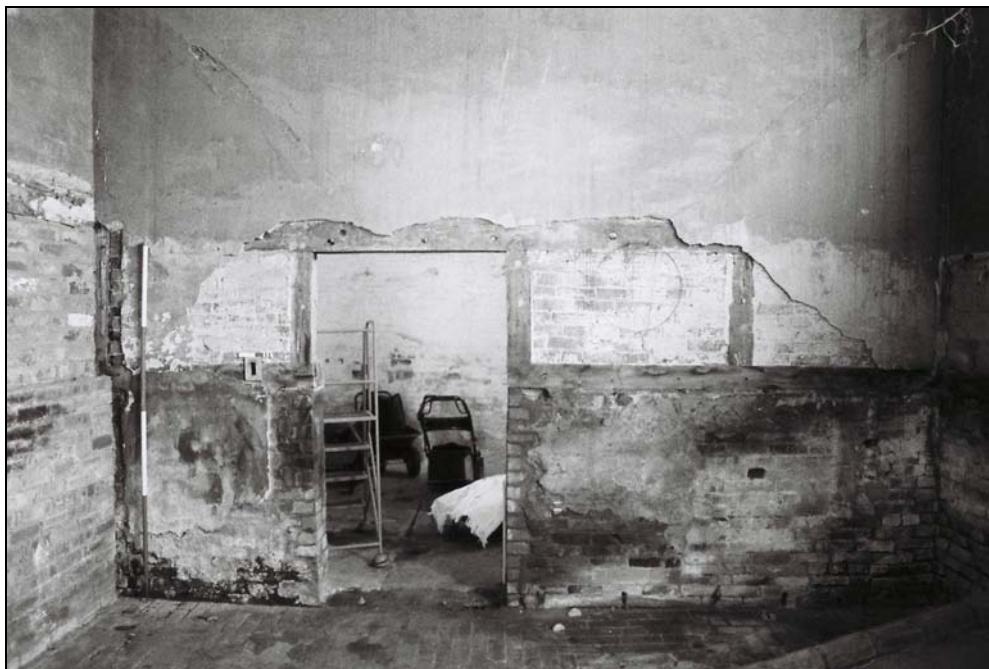
Plate 17, 35: room 3, View of the south wall with exposed timber and brick noggin, from the north

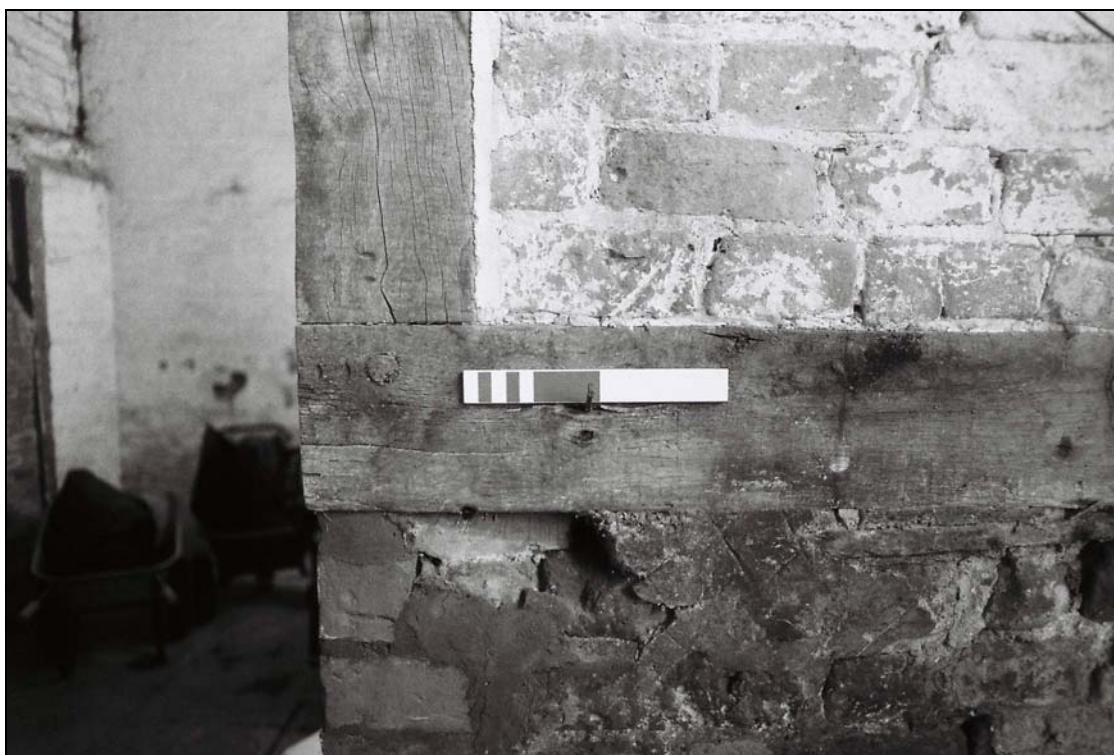
Plate 18, 37: room 3, detail of carpenter's marks to the north facing wall, from the north

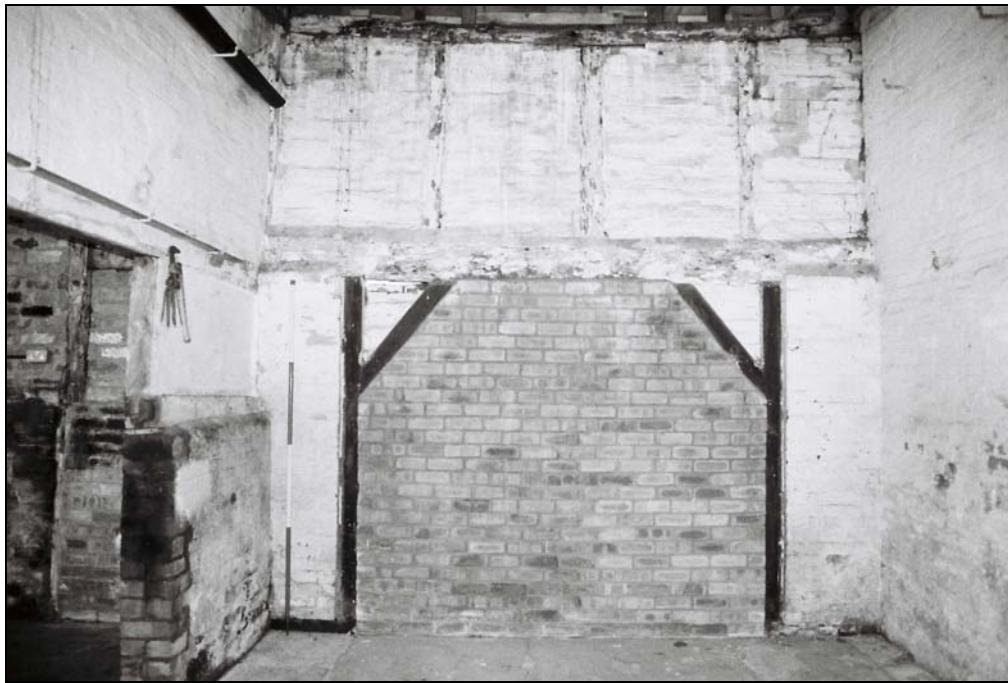
to the centre of the east wall. This wide doorway to the east wall, features a high beam or rail, just above head height (c.2m: **Plate 19**, 41), which could represent an opening for a store/cartshed, which was historically remodeled into a garage probably during the early 20th century. The walls are lime-washed and consist of box framed oak timbers with 18th/19th infill brickwork. There is an absence of braces to the external walls and the wall timbers, as with Room 3, sit above brick infill/hogging. The cross wall between rooms 3 & 4 features rectangular paneling using reused oak timbers as evidenced by the frequent dowel holes. However the south wall (**Plate 20**, 48), is entirely of Victorian brick (0.23m x 0.11m x 0.37m) and denotes an internal skin (confirmed on inspection of the upper wall in the attic). The floor consists of flagstones arranged in an imbricate pattern. Natural light has been inserted via two casement windows high in the west wall. Apart from the east wall, the walls feature rows of hand forged hooks consisting of 2 rows of five to the north and south walls, and 2 rows of two to the west wall. The purpose of these hooks was probably to store horse carriage harness. NB there are no sandstone lower walls.

Plate 19, 42: room 4, view of the west wall with high beam/rail, from the east

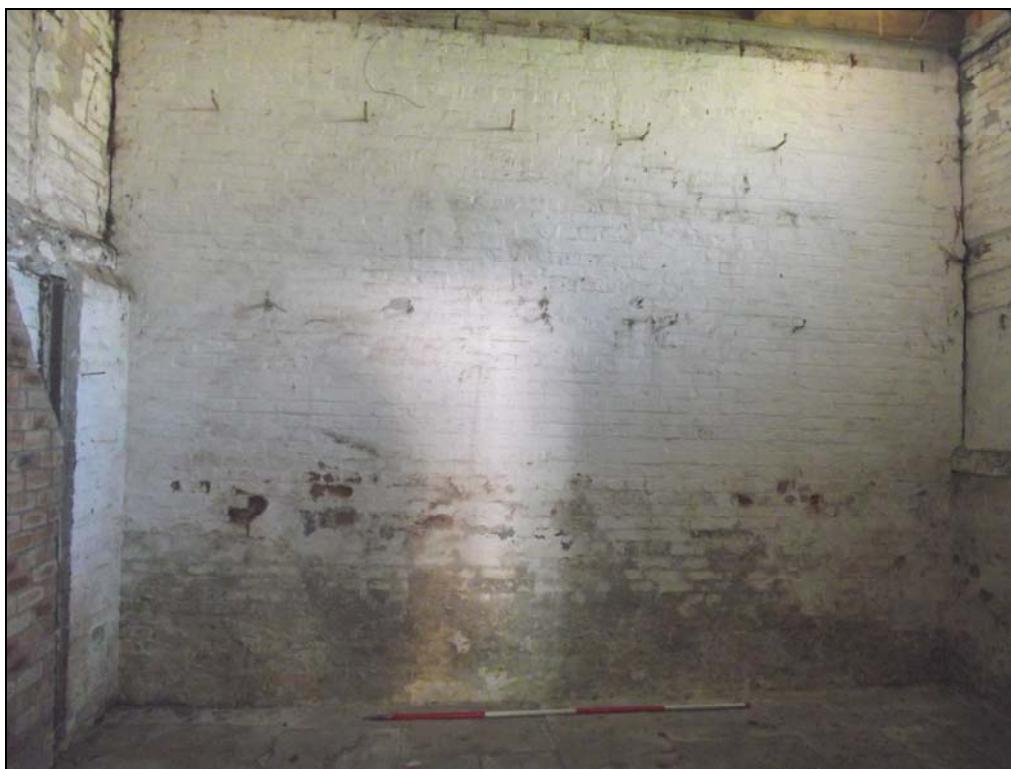
Plate 20, 48: view of the inserted brick south wall with two rows of bracket hooks [8], from the north

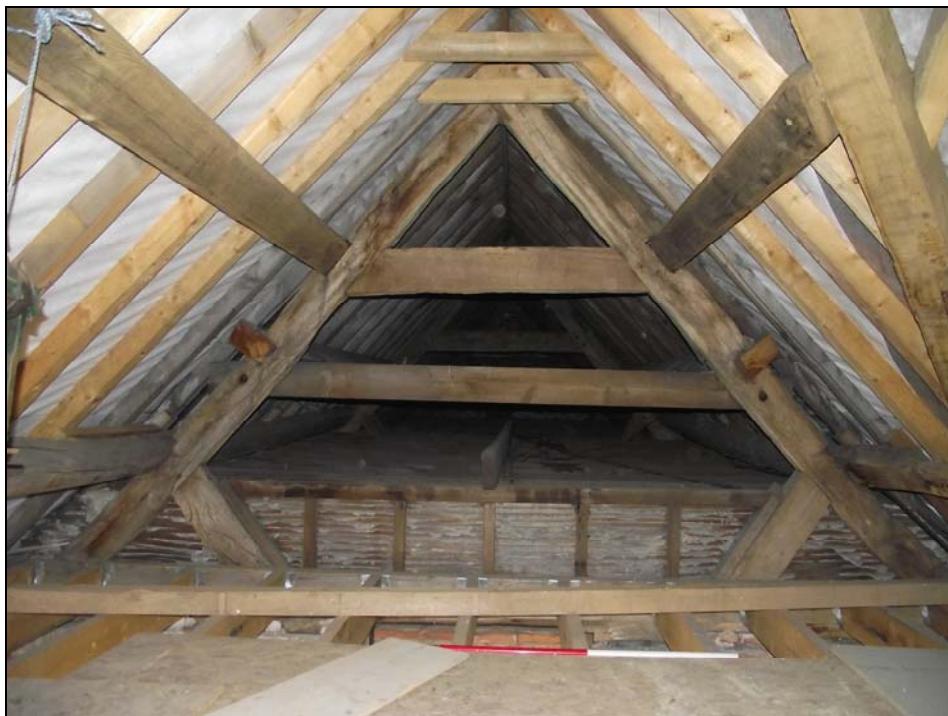
Plate 21/55: View of the surviving roof truss T1, from the west looking into the phase 4 extension (in separate ownership)

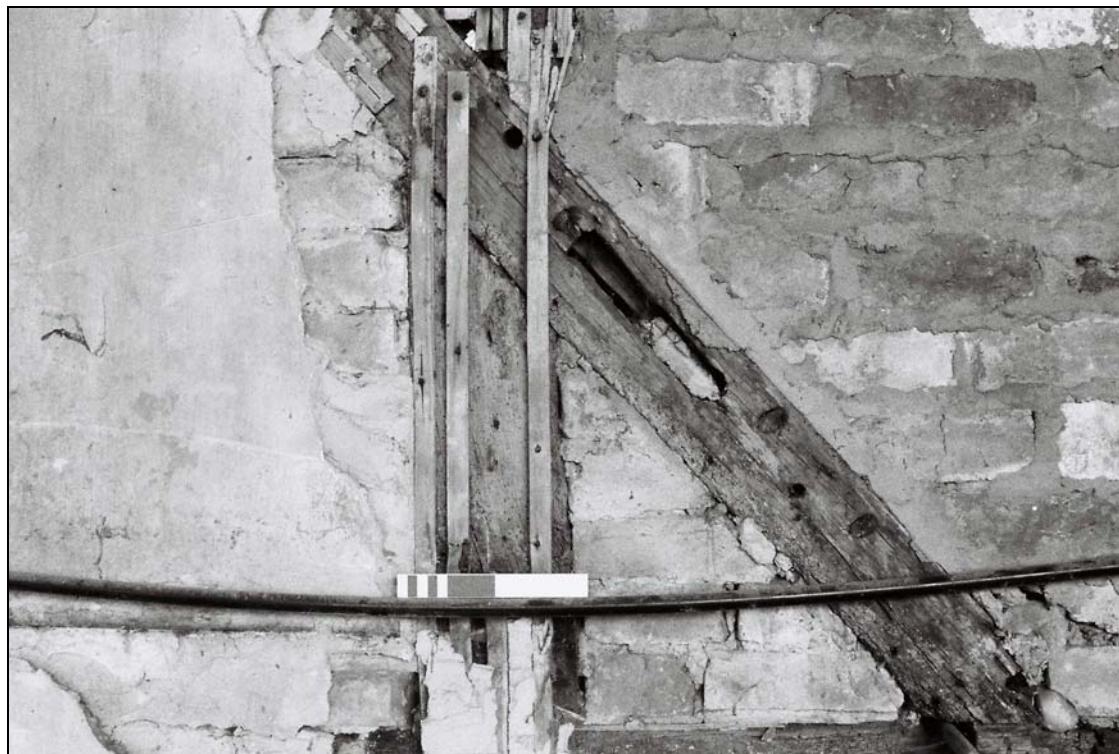
Plate 22/65: detail of the east wall (re-used straight brace), from the west

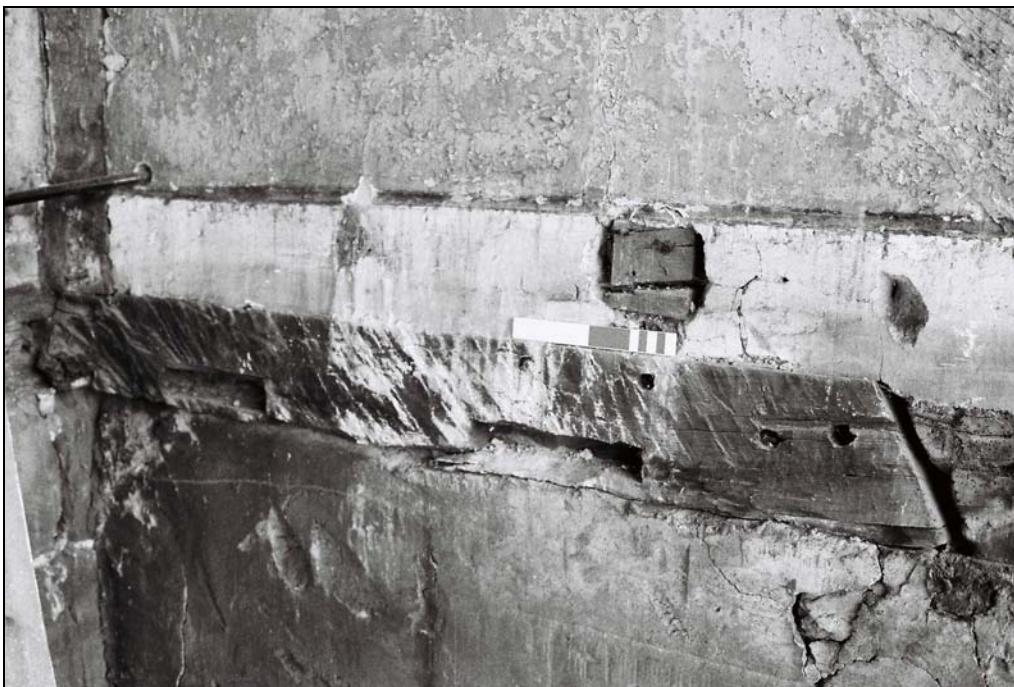
Plate 23/66: detail of the south wall (re-used sill beam), from the northwest

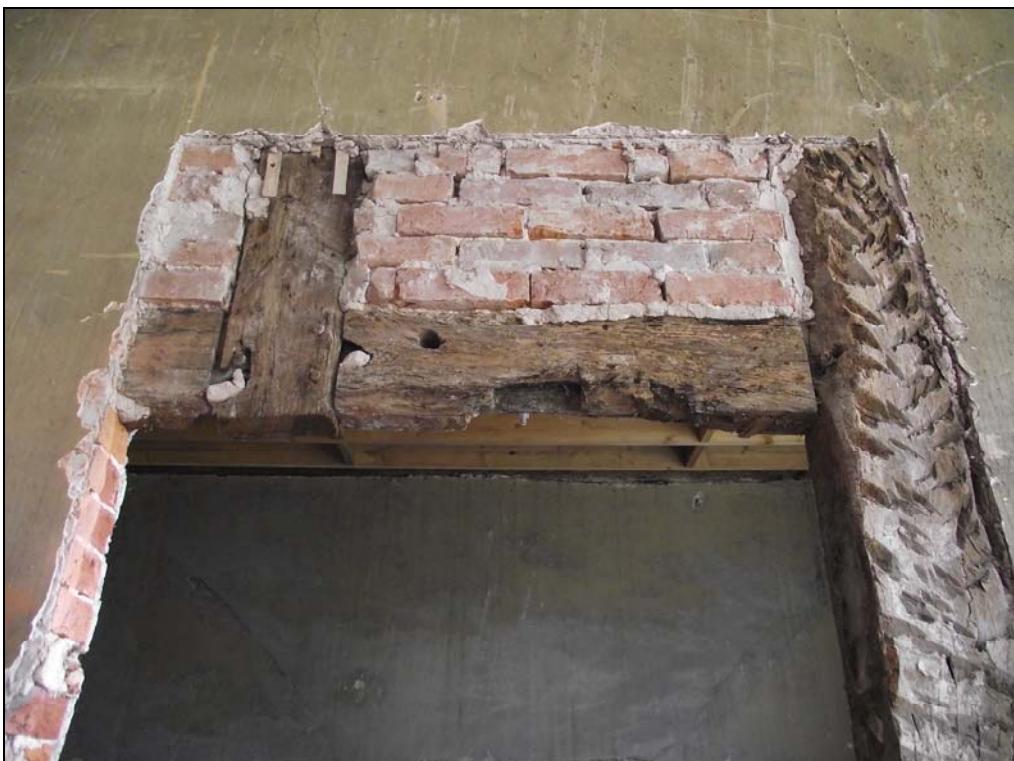
Plate 24/67: detail of the frame rail to the south wall
