**2 OLD EPWORTH ROAD WEST, HATFIELD,
DONCASTER, SOUTH YORKSHIRE:
AN ARCHAEOLOGICAL BUILDING RECORD**

On behalf of G.A. Mell (Builders) Ltd

CS Archaeology

July 2014

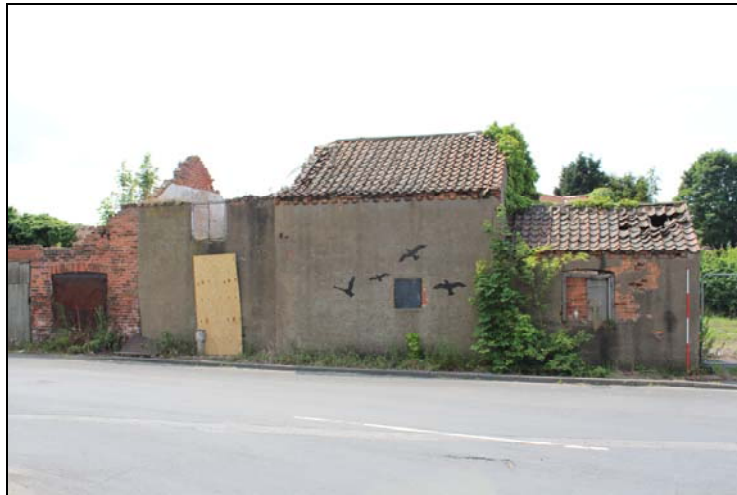
5.1.1 The buildings are showing signs of major structural collapse (**Plates 1, 7 & 2, 3**). External phasing of the farmhouse (Blg. A) is possible due to the absence of cement render in strategic areas of the building. There is a vertical building line between the single storey extension (Blg. A2) and the main 2 storey house (Blg. A1: **Plate 3, 62**), a stepped in wall between the main house (Blg. A1) and the 2 storey extension (Blg. A3), which has allowed for the phasing of the farmstead. More precise phasing/dating is not possible because of the use of very similar slope moulded bricks and the general obscured conditions of subsequent internal and external finishes.

Plate 1, 1: view of the front NE Elevation, looking south southwest

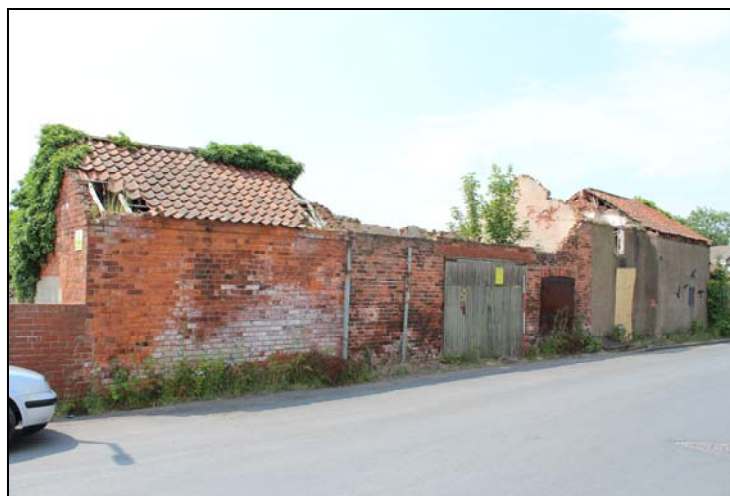
Plate 2, 5: oblique view of the front NE Elevation, looking west

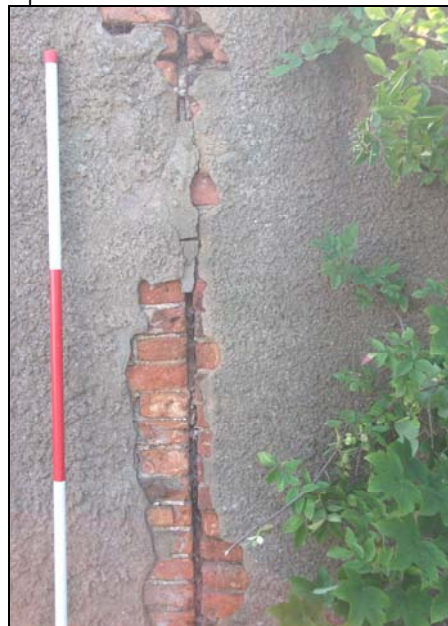
Plate 3, 62: Vertical building line between the house (Blg. A1 and the extension (Blg. A2) looking southwest

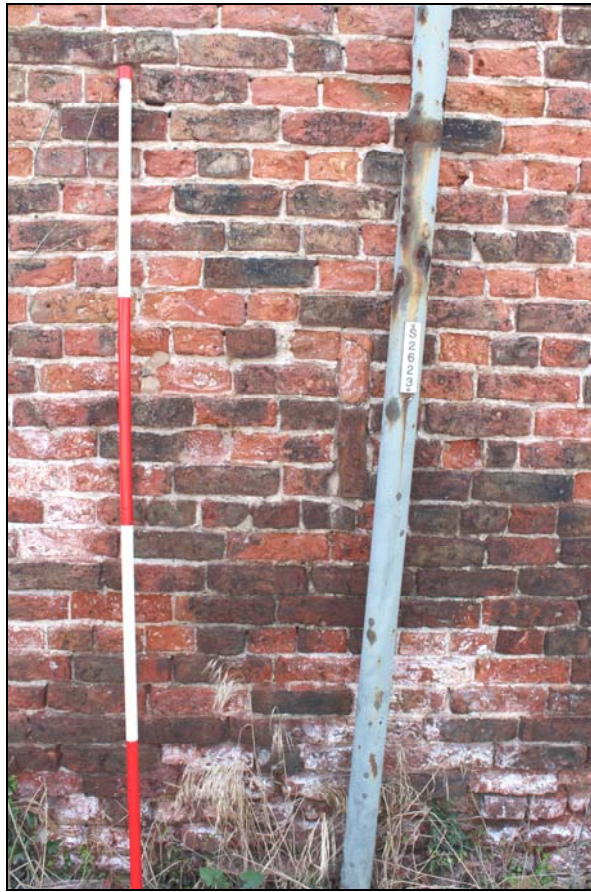
Plate 4, 61: View of the brickwork between the barn left (Blg. B, and the house right (Blg. A2), looking southwest

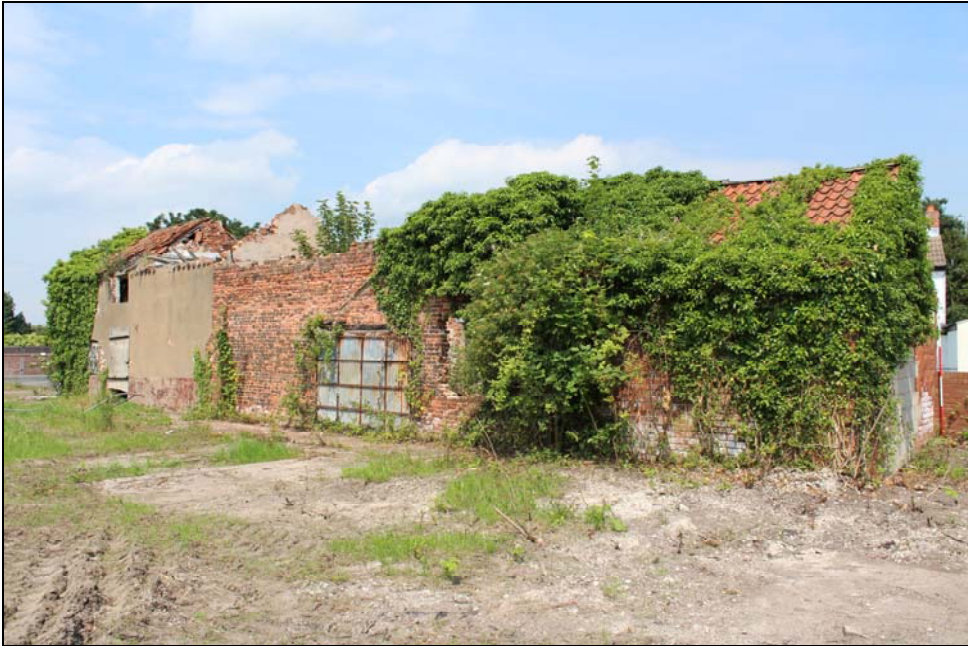
- 5.1.7 The rear Southwest Elevation is again obscured by render and ivy which totally obscures the only window to the garage (**Plates 6, 9 & 7, 10**). The Barn's walls are relatively un obscured and this allowed for the recording of two original features; a doorway [O] and further ventilator [M]. The doorway [O] is evidenced by surviving arched brick work (**Plate 8, 11**). This doorway is a significant feature indicating that the barn appears to have originally served as a hand threshing barn and the doorway [O] was originally the barn's winnowing door, built to provide a cross flow of air for processing cereals.

Plate 6, 9: general oblique view of the rear SW Elevation, looking north northeast

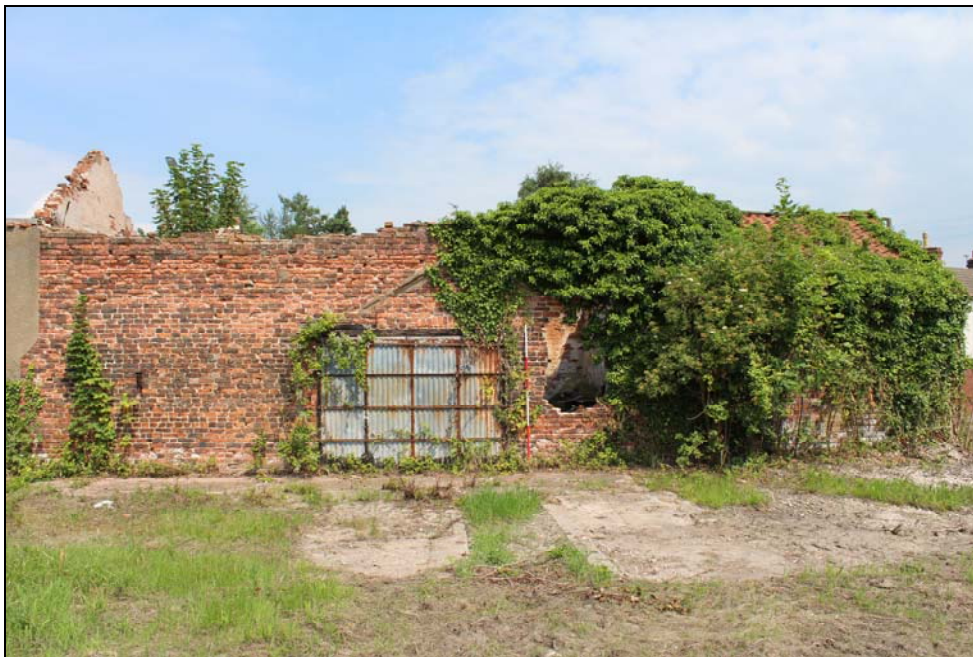
Plate 7, 10: the Barn (Blg. 2), view of the rear SW Elevation of the barn with obscured garage, looking northwest

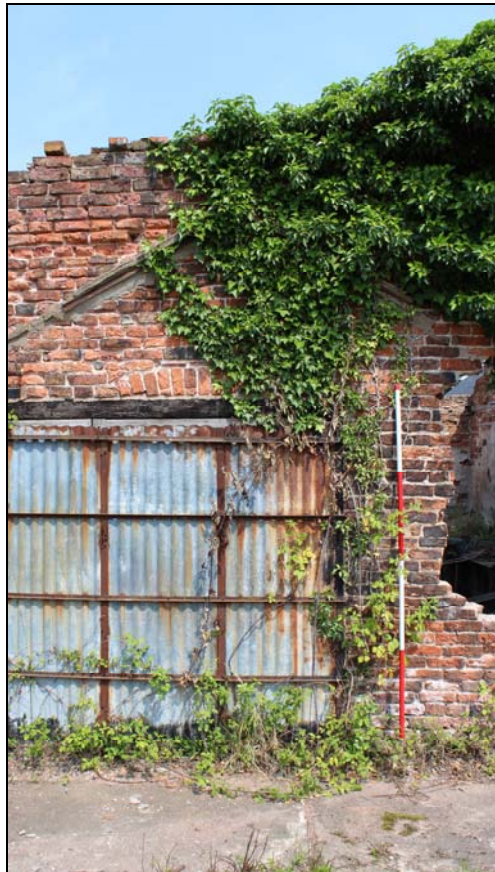
Plate 8, 11: detail of the roof scar [N] and arched doorway [O] above the modern inserted doorway. looking east northeast

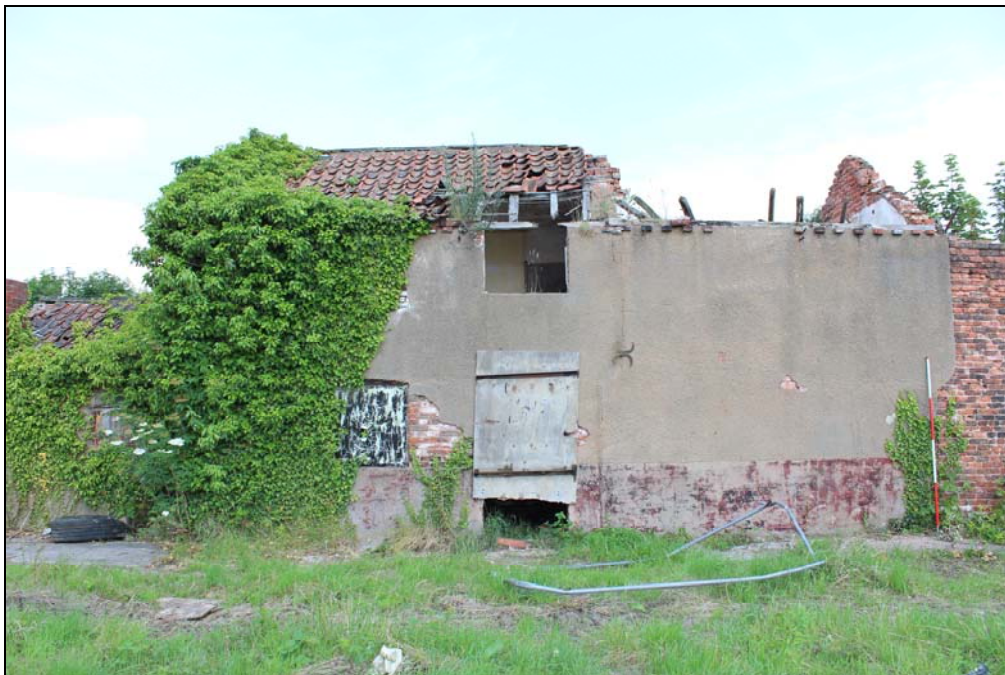
- 5.1.8 The farmhouse walls are largely obscured by render and ivy (**Plates 9 & 10, 13, 14**). The later 2 storey extension to the farmhouse (Blg. A2) provided evidence for a further two windows [L & K] indicated by characteristic cracking to the render and sections of exposed brickwork. The revealed fenestration mirrors that to the northeast elevation. Historic fenestration of the farmhouse can be seen in the historic photograph (**Plate 11**) and consisted of 'Yorkshire' sliding sashes and arch-headed windows, similar in style and construction throughout the farmhouses different building phases. NB **Plates 10 & 11** also demonstrate the degeneration of the house during the late 20th century.

Plate 9, 13: view of the rear SW Elevation, looking east northeast

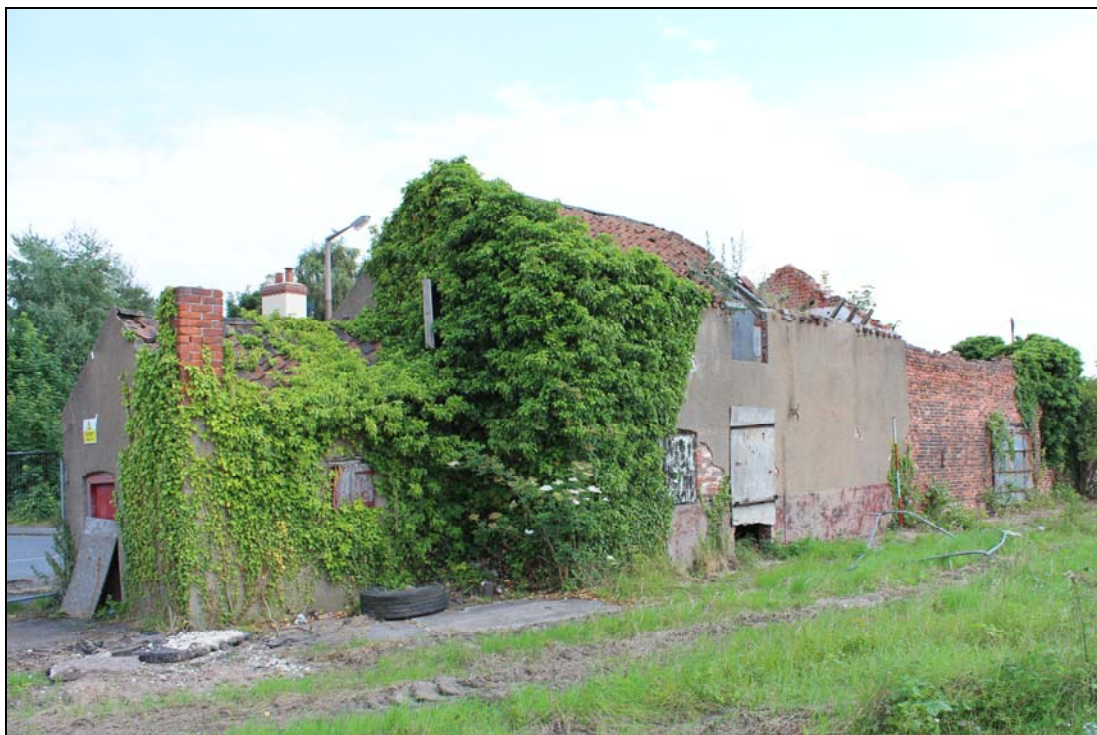
Plate 10, 14: general oblique view of the rear SW Elevation, looking south southeast

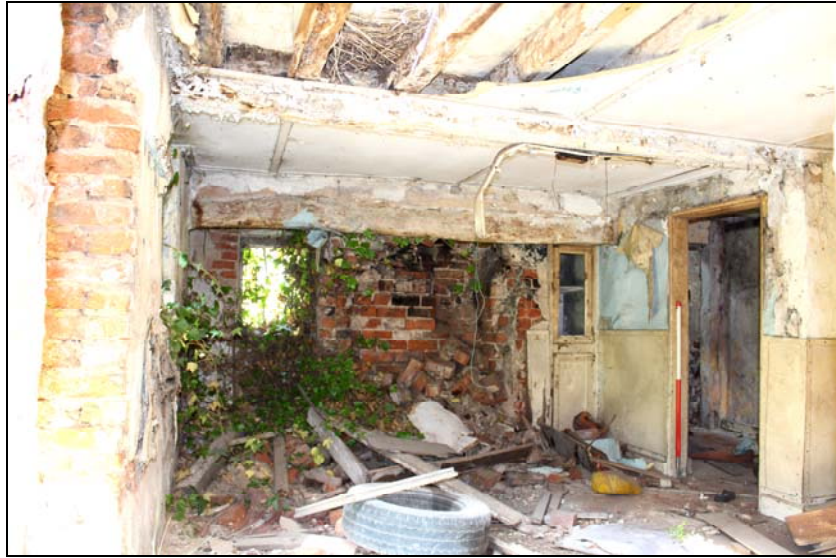
- 5.2.3 Room 3 (*l.* 4.715m, *w.* 3.5m & *ht.* 1.958m) served as the *Kitchen/Living room* and features a now removed fireplace to the northwest wall (**Plate 15, 44**). Fenestration consists of a large window to the southwest wall and a smaller one to the northwest wall, between the southwest wall and the fireplace. Access to this room is via an external front door to the southwest wall and two internal doorways to the Lobby (Rm. 2) and the Parlour (Rm. 4). There is a further internal doorway to the under stairs store room (Rm. 5). The room is in a poor condition with prolonged water ingress from the roof which has collapsed the ceiling just inside the front door. This disintegration of the ceiling allowed a significant section through the ceiling and first floor (**Plate 16, 46**). This shows a reed (0.01m deep) and lime-crete floor (0.065m deep) overlying the chamfered oak beam and joists. The overall shape of the room is rectangular but appears to have been annexed along the northeast wall by the Lobby (Rm. 2) and the staircase (Rm. 6). There is a solid floor which still retains its historic coverings of linoleum and carpet on top of what appears to be a 'quarry' tiled floor. The walls are plastered and finished with successive layers of lime wash. Hardboard paneling is a modern feature of the decorative treatment to the lower walls. Hardboard also obscures most of the ceiling, but in the exposed areas the original timber of the first floor can be seen. The timbers are oak (throughout) and feature decorative stop chamfers. The central cross beam [P] (*ht.* 0.26 x *w.* 0.21m) displays its stop chamfers close to the southwest wall and significantly to the northeast wall of room 3, indicating that either the joists did not originally extend to the across the Lobby (Rm. 2's northeast wall), suggesting re-used timbers which lacked the length to span the full house width. Examination of the end of the cross beam [P] in room 2 indicates it had been truncated flush with the southwest wall, suggesting that the stop chamfers may have been a later decorative treatment. Rather perplexingly the oak ceiling joists also feature stop chamfers which was consistent and offset with the cross beam but carried into the southeast wall, indicating this wall was later than the ceiling. The joists were set 0.26-0.27m apart.

Plate 15, 44: room 3, view of the Kitchen from the Parlour (Rm. 4), looking north

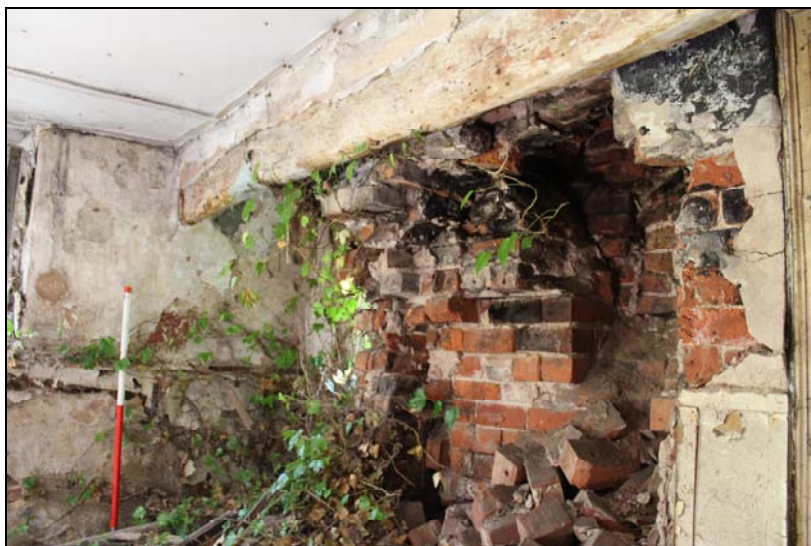
- 5.2.4 The fireplace (**Plate 17, 19**) in room 3, has been removed but evidence from fragments of still on the floor indicates that until recently it housed a Victorian cast iron range, this had been removed causing extensive damage to fireplace. On the plus side this did allow views of the different phases of the fireplace which consisted of at least 3 phases. Phase 1 is represented by the low bressumer beam [Q] above the fireplace, which probably evidences a support for a smoke hood. This bressumer beam [Q] was slender, in cross section it measured *ht.* 0.14m x *w.* 0.09m and was bricked up to the ceiling using the slope made bricks (e.g. Plate 34 right). Phase 2 of the fireplace is represented by the 16th/17th century brick cheeks that reduced the fireplace and then the 19th century brick infill associated with the cast iron range.

Plate 17, 79: oblique view of the small brsummer beam [Q] with slope made bricks above, looking west

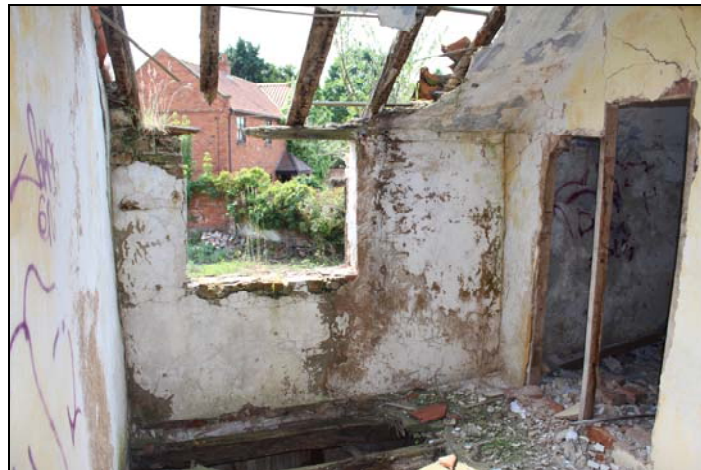
- 5.2.9 Room 8 (*l.* 2.9m, *w.* 2.37m & *ht.* 2.46m), is the second bedroom. There is a central window to the southwest wall (**Plate 25, 26**). The bedroom's northwest wall has suffered a collapse but this does allow views of the vertical timber studs which are in-filled with slop moulded bricks bonded in lime mortar. Again the walls are plastered and lime washed and the under drawn ceiling is pitched at the eaves. There is a 4 panelled door laid on the remains of a dressing table which features a 'suffolk' style hand forged latch with trefoil pattern. The bosses noted in room 7 are also evident to the upper walls.

Plate 25, 26: room 8, general view with exposed stud wall, looking southwest

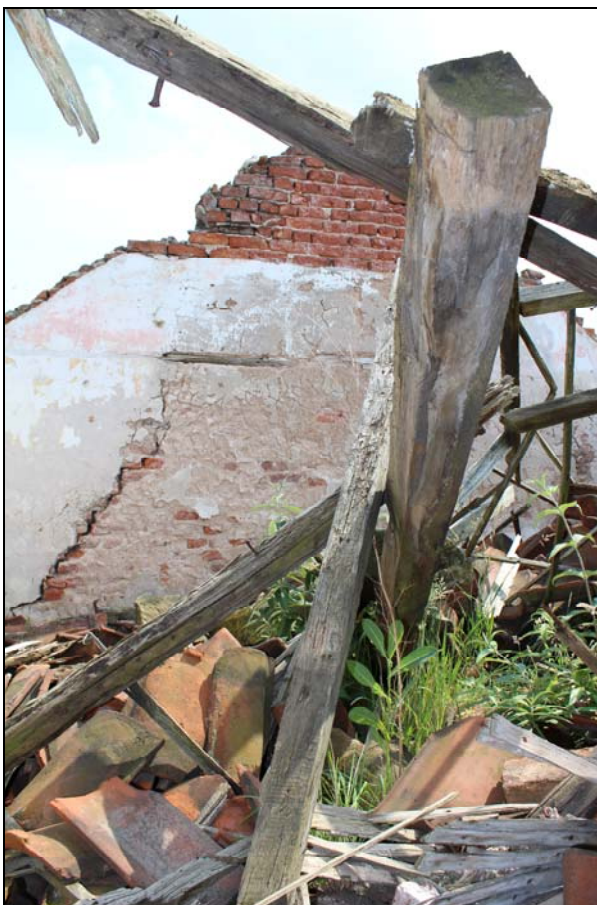
- 5.2.10 Room 9 (*l.* c 5.2m, *w.* c 3.8m) was not available to survey, views from the landing (Rm. 5) provided some coverage (**Plates 26 & 27, 28, 27**) with views of its collapsed roof purlin

Plate 27, 27: room 9, general view of the collapse roof and SE gable wall, looking southeast

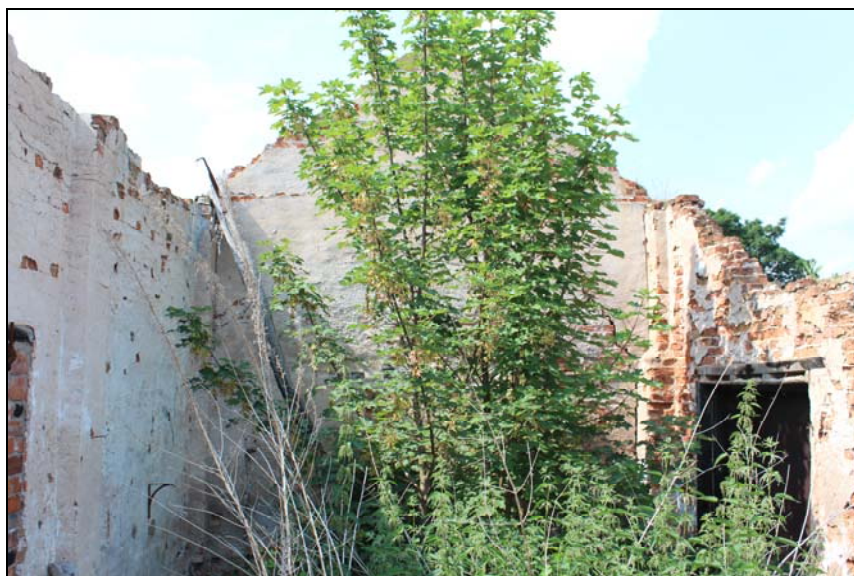
- 5.2.11 The Barn, Room 10 (*l. 9.08m, w. 4.54m*) represents the former barn, which had most recently been used as a tyre store the evidence for which obscured most of the room (**Plate 28, 57**). Some fire damage is evident and there is now no roof. The current doors to the northeast wall (**Plate 29, 58**) appear to have been either enlarged or inserted as is a doorway to the garage (Rm. 11) in the centre of the southeast wall (**Plate 30, 52**). The internal walls consist of bare brickwork with opposing brick buttresses, which would have supported the transverse roof trusses (no longer extant) which indicates a three bayed building. The walls had been historically rendered probably during the 20th century. NB there was no evidence internally for the winnowing door [O] (**Plate 31, 52**).

Plate 28, 51: *The Barn*, room 10, general view of the former barn, looking north northwest

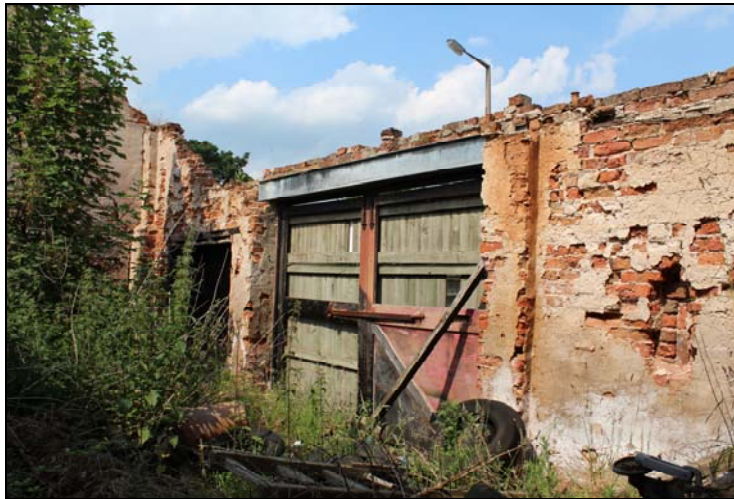
Plate 29, 58: *The Barn*, room 10, View of the front NE wall with barn door and inserted window [E], looking north

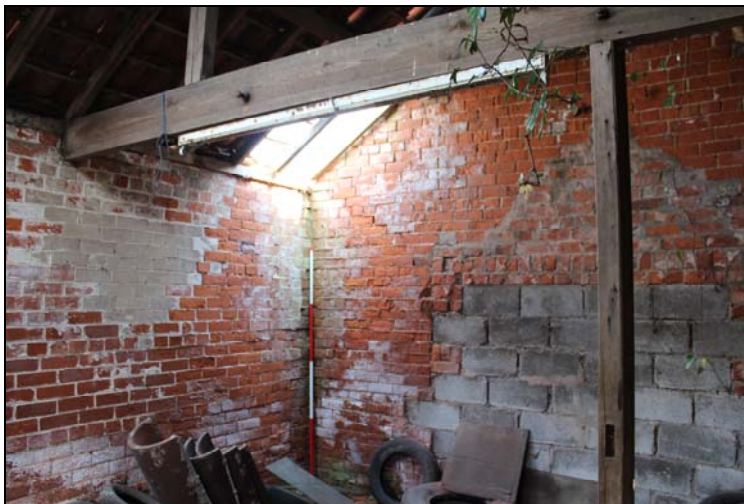
Plate 32, 54: *The Garage*, room 11, general view with the blocked garage doorway (SE wall), looking southeast
