**The Former Coach House,
The Coppins, Doncaster Road, Thrybergh,
Rotherham, South Yorkshire:
An Archaeological Building Record**

CS Archaeology
March 2010

Project Number: 51

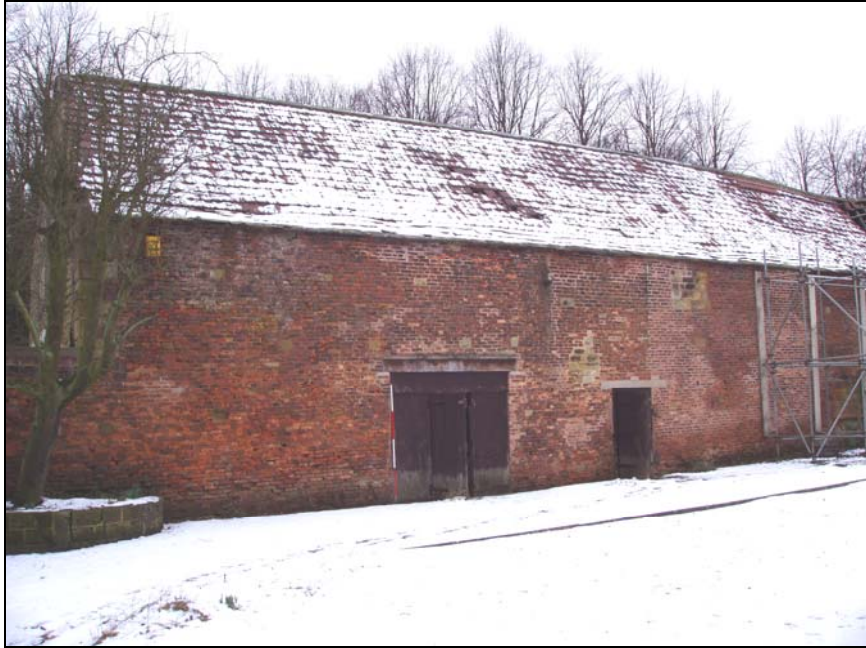
Plate 1, 1: oblique view of the rear *East Elevation*, from the southeast

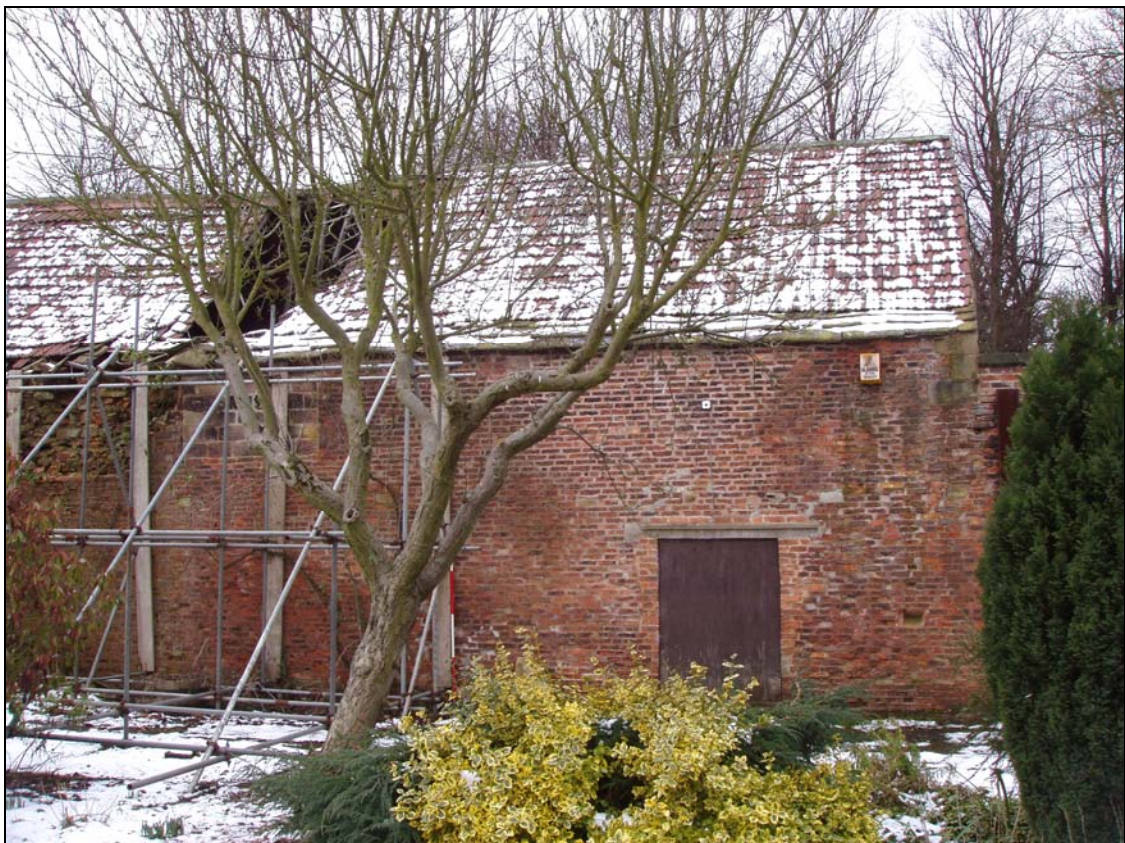
Plate 2, 4: view of the central/northern end of the *East Elevation*, from the east

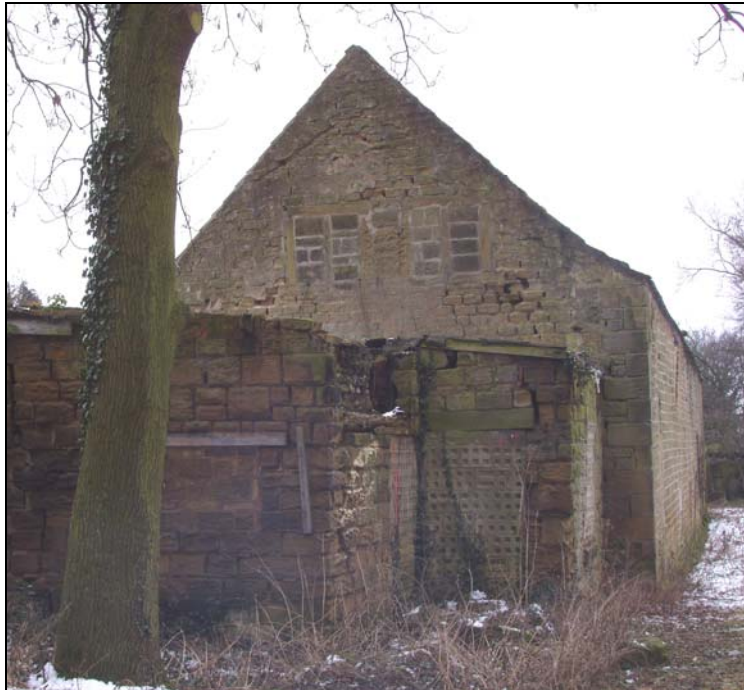
- 7.2.3 The *North Elevation* is of sandstone rubble with quoins. This gable elevation has partially been obscured by a later building (**Plate 3, 5**). This building's present roof is at first floor level, but its gabled roof scar can still be discerned at second floor level. There are four blocked mullion windows [1] two of which are visible in **Plate 4 (20)**. Between the lower two blocked mullions is a blocked inserted doorway. The fenestration in the north Elevation is at odds with the southern gable i.e. the first and second floor windows are not vertically aligned, suggesting that the inserted doorway may have replaced an original window.

Plate 3, 5: view towards the *North Elevation* with the later appended buildings, showing the blocked upper mullions [1], from the north

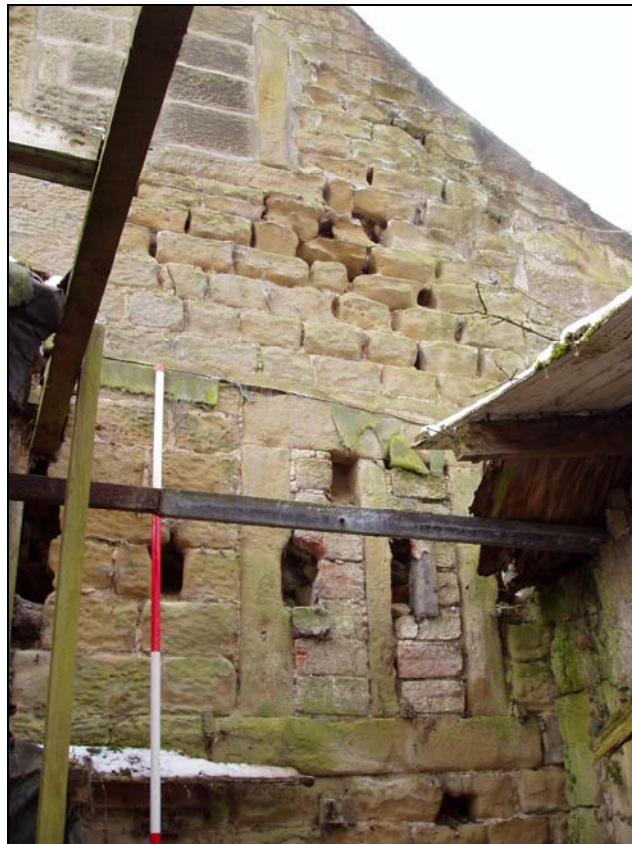
Plate 4, 20: detail of one of the two lower blocked mullion windows [1], from the northeast

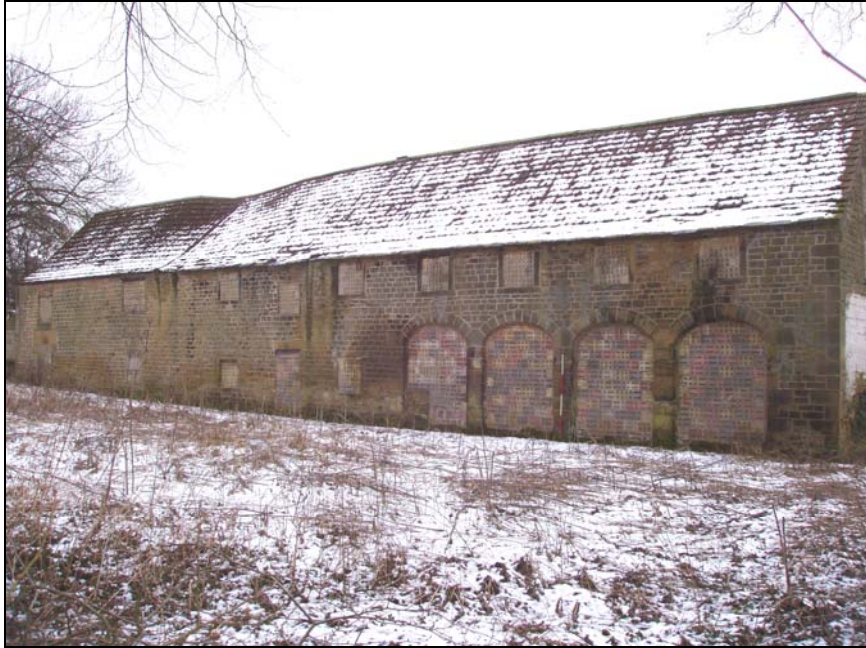
- 7.2.4 The *West Elevation* historically represents the front of the building and features an array of original openings (**Plate 5, 11**). These include most of the first floor windows

Plate 5, 11: oblique view of the *West Elevation*, from the southwest

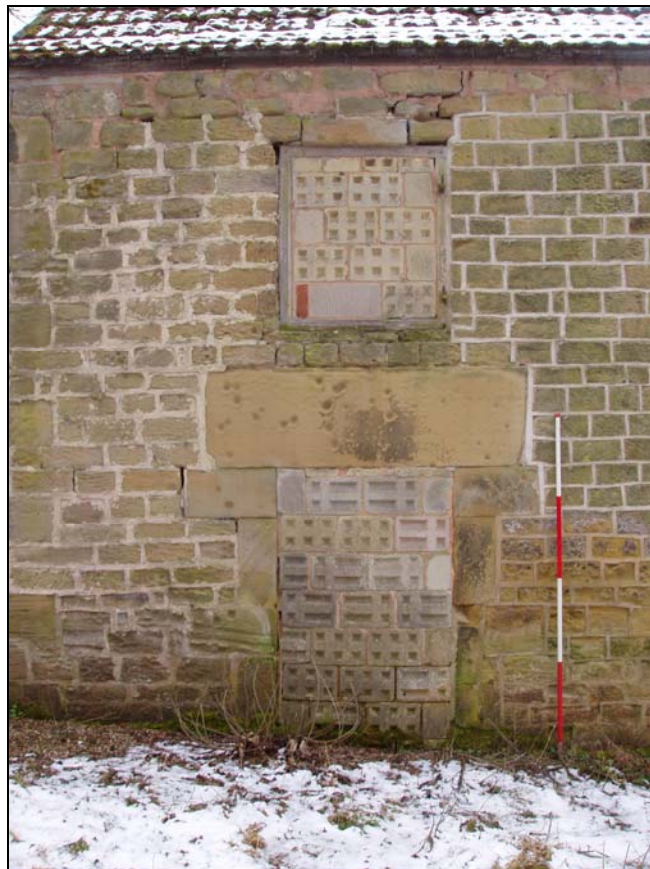
Plate 6, 7: detail of exterior quoined doorway [2] to the *West Elevation*, from the west

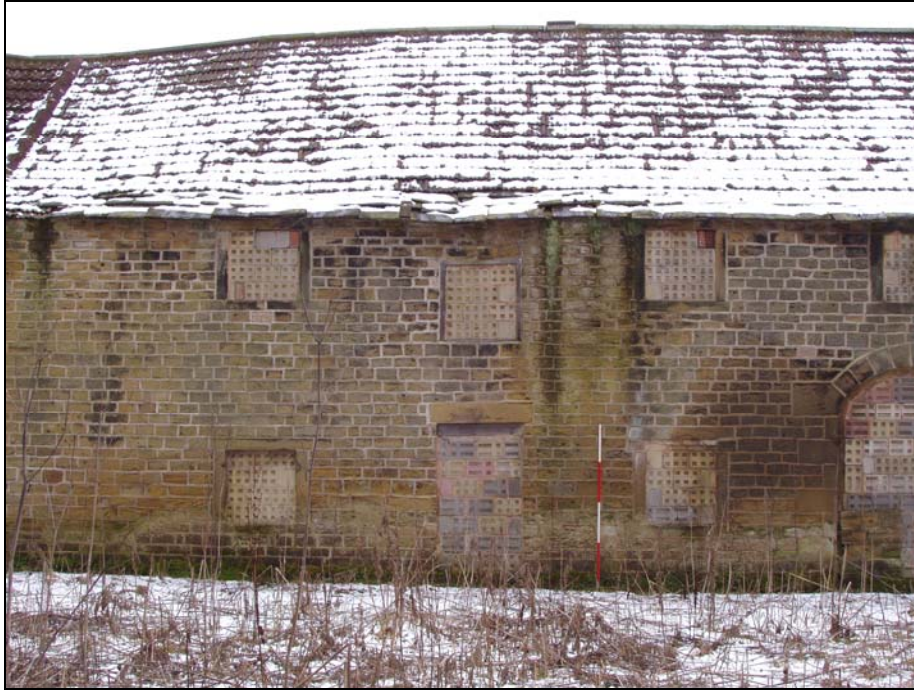
Plate 7, 9: view of the central section of the *West Elevation*, from the west

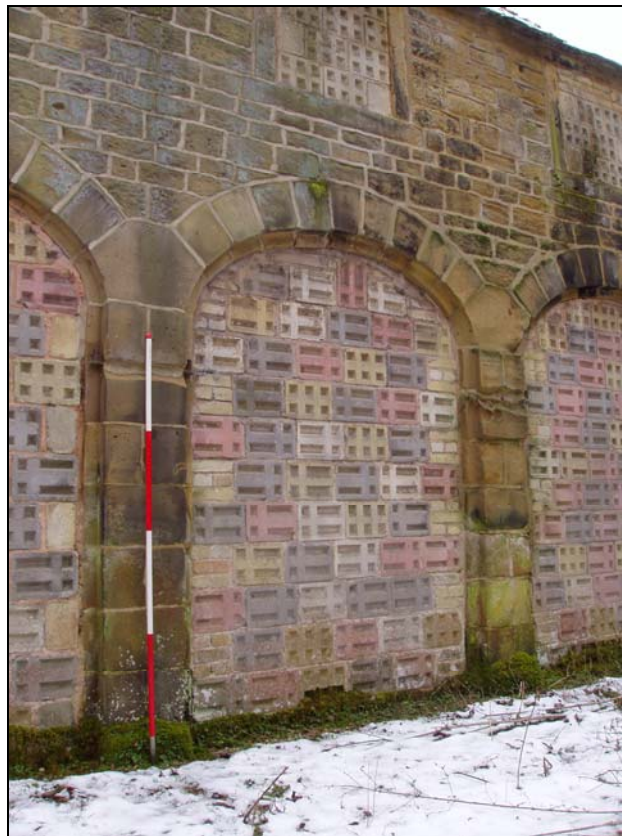
Plate 8, 12: detail of the coach doorways [3], from the northwest

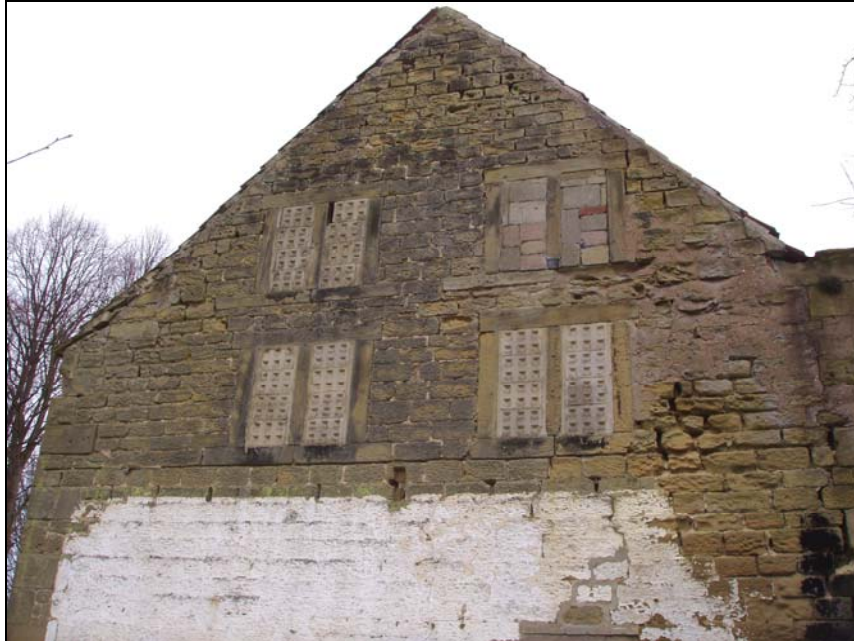
- 7.2.5 The *South Elevation* is similar to the northern gable but is largely unmodified. There are 4 original 2-light mullion windows [4], two at first floor and two at second floor levels (directly above each other). There is an inserted doorway at ground floor level (**Plate 9**, 14), but no other original openings could be discerned.

Plate 9, 14: view of the South Elevation with blocked mullion windows [4] to the first and second floor level, from the south southeast

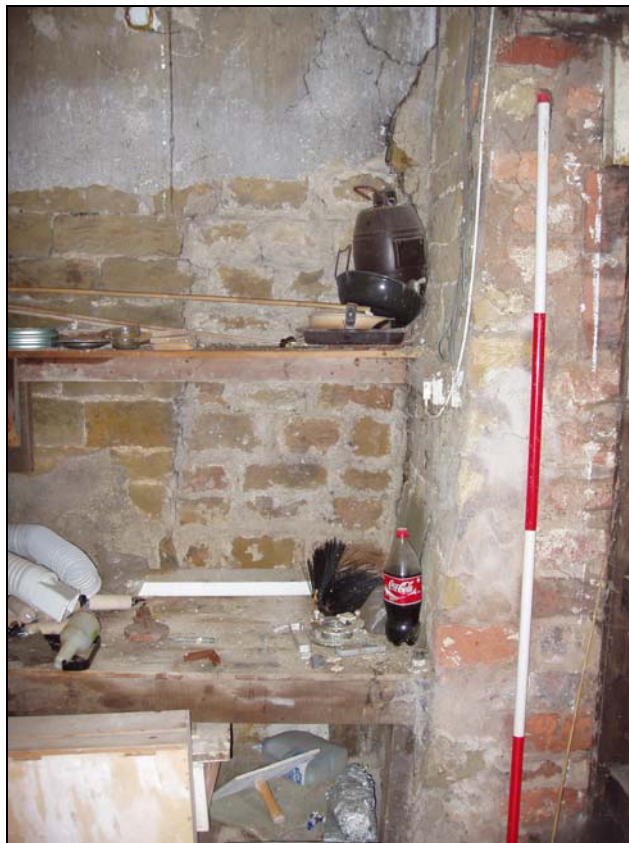
Plate 10, 36: view of the blocked doorway [6] to the north wall, from the north

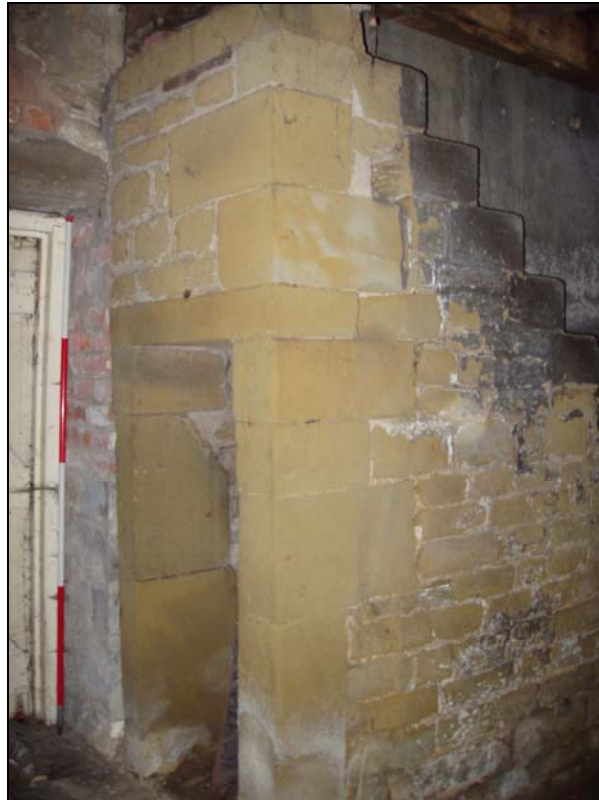
- 7.3.3 To the southwest corner of the room is a quarter-turn stone staircase ([Plate 11](#), 28) which accesses the first floor. The staircase features 13 steps with worn treads. The structure abutts the south wall and therefore it was initially thought that this was a later insertion however the ashlar masonry features monumental sized sandstone blocks and is consistent with the internal masonry seen in the north end of the building i.e. the dividing wall between rooms 3b and 4. At the high east end of the staircase is a 0.63m x 1.6m high recess which was designed originally for storage or as an economical use of stone. The west wall (Room 1) features the three arched coach doorways, which average 2.02m in width and 2.9m in height, two of which can be seen in [Plate 12](#) (35).

Plate 11, 28: general view of the stone steps [5], from the northeast

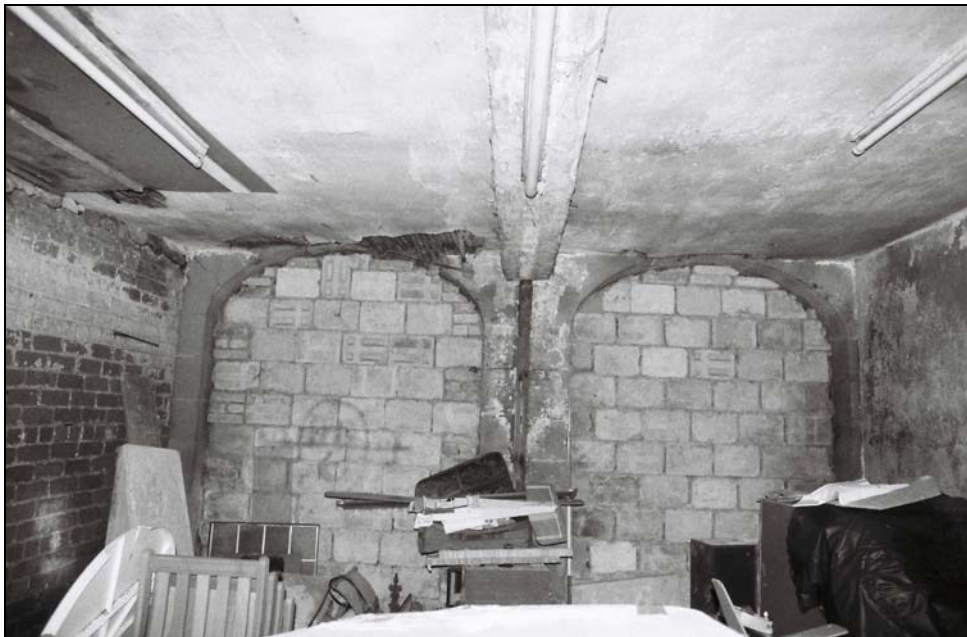
Plate 12, 35: detail of the 2 central coach doorways [3], from the east

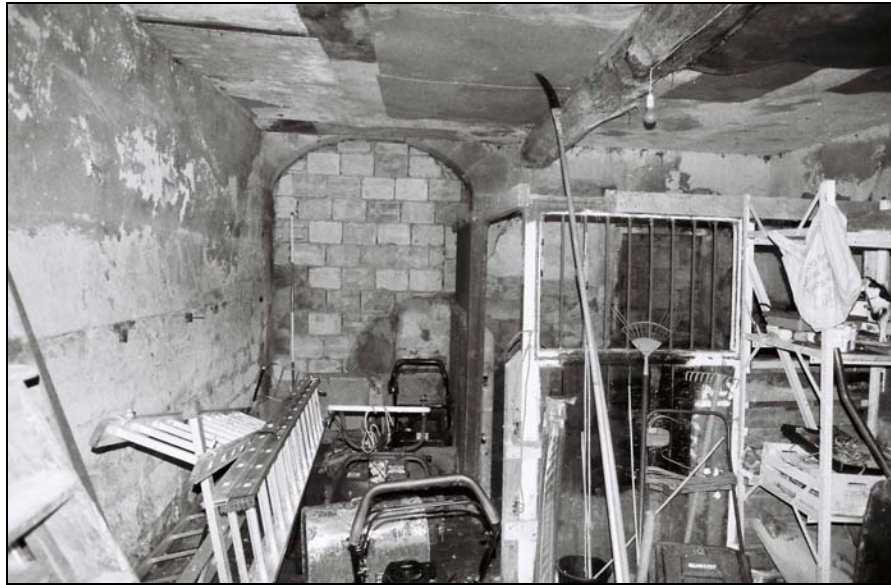
Plate 13, 38: general view towards the single coach doorway [3] and one of the original windows [7], from the east

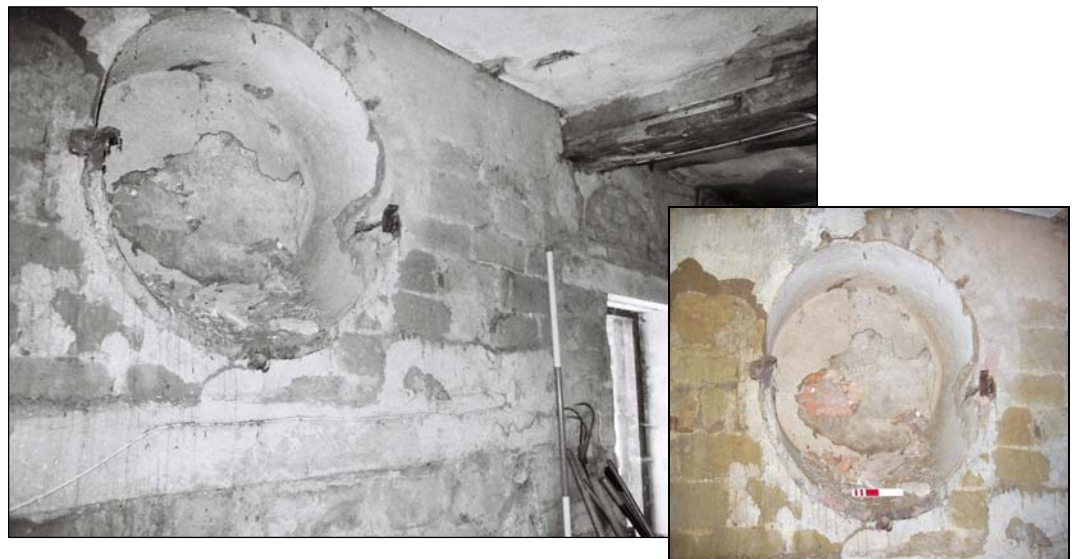
Plate 14, 42: detail of the circular hayrack [8] to the east wall, from the northwest

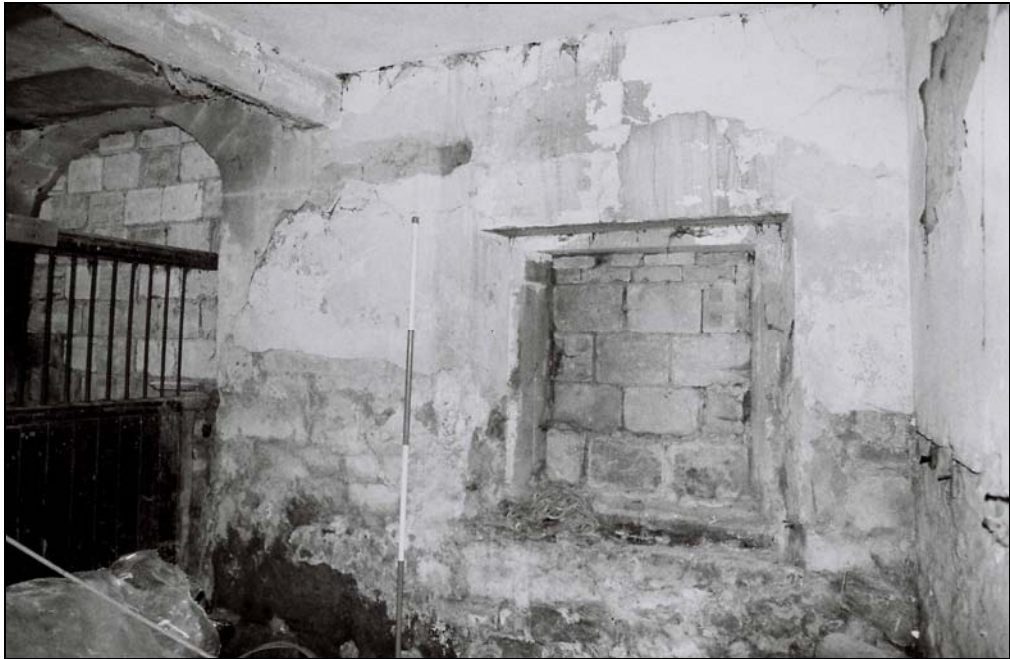
Plate 15, 41: view of an original window [7] to the west wall, from the east northeast

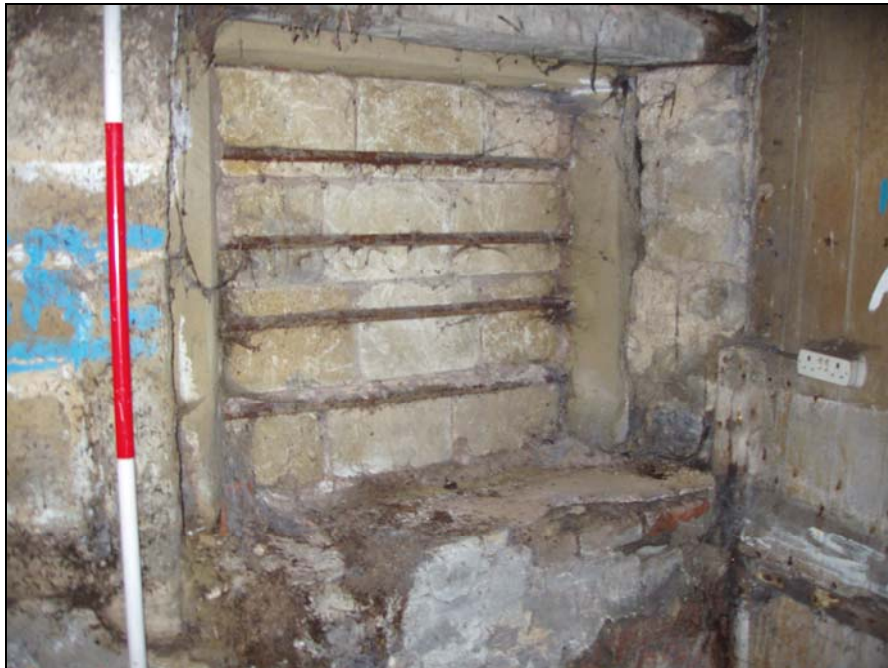
Plate 16, 82: detail of original windows with horizontal bars, from the southeast

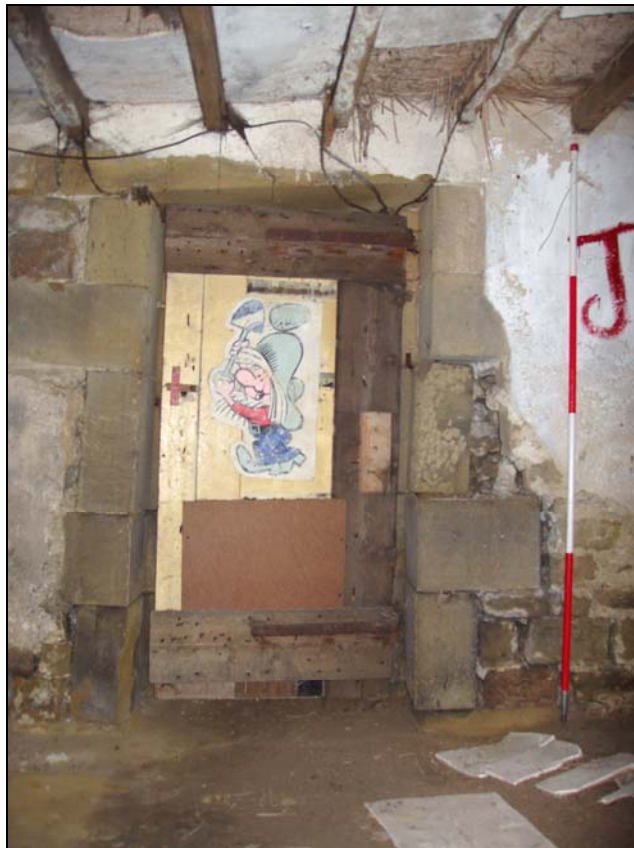
Plate 18, 53: detail of the doorway [9], from the south

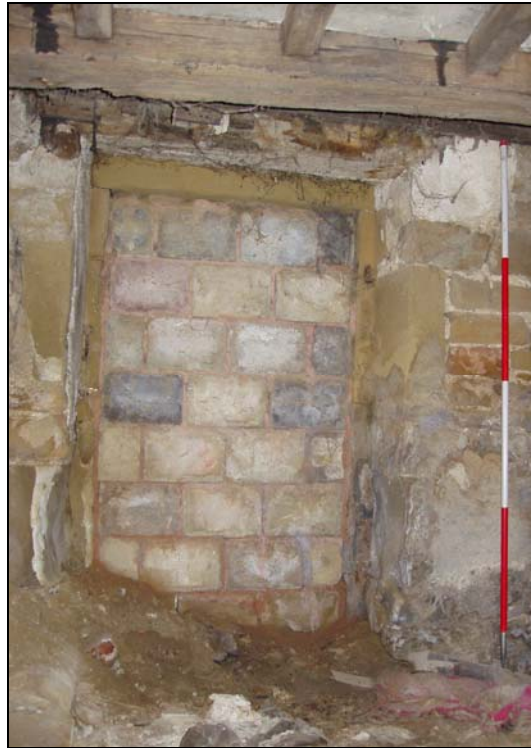
Plate 19, 58: detail of doorway [2], from the east

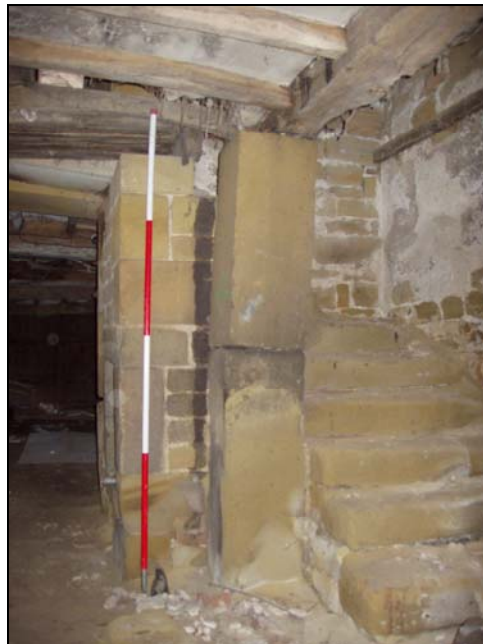
Plate 20, 59: view of the inserted quarter-turn stone staircase [11], from the north

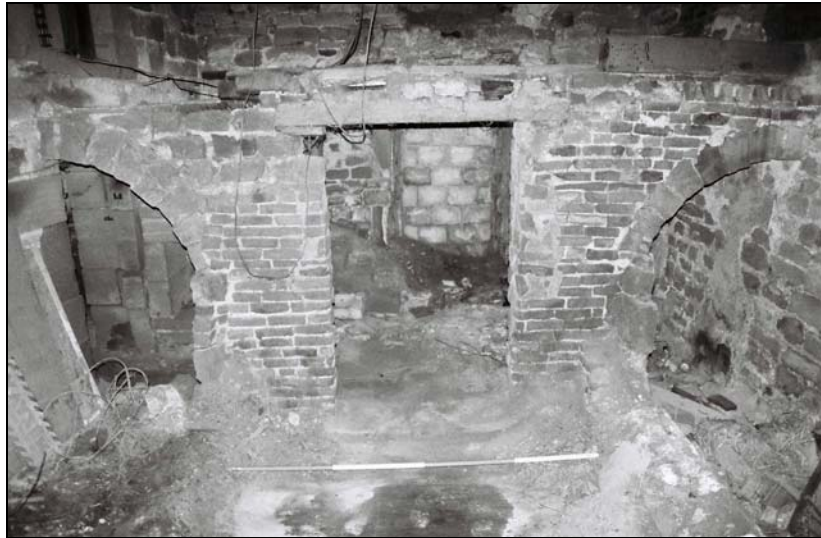
Plate 21, 107: view of the arched openings [10], from the east

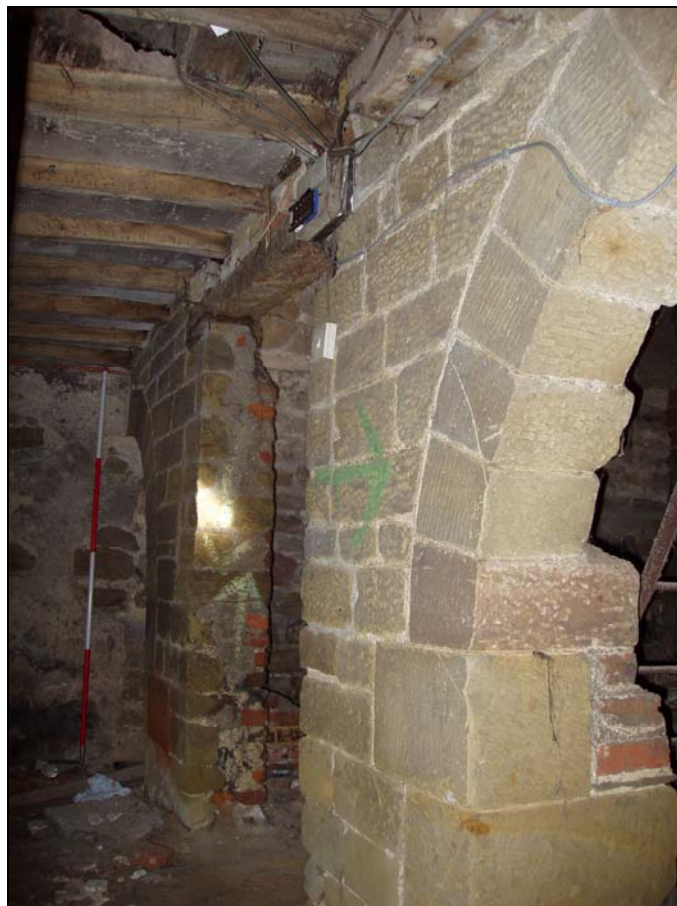
Plate 22, 109: detail of the southern arched opening [10], from the southwest

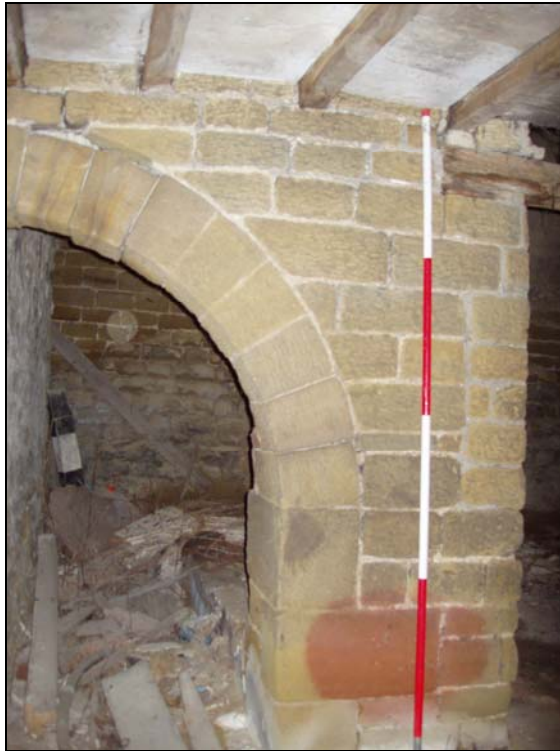
Plate 23, 57: detail of the northern arched opening [10], from the west

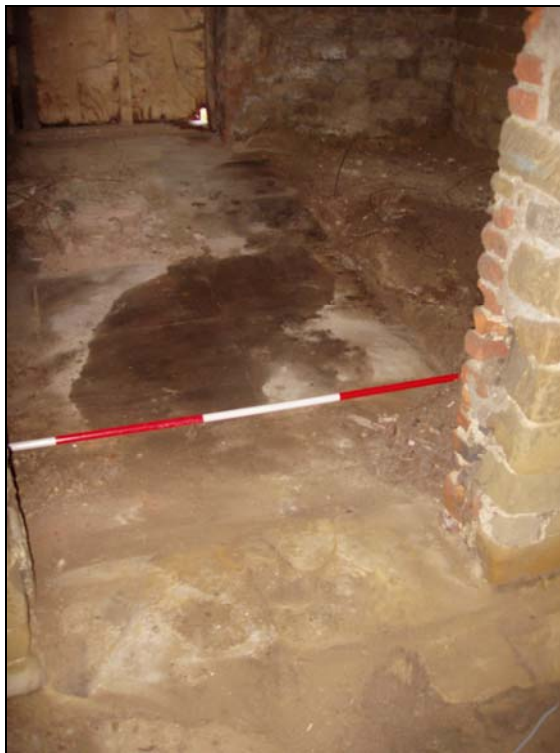
Between the two arches is a wide (1.15m) remodeled doorway which was probably inserted, and there are vertical building lines next to the rebuilt door jambs, possibly suggesting that there may have been a central arch, which was removed to facilitate access through to room 4 and doorway [2]. However to the front elevation [10] there is an absence of quoins which characterise the two side arches. Opposing the remodeled doorway [10] to the east wall is an inserted doorway linked by an inclined flagstone floor (**Plate 24**, 106).

Plate 24, 106: view of the inclined flagstone floor through the modified square headed opening [10], from the northwest

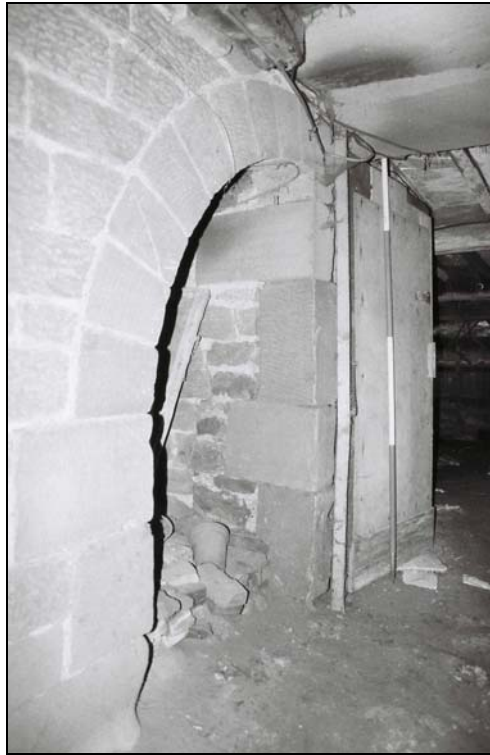
- 7.3.9 A key to the phasing of the room probably lies with the different masonry techniques. The arched wall [10] features diagonal tooling in contrast to the smooth ashlar treatment of the walls to the main building (**Plate 25**, 110). Similar masonry to that in the arched wall was noted by the author last year featuring very similar tooling [10], (CS Archaeology 2009), and was dated to 1730, suggesting not only that the masonry was carried out by a highly skilled mason, but that wall [10] was a later insertion. The function of room 5 is problematic, not enough of the vault, and more importantly the floor above it remains (**Plate 26**, 66), but it could have served as a raised granary. NB that the vault did not block/obscure any original features is inconclusive.

Plate 25, 110: detail of the southern arched opening [10], from the northwest

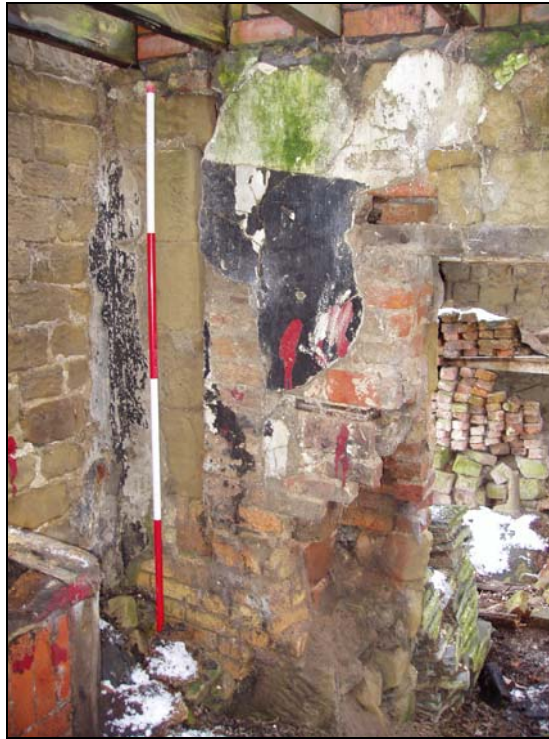
Plate 27, 24: detailed view of the vertical building line, from the north northwest

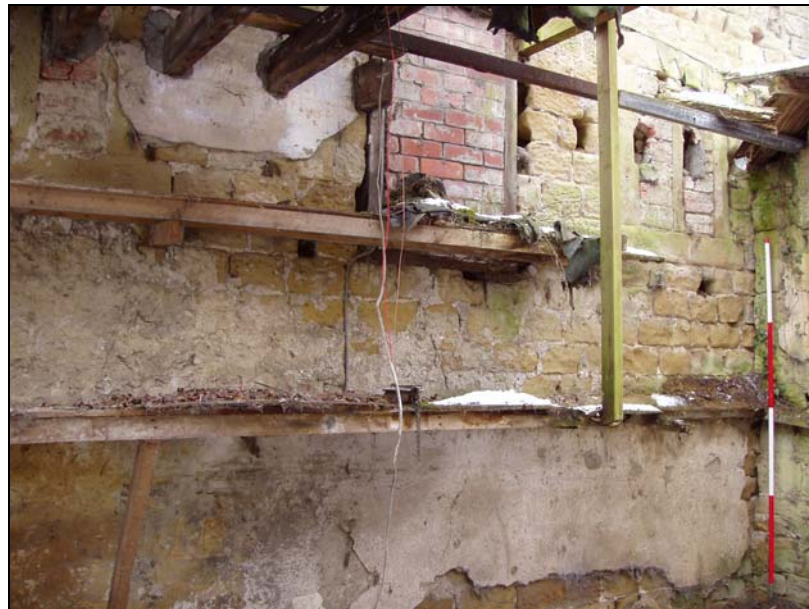
Plate 28, 16: general view of the north wall with the blocked 2 light mullions windows [1],
from the north east

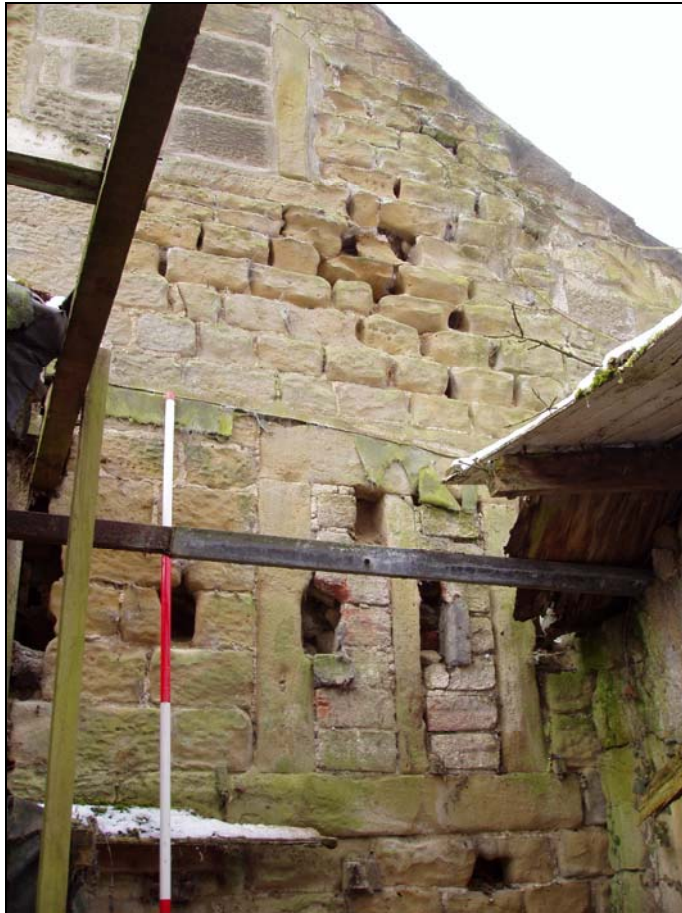
Plate 29, 20: detail of one of the two lower blocked mullion windows [1], from the northeast

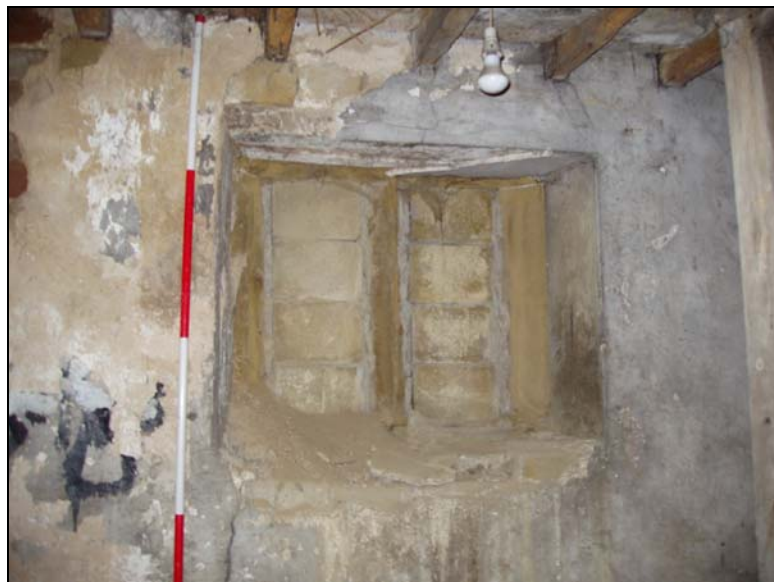
Plate 30, 91: detail of the blocked window [1], from the north

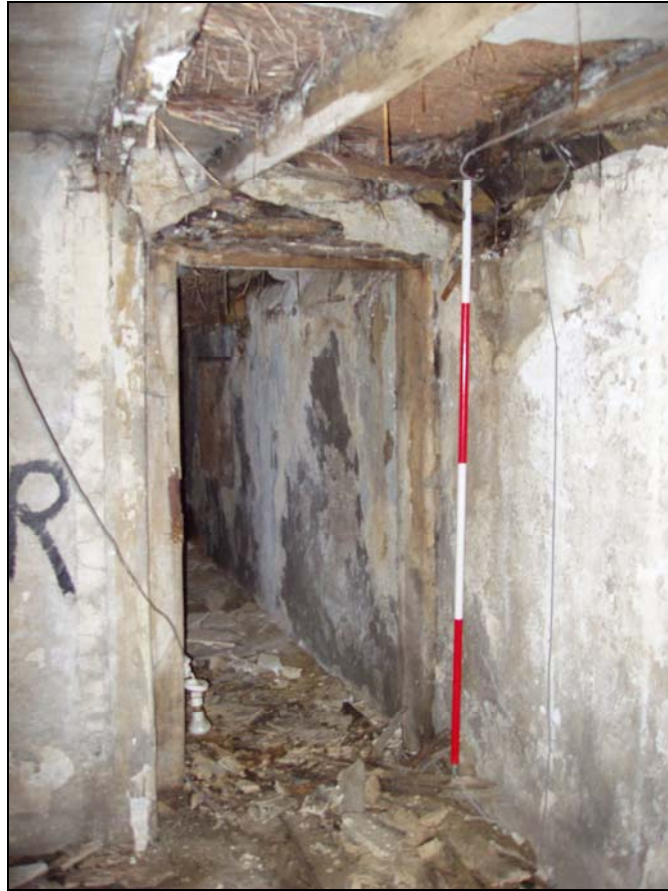
north wall retains an original doorway into room 12 but the door is no longer in situ (**Plate 31**, 90).

Plate 31, 90: view of the original doorway [14], from the south

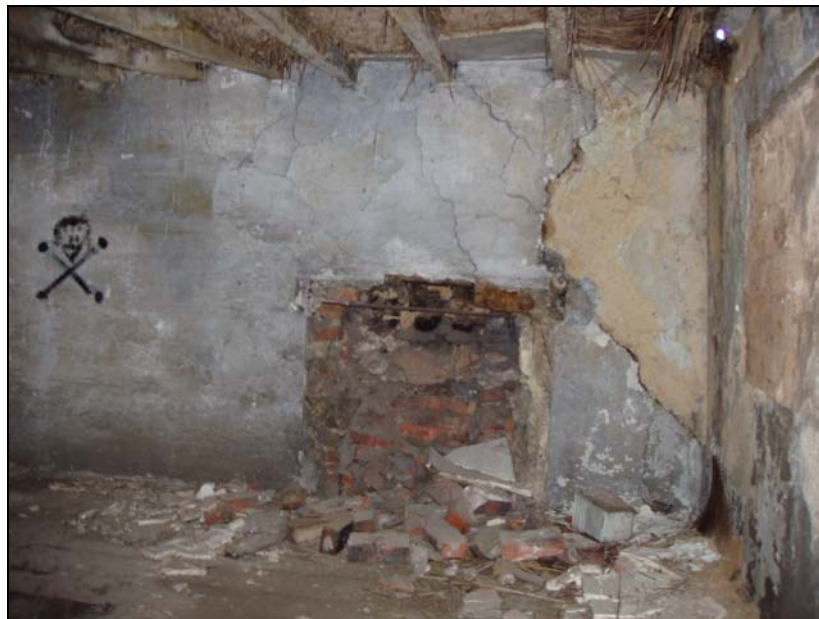
- 7.3.14 *Room 12* is similar to Room 11 with two windows [7] to the west wall and timber floor boards but in contrast a fireplace has been inserted into the north wall (**Plate 32**, 89).

Plate 32, 89: general view of the inserted fireplace, from the southeast

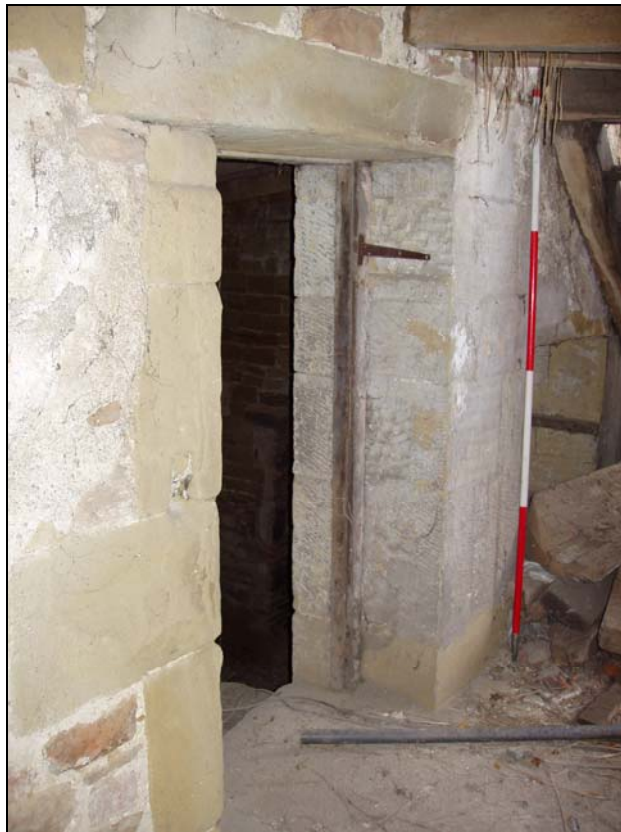
- 7.3.15 *Room 13* was unable to be accessed because of safety considerations.
- 7.3.16 *Room 14* was largely non-existent due to severe structural collapse. The floor was still largely in place but the roof and ceiling had collapsed (**Plate 33**, 73). The north wall featured a quoined doorway [12] and an adjacent hatch [13]. The hatch [13] would have directly accessed the floor on top of the vault (Room 15: **Plate 34**, 72).

Plate 34, 72: view of the first floor doorway [12] with adjacent hatch [13], from the west southwest

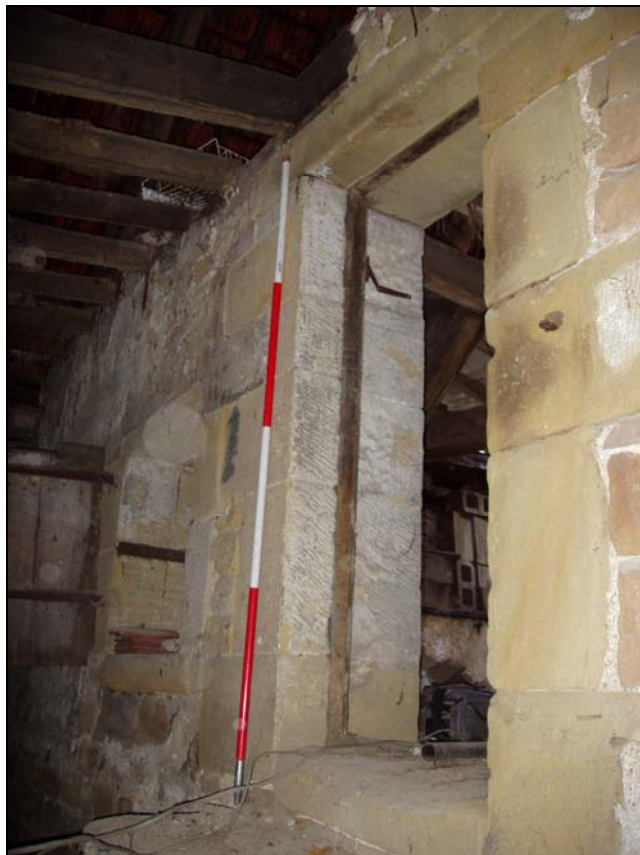
Plate 36, 117: oblique view of the south wall with doorway [12] and hatch [13], from the northwest

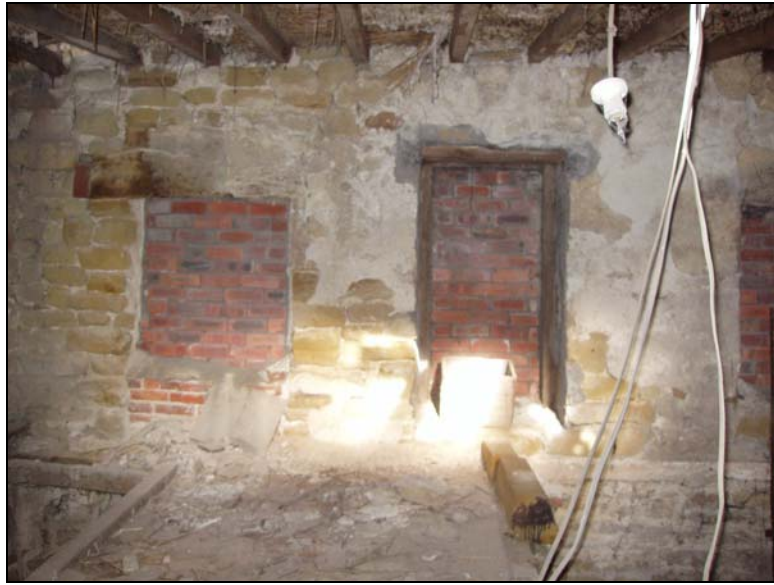
Plate 37, 71: general view of the north wall with blocked openings [1], from the south

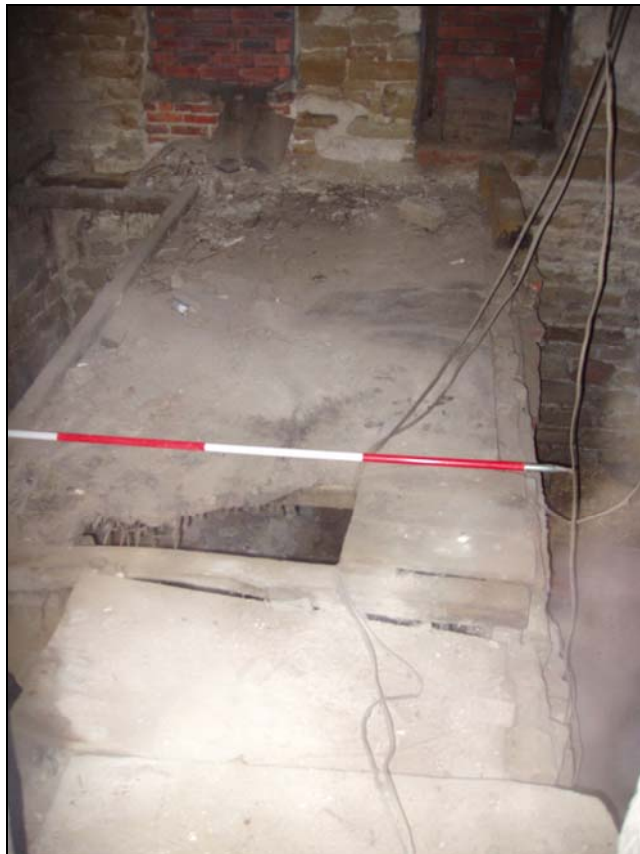
- 7.3.17 The vaulted floor in room 15 had been removed, thus allowing views from the ground floor. The south wall featured the substantial rubble wall with ashlar quoins to the doorway and ashlar surround to the hatch [13] (**Plates 35 and 36**, 68 and 117). The north wall (**Plate 37**, 71) features the 2 blocked mullion windows [1] and a central inserted doorway that would have accessed the first floor of the adjacent phase 3, 2-storey building. A surviving section of limecrete floor was in situ towards the centre of the room (**Plate 38**, 114).

Plate 38, 114: view of the remaining limecrete floor, from the south

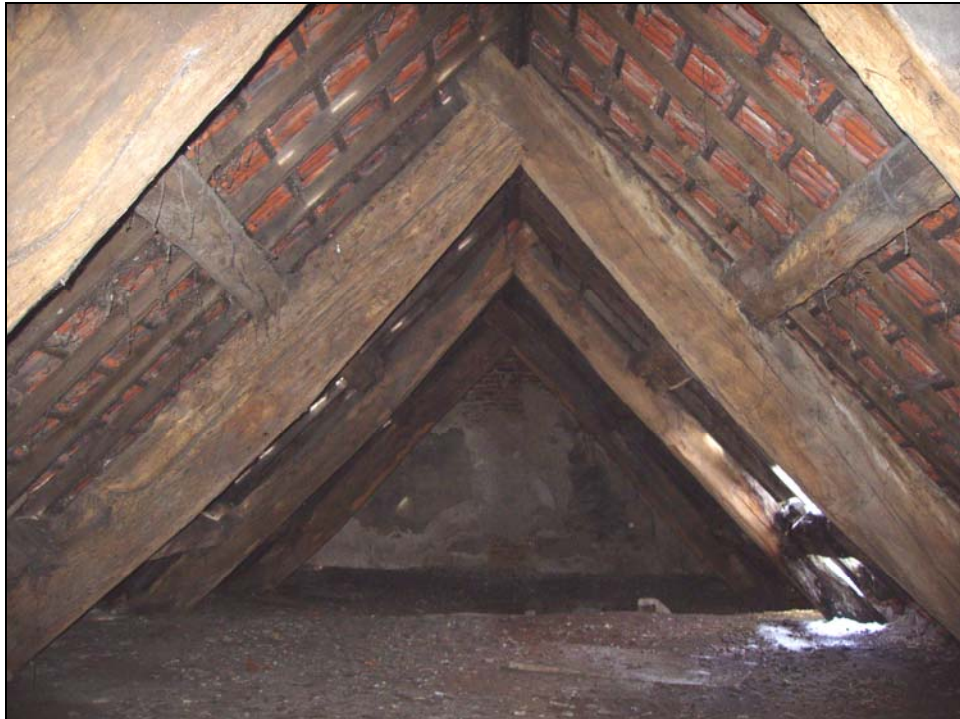
Plate 39, 92: view of the roof with its principal rafter trusses, from the south

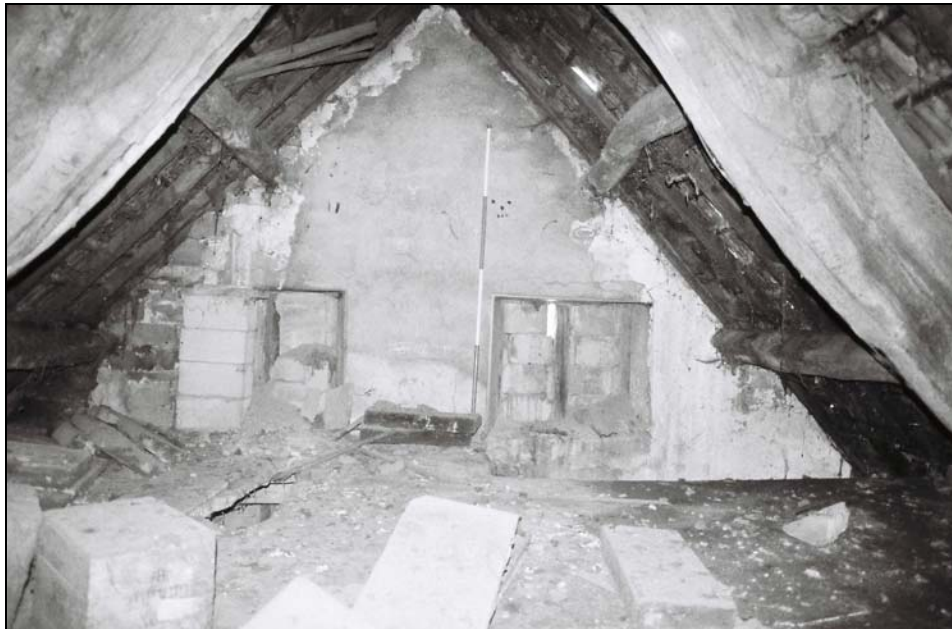
- 7.3.18 The second floor was only partially available to the survey. It is accessed via two wooden staircases at the south and north ends of the building. The southern staircase was an inserted quarter-turn wooden staircase that bisected one of the mullioned windows [4]. The room comprised of 40% of the floor's entire area – and represented a long attic room with limecrete floor and exposed roof. There is no evidence for any form of original or later inserted ceiling. The principal rafter roof trusses feature reused oak timbers, evidenced by series of mortice holes **Plate 39**, 92. *The second floor windows are visible to the south wall* (**Plate 40**, 95).

Plate 40, 95: view of the southern gable wall with blocked windows [4], from the north

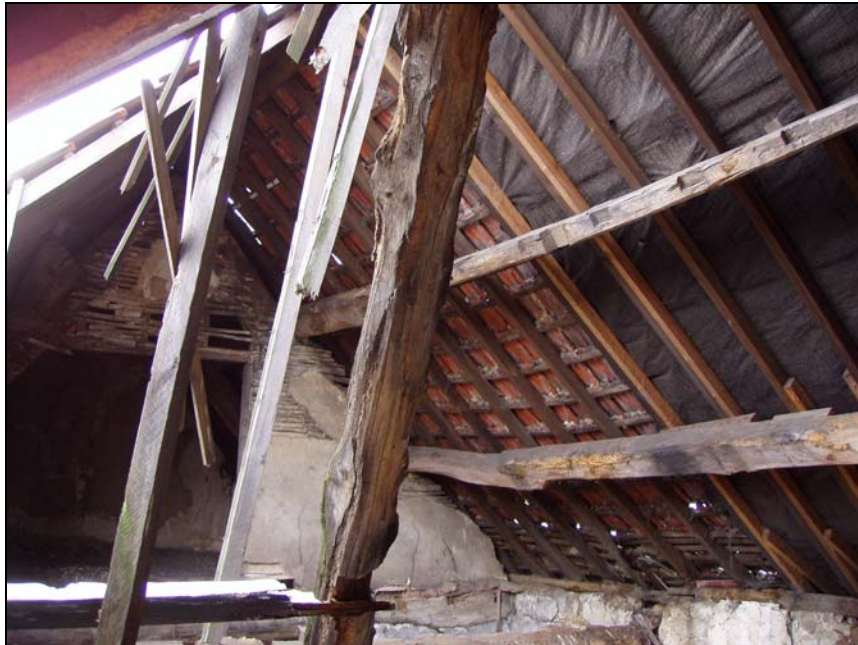
Plate 41, 79: view of the roof with fallen truss, from the southeast

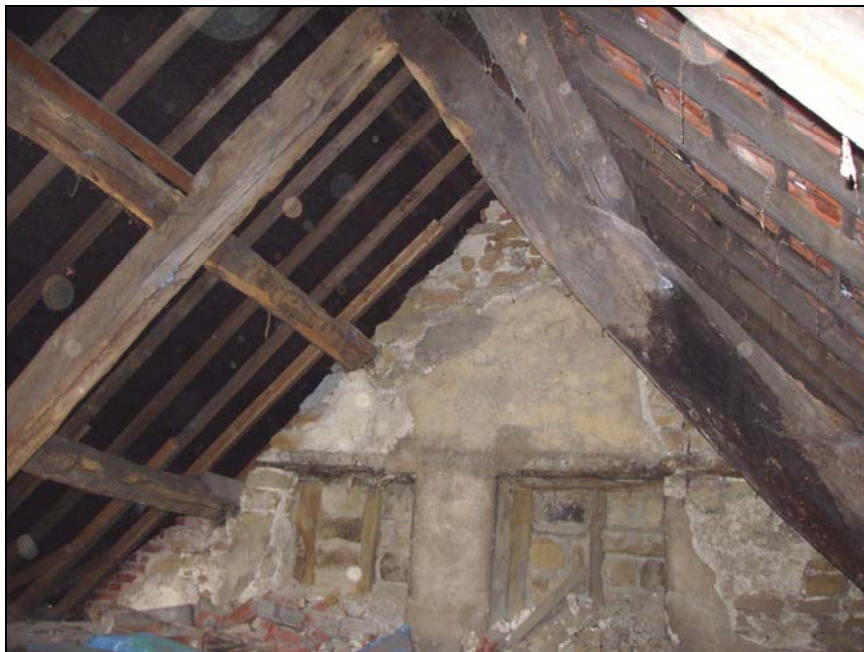
Plate 42, 78: general view towards the blocked mullion windows [1], from the south
