**BENTS GREEN SCHOOL, RINGINGLOW ROAD,
ECCLESALL, SHEFFIELD, SOUTH YORKSHIRE:
AN ARCHAEOLOGICAL WATCHING BRIEF**

For Vinci Construction UK

CS Archaeology
March 2010

Project Number: 48

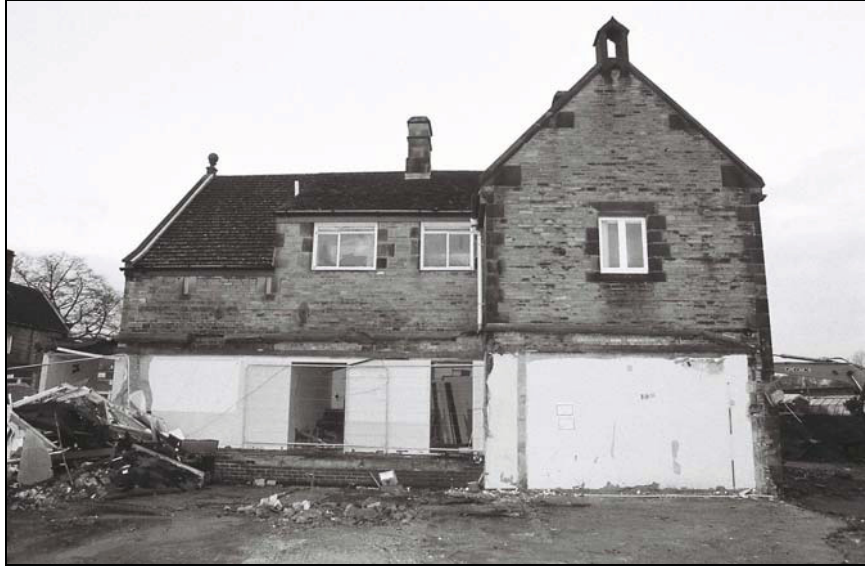
- 6.1 Demolition of the two historic buildings (**Figure 2**: Buildings 2 and 3) started at the east facing elevation of Building 3 (**Plate 1**).
- 6.2 The modern 20th century buildings had been removed prior to the watching brief, allowing unobscured views of the elevation. Building 3 is 'L' shaped in plan (16.5m x 8.9m) and abutts Building 2's eastern gable. Building 2 is also 'L' shaped in plan (21.4m x 16m). The roof was found to have been replaced recently using concrete graduated heritage style tiles.

Plate 1: Building 3, general view of the *East Elevation*, from the east

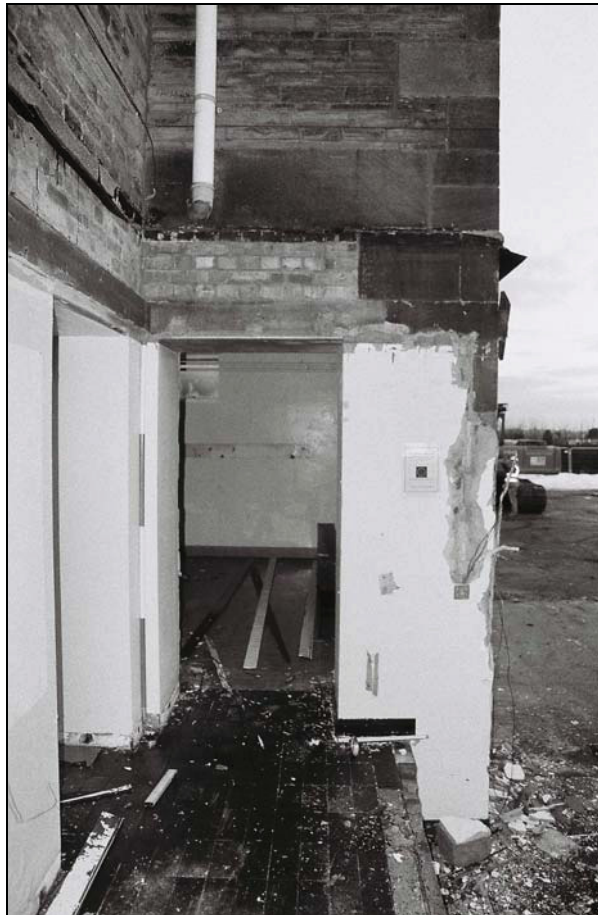
- 6.3 Building 3 has original features to the roof, which include 2 stepped chimney stacks with mouldings, a small bell tower to the apex of the eastern gable. To the first floor are 2 narrow slit ventilators to the south of the elevation, further ventilators would have probably run along the elevation, but these were removed when the 2 dormer windows were constructed. Just below the 2 ventilators, 2 cast iron plates from wall ties are also in situ. To the gable, also at first floor level is an original quoined window with replacement window. To the ground floor, *South Elevation*, an original doorway was observed (**Plate 2**) denoted by a substantial ashlar lintel with associated door/wall quoins (**Figure 3: [1]**).

Plate 2: Building 3, detail of an original doorway [1] denoted by ashlar lintel and associated quoins, from the south

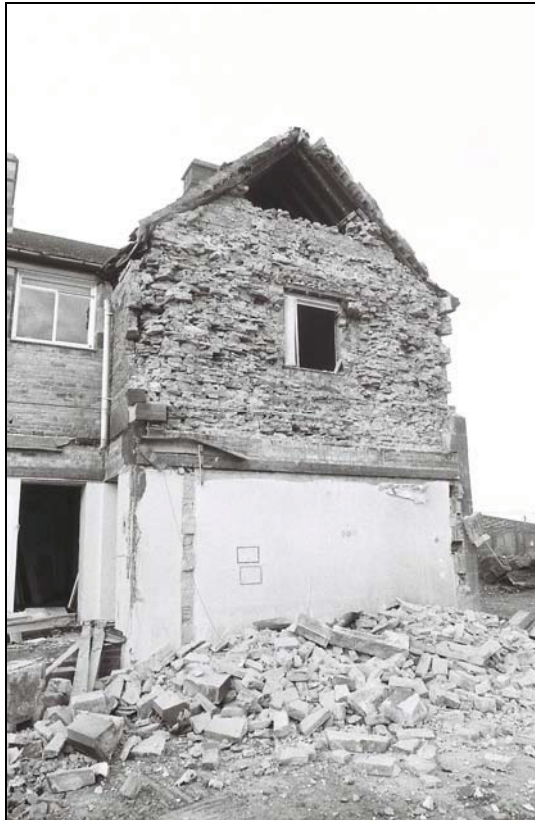
- 6.4 The demolition entailed removing as much building stone for re-use in future gabions so the stone was effectively peeled from the walls (**Plate 3**) and stored separately. The remaining material (wood and brick) was removed from site.

Plate 3: Building 3, view of the partially demolished *East Elevation*, from the southeast

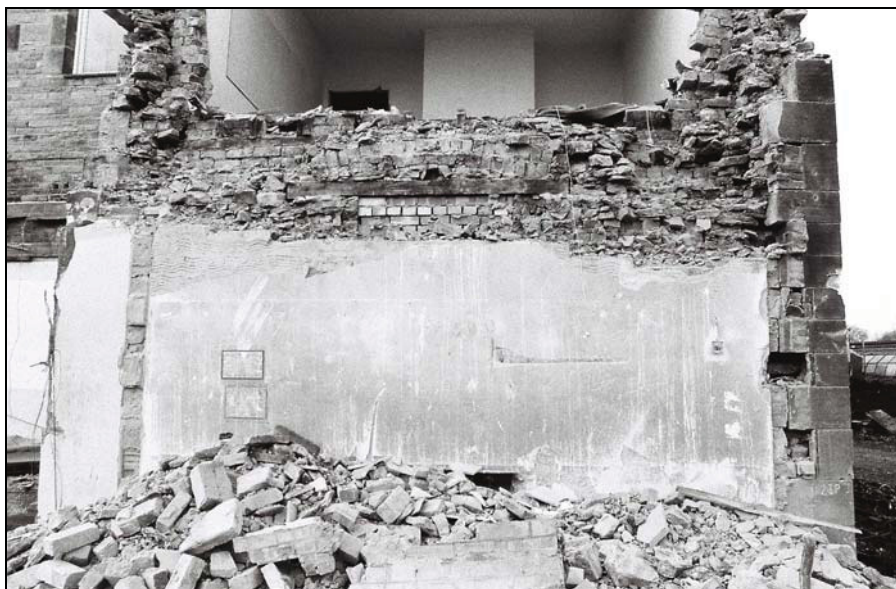
- 6.5 During this operation a previously blocked window was revealed directly below the quoined in situ window to the first floor. The blocked window [2] is represented by a timber internal lintel with arched brickwork above (**Plate 4**). Gradual demolition of the building resulted in a complete cross section of the building. The north end of the building was originally the residential end as evidenced by the blocked chimney breasts to the west walls (**Plate 5**). The section also shows the brick inner walls, traditional joist and boarded floor with lathe and plastered ceilings to the ground and first floor rooms. The roof features common rafters supported by a set of purlins to each pitch and a vertically positioned ridge purlin.

Plate 4: Building 3, detail of a blocked and obscured window [2] represented by the timber lintel and arched brickwork above to the lower *East Elevation*, from the east

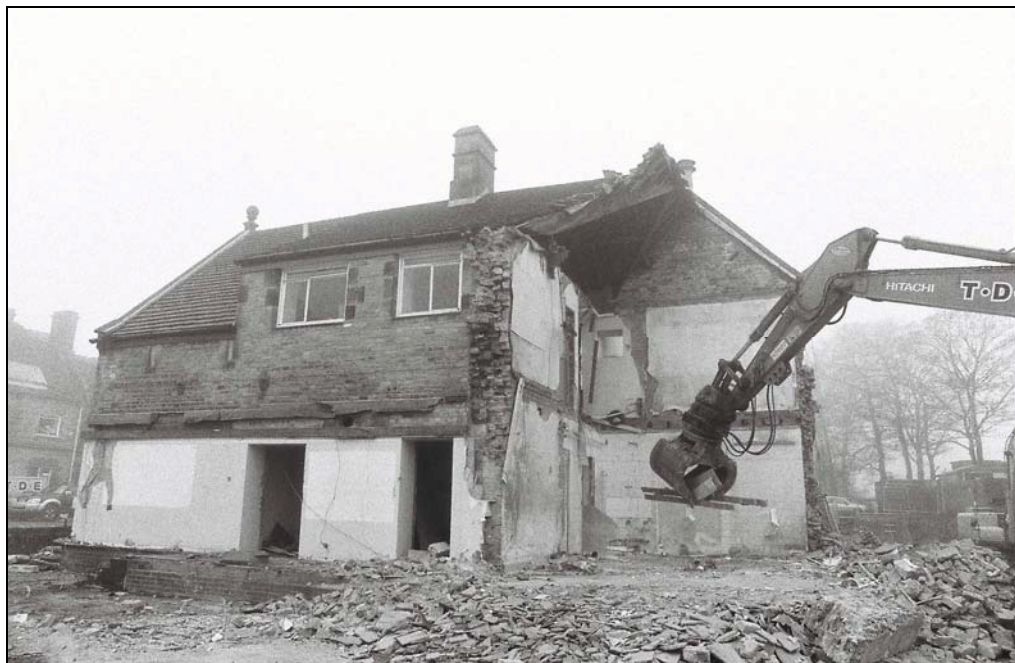
- 6.6 The roof yielded further information as the demolition proceeded (**Plate 6**). A diagonal principal rafter facilitated the right angled change of direction (**Figure 3**). NB the west wall, of building 3, may have contained blocked windows but none were revealed during the watching brief. The arrangement of the southern end of the building was revealed (**Plate 7**). This showed that the original arrangement of the ground floor was as an open room or workshop (6.5m x c.6m). This original arrangement was evidenced by two transverse beams [4]. Once the beams were removed, it was realised that they were composite with a central steel plate bolted together with a traditional stop chamfer to the underside (**Plate 8**). The beams were 7m long, 0.22m wide and 0.2m high. Directly above the northern beam (**Plate 7**) was king post roof truss [5]. The truss featured a raised king post to facilitate head height access throughout the original loft space. Once removed and examined off site, (**Plates 9 and 10**) the trusses tie-beam was braced to the principal rafter. This was to increase head height to the original room.

Plate 6: Building 3, general view, from the northeast

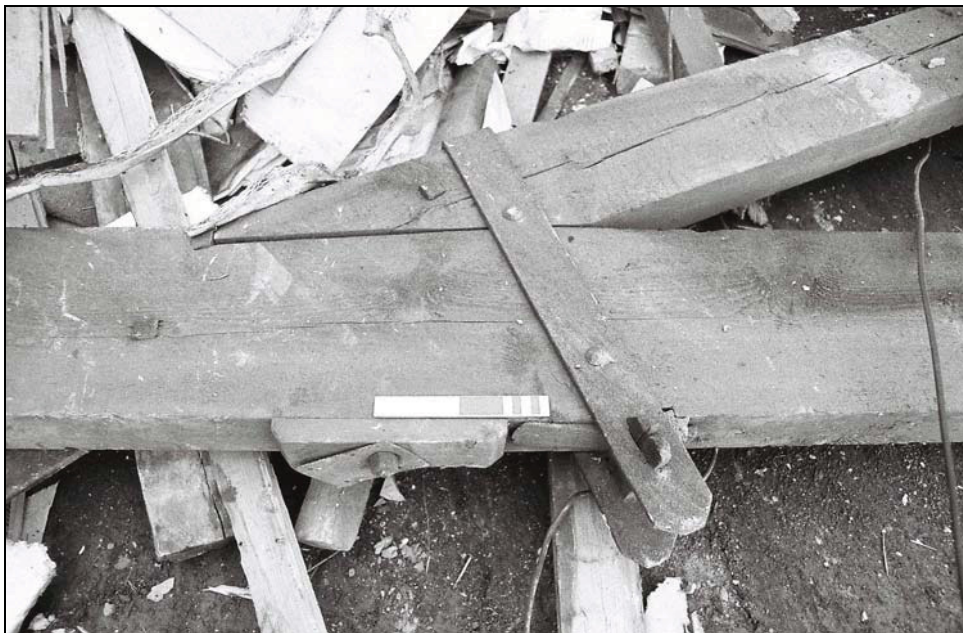
Both the tie-beam and brace featured a scribe joint, that was bolted and then strapped and bolted, and finally the joint finally tightened with iron wedges, to the principal rafter, (**Plate 10**).

Plate 10: Detail of the roof truss [5] at the junction of the brace and principal rafter with its strengthened joint

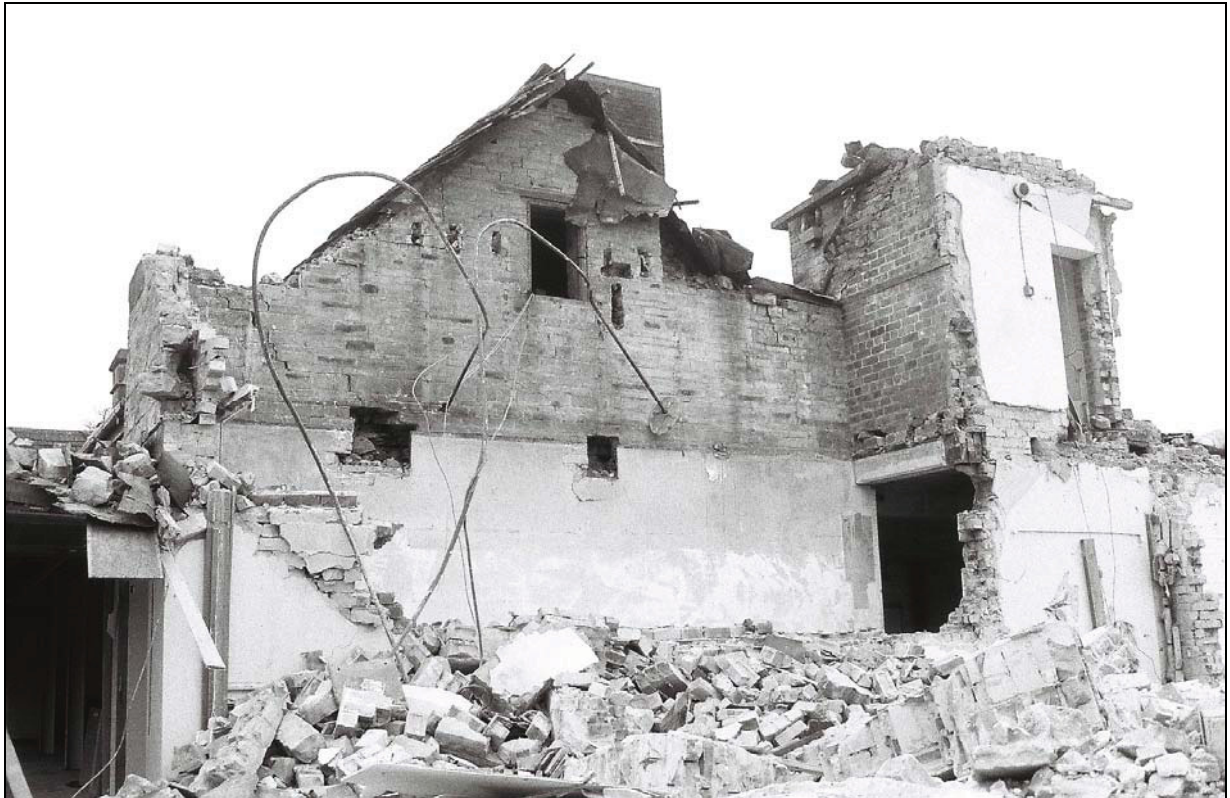
- 6.7 After the demolition of Building 3's east and south wall, Building 2's gable wall was fully exposed (**Plate 11**). This shows that the beams [4], wall ties [6] and roof were inserted into the pre-existing gable wall, obscuring and truncating the east facing gable window [7]. An original doorway [16] was also revealed beneath the inserted first floor bathroom. Removal of the iron wall ties allowed a detailed view of the wall plate (**Plate 12**).

Plate 11: General view of Building 2's eastern gable wall with in situ window (and inserted tie bars [6]), from the south-east

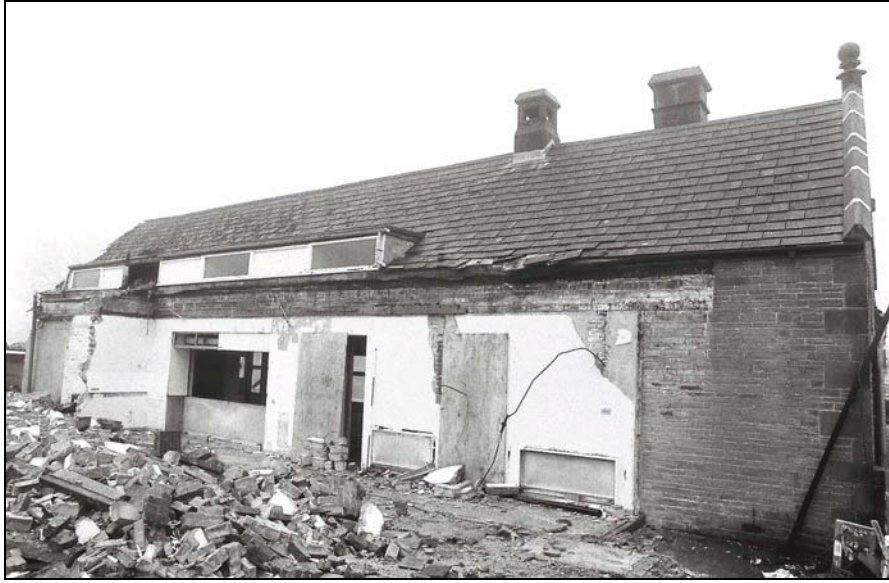
- 6.8 Building 2's *North Elevation* was recorded without obscuring the kitchen extension (**Plate 13**). The roof remains relatively unmodified, apart from recovering in modern concrete 'heritage' slates, and the original bell tower and decorative ball finial are evident. Internally the roof consisted of a series of similar collared 'A' frame, rafter trusses facilitating a long attic illuminated at the eastern end by window [7], with an underdrawn ceiling throughout. Most recently this large room served as the school dining hall incorporating a modern central heating system. No evidence was found to indicate that this room was originally heated, and this is supported by an absence of blocked fireplaces, just a bell tower at the western end. No trace of any divisions were evident suggesting that the eastern half of building 2 originally represented a large internal space 14.5m long x 7.6m wide. The wall to the *North Elevation* displays no original fenestration or access points, although it has been heavily modified to facilitate large modern serving hatches.

Plate 13: The heavily modified *North Elevation* with the former kitchen and chimney removed, from the northwest

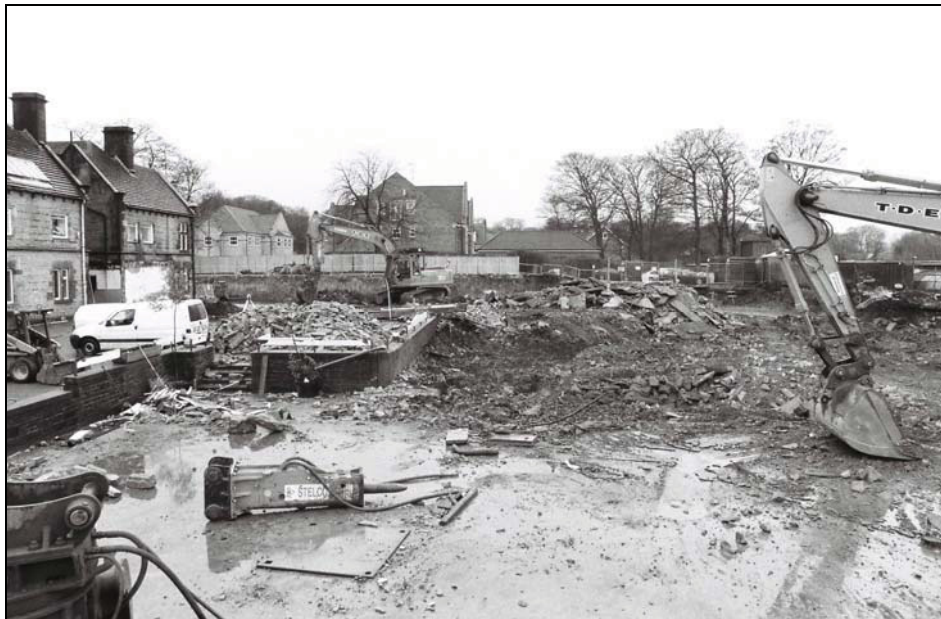
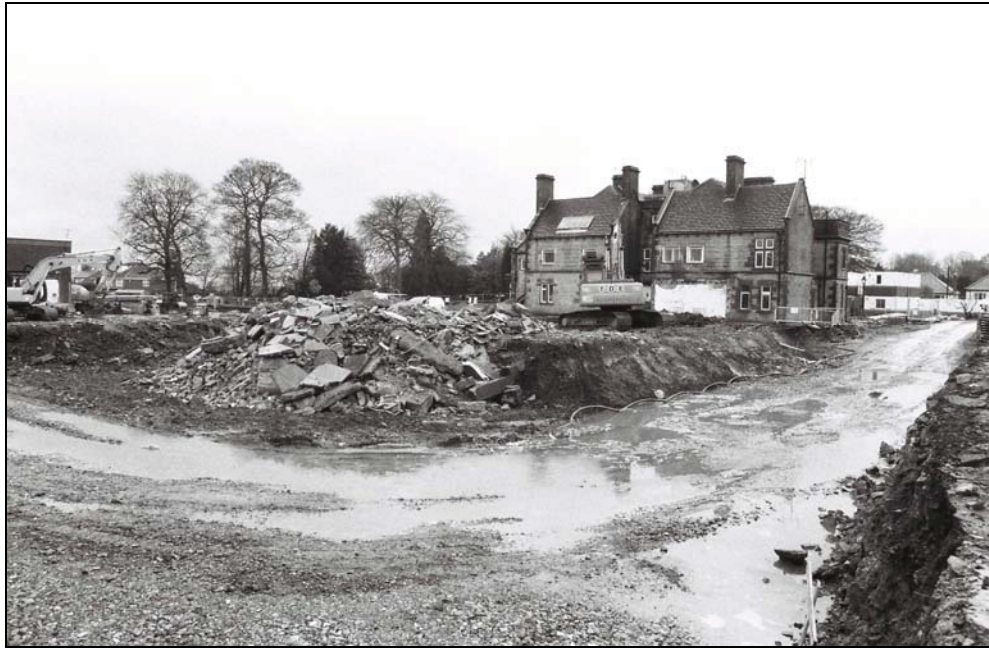
- 6.11 After completion of the demolition (**Plates 20 and 21**) underlying stratigraphy was examined across the footprint of the building revealing truncated natural shale bedrock with overlying drift deposits of clay. This indicates that the construction of Buildings 2 and 3 had truncated potential archaeological deposits and the watching brief was concluded.

Plate 20: Post-demolition view, from the east

Plate 21: Post-demolition view, from the northwest

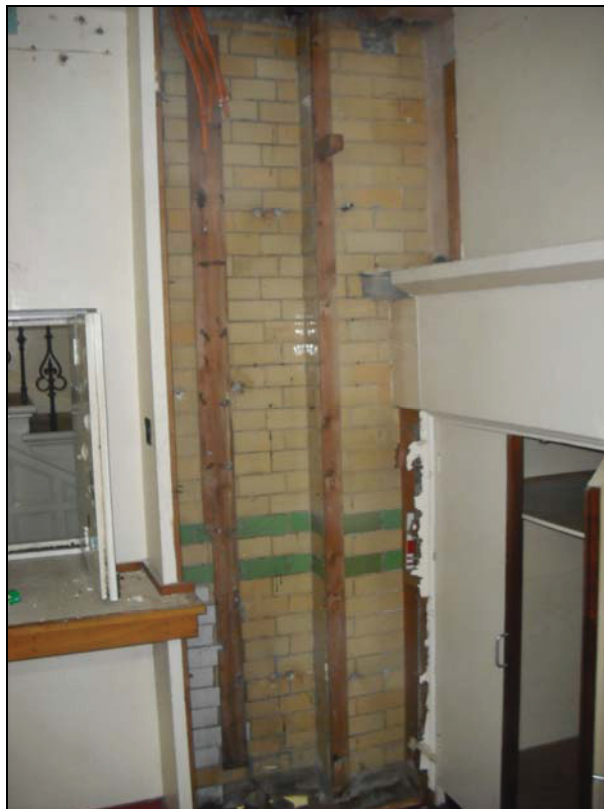
Archaeology 2008: Figure 16). Removal of the modern heating system was particularly useful in the *Kitchen* (Building 1, Room 0/3) where the original tiles were exposed (**Plate 22**). The tiles were cream with a twin band of green at thigh height and provided insight into just how the kitchen looked during the Victorian period. Directly above the *Kitchen*, pipe removal also revealed earlier wall covering (**Plate 22**), a foliate embossed design to the lower walls of the former bedroom (Building 1, Room 1/12). In the former *Servants Hall* (Building 1, Room 0/20) similar tiles to the former kitchen, noted above were also revealed (**Plate 24**) indicating a uniformity of decorative treatments away from the principal rooms. Externally a further record was made of the junction between the phase 1 (1774) and phase 2 (1820s) building, without the presence of an obscuring wall (**Plate 25**). To the rear of the building evidence for the modification of the original design was revealed in the form of an inclined roof scar (**Plate 26**). This roof scar appears to represent a glass canopy that was constructed over a created rear entrance, a development of the original plan (CS Archaeology 2008: Figures 7 and 19) involving the removal of a mullioned window and insertion of a doorway. The plan of the building in 1894 depicts this area to be occupied by a large rectangular structure, possibly a conservatory, appending to the building's *North Elevation*.

Plate 22: Detail of the original Victorian tiling in the former and original 'Kitchen' (Room 0/3), from the west

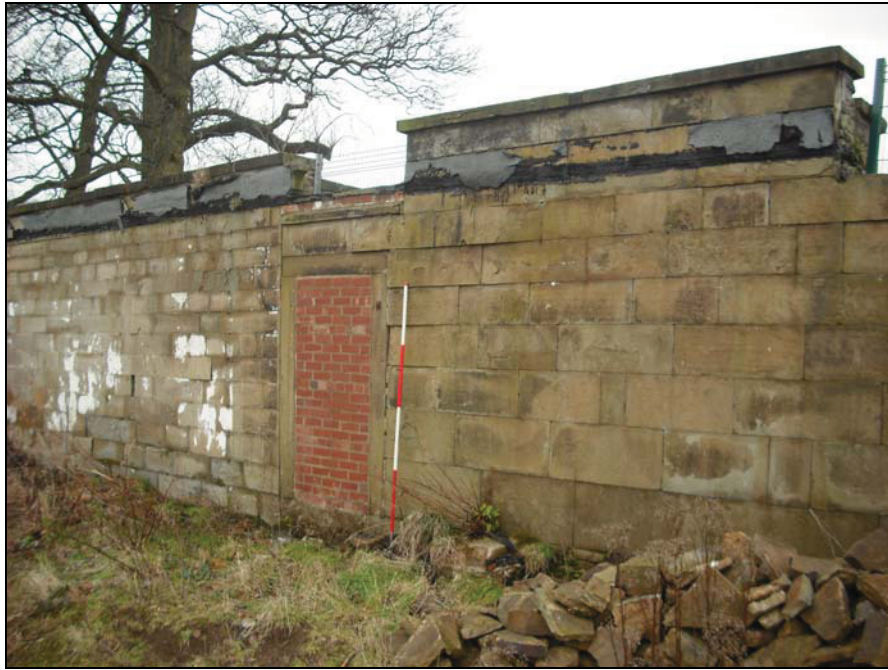
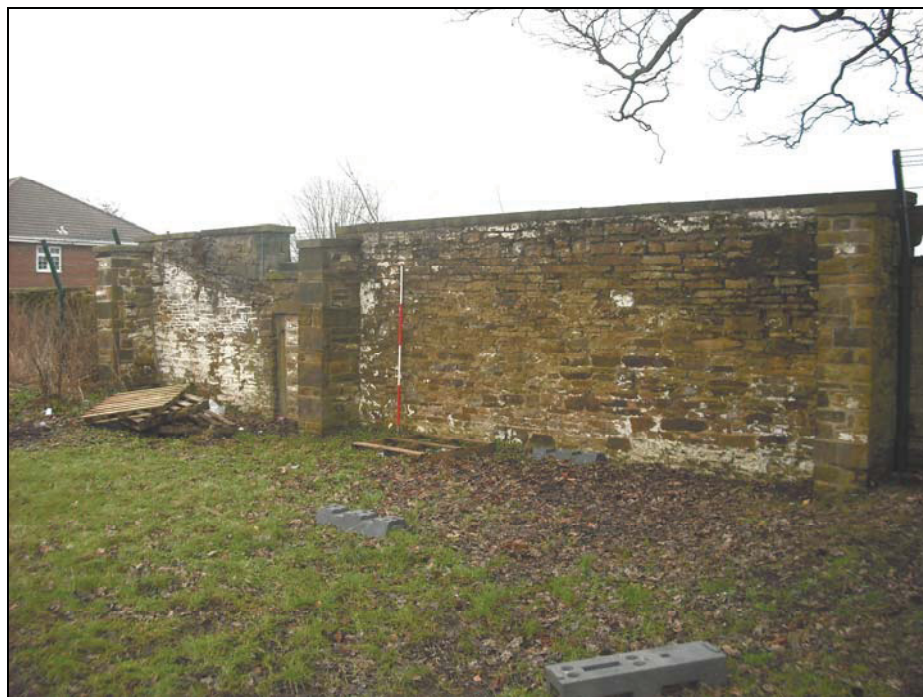
- 6.13 Within the wider grounds an imposing ashlar wall was recorded (**Plates 27 and 28**). It features a doorway with ashlar surround and forms the only surviving extant element of a building. This building was not depicted on the 1st edition Ordnance Survey map and is first depicted on the 1894 map and was therefore built between 1855 and 1894. This building's function is unknown but it accessed the extensive system of walkways and glass houses. The present extant wall bears evidence of once being an internal wall by the presence of adhering lime wash to both the south and north facing elevations. Viewed from the north, the internal walls are particularly evident and the return of the wall to the west is also evident (**Plate 28**).

Plate 27: Oblique view of the south ashlar elevation, from the east southeast

Plate 28: The *North Elevation* of the walled garden's north wall with lean to roof line and lime wash still adhering, from the northwest
