LEVEL 2 HISTORIC BUILDING SURVEY

Agricultural Buildings at Stonton Road, Church Langton, Leicestershire [Grid Reference: SP728943]

Report Date: September 2010

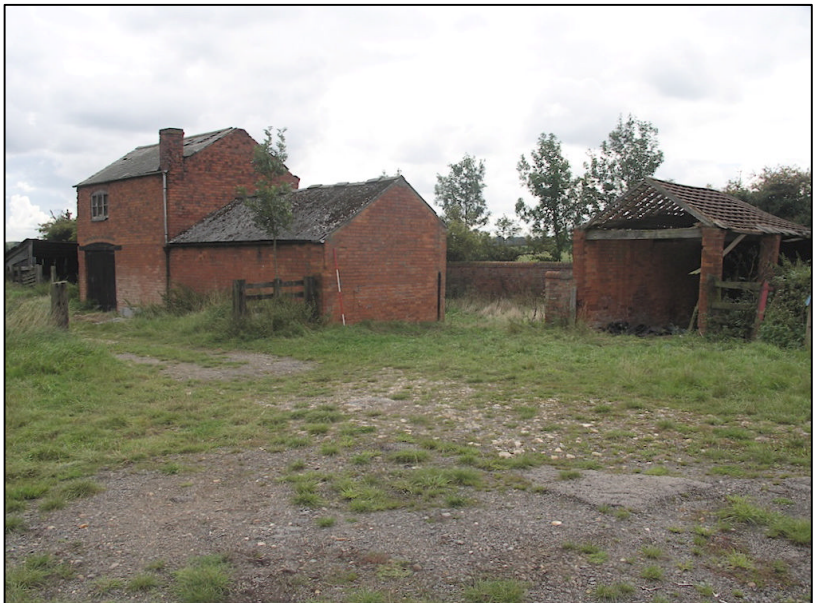
Plate 1:

- 4.1 These redundant farm buildings stand within undulating open countryside on the western slopes of the River Welland valley [Plate 1] about 1.5 km (1 miles) to the north of Church Langton on the east side of Stonton Road close to its junction with Cranoe Road [NGR SP728943] (see Figure 1).

- 4.4 To the north of this group of traditional farm buildings is a large, modern Dutch barn [Plate 1].

View looking south-east across the Welland valley showing the farm buildings within the wider landscape

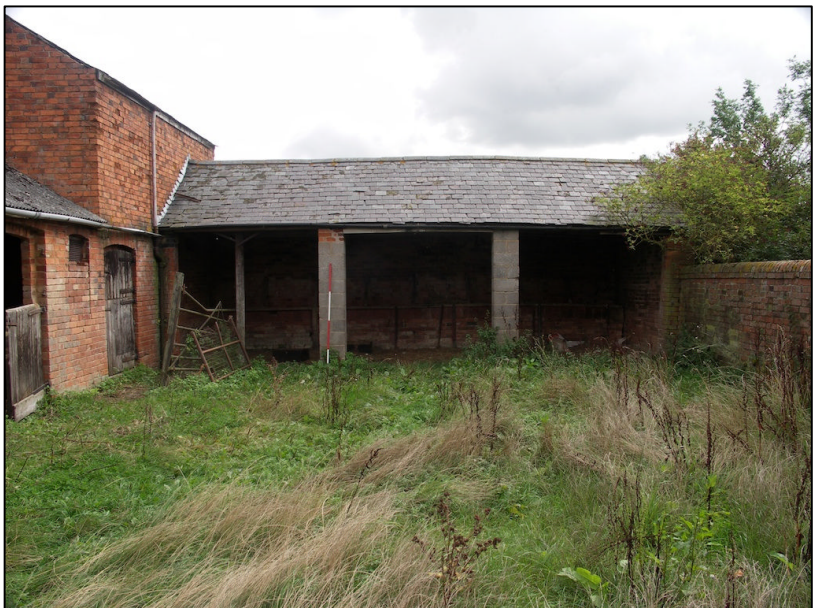
Plate 2:

View looking south-east towards the front elevation of the single and two storey range with the detached cattle shelter alongside (right)

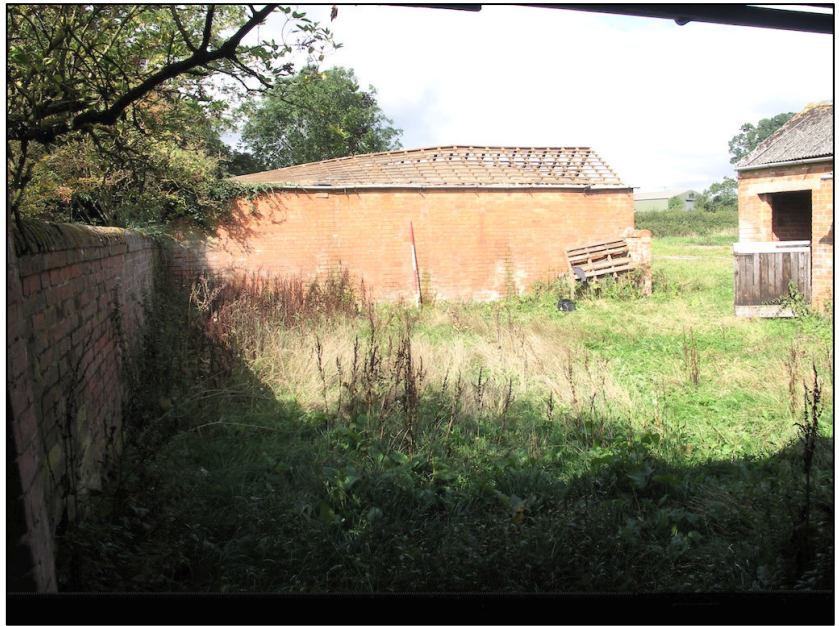
Plate 3:

- 6.17 Attached to the rear of the northern range is a single storey cattle shelter, rectangular in plan on a north-south axis with a blank brick wall to the rear (east facing) elevation [Plate 8] and a three bay open front to the foldyard [Plate 3].

- 6.18 The animal shelter is constructed of brick, laid in a Flemish Garden Wall bond however the original brick piers in the front elevation have been replaced by blockwork [Plate 3].
- 6.19 The roof is covered with slates [Plates 3 & 8] supported by timber rafters and purlins that span between the end gable walls with two king post trusses [Plate 17].

View looking east across the foldyard towards the open fronted cattle shelter along the eastern side of the range

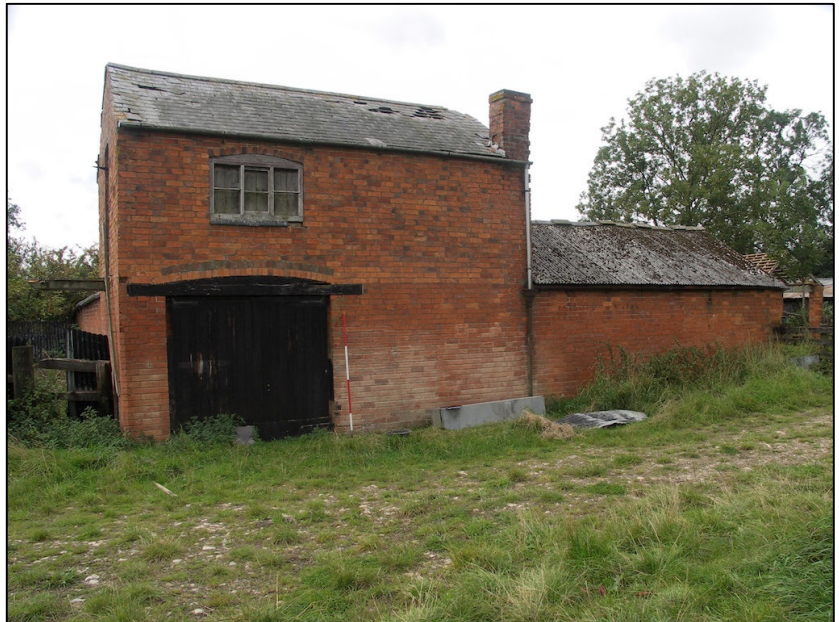
Plate 4:

6.3 There is also a separate cattle shelter with its brick rear wall onto the foldyard along the western side of this complex [Plate 4].

View looking west across the foldyard towards the rear wall of the detached cattle shelter with the boundary wall along the southern side of the foldyard

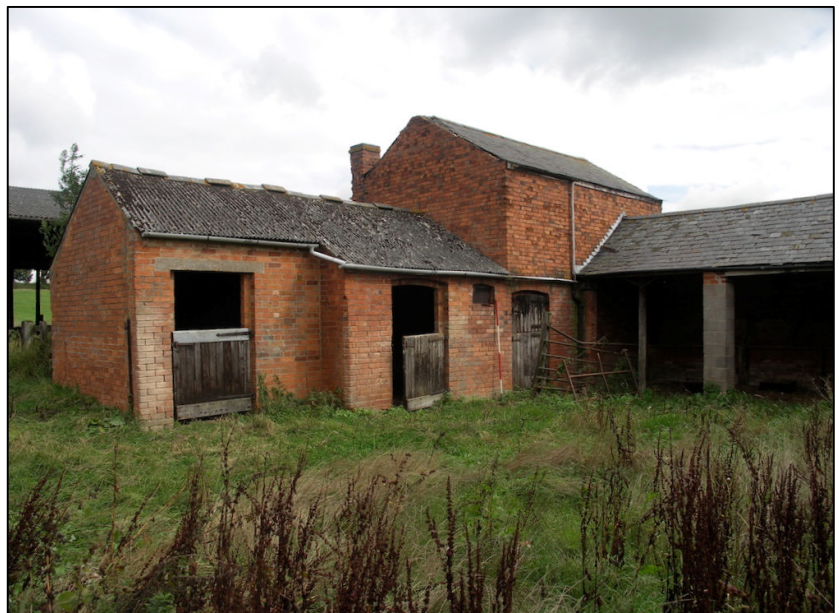
Plate 5:

6.7 The loft over the implement shed is also a later addition, there is a noticeable horizontal break between the red brick of the ground floor and a more orange brick of the upper floor in the north facing elevation and eastern gable [Plates 5 & 8]. This also appears to be a softer brick given the greater degree of spalling in the upper storey brickwork compared to the ground floor.

View looking south to the front elevation of the northern range of buildings showing the distinct horizontal break in the brickwork above the double door

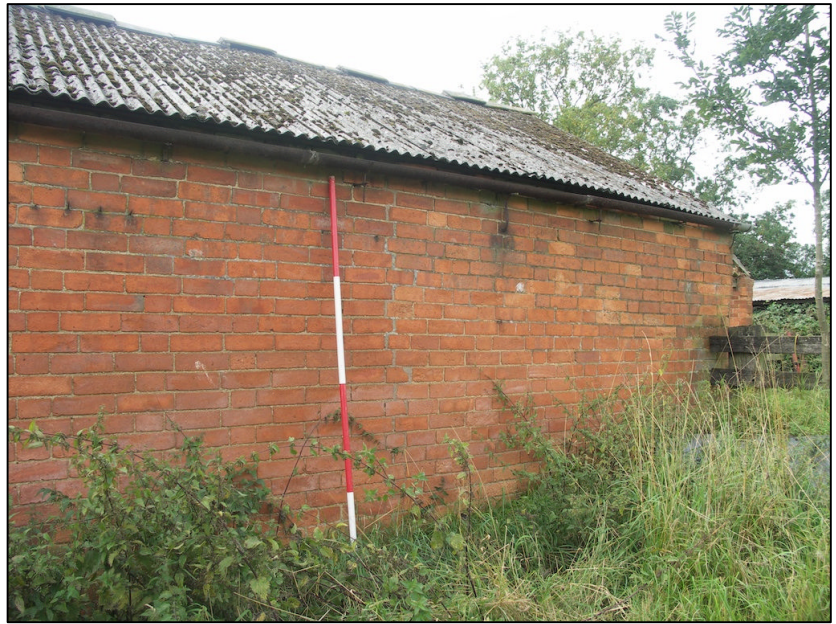
Plate 6:

6.6 Subsequently a second loose box appears to have been added to the western end of this range. This is clearly differentiated by its narrower width and the concrete lintel over the door as opposed to the brick segmental arch seen over the doors in the rest of this range [Plates 6 & 11]. There is also further evidence of an extension of the original range in the north-facing elevation. Whilst this elevation gives the appearance of being built as a single wall there is a noticeable break in the bonding pattern towards the western end of this range where the extension has been tied into the rest of the building. This is now highlighted by a vertical line of concrete pointing [Plate 7].

View looking north-east to the rear elevation of the northern range of buildings showing the arrangement of doors and the narrow metal ventilator window

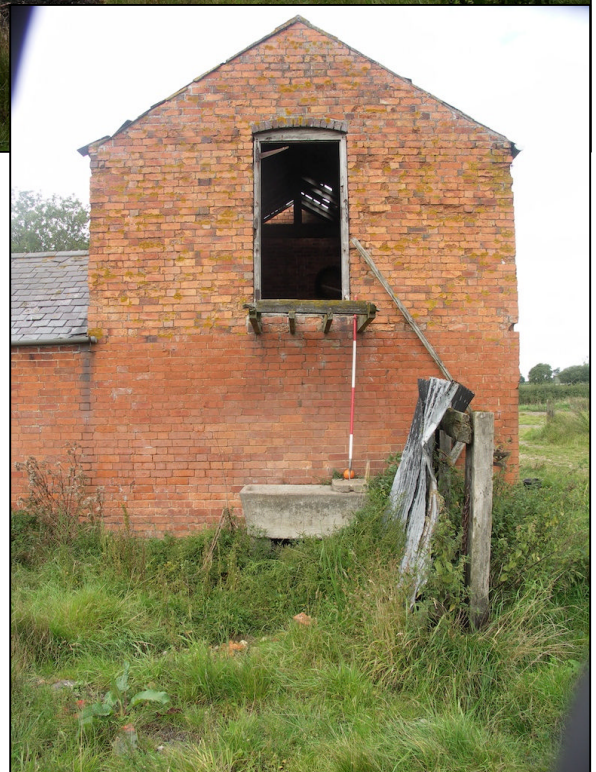
Plate 8:

6.8 There are no internal stairs in this part of the building, or any evidence of stairs, indicating that the only access to the loft was by the external doorway in the end gable [Plates 8 & 9].

View looking west of the rear wall of the cattle shelter and gable of the northern range with the first floor loft doorway

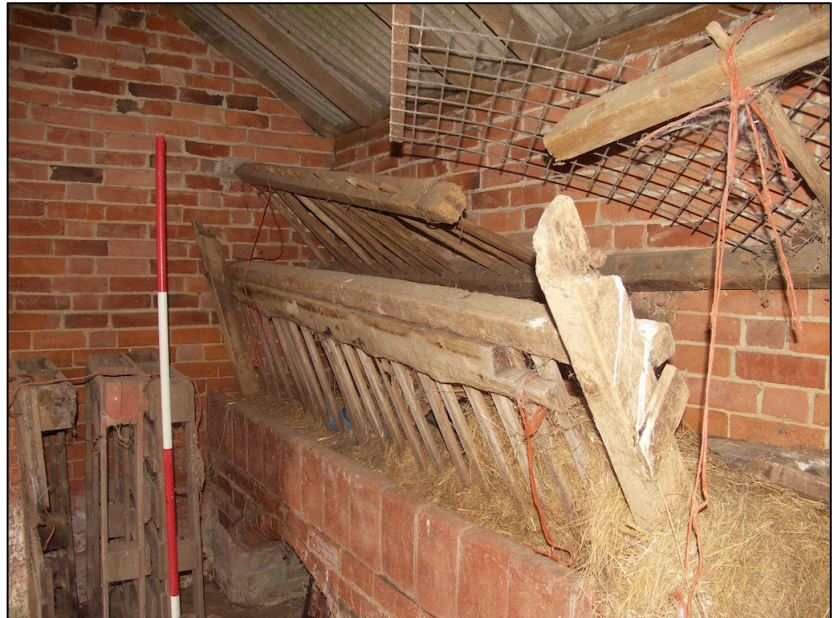
Plate 13:

6.10 Internally the ground floor of the implement shed is constructed of blue engineering bricks with timber boarding to the first floor loft [Plate 12]. The floors within the single storey cattle boxes are constructed of red brick and the middle bay has a noticeable channel running towards the rear wall into the foldyard [Plates 13 & 15].

Internal view of the middle loose box showing the brick-built feeding trough with tethering rings fixed to the front wall of the trough and the timber hay racks and central drainage channel within the floor

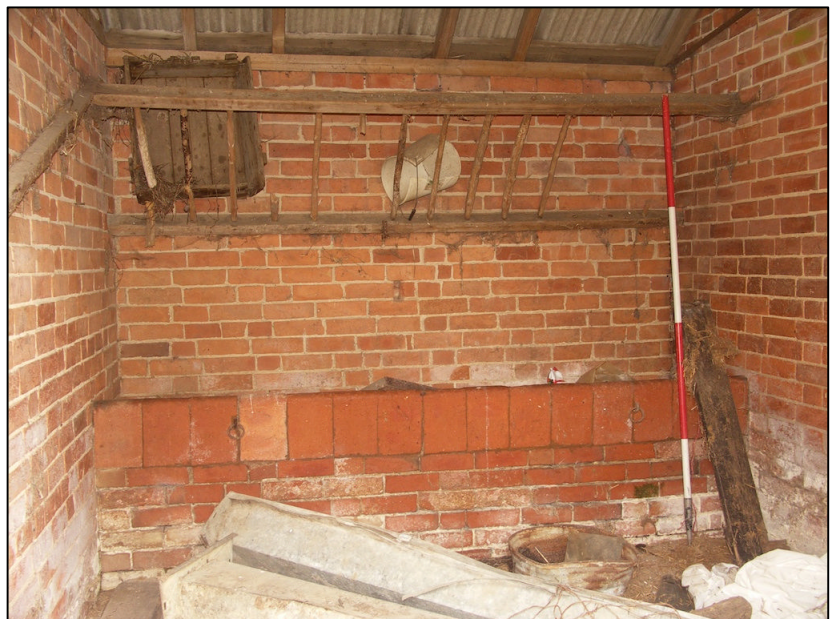
Plate 14:

- 6.14 Internally these loose boxes have retained their original brick-built feeding troughs against the rear (north-facing) wall and the timber hay racks also survive [Plates 13, 14 & 15]. Peters (pp 66) notes that the provision of hay racks was normal before 1840 but thereafter omitted, supporting the dating evidence for these buildings to no later than the mid-19th century.

Detailed view of the timber hay racks
