FEEDER CANAL, SLOPES GARDEN, LYME PARK, CHESHIRE

Archaeological Watching Brief

Matrix Archaeology

Report No. 2018-08
(Project Code: MA665)

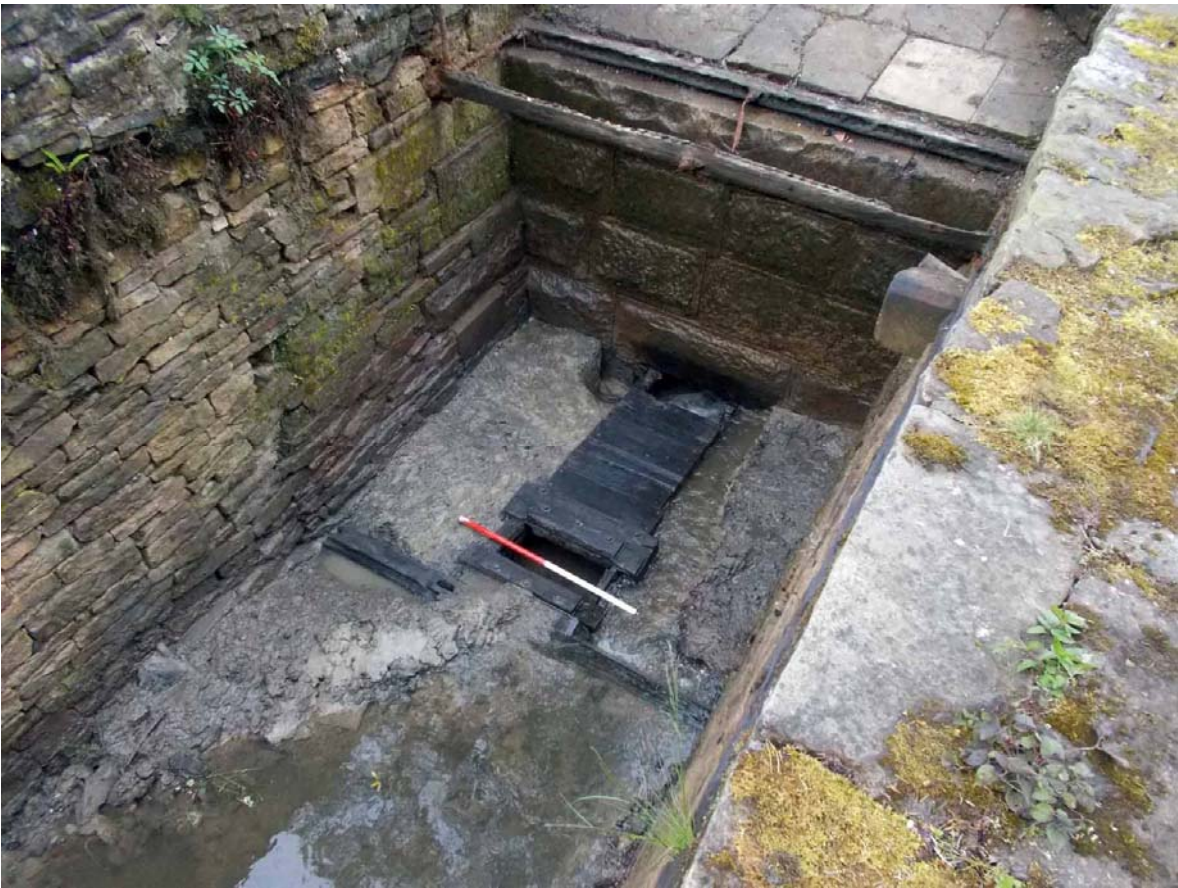
Plate 3. Timber culvert exposed and cleaned up, viewed from east.

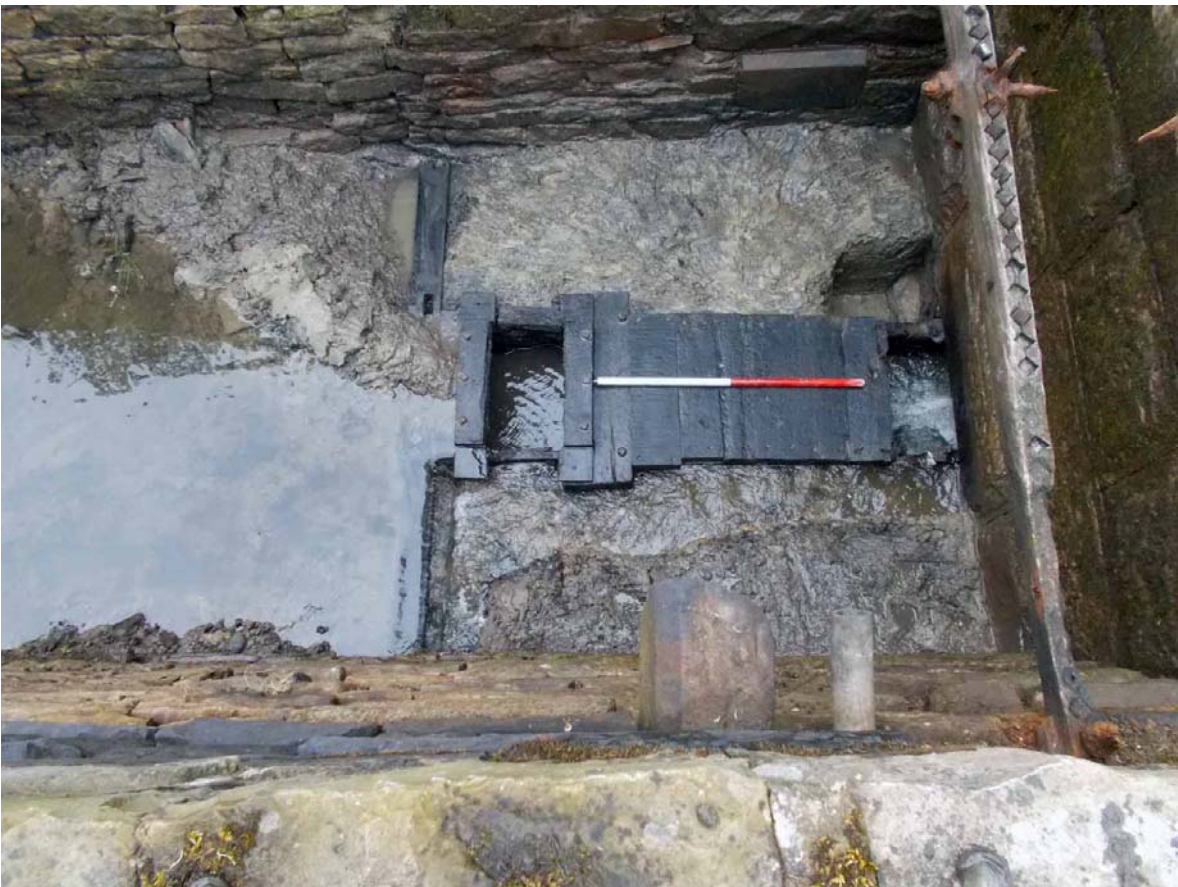
Plate 4. Timber culvert exposed, note surrounding puddled clay, viewed from north.

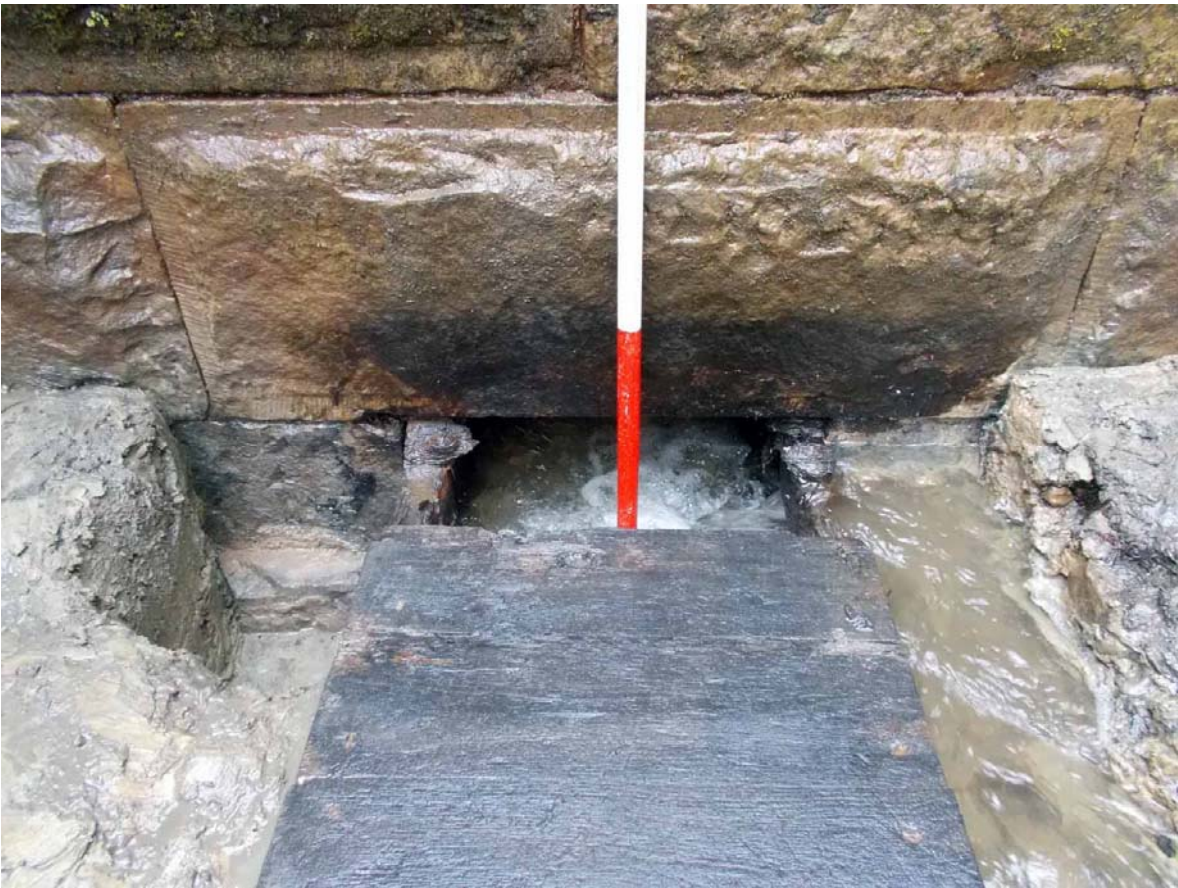
Plate 7. Culvert and aperture in dam base, note missing roof planks, viewed from east.

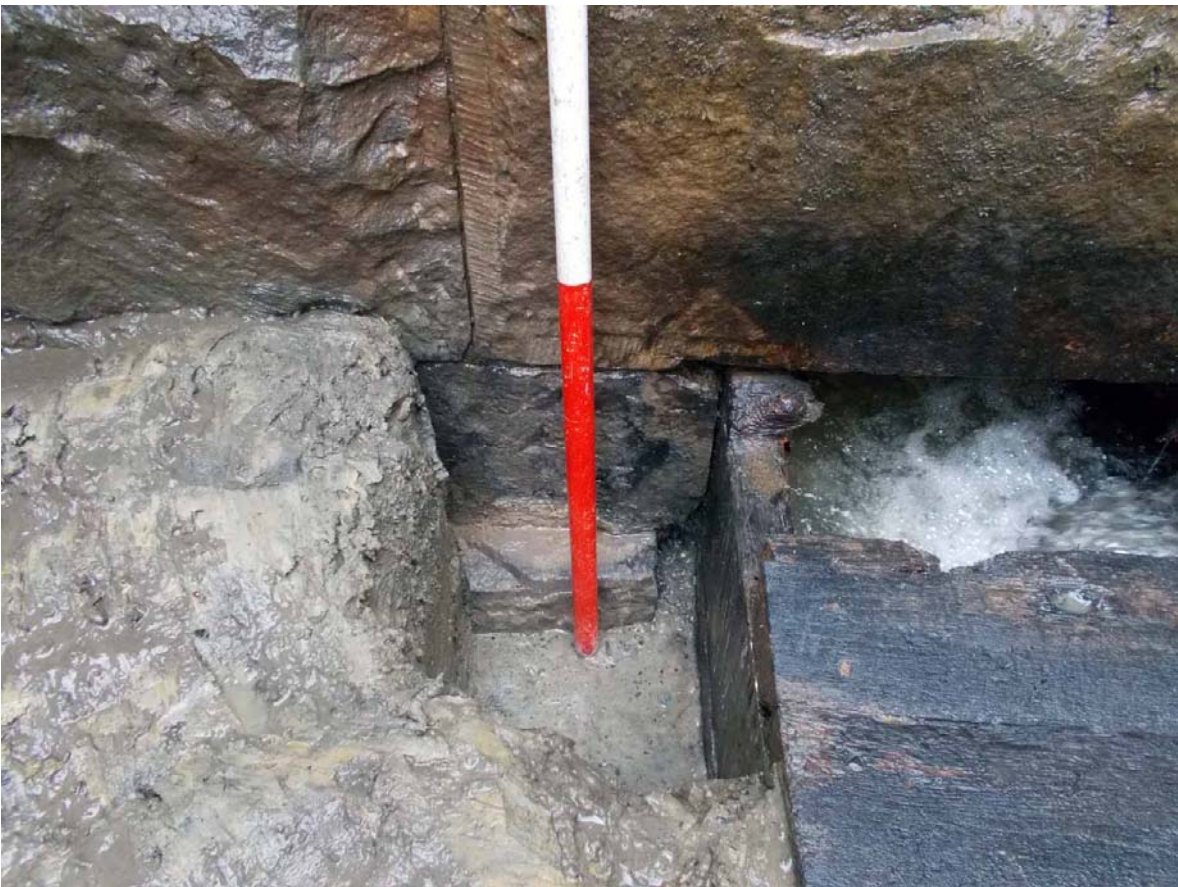
Plate 8. Sondage in puddled clay showing stepped footing of dam, viewed from east.

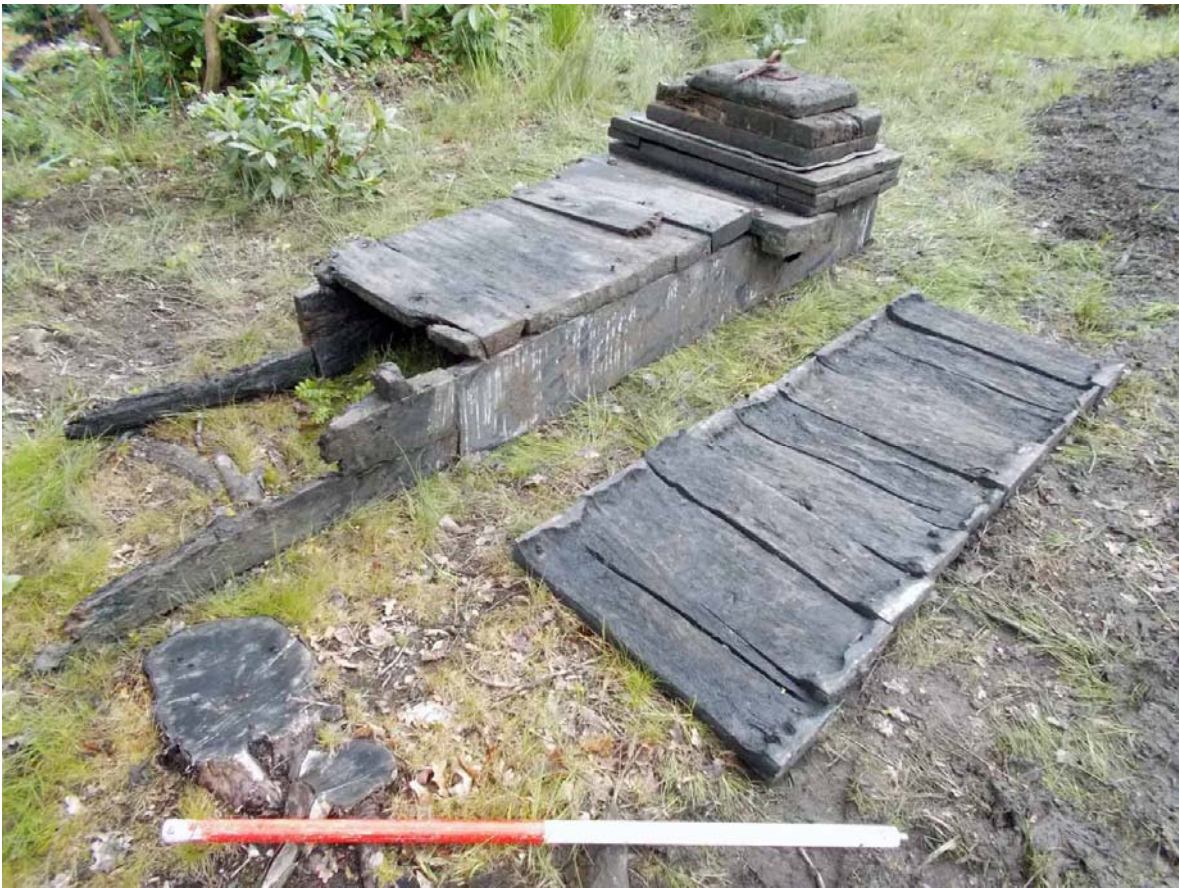
Plate 10. Reassembled ex-situ culvert, note worn base timbers.

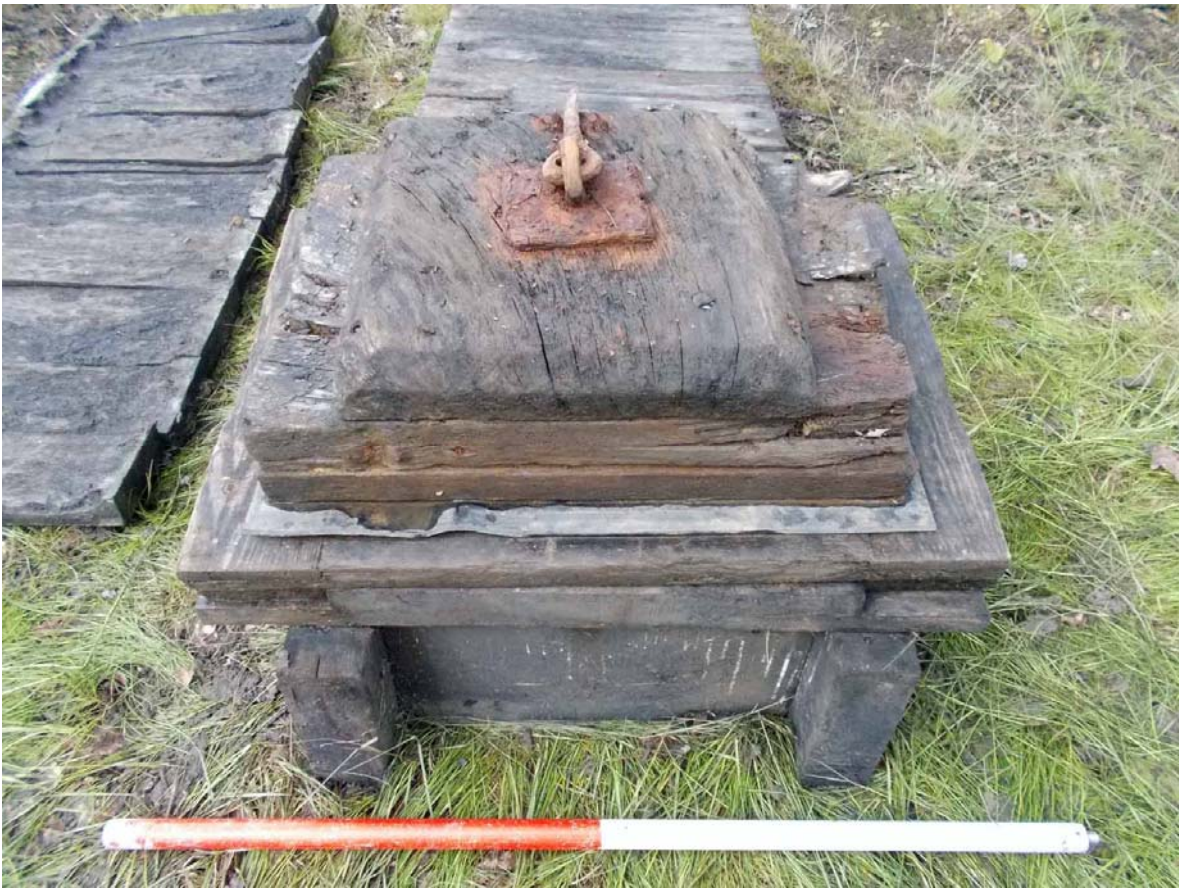
The shaped wooden plug was described in the 2016 report. The remains of an iron loop or staple was also noted on the upper surface. It sat directly to one side of the central lifting loop and was possibly an attachment point for a chain. A section of hand-forged chain was recovered from the silt (Plate 52 and Appendix). A new rubber seating had been fitted to the plug after 2015.

Plate 12. Intake timber plug with rubber seal.

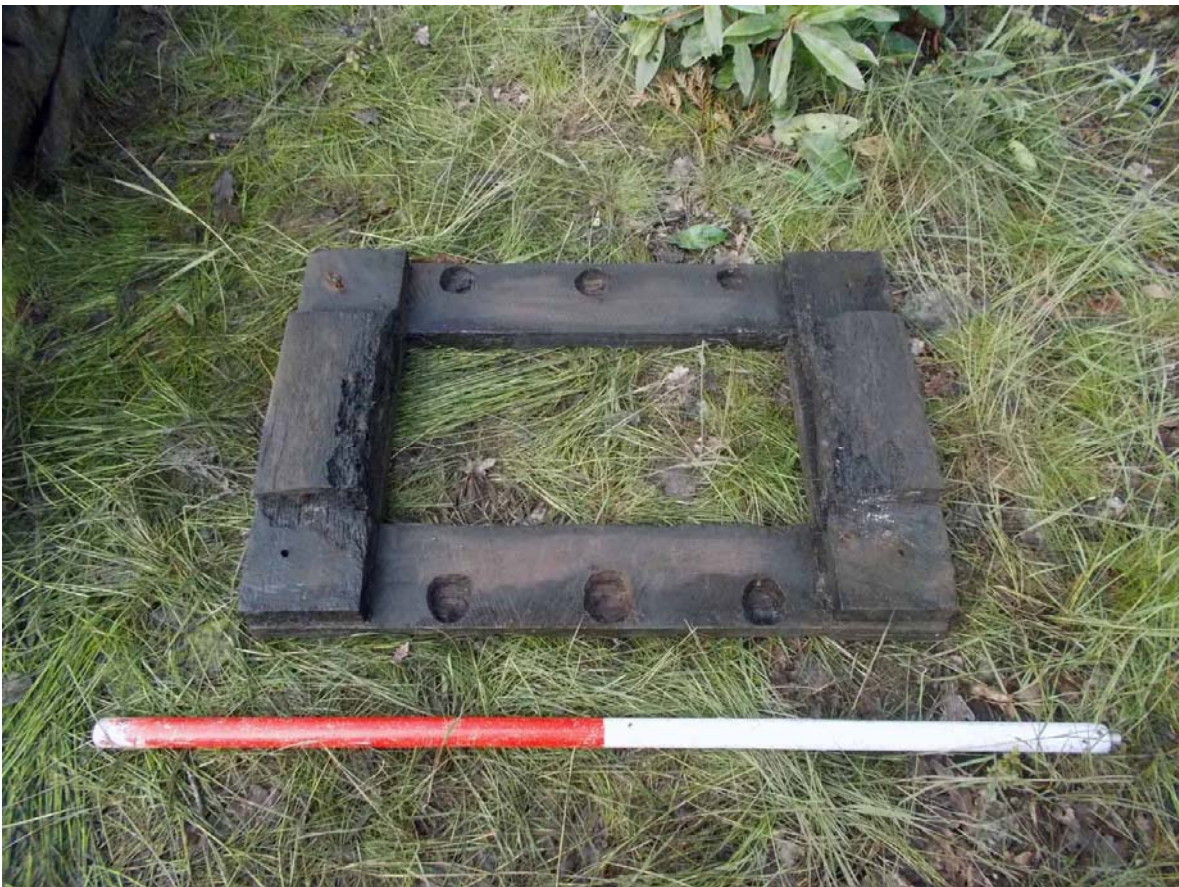
The intake was formed from heavier timbers fixed to the side walls with large, square-headed screws or coach bolts. These fixings, with hand forged heads, possibly dated to the second quarter of the C19. The large timbers supported an upper frame or flange plate, to seat the wooden plug. Circular saw marks were noted on the flange plate elements and chiselled or gouged recesses on the underside allowed for countersinking of the screw heads (Plate 15).

Plate 15. Underside of timber flange plate, note gouged recesses for screw heads.

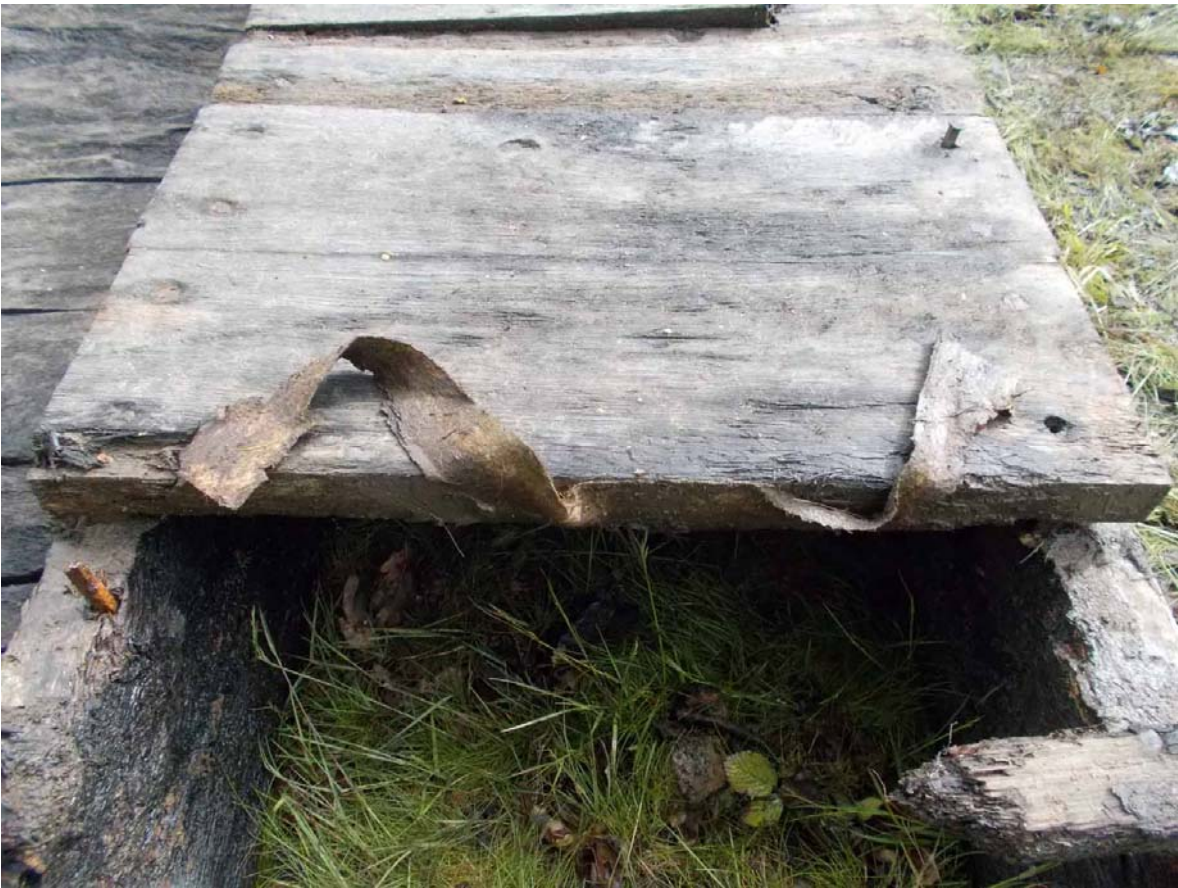
Plate 16. Jointing material between culvert timbers. Possibly a felt strip.

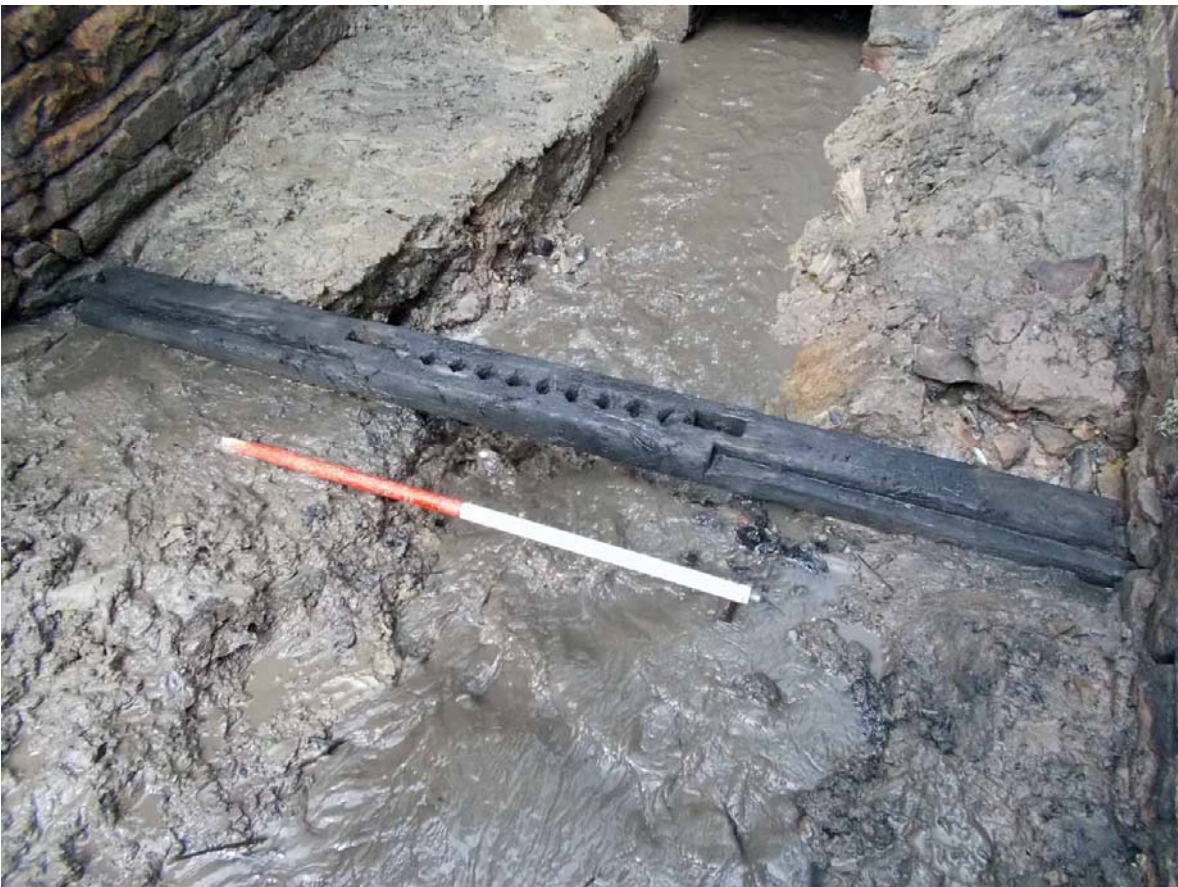
Plate 17. Base rail cleaned up, note holes for former central debris trap, viewed from east.

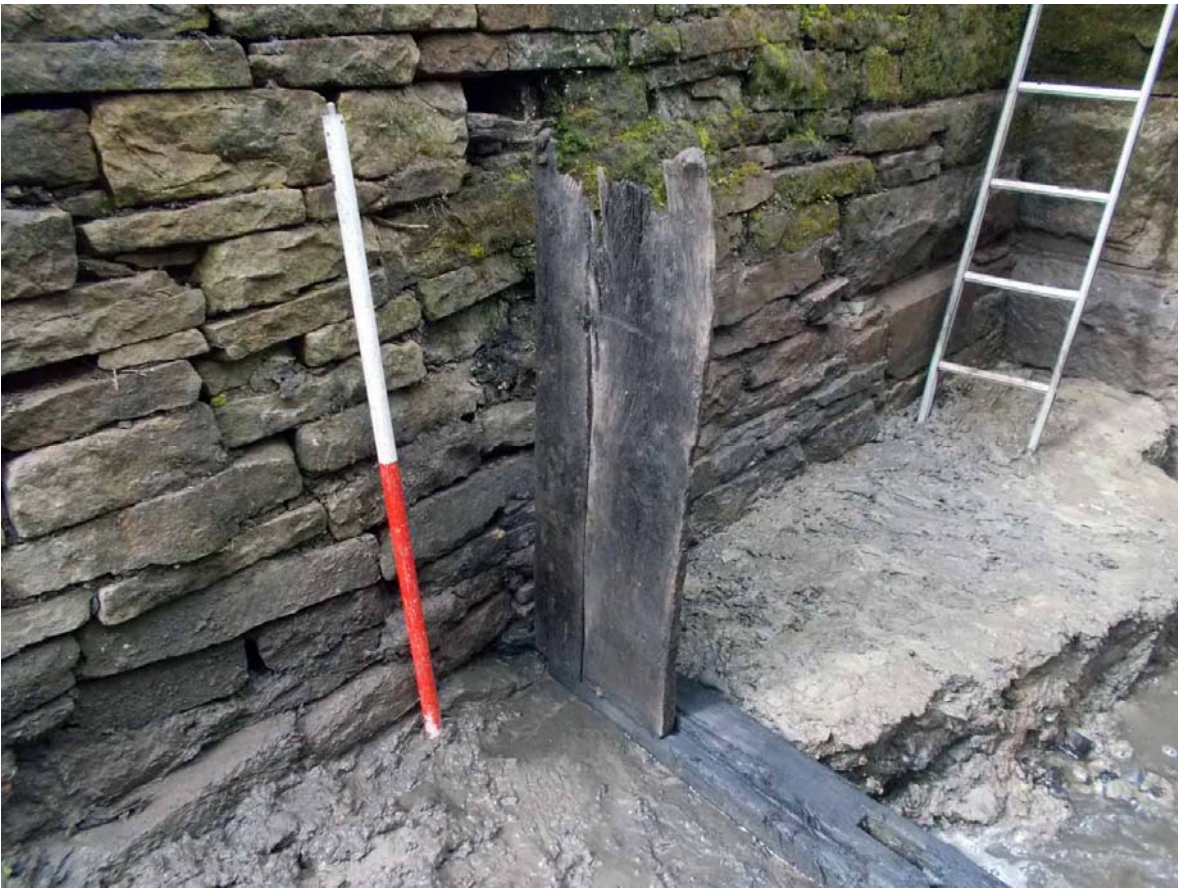
The timber beam lying directly to the east of the box culvert was also thoroughly excavated and examined. The previous identification of a submerged barrier or fence were confirmed (Plate 18) and the suggestion of water being guided directly into the culvert's intake proved correct.

Plate 18. Base rail and partly reassembled barrier/fence. Note decayed top rail within recess, near top of photo, viewed from north-east.

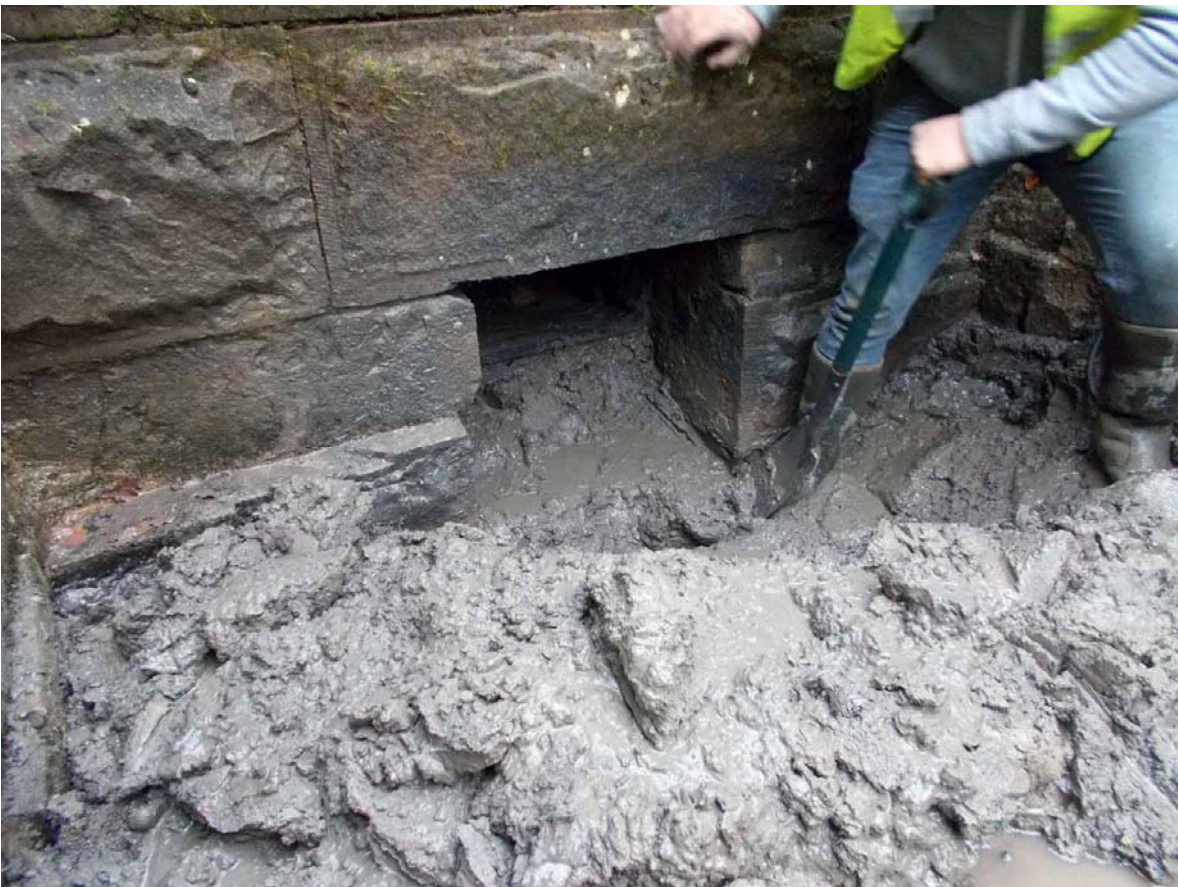
A small sondage, and further probing with a road pin, failed to find either a solid floor to the opening or any continuation of the stepped footing. This was confirmed on 30 October 2017 by further excavation works, after the flow of water had been stemmed (Plates 21 and 22).

Plate 21. Further excavation within aperture, 30 Oct. 2017, viewed from south-east.

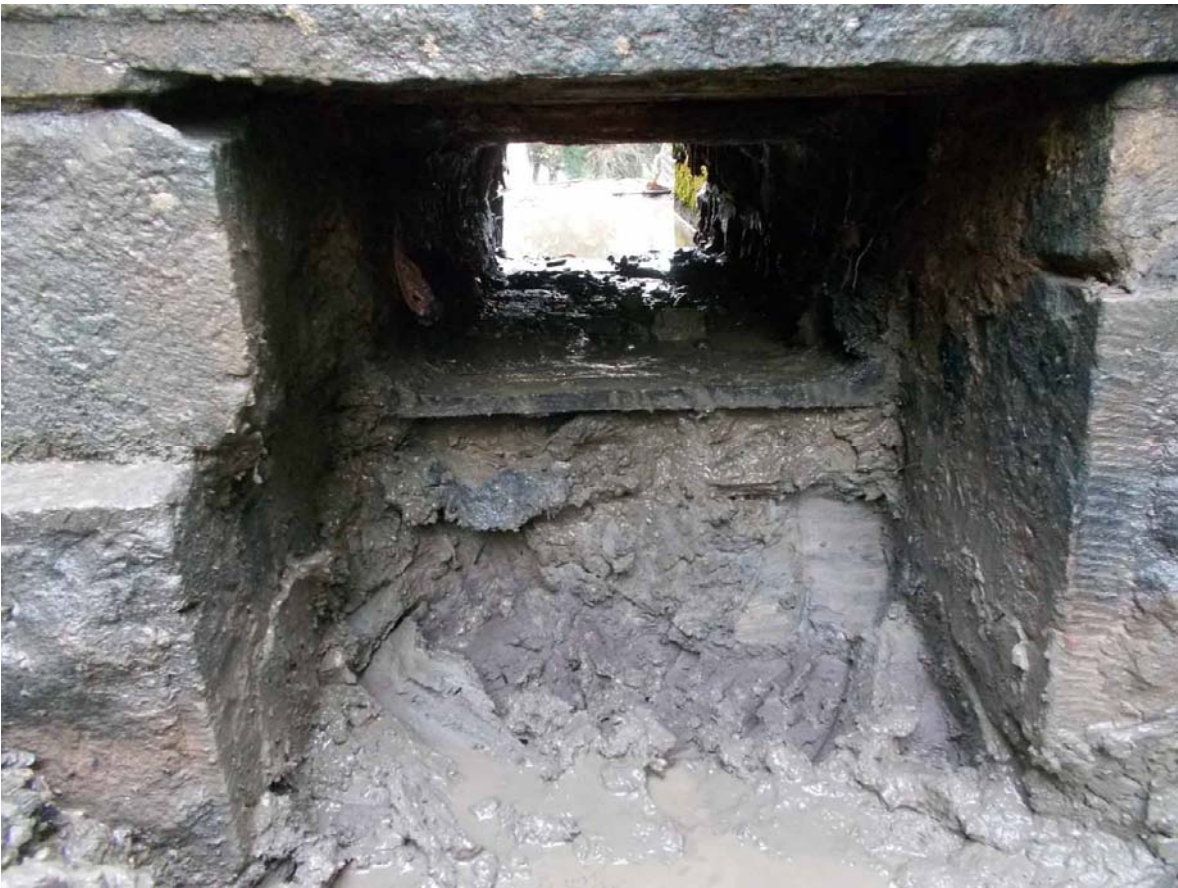
Plate 22. Completed excavation with same clay extending below base of culvert and dam footing, viewed from east.

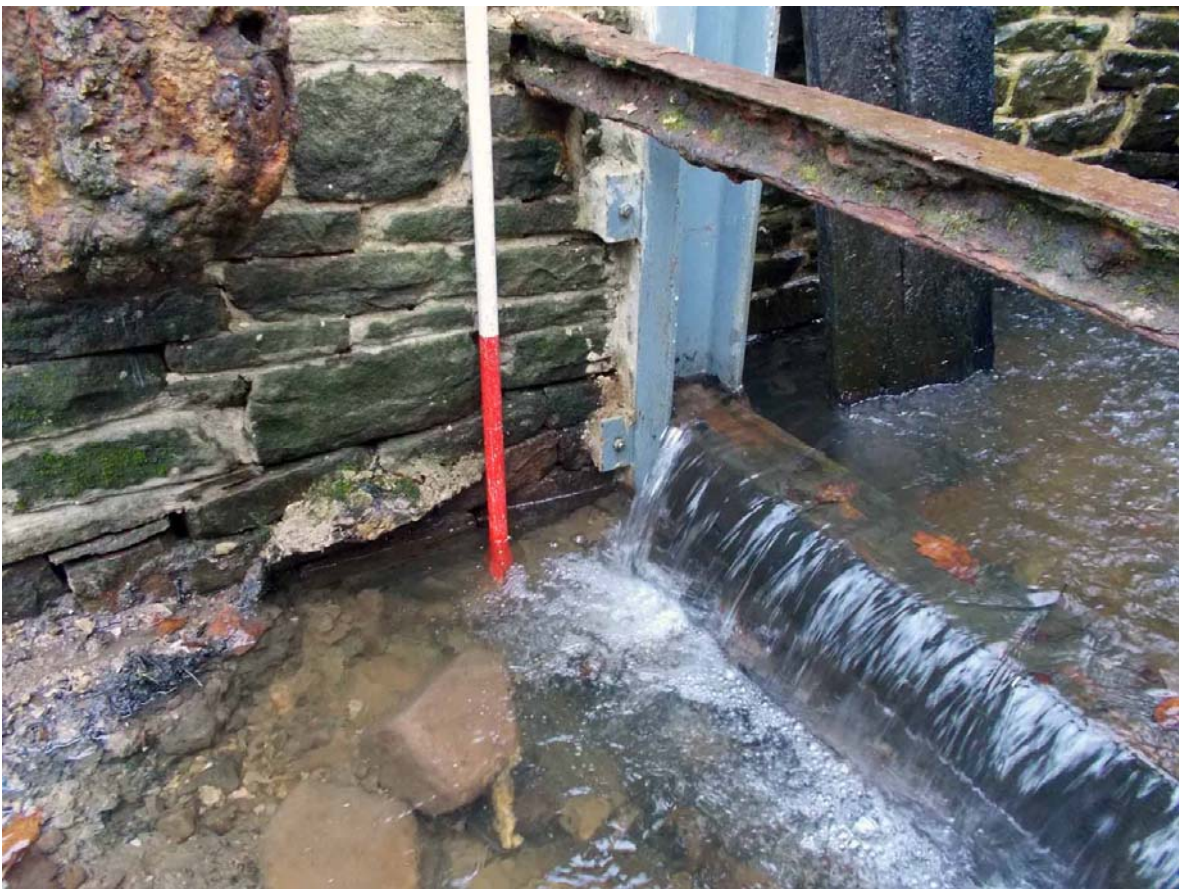
Plate 32. Detail showing north side wall, extending 0.22m below top of puddled clay, viewed from south.

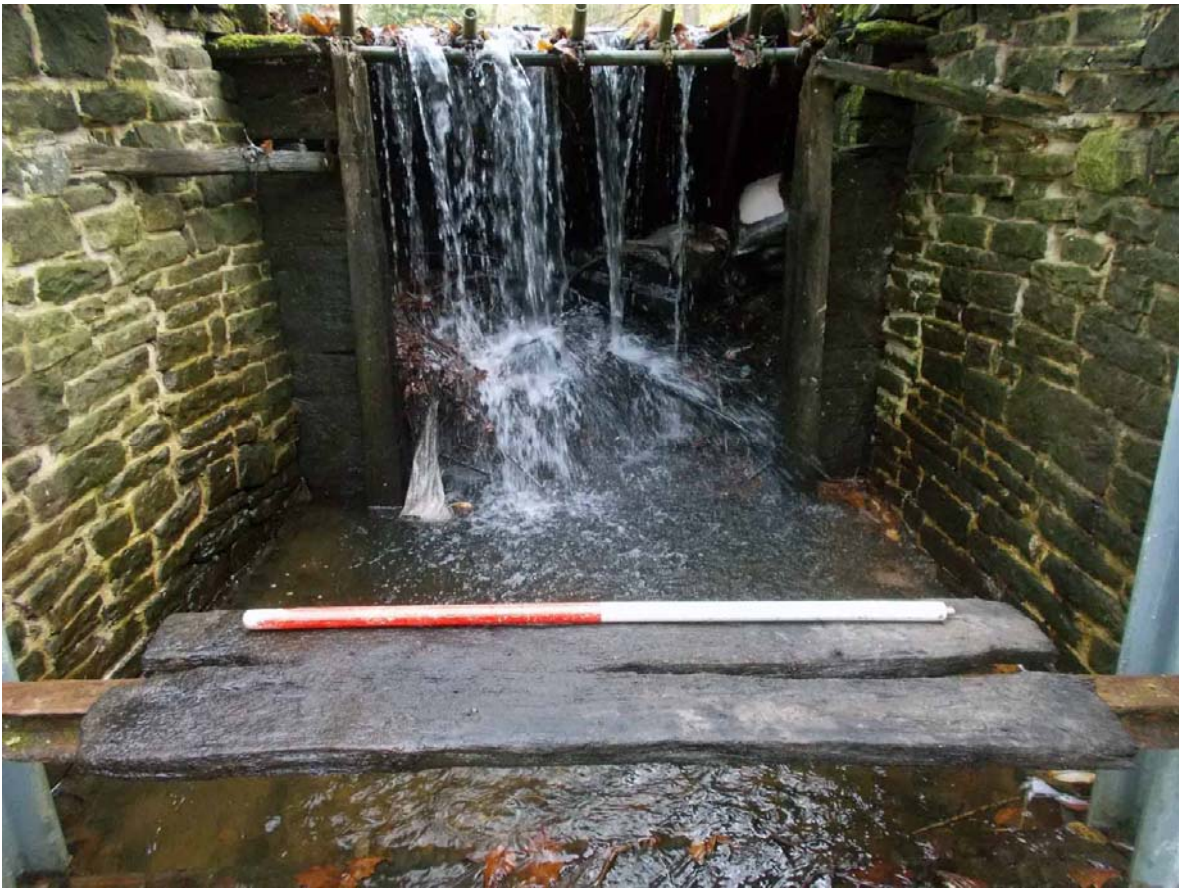
The de-silting process had uncovered the complete structure down to the clay base of the channel. As expected, the bottom of the grooved posts and side planking, were surrounded and sealed by the puddled clay. A 0.35m by 1.29m plank, found propped against the side wall, had clearly been located between the posts, and was evidently the lowest drop board. The 40mm thick oak or elm timber was heavily worn (Plate 33).

Plate 33. Worn drop board removed from original structure, visible in background, viewed from west.
