Archaeological Building Recording
at the former
LIVE AND LET LIVE PUBLIC HOUSE,
BLAGDON, NORTH SOMERSET.
for
Halsall Construction

Report No. 2536A/2012
Accession No. WESTM: 2011.25

Archaeological Building Recording
 at the former
LIVE AND LET LIVE PUBLIC HOUSE,
BLAGDON, NORTH SOMERSET.

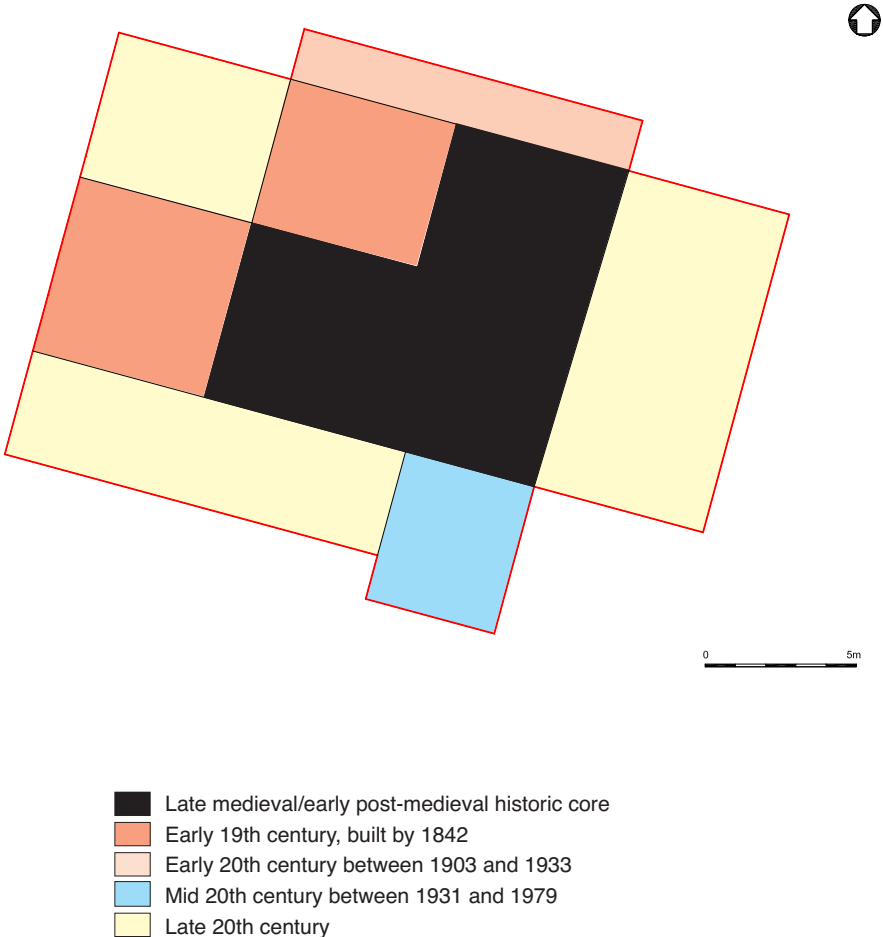
Fig.14 Phased block plan of the Live and Let Live

- 6.1 The survey of the historic core of the Live and Let Live public house revealed a number of features relating to the sequence of development of the building. These in conjunction with the historic research and the map evidence have allowed a very basic phasing of the site to be produced (**Fig. 14**).

- 6.2 The earliest phase of the building was represented by the clay bonded rubble construction, which formed the principal build of the two rooms on the ground floor. Unfortunately the wall between these two rooms had been thinned and substantially re-pointed/rebuilt in the 20th century so the relationship between the two had been lost. However the form of construction, clay with few inclusions bonding rubble stonework forming walls c. 0.68m thick, suggests that even if not contemporary with each other the two sections probably both date from the late medieval period, possibly the 16th century. The features forming the next clear phase are a number of elements constructed with white or pinkish lime mortar, including the raising of the roofline on the first floor and the construction of the stone staircase in the north-east corner of room 1. The use of lime mortar probably indicates an 18th century date, although it may be earlier. The block to the north-west of the historic core appears to be in place by 1842, based on the tithe map, but may of course have been constructed considerably earlier, possibly in the 18th century. On the ground floor a number of alterations are made using a mid grey mortar in the early 20th century, and the roofline on the first floor appears to have been raised for a second time. Most of the other alterations to the historic core, blockings and new openings, are related to the additions made around it later in the 20th century, with the toilet block and veranda added on the north side by the 1930s, the beer cellar added on the south side in the middle part of the century and additions made on the east, south, and west side of the building after 1979.

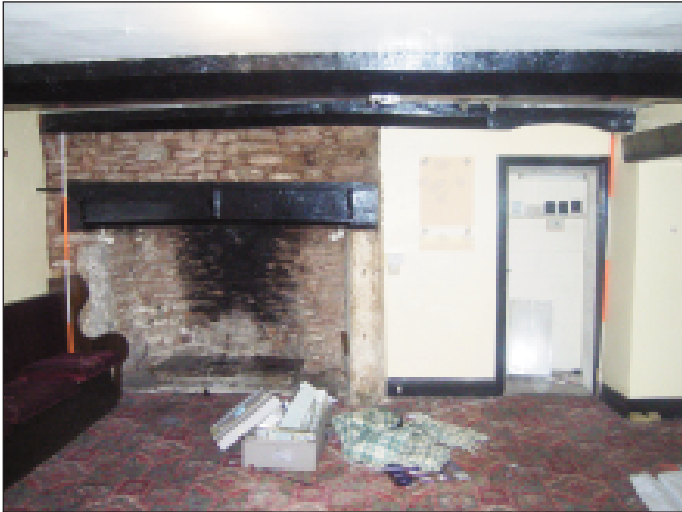
Plate 1 West internal elevation of room 2 of the historic core ground floor, looking west

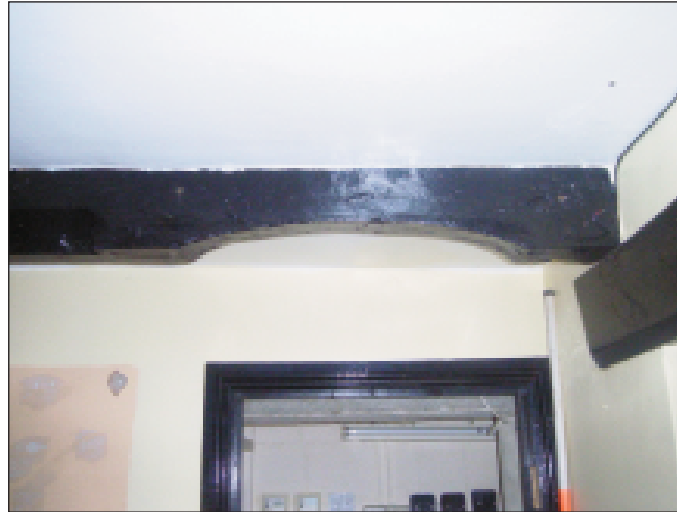
Plate 2 Cut in west beam of room 2 for a former opening, looking west

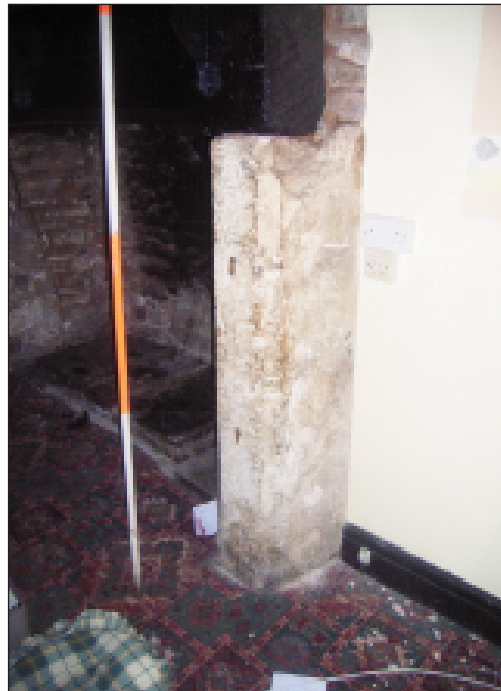
Plate 5 Stone slab, possible former gate-post, forming the north side of the fireplace in room 2, looking south-west

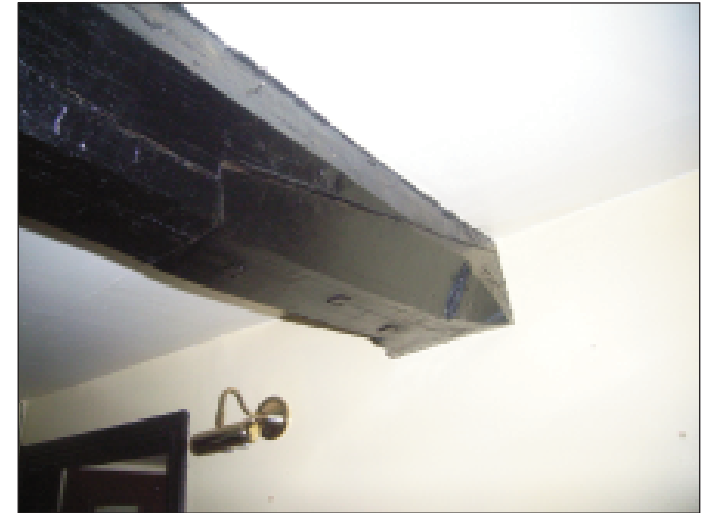
- 5.7 Both ground floor rooms contained ceiling beams with carved stops at each end. The beams in room 1 had shouldered steps and run-out stops, while in room 2 the beams had the more common step and run-out stop (**Plates 6 & 11**), suggesting they were not contemporary with each other.

Plate 6 North end of room 2 beam with carved stops, looking north-west

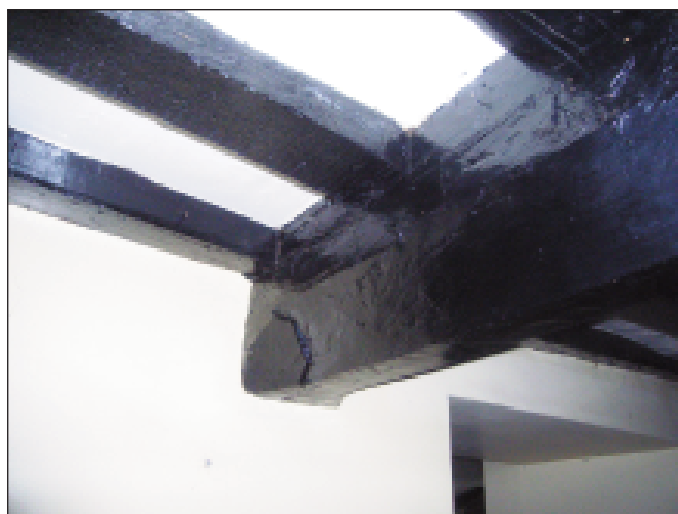
Plate 11 East end of room 1 central beam with carved stops, looking south-east

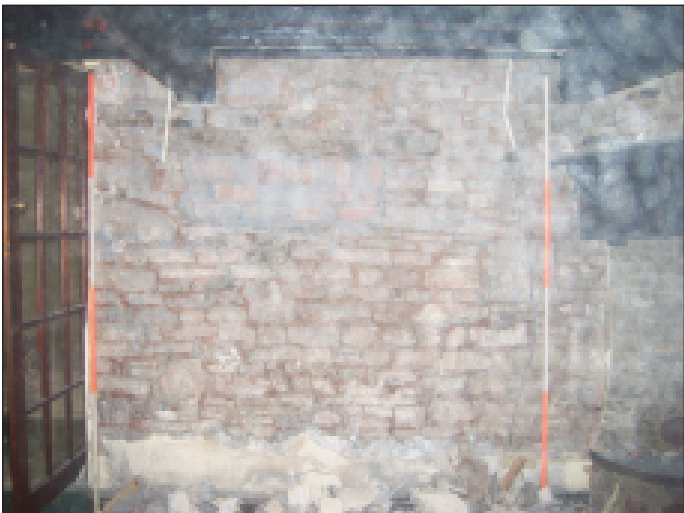
- 5.4 The west elevation of room 1 (**Plate 16**) was largely clay bonded rubble stonework. It did however contain a brick blocking of an unusually short and wide window opening. The window presumably went out of use when the block to the west of room 1 was built, which based on the tithe map had occurred by 1842, however based on the size of the bricks and the grey mortar the blocking probably dates to the early 20th century. The east wall comprised only a small section of clay-bonded rubble build at the north end (**Plate 17**). The middle section comprised modern concrete blockwork and the south end of the elevation was a modern opening into the dining room that was added in the late 20th century. A wooden lintel surrounded by grey mortar and a splay on the north side of the concrete blocks also using grey mortar indicate the presence of a window in this area, confirmed by a photograph of the east side of the building (**Fig. 9**) from the 1950s. Beneath the grey mortar was a section of rubble bonded with lime mortar that extended to the floor and may indicate an earlier doorway in this place. The south elevation (**Plate 9**) comprised a large central opening into Room 2 partially blocked by a stud wall and sections of stonewall which had been substantially thinned and re-pointed or possibly sections of it rebuilt.

Plate 16 Stripped west elevation of room 1, looking west

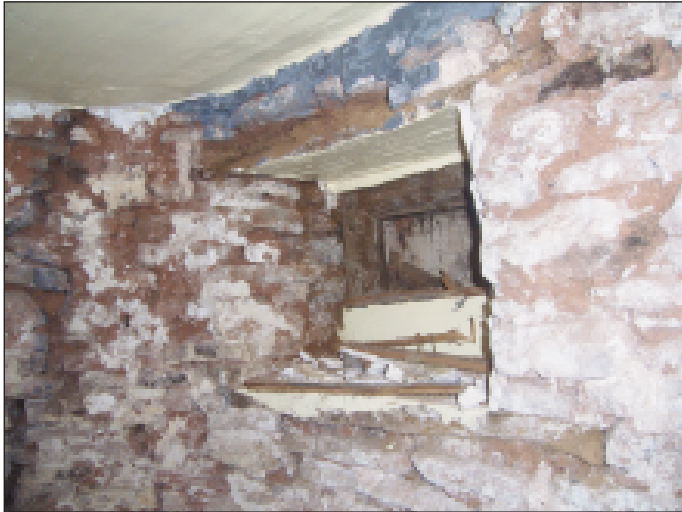
- 5.3 Room 1 was the smaller of the two rooms that formed the ground floor historic core, located to the north of room 2. The principle feature of the room was the fireplace located in the north wall (**Plate 7**). This had been opened out to provide extra seating on either side of it, a photograph from the first half of the 20th century showing that it formally included a brick inner fireplace (**Fig. 10**). A wooden beam on the eastern side of the fireplace may have indicated the former location of a bread or warming oven. To the east of the fireplace was a narrow stairwell (**Plate 18**), the walls of which were clay bonded while the stone steps used a pinkish lime mortar suggesting a possible 18th century date for the staircase, although it may of course have replaced an earlier stair. A small blocked original window was located part way up the stairwell (**Plate 19**).

Plate 19 Original window in wall of stairwell, looking north-east

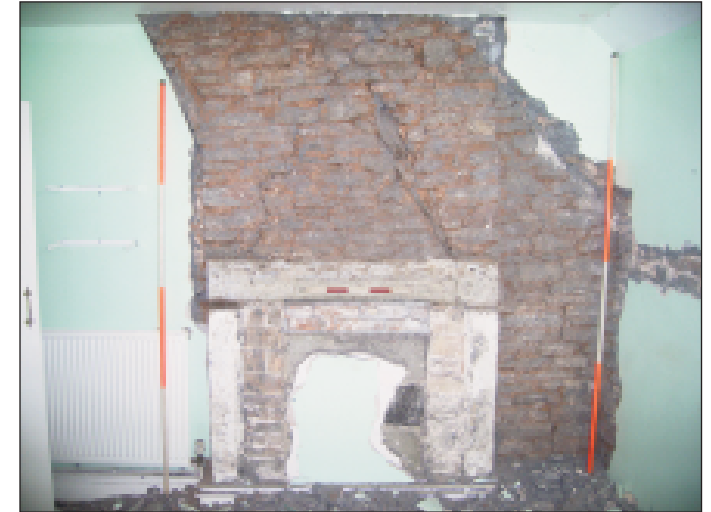
- 5.9 Room 4 had sections of plaster removed from the east and south elevations, with the east section revealing an original fireplace (**Plates 21 & 22**), formed from two stone uprights surmounted by a wooden beam. This was subsequently reduced in size by the insertion of sections of brickwork bonded with lime mortar on either side, and then again reduced with an iron beam inserted and brickwork bonded with grey mortar in place above it, with the fireplace finally being blocked completely with concrete blocks. The original roofline of the building was also identified on this elevation with a number of repairs carried out on the clay bonded roofline in white lime mortar and then an upward extension carried out in pinkish lime mortar. The level of the upward extension was confirmed by the south elevation (**Plate 23**) where stonework bonded with pinkish lime mortar sat above clay bonded material. A possible beam slot was also found, within the lime mortar section blocked with bricks and grey mortar.

Plate 21 Stripped area in room 4, 1st floor exposing an original fireplace, looking east

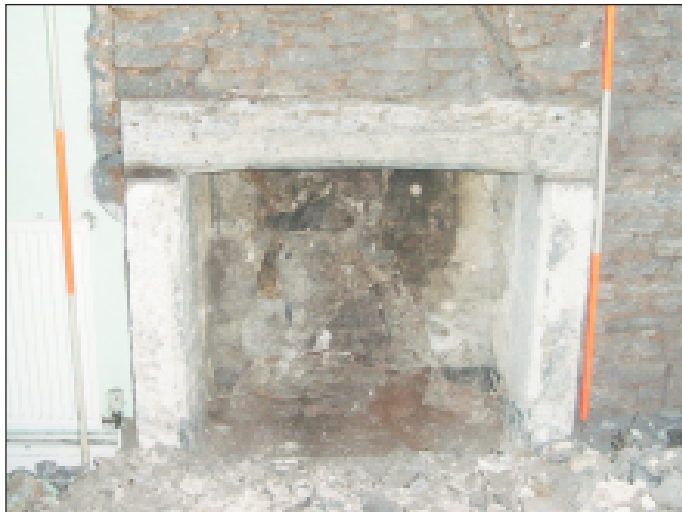
Plate 22 Original fireplace in room 4 opened up, looking east

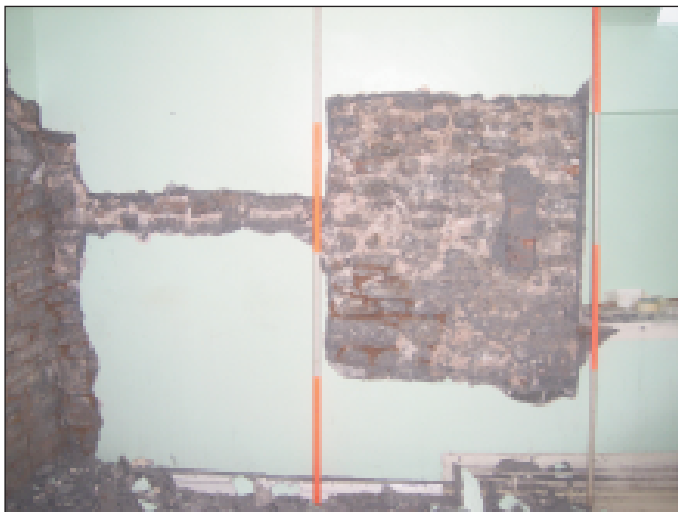
Plate 23 Stripped area in room 4, 1st floor exposing a possible beam slot, looking south

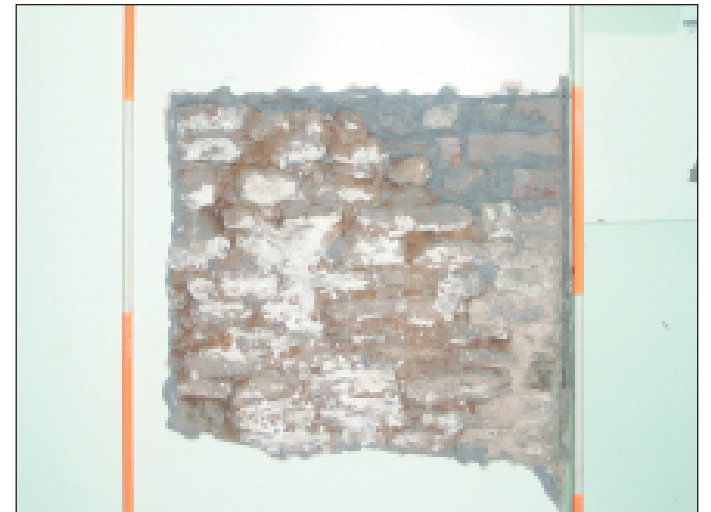
Plate 24 Stripped area in room 3, 1st floor exposing phases of stonework, looking east

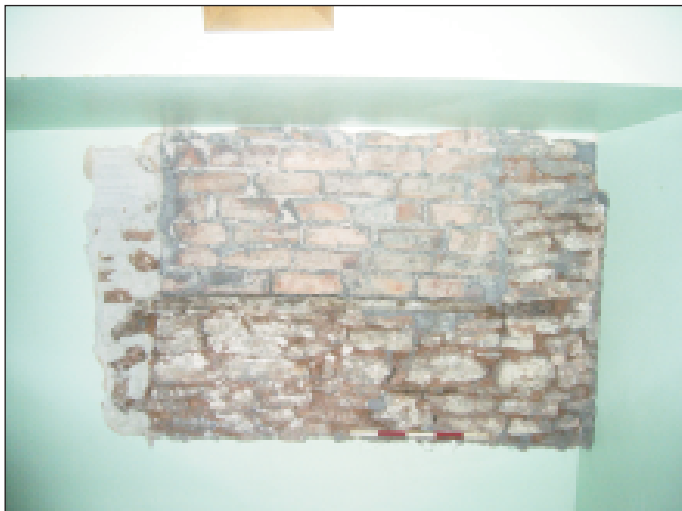
Plate 25 Stripped area in room 3, 1st floor exposing a blocked opening, looking north

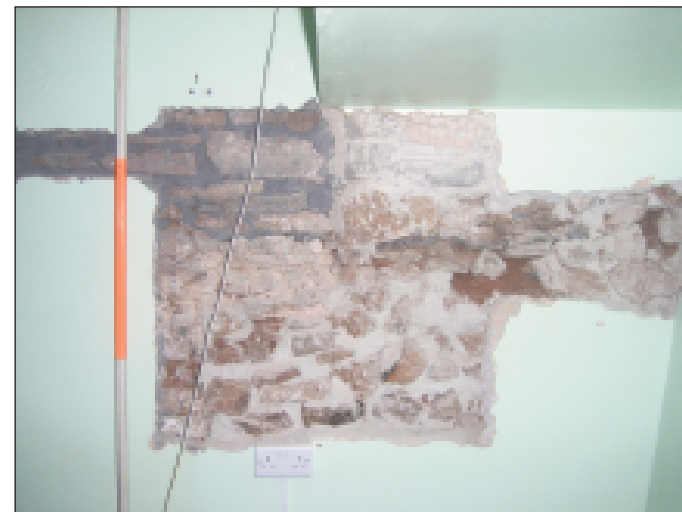
Plate 26 Stripped area in room 3, 1st floor exposing phases of stonework, looking west

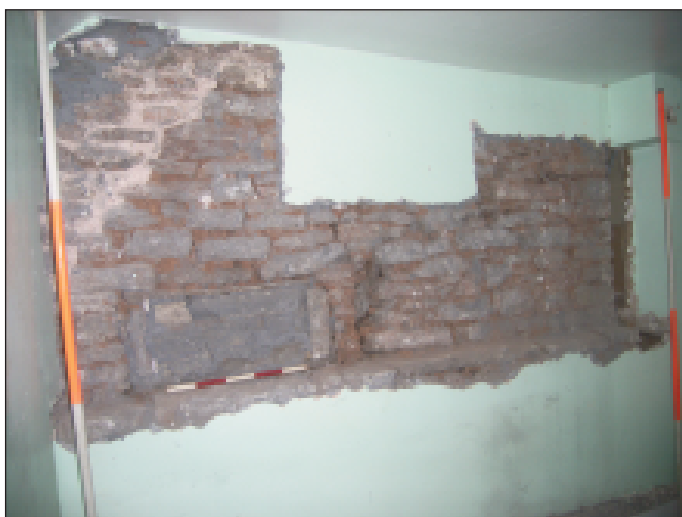
- 5.10 No area was stripped in room 5 as the only historic elevation of this room had been investigated in room 4. Room 6 had an area on the west elevation stripped, which revealed two former rooflines and a small blocked opening, possibly a cupboard (**Plate 27**). The roof

Plate 27 Stripped area in room 6, 1st floor exposing former rooflines and a blocked cupboard, looking north-east

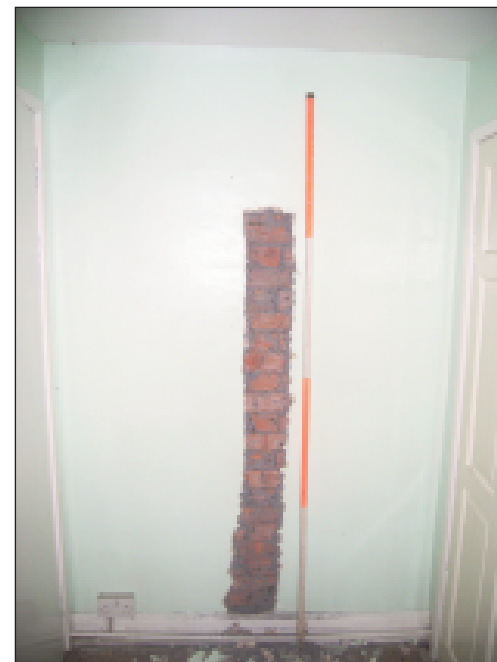
Plate 28 Stripped area in room 6, 1st floor exposing brickwork, looking north
