Mill Hall, Dunnings Lane,
Pulham Market
Norfolk

Historic Buildings Recording

OA East Report No: 1057

Historic Building Survey

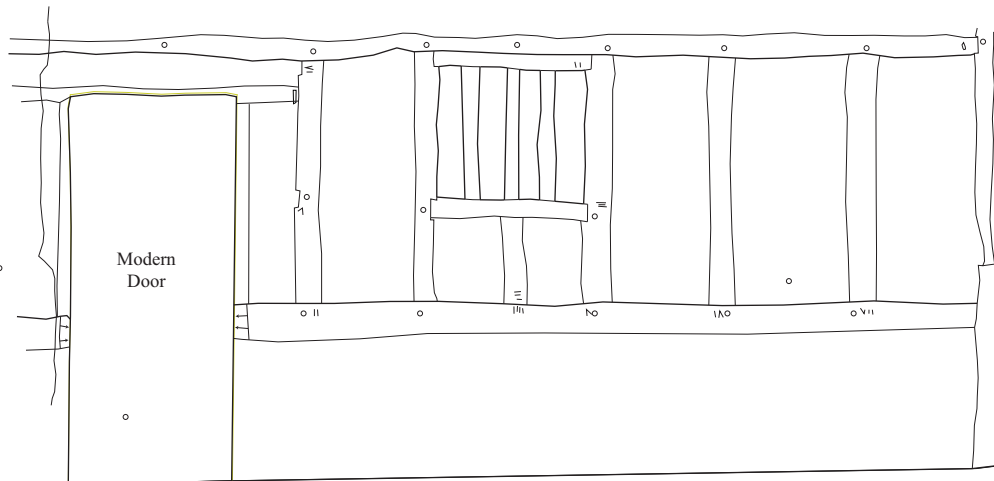
Elevation 1a Ground floor, G1

construction (plate 6). Carpenters marks recorded here also provides evidence that this represents one phase, with little alteration or repair and that the window is also in its original location. It is difficult to tell if the door recorded in this elevation is in its original location. The sill beam which rests upon the plinth to hold the timber structure has a chamfered end where the entrance is located. It is not possible to tell if this is original or added when a doorway was inserted. The location of door on a gable end in this period is certainly not common.
