The Ancillary Buildings Associated With High House, Purfleet, Essex

Historic Buildings Assessment

February 2009

Client: The Regeneration Practice

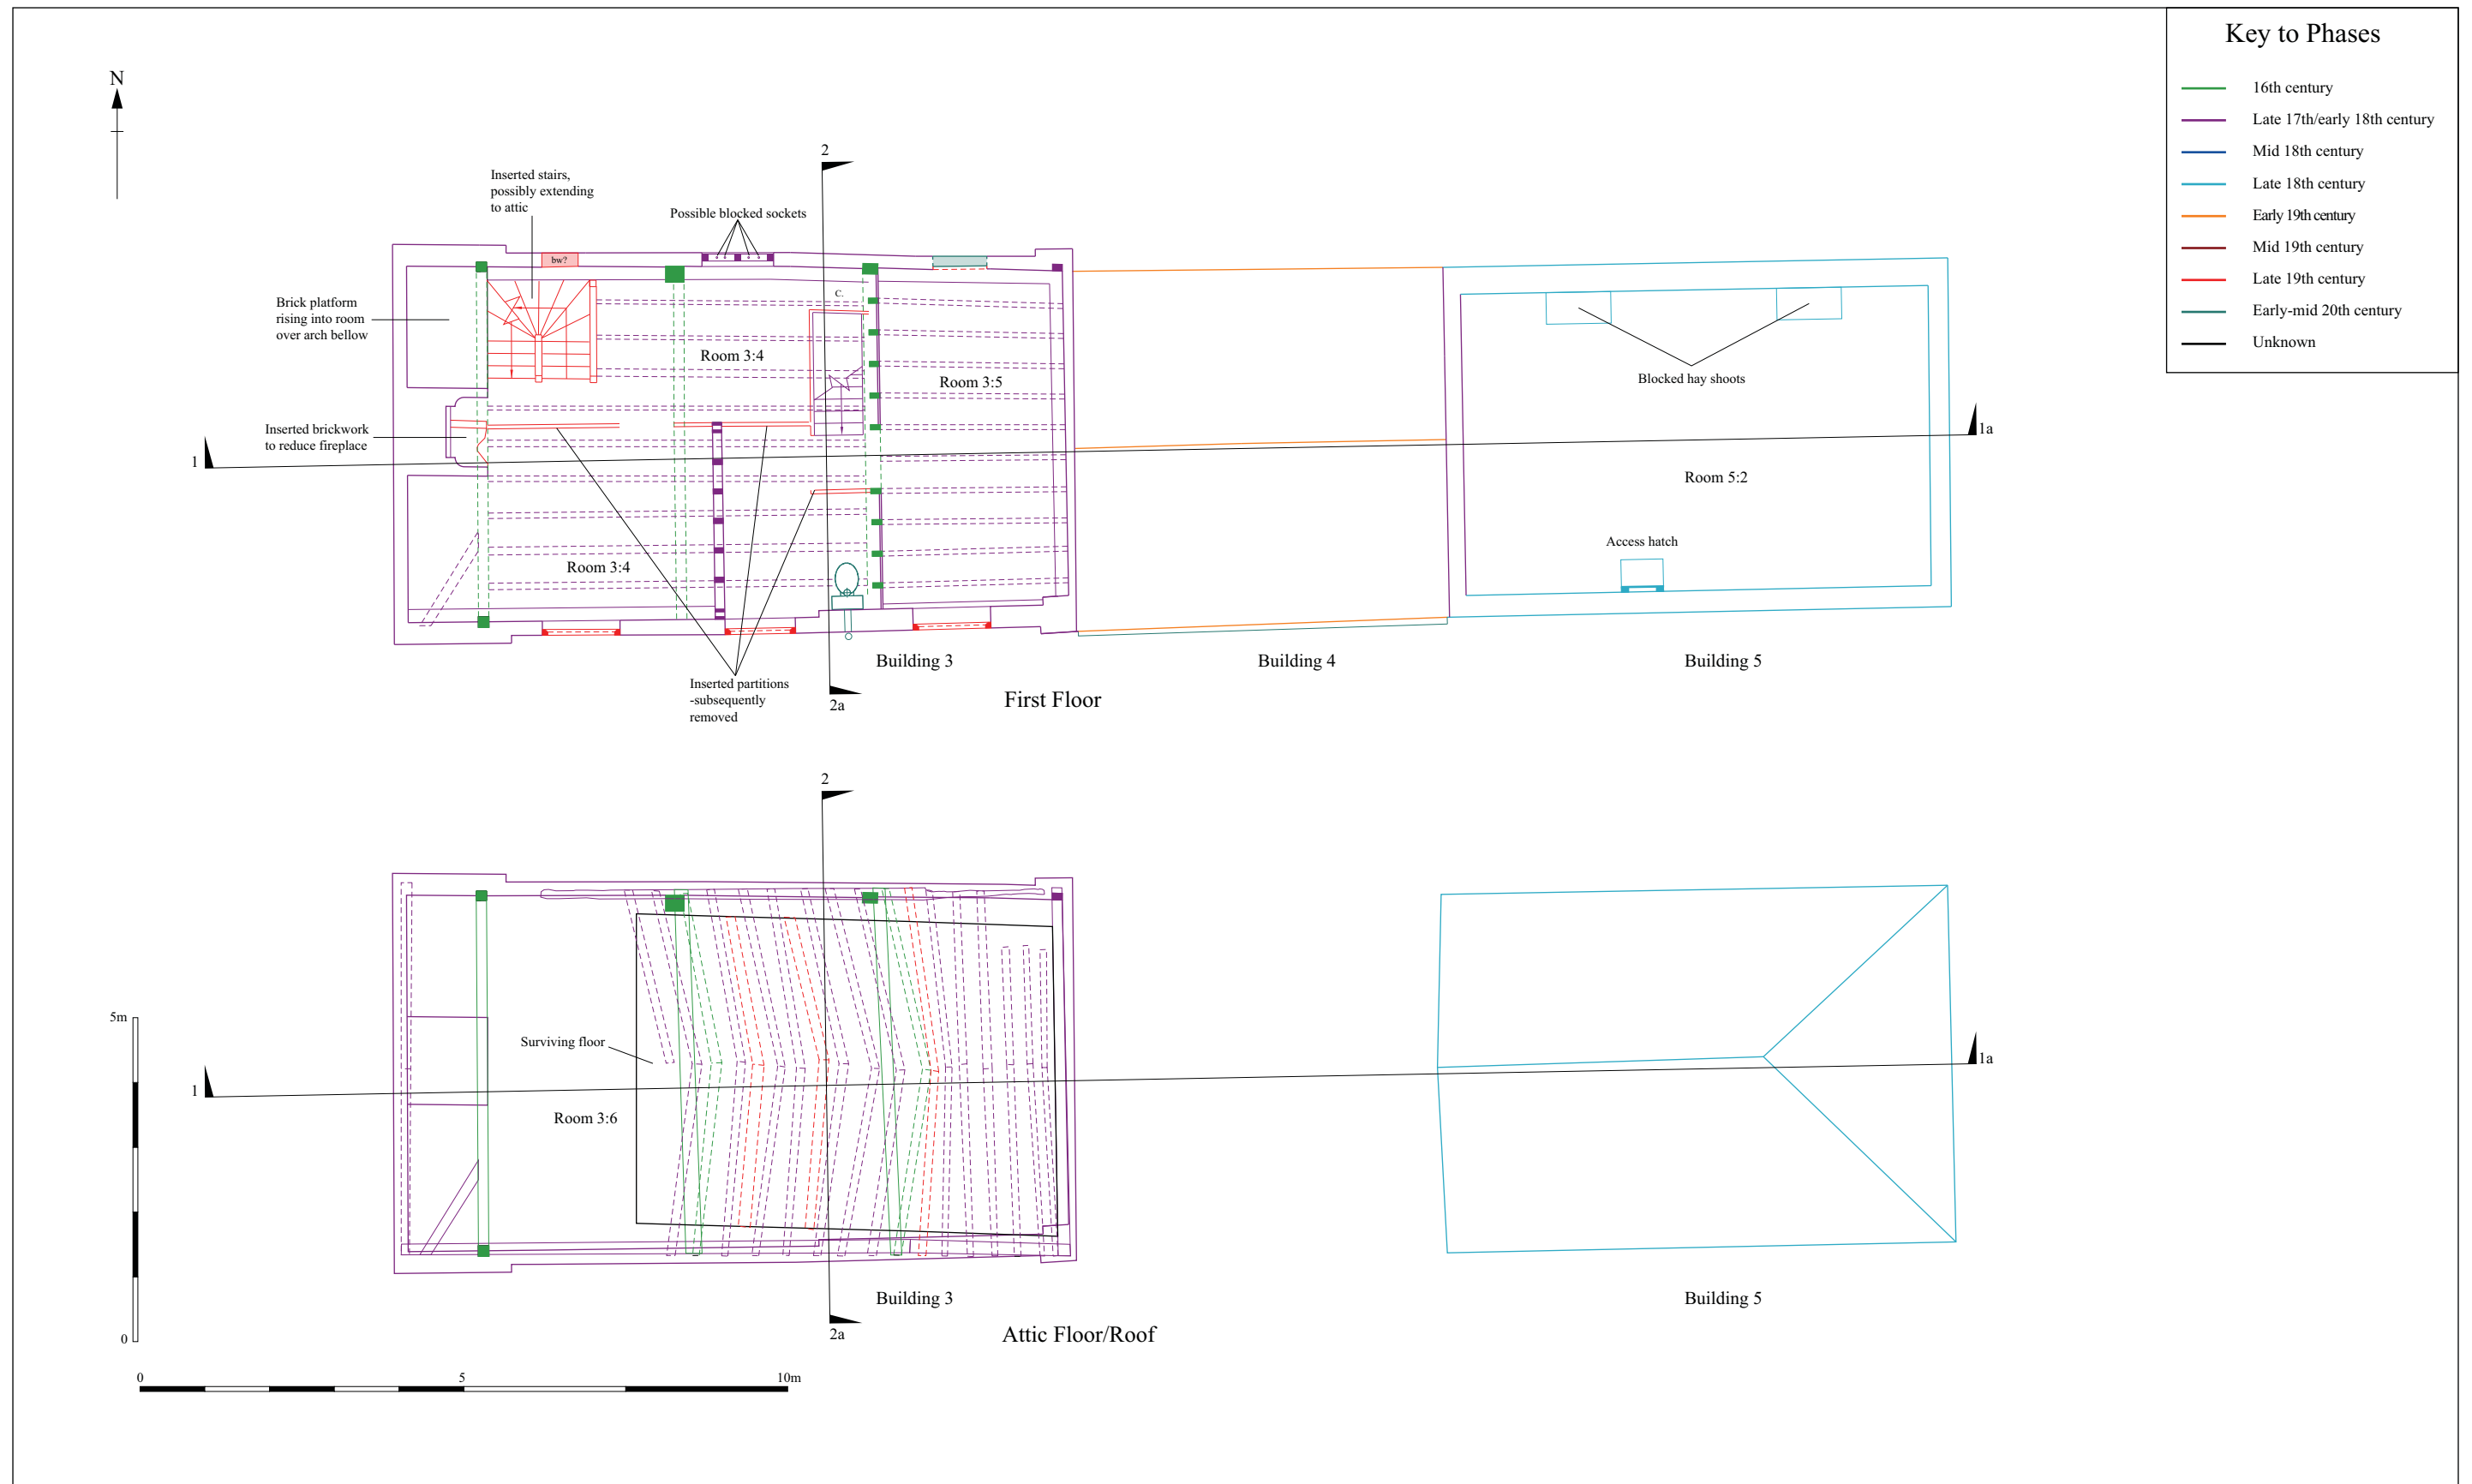
Figure 7: First floor and attic/roof plans of Buildings 3, 4 & 5 at 1:100 (produced from data supplied by The Regeneration Practice)

- 3.3.30 Room 3:5 is visible in plan on Figure 7. Room 3:5 is a small room on the first floor and is also in a very degraded state of preservation, with much rubble covering the floorboards. The north, south and east walls are all of brick construction and the west wall is a timber stud wall, the lower 1m of which is close-boarded and the remainder of the walls has been horse-hair plastered and lime-washed (with some repairs to the plaster using a soft mortar-like substance) – the top part of the western wall has lathes. As with Room 3:2 below, the brick pier in the construction of the wall is visible protruding slightly into the south east corner of Room 3:5. It is here that the only piece of plain board skirting survives painted dark green as it is in other rooms of the building. The joists of the attic floor are visible having been lime-washed, in-between which some lath and plaster survives. The entire north end of the ceiling has caved-in due to

damage to the roof above, which has caused much further damage to the rest of the room. The ingress of water has led to the partial rotting of a structural timber in the north east corner of the room that is embedded into the north wall.

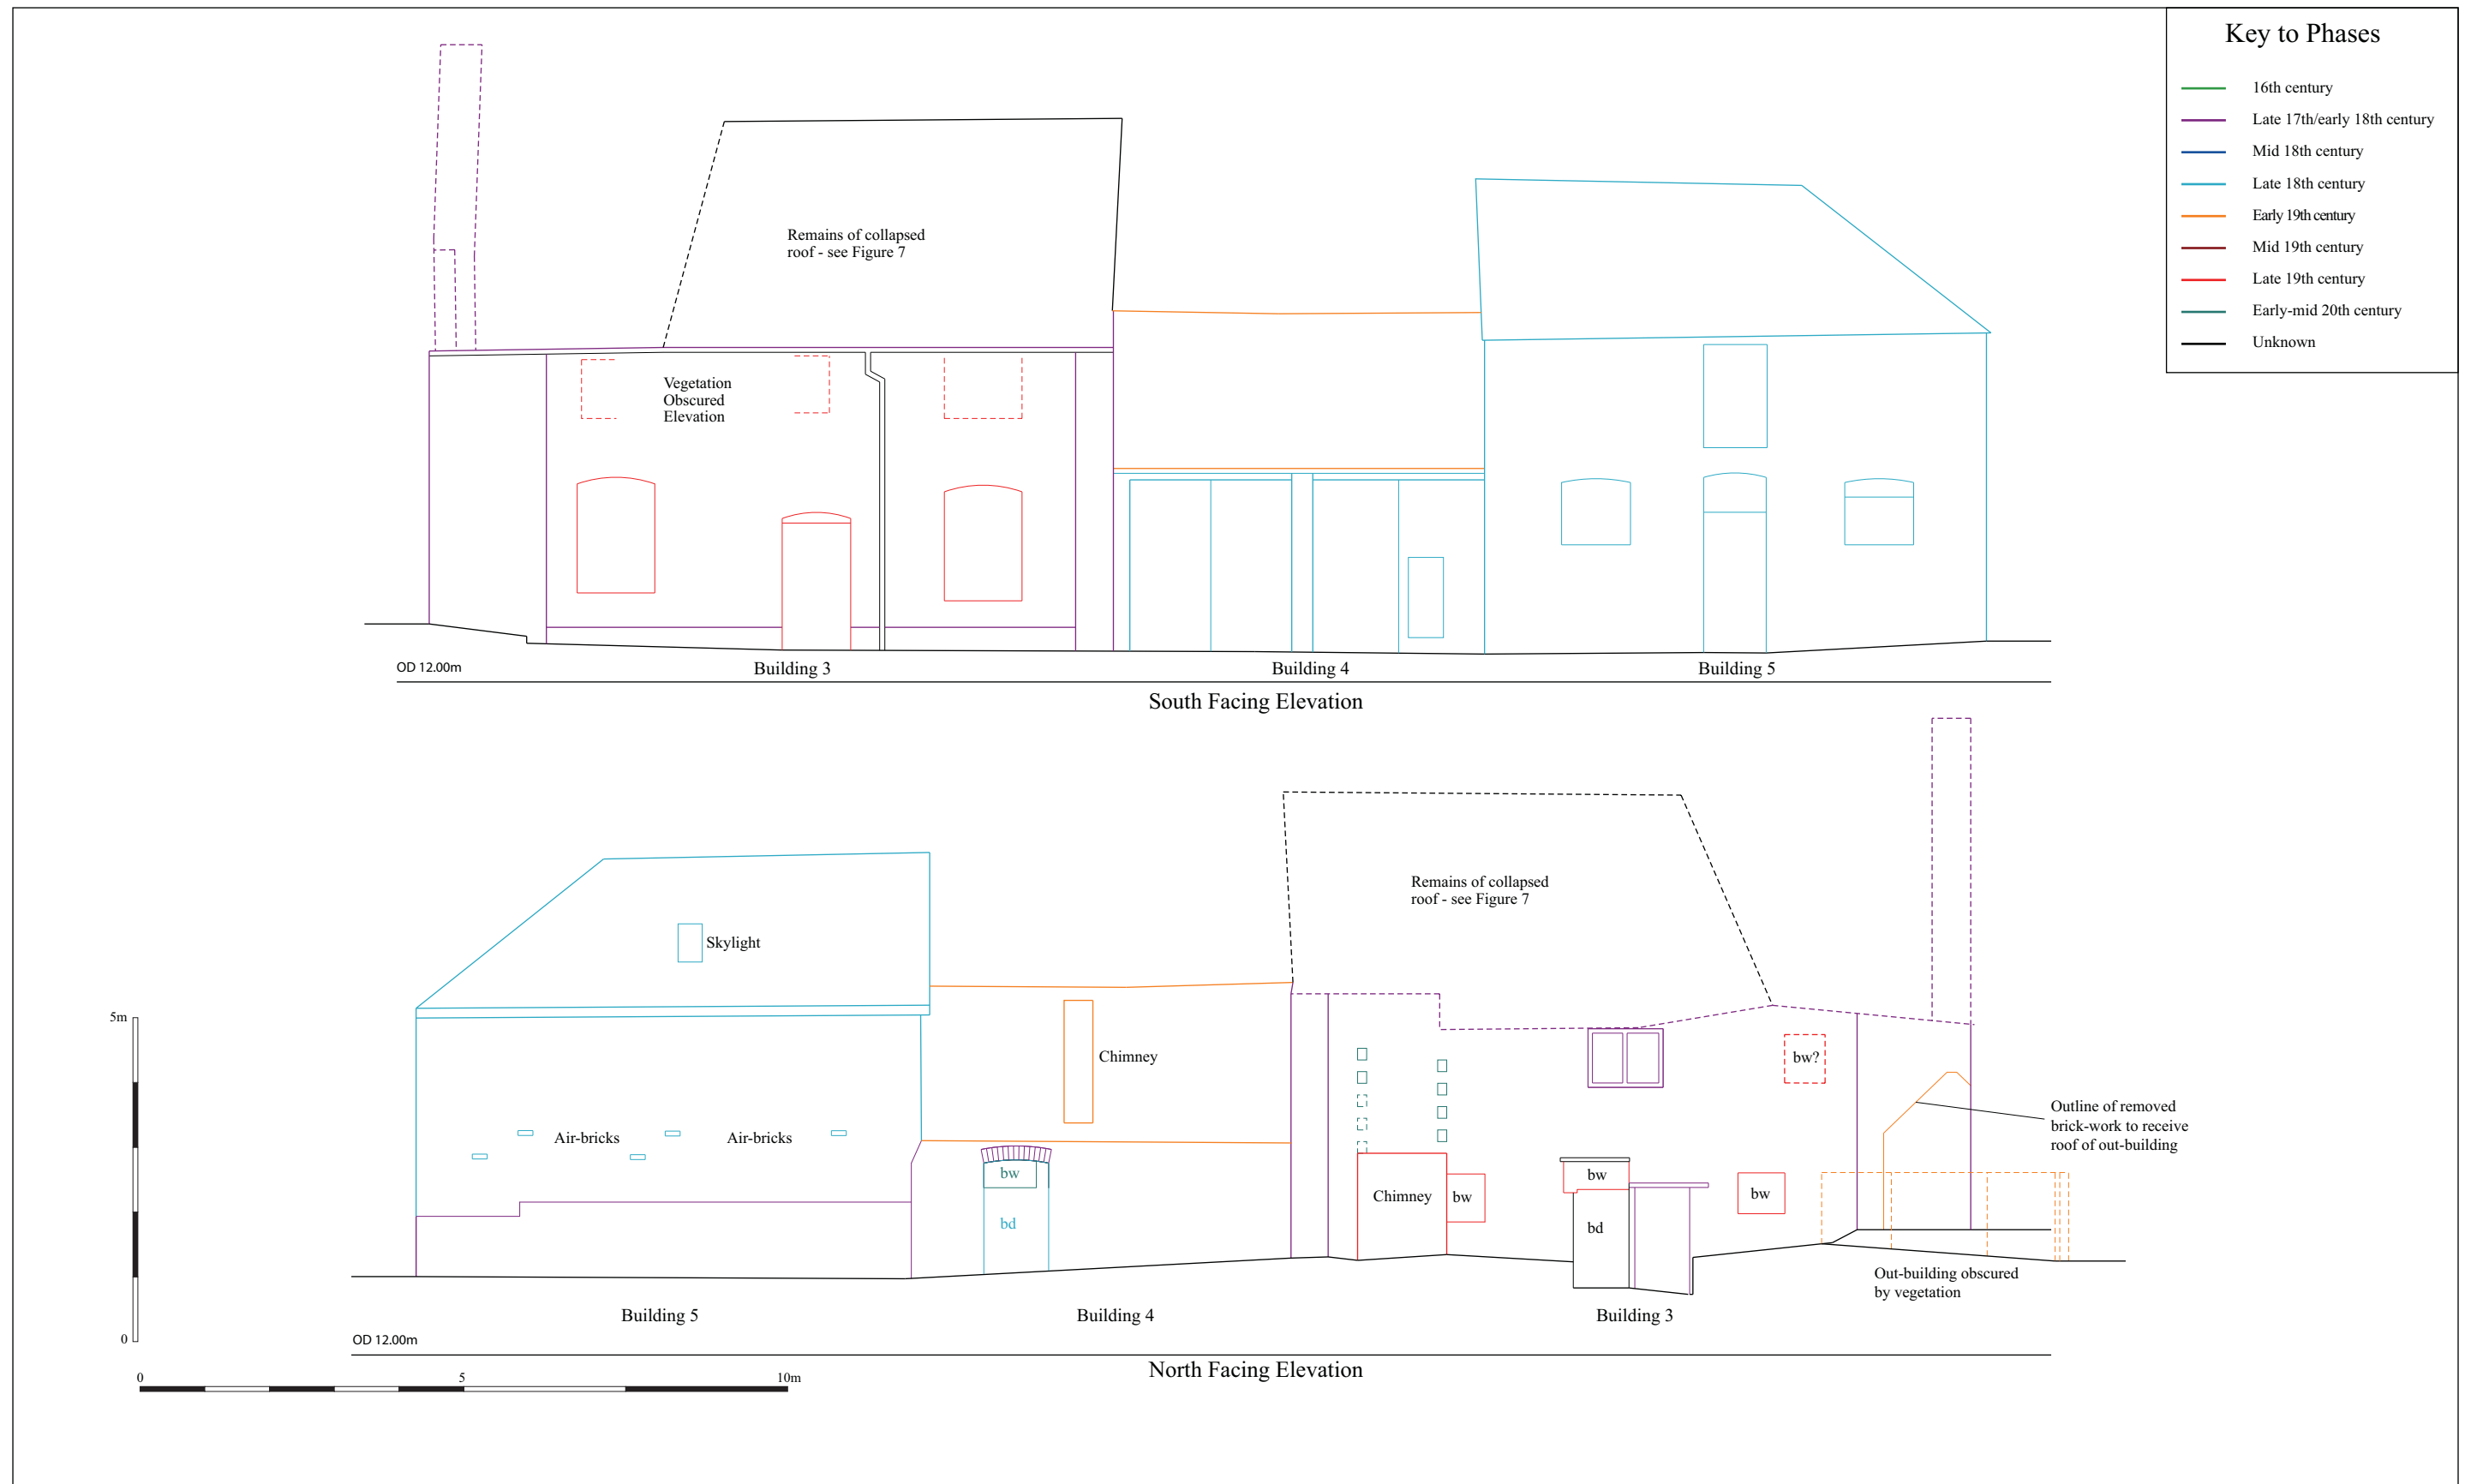
Figure 8: South and north facing external elevations of Buildings 3, 4 & 5 at 1:100 (produced from data supplied by The Regeneration Practice)

- 3.3.6 The north facing elevation (Figure 8) has by far the most complex visible sequence, with many alterations having been made. The brickwork is similar in this elevation to the other visible brickwork (the east and west facing elevations) constructed using dark red bricks in no particular bond, although some areas have a distinctly English bond, others Stretcher bond and there are large areas of the elevation which comprise solely of headers. This may indicate repairs but given the nature of the building it is likely that the erratic bonds are due to the vernacular nature of the buildings construction. In addition to the brick pier on the western corner of the north facing elevation there is one that emulates the one on the western side of the south facing elevation on the western side of the north facing elevation. A single storey structure – of which only some walls and fireplaces survive – has been tacked onto the north west corner of Building 3 (see 3.3.8-3.3.10 below) and the line of a wall and roof of this structure can be seen where some of the brick pier on the western end of the north facing elevation of Building 3 was removed (marked on Figure 8).

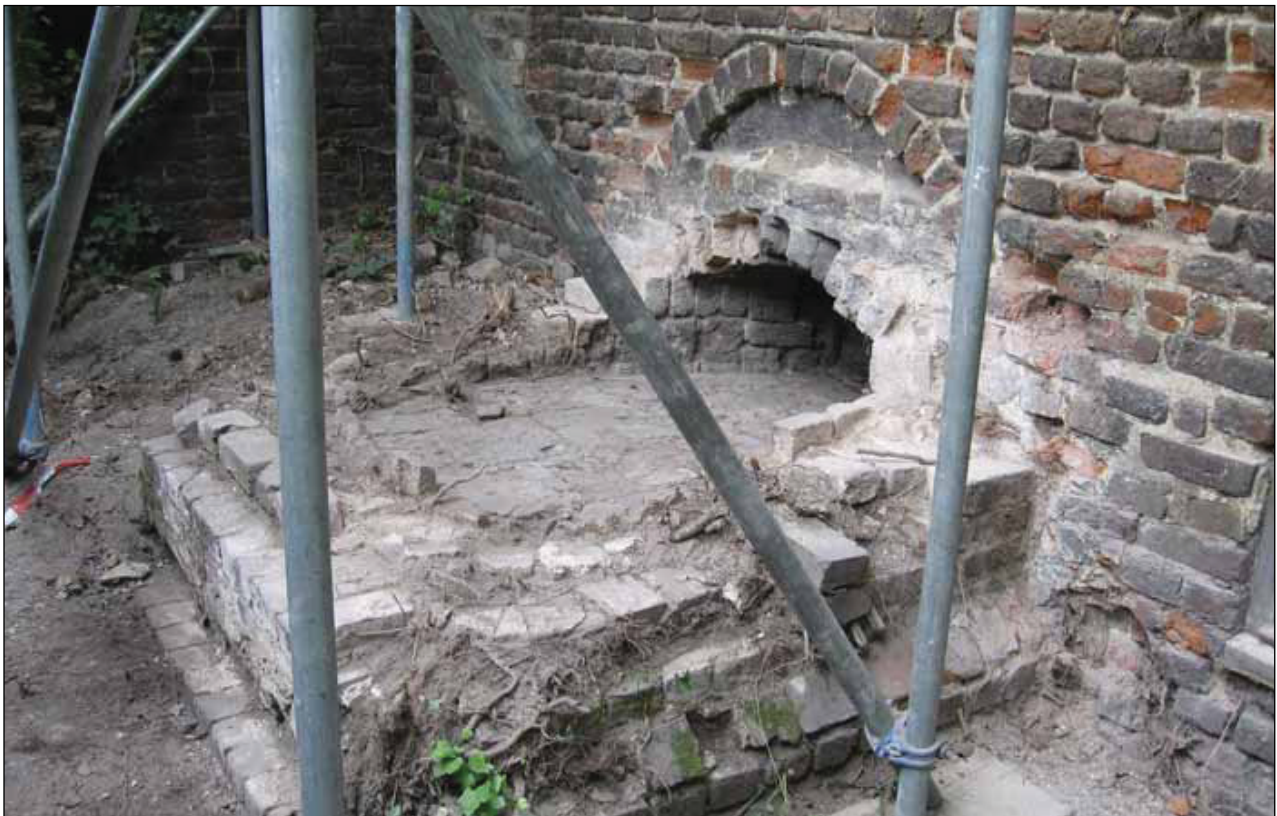
- 3.3.5 The most prominent feature of the west facing elevation are the remains of the bread oven extending from the centre of the elevation at ground level (Plate 6). The plinth base is approximately 1.5m square in plan and although there has been much damage by roots to the two courses of brickwork (which is probably why a canted edge only survives on the south side) the majority remains intact. Raised a further two courses, the sub-circular oven floor surface is constructed of square tiles (damaged by burning) which are surrounded by the foundation bricks of the oven wall, which itself is missing. Some of the bricks incorporated into this wall structure have been frogged implying that the bread oven has been repaired at some point during or after the 19th century. The sub circular nature of the oven floor and the surviving bricks of its wall/roof that are embedded into the wall of the west facing elevation of Building 3 suggest the bread oven would have been dome shaped. In respect of this bread oven there is a brick relieving arch in the west facing elevation of Building 3 and also a small rusted/degrading iron door at the floor level of the oven that leads to the flue of the internal chimney stack (Plate 7). It is through the corresponding internal fireplace and then this door that the faggots (to heat the oven) and foodstuffs would have been passed.

Plate 6: View of bread oven on west gable of Building 3, from south west

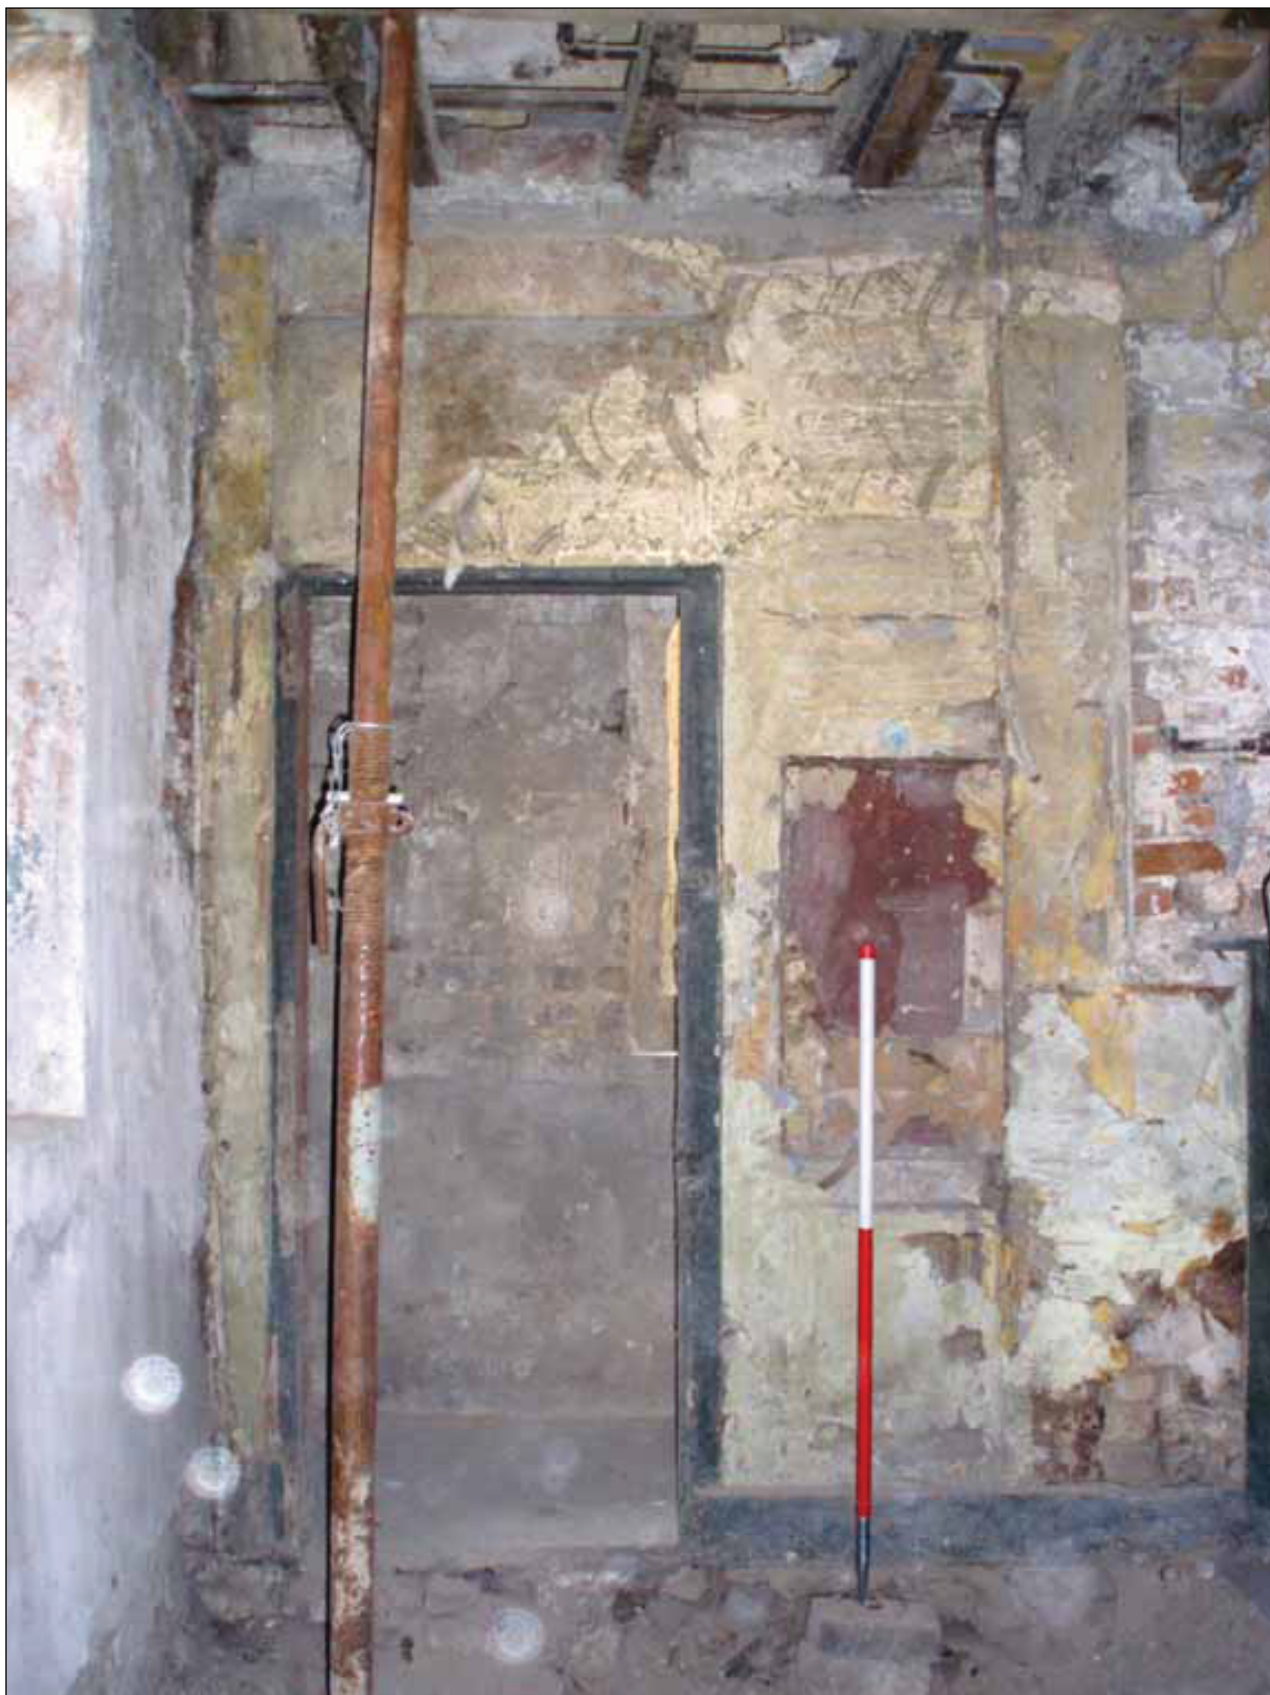
- 3.3.17 The alcove to the south of the fireplace has been partitioned off by the re-use of a section of wall panelling, creating a cupboard (Plate 13). This has not only been carried out very crudely but has suffered much damage and neglect making analysis difficult. The northern section of this partition consists of one piece of double sided panelling consisting of two smaller plain rectangular panels and one larger plain rectangular panel in the centre – although the top panel is only visible from inside the alcove. Although none of the panels have mouldings they are all raised with angled fields and the lower panel is actually hinged on two butterfly hinges, which were used throughout the 17th and 18th centuries (Hall 2005, 52-53). Another interesting point is that there are two rail pieces separating the top and middle panels, suggesting the design encompassed a picture rail. The southern section of this partition includes a doorway – unfortunately with no door surviving – and is possibly also re-used from a panelled stud wall, possibly the same section as the panels. The south wall of this southern alcove is also lined using a panel of tongue-and-groove boards which seems to be made up of three sections in its height. The top section has remained in place, the middle section has slipped out of position and the bottom section is almost all missing. Several layers of Victorian style wallpaper with roller printed designs survives on both sides of the panelled partition that now separates this alcove from the room as well as the tongue and groove panelling on the south wall of the alcove. This missing panel reveals unusual brick work in the wall (Plate 14) where after rising flat for four or so courses the wall becomes slightly curved (see inset, Figure 6) implying it was constructed in order to accommodate something large and circular.

Plate 13: Inserted panel south of fireplace in Room 3:3, taken from east

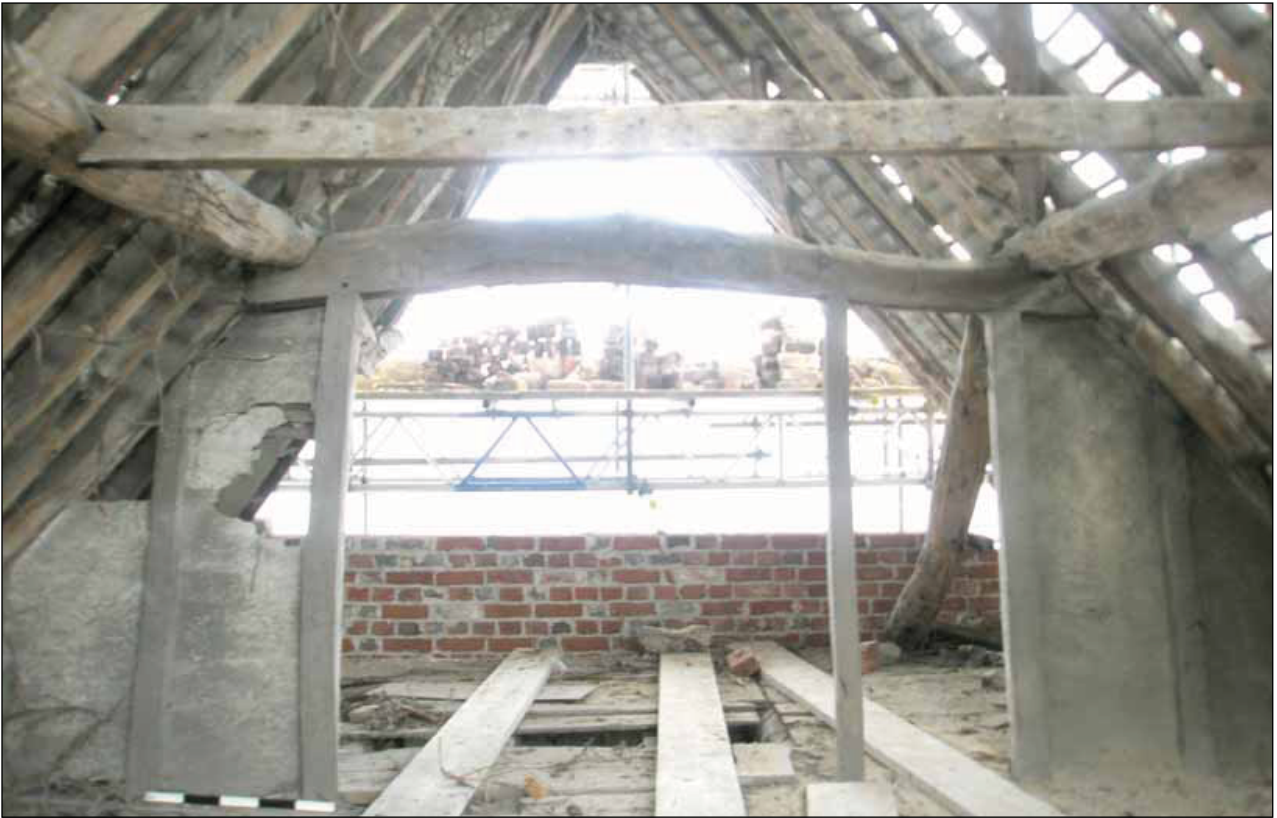
- 3.3.33 The Room 3:6 is visible in plan on Figure 7. The attic space (Room 3:6) has suffered very badly from exposure damage, mostly as a result of racking, in which the rafters have leant to the east causing the total collapse of the west end of the roof. The east gable and upper section of the chimney stack at the west end have been totally rebuilt during repair works that were under-way at the time of this investigation. In order to rebuild the collapsed rafters the floor surface has been partially re-built using boards and scaffolding planks. Two collar and tie-beam trusses survive (the eastern-most of these is shown in Section 2, Figure 9 and Plate 21), each with queen struts and the eastern truss has five extra struts leaving a void in the centre. Other than the larger central void, the gaps between these struts in the eastern truss have/had lathes on the eastern side which have been plastered on both sides, in effect creating a smaller room. The collars support heavy clasped purlins and subsequently the common rafters, which are of much the same dimensions as the principle rafters, all rafters have had sprockets added.

Plate 21: Eastern truss in Room 3:6, taken from west

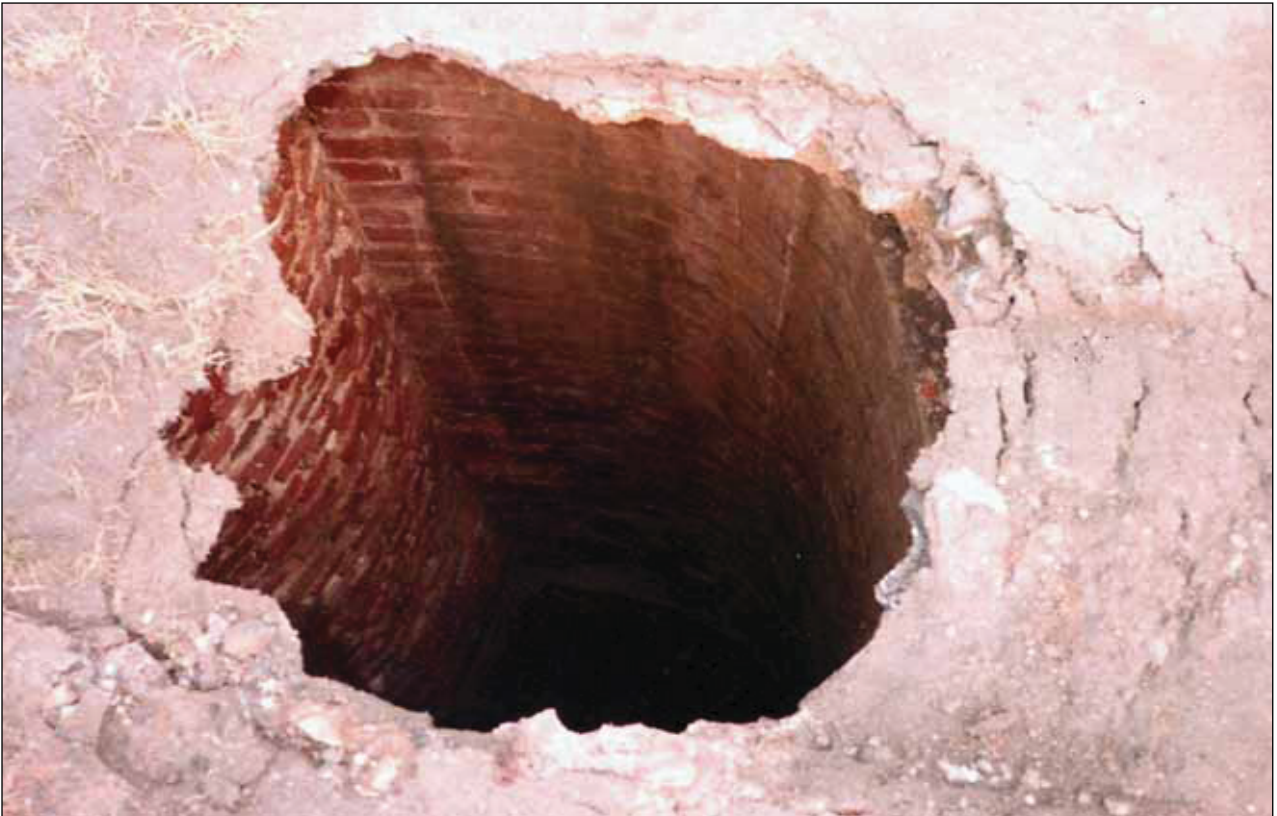
Plate 39: Collapsed ground over a holding tank in the centre of the main courtyard, c.1985. The wall of the well shaft is visible on the left (photograph of unknown origin)

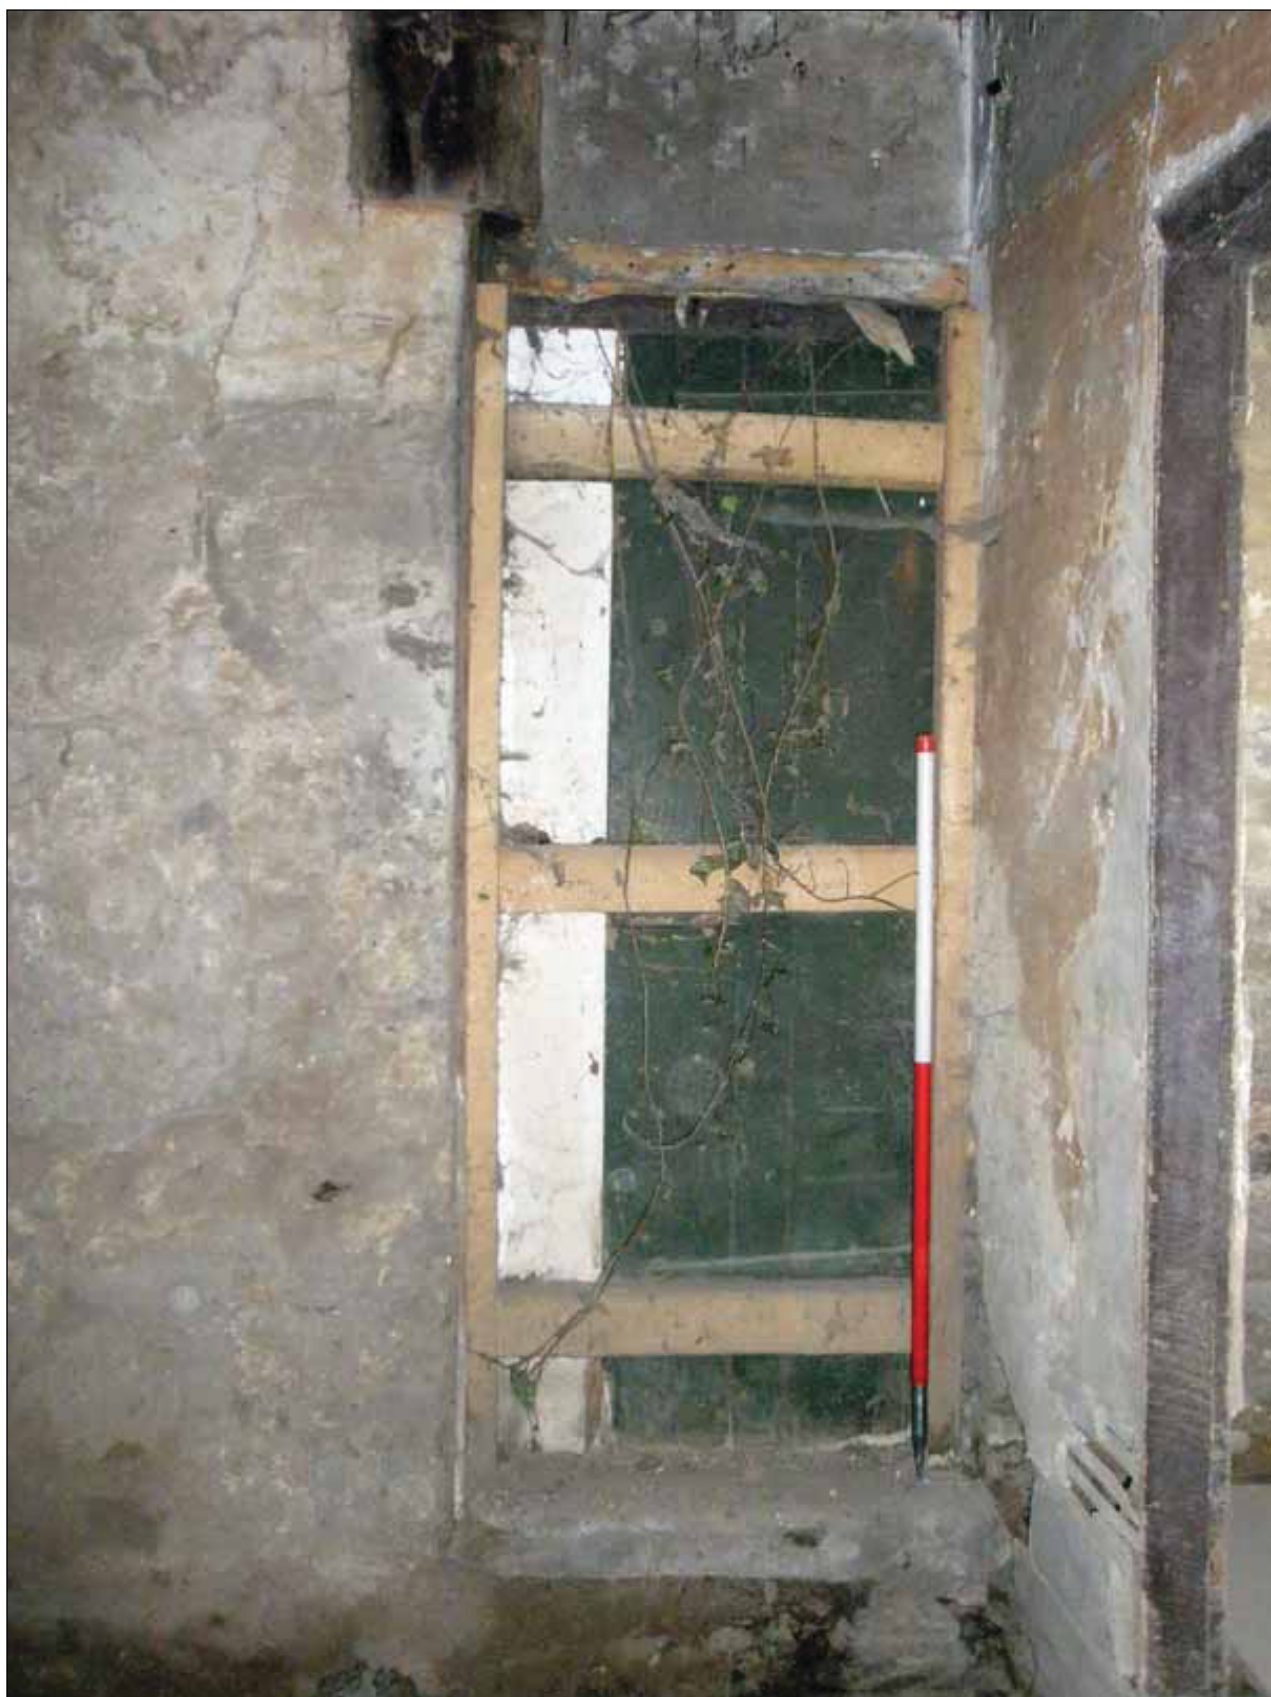
Plate 40: Door and cut wall-post in north wall of Room 3:3

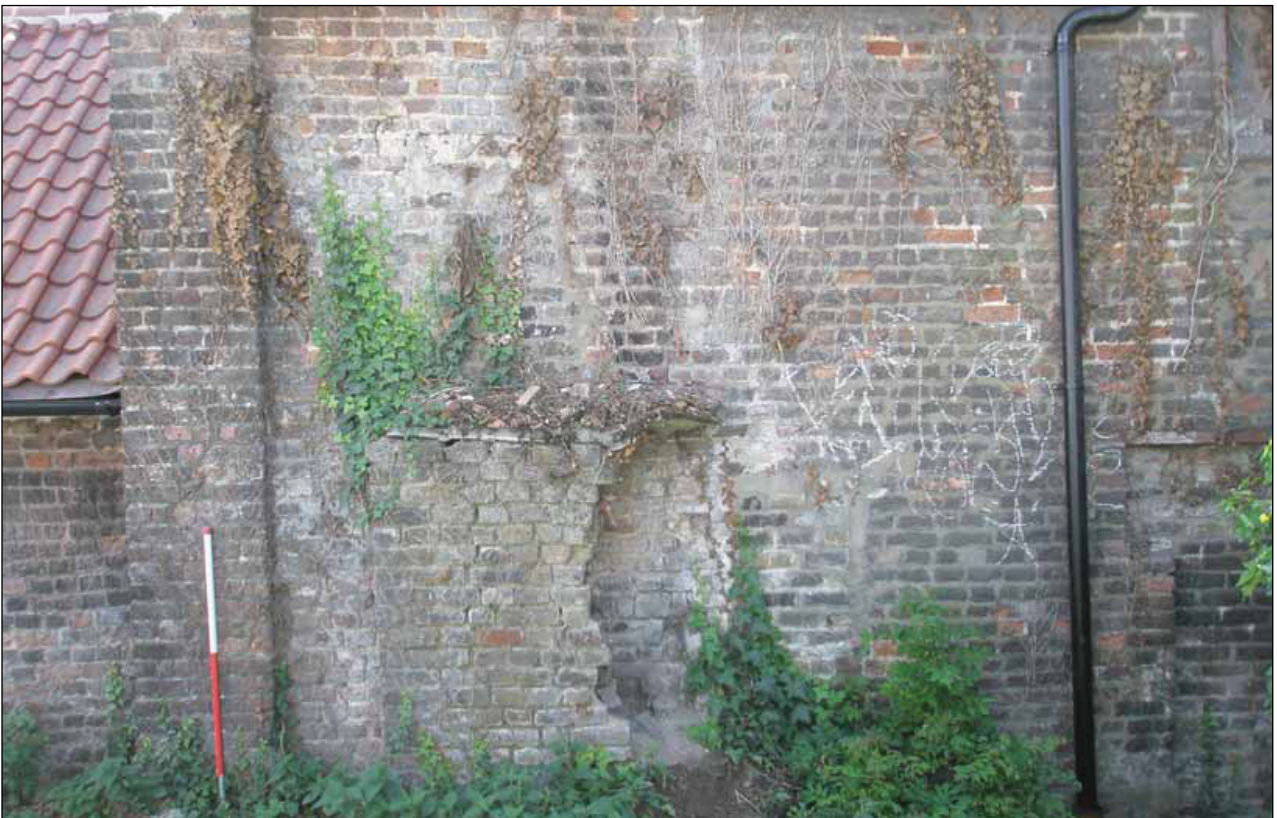
Plate 42: Partially removed chimney stack on north wall of Building 3

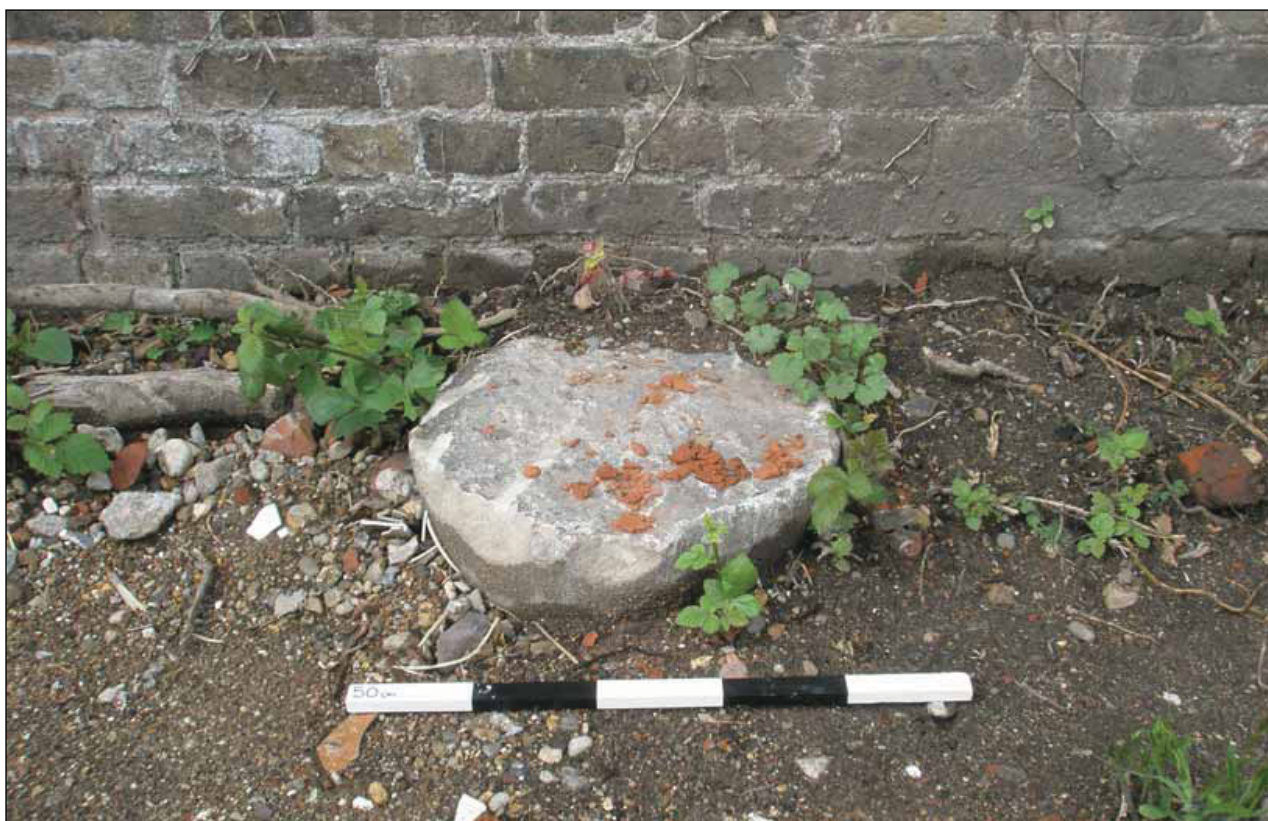
plate 44: Upturned and buried staddle in front of Building 5
