**St Wilfrids Church**

**Calverley**

Archaeological Watching Brief

Report no. 2767

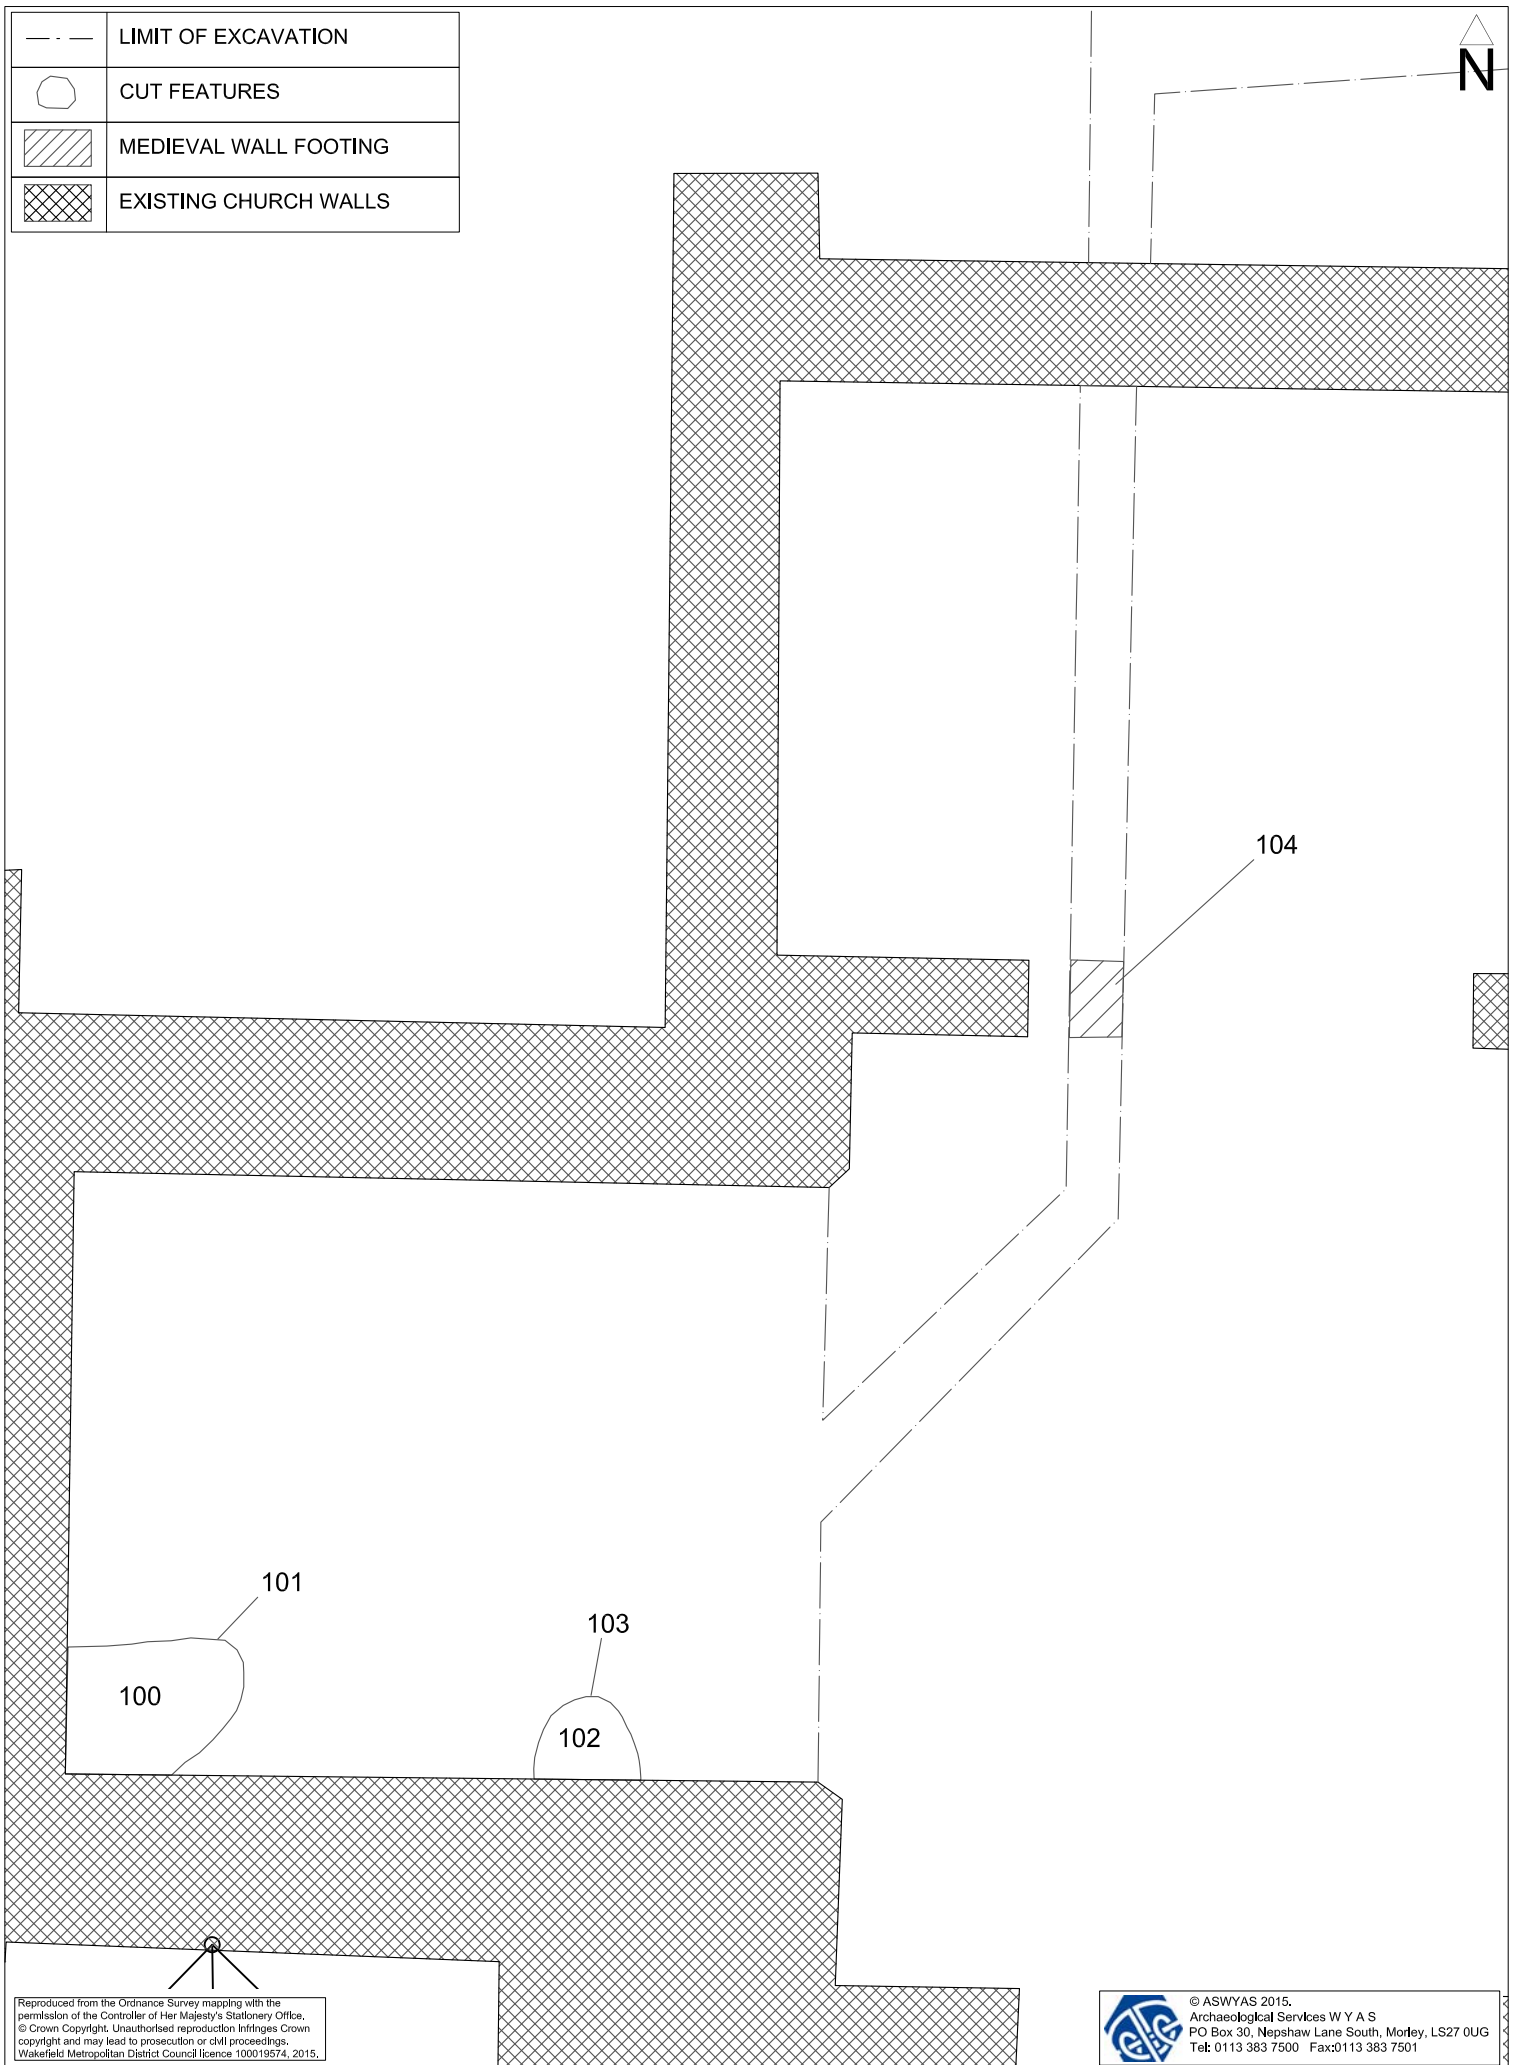
Fig. 3. Plan of archaeological features (1:50 @ A4)

An area of 5m x 4m, within the standing walls of the tower was reduced by around 500mm. This exposed the base of the tower's foundations which were a single course of stone 200mm thick, bonded with lime mortar and laid directly onto the sandstone bedrock. A further 250mm of bedrock was excavated beneath the foundations to reach the desired level. Two features were observed cutting the natural and they extended beneath the tower's foundations.

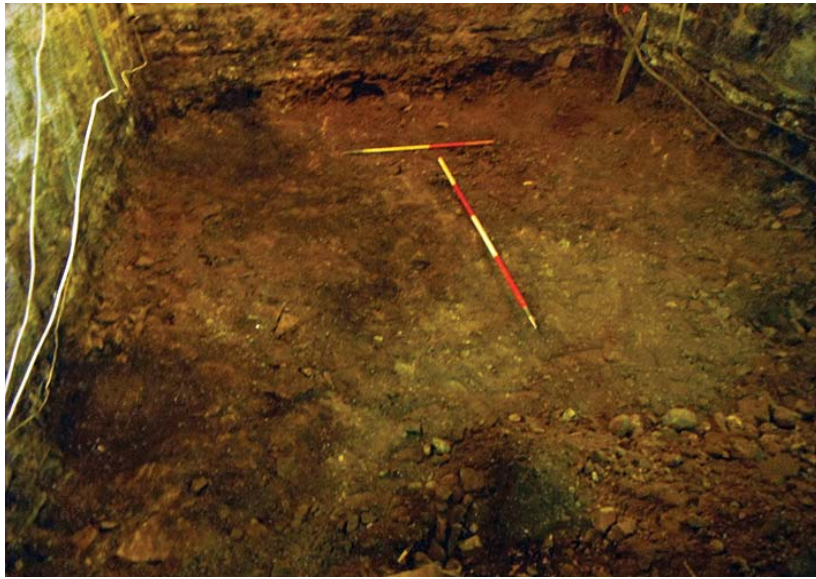
Feature [101] measured 1.14m long and 0.88m wide before extending beyond the south-west corner of the tower. It was backfilled with a charcoal-rich, blackish sandy-silt with frequent brick or tile and mortar fragments (100). A stem fragment of undated clay pipe was recovered from the surface of the fill. The feature had a sub-rounded, elongated shape with steep sides and east-west alignment. This was consistent with a grave cut though its modern fill suggests it post-dates, and therefore undercuts, the tower wall (dated to the 13th or early 14th-century), rather than being sealed by it. As it is unlikely a grave would undercut an existing wall, feature [101] is much more likely to be an inspection pit for the foundations. Feature [103] was similarly seen undercutting the southern wall of the tower 3m to the east, though the lack of an east-west alignment again suggests the feature is not a grave. The feature was backfilled with a blackish silty-sand with occasional small lime mortar fragments (102).

*Plate 1. View of tower excavation and features 101 and 103, looking west*

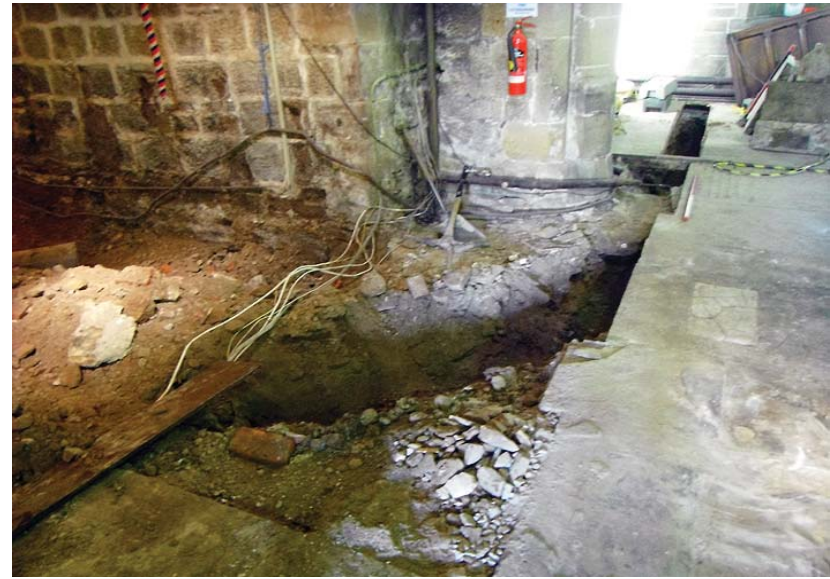
The drainage trench extended for 9m from the tower, across the west end of the nave and northern aisle and measured 600mm deep and 300mm wide towards the church's present exterior northern wall. No archaeological features were seen beneath the flagstones aside from an east-west aligned wall foundation between the nave and northern aisle (104). The foundation was a single course of stone, measuring 1m in width and 200mm in depth, again laid directly onto the bedrock. As the aisles and gothic arches are 15th-century additions to the nave, it is likely that the footing was the base of the exterior wall of the nave during an earlier phase of the church's construction, possibly dating to the 11th or early 12th-century. The drain was inserted beneath the footing, allowing it to be preserved in-situ.

*Plate 2. Completed drainage trench across the nave, looking north*

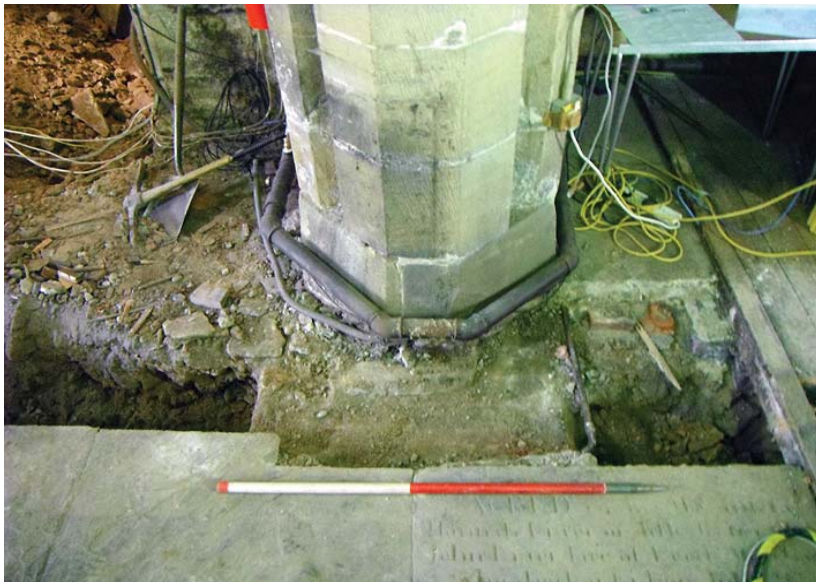
*Plate 3. Base of gothic pillar on base of earlier foundation, looking west*

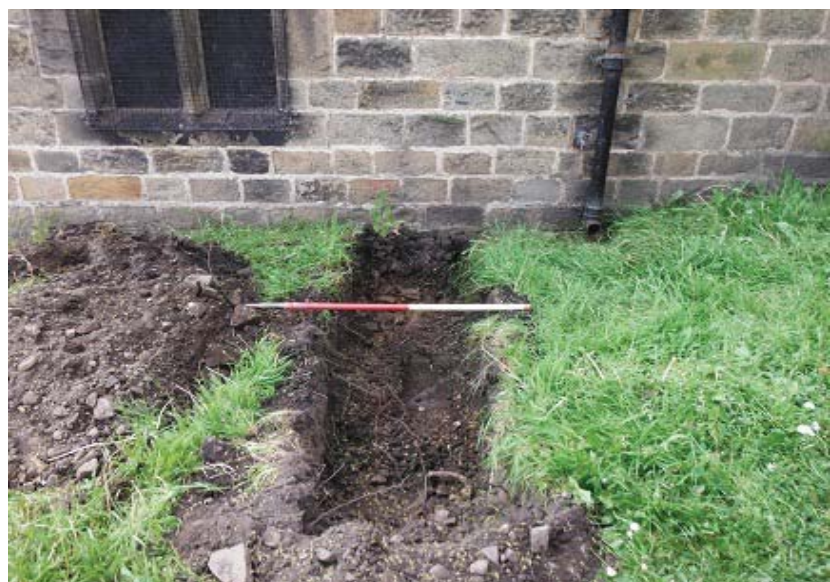
Beyond the northern wall of the church the drain extended for around 17m before feeding into an existing drain. Here the trench increased to 800mm wide and dropped to a level of 1.3m in depth. The drain managed to avoid disturbing any in-situ burials, although a small amount of disarticulated human remains were disturbed which were returned to the church for reburial.

*Plate 4. Excavation of topsoil from external drain trench, looking south*
