**First White Cloth Hall  
Kirkgate, Leeds  
West Yorkshire**

Archaeological Watching Brief  
and Structural Watching Brief

Report no. 3460  
October 2020

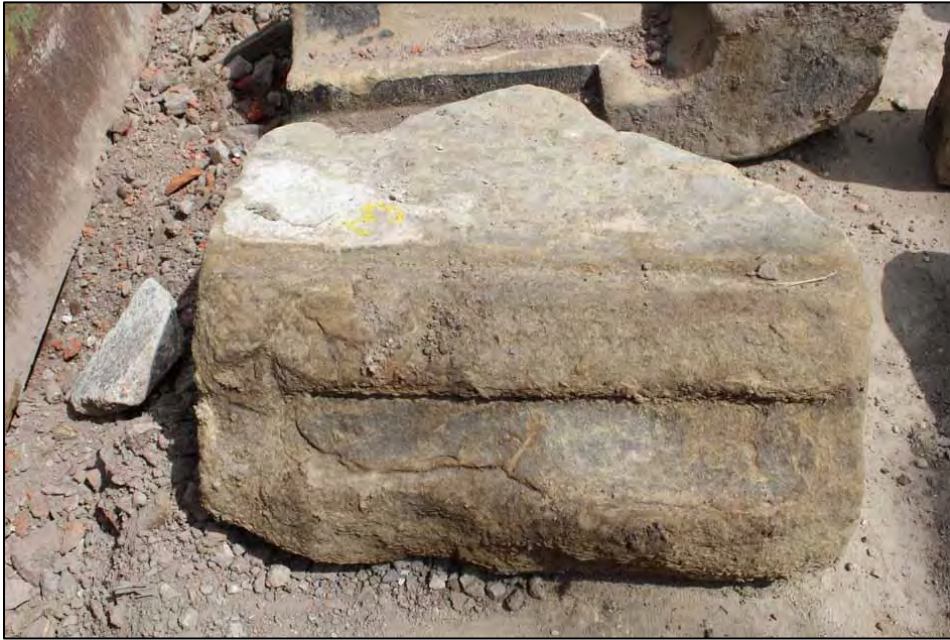
**STONE 3**

<b>Condition</b>	<b>POOR</b>
<b>Measurement</b>	L:600mm
<b>Description</b>	Cornice piece

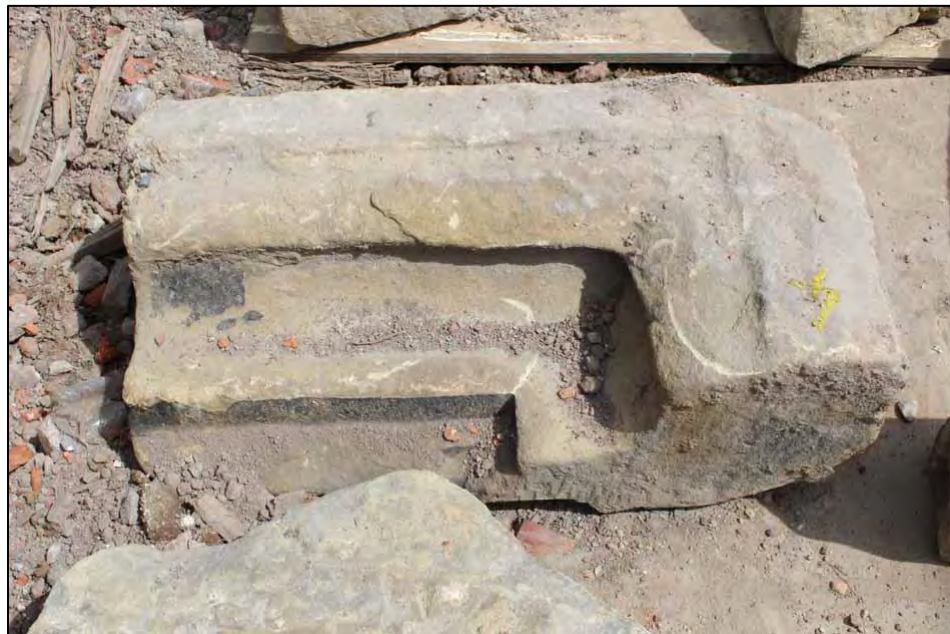
**STONE 4**

<b>Condition</b>	<b>GOOD</b>
<b>Measurement</b>	L:800mm W:450mm D:260mm
<b>Description</b>	Probable corner cornice piece

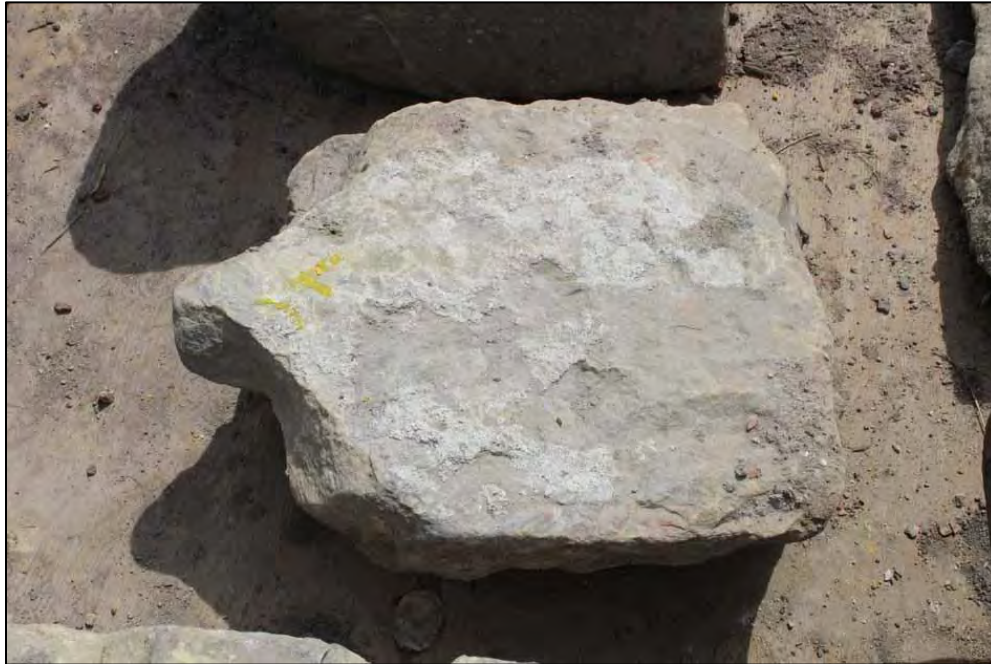
**STONE 7**

<b>Condition</b>	MODERATE
<b>Measurement</b>	L:370mm W:300 D:150mm
<b>Description</b>	Unidentifiable - shaped to a rough point to one end

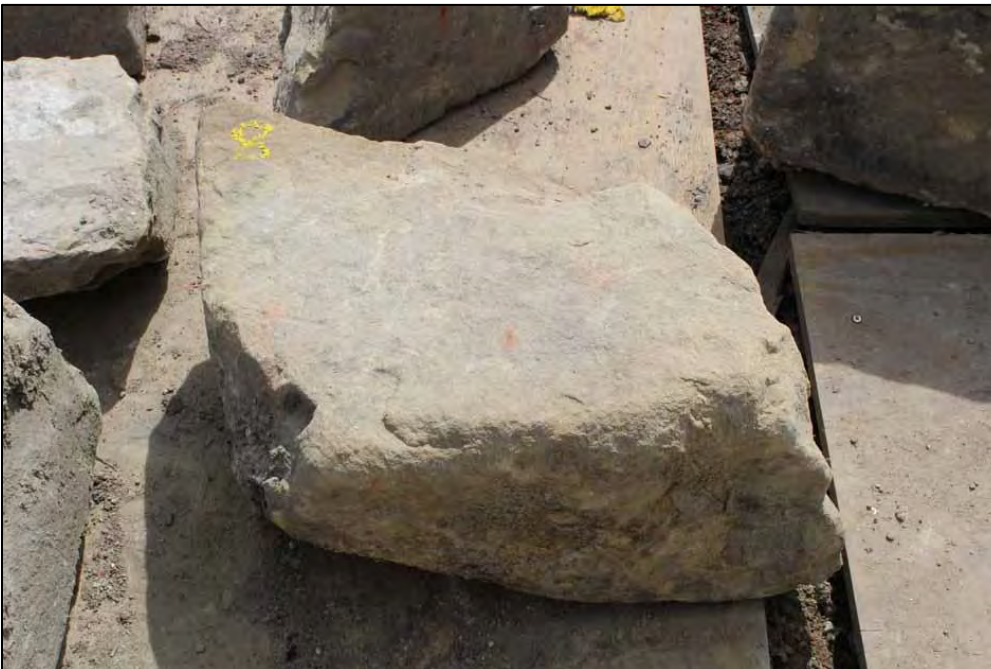
**STONE 8**

<b>Condition</b>	POOR
<b>Measurement</b>	L:450mm W:400mm D:260mm
<b>Description</b>	Unidentifiable - possible base piece

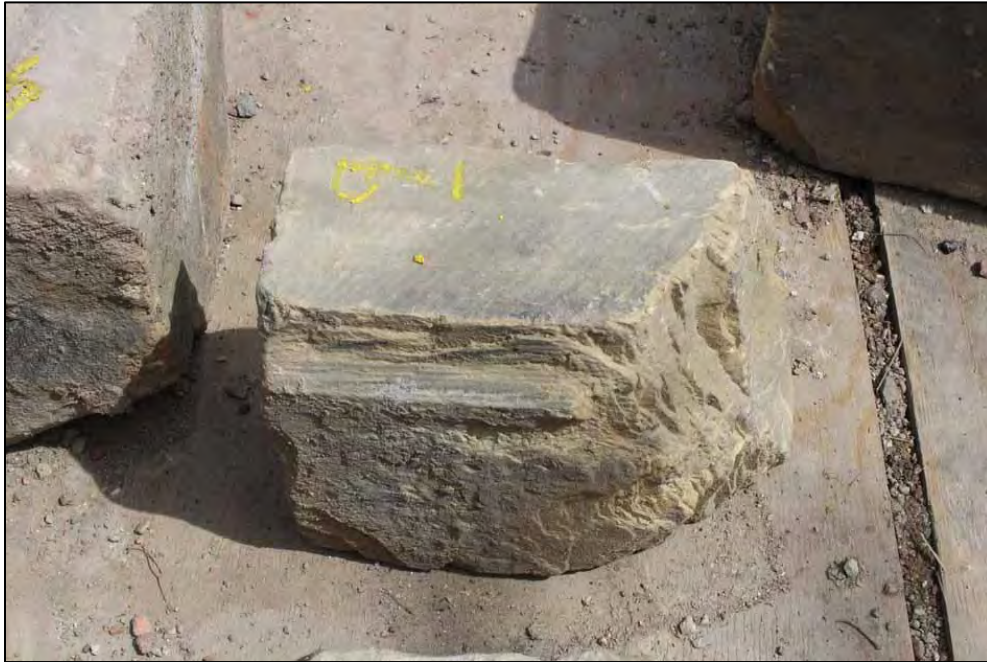
**STONE 9**

<b>Condition</b>	MODERATE
<b>Measurement</b>	L:300mm W:260mm D:130mm
<b>Description</b>	Possible door/window surround (sawn face)

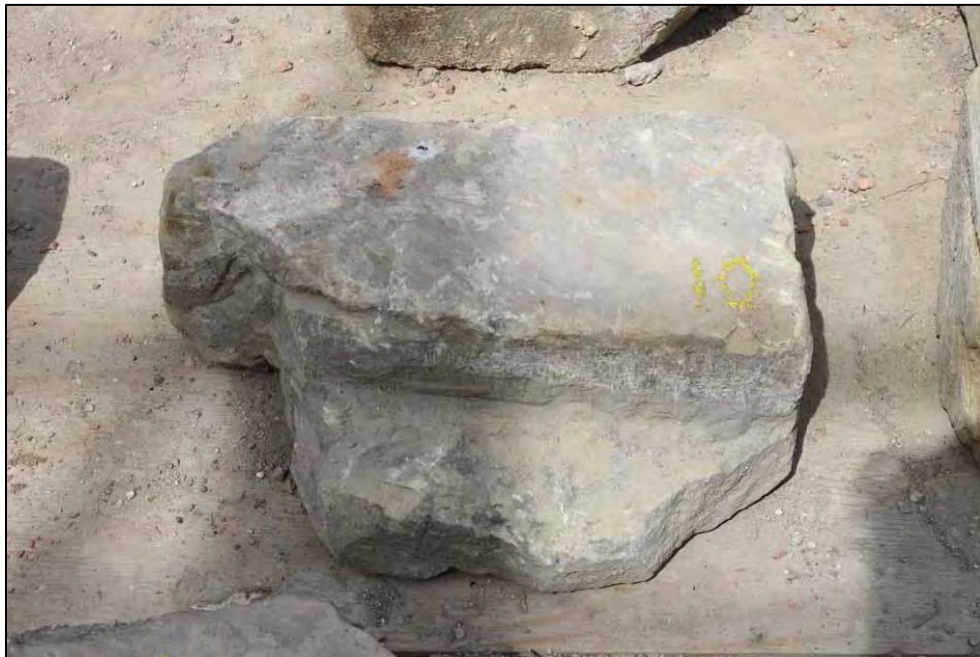
**STONE 10**

<b>Condition</b>	MODERATE
<b>Measurement</b>	L:440mm W:350mm D:180mm
<b>Description</b>	Possible base piece (stepped)

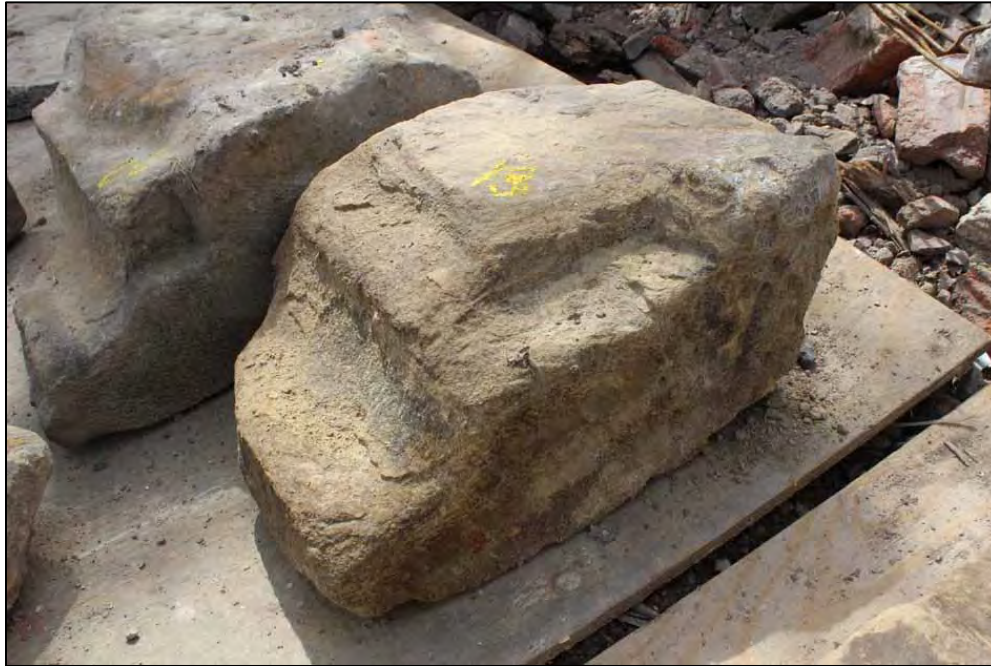
**STONE 13**

<b>Condition</b>	GOOD
<b>Measurement</b>	L:500mm W:350mm D:260mm
<b>Description</b>	Uncertain - possible plinth or cornice

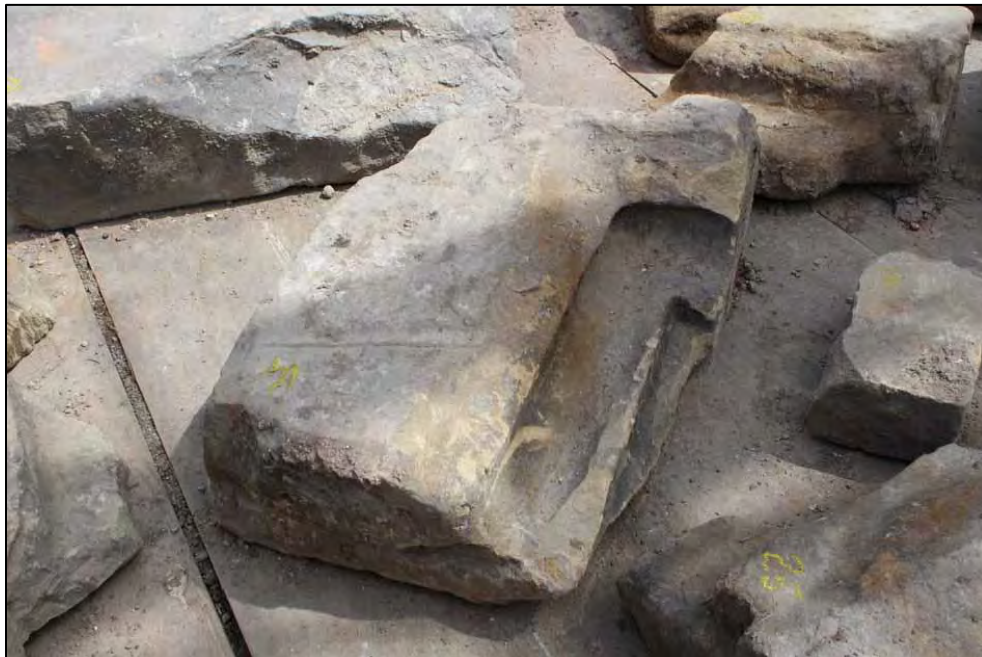
**STONE 14**

<b>Condition</b>	GOOD
<b>Measurement</b>	L:900mm W:600mm D:260mm
<b>Description</b>	Corner cornice, same as Stone 4

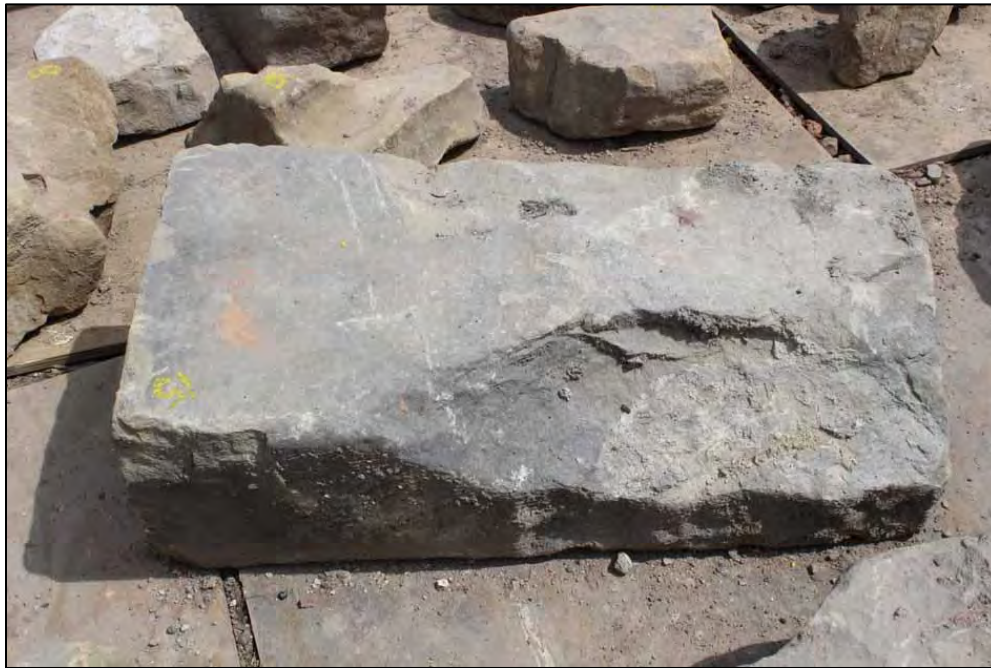
**STONE 15**

<b>Condition</b>	GOOD
<b>Measurement</b>	L:1000mm W:500mm D:260mm
<b>Description</b>	Column/pillar section for archway

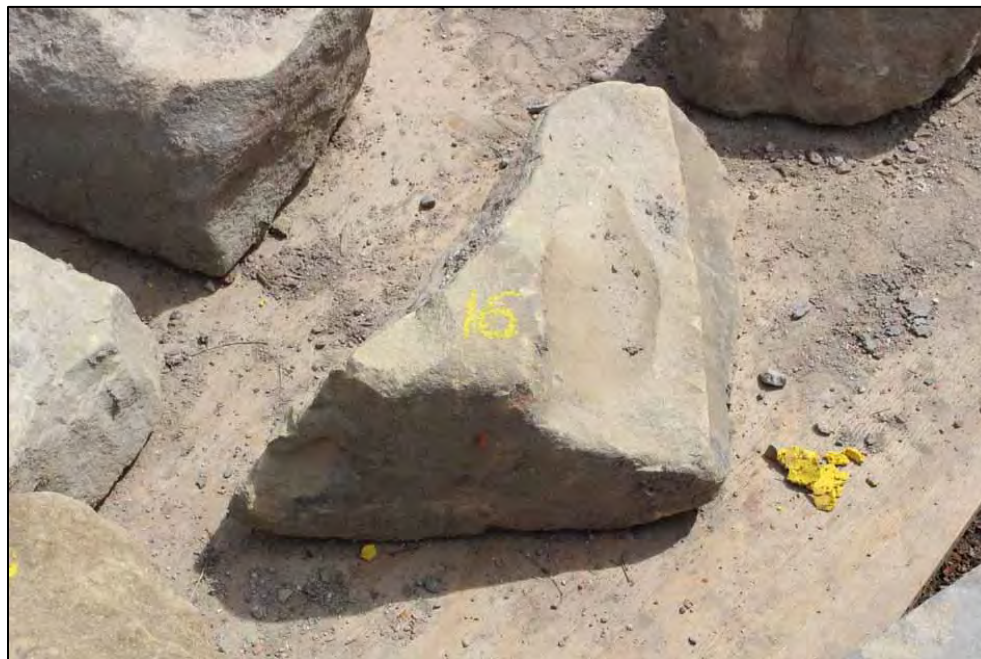
**STONE 16**

<b>Condition</b>	POOR
<b>Measurement</b>	L:400mm W:400mm D:230mm
<b>Description</b>	Probable cornice fragment

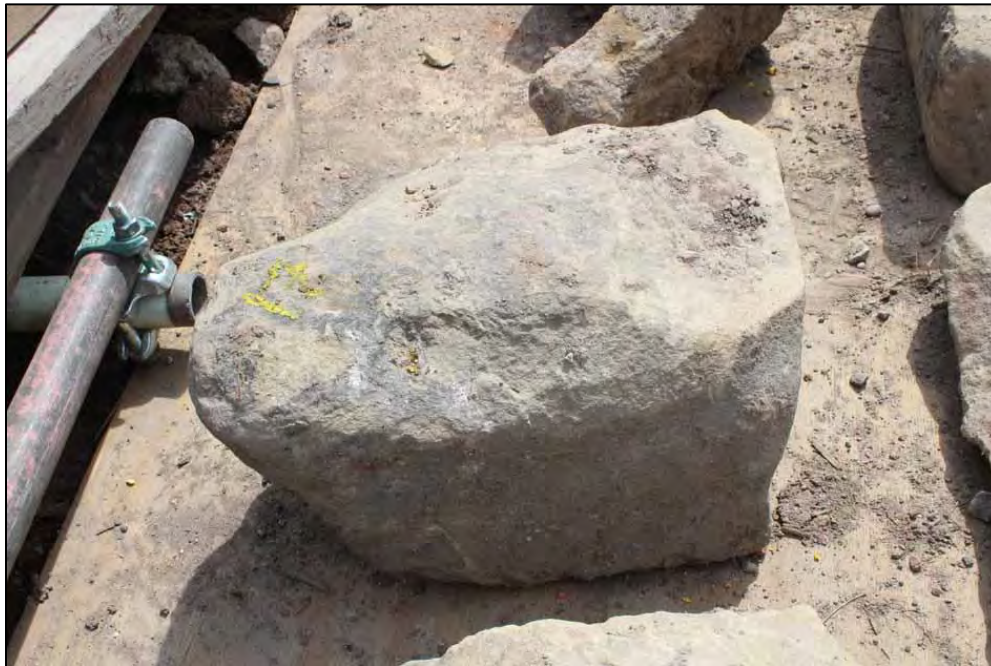
**STONE 17**

<b>Condition</b>	<b>POOR</b>
<b>Measurement</b>	L:400mm W:300mm D:280mm
<b>Description</b>	Unidentifiable

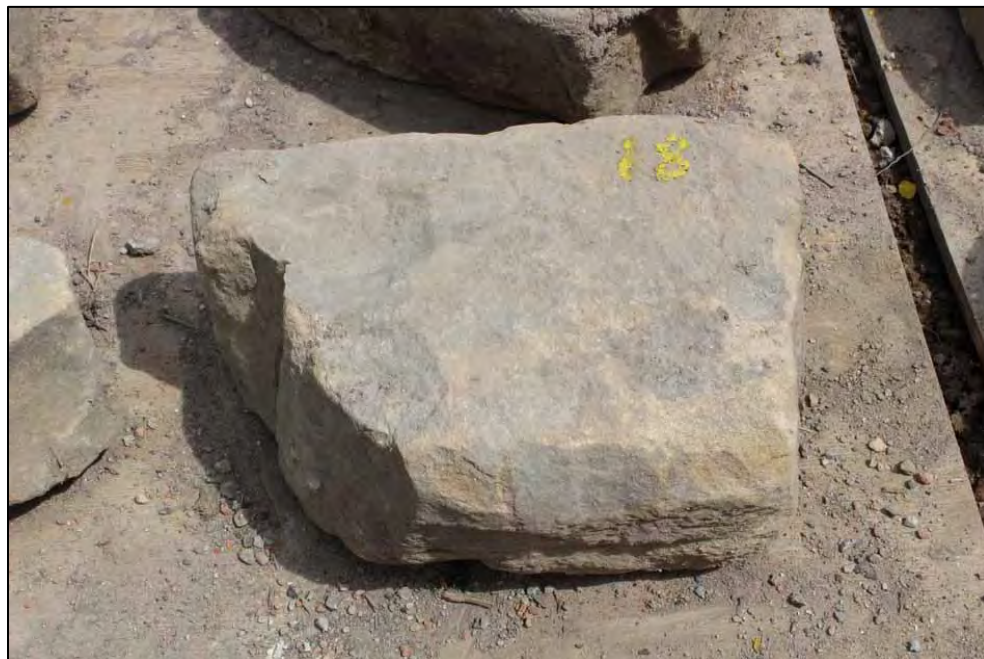
**STONE 18**

<b>Condition</b>	<b>POOR</b>
<b>Measurement</b>	L:400mm W:280mm D:180mm
<b>Description</b>	Unidentifiable - possible base piece

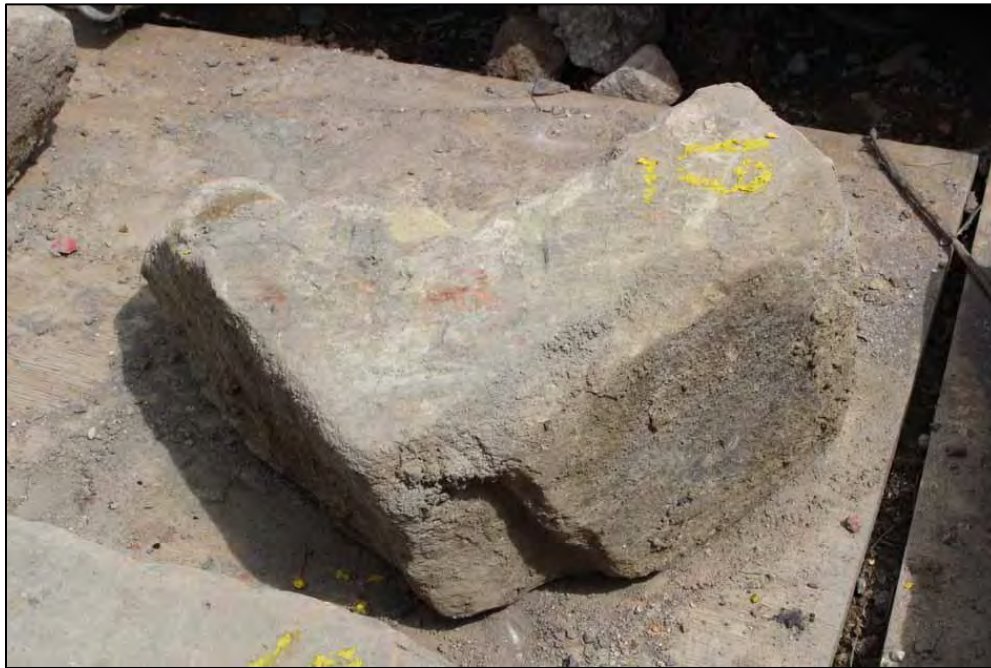
**STONE 19**

<b>Condition</b>	POOR
<b>Measurement</b>	L:330mm W:260mm D:380mm
<b>Description</b>	Probable keystone
