# Saw Shed, Lee Quarry, Bacup

### An Archaeological Recording and Monitoring Programme

By J.M. Trippier Archaeological and Surveying Consultancy

Part 2: Results

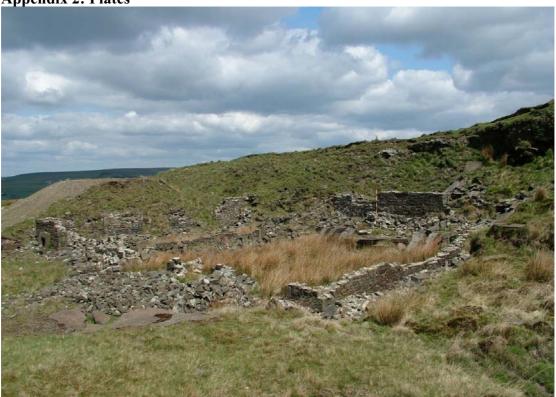
Plate 1: View of Sawshed prior to excavation and conservation. The grass covered artificial mound lies beyond. Note unfinished manhole surround resting against wall at extreme left of photo

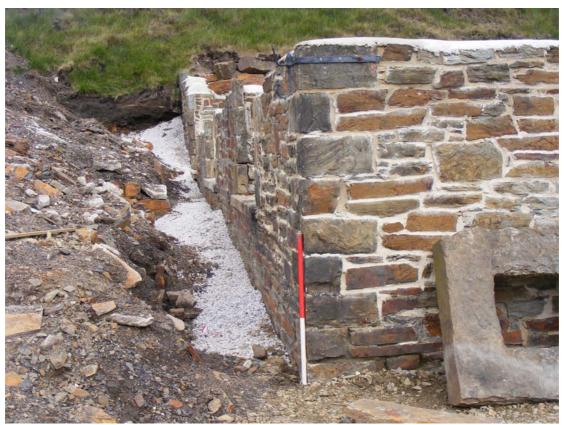
Plate 7: New drain excavated at base of north wall (manhole surround replaced)

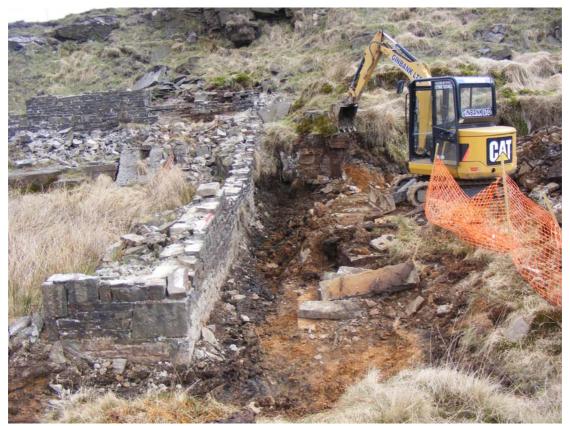
Plate 8: Excavation of trench for new drain at base of south wall

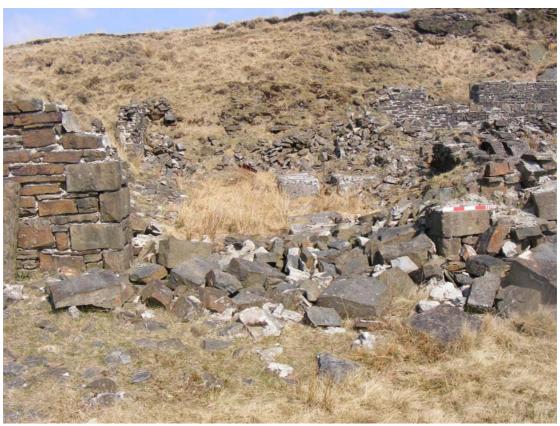
- 7.4 The other area of concern was the east wall of the Sawshed which had been built hard against the adjoining hillside. Fallen stone and vegetation were now overlying the ruined wall to such an extent that access for suitable conservation work was not possible (Plates 11 & 12). So again, this part of the hillside had to be removed and terraced both to relieve the pressure on the wall and to enable the conservation masons to proceed with their work. Because of the difficulties in getting machines into this restricted space this area had to be largely excavated by hand (Plate 13). The hillside itself was stabilised by the laying of large stone blocks behind the newly excavated wall (Plate 14).

Plate 11: Rear (east) wall of north bay substantially overborne by adjoining hillside. The scale bar is on the front (west) wall of the shed

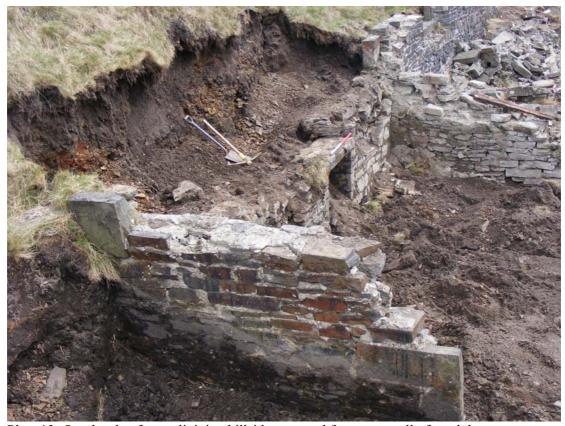
Plate 13: Overburden from adjoining hillside removed from east wall of north bay

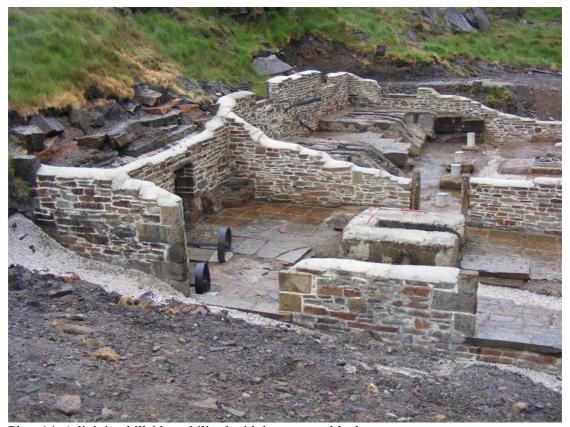
Plate 14: Adjoining hillside stabilised with large stone blocks

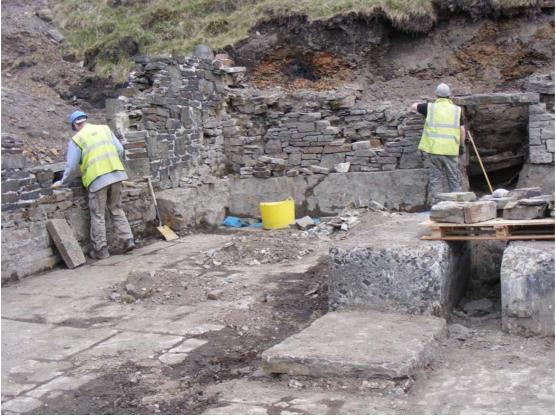
Plate 16: North and east walls of north being rebuilt by Anthony and Duncan

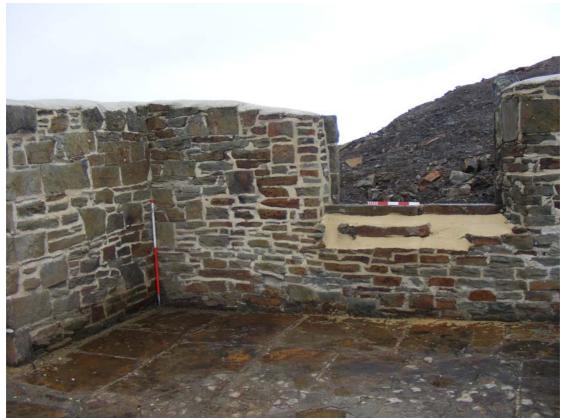
Plate 17: The wrong colour of mortar!

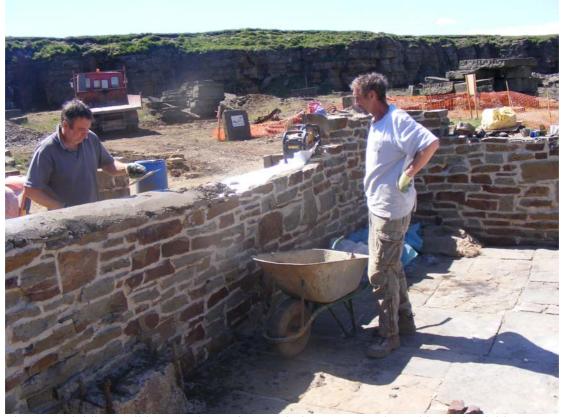
Plate 18: Dividing wall between bays after repointing. Concrete haunching being laid by Duncan as Anthony looks on.

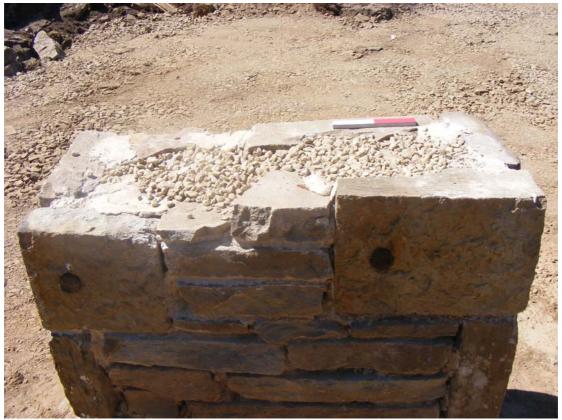
Plate 19: An example of gravel filling to wall top

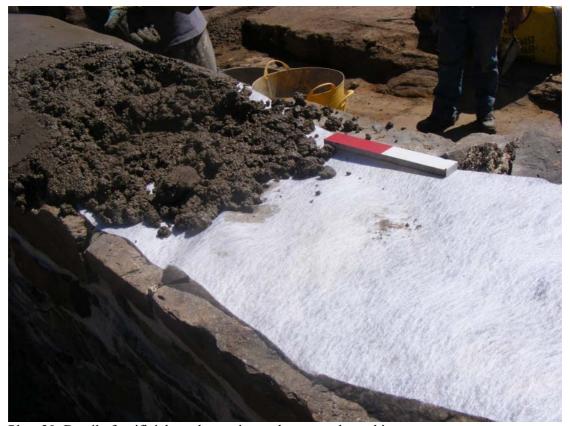
Plate 20: Detail of artificial wool covering and concrete haunching over

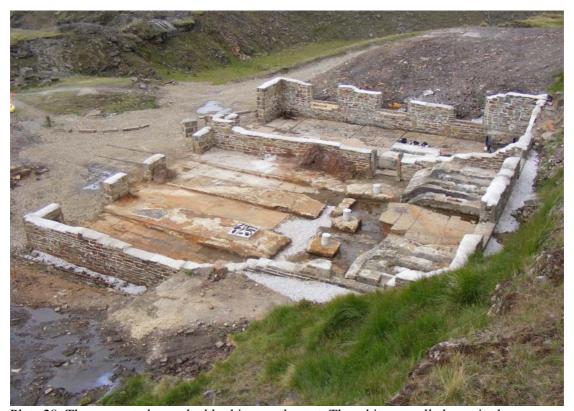
Plate 28: The excavated saw shed looking north west. The white gravelled area in the south bay marks the open drain which now holds a pipe debouching into the new drain outside the south wall.
