ASHCOMBE FARM, STOODLEIGH, TIVERTON, DEVON

RAPID HISTORIC BUILDING APPRAISAL

Stewart Brown Associates

February 2018

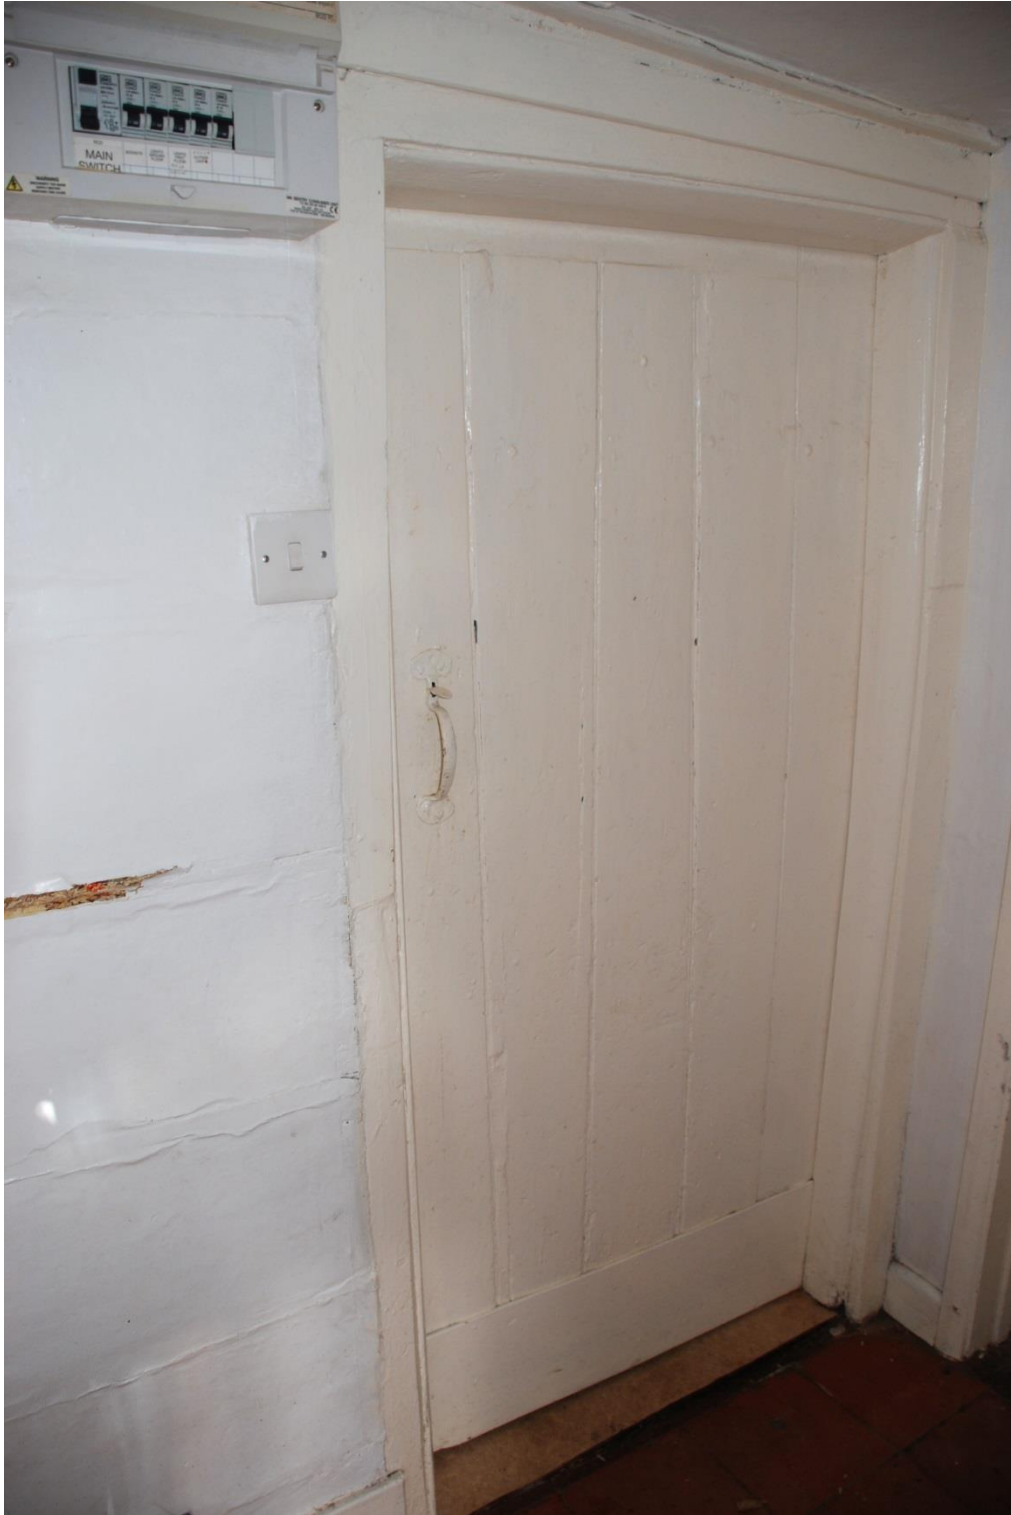
A survival from the 18th-century internal partitions is that of the lobby just inside the main entrance, which is timber framed and clad with horizontal planks, at least on its south side. This partition also contains one of the two oldest surviving doors, that leading into the central service room from the lobby (Fig. 3).

Fig. 3 The horizontal planked side wall of the lobby and plank and batten door leading into the central service room.

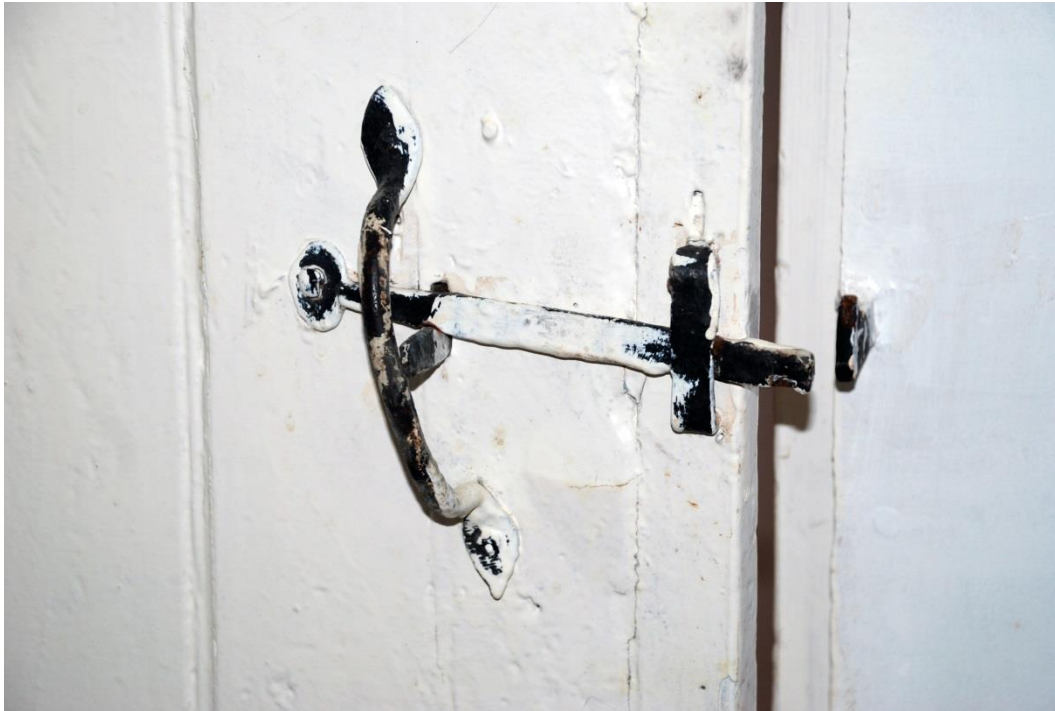
The door retains its original iron handle and internal latch (Fig. 4).

Fig. 4 18th-century handle and lifting bar latch on inside of door into central service room.

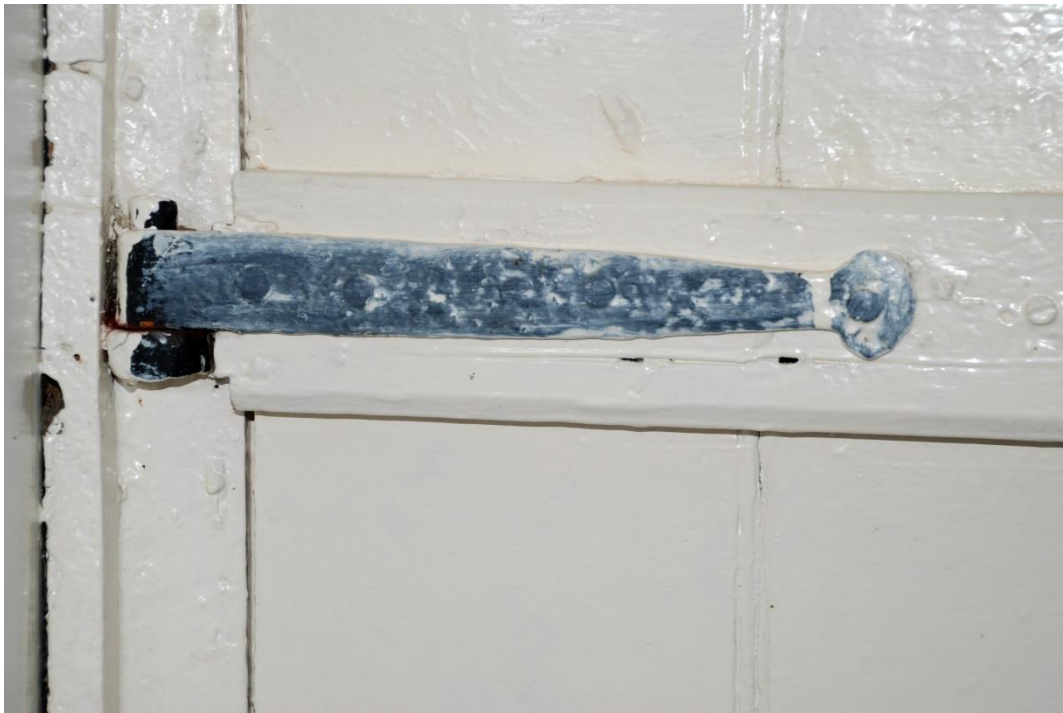
The door has an iron hinge hung from a pintle (Fig. 5).

Fig. 5 Strap hinge hung from a pintle on inside of door into central service room.

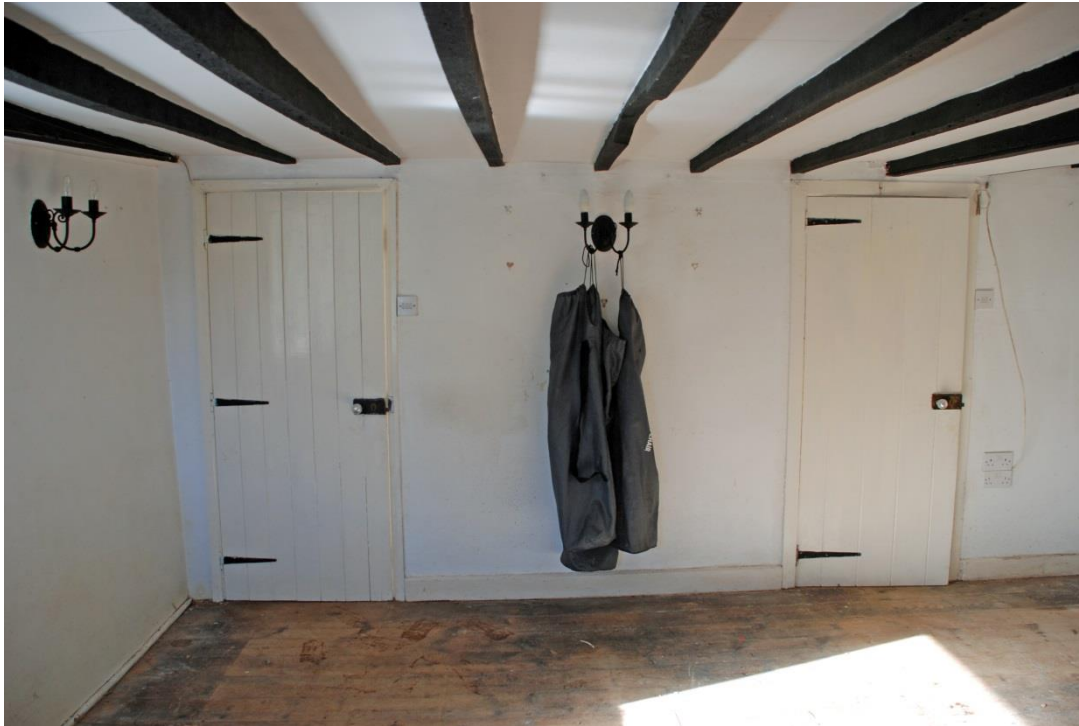
All other ground-floor partitions and doors appear to have been rebuilt in the 20th century, The doors have narrow regularly-sized planks and standardised hinges with uniform taper fixed with screws (Figs 6 and 7). They also have plastic door knobs.

Fig. 6 20th-century replacement doors with narrow planks leading into the parlour.

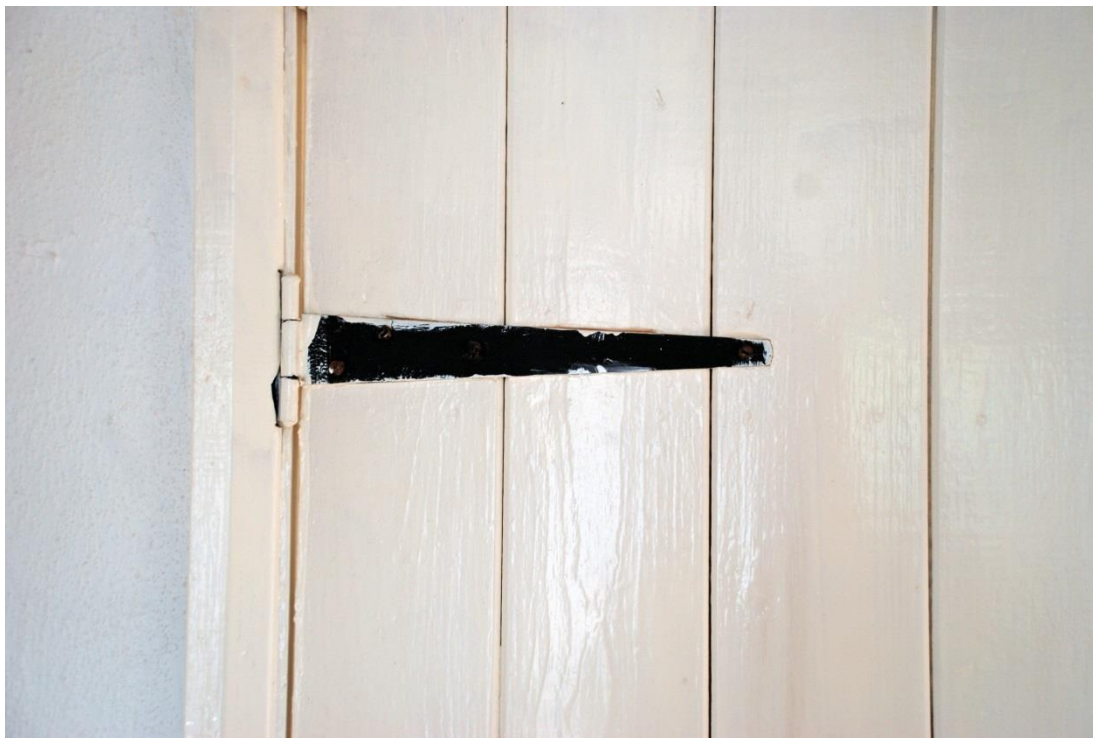
Fig. 7 20th-century iron hinge fixed with screws on most doors.

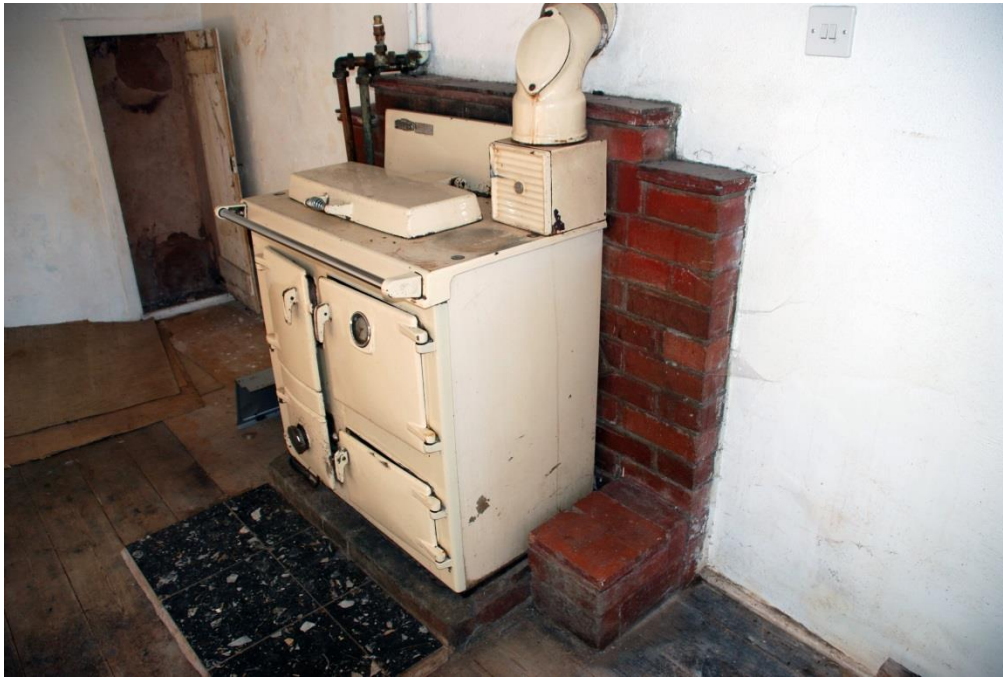
Both of the ground-floor fireplaces have been extensively altered in recent times (Figs 8 and 9).

Fig. 8 The parlour fireplace with modern brick insertion and range.

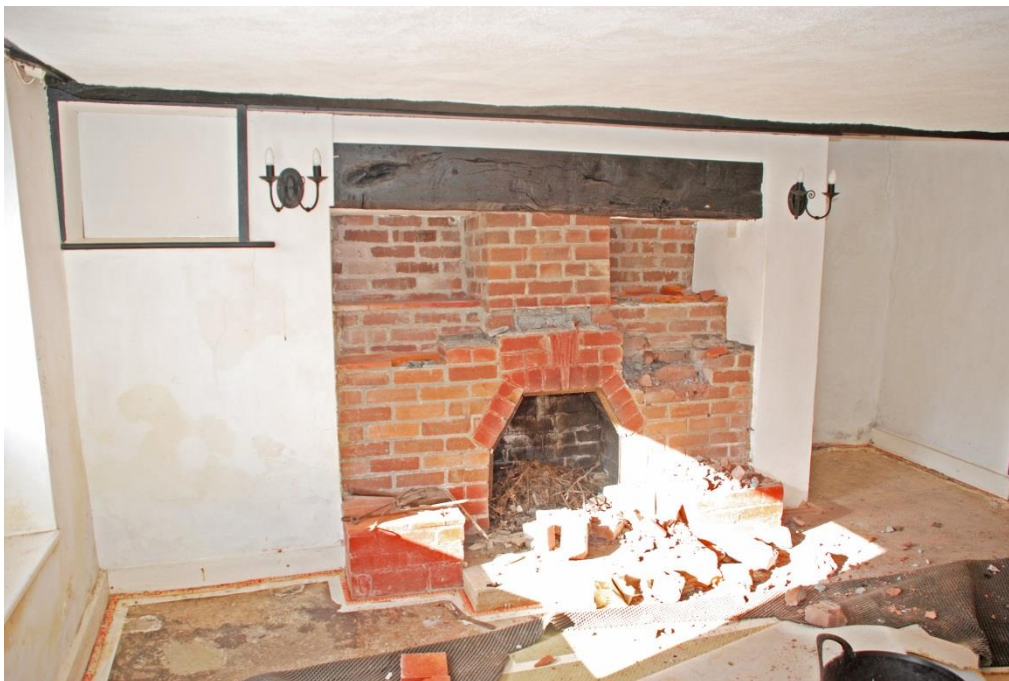
Fig. 9 The kitchen fireplace with modern brick infilling beneath old timber lintel.

The kitchen/living room fireplace has an old timber lintel above it with a chamfer which tapers out at each end in accord with the old fireplace opening. It has two peg-holes in it however suggesting that it may have been salvaged from elsewhere and used in this context at the same time as the brick insertion. On the north side of the kitchen fireplace there is a recess with a curved back extending down to floor level. This may be a remnant from a boiling furnace. Side ovens occur next to fireplaces from the 17th to the early 19th century when they began to be replaced by ranges containing ovens. The kitchen once had direct access to the central service room by a doorway at its north-east corner. The doorway has since been blocked to create a small larder beneath the stair.

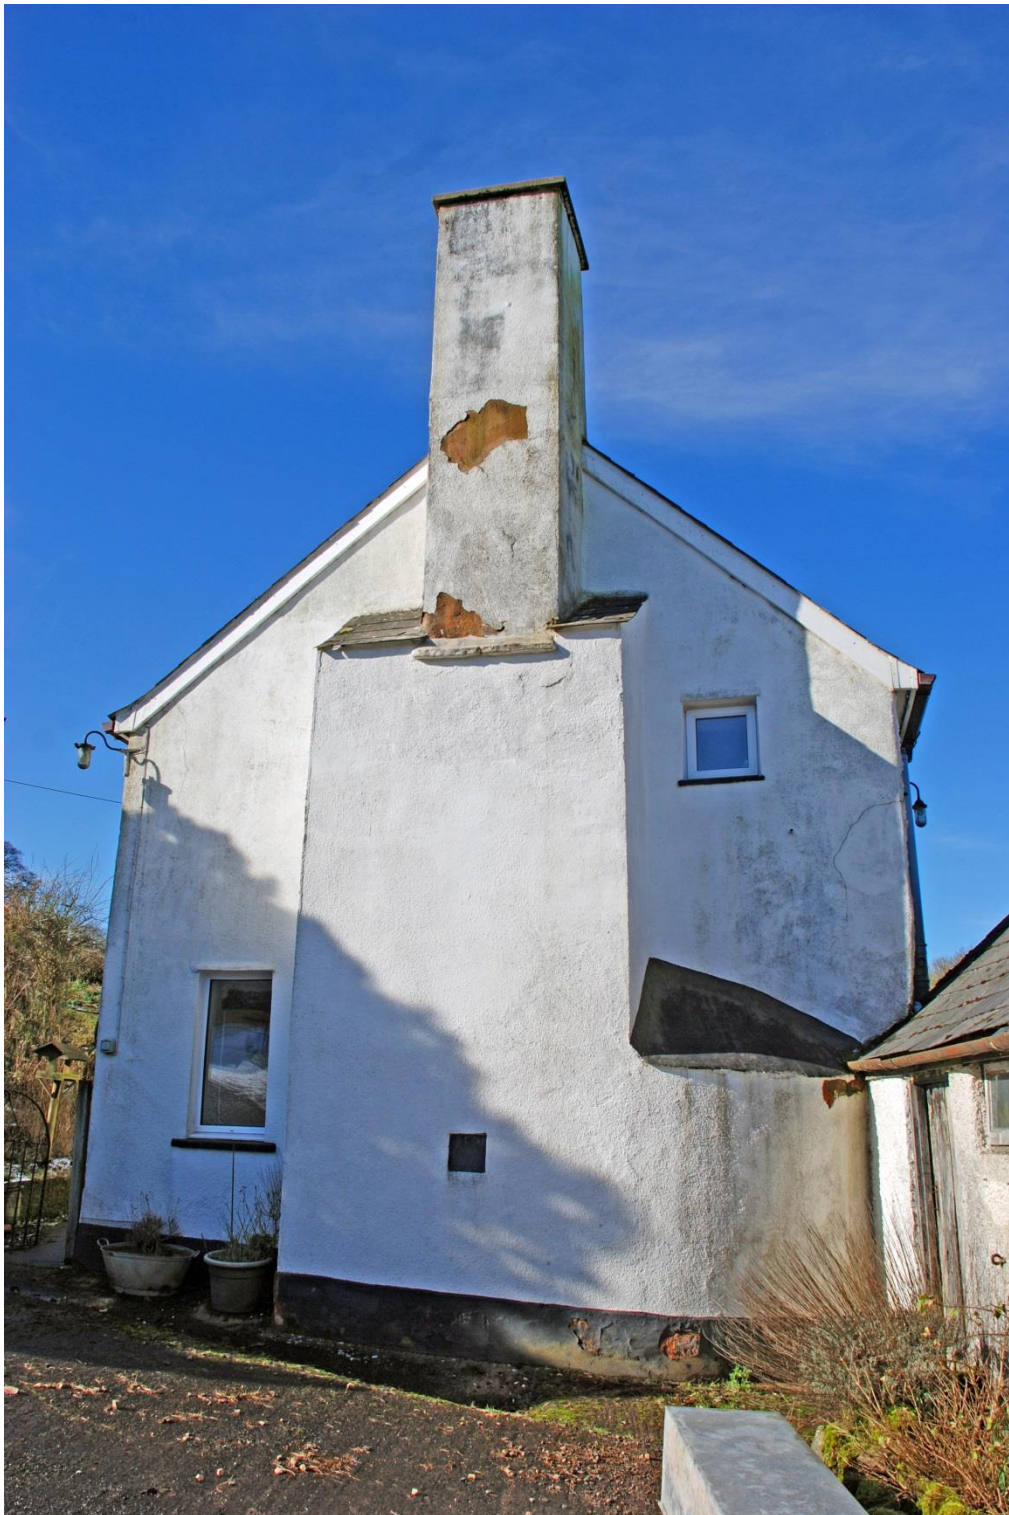
Both retain external ground-floor round projections for side ovens (Figs 10 and 11) but it is not known whether anything survives from the ovens themselves since they are now entirely covered over on the inside.

Fig. 10 The east gable end of the house showing round ground-floor projection for oven next to the parlour fireplace.

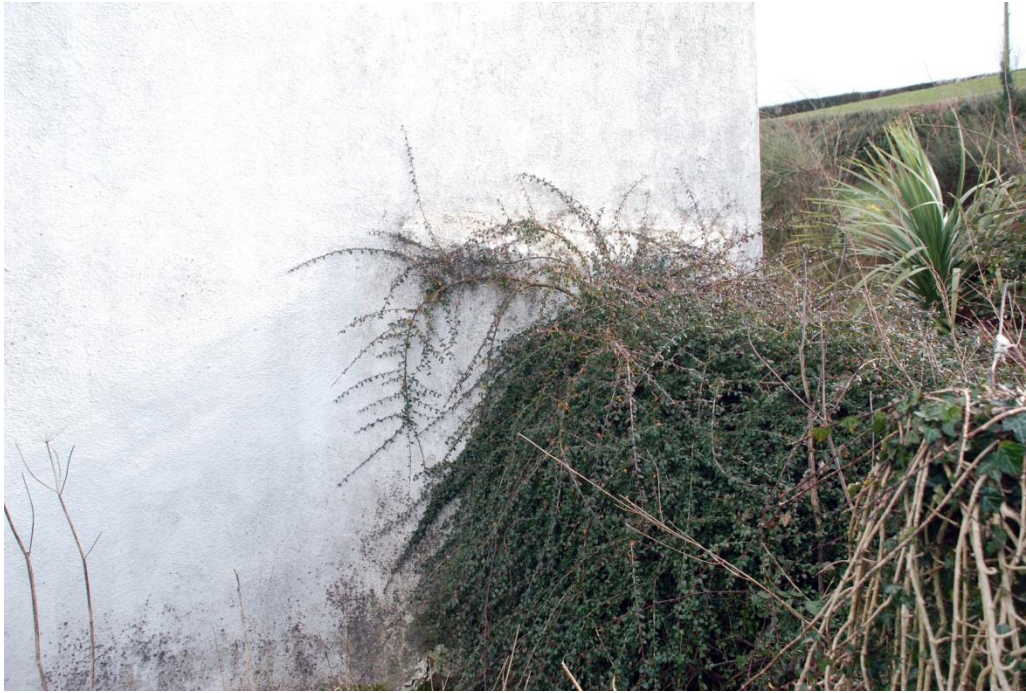
Fig. 11 The external ground-floor round projection for an oven next to the kitchen fireplace.

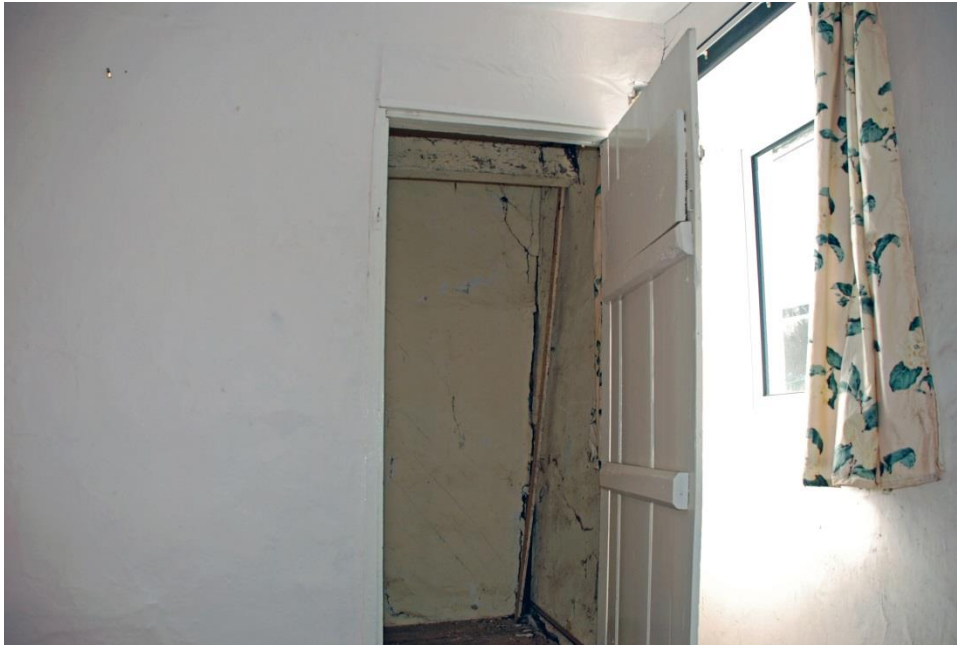
Fig. 12 The cupboard in the master bedroom, showing a surviving section of tie/ceiling beam.

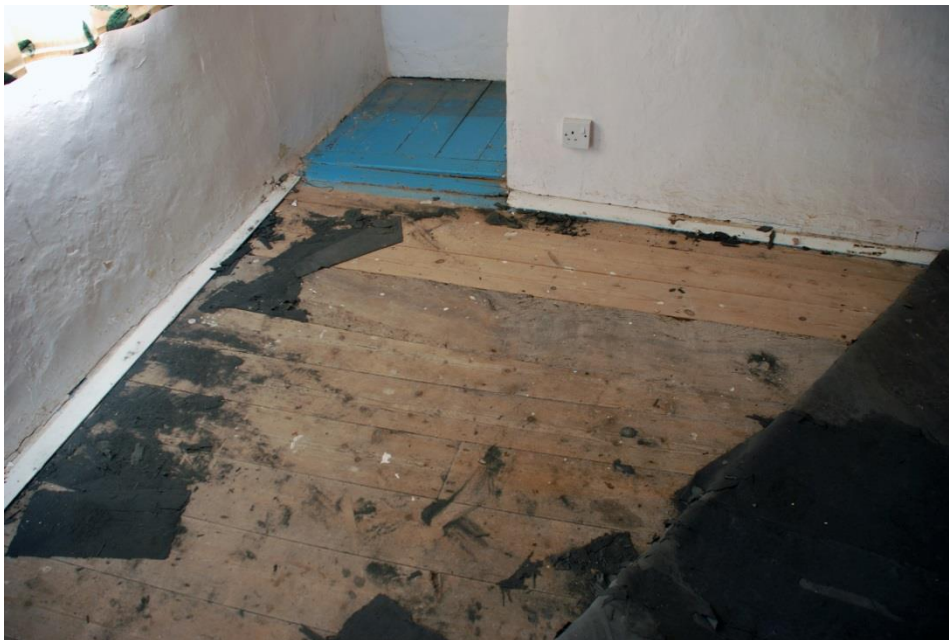
Inside the cupboard is a surviving length of ceiling beam (more below). The master bedroom also retains one wide oak floor board, now mostly replaced by later narrow softwood ones (Fig. 13).

Fig. 13 A wide oak floor board (toward the rear) survives in the master bedroom amongst later narrower replacements.

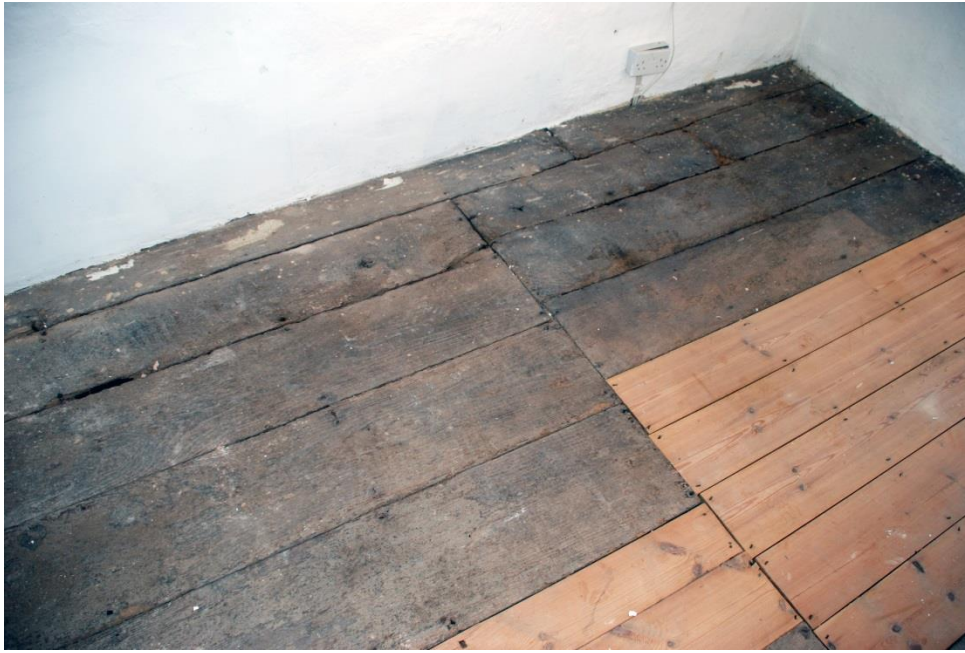
In the middle bedroom, further old floor boards survive, but these are of softwood (Fig. 14).

Fig. 14 Old floor boards in the middle bedroom.

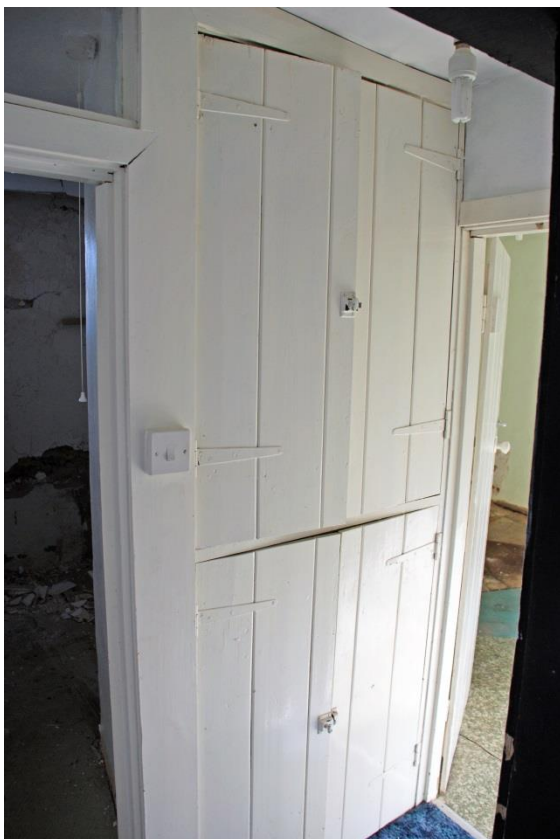
The smallest easternmost bedroom has had a bathroom and toilet inserted at its northern end together with an airing cupboard, which has the same style doors as the 20th-century replacement doors throughout the house (Fig 15).

Fig. 15 The airing cupboard doors.

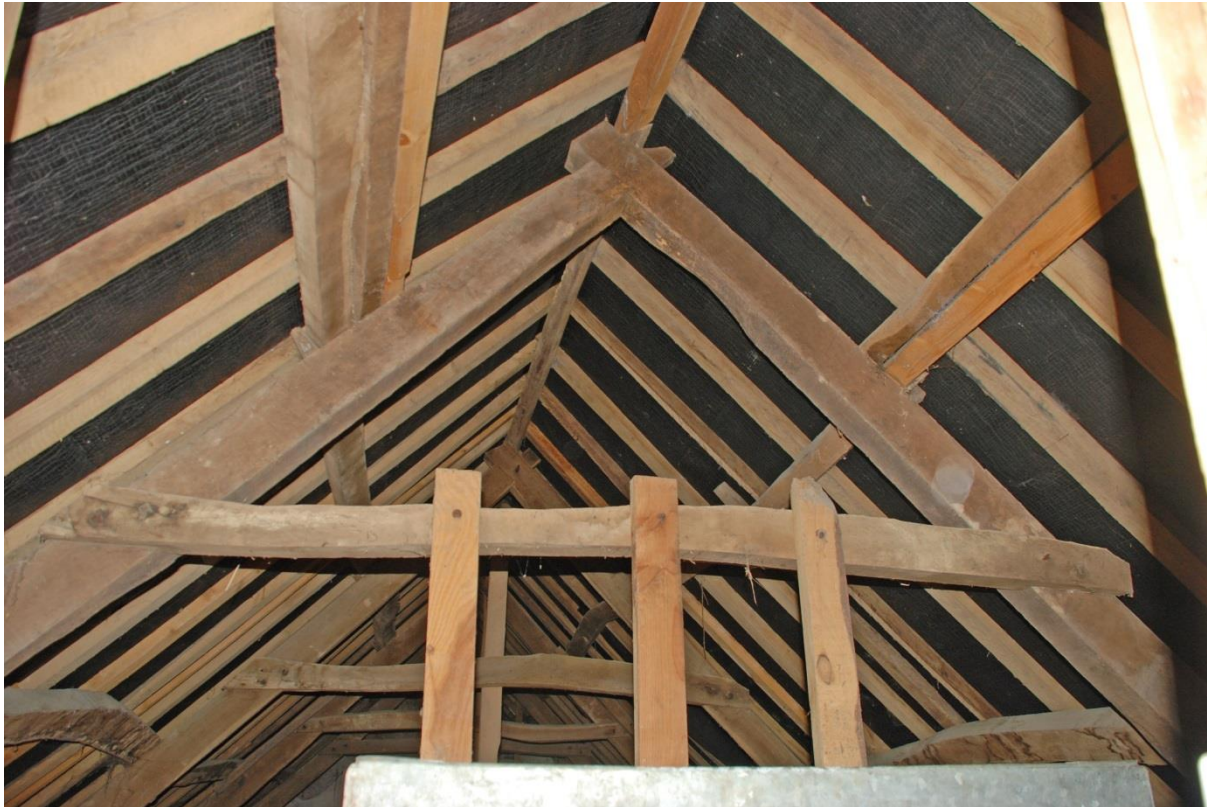
The roof is of crude A-frame construction with a collar which is halved onto the principals and pegged and nailed in place. The apex is formed by a pegged tenoned joint between the principals, in which the tenon and opposing principal extend upward to clasp a diagonal ridge (Fig. 16).

Fig. 16 The 18th-century roof, showing crude construction not intended to be exposed and viewed.

The purlins are irregularly shaped and carried on the backs of the trusses (through purlins); some have been replaced in modern times, as has part of the ridge. Some rafters have also been replaced recently, probably when the roof covering was replaced with fibre cement tiles (Fig. 1).

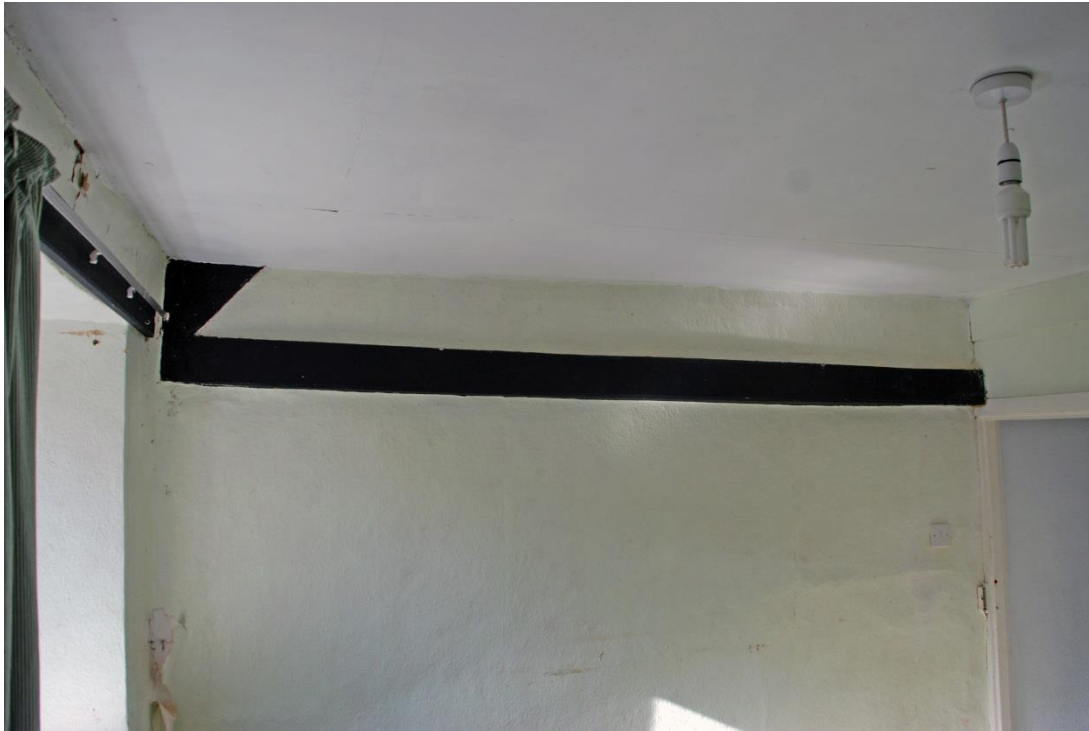
The trusses once sat on tie beams or ceiling beams, most of which have been cut away in order to raise the ceiling height of the first floor leaving only stubs at each end (Figs 17 - 19). This probably happened in the 20th century when the internal partitions and doors were rebuilt or replaced. Only the tie/ceiling beam beneath the easternmost truss survives intact (Figs 17 and 18). One other survives in part, shown in Fig. 12 within the cupboard in the master bedroom. The remainder of the beam was removed when the ceiling above the stair was raised to the same height as the rest of the first floor.

Fig. 17 The sole surviving intact tie/ceiling beam beneath the easternmost truss, looking west.

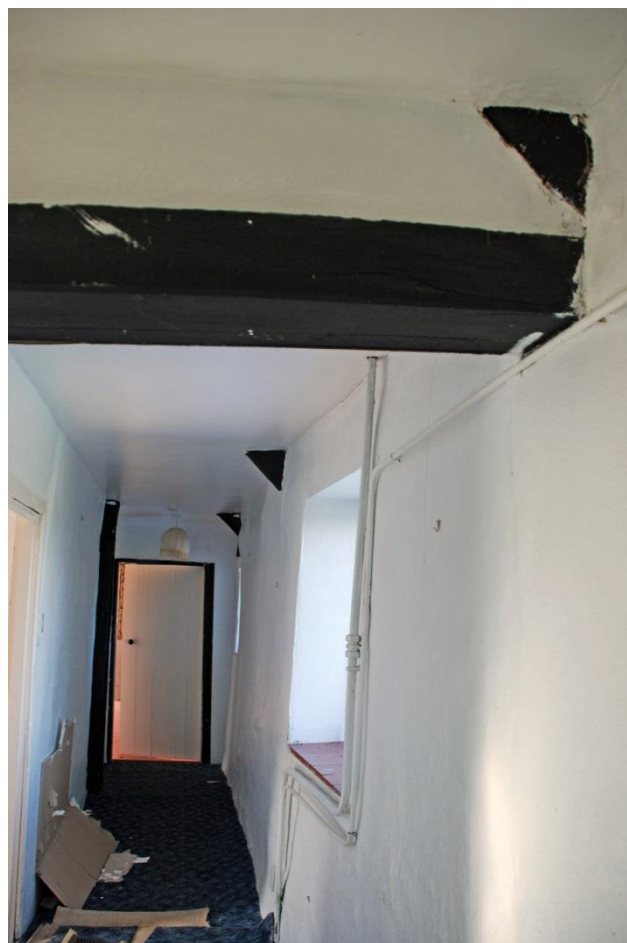
Fig. 18 The north end of the surviving tie/ceiling beam, looking west, showing the ends of two further trusses now without the original tie/ceiling beams beneath them.

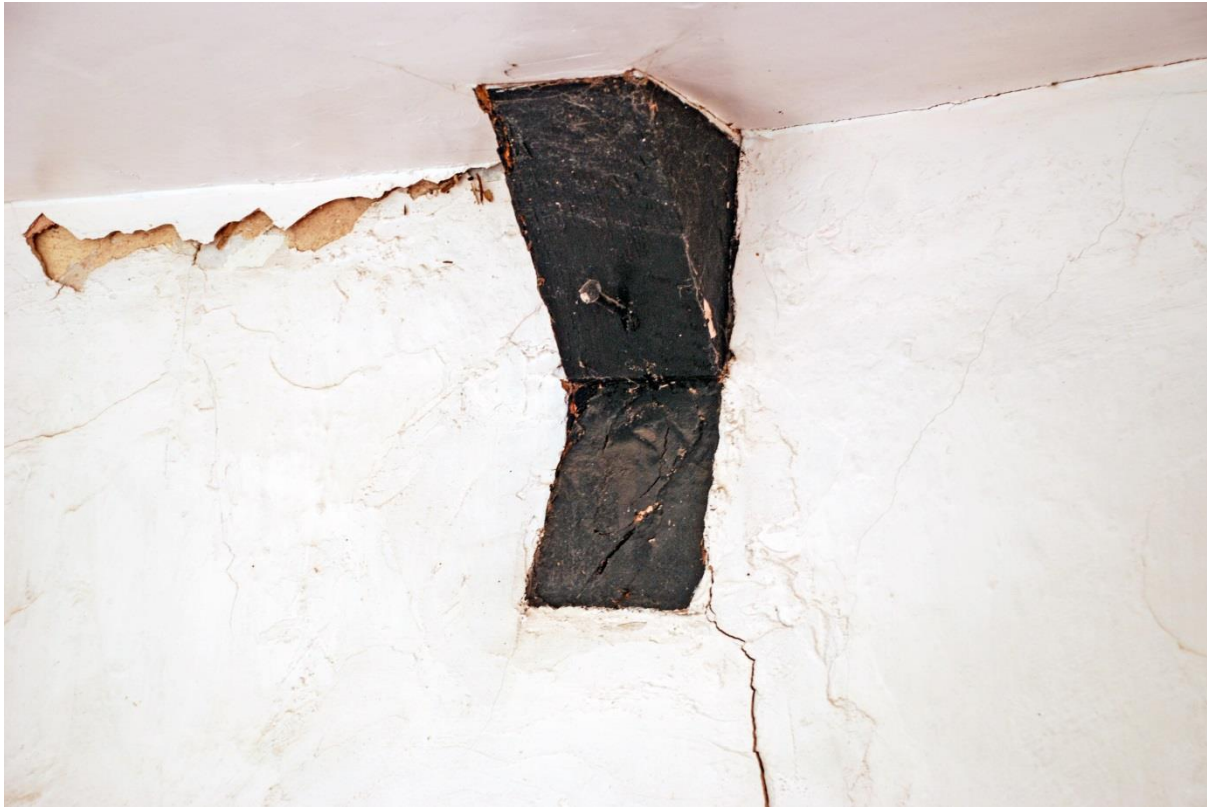
Fig. 19 The sawn-off stub of the tie/ceiling beam beneath the westernmost truss in the master bedroom.
