BERRY POMEROY GATEHOUSE ROOF 1998

ARCHAEOLOGICAL RECORDING

BERRY POMEROY GATEHOUSE ROOF;
BERRY POMEROY CASTLE
ARCHAEOLOGICAL RECORDING
1998

By Stewart Brown and Aidan Matthews

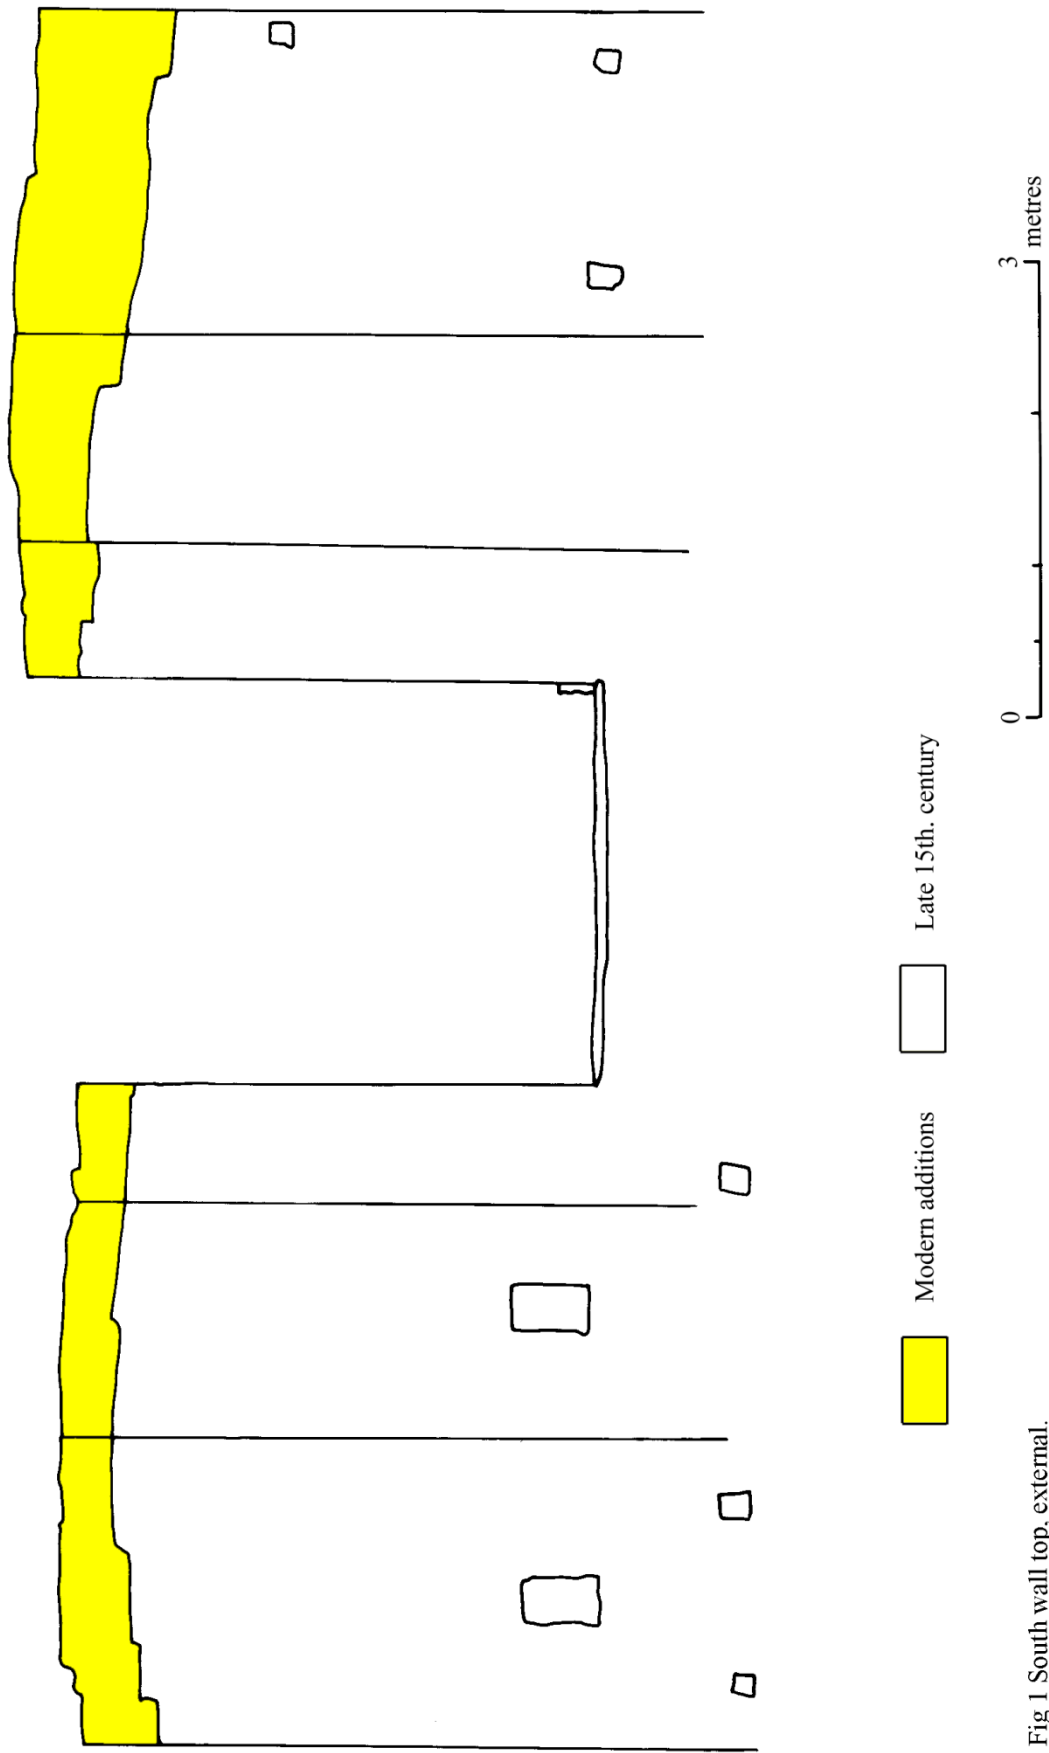
Fig 1 South wall top, external.

The gatehouse wall tops were all raised in height in 1982. The junction between original medieval masonry and modern additions was discernable in most places, although occasionally obscured by extensive modern pointing (Figs. 1-4). As found throughout the gatehouse masonry, medieval fabric is characterized by the use of white lime mortar bonding with gravel aggregate, whilst modern replacements and repairs were made using grey cement mortar.

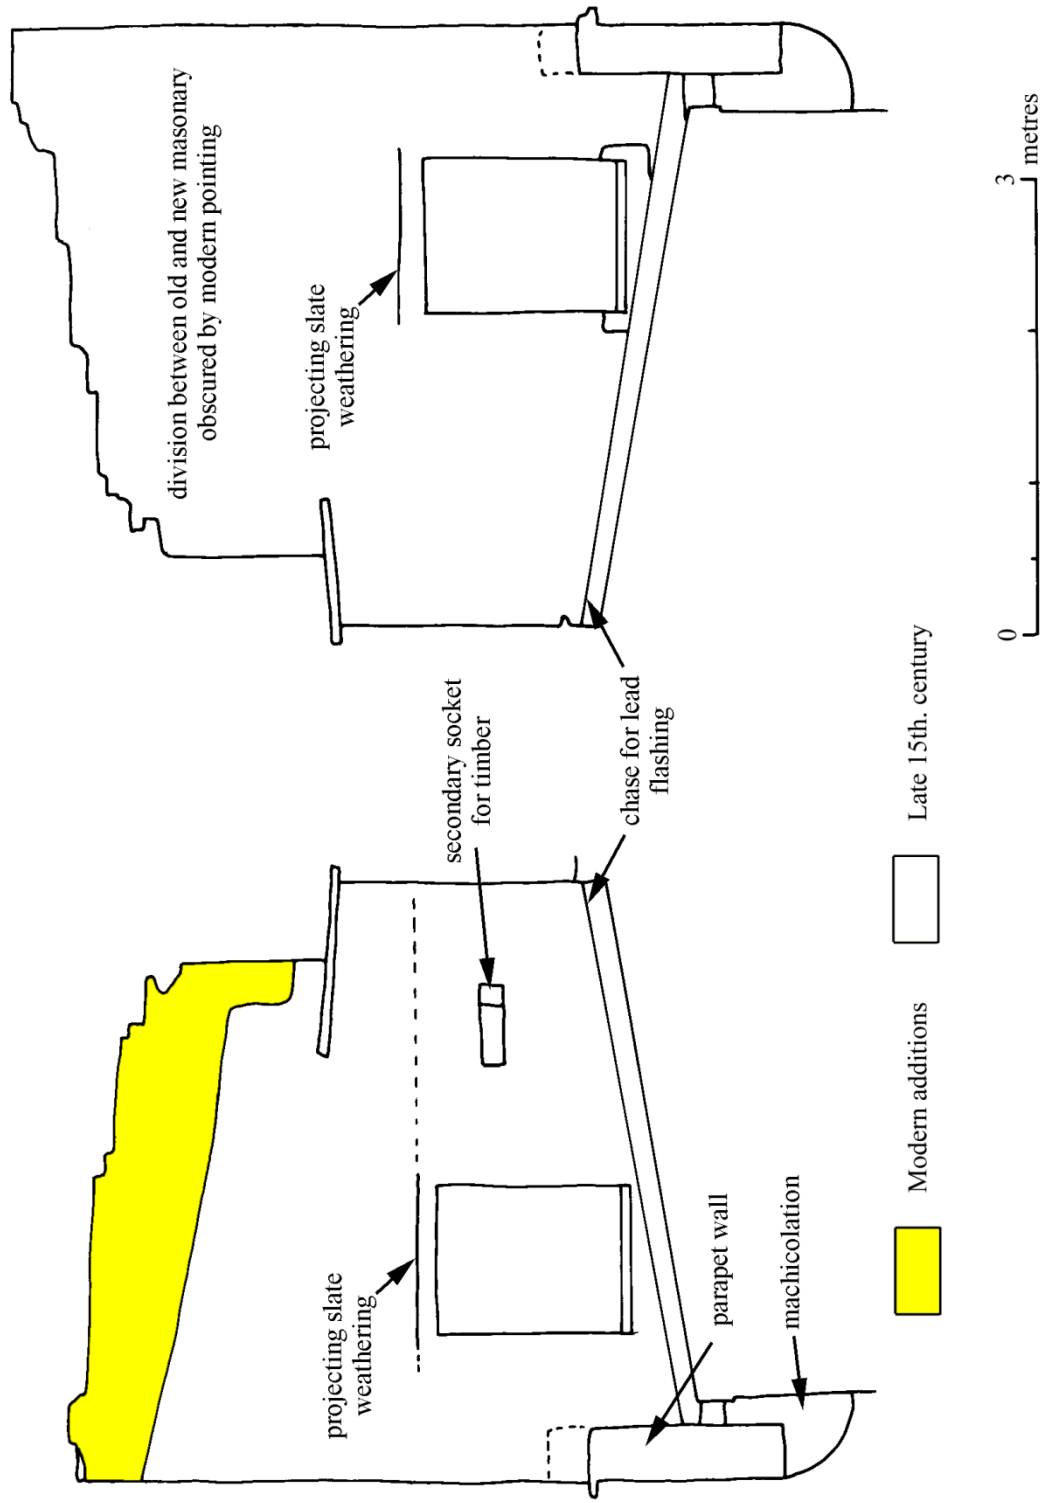
Fig 4 Western tower, east wall top, external (left) and eastern tower, west wall top, external (right).

Between the two turrets there is a monopitch roof sloping southwards toward a low parapet wall at the front of the gatehouse. The parapet wall is corbelled out from the front wall in order to accommodate a machicolation, through which water from the roof drains away. This arrangement appears to have been little different when the gatehouse was first built. It is clear that the monopitch roof has always sloped at the present angle, since there are original chases in the flanking walls for lead flashing. The parapet wall was 0.28m higher than at present, as indicated by scars in the flanking walls. Another original feature observed in 1998 is the projecting slate weathering course over the rectangular openings leading out from the adjacent turret rooms. The course can be traced from the opening to the north wall of the turret (at least on the western turret), although here the slates do not now project from the face of the wall. This may possibly indicate that part of the area was originally sheltered from the worst of the

A secondary socket survives in the western flanking wall, evidently cut into the masonry in order to seat a horizontal timber. The function of the inserted timber is unknown, although it would not be surprising if it was somehow related to the operation of the portcullis winding drum.

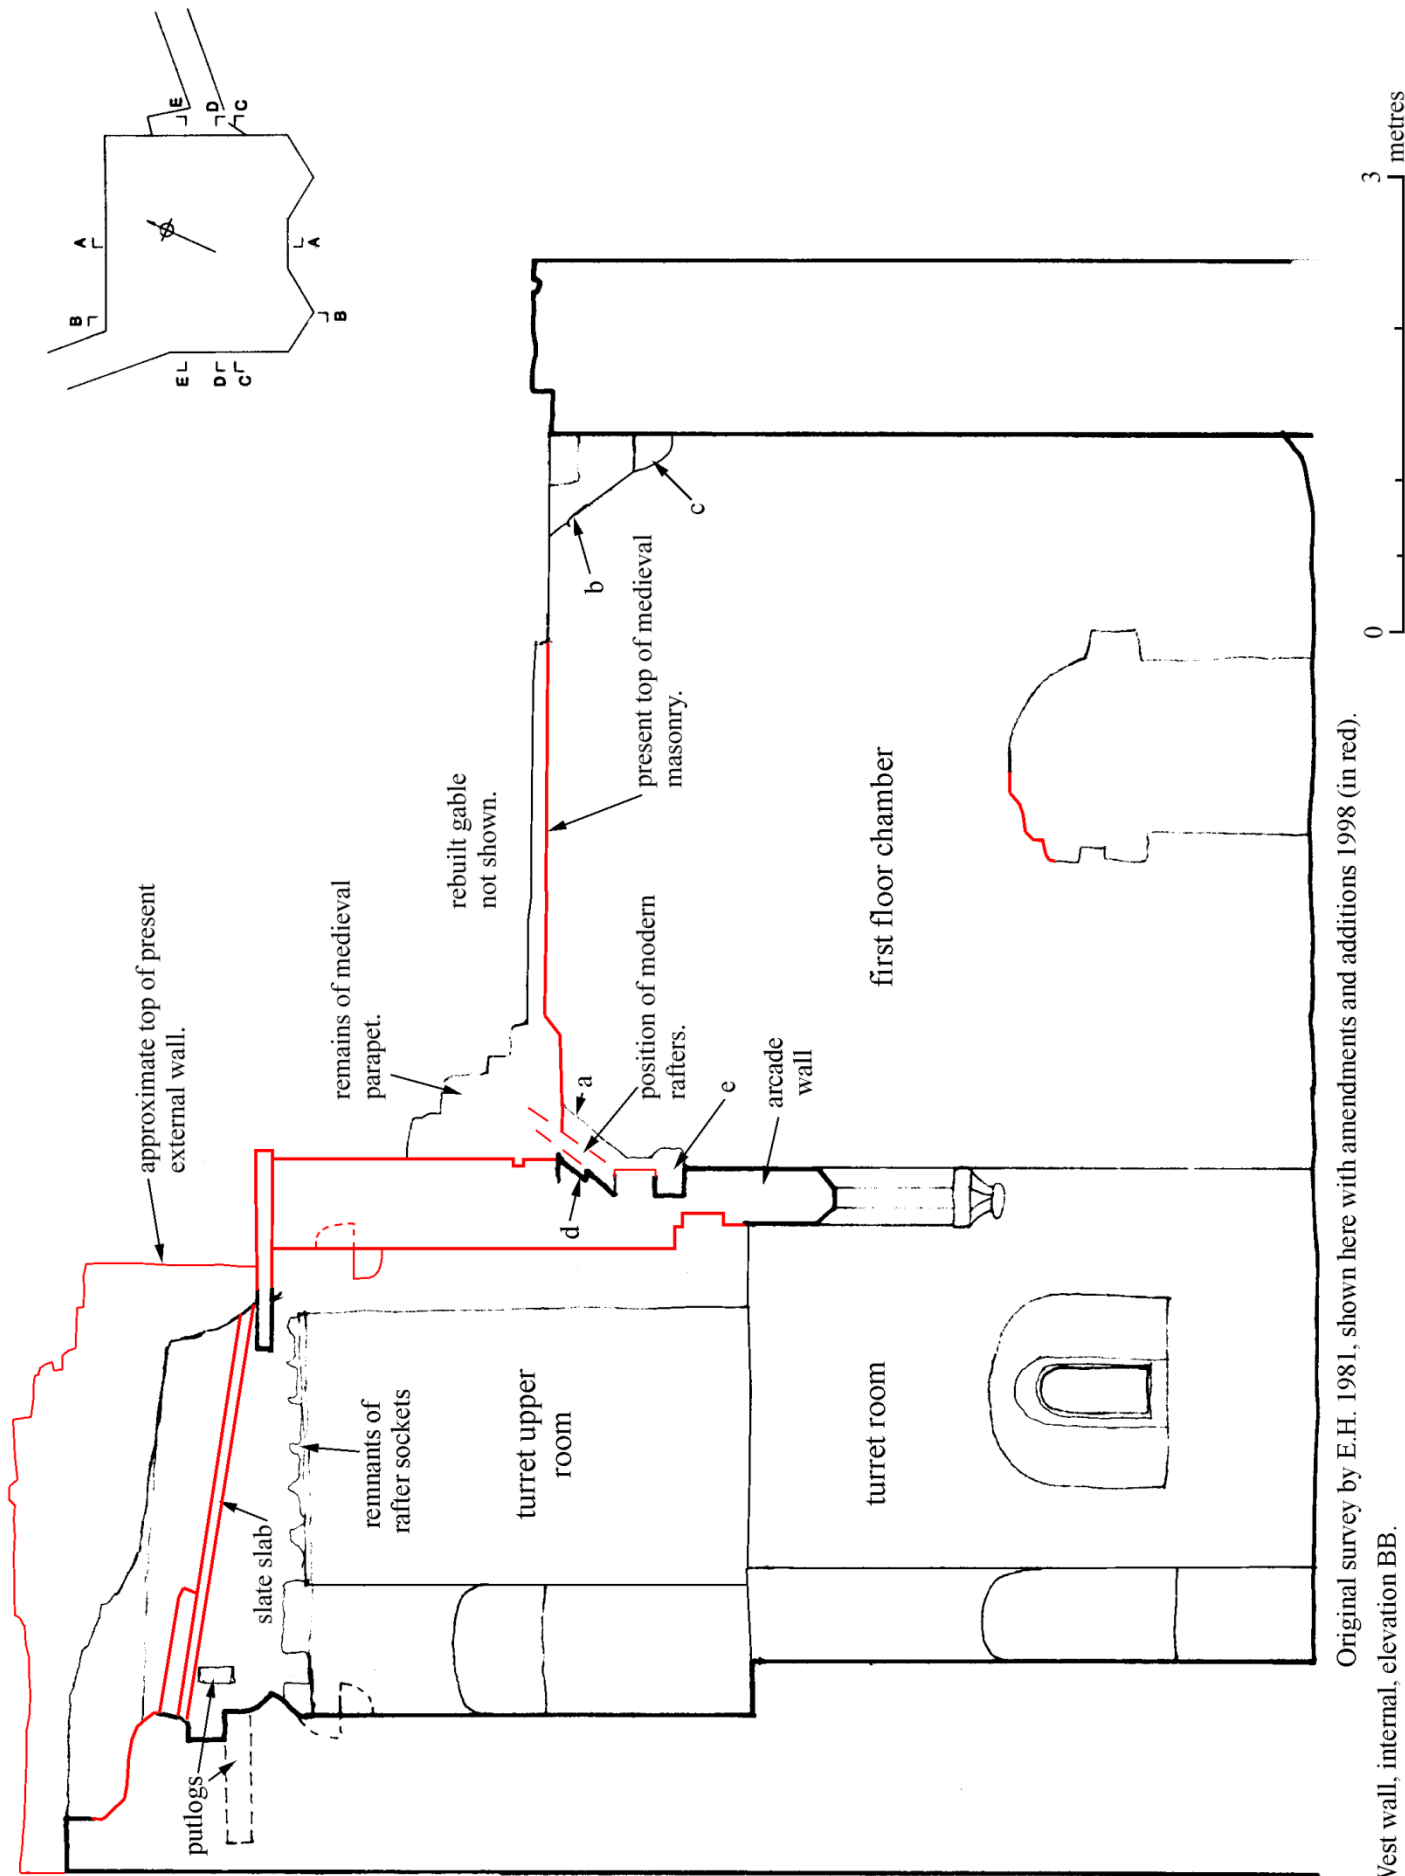
Fig 5 West wall, internal, elevation BB.

Harry Gordon Slade's reconstruction includes, in place of corbels, a timber wall plate extending the entire length of the south side of the room, set at the same level as the corbels opposite. On this he placed the new truss feet. The survey indeed shows a horizontal chase in the wall at this height (Fig. 5, e - shows the profile of the cast which is c. 0.2m square), but whether this chase originally held a continuous wall plate is debatable. It is certainly possible that the trusses once sat on stone corbels on this side as well, and that short horizontal timbers set into the wall spanned the bays between them.

The form of the original roof trusses is unknown. The only surviving evidence comprises scars in the original plasterwork at each end which appear to represent the positions of arch braces for the former principals (Fig. 5, a, b; Plate 1 shows the best preserved example at the east end of the chamber), the braces rising from stone corbels (eg Fig. 5, c). The scars are shown as straight lines in the 1981 survey, but appear slightly curved according to measurements taken in 1998. The evidence is insufficient to be certain about the detailed appearance of the truss form, but indicates an arch-braced type. The corbels are of red sandstone from the Torbay area.

It is clear from the casts of the medieval timberwork that the roof members were already set in place when the medieval masonry was raised around them. Other timbers were also encased in the same manner. On the south side of the roof, the wall above the aisle arcade rises much higher than the roof over the first-floor chamber, forming the north walls of the two towers of the gatehouse. This wall is thicker in its higher part than its lower. It was built partly overlapping the roof of the first-floor chamber, its north side resting on the feet of the original rafters, which thus became encased in masonry during construction. The rafter feet have left their permanent casts or impressions in the medieval stonework. Other casts of former timbers survive to each side of the rafter sockets showing that wooden boards were laid horizontally across the backs of the rafters, spanning the space between them, in order to provide shuttering for the construction of masonry above. It is clear from the stepped shape at the rear of the casts (Fig. 5, d) that the lower boards were overlapped by the ones higher up the rafter.

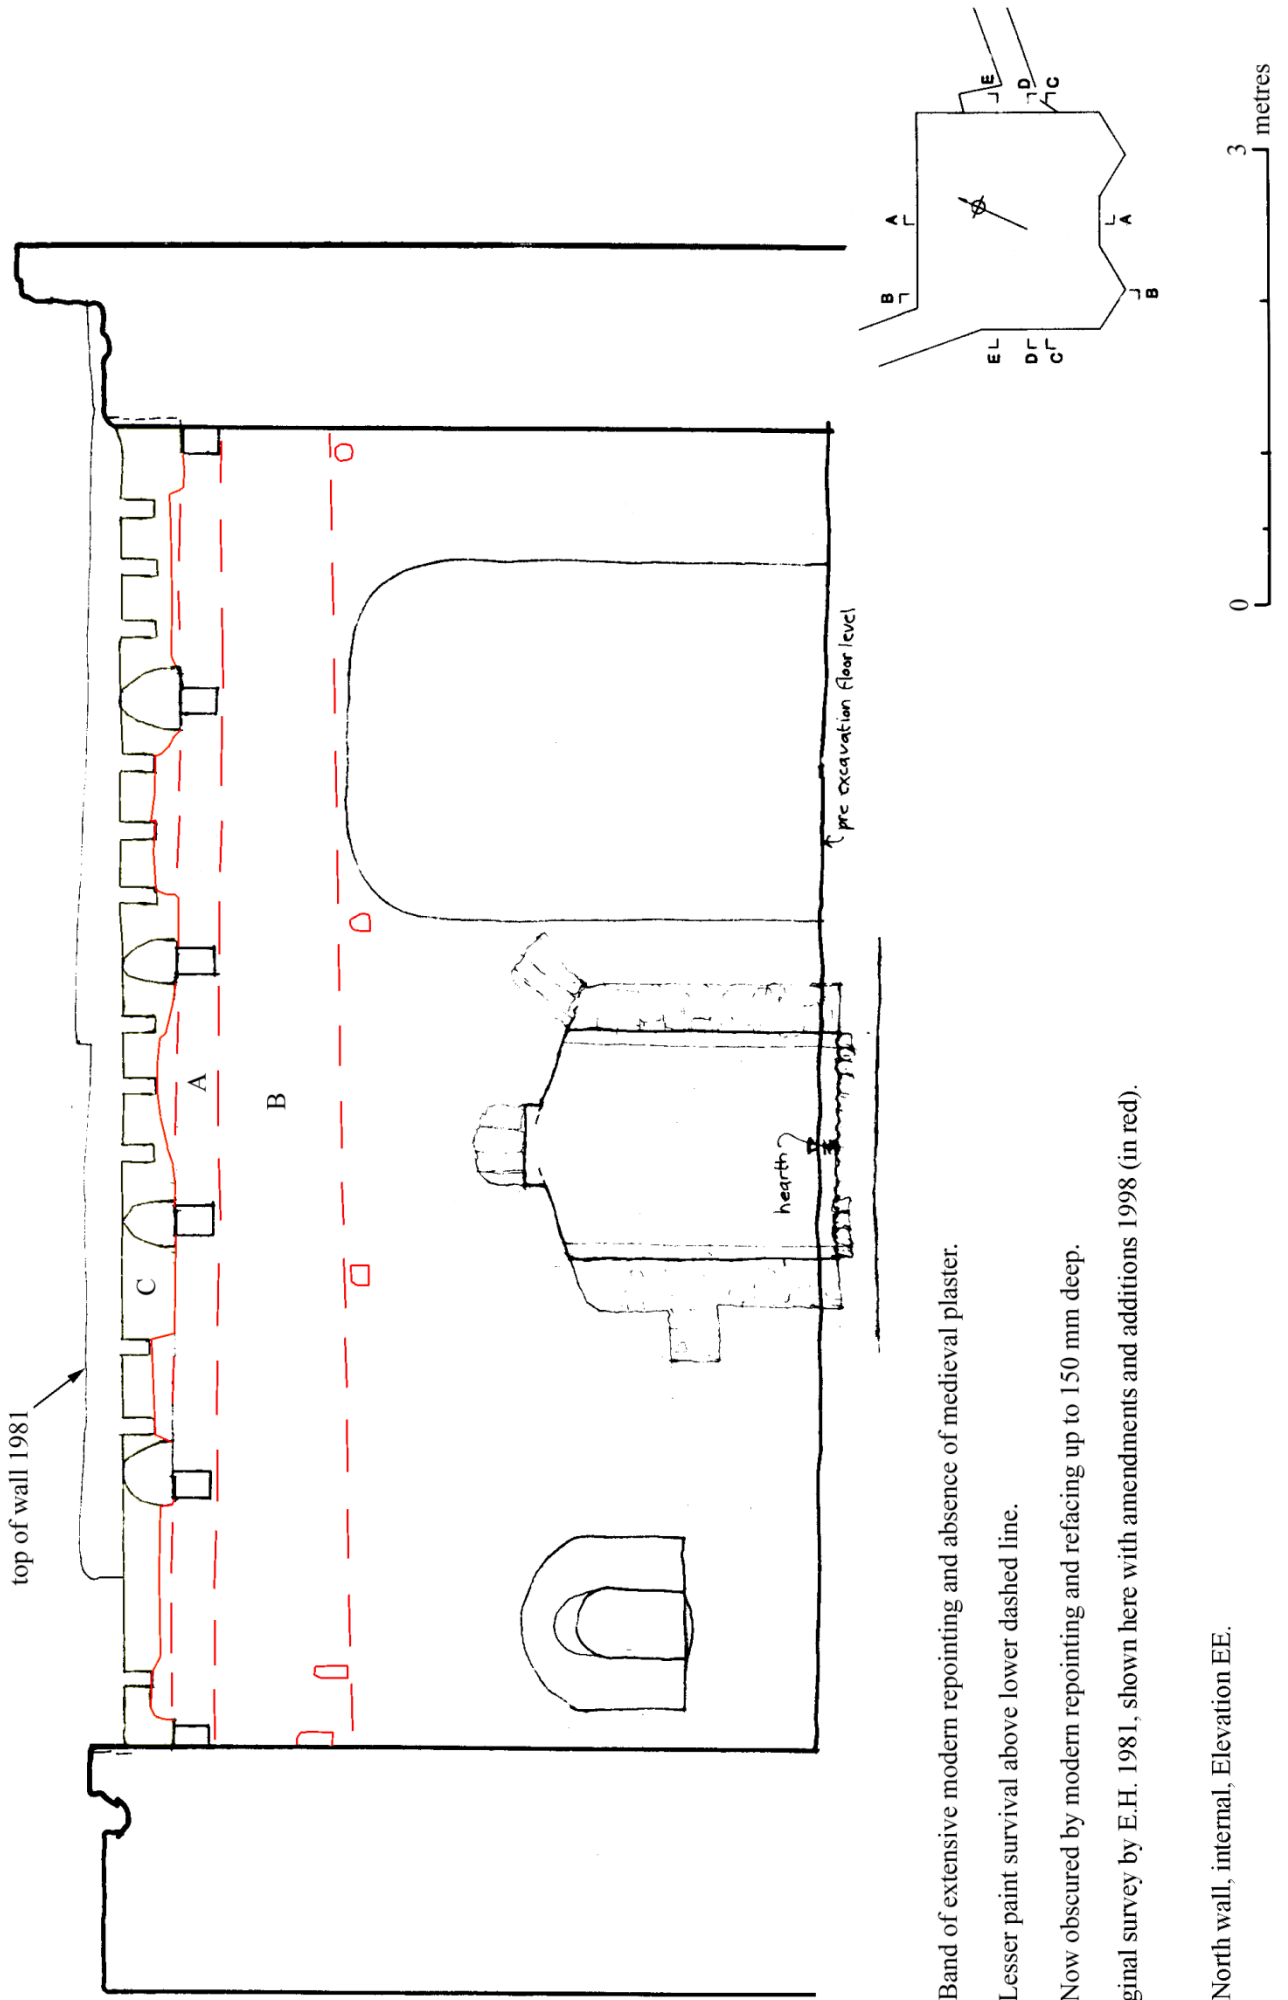
Fig 7 North wall, internal, Elevation EE.

Between the corbels in the north wall there is a band or zone of extensive modern repointing, but no equivalent chase to that surveyed on the south (sufficient medieval masonry facing is visible amongst the modern repointing to show that no hollow chase ever existed here). Within this zone, there is no medieval plaster, although areas of well-preserved plaster survive both immediately below and above. There seems to have been some kind of horizontal linear feature on the surface of the wall, extending between the corbels at the same level as the chase opposite, but not recessed into the wall.

A row of five secondary sockets survives in the north wall of the first-floor chamber, set on average 0.9m below the level of the stone corbels. Immediately above the level of the sockets, there is a distinct line on the wall above which less red paint survives than below. The sockets may have been associated with an inserted ceiling of 16th- or 17th-century date, but the presence of only one corresponding socket in the south wall, at its west end, is puzzling, suggesting that either such sockets have been carefully infilled so that they are no longer detectable, or that the later ceiling was supported in some other manner (or possibly did not extend across the full width of the room).

- A. Band of extensive modern repointing and absence of medieval plaster.
- B. Lesser paint survival above lower dashed line.
- C. Now obscured by modern repointing and refacing up to 150 mm deep.

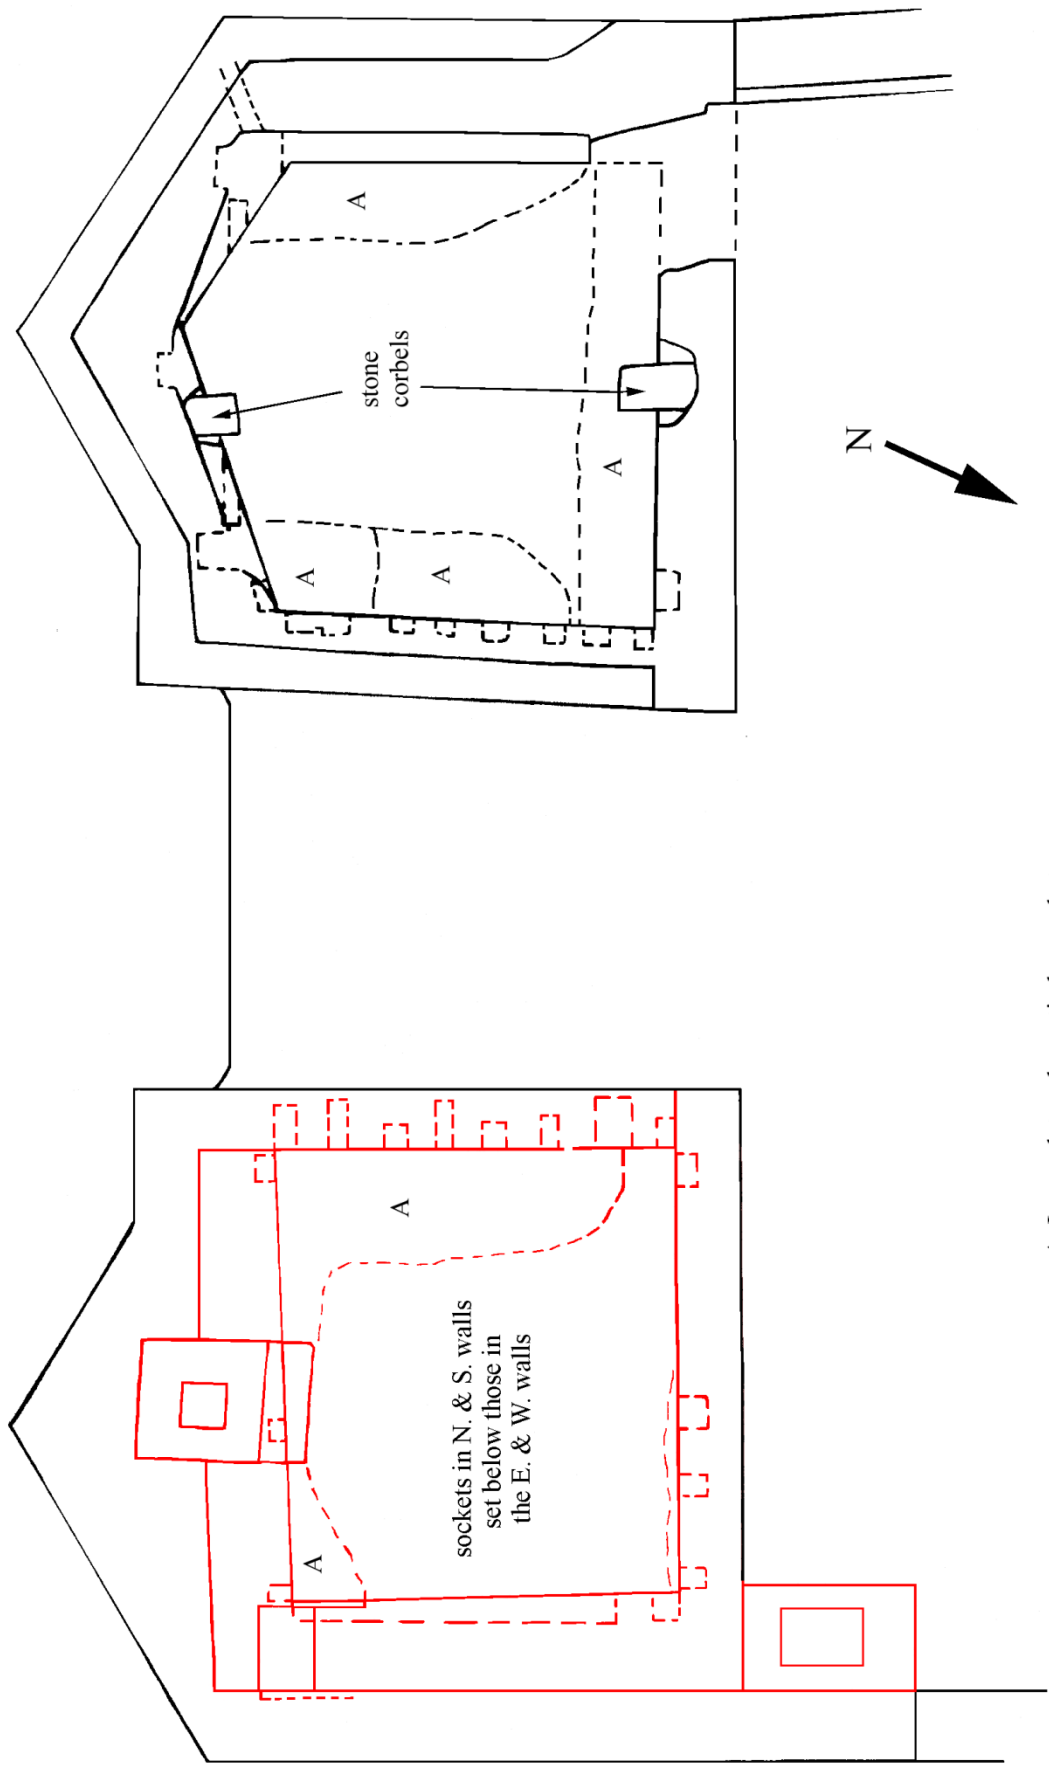
Fig. 8 Roof plan of gatehouse towers.

The turret roofs appear to have been built up in the following manner. First a series of closely-set square timber joists were laid E-W. These were decked over with boards (the board ends have left wide narrow sockets immediately above the larger square ones). Large slate slabs on average 0.1m thick were then laid on the decking. More masonry was then built up on the slate slabs, incorporating large reinforcing timbers laid N-S, with a second layer of slate slabs 0.1m thick above this. These latter large timbers, which left sockets in the masonry of the south wall, may not have extended the full width of the turret to the north wall, since the overall depth of roof capping was considerably thinner on this side (0.25m compared to 0.6m on the south side), probably too thin to have accommodated them. The uppermost slate slabs are set at a shallow angle sloping down toward the north (8cms drop in a metre). Above roof level, remnants of the original parapet walls survive, showing that these were 0.4m-0.48m thick, the same as the ones built in 1982.

Secondary ceilings were inserted just below the original ones in both turrets. In the east turret three square timbers approximately 0.12m square were inserted from north to south. In the west turret a large ceiling beam was inserted from north to south at a slight angle across the room. The beam was supported by projecting stone corbels, one at either end, both of which were clearly inserted at a later date since they show evidence of packing around them. A small square timber similar to those in the east turret was inserted on the east side of the room, and another may possibly have existed on the west, although no evidence for such a timber now survives.

The new ceiling timbers were probably needed to strengthen failing timbers of the original ceiling, since the weight of the slate and masonry capping above must have been considerable. Whether the new ceilings were makeshift in appearance, or made to resemble ceilings elsewhere in the 16th- and 17th-century house, perhaps by plastering them over, it is now impossible to know.

A. Large slates above timber sockets.

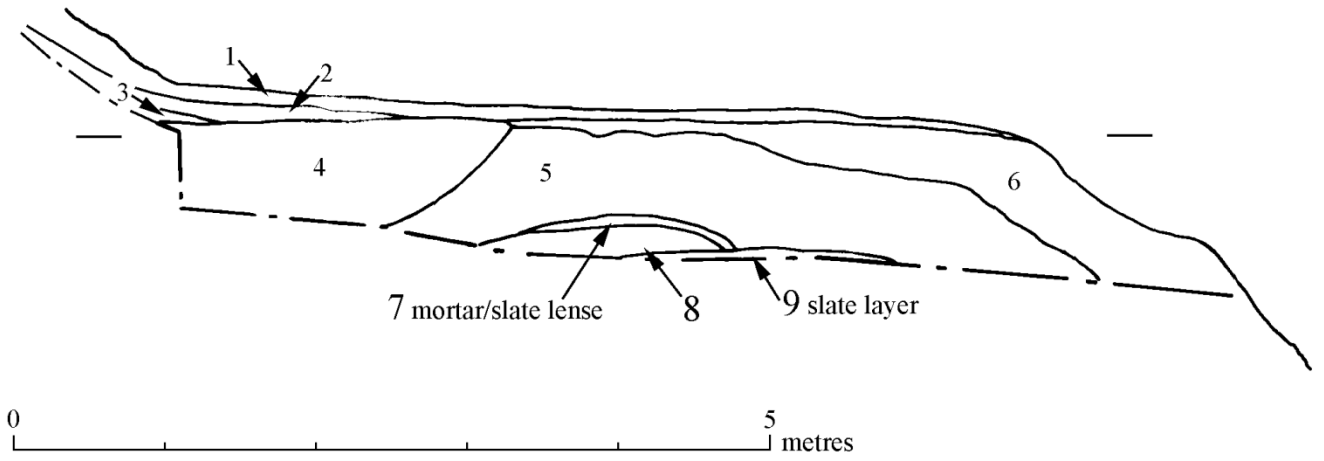
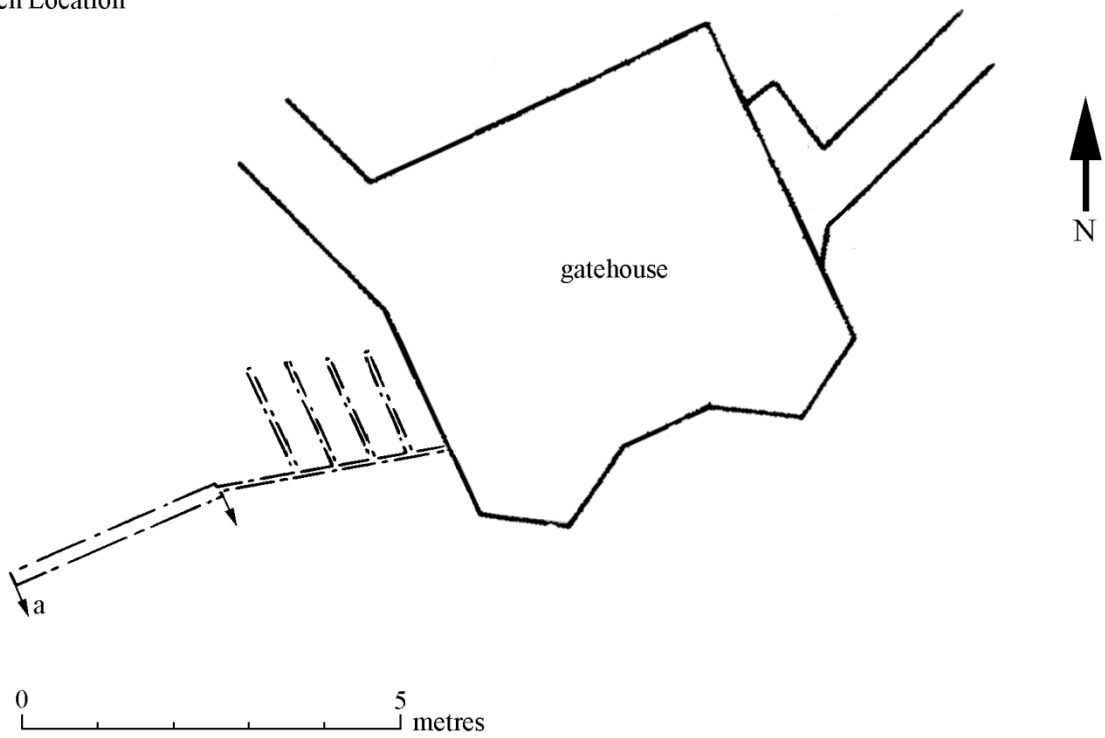
Fig 9 Section a looking south and its location.

A section drawing was made of the 1m deep trench stratigraphy (Fig. 9, section a); the other shallower trenches revealed only topsoil on average 0.2m deep and the uppermost levels of rampart construction material, comprising clay and limestone rubble (n.i.).

Nowhere did the trench excavation uncover natural geological deposits, so the observed stratigraphy relates only to the uppermost levels of some of the archaeological features and layers in this area. Contexts 1, 2, and 6 all produced modern finds including plastic and asbestos, and can be disregarded. The remaining deposits appear to be associated with two features: a 4.5m wide earth bank (contexts 5, 7-9); and an infilled ditch, a little over 2m wide (fill - context 4). The ditch fill produced 6 fragments of late medieval/early post-medieval ridge tile and two pottery finds: a sherd from a late medieval/ early 16th-century striped jug; and a fragment of local green-glazed ware with white fabric dating from the 17th century, ie dating for the group is 17th century.

The bank was raised on the lip of a natural slope leading westwards below the castle. It may possibly have formed part of the castle defences on this side. The ditch was infilled mostly with demolition debris, including fragments of roofing tile. The ditch appears to have been cut into the back of the bank and may therefore be later in date rather than contemporary. The ditch is likely to have drained water into the nearby defensive ditch protecting the front of the castle, but whether such a narrow feature was ever intended to form and integral part of the defences is questionable. A more full interpretation of the stratigraphy existing in this part of the site may be possible in the future if excavation reveals its complete depth to bedrock.

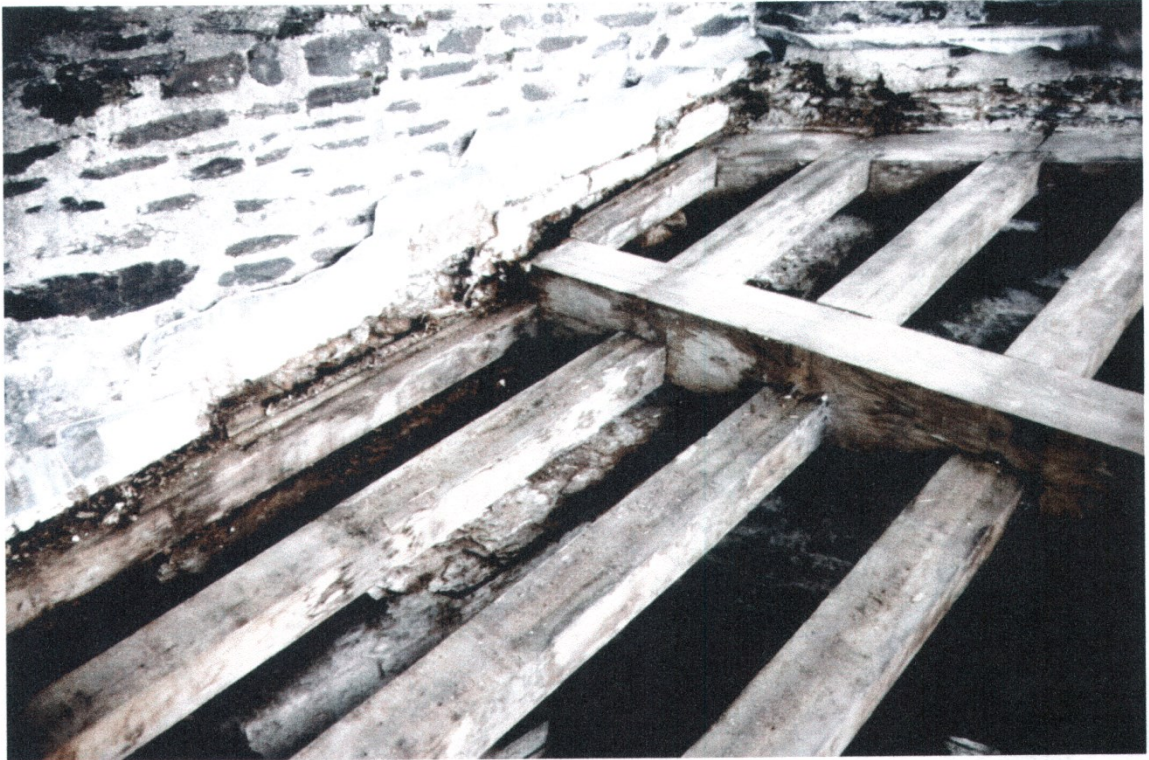
Plate 1 The roof joists of the western tower showing rot.

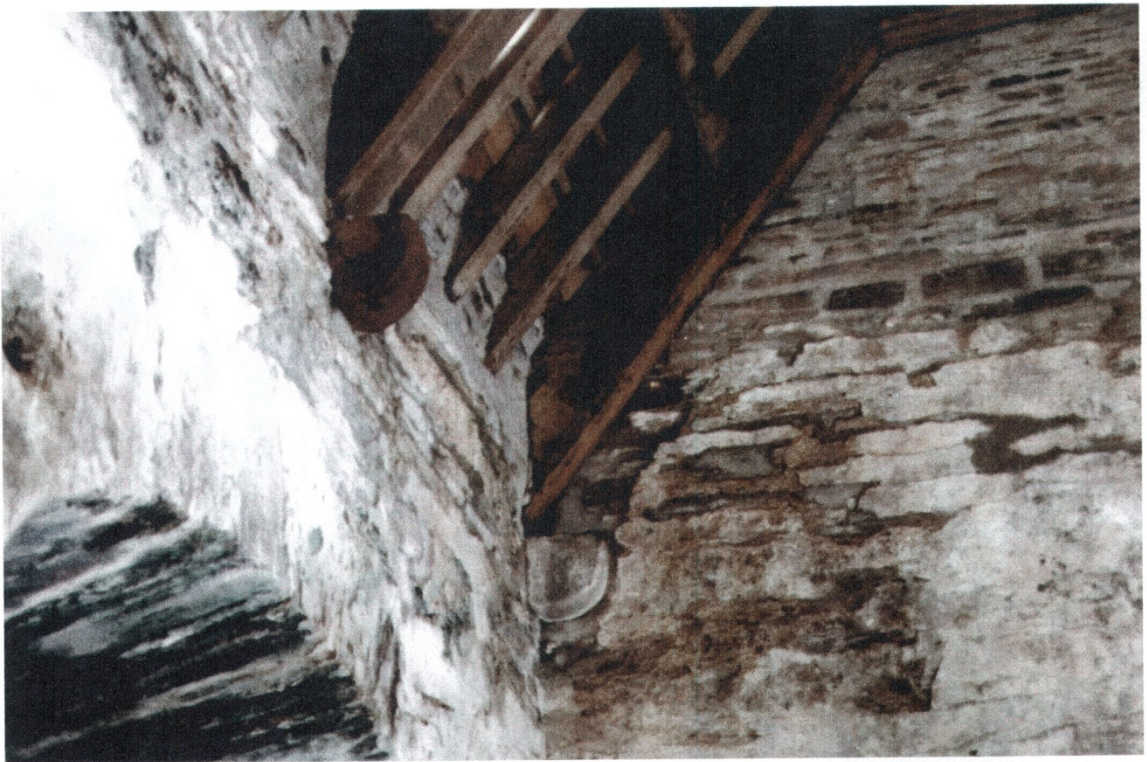
Plate 2 The west wall of the chapel showing a scar above the corbel for an arched brace.
